LIFE CONSIDERATIONS OF THE SHUTTLE ORBITER DENSIFIED-TILE  
THERMAL PROTECTION SYSTEM

Paul A. Cooper and James Wayne Sawyer  
NASA Langley Research Center  
Hampton, Virginia

SUMMARY

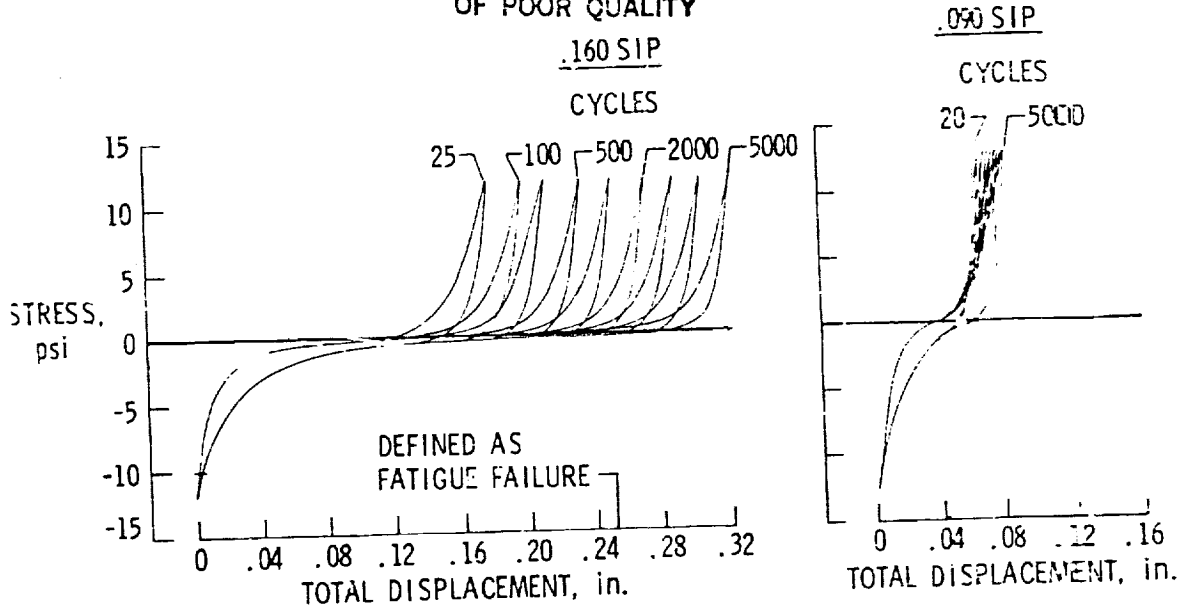
Figure 5.- SIP extension under fatigue loading.

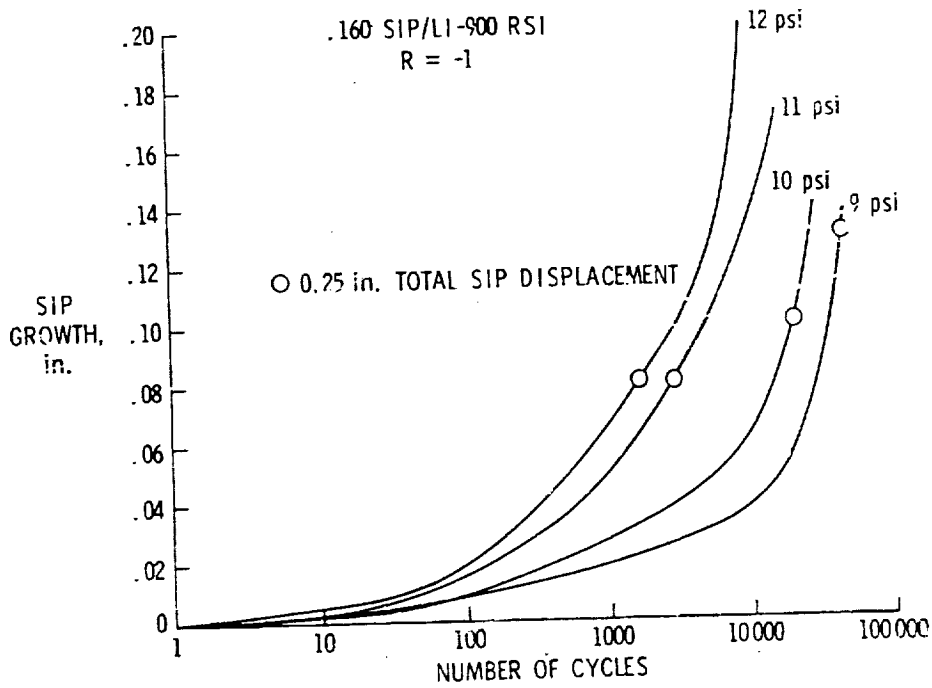
Figure 6 shows the measured growth of the 0.160 SIP during the fatigue test for various applied stress levels and indicates the number of cycles at which total displacement is equal to the assumed failure criteria of 0.25 in. As the number of cycles increases, the SIP transverse fibers continue to stretch and unravel resulting in an increase in total specimen travel and a continual loosening of the tile. The growth rate increases nearly exponentially as the growth increases.

Figure 6.- Measured growth of SIP displacement under sinusoidal fatigue loading.

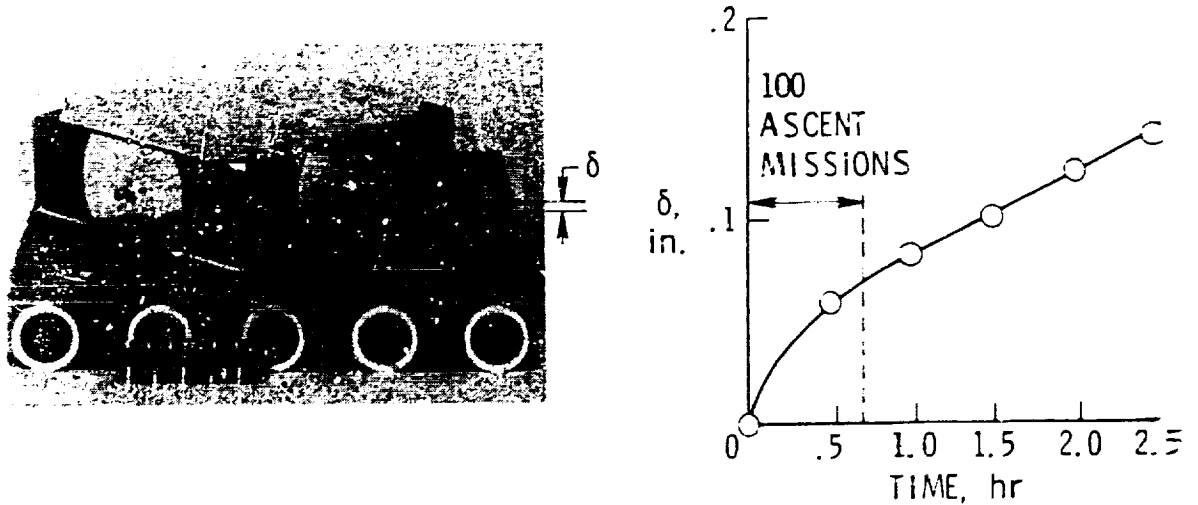
Figure 12 contains a picture of the tile after completion of the dynamic load test and before the final test-to-failure. The top plate shown in the figure replaces the load attachment disk used during the dynamic test so that the larger tensile loads required to fail the system can be applied. The figure also contains a plot of the development of permanent growth of the SIP at the highest stressed corner as the dynamic test progressed. By the conclusion of the test, the SIP had a permanent extension at this corner equal to the initial thickness of the SIP (i.e., 100-percent increase in thickness). Figure 13 presents a comparison of the applied stress vs. displacement measured during the 15-psi static uniform load tests

Figure 12.- Permanent growth of SIP subjected to random dynamic loads.

performed before and after the dynamic test. The peak-to-peak measurement of 0.052 in. is an indication of the degree to which the SIP has loosened. The tile failed during the final test-to-failure in the parent undensified region at an ultimate static load of 422 lb. This failure load was 70 percent greater than the original bond verification load.

Results of the random dynamic load test shown in Figure 12 indicate that a permanent SIP extension of 0.034 in. would occur under the simulated loads well before the 100-mission flight desired lifetime has been completed. One could conservatively estimate that this extension coupled with the increased loosening of the SIP shown in Figure 13 would cause a step of the order of 0.04 in. assuming the neighboring tile was under compression or at least remained unextended. Thus, if the assumed load simulation used in the random dynamic load tests is realistic and the thermal predictions of reference 6 are an accurate evaluation of actual conditions, increased incidence of burned filler bar can be expected during the lifetime of the orbiter.

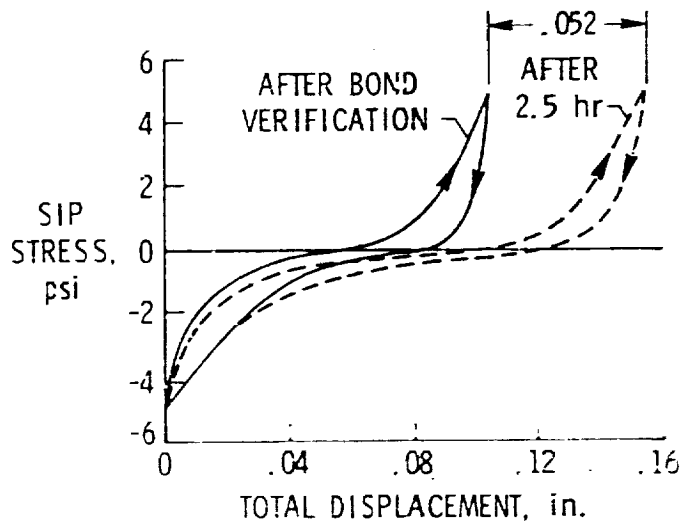
Figure 13.- Loosening of TPS due to multimission random dynamic loading.

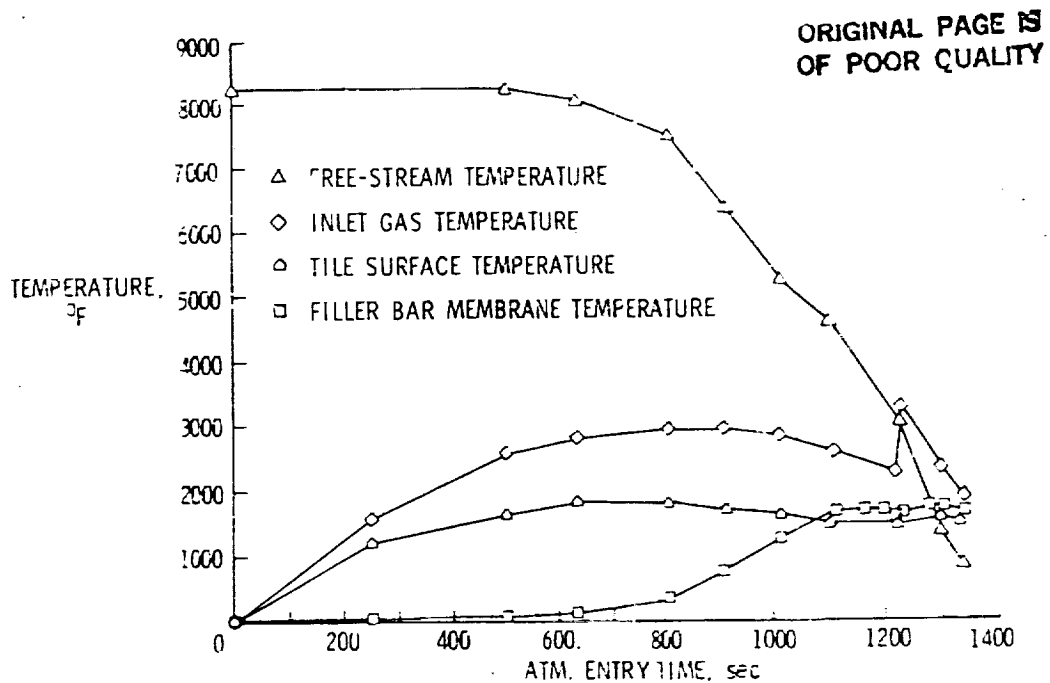
heating observed in the tile-to-tile gaps of the orbiter. A flow model was developed in the referenced study to determine the pressure loading and flow rates in the gap during entry. A thermal model of adjacent tiles, the tile-to-tile gap and step, filler bar, and SIP was used to predict temperature distributions throughout the system. Tests have shown that temperatures greater than 1375°F will cause charring of the RTV and filler bar to a degree which requires replacement of the filler bar. The computed temperature distributions at a wing location where a 0.05 in. step is assumed are shown for various locations in a gap in Figure 14. The peak filler bar temperature calculated for the assumed step is 1750°F. A similar study for a 0.03-in. step yields a maximum filler bar temperature of 1290°F. Thus, from a linear interpolation between these two conditions, the critical temperature for filler bar burning is reached under the flow conditions of the study when a step between tiles of 0.034 in. exists.

Figure 14.- Calculated temperature of tile and filler bar at wing location during reentry, Step = 0.06 in., ref. 6.

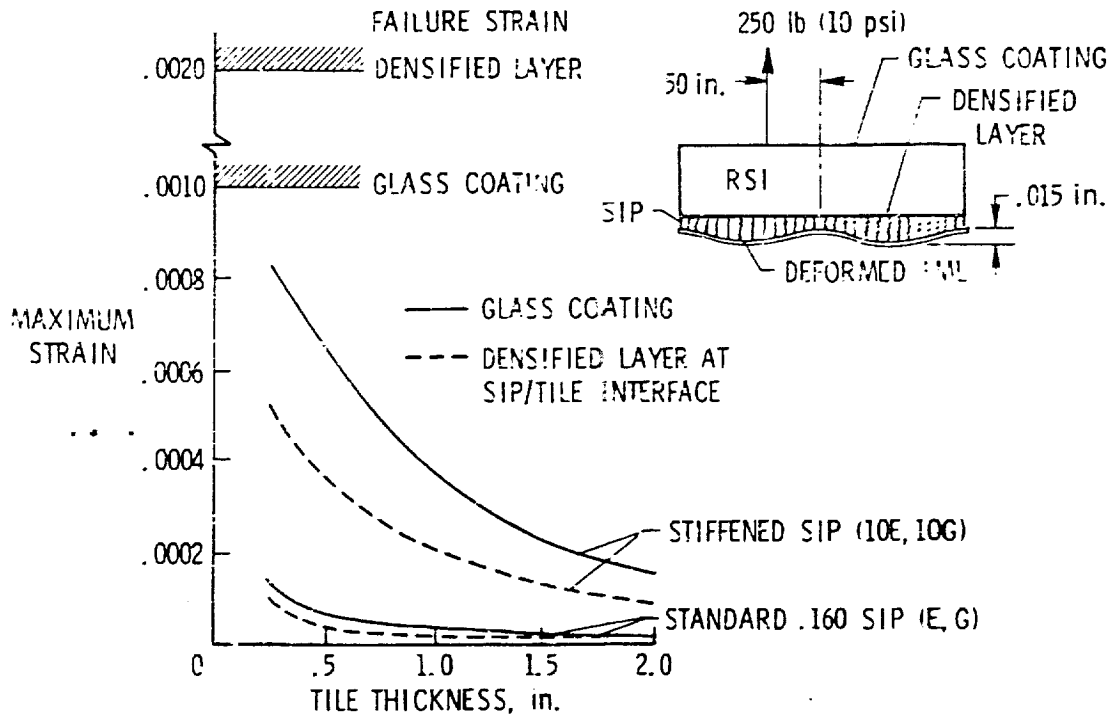
Using the analysis and the experimentally determined modulus of the densified region, a study was made of the maximum inplane strains in densified tiles of various thicknesses ranging from 0.25 in. to 2.0 in. The tiles were subjected to an inplane substructure strain equal to the yield strain of the aluminum plus the unconstrained thermal strain caused by a rise in substructure temperature of 280°F. In addition, the tiles were subjected to a tensile load of 250 lb offset from the tile center by 0.5 in. This combined load condition is greater than any actual condition expected on the orbiter tiles. Results of the study for a standard 0.160 SIP and a SIP with ten times the stiffness of the standard SIP are shown in Figure 15. Only for the thinnest tiles does the maximum strain in the densified region and the top coating approach the inplane failure strain. Thus, a considerable increase in SIP stiffness can be tolerated without compromising the inplane integrity of the tiles. A 0.090 SIP has approximately three times the stiffness of 0.160 SIP. This is well within the acceptable stiffness range to function properly as an isolator of inplane strains.

Figure 15.- Effect of SIP stiffness on tile inplane strains for a range of tile thicknesses.
