### POSTBUCKLING RESPONSE OF GRAPHITE-EPOXY PLATES LOADED IN COMPRESSION

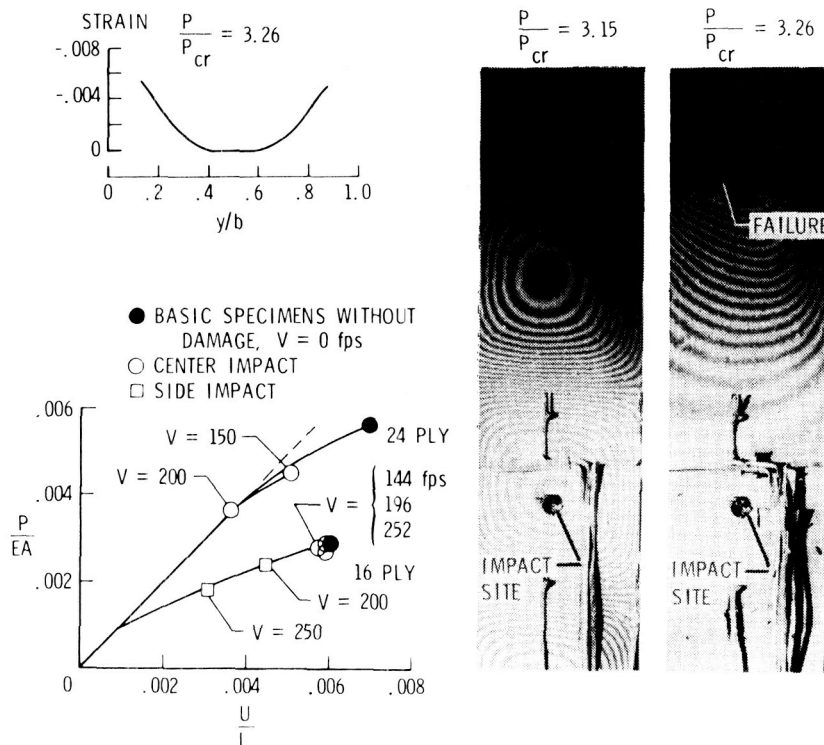
Figure 4

The effects of low-speed impact damage on the postbuckling behavior of flat T300/5208 graphite-epoxy plates similar to those described in Figure 1 were studied in reference 1 and some typical results are shown below in Figure 4. Specimens were impacted with 0.5-inch-diameter aluminum balls at various impact speeds  $V$  and then tested to failure. Measured end shortening results  $U$  for typical 16- and 24-ply quasi-isotropic specimens are shown in the lower left figure as a function of the applied load  $P$ . End shortening is normalized by the plate length  $L$  and the applied load is normalized by the plate longitudinal modulus  $E$  and cross-sectional area  $A$ . The filled circles represent failure of specimens without impact damage and the open symbols represent failure of specimens with impact damage. The open circles represent failure of specimens impacted in the center and the open squares represent failure of 16-ply specimens impacted near a specimen side. The results indicate that impact damage in the center of the 16-ply specimens had little effect on postbuckling strength regardless of the impact speed. The left photograph shows the moire-fringe pattern corresponding to the out-of-plane deformations of a 16-ply specimen loaded to approximately three times the buckling load and the right photograph shows the moire-fringe pattern corresponding to the failed specimen. Failure occurred along a buckling-mode nodal line away from the impact site. The membrane strain distribution across the specimen just before failure is indicated in the upper left figure. Apparently, the strain in the center of a 16-ply specimen is not high enough to cause the impact damage to propagate to fail the specimen. The results also indicate that impact damage in the center of the 24-ply specimens and at the sides of the 16-ply specimens decreases postbuckling strength as impact speed increases. Apparently, the strains at these impact sites are high enough to cause the impact damage to propagate to fail the specimens.

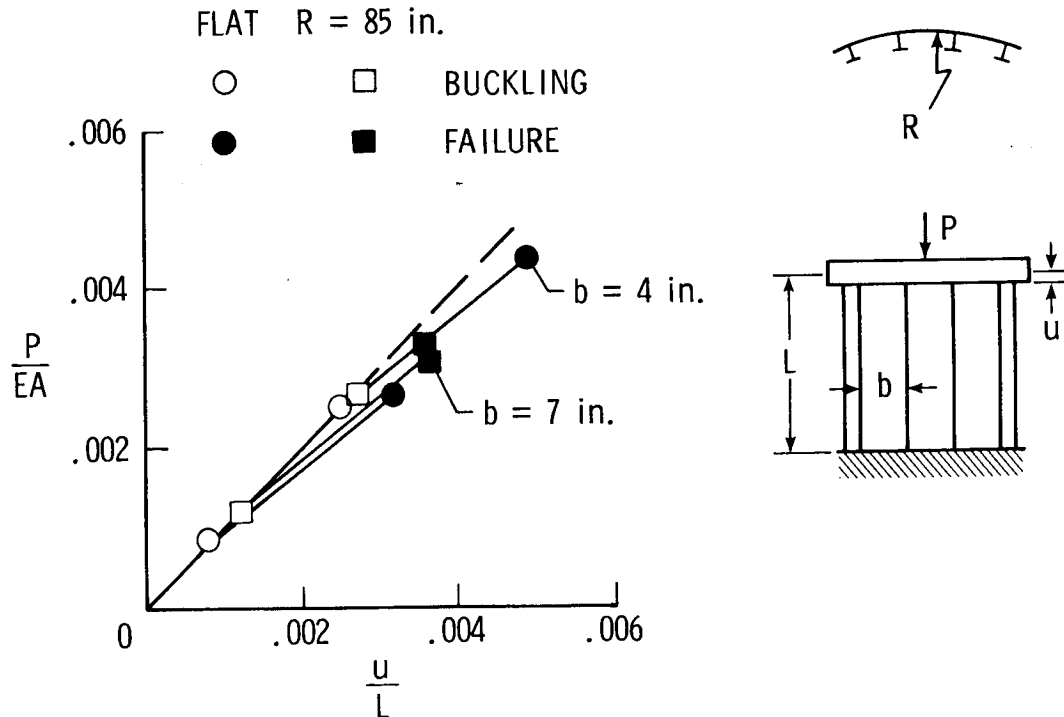
Figure 12

Curved graphite-epoxy stiffened panels were loaded to failure in compression to study their postbuckling behavior. The panels were made from T300/5208 graphite-epoxy tape and had an 85 inch radius. The panels had the same 16-ply-skin and stiffener designs as the flat panels described in Figure 5 and had a 4.0- or 7.0-inch stiffener spacing. The results of the tests of these panels are shown in Figure 12. End shortening results  $u$  (normalized by panel length  $L$ ) are shown as a function of the applied load  $P$  (normalized by the panel longitudinal modulus  $E$  and cross-sectional area  $A$ ). The results for the corresponding flat specimens from Figure 5 are shown for comparison. The square symbols represent the curved panel results and the circles represent the flat panels. The open symbols represent buckling and the filled symbols represent failure. As expected, buckling loads for both curved panels are higher than for the corresponding flat panels. However, the flat panel with 4.0-inch stiffener spacing failed at a higher load than the corresponding curved panel, and the curved panel with the 7.0-inch stiffener spacing failed at a higher load than the corresponding flat panel. Additional testing and analyses are currently being conducted to resolve this apparent anomaly.

16-PLY SKINS

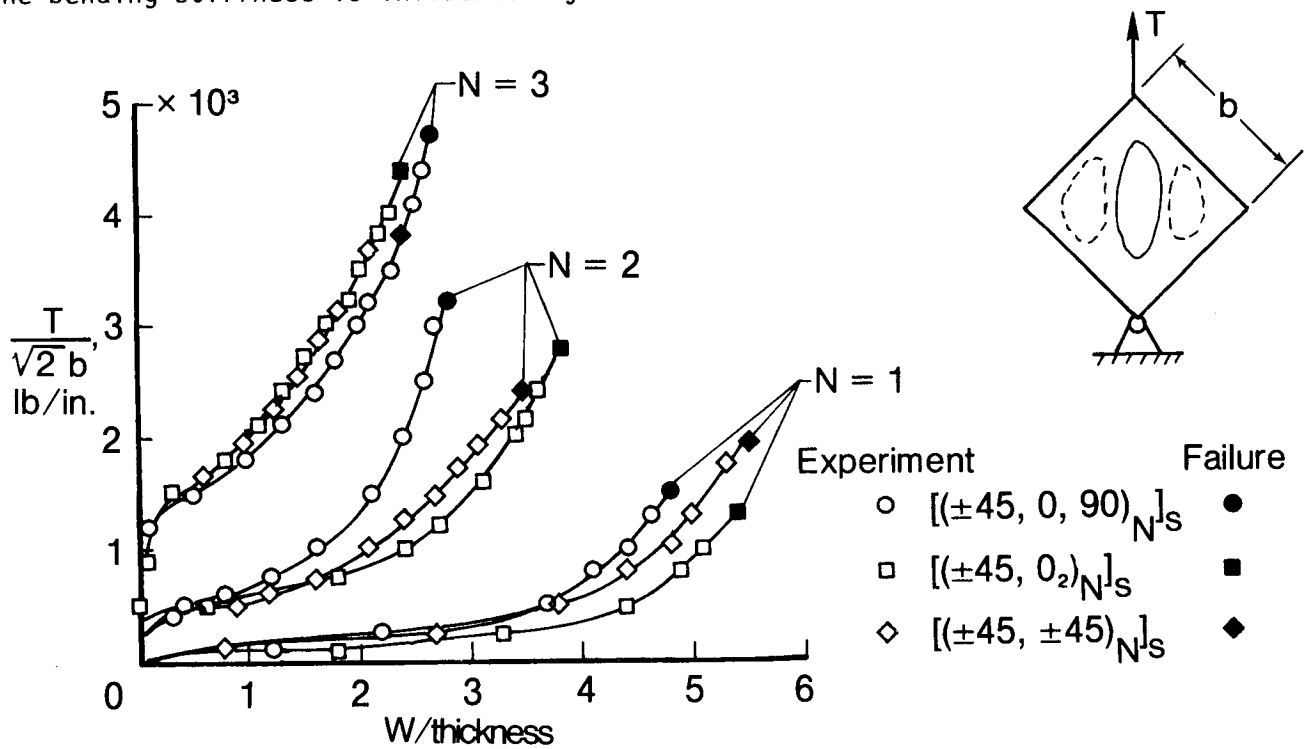
Out-of-plane deflections measured near a point of maximum buckling-mode amplitude are shown in Figure 14 for the 8-, 16-, and 24-ply webs described in Figure 13. The applied shear flow ( $T/\sqrt{2}b$ ) is plotted on the vertical axis and the out-of-plane deflection  $w$  normalized by the web thickness is plotted on the horizontal axis. The symbols represent test data for the various laminates defined in the figure. The filled symbols indicate failure. The 8-ply webs had maximum out-of-plane deflections at failure of over five times the thickness. There was significant reduction in the maximum deflection when the thickness of the specimen was increased from 8 plies to 16 plies and a further reduction when the thickness was increased to 24 plies. The results shown in the figure indicate that a significant amount of bending can occur when a graphite-epoxy shear web is loaded into the postbuckling range and the bending stiffness is influenced by the thickness.

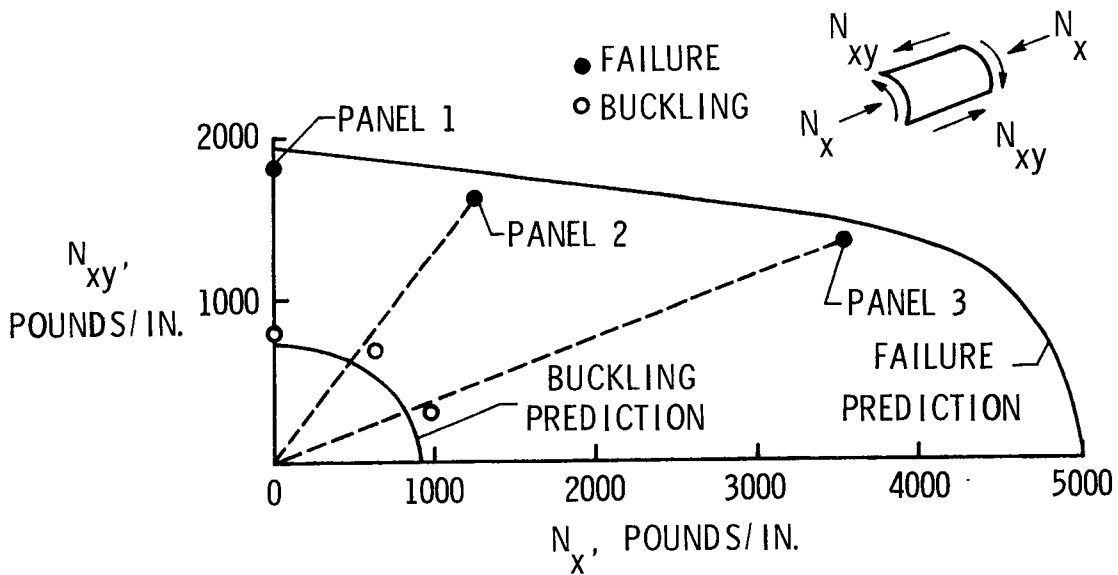
Figure 18

The results of the shear and combined shear and compression tests of the panels described in Figure 17 are shown in Figure 18. Three panels were tested to failure. The first panel was loaded in shear only, the second panel was loaded with approximately equal magnitudes of shear and compression stress resultants and the third panel was loaded with approximately three times as much compression as shear. The predicted buckling and failure interaction curves for shear  $N_{xy}$  and compression  $N_x$  loading are shown on the figure. The open circles on the figure represent the buckling data from the tests and the filled circles represent failure of the specimens.
