Development of an Extra-vehicular (EVA) Infrared (IR) Camera Inspection System

This paper discusses the on-orbit RCC inspection measurement concept and requirements, and then presents a detailed description of the EVA IR Camera System design.

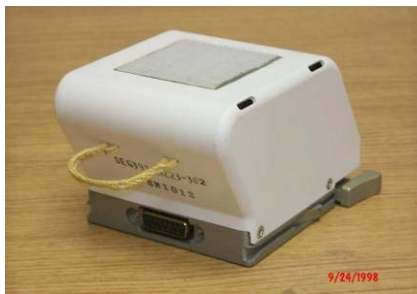
Figure 2. EHIP Battery

Space flight qualification for batteries is a complex and time consuming exercise. Therefore, we decided to look for a pre-qualified battery to use in the camera. We found that the EHIP battery (figure 2) was the right form factor and had the right amount of energy storage. This is the battery used to power the headlights on the space suit helmets. The camera housing was adapted to accept the EHIP battery. The DC-DC converters were designed to convert the batteries 6 volts to 12 volts for camera use. A battery voltage monitor was designed to alert the astronauts when approximately 75% of the battery charge is depleted.

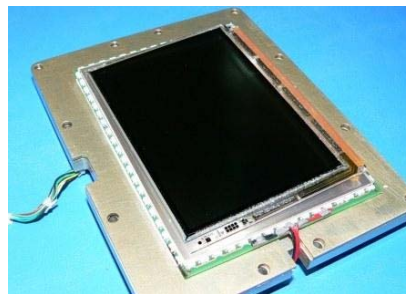
Figure 3. LED backlight replacing Fluorescent tube

During the vacuum testing it was discovered that the high voltage used for the cold cathode fluorescence (CCF) backlighting was generating a corona. It was decided that LCD displays CCF would be replaced with an array of white LEDs (figure 3). These LEDs were brighter than the CCF and would accommodate daylight viewing as well as eliminate the high voltage issue.

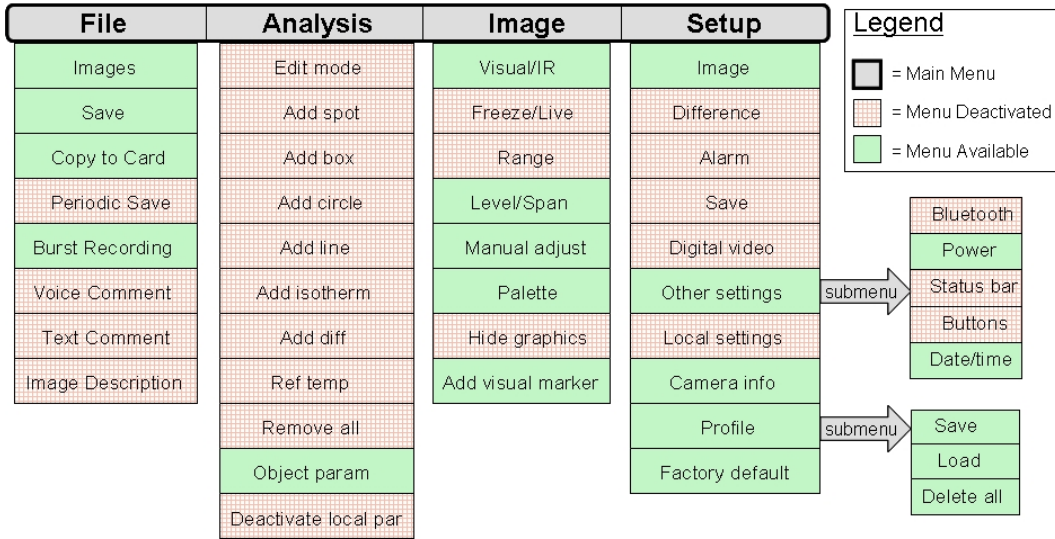
The system menu display (above) was simplified considerably to increase user efficiency. The above figure summarizes the results of this optimization.
