Nondestructive Evaluation of Foam Insulation for the External Tank Return to Flight

James L. Walker* and Joel D. Richter*
NASA/Marshall Space Flight Center, Huntsville, AL, 35812

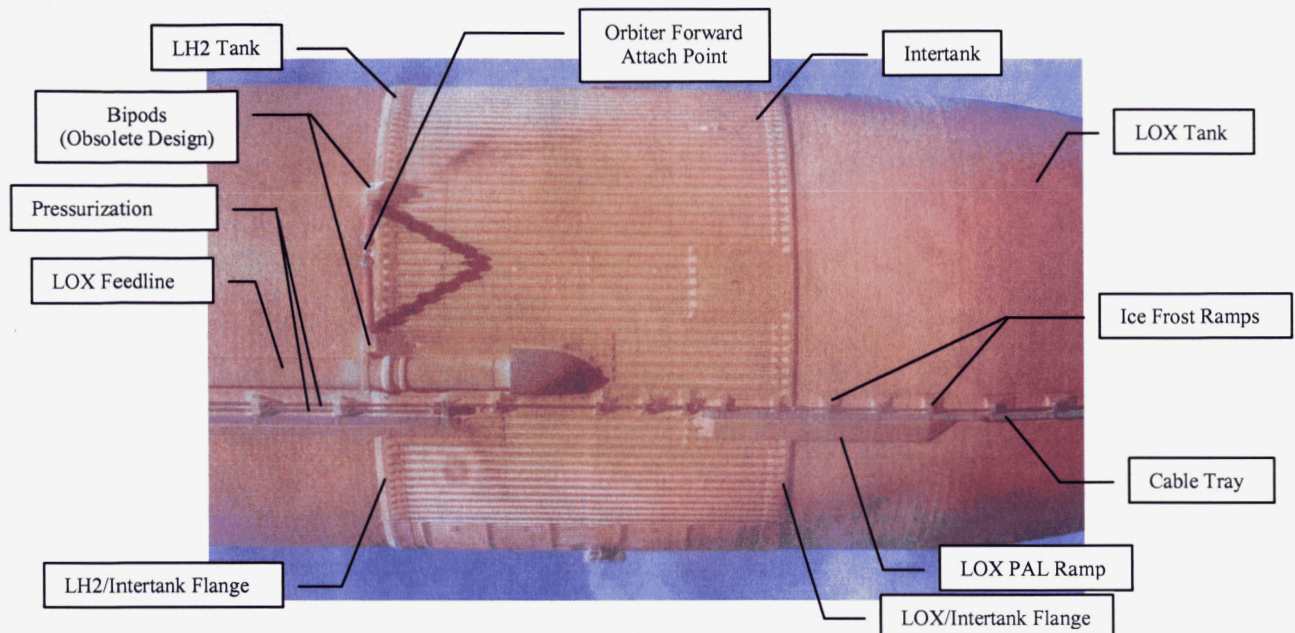
Figure 1. ET with Major Parts Labeled

a high debris generation region. To a lesser degree the flange between the intertank and the oxygen tank is also of concern. The bipod ramps, although redesigned to be much smaller than the ones that flew on Columbia's final mission, are still thicker than the surrounding acrage foam and an area of continued interest. The PAL ramps which help to shield the cable tray and pressurization lines are very thick, large pieces of foam that received a lot of attention during the RTF period because of their size. These ramps were eliminated after the Discovery, STS114, flight. Figure 1 shows a picture of a labeled ET following separation from the Orbiter.

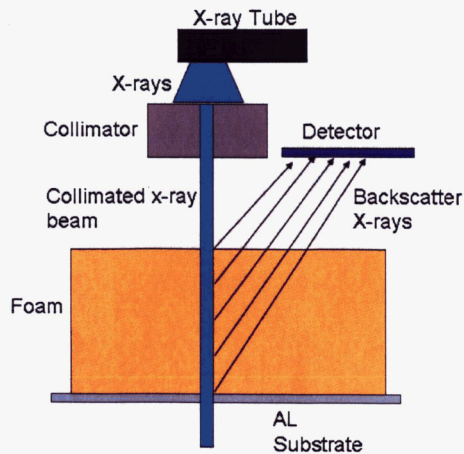
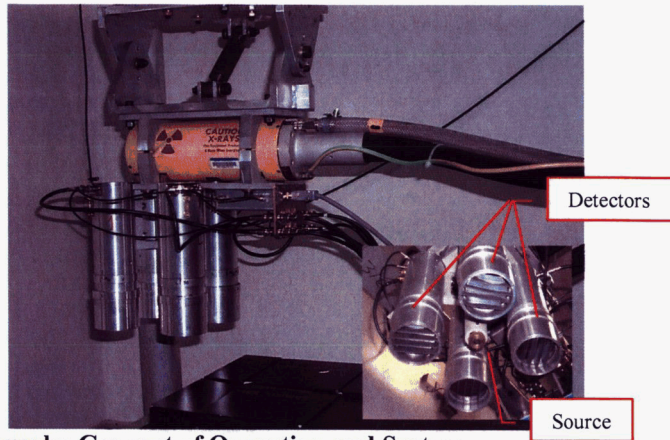
Figure 2. Backscatter Radiography Concept of Operation and System

Backscatter Radiography³ utilizes a collimated x-ray beam to illuminate the test article at a specific location while detectors mounted around the source measure photons scattered back from the test article, primarily via Compton scattering. This approach allows for a single sided radiographic type inspection. It also performs well on materials with low atomic numbers, such as SOFI, because the amount of Compton scattering is a function of the atomic number. Figure 2 shows a diagram and picture of the backscatter x-ray system.

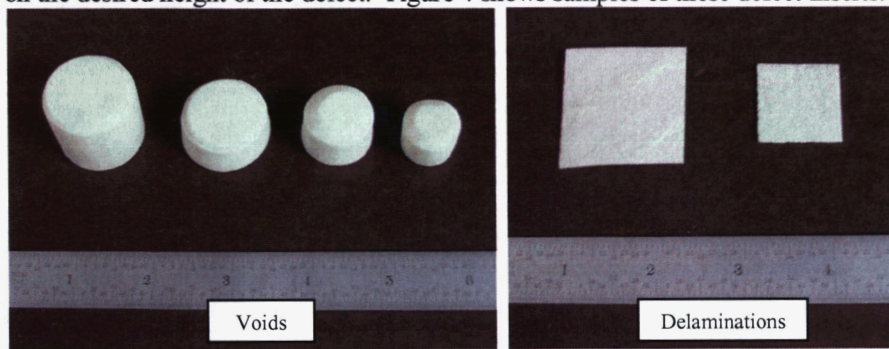
Figure 4. Artificial Defects Used for POD Test

Once the selection was made, contracts were initiated with the vendors to build "factory floor" hardened models and incorporate some advances made since the systems used for the down selection were built. When these models were received, a short set of experiments was performed to optimize the settings and then a Probability of Detection (POD) test was run. Based on the then current understanding of foam failure, artificial defect creation and foam inspection, the decision was made to use thin walled cylinders of cured foam for voids and thin sheets of cured foam for delaminations. Testing by way of cross sectioning through the sprayed over defect inserts showed that the SOFI inserts would blend in with the SOFI sprayed over them leaving a void for the hollowed out cylindrical inserts or a delamination under the thin wafer insert. These inserts were either glued to the substrate or inserted between spray passes depending on the desired height of the defect. Figure 4 shows samples of these defect inserts.

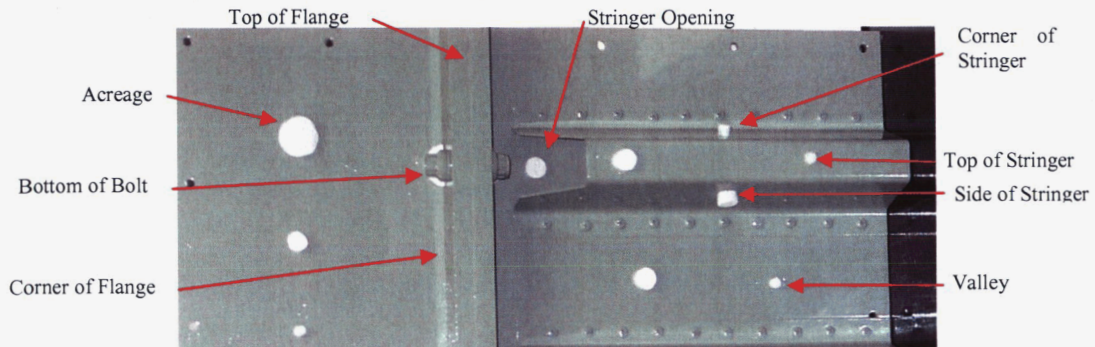
Figure 5. POD Panel Before Spray with Artificial Defects Applied

The POD was designed using a 29 out of 29 statistical logic to obtain the required 90% detection capability with 95% confidence for a single defect size. The test was run with voids of three different diameters, starting at the targeted 1" diameter cylinder then going smaller in two steps down to a 0.5" cylinder. Delaminations were not considered to be critical, but to determine basic NDE capability they were inserted in the test panels to provide a feel for their detection limits. Based on preliminary development testing it was determined that there was an effect of substrate geometry on detection capability. Certain geometries could mask a defect. To cover all the geometric variations, each of these defect sizes was placed in one of nine different locations. These areas, shown in Figure 5, were on and around the intertank stiffeners, on and around the flange and out in the flat acreage area of the tank. In addition to the previously mentioned variables, all the testing was run with two different foam thicknesses to determine detectability in both thick and thin foam simulating the PAL ramp and the hydrogen tank to intertank flange. With the exception of a small subset to test depth dependence, all defects were placed directly on the substrate. In order to accommodate all these variables, nearly 2000 defects were placed on 75 test panels. To gain an understanding of inspection repeatability and the dependence of results on the interpreter, the POD inspections were performed by four operators for each method and the data was analyzed by four different interpreters for each method.

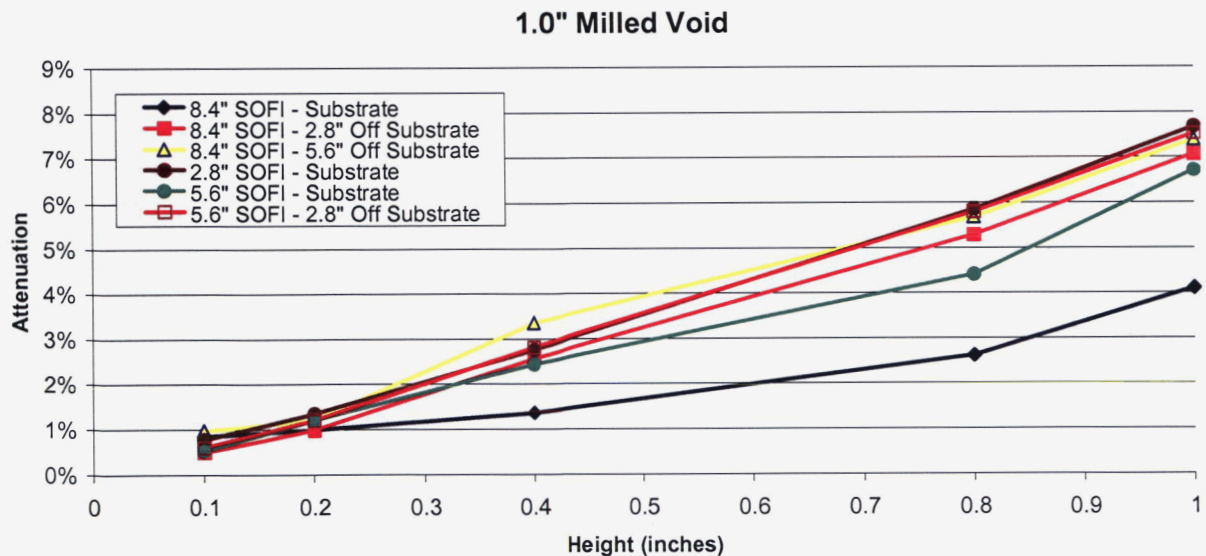
Figure 6. The Effect of Void Height on Defect Detection (Backscatter Radiography)

As a result of the POD work two studies were initiated to further define the capability of the two NDE methods. First, a study into detection of naturally occurring voids was initiated. Here, panels were sprayed with the intent of creating voids. The panels were then inspected with both methods and then dissected to determine the true defect count. The results showed that the threshold for detection was around the 1" level. The other factor which came out of the POD test was that the methods had a threshold of detection based on defect height. In order to quantify what that height was a series of test blocks with progressively shallower flat bottom holes were inspected. These blocks were stacked so that the effect of void depth versus height and diameter could be determined. As expected, the results showed that as defect height decreased so did signal strength. The detection threshold for a 1" diameter milled defect was found to be approximately 0.2". This confirmed the POD results that delaminations would be very difficult to detect with either method. A sample showing this trend for 1.0" voids under various levels of SOFI is given in Figure 6.

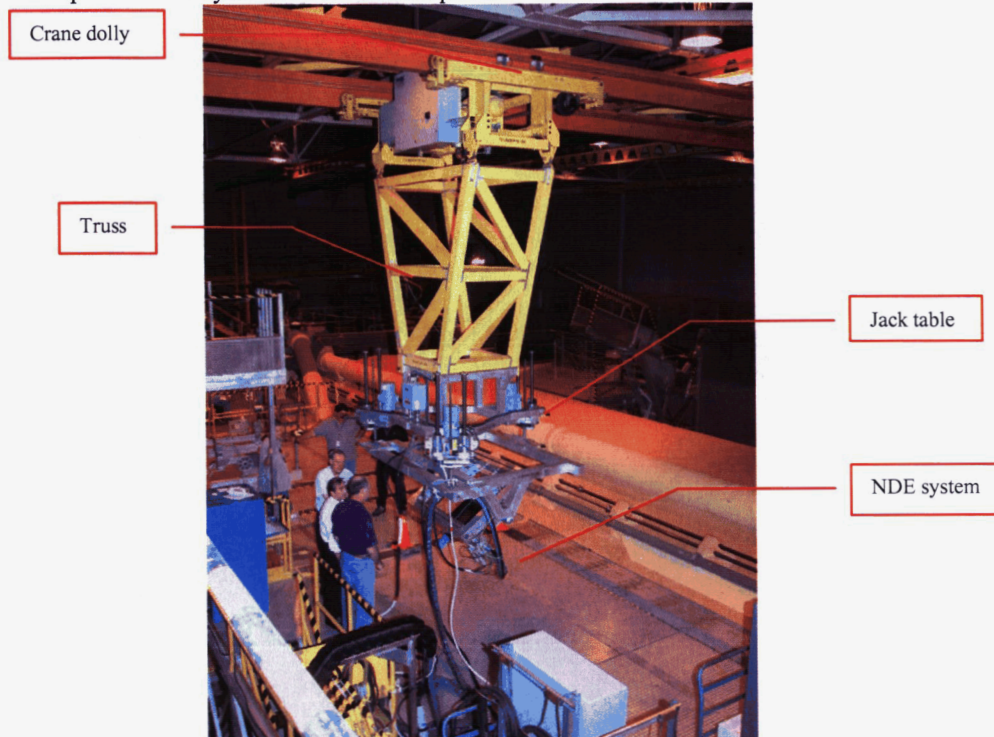
Figure 7. Tooling Access to the ET

During the time the POD study was conducted, tooling was fabricated to suspend the backscatter x-ray and terahertz imaging systems over the ET. The tooling made use of an overhead crane dolly to provide course axial and lateral motion over the tank, positioning the NDE scanning tables over the region of interest. A truss was mounted to the crane to get the scanning table to a fixed nominal height away from the tank. A three legged jack table was mounted from the truss that allowed the scanning table to be gimbaled. The jack table could then raise, lower and tilt the scan table to position the systems in the correct plane.

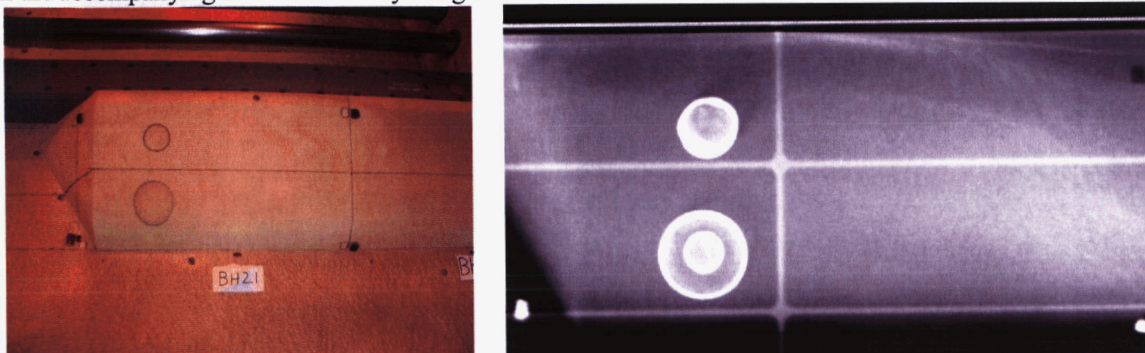
Figure 8. Typical Scan Zone and an Example Backscatter Radiography Scan

The general procedure for inspecting the PAL ramps involved first marking a grid on the PAL ramps then methodically following that grid down the tank with each NDE system. A sample zone is shown in Figure 8 along with the accompanying backscatter x-ray image.
