Invited Talk at the World Ceramics Congress (CIMTEC 2006)

In-Space Repair of Reinforced Carbon-Carbon Thermal Protection System Structures

M. Singh
QSS Group, Inc.
NASA Glenn Research Center
Cleveland, OH 44135

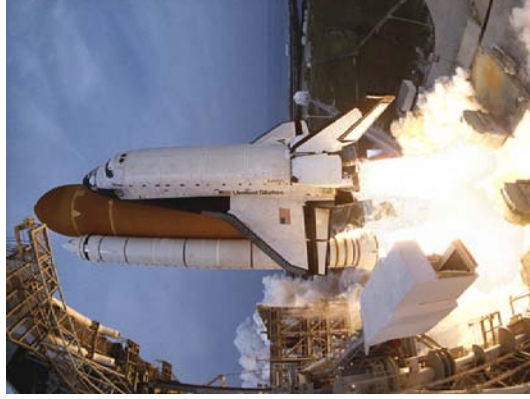
Launch Pad Debris

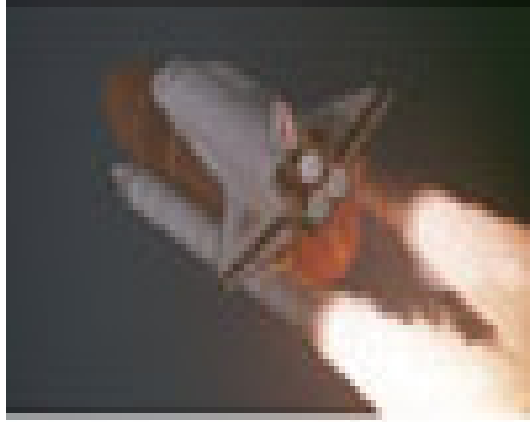
Accent EFT Foam Damage

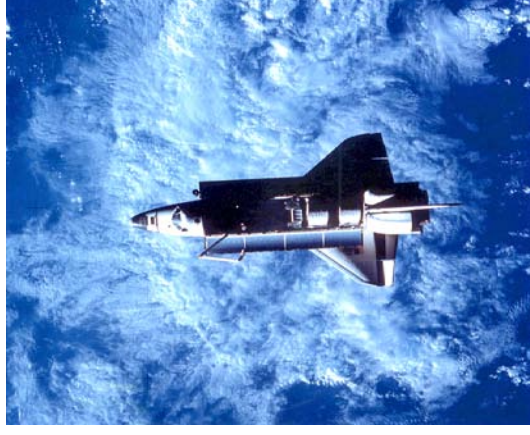
On-Orbit MMOD Damage

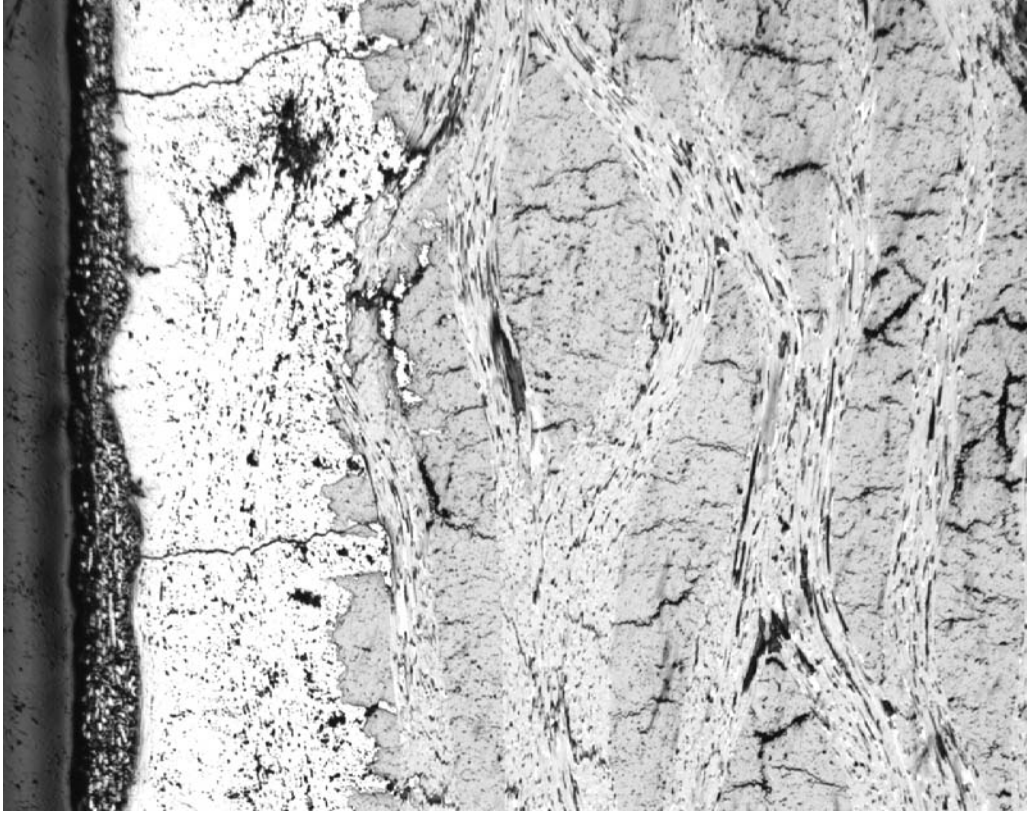
Cross Sectional View Showing Carbon/Carbon, SiC, and Type A Sealant

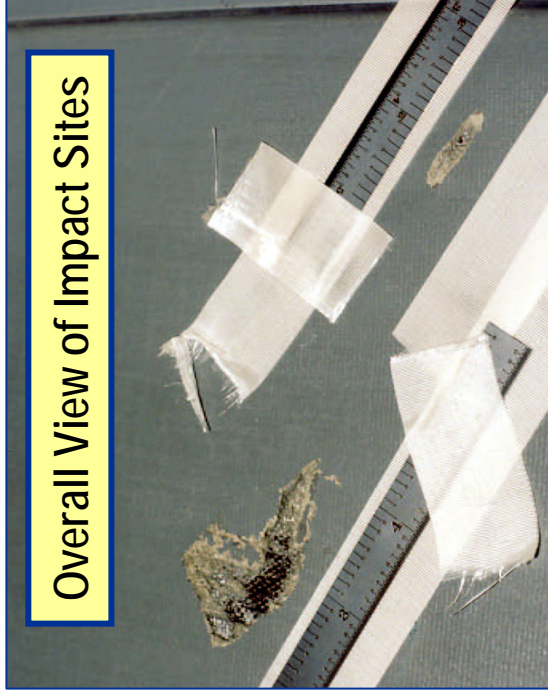
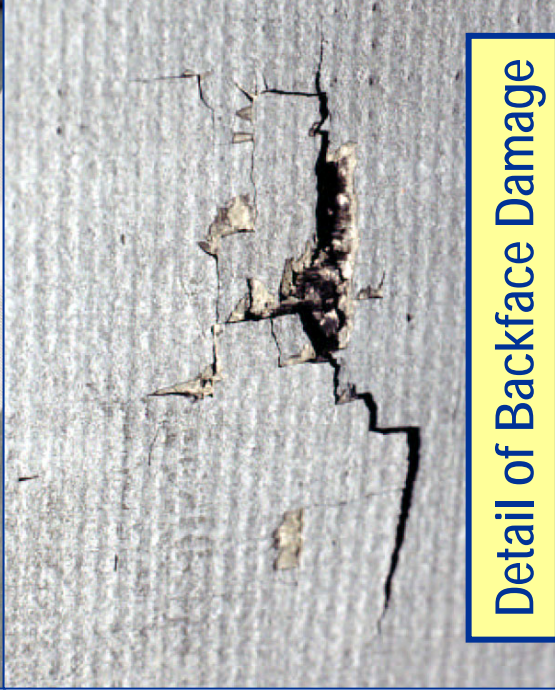
STS-45 Impact Damage on Atlantis WLE Panel 10R

Damage to Leading Edges During Impact Testing on Ground

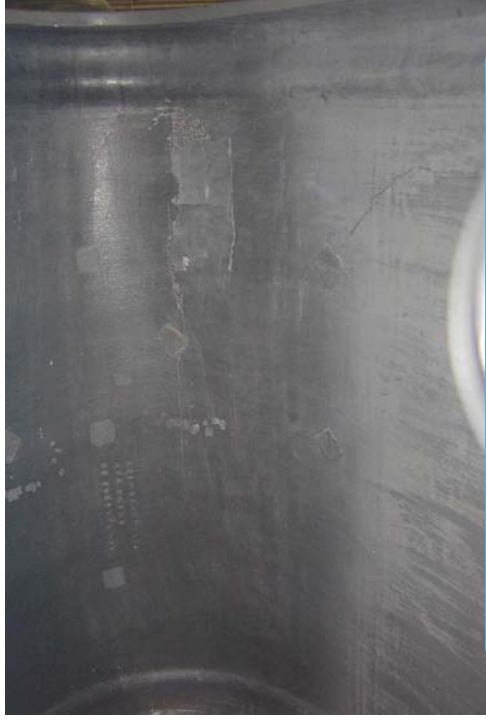
IML Damage Surface Panel 9L

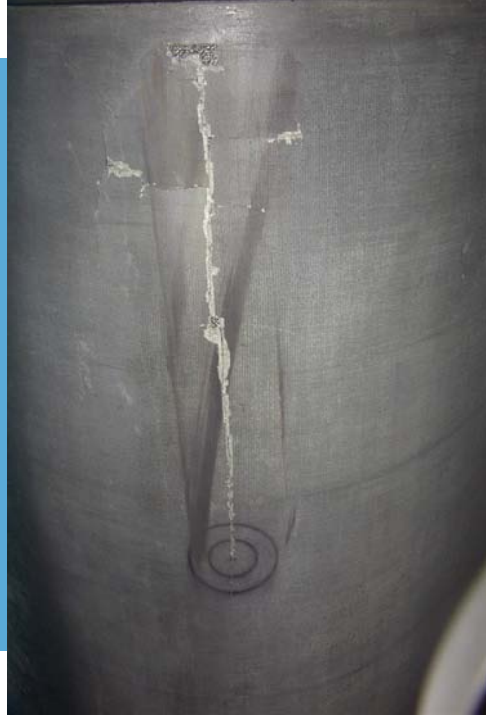
OML Damage Surface Panel 9L2

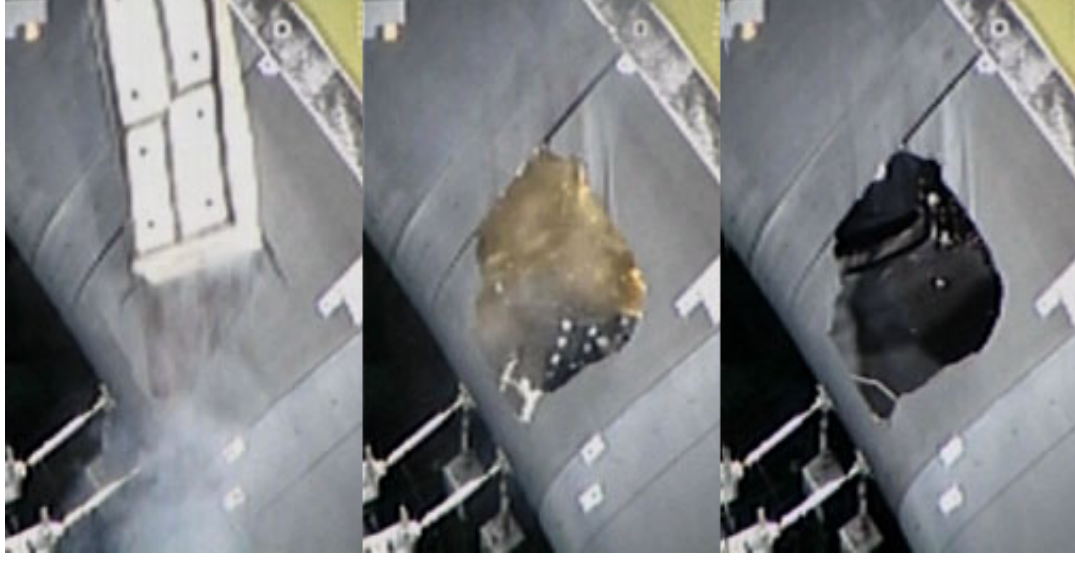
**Foam Blasts
16-inch Hole
in Final
Shuttle Test
@SWRI, TX,
July 7, 2003**

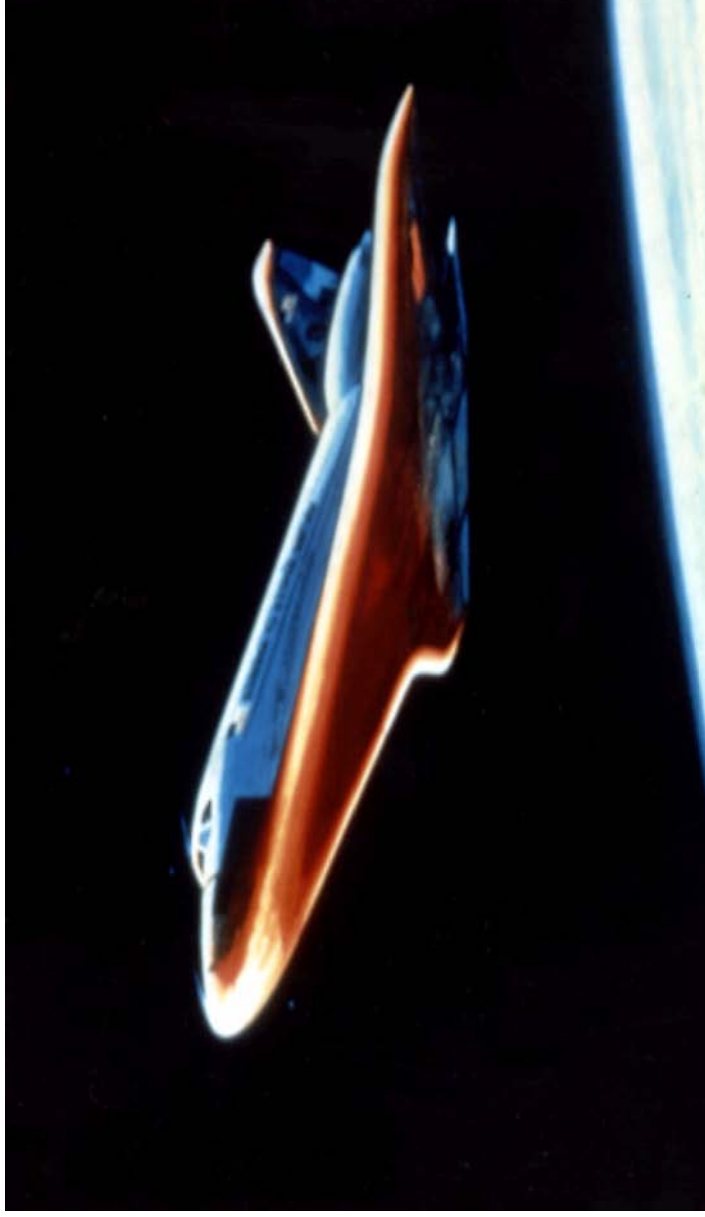
Space Shuttle Re-entry Conditions are Quite Harsh and Extreme

- Temperature to 2000 K
- Reduced pressure--0.005 to 0.010 atm
- Gases--O₂, N₂, CO₂
 - Shock leads to O, N and ions
- Short times ~15 minutes/re-entry
- Best simulated with arc-jet

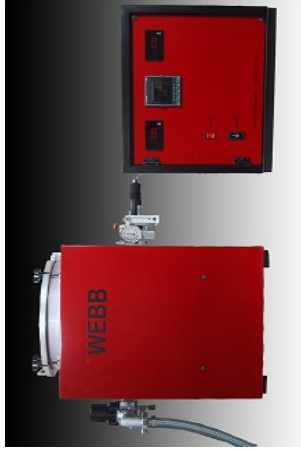
Simulated Testing in High Temperature Furnace (1650 C)

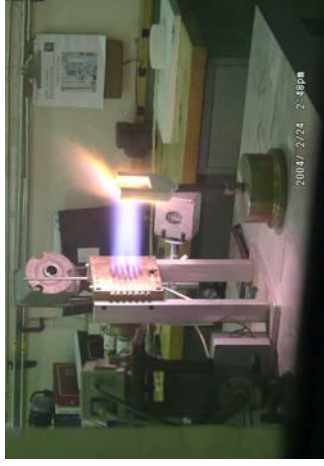
QARE Rig Testing (GRC)

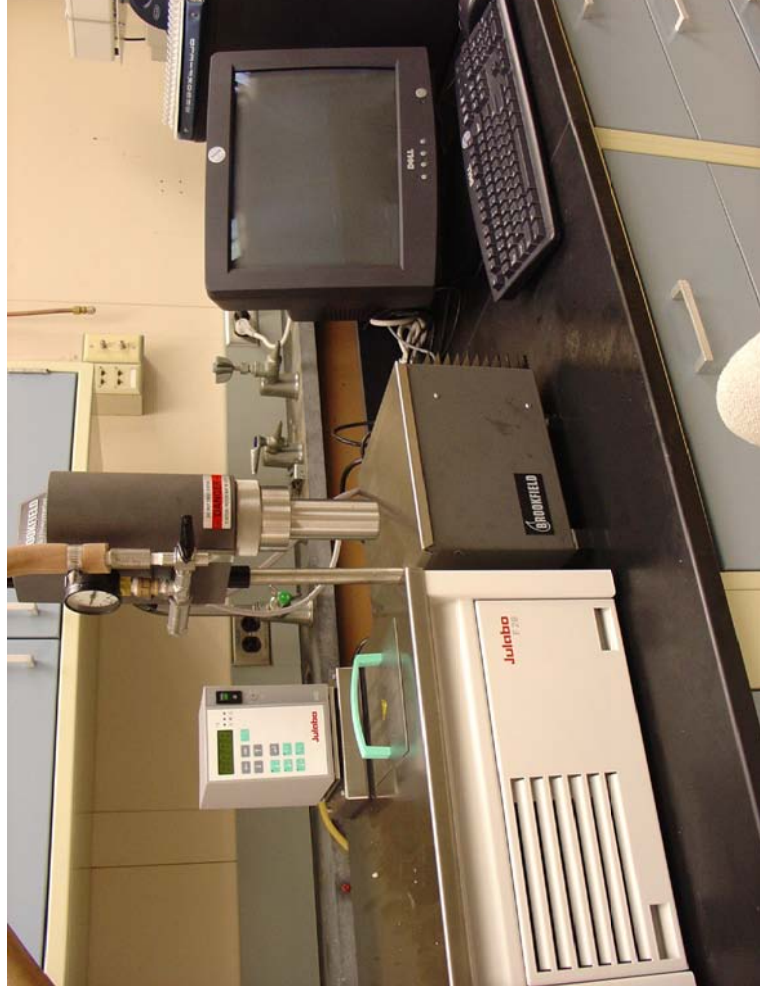
Brookfield PVS Rheometer Used for the Viscosity Measurements

*The temperature control bath has capability from
– 20 C (- 4 F) to 180 C (356 F)*

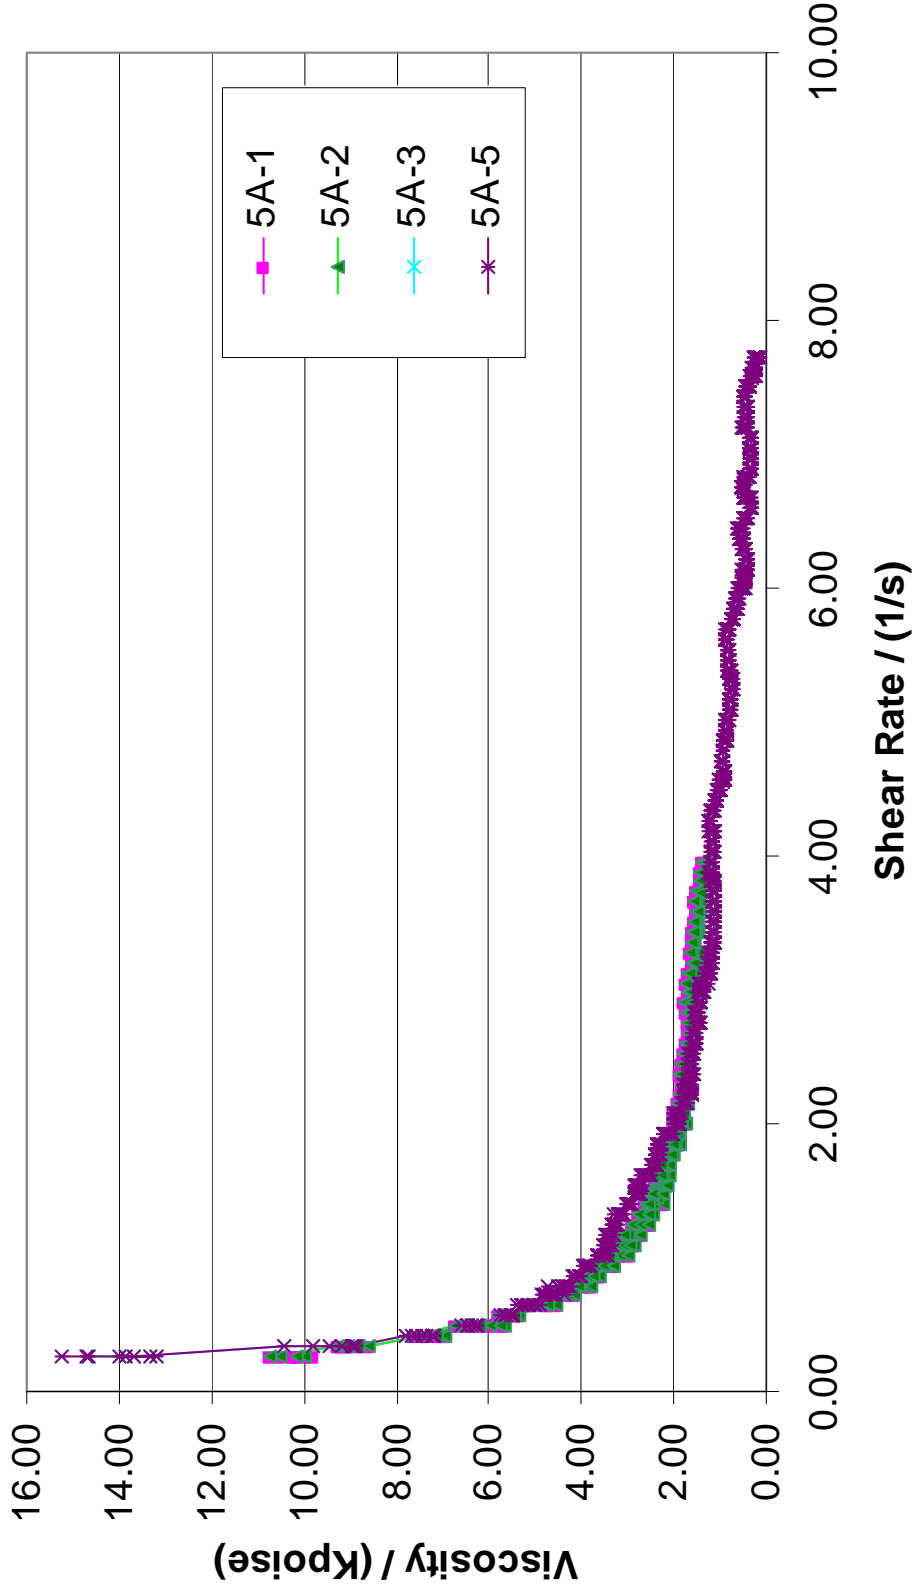
Reproducibility of GRABER 5A

Materials made at different times and in varying amounts show consistent viscosity

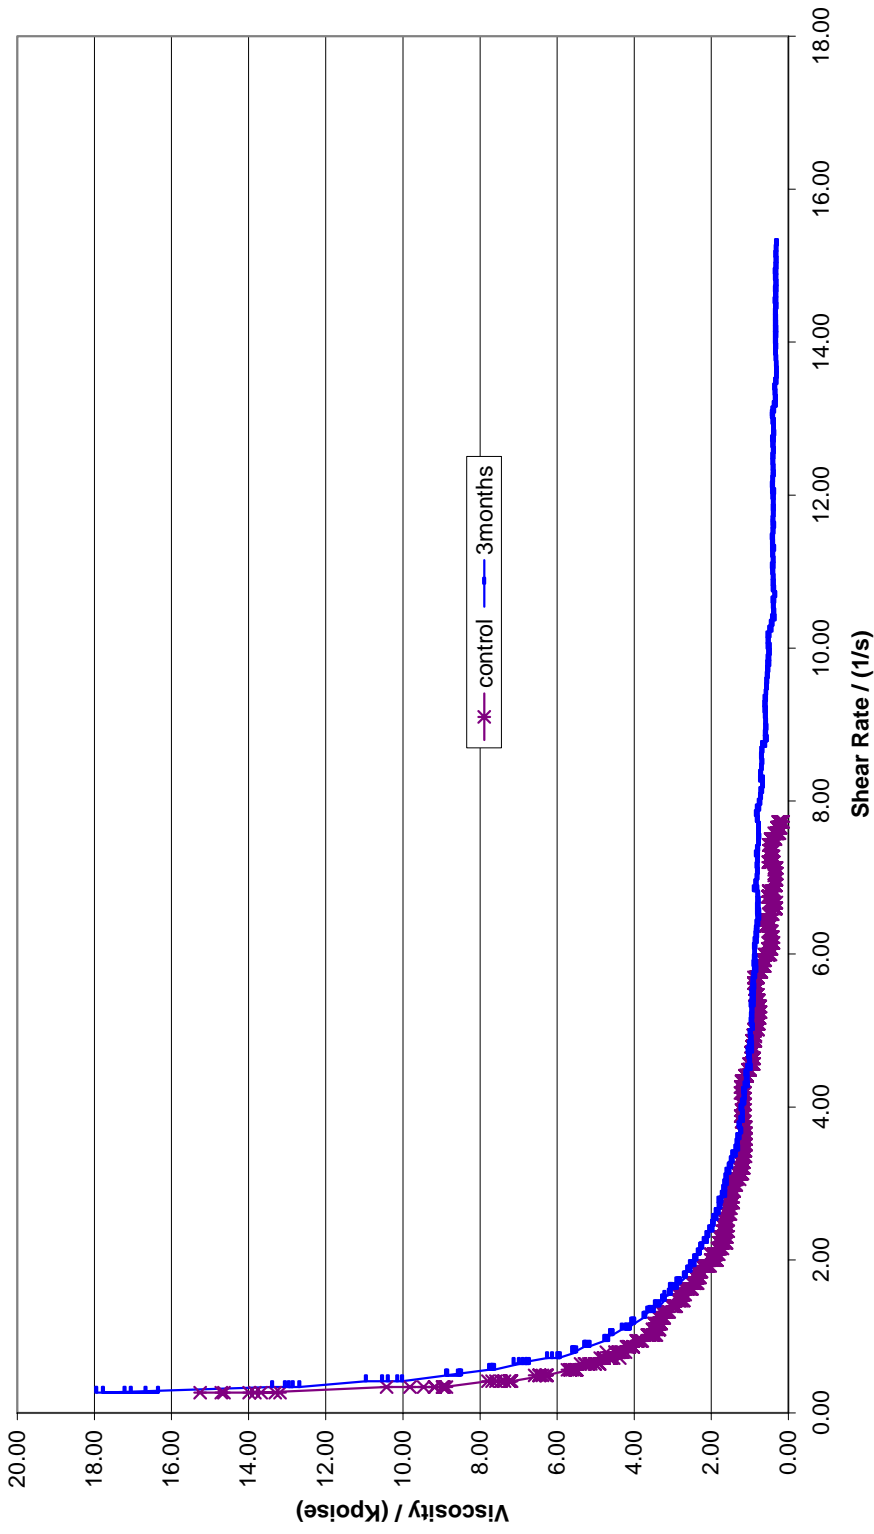
Viscosity of GRABER Stored at Room Temperatures

Materials stored for different times at room temperature show consistent viscosity

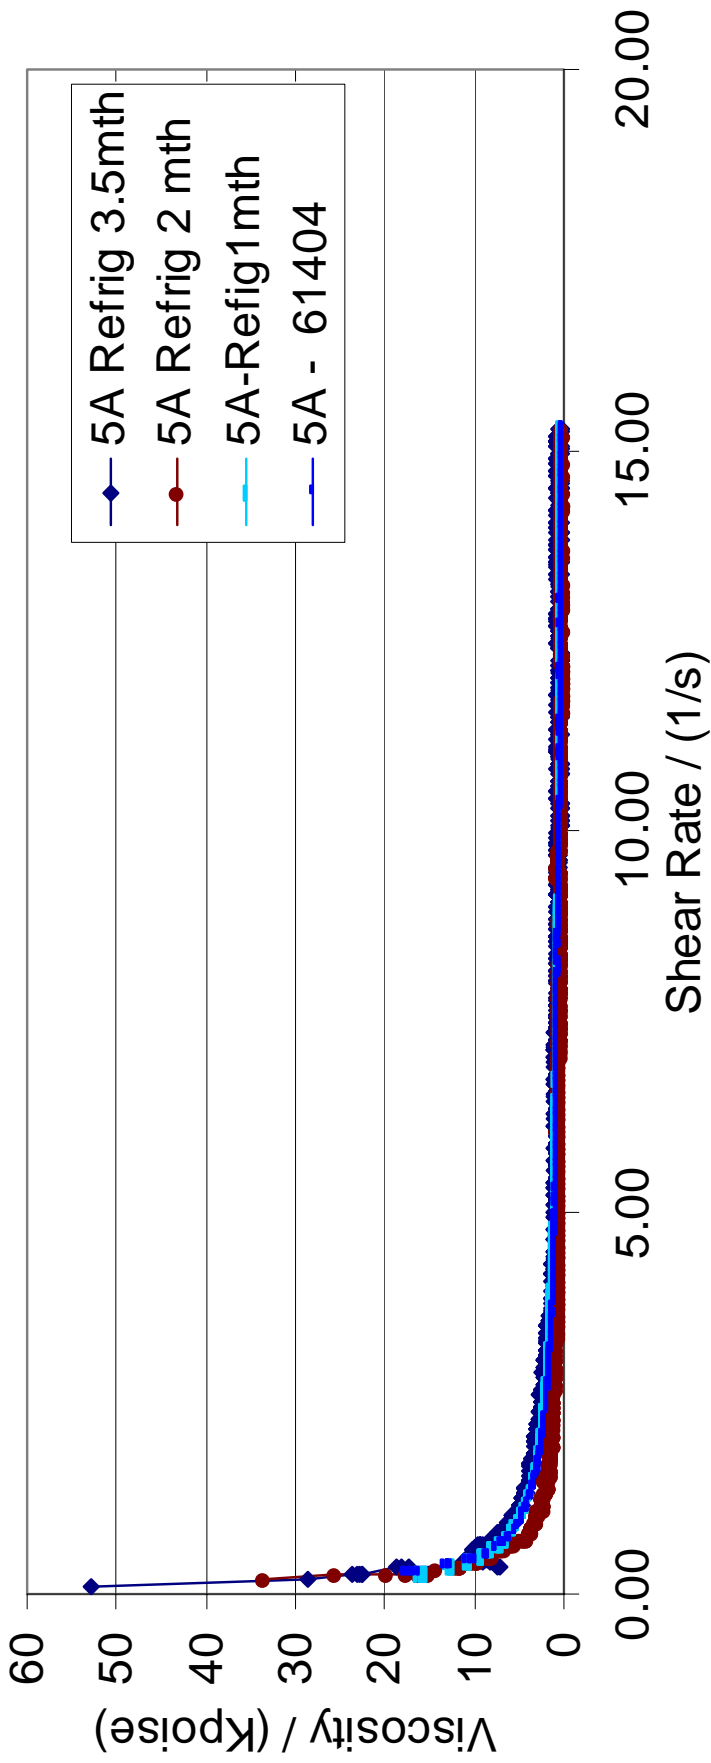
Storage Temperature Effects on GRABER 5A

Material Stored in a Refrigerator at 0 C

Materials stored for different times (1-3 months) had similar type of viscosity behavior as freshly prepared materials

Material was Tested under Vacuum

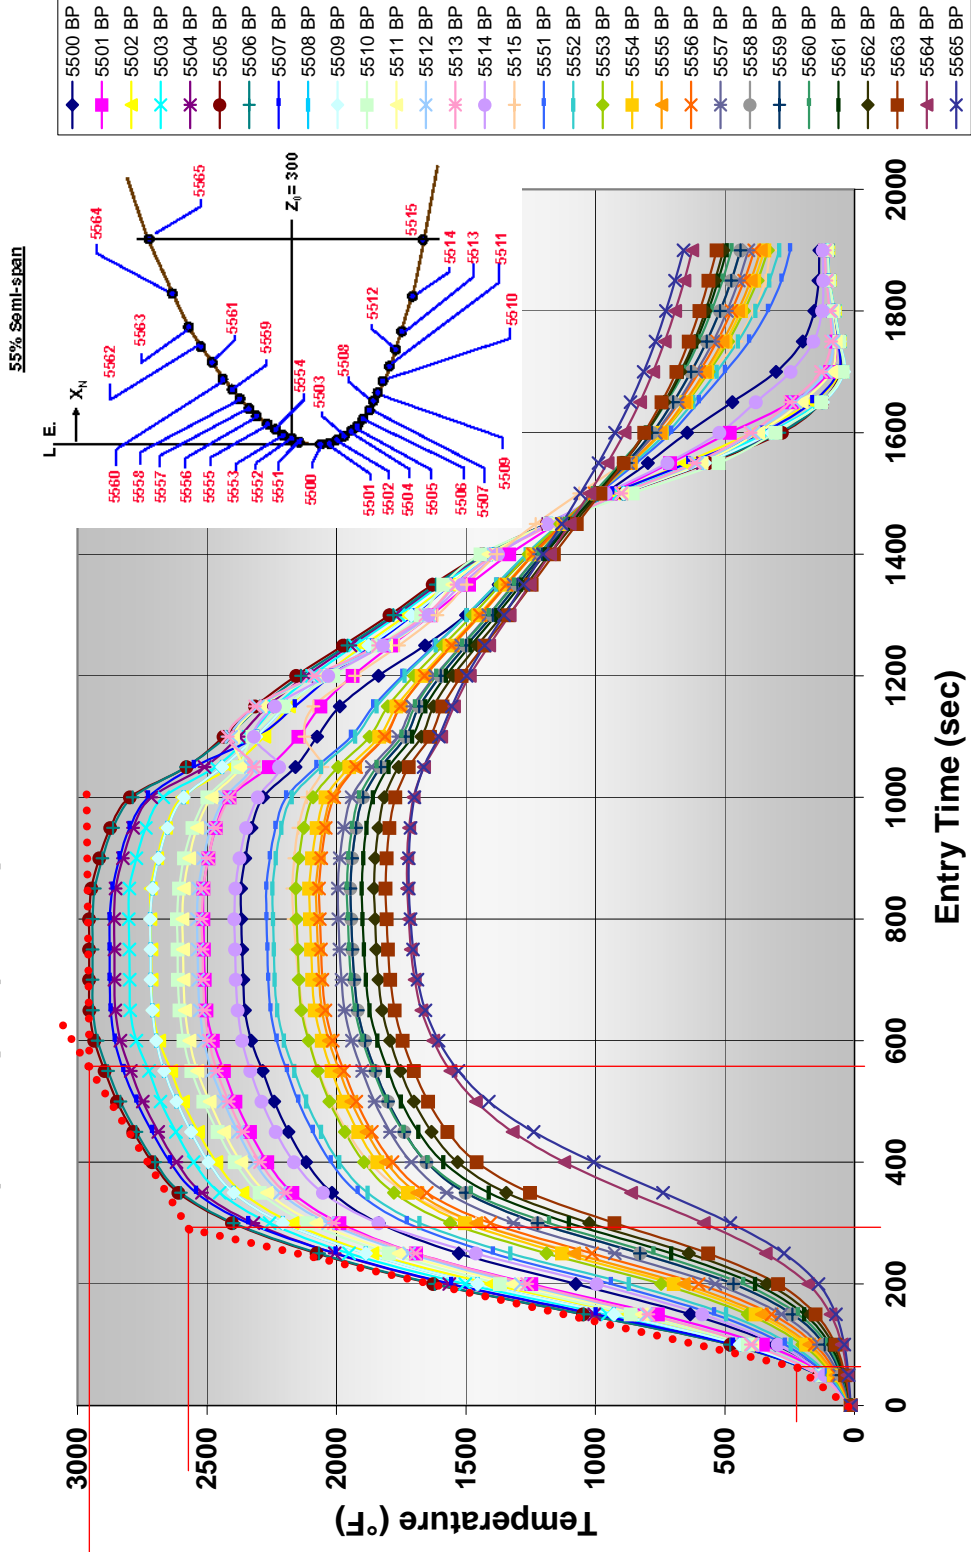
WLE Entry Temperature Profiles

Panel 9 (55% Span) Temperature Profile for Nom ISS EOM

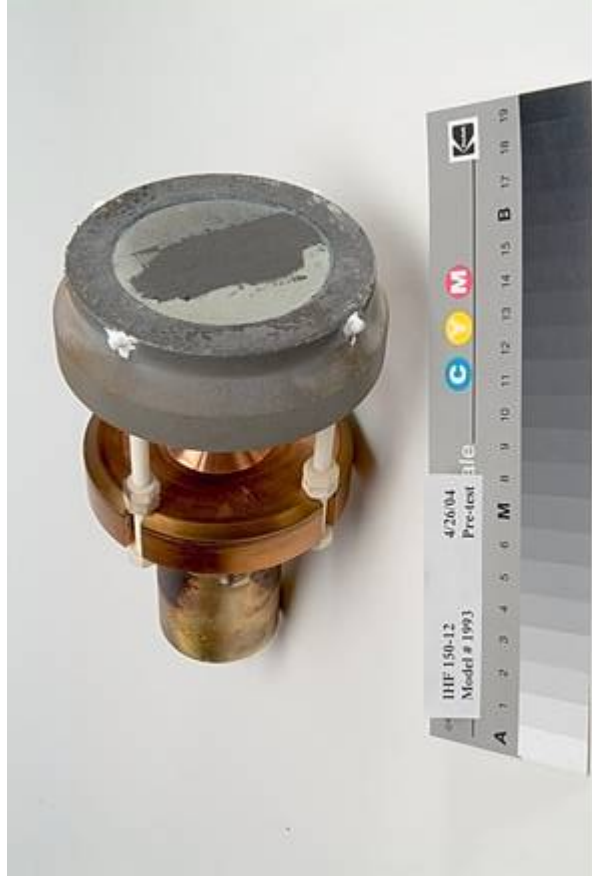
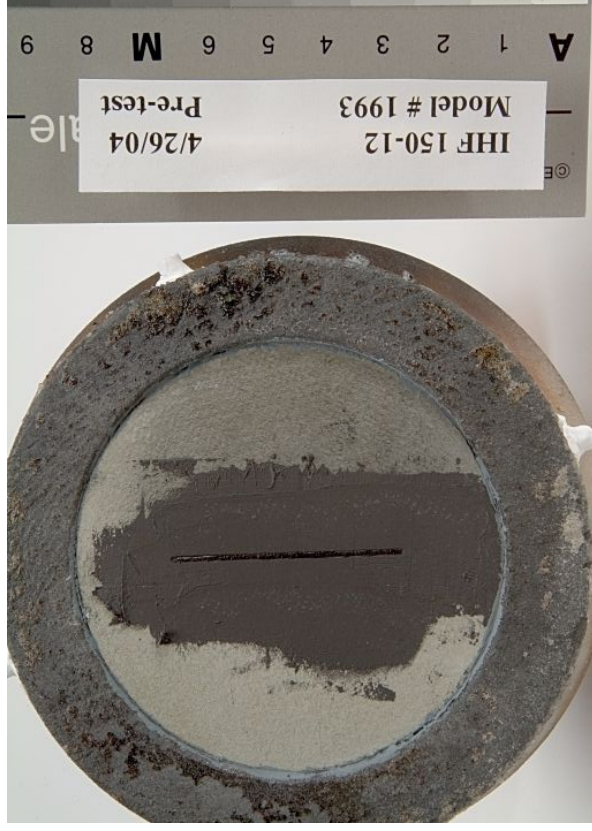
Pre-Test Photographs of Repaired Specimens

Run 12 – Model 1993

(0.035” or ~0.89 mm wide crack, GRABER-5A)

Percent Argon = 6% @ 2960F condition
Add air = 11.6% @ 2960F condition
Anomaly: water leak from electrode, which allowed water vapor in the stream

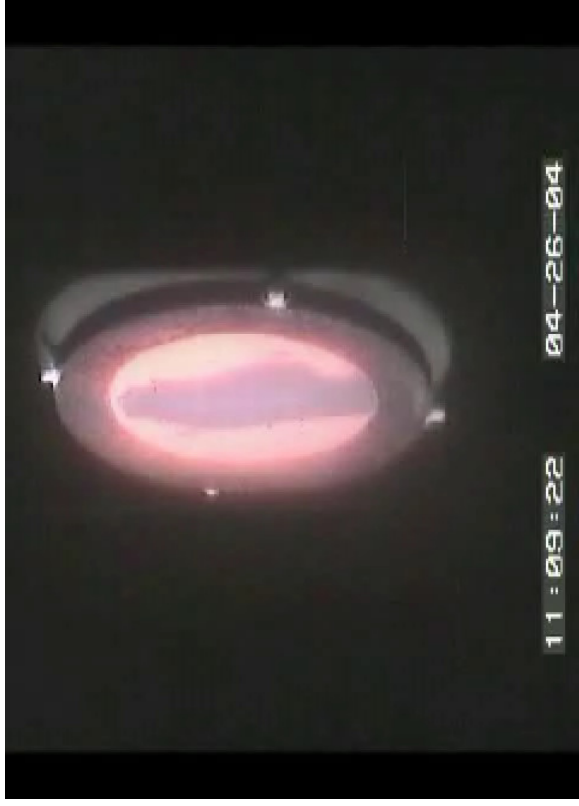
Front View

ArcJet Testing of Repaired Specimens

Run 12 – Model 1993

(0.035” or ~0.89 mm wide crack, GRABER-5A)

Percent Argon = 6% @ 2960F condition

Add air = 11.6% @ 2960F condition

Anomaly: water leak from electrode, which allowed water vapor in the stream

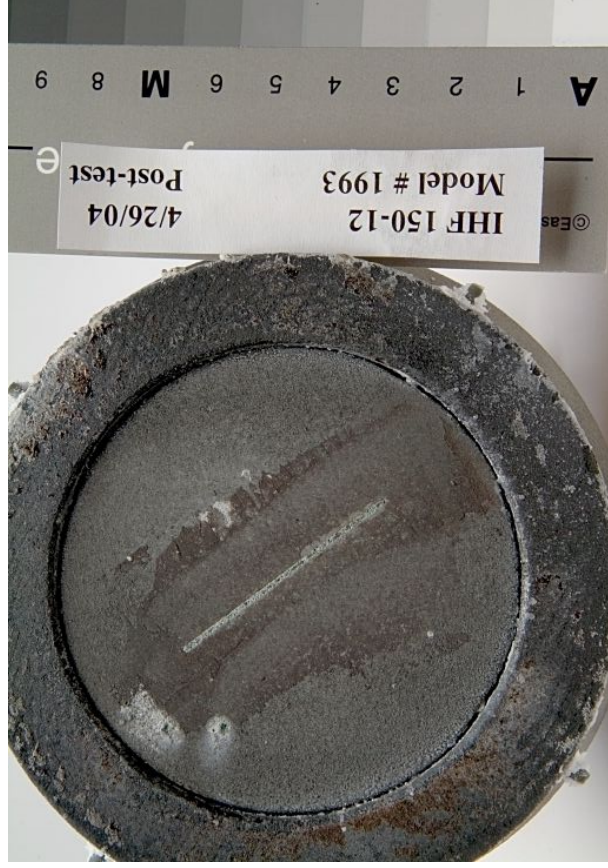
Post Test- Front Side

ArcJet Testing of Repaired Specimens

Run 12 – Model 1993

(0.035” or ~0.89 mm wide crack, GRABER-5A)

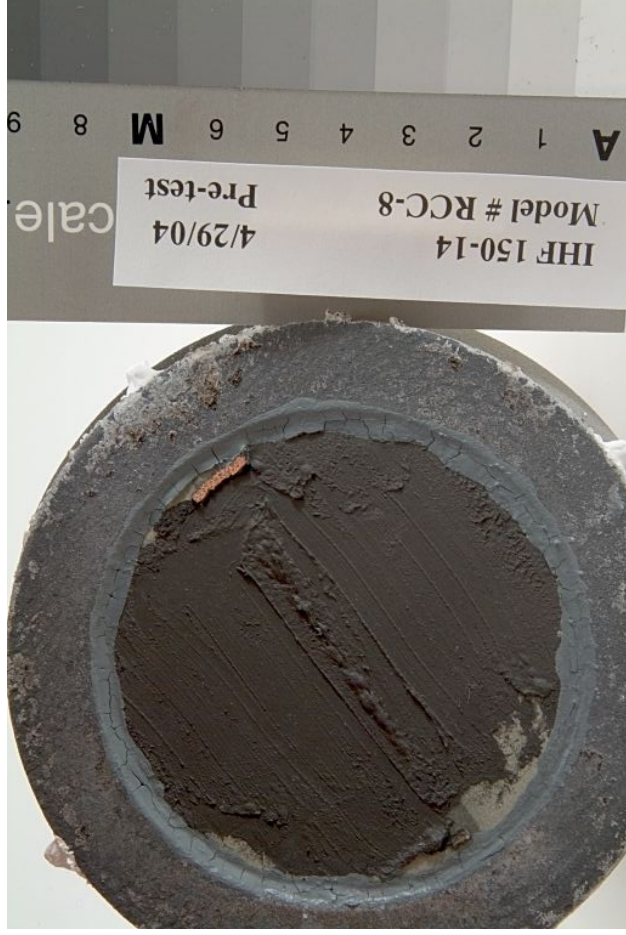
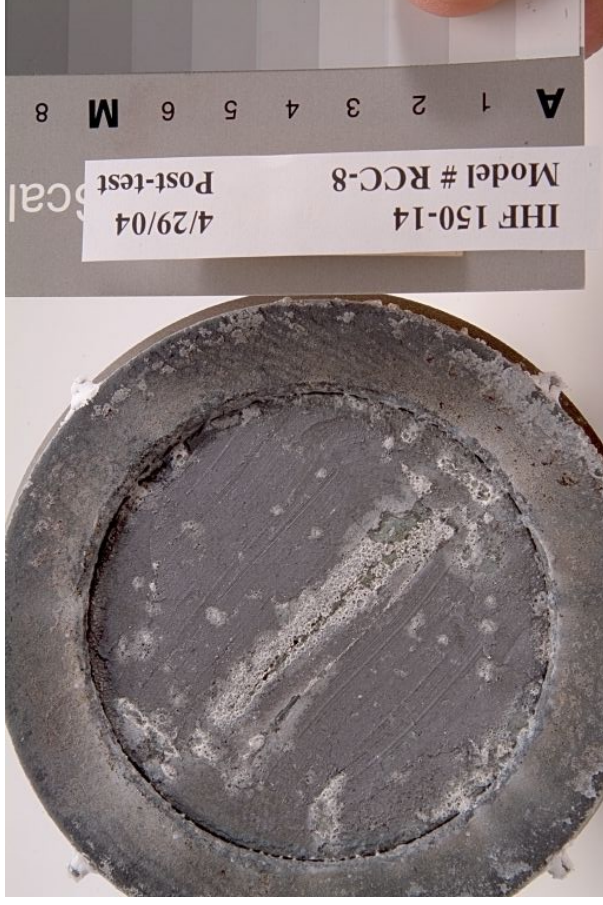
ArcJet Testing of Repaired Specimens

Run 14 – Model RCC 8

(0.062” or ~1.58 mm wide crack, GRABER-12A)

Percent Argon = 6% @ 2960F condition

Add air = 11.6% @ 2960F condition

Temperatures on model face were higher than previous runs (~3100F)

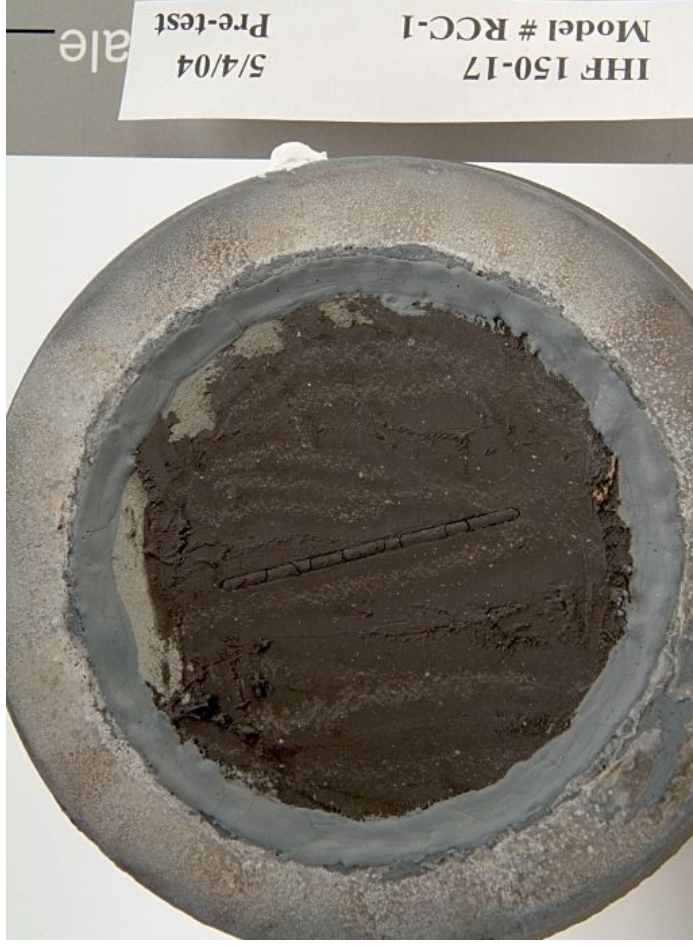
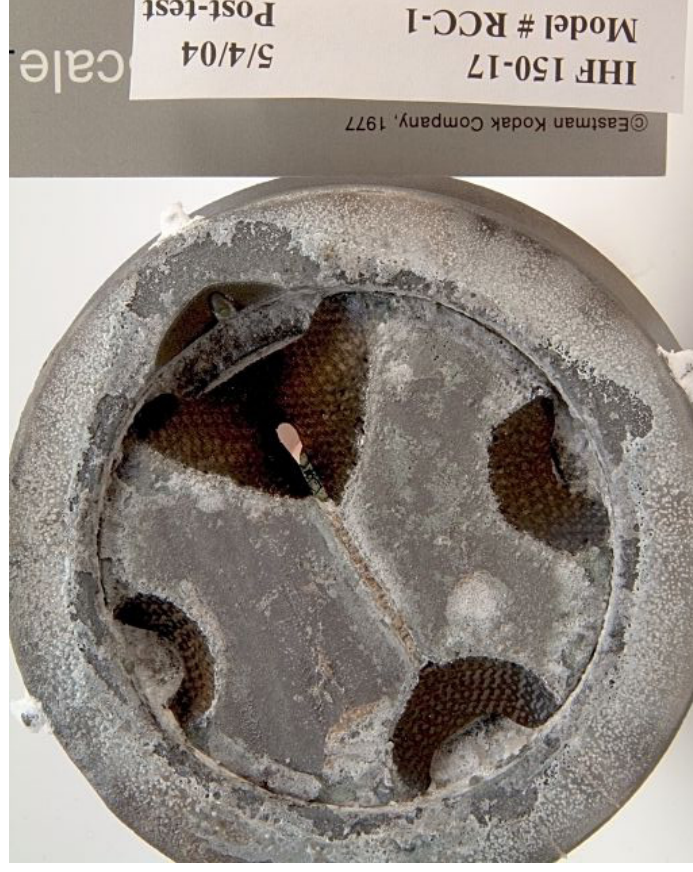
ArcJet Testing of Repaired Specimens

Run 17 – Model RCC 1

(0.062” or ~1.6 mm wide crack, GRABER-5A)

Percent Argon = 6% @ 2960F condition

Add air = 11.6% @ 2960F condition

Anomaly: Edge failure, sample removed after ~130 seconds @ 2960F condition

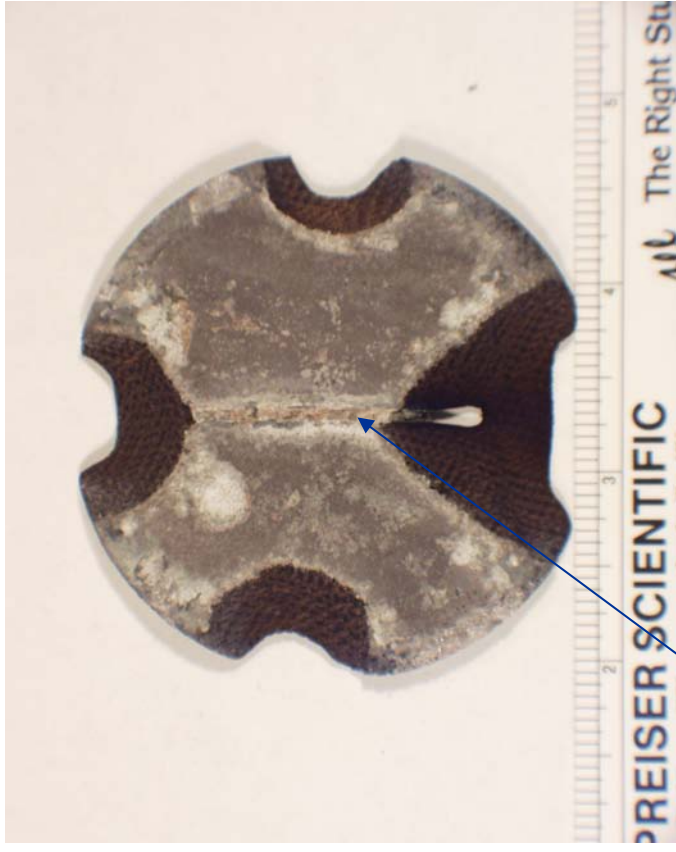
Front side

ArcJet Sample 150-11, RCC-1, GRABER 5, 0.062” Crack Width

Crack filled with Graber material

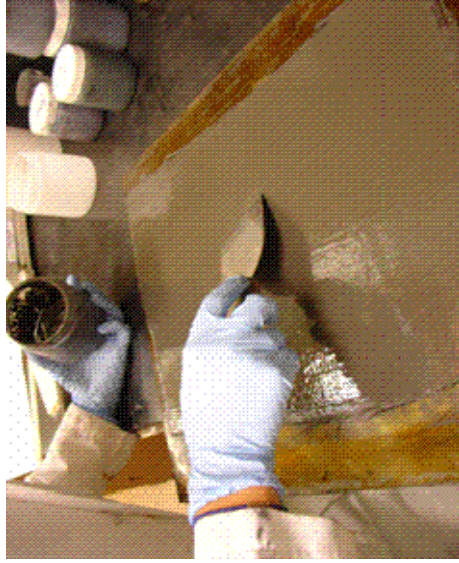
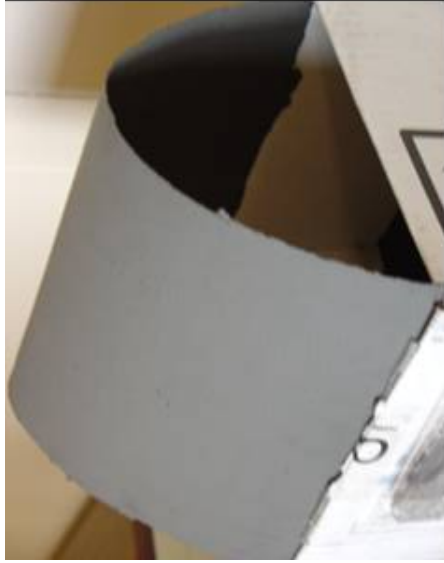
DEVELOPMENT

Integrated System for Leading Edge and Tile Repair (InSTALER)

Flexible Ceramic Overwrap

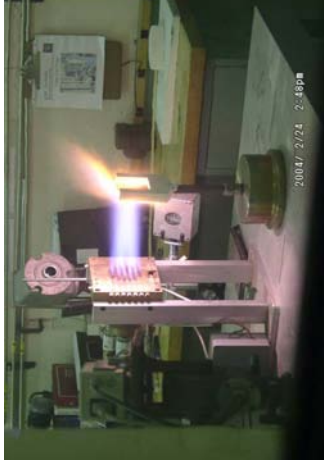
TESTING

QARE Rig
Testing (GRC)

HYMETS
(LaRC)

ArcJet
Testing at
JSC, ARC,
and LCAT

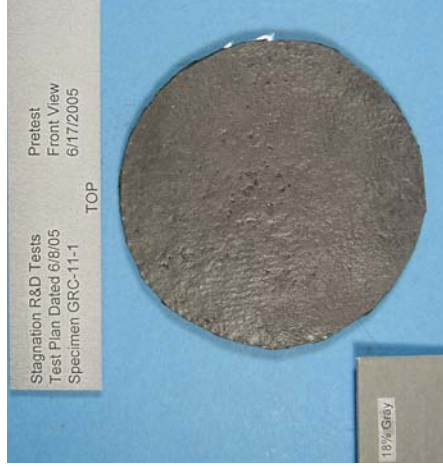
Pre-Test

Integrated System for Leading Edge and Tile Repair (InSTALER)

Flexible Ceramic Overwrap

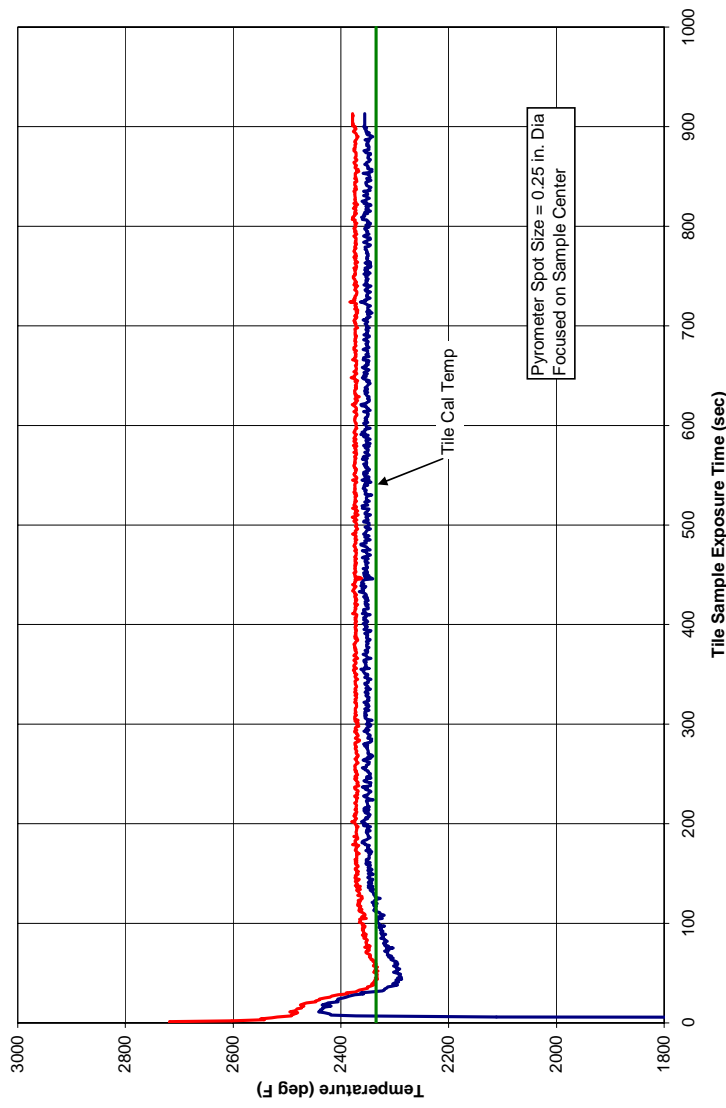
Test Sample Temperature Response
 Sample: GRC-11-1, Run 1588
 — FAR HI — FAR LOW — Tile Calibration Temp

Excellent Plasma Performance in ArcJet Tests
