NASA/TM—2007-214938

Three-Dimensional Digital Image Correlation of a Composite Overwrapped Pressure Vessel During Hydrostatic Pressure Tests

Duane M. Revilock, Jr.
Glenn Research Center, Cleveland, Ohio

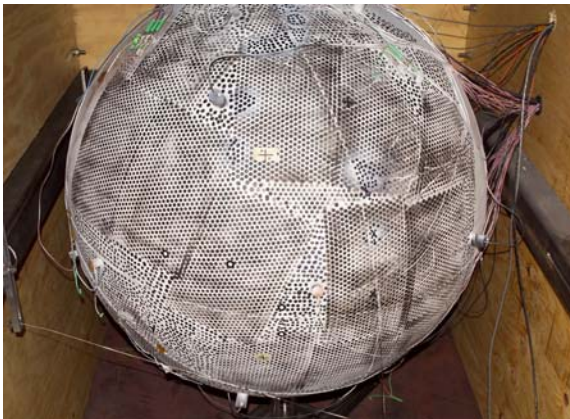
Figure 2.—COPV dot pattern painted on vessel for digital image correlation.

The DIC system used in this test program was developed by GOM mbh of Braunschweig, Germany and utilizes a software package called ARAMIS. The ARAMIS software uses principles of three-dimensional image correlation photogrammetry that gives full-field displacement and strain measurements. The system requires spraying random high contrast dot patterns onto a sample; this pattern is then tracked in ARAMIS by thousands of unique correlation areas known as facets. The center of each facet is a measurement point that can be thought of as a three-dimensional extensometer. Arrays of them form in-plane strain rosettes. The facet centers are tracked in each successive pair of images, with accuracy up to one hundredth of a pixel. Figure 2 shows a 3/8 in. dot pattern used on the 40 in. vessel.

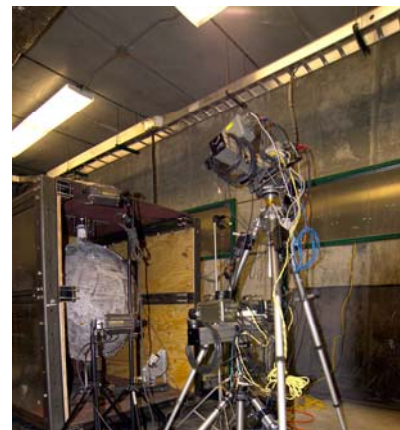
Figure 3.—Three-dimensional digital image correlation system setup.

Two three-dimensional digital image correlation systems with Phantom v7.0 high speed cameras (Vision Research Corp. Wayne, NJ) were used in the tests, one focusing on the upper boss area and the other on the equator of the vessel (fig. 3). The high speed cameras are not standard with the DIC system but have been validated by the NASA Glenn Ballistic Impact lab during impact test studies for the Space Shuttle Program after the Columbia Accident (refs. 10 to 12). The digital high-speed cameras were used at a resolution of 512 by 512 pixels giving a recording speed range between 100 to 8,000 frames per second. The Phantom cameras act as a stereo pair to create a volume of area in which the ARAMIS software can take measurements. This volume varies with the angle of the cameras and lens choice. Camera setup consisted of 16-mm lenses with the cameras angled at 15.3°, giving a measuring volume of 1060 mm/875 mm/875 mm. To calibrate for this volume, the camera resolution was set at 800 by 600 pixels and a 1200-mm NIST-traceable calibration cross was rotated and moved in specified locations to calibrate the sensor. The cameras used IRIG time for synchronization, which provided accuracy within 1 μ s between images. Each DIC system was able to solve approximately 70 in.² of area on the vessel. Both DIC systems were used at WSTF during all of the pressurization cycles. The 40 in. COPV was filled with water and pressurized at 5 psi/sec and at 50 psi/sec to its proof pressure, at 50 psi/sec to its maximum operating pressure, and at 50 psi/sec to burst.

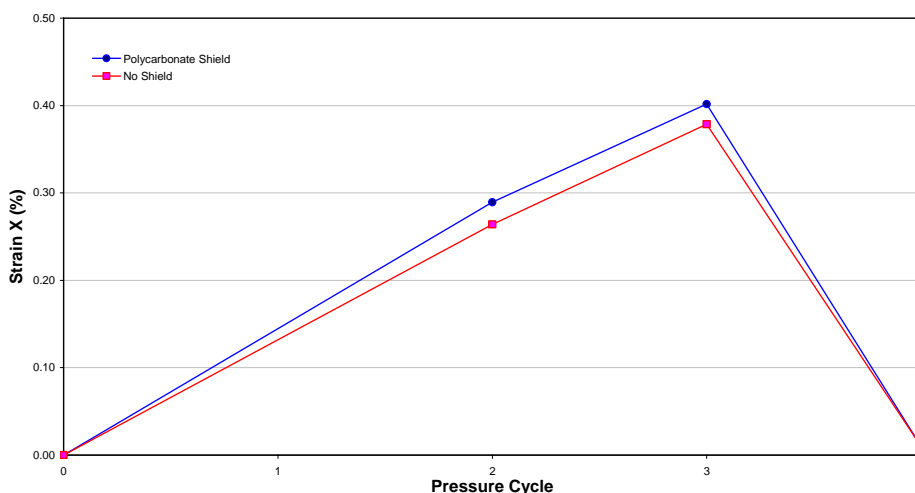
Figure 4.—X- strain comparison viewing through polycarbonate shield.

Due to the high pressures during testing, a 1.25 in. layered polycarbonate shield was bolted to the test chamber in front of the cameras to provide protection for the cameras and other test equipment. Since the DIC was not calibrated with the shield between the cameras and the vessel two tests were conducted a low pressures to measure its effect. The tests showed that the shield caused an increase in the maximum displacement readings. These higher readings were a result of the optical abnormalities in the shield and a magnifying effect. Figure 4 shows the X strain comparison at a point on the vessel with the same coordinate system with and without the shield indicating the higher strain readings.

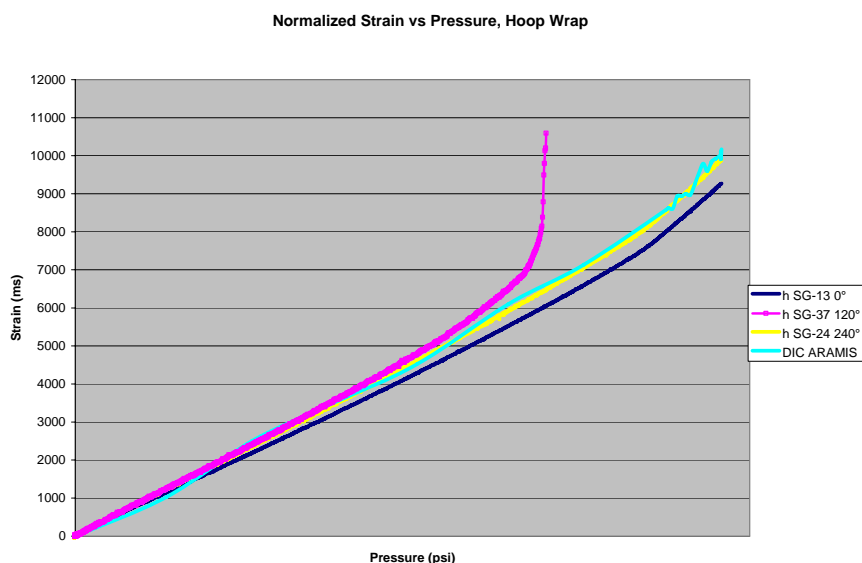
Figure 5.—Comparison of Digital Image Correlation Strain to Gages at the Equator of COPV.

The vessel was instrumented with 35 strain gages to measure strains in the hoop direction of the fiber wrap at multiple locations around the vessel. For comparison purposes, one DIC system was aligned to view four of the mounted gages. Figure 5 shows a comparison of the hoop strain measured with the DIC system and the strain measured with the strain gages near the equator of the vessel during the burst cycle.

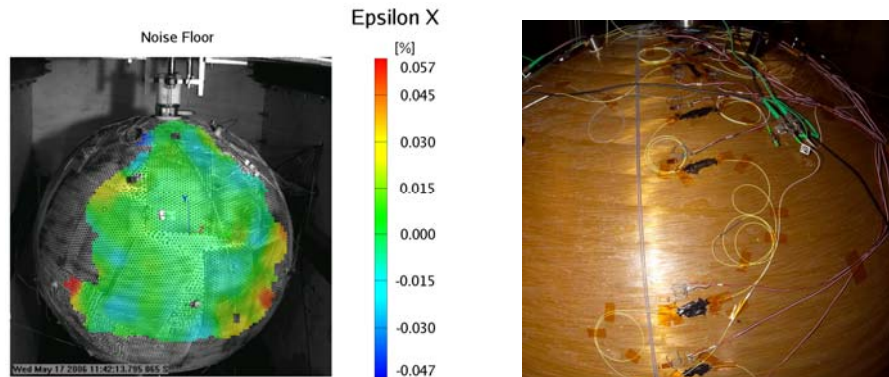
Figure 6.—Full field strain X showing hot spots at edges and instrumentation cable field in the same location.

Due to the curvature of the vessel, the effect of viewing through the polycarbonate shield, and visual interference from multiple instrumentation devices with cabling, the system was not able to compute consistent strains at the edges of the solved areas. Figure 6 shows the highly instrumented area the DIC is solving in and a snapshot of the noise floor from one of the tests. The full field strain x noise floor for most of the vessel is under 0.015 percent strain which is normal for this type of setup but it also indicates high and low localized strain regions at the edges of the solved area and at instrumentation locations. These high and low localized spikes occurred during each test and at various locations. To analyze this type of data a careful look at each point was needed to determine how accurate it was. During the pressurization cycles most of the spikes were located at points where the instrumentation cables were able to move. It was concluded that this movement was the source of the majority of the high noise floor regions. This made it difficult to determine the time and location of fiber failures during the burst cycle.

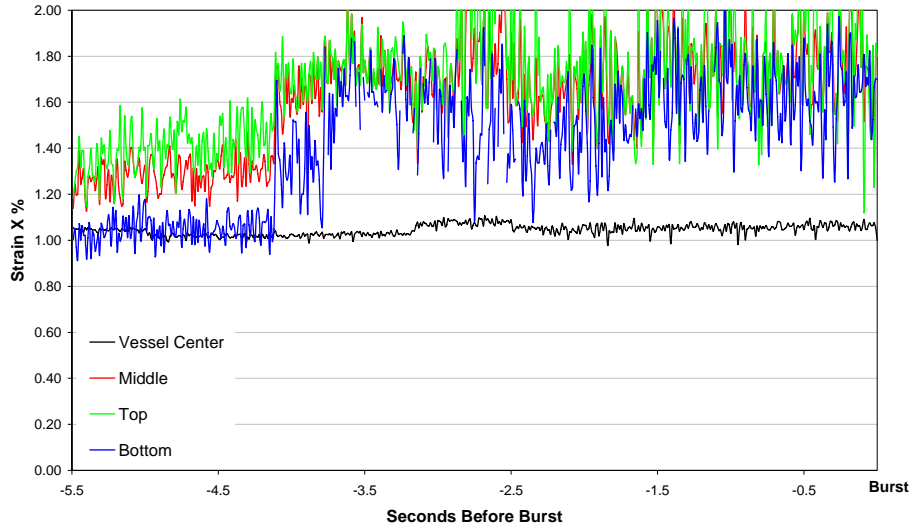
Figure 8.—Localized Point Strain Increase in Wrap Four Compared to Vessel Center. (Due to curved surface each point is created with a new coordinate system).

During the burst pressurization test at approximately 4.1 s before burst the DIC system showed a localized strain increase in the fourth wrap of the Kevlar in the upper portion of the boss area (figs. 7 and 8). These points (created with a new coordinate system with x being in the direction of the wrap) show strain progression from approximately 1.35 to 1.7 percent without visual fibers failing. Figure 9 shows the 26 percent increase in strain in this localized region which indicates a possible fracture in the titanium liner. This was supported by post test analysis which showed a crack in the liner at this location and an eddy current sensor located approximately 6 in. away indicating a thickening of the liner possibly due to stress relief as a result of the fracture. However, the closest strain gage approximately 2 in. away showed no indication of an increase in strain. This demonstrates the high degree of localization possible which may not be detected by functional strain gages unless one is located exactly at the fracture site.

Figures 8 and 9 also show more noise in the outer edges of the solved area than in the central region which is believed to be caused by the high viewing angle of the cameras to the curved surface and viewing through the polycarbonate shield. Even with this high noise the system is capable of showing trends of the strain increase. The system was also able to detect decreases in strain at the locations of fiber failure as the vessel approached burst. Figure 10 shows an example of a fiber failure during the burst test. The high speed video that supported the DIC system became very useful in visualizing the fiber breakage and matching it with the strain map to insure the data was not noise in the system.

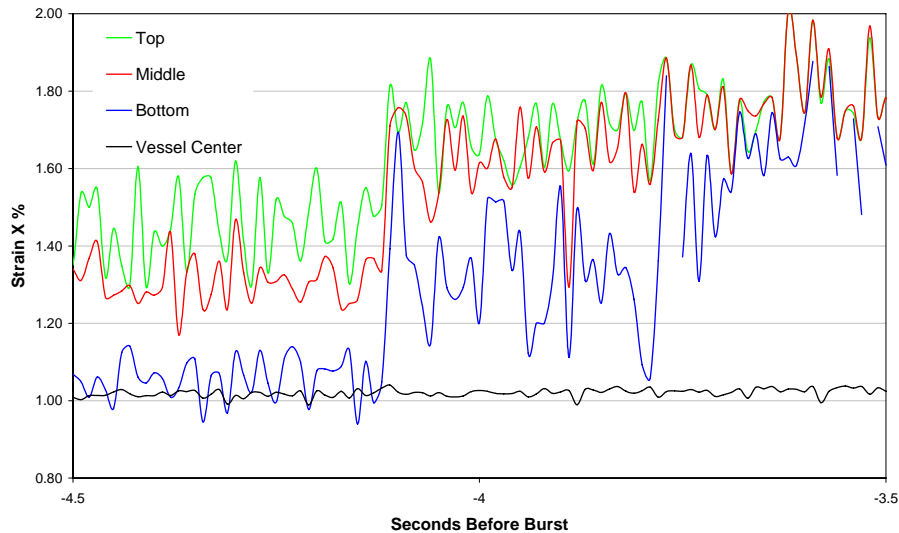
Figure 9.—Close up view indicating strain increase from top to bottom of wrap four.

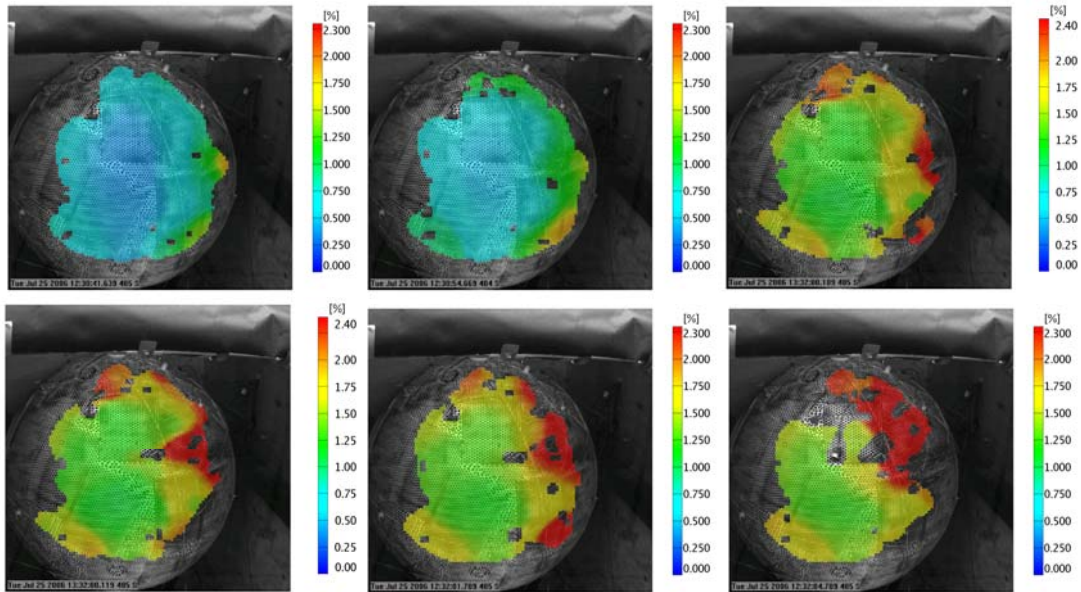
Figure 12.—Full field principal strain increase of the vessel during burst test.

This higher strain offset around the edges of the vessel is common for curved objects during similar tests and is generated by the high viewing angle of the cameras to the curved surface and by viewing through the polycarbonate shield. The data in the offset area consistently shows higher values but still is able to determine trends. Figure 12 shows a sequence of graphs of the principal strain during the burst test. The graphs indicate an increase in strain progressing from the right to the left with magnitudes above 2 percent which permeates past the offset area. This is consistent with post test analysis which showed that the vessel failed on the right side. Overall the DIC showed an increasing trend of principal strains on the right side of the vessel that mounted gages were unable to provide since they were only mounted in the one direction.
