EVALUATION OF A HIGHLY ANTICLASTIC PANEL WITH TOW OVERLAPS

K. Chauncey Wu
NASA Langley Research Center

Zafer Gürdal
Delft University of Technology

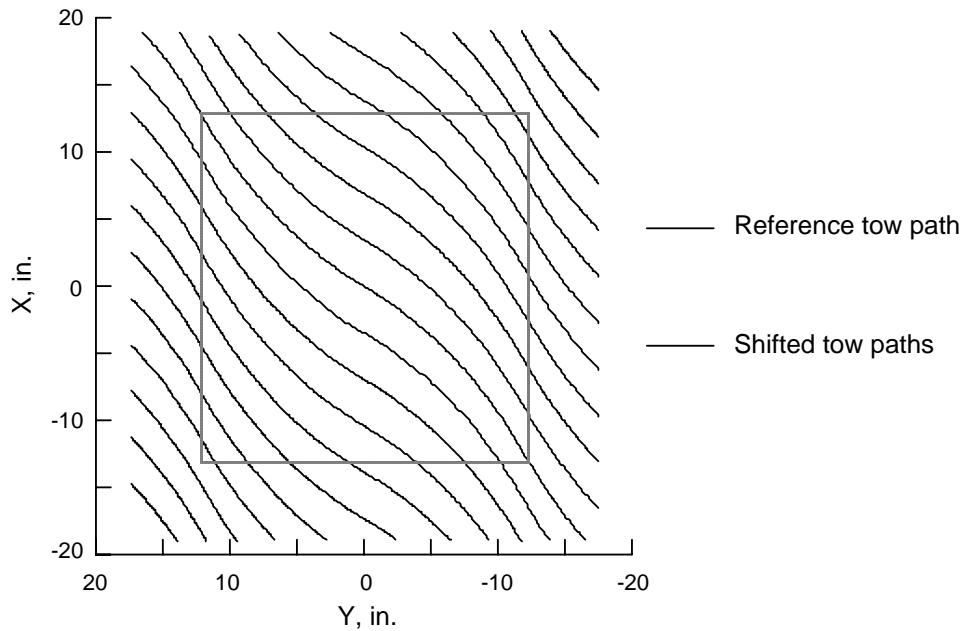
Figure 2. Variable stiffness ply tow paths.

The fiber angle (oriented with respect to the panel axial centerline) for a variable stiffness ply of this panel is illustrated in Figure 2, and decreases linearly from 60 degrees along the axial centerline, to 30 degrees near the panel edges 12 inches away. These variable stiffness plies (denoted by the Greek letter Θ) comprise the interior 16 plies of the nominal 20-ply $[\pm 45/(\pm \Theta)_4]_S$ panel layup.

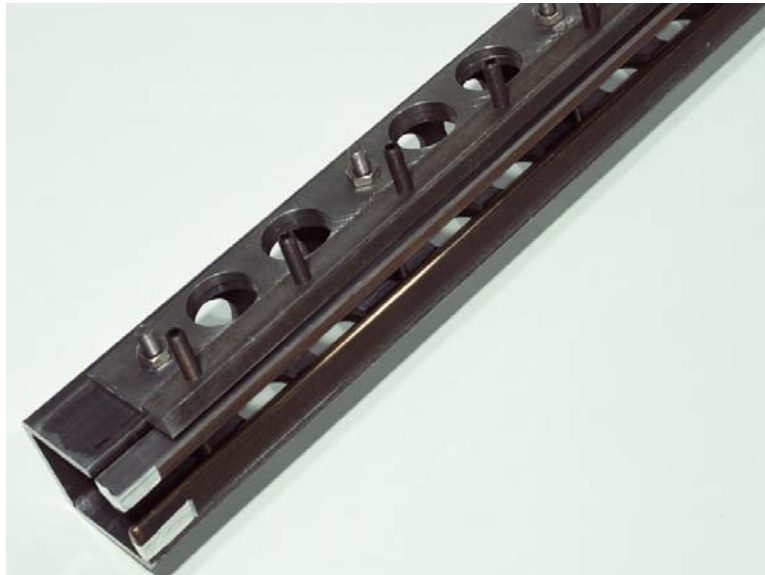
Figure 9. Vertical edge test fixture.

In essence, both types of test fixtures developed for the horizontal and vertical panel edges function much like a common C-clamp, wherein rotation of a threaded fitting drives two clamping surfaces closer together. The test fixture design for the vertical panel edges is shown in Figure 9 and resembles a continuous C-clamp that is extruded along the panel's length. For the horizontal edge fixture shown in Figure 10, each test fixture had seven discrete pairs of threaded rods with attached swiveling pads evenly spaced along a rectangular frame (welded from steel L-channel) that encompassed the width of the panel.

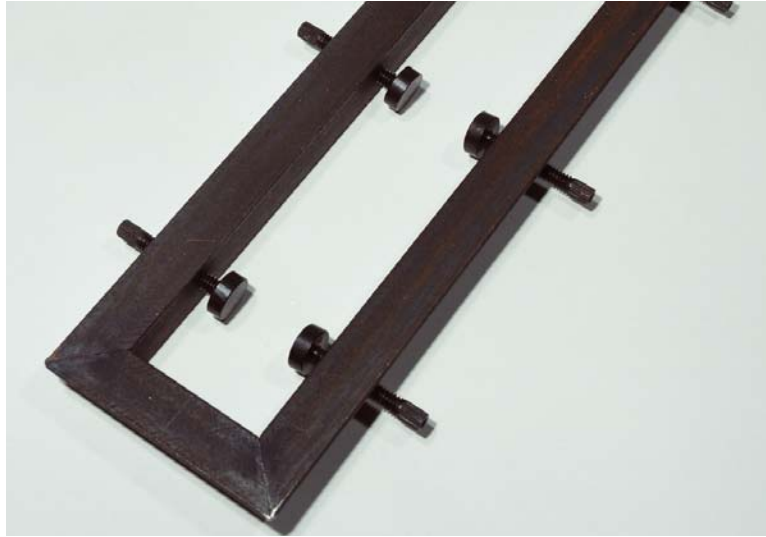
Figure 10. Horizontal edge test fixture.

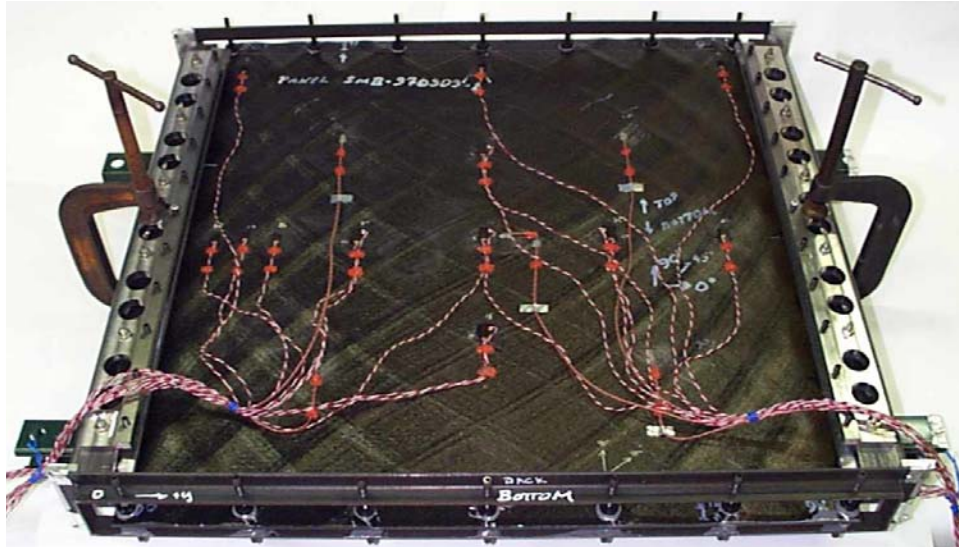
Figure 12. Panel with installed test fixtures.

The front set of swivel pads on the horizontal fixtures were first aligned level and fixed in place using epoxy, since they would be in contact with the smooth front surface of the panel. A 1/4 inch-thick spacer plate was placed between the ends of the vertical fixtures and the horizontal fixture, and held in lightly place with nuts and threaded rods. These spacer plates ensured that there was 1/2-inch of axial displacement available under axial loading. The horizontal fixture was adjusted transversely to align it with the panel axial centerline. The back set of swivel pads on the horizontal fixtures were then tightened to flatten the horizontal edge of the panel, set with a torque wrench, and fixed in place with epoxy. The panel with all of the vertical and horizontal edge test fixtures installed is shown in Figure 12, with a detail view of one corner of the panel shown in Figure 13.

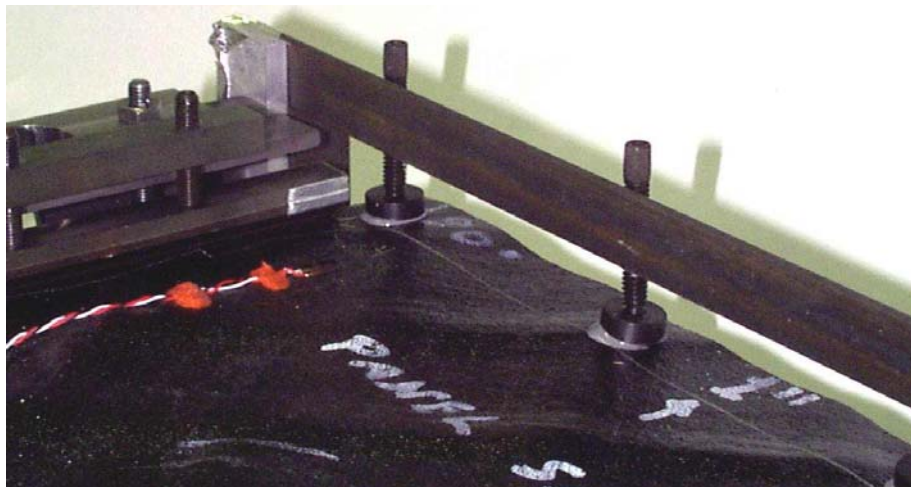
Figure 13. Detail of panel with installed test fixtures.

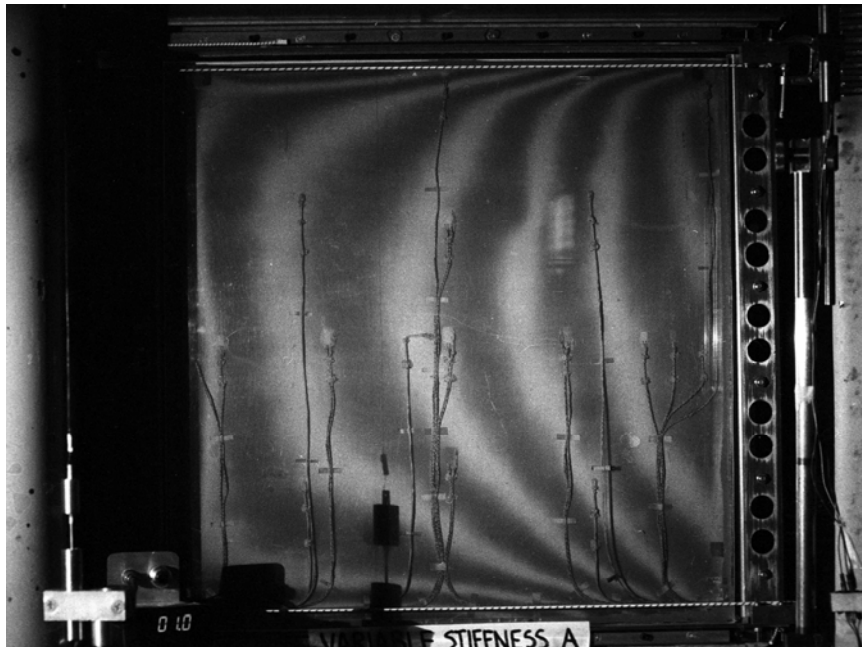
Figure 15a. Front of panel test setup.

The panel and its attached test fixtures were then installed in a 300 klb-capacity mechanical test stand for the end compression test. The front and back of the panel in the test stand are shown in Figures 15a and 15b. The photograph of the panel front also shows part of the shadow moiré system used for qualitative measurement of the panel normal deflections. Affixed to a clear Lexan sheet mounted in front of the panel, this grid is comprised of a set of thin, equally spaced black lines used to project shadows from a polarized light onto the white-painted front of the panel.

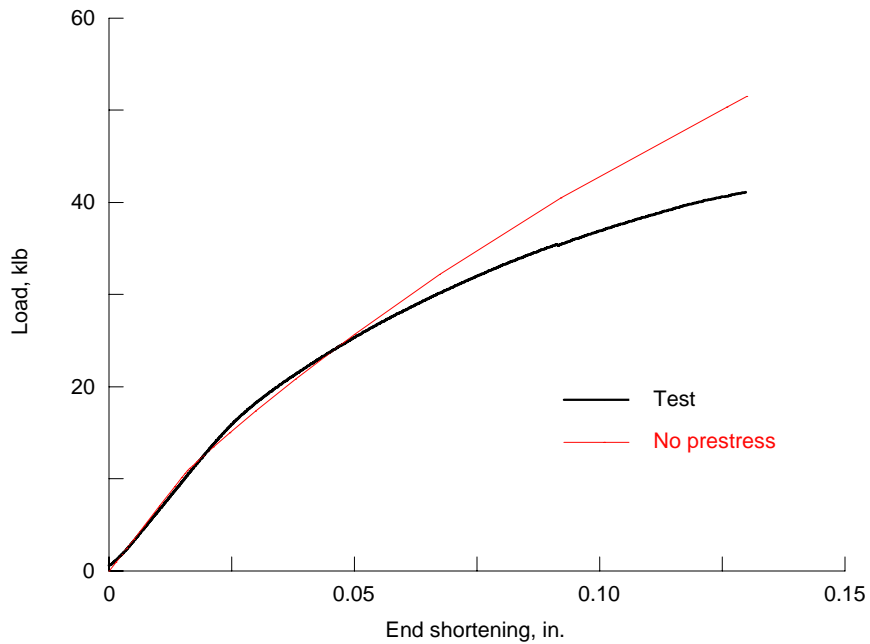
Figure 16. Load vs. axial deflection.

The panel was then loaded to failure in a displacement-control mode at a load rate of approximately 2 klb/min. The average axial deflection of the panel was computed from the four LVDT readings at the platen corners, and is plotted against the corresponding axial load in Figure 16. The average axial deflection shown has been shifted to permit the panel linear prebuckling response to pass through the plot origin. The best-fit slope of the linear prebuckling response is defined as the

panel axial stiffness, and is computed as 649.86 klb/in. between 2 and 13 klb applied load. Above 13.6 klb load, the axial deflection became increasingly nonlinear and the axial stiffness decreased until the panel finally failed at 41.1 klb applied load. The average measured axial deflection at failure was 0.130 inches.

The measured normal deflection at the panel center is plotted in Figure 17. The deflection increased slowly below about 18 klb, and then increased in a roughly linear manner to 0.917 inches at failure. Small discontinuities were observed in the measured load-deflection curves of Figures 16 and 17, which were indicative of a local failure somewhere within the panel near 35 klb load. Shadow moiré

A geometrically nonlinear analysis of this case was then performed with an applied end shortening of 0.130 inches. The predicted load and deflections from this analysis are plotted in Figures 16 and 17 with the corresponding test data. While close during linear prebuckling, the analytical axial deflections were

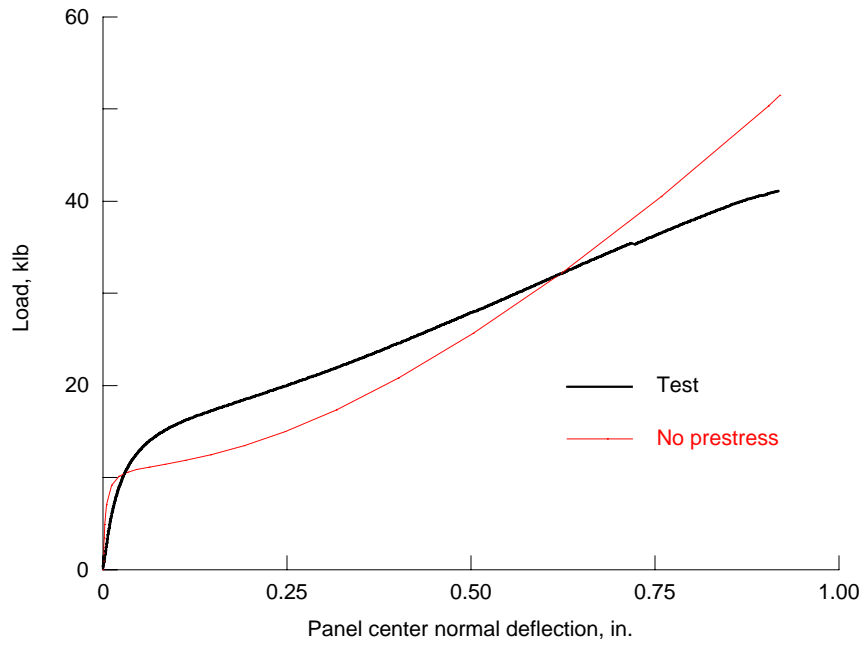
Figure 17. Load vs. normal deflection.

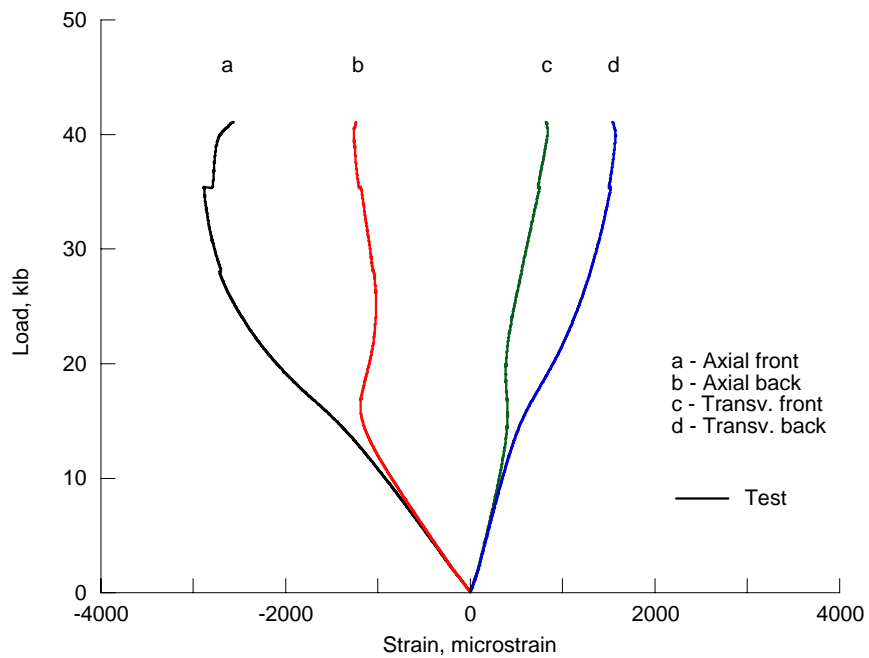
Figure 19. Load vs. strain at panel center.

Axial and transverse strains from gages located at the panel center are also plotted against the axial load in Figure 19. The strains are very close at low loads and diverge slowly up to about 16 klb load, which indicates that minimal bending is taking place. At loads above 16 klb, the back-to-back strains diverge rapidly, and bending at the panel center increases as the response moves deeper into the postbuckling region. Using the test data plotted in these figures, the panel experimental buckling load is estimated to be 17.5 klb, with a coefficient of variation of 8.6 percent.

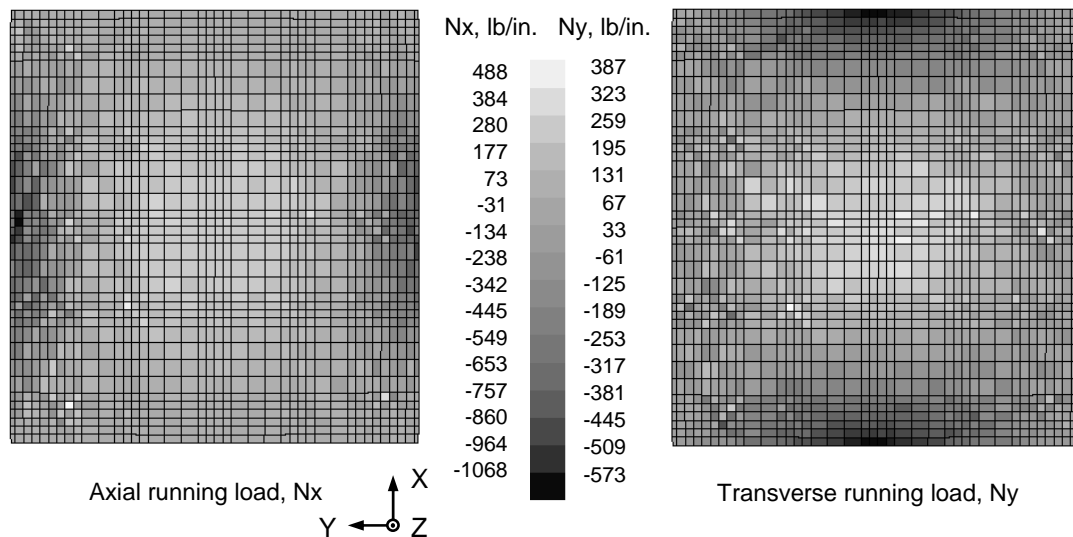
Figure 20. Internal running loads from mechanical prestress.

The geometric imperfections measured after installation of the test fixtures (Figure 14) were subtracted from the measured geometric imperfections taken after completion of the panel curing process (Figure 8). This full-field set of deformations was then imposed as applied displacements onto the finite element model of the cured panel, thus forcing the model into the fixtured configuration. Predicted internal stress resultants N_x and N_y generated in the panel are shown in Figure 20. The panel center has large tensile loads in both directions, with compressive stresses along the free edges parallel to the axes of the running loads.

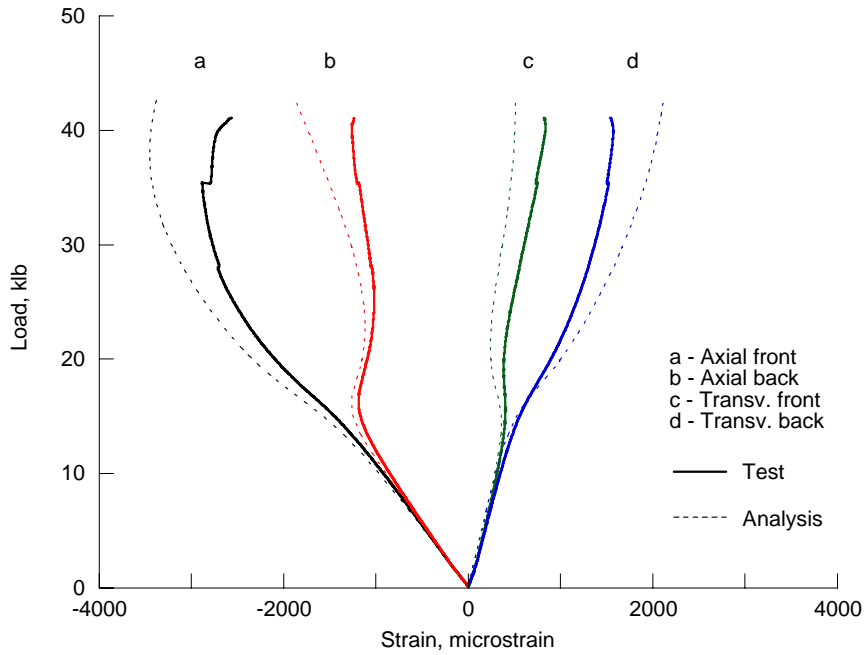
Figure 23. Load vs. strain at panel center.

are plotted in Figures 22 and 23 for the normal deflection and strains (respectively) at the panel center, and also agree well with the corresponding experimental results.
