Particle Analysis Pitfalls

David Hughes
GSFC

Tony Dazzo
Swales Aerospace

Introduction

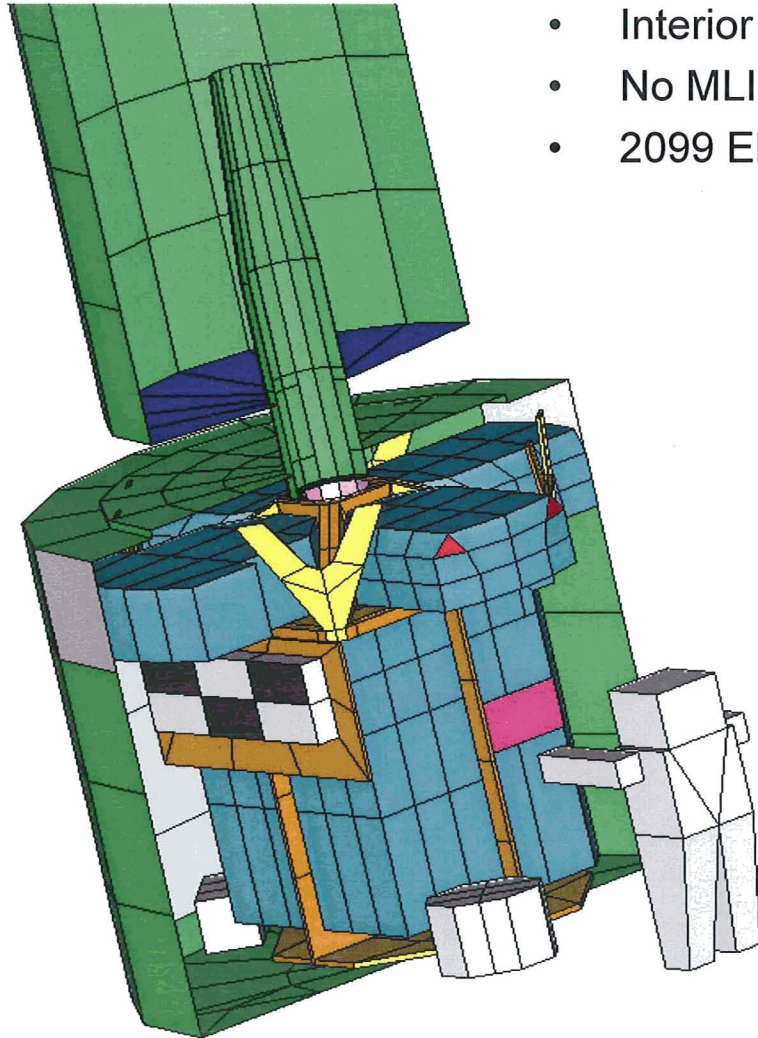
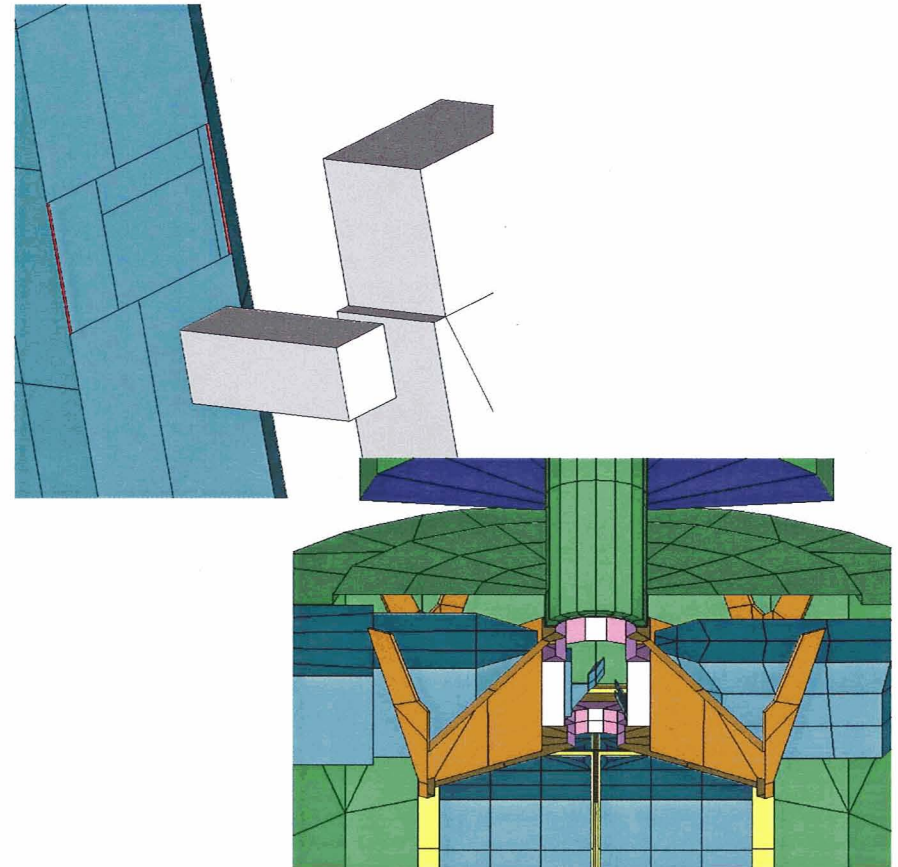
STIS Repair: Finite Element Mesh

- Interior of HST + 1 Astronaut
- No MLI / Harnesses, No Orbiter
- 2099 Elements

- Finite element mesh created in I-DEAS
 - Currently, only internal surfaces
 - Individual components modeled with coarse, medium, and fine meshes
- Black-body viewfactors generated using I-DEAS TMG Thermal Analysis
- Grey-body viewfactors calculated using Markov method
- Particle distribution modeled using an iterative Monte Carlo process (time-consuming); in house software called MASTRAM
- Differential analysis performed in Excel
- Visualization provided by Tecplot and I-DEAS

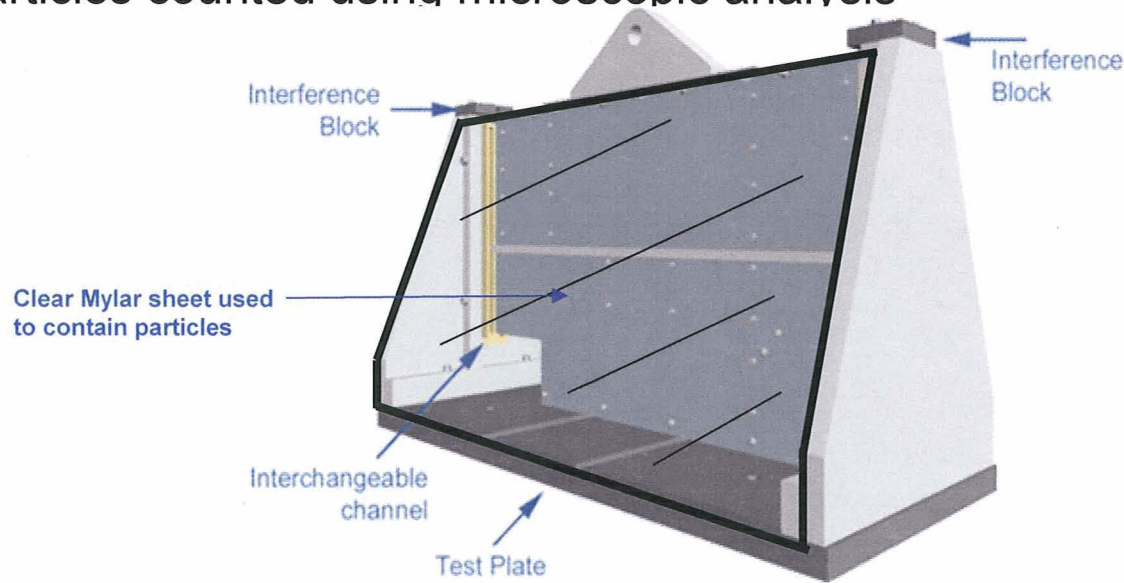
Test Configuration

- This study determined the debris generated during the card removal in a series of different card-lok configurations
 - Card-loks fully locked
 - Interference blocks used
 - Card-loks locked and then unlocked
- Particles vacuumed onto gridded filter paper after test run
 - Particles counted using microscopic analysis

- Caveats
 - Nominal case produced more particles than Card-Locked case
 - Used the Nominal case for conservatism
 - Test boards were warped, so may have generated more particles during insertion than the flight boards will

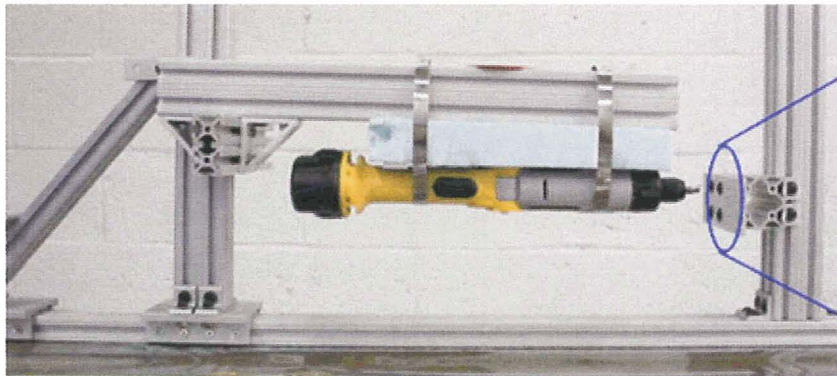
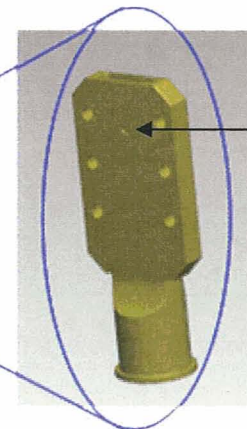
Fastener through-hole

- Determined contamination generated as it correlated to driver speed, force applied to fastener, and stuck/unstuck fastener
- Utilized the CATs team's Head Deformation Test configuration
 - Particle Capture Vacuum Attachment (PCVA) was designed to capture particles for contamination study
- PCVA mounted to fastener mounting plate
 - Bottom of PCVA was attached to filter holder, then the filter holder to a vacuum
- Fastener was extracted through through-hole or left bound for three seconds as determined by test plan
- Filter caught particles as fastener was extracted, and tapelifts were performed on fastener head and driver bit
 - Particles counted using microscopic analysis

- Caveats
 - Only tested #4 torque set fasteners
 - Fastener #4 torque set – 39 count present
 - Fastener #4 SHC – 56 count present
 - Fastener #8 SHC – 16 count present
 - Metallic particles, only
 - In use, tool shaft might chip Lexan cover, but test setup prevented this
 - Locking compound did not shed an appreciable number of particles
