APPLICATION OF TERAHERTZ RADIATION TO THE DETECTION OF CORROSION UNDER THE SHUTTLE'S THERMAL PROTECTION SYSTEM

ABSTRACT. There is currently no method for detecting corrosion under Shuttle tiles except for the expensive process of tile removal and replacement; hence NASA is investigating new NDE methods for detecting hidden corrosion. Time domain terahertz radiation has been applied to corrosion detection under tiles in samples ranging from small lab samples to a Shuttle with positive results. Terahertz imaging methods have been able to detect corrosion at thicknesses of 5 mils or greater under 1" thick Shuttle tiles and 7-12 mils or greater under 2" thick Shuttle tiles.

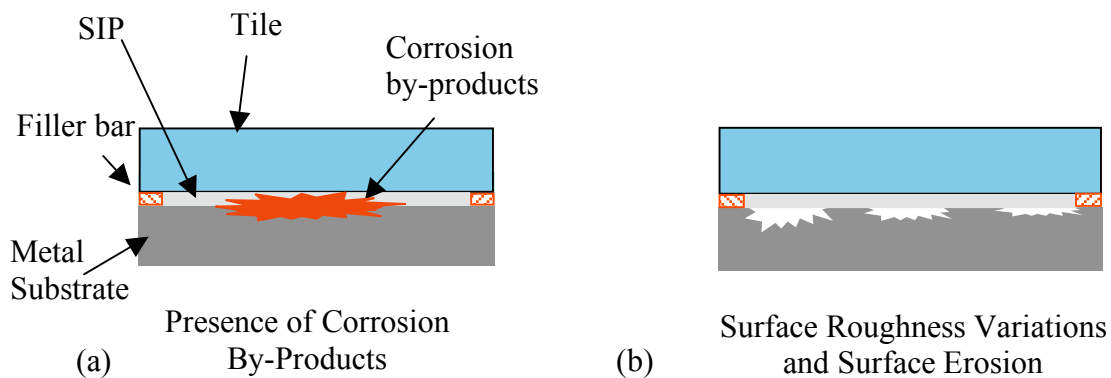
Figure 1. Outline of the structure and the attachment of tiles to the metal substrate. Panel (a) represents a schematic diagram showing the presence of corrosion by-products and panel (b) is a schematic diagram showing the effects on the metal surface without corrosion by-products.

The structure of the shuttle tile mounting system is roughly outlined in Fig. 1. The tiles are bonded to a felt-like pad that is known as a Strain Isolation Pad or SIP. The SIP is next bonded to the metal surface of the Shuttle. At the edges of the tiles, a strip of material called a filler bar is attached to the metal substrate, but not to the tile. These materials that are attached to the metal are porous, as are the tiles, and can hold moisture if exposed to water.

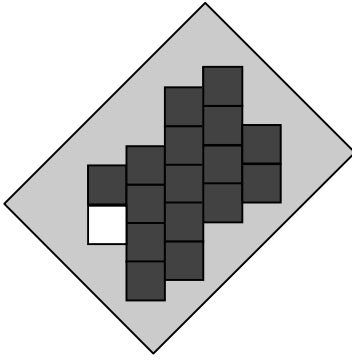
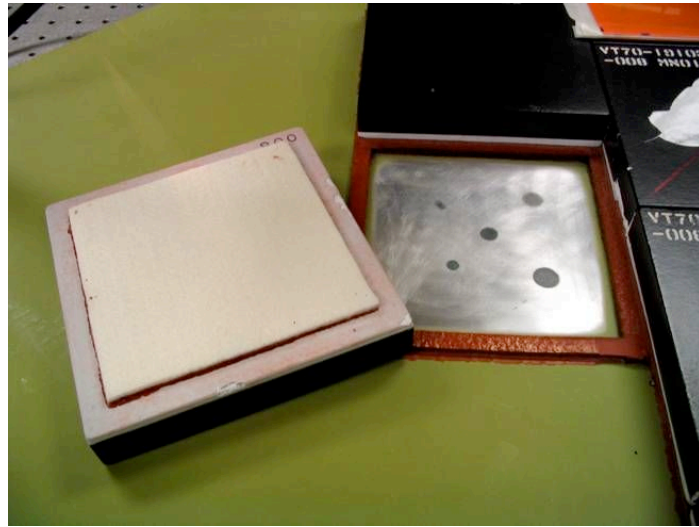
Figure 2. The first corrosion test article. (a) The lay-up of the 6" square tiles. (b) A photo of the corrosion pattern under the tile that was not attached.

Figure 2 shows features of the first corrosion test article. This test article had originally been developed for foam impact studies. The tiles were six inch square and approximately one inch thick. Figure 2a is the tile lay-up pattern. A tile on the lower left corner of the test article (Fig. 2a) was removed and left unattached for this first test as shown in Fig. 2b. The substrate had the protective primer removed and five areas of corrosion were electrochemically created. The corrosion creating process involved placing a containment ring on the surface to hold a small amount of a salt solution. A current was passed through an electrode in the solution to generate the corrosion. The amount of current and the length of time were formulated to produce the desired depth and diameter of the corrosion. The corrosion products were left in place. A second tile was removed and a similar corrosion pattern was developed, but for that location, the tile was reattached and its location was not disclosed. For the exposed tile, the corrosion pattern in Fig. 2b was: the top left spot was 0.25" in diameter and had approximately 2.4 mils corrosion depth; the top right spot was 0.375" in diameter and was too shallow to measure accurately with an optical microscope; the center spot was 0.375" in diameter and the corrosion was 11.8 mils deep; the lower left spot was 0.25" in diameter and the corrosion as 37.4 mils deep; and the lower right location was 0.50" in diameter and 29.5 mils deep. A follow-up sample, similar in construction to the first test article, was manufactured and used as a blind test sample, i.e., it was not disclosed as to which tile locations were compromised or what corrosion existed under those tiles.

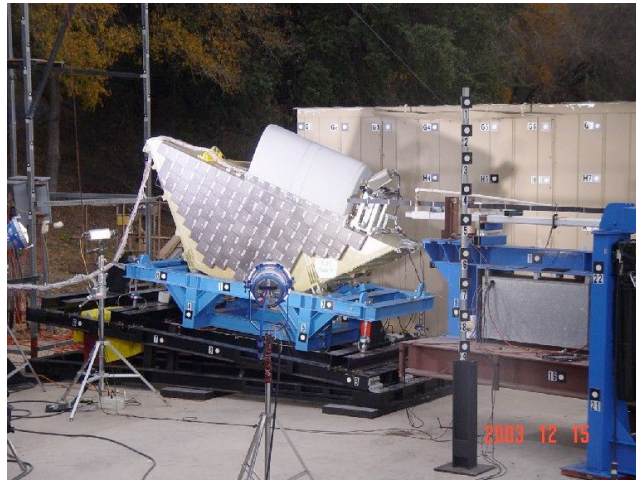
Figure 3. Photo of the T35 training article, which was also used for foam impact testing.

The final test article is the T35 training article (see Fig. 3), which was originally used to train technician staff to install thermal tiles and carbon-carbon leading edge panels. This article had been used for foam impact testing and accurately represents the actual Shuttle structure. No artificially induced corrosion was created in this article.

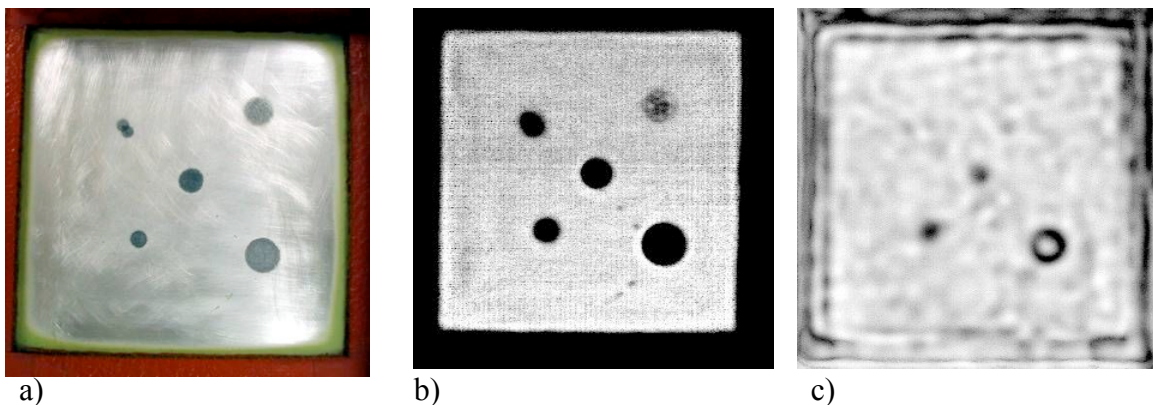
Figure 4. Corrosion images of first test sample. a) Photo of corrosion on metal substrate. b) Terahertz image of metal substrate without tile. c) Terahertz image of metal substrate with intervening 1" tile.

Initial results of imaging corrosion under tiles are illustrated in Fig. 4. Figure 4a shows a photograph of the corrosion area prior to the placement of the tile with the five regions of corrosion visible. Figure 4b is a terahertz amplitude image of the metal substrate showing the corrosion areas without any intervening tile or SIP attachments. All five regions of corrosion are detectable. Figure 4c is a terahertz image of the substrate with the SIP and a 1" tile covering the corrosion areas. In Fig. 4c, the 11.7 mil and deeper corrosion areas were most detectable after integrating the data over the lower frequency ranges (75 - 100 GHz). The 2.5 and shallower corrosion was not detectable due to the image noise induced by the SIP and the tile.

As a further test, this panel also has a tile that was covering a similar set of corrosion areas whose location was not disclosed. After scanning all the tiles for additional corrosion areas, it was readily evident which tile was covering the corrosion region. An image similar to the image in Fig. 4c was obtained.

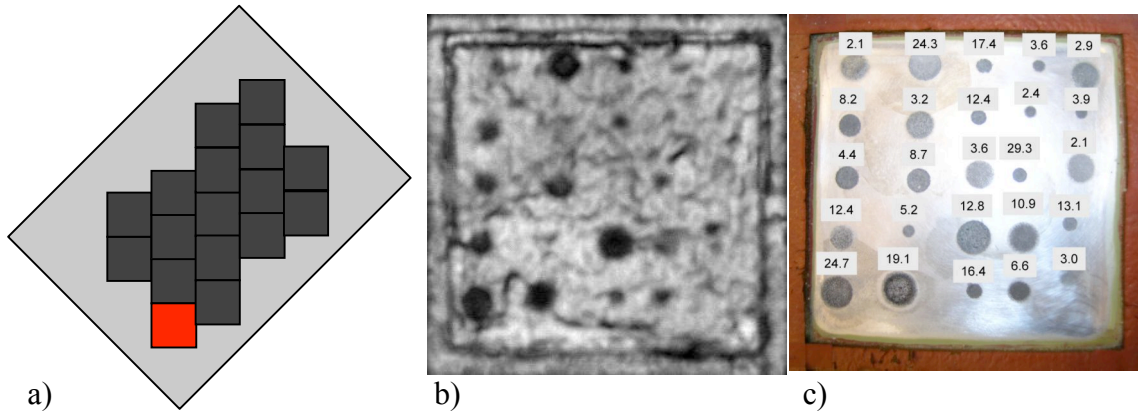
Figure 5. Corrosion images of blind test sample. a) Tile lay-up of the test sample. The indicated square is the location of the tile that was ultimately identified as the tile with hidden corrosion. b) Terahertz image of metal substrate with corrosion hidden by the tile. c) Photograph of the corrosion areas with the depth of corrosion labeled.

For the next test, another 17 tile test panel which had man made hidden corrosion was scanned. This test article was considered a blind test article, and no information was provided prior to reporting the scan results. All scanned tiles produced images similar to each other except one, which is presented in Fig. 5. Fig 5a indicates the location of the tile with hidden corrosion. Figure 5b shows the terahertz image. In this case, the general background pattern was different from the other tile scans and many areas of corrosion were evident. Figure 5c is a photograph of the corrosion areas, which was provided at the end of the testing. The depth in mils of each corrosion site is shown in the photo. Figure 6 is a graph that indicates qualitatively which corrosion sites were detectable and it plots those areas as a function of depth vs. the corrosion area's diameter. It should be pointed out that the determination of whether an area indicated corrosion or not depended both on the terahertz image in Fig. 5b as well as on an investigation of the cross sectional terahertz

image (a time slice of the data that was created in a manner similar to an ultrasonic B-scan) of the suspect area. It is evident that the detectability limit lies in the five mil range for detecting corrosion under one inch tiles.

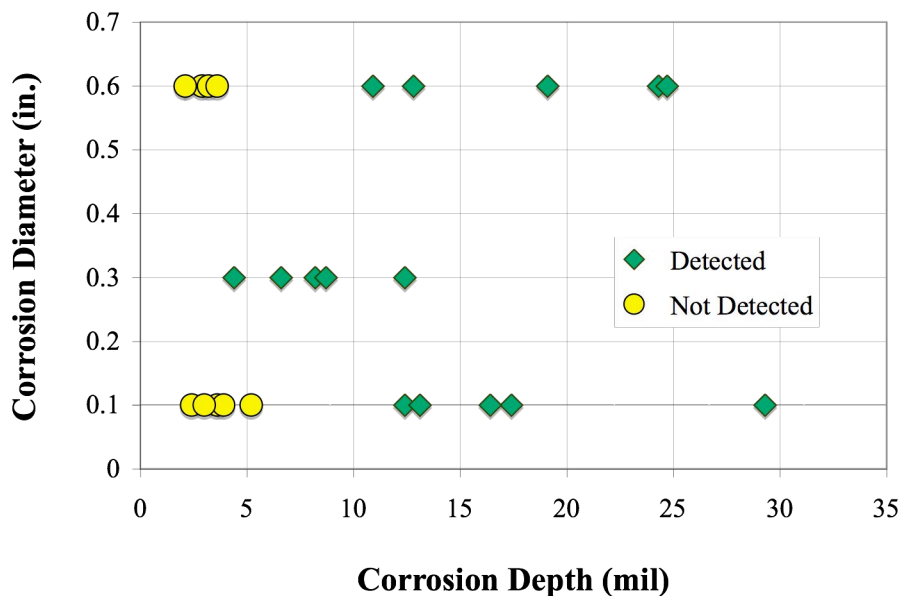
Figure 6. Graph showing the detection vs. corrosion geometry for a 1'' tile.

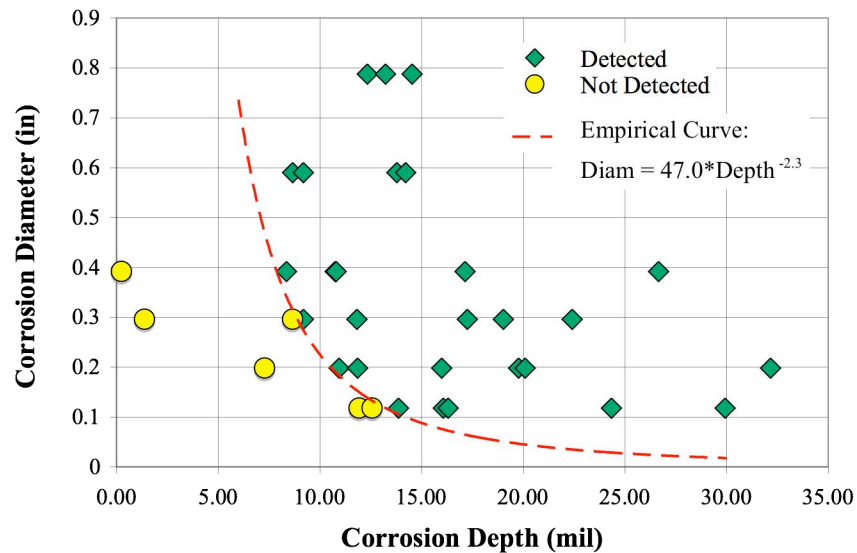
Figure 7. Graph showing the detection vs. corrosion geometry for a 2” tile.

As a follow up to these tests, a twelve-inch square test panel that had 36 areas of corrosion was manufactured. This panel then had tiles of additional thicknesses laid on top and scanned. Figure 7 is a graph showing the corrosion detectability under two inch tiles. In this case, the thicker tiles further degraded the signal for corrosion detection. The detectability of the corrosion areas is plotted against the corrosion depth vs. the corrosion area’s diameter. A dashed line was generated that separated the detected corrosion areas from the undetected areas. The effect of diameter on the detectability is more evident in this graph. The detectability ranges from below seven mils at 0.3 in. diameter up to twelve mils at 0.1 in. diameter.

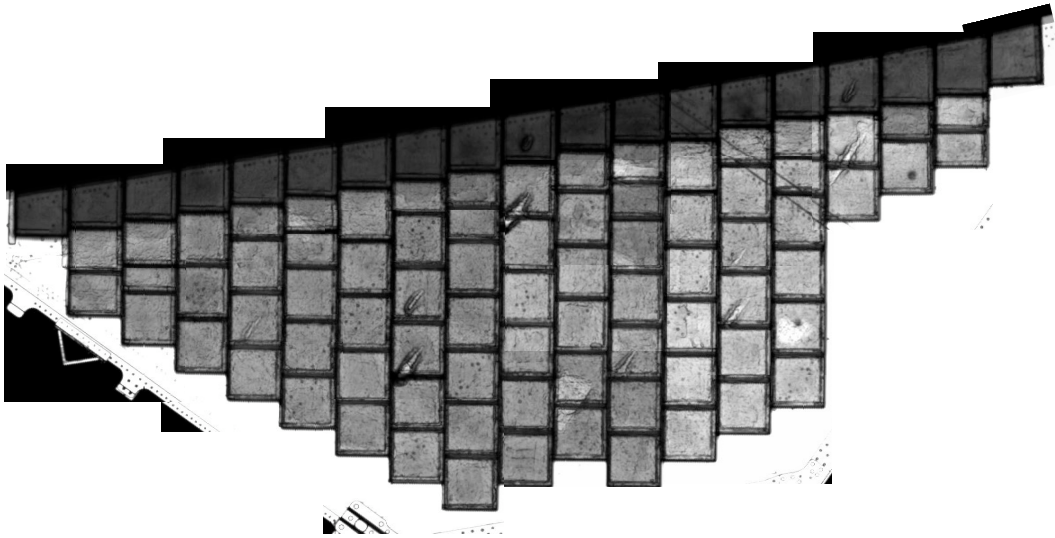
Figure 8. Terahertz image of the T-35 test article showing impact damage, subsurface structures, and tile repairs.

These tests illustrate the detection limits on flat plates. The orbiters’ tile surfaces, which are more complex than flat plates, include curved and uneven surfaces, fasteners, joints and substructure. Additionally, the tiles may be marred or repaired in ways that affect terahertz images. To evaluate the effects of these conditions, further tests on a more representative sample were desired. It was decided that the next step was to apply terahertz imaging to a training article that had realistic structures similar to a shuttle’s structure. Those measurements took place at NASA Kennedy Space Center and are shown in Fig. 8. This training article was approximately ten feet long and four feet high and was scanned in smaller regions. Figure 8 represents a collage of the images. This training article has numerous damaged tiles, which are easily seen in the terahertz image. Hy-Lock fasteners were readily evident, especially at the joints. The edge of the training article has a set of high density tiles which are seen as much darker in the image. In addition to the impact damaged tiles which look like either wide streaks in the terahertz image or as lighter areas, there were two repaired tiles which appear as dark dots in the image and are easily identified on the right hand side of Fig. 8. Figure 9a shows a terahertz close up of the training article’s edge. Figure 9b shows a cross-sectional view of one scan line from Fig. 9a. At the right side of the cross-sectional image, there is a leveling compound under the

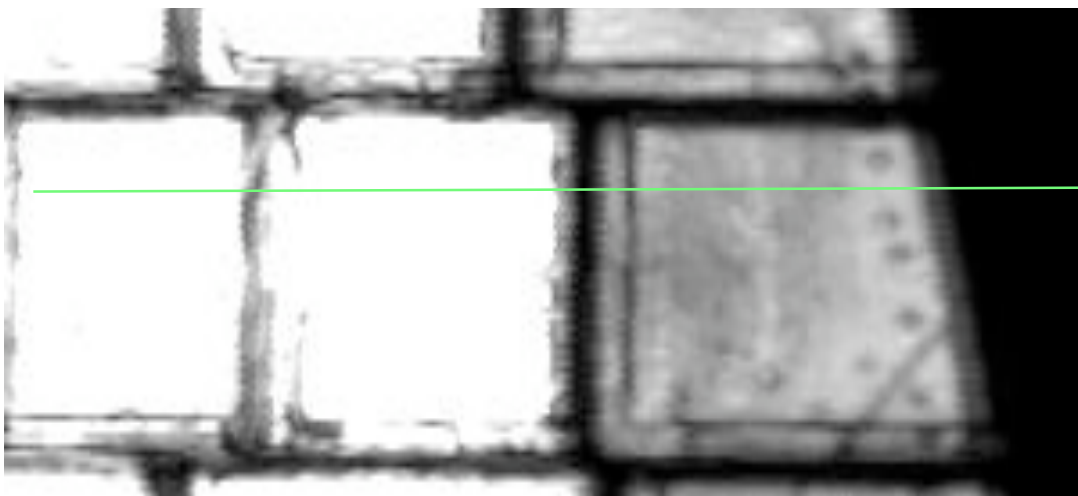
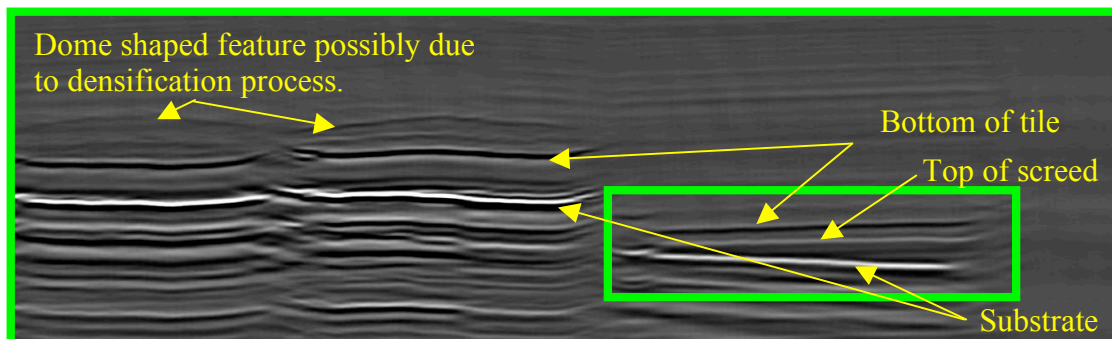
Figure 9. Close up terahertz image from the T-35 training article. A) A terahertz image showing three tiles, one high density and two low density tiles. B) A cross section terahertz image showing the bottom of the tiles, the substrate, and presence of a leveling compound (called “screed”).

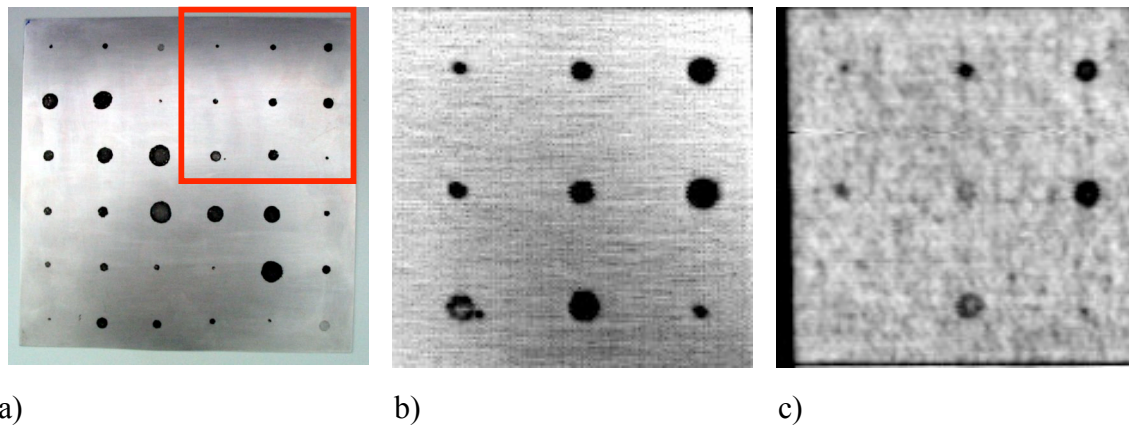
Figure 10. Corrosion images of FRSI test sample. a) Photo of the corrosion sample. The indicated area shows the region scanned in images b) and c). b) Terahertz image of metal substrate without FRSI layer. c) Terahertz image of metal substrate with one FRSI layer.

In addition to tiles, there are other thermal protection materials that are used on the orbiters. One such material is called FRSI for Felt Reusable Surface Insulation. Figure 10 shows the results of scanning with a single layer of FRSI (approximately one half inch thick) on a plate with surface corrosion. Figure 10a is a photograph of the corroded test plate. Figure 10b is a terahertz image of a corner of the corrosion test plate without any FRSI layers. Figure 10c is a terahertz image made with a single layer of FRSI covering the corrosion plate. It is clear that the FRSI insulation degrades the image, as several corrosion regions in Fig. 10b are no longer discernable in Fig. 10c. The degradation is roughly equivalent to that which occurred for two inch thick tiles.
