NASA/TM-2008-215308

Characterization of Fatigue Damage for Bonded Composite Skin/Stringer Configurations

Isabelle Paris and Michael Cvitkovich
National Research Council
Langley Research Center, Hampton, Virginia

May 2008

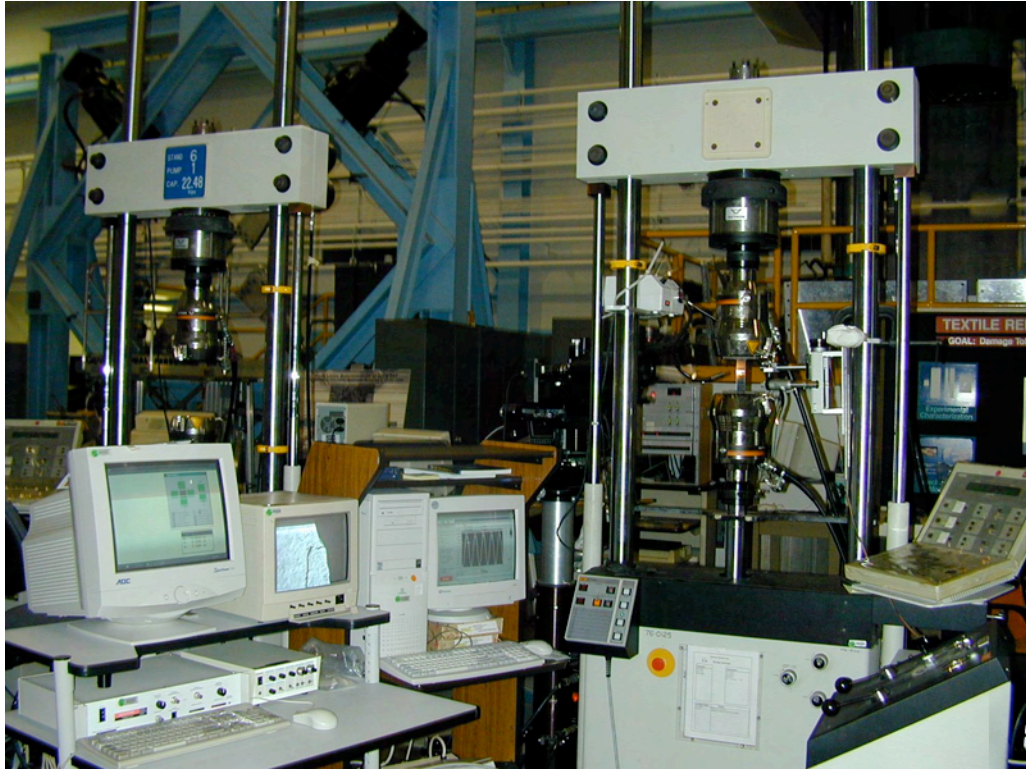
Figure 2. Fatigue tension test set-up.

(a). Test set-up.

(b). Specimen in the loading grips.

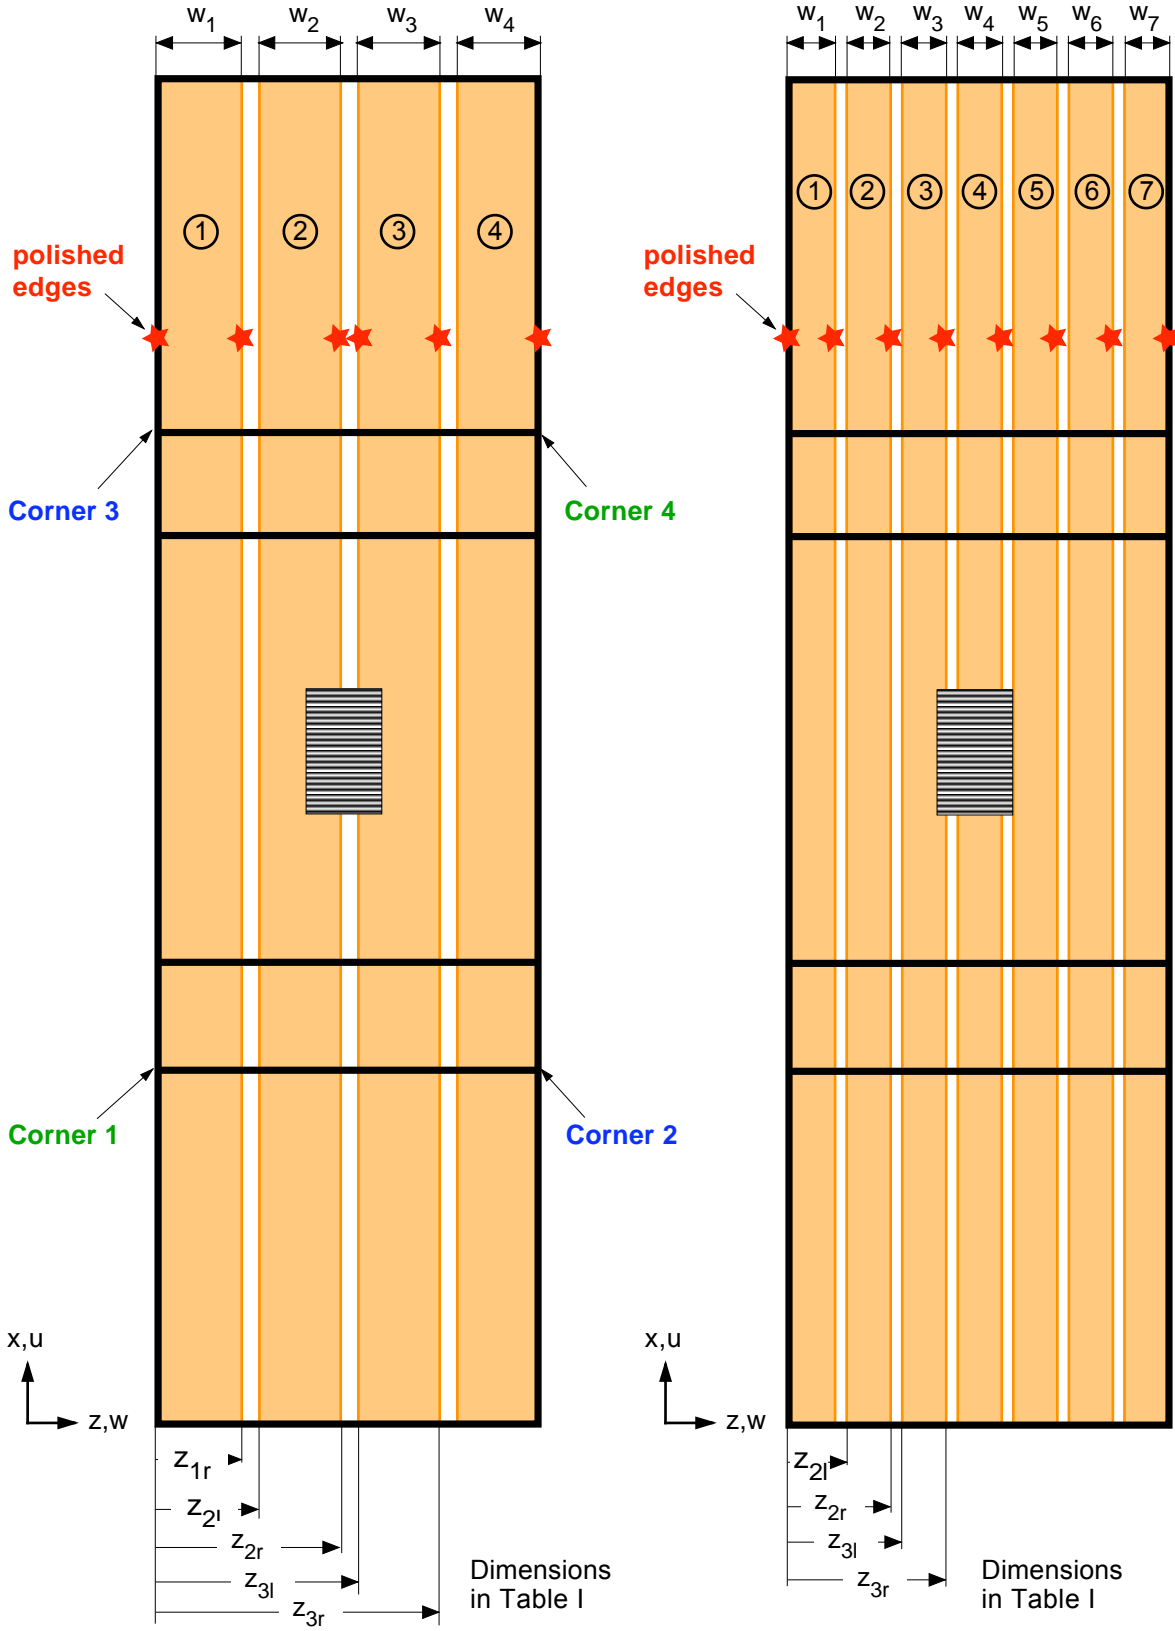
Figure 6. Cutting of specimens.

(a) Specimen 8B-06

(b) Specimen 10B-03

and more uniform compared to the other edge. The observations were verified by cutting the specimens into slices as shown in Figures 6 and 7. Micrographs of the edges were obtained to reveal the growth in the interior of the specimen. The observations are discussed later.

The images for the other specimens (10B-03, 9B-02 and 7B-06) reveal a similar growth pattern as shown in Figures 17, 18 and 19. For specimen 10B-03, shown in Figure 17, the observations were also verified by slicing the specimens as shown in Figures 6 and 7. The observations from micrographs of the edges are discussed later. For specimen 10B-03, shown in Figure 18, the gray intensity is less pronounced which made it more difficult to determine how far the contrast fluid had penetrated into the damaged section. For specimen 7B-06, the delamination lengths measured at the polished edges of corners 1 to 4 were added to Figure 19. The measured lengths are listed in Table III.

Two specimens (8B-06 and 10B-03) were cut into slices as discussed earlier. The slices are shown in Figures 6 and 7. The edges marked with a red star in Figure 6 were polished and micrographs were obtained to reveal the growth in the interior of the specimen. The micrographs taken across the width of specimen 8B-06 along the flange edge from corners 3 to 4 were assembled as shown in Figure 20. A detail of an x-ray radiograph (taken from Figure 16c) and a sketch of the slices (taken from Figure 6a) were included to help identify the location of the micrographs with respect to the specimen width. At the specimen edges (corners 3, $z_{11}=0.0$ mm and 4, $z_{4r}=25.578$ mm), only one delamination type (B, in red or A1, in light blue) was observed as discussed earlier and shown in Figures 14 and 15. Based on the observations at the edges of the specimen, a simple transition from delamination type B to type A1 was expected to occur in the interior of the specimen. The micrographs, however, reveal a more complex pattern where both delaminations (B and A1) are present simultaneously across most of the width of the specimen. The mechanics of the failure are discussed below. The delamination lengths were measured using image analysis of the scanned and stitched micrographs. The delamination lengths are listed in Table IV. The delamination outline seen in the X-ray image (dark area) captured the size of the delamination well, which is shown by adding delamination lengths (B, in red or A1, in light blue) measured from the micrographs. The images obtained from X-ray radiography, however, were not able to reveal the complexity of the damage pattern observed. An ultrasound inspection, which includes a D-scan, time-of-flight scan or depth scan may be required to identify the complete pattern.

The micrographs taken across the width of specimen 10B-03 along the flange edge from corners 3 to 4 were assembled as discussed above and are shown in Figures 22a and b. A detail of an x-ray radiograph (taken from Figure 17d) and a sketch of the slices (taken from Figure 6b) were included to help identify the location of the micrographs with respect to the specimen width. The same complex pattern as discussed above for specimen 8B-06 is observed here, and both delaminations (B, in yellow and A1, in magenta) are present simultaneously across most of the width of the specimen. The delamination lengths measured at the edges are listed in Table III.

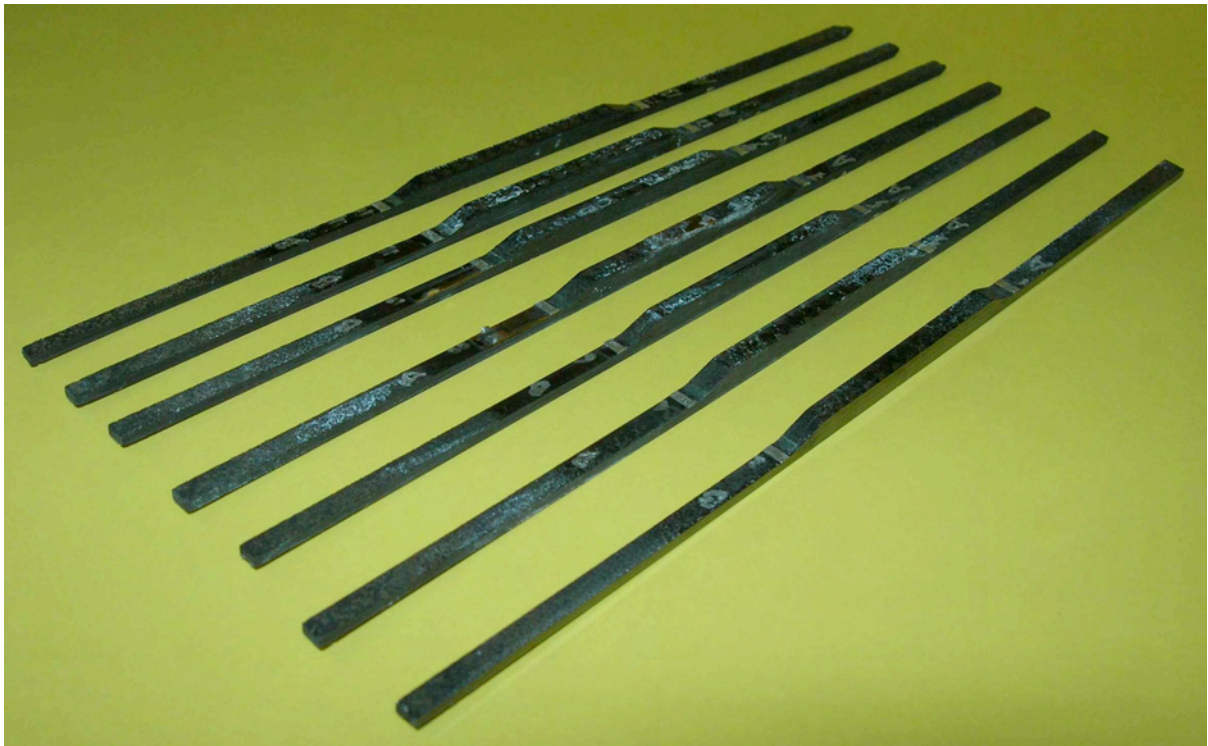
Figure 7. Sectioned specimens.

(a). Specimen 8B-06 cut into four slices.

(b). Specimen 10B-03 cut into seven slices.

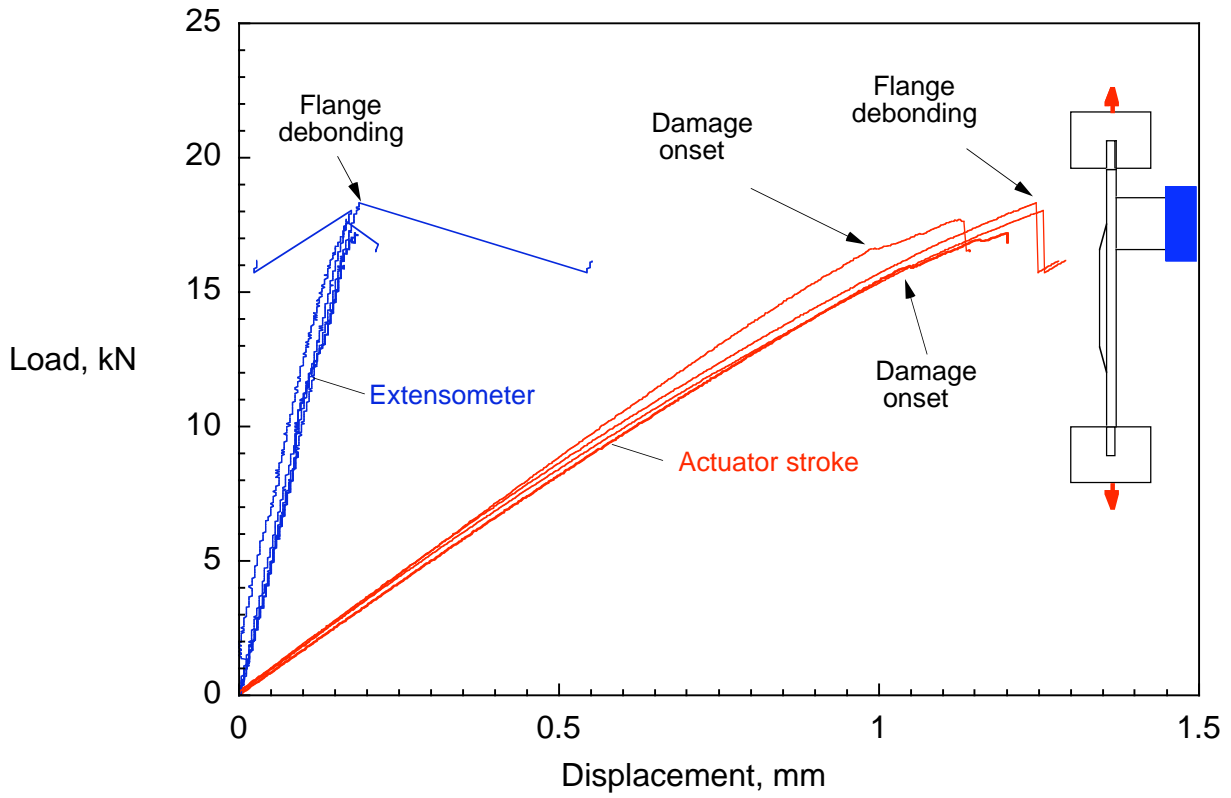
Figure 8. Load-displacement plots for quasi-static tension tests [7].

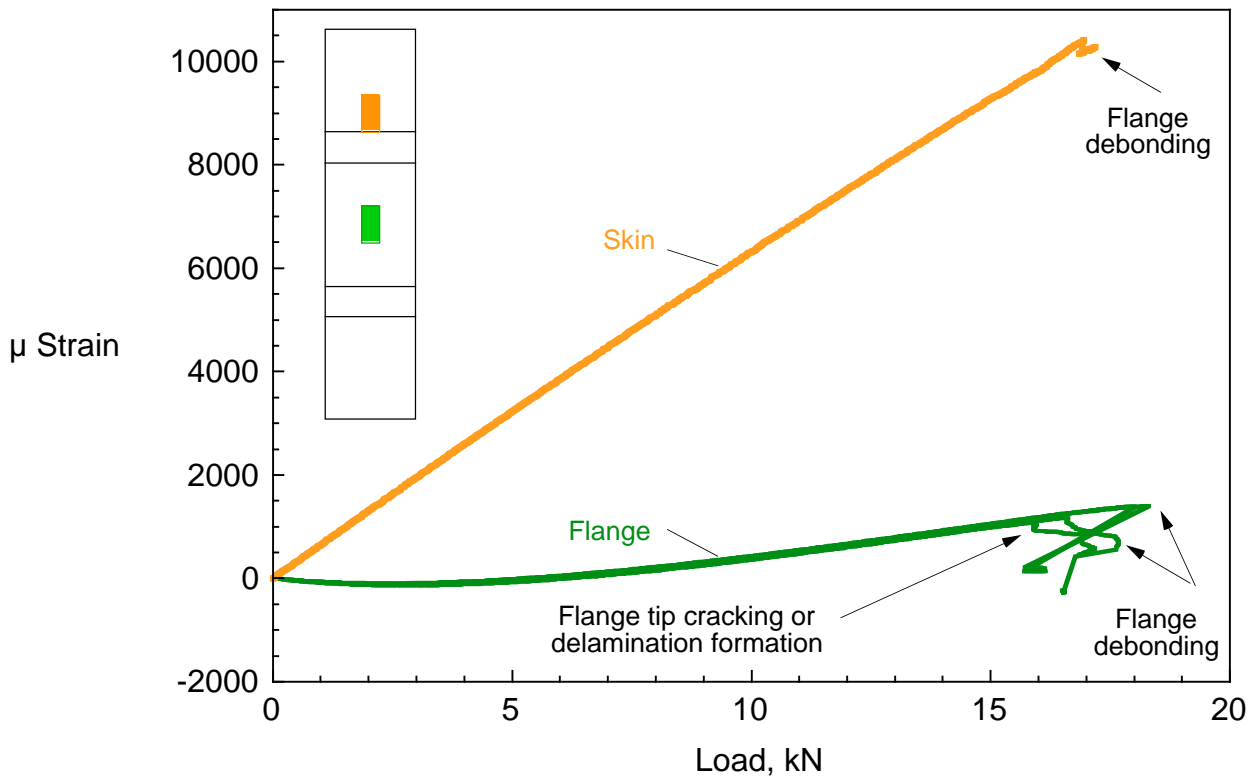
Figure 9. Flange strain-load plots for quasi-static tension tests [7].

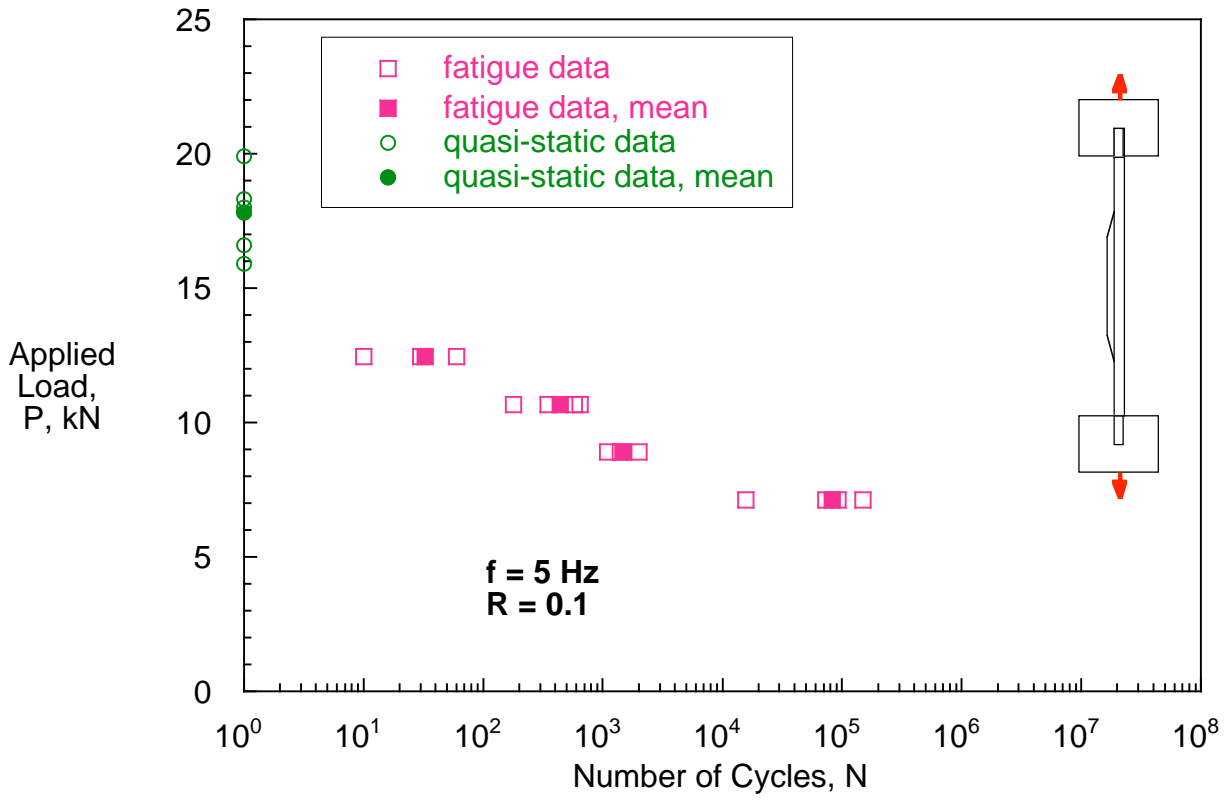
Figure 10. Matrix crack onset fatigue life for composite skin/flange debonding [7].

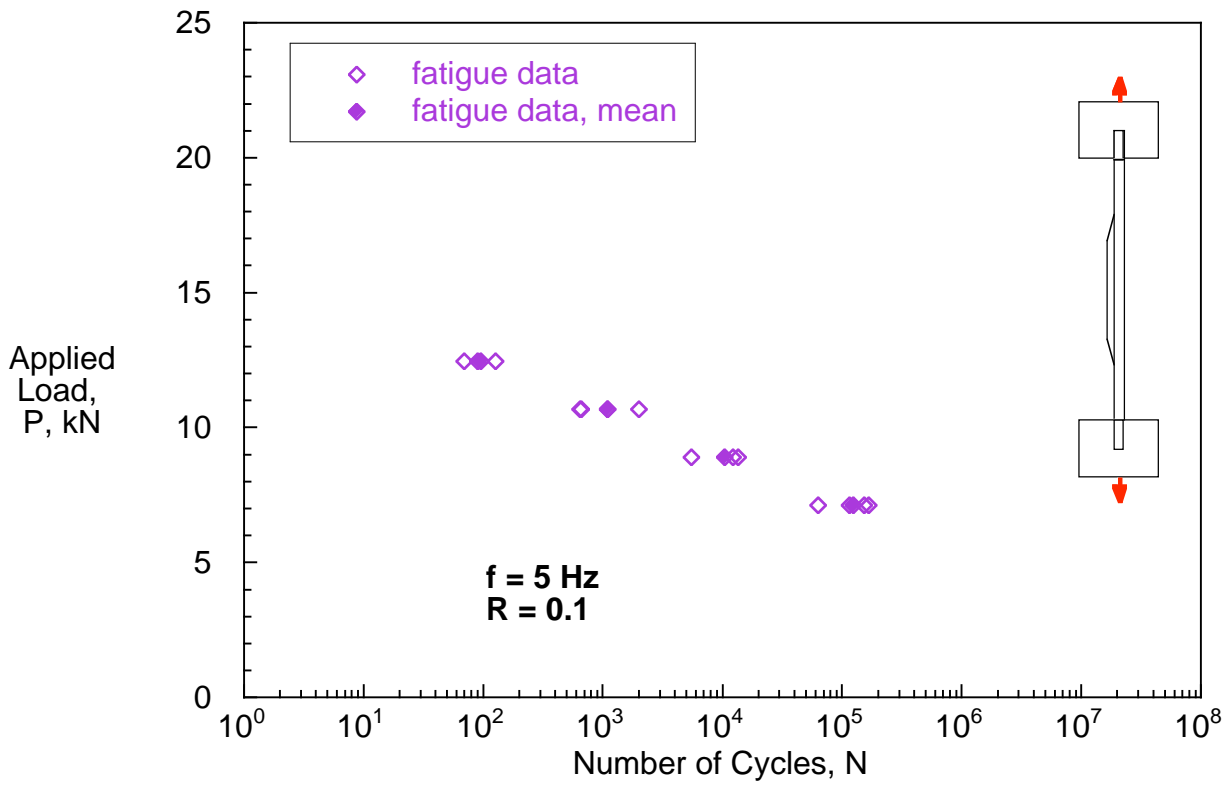
Figure 11. Delamination onset fatigue life following matrix cracking for composite skin/flange debonding [7].
