Guidance, Navigation & Control (GN&C) Best Practices for Human-Rated Spacecraft Systems

Neil Dennehy
NESC

Program Management Challenge 2008

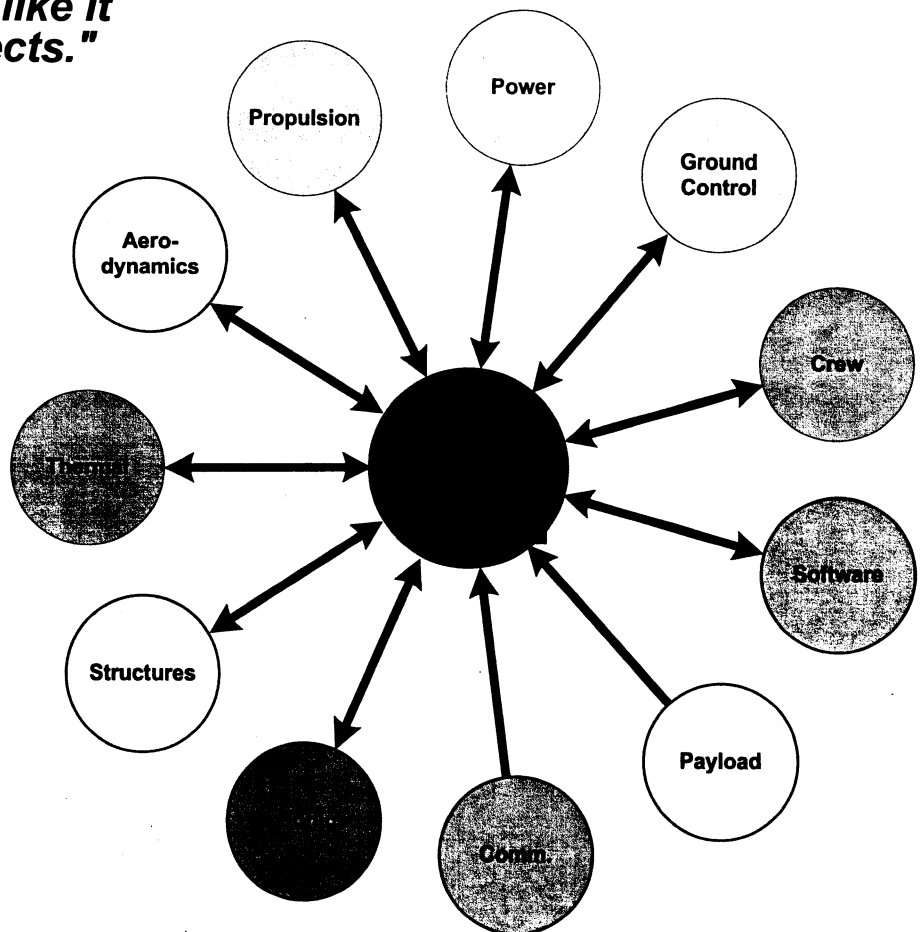
GN&C Interacts With and is Influenced by Virtually All Other Spacecraft Subsystems

Consider: How do faults in other subsystems affect GN&C?

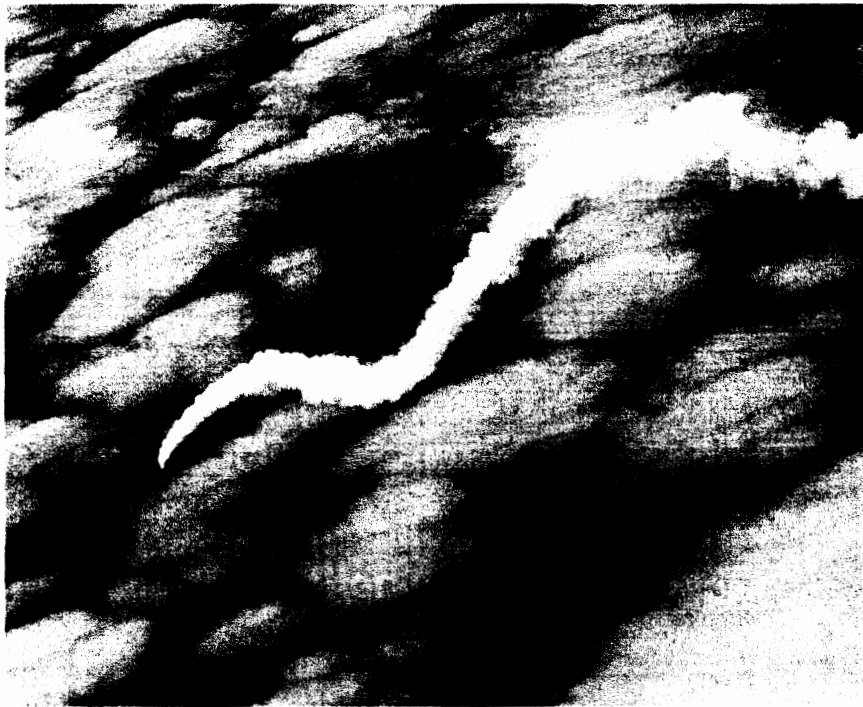
X-43A / Pegasus Launch June 2, 2001

NASA Dryden Flight Research Center Photo Collection
<http://www.dfrc.nasa.gov/gallery/photo/index.html>
NASA Photo: EC01-0182-11 Date: June 2, 2001 Photo by: Jim Ross
The X-43A/Pegasus combination dropped into the Pacific Ocean after losing control early in the first free-flight attempt.

- The trajectory that was selected to achieve the mission was at a lower altitude (i.e. a higher dynamic pressure) than a typical Pegasus trajectory.
- Flight went as planned after B-52 drop until pitch-up maneuver.
- Diverging roll oscillation at 2.5-Hz frequency occurred during pitch-up.
- Roll oscillation continued to diverge until about 13 seconds into flight.
- Rudder electro-mechanical actuator stalled & ceased to respond to autopilot at that point causing loss of yaw control.
- Loss of yaw control caused X-43A stack sideslip to diverge rapidly to over 8°.
- Structural overload of starboard elevon occurred at 13.5 sec.
- Loss of control caused X-43A stack to deviate significantly from planned trajectory.
- Vehicle terminated by range control about 49 sec. after release.

1. The vehicle control system design was deficient for the trajectory flown due to inaccurate analytical models which overestimated design margins.
BP #8: Over-reliance/Over-Confidence on Pegasus heritage.
BP #17: Failure to adhere to "Test as You Fly" approach.

2. Failure triggered by divergent roll oscillatory motion at 2.5 Hz, caused by excessive control system gain.
BP #12: Insufficient control system stability margins.

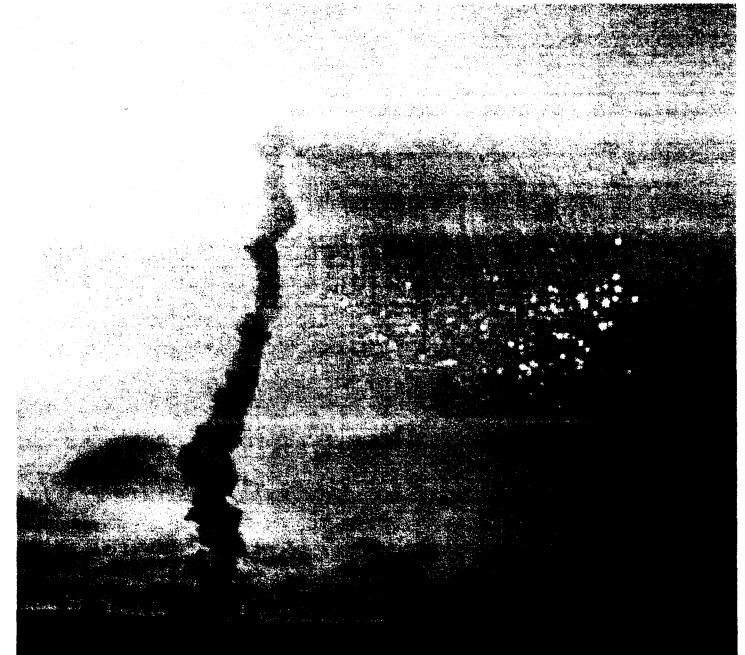
- 39 seconds into the flight the primary Inertial Reference Unit (SRI-1) stopped sending correct attitude data due to a software exception.
- The On-Board Computer (OBC) switched to the backup inertial unit, but SRI-2 also failed due to its independently determined (but identical) software exception.
- The OBC could not switch back to SRI-1 so it took data that was actually part of a diagnostic message written to the bus by SRI-2. This data was interpreted as flight data and used for thrust vector control.
- The sudden swivelling of both solid booster nozzles up to the limit caused the launcher to tilt sharply giving rise to intense aerodynamic loads leading to destruction of the vehicle.

2. Switchover to the backup unit was accomplished, but SRI-2 immediately failed in the same way as SRI-1.
 - BP # 7: *Evaluate if redundancy using identical GN&C components increases or decreases reliability.***

3. The OBC could not switch back to SRI-1 so it accepted SRI-2 diagnostic data as attitude data and generated improper TVC commands.
 - BP #3: *Ensure that Abort/Safe Haven strategies/functions are properly implemented. Ariane-5 was lacking a simple and reliable “Never Give Up” flight control capability.***
