FULL-SCALE HYDRODYNAMIC EVALUATION OF A
MODIFIED NAVY J4F-2 AMPHIBIAN WITH A
0.425-SCALE XP5M-1 HULL BOTTOM
TED NO. NACA DE325

By Norman S. Land, John M. Elliott,
and Kenneth W. Christopher

Langley Aeronautical Laboratory
Langley Air Force Base, Va.

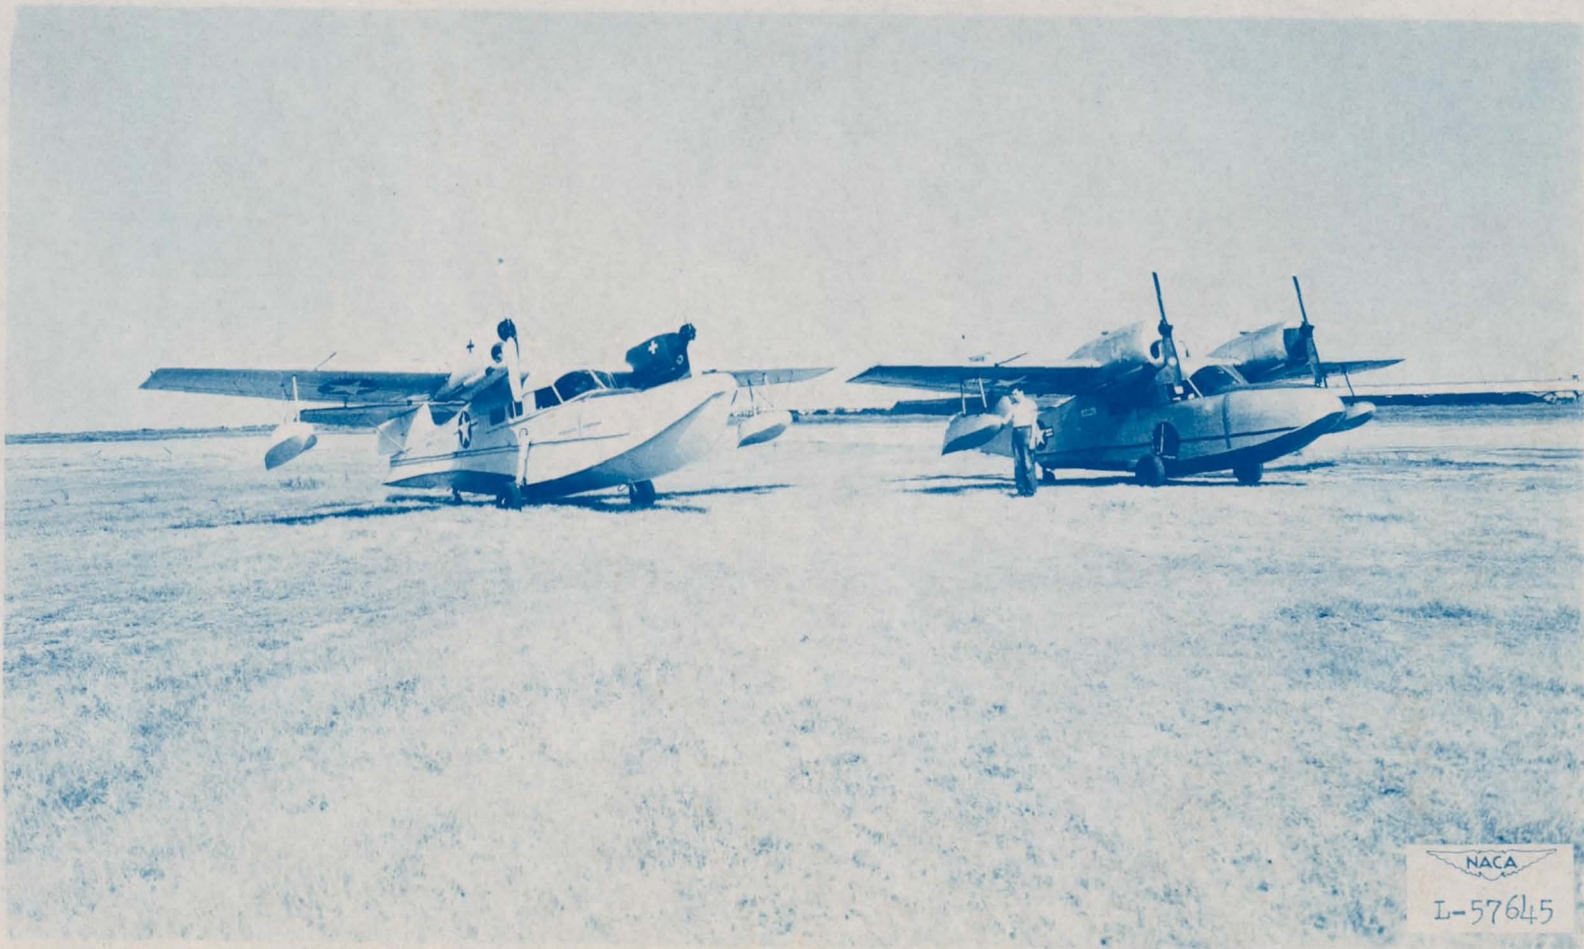
Figure 2.- Three-quarter front view of J4F-2 with 0.425-scale XP5M-1 hull bottom and standard J4F-2.

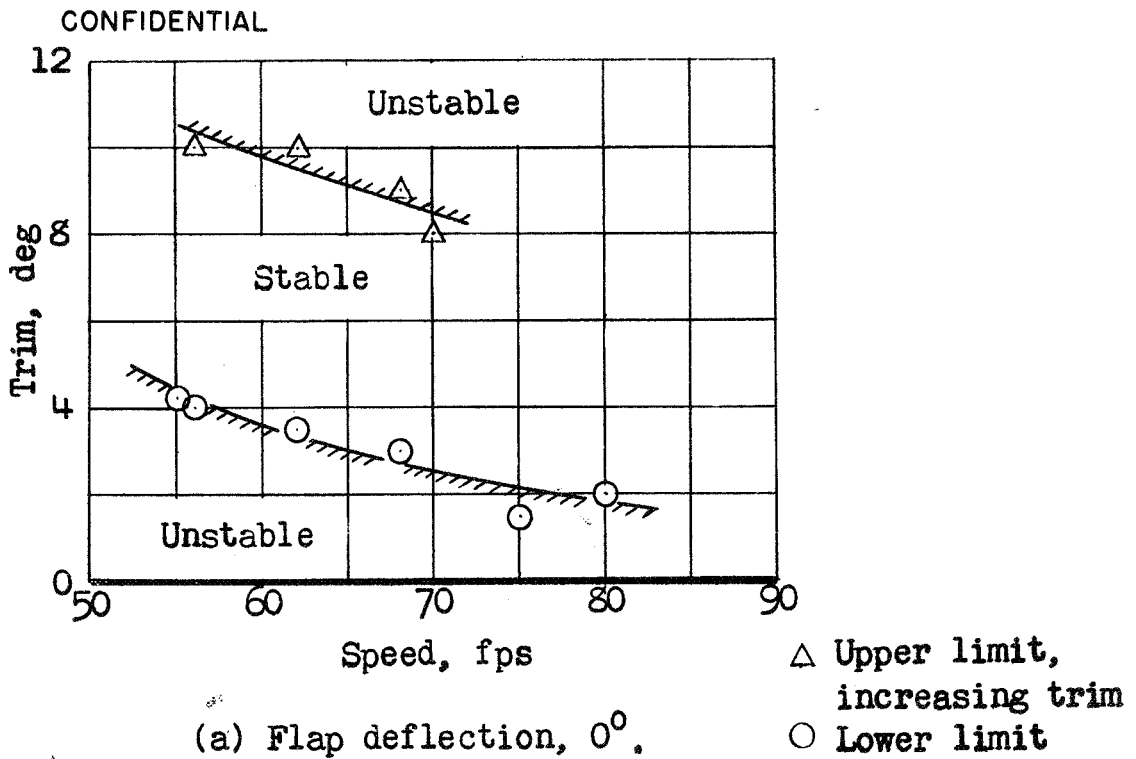
Figure 6.- Trim limits of stability.

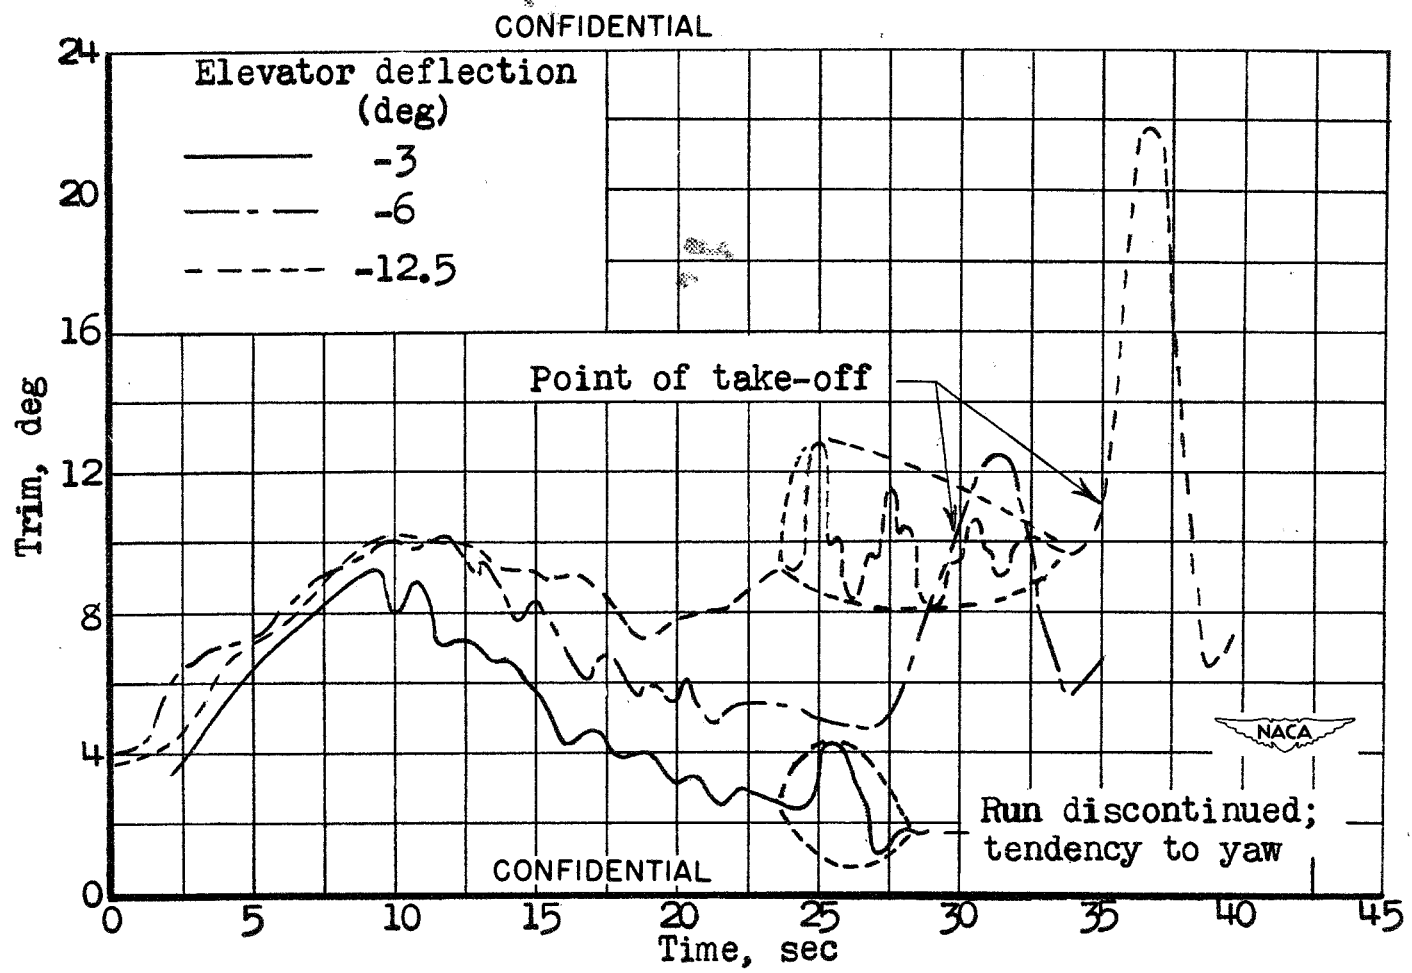
Figure 7.- Typical time histories of trim during take-off. Center of gravity, 25 percent mean aerodynamic chord; flap deflection, 0°.

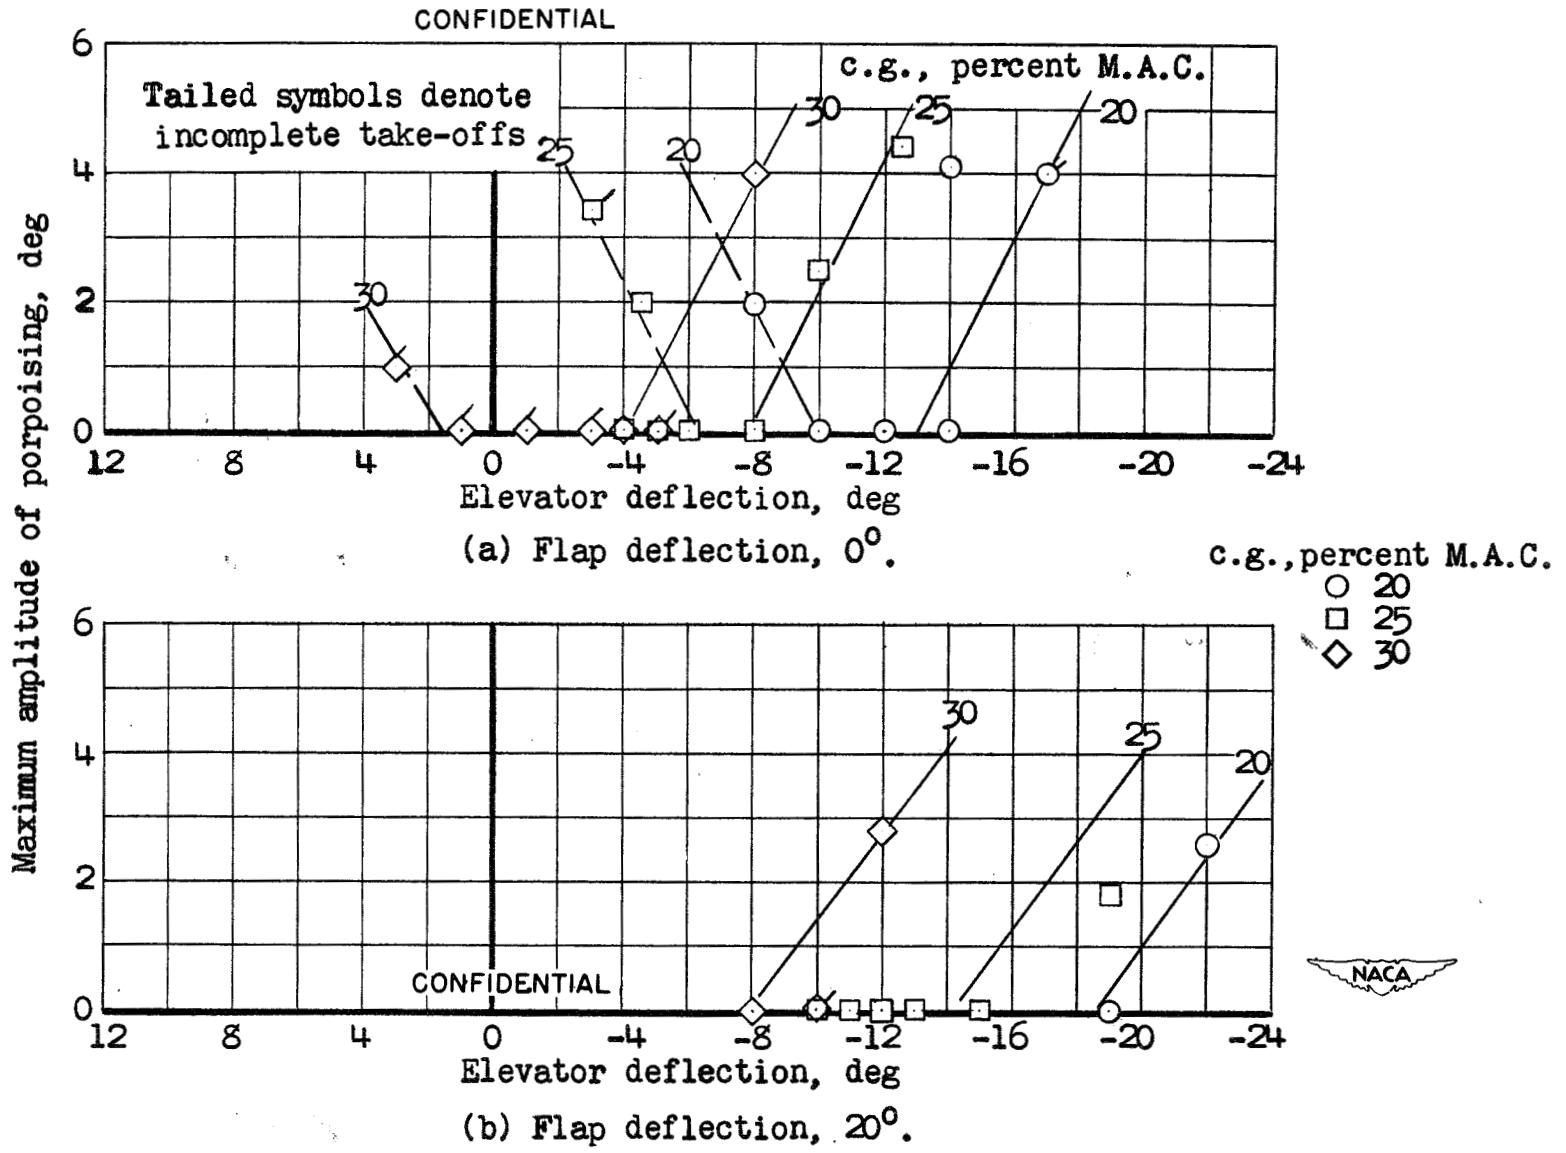
Figure 9.- Maximum amplitude of porpoising during take-off.

These limits for deflection of the elevator as determined by lower- and upper-limit porpoising (fig. 9), by low trims at high speeds (fig. 10), and by abrupt upward pitch at getaway (fig. 11), are plotted against center-of-gravity location in figure 13. This figure shows that porpoising did not limit the elevator range, but the range was limited by low trims at high speeds and by objectionable jump take-offs. The range of fixed-elevator deflections suitable for take-off is seen to be 5° or less.

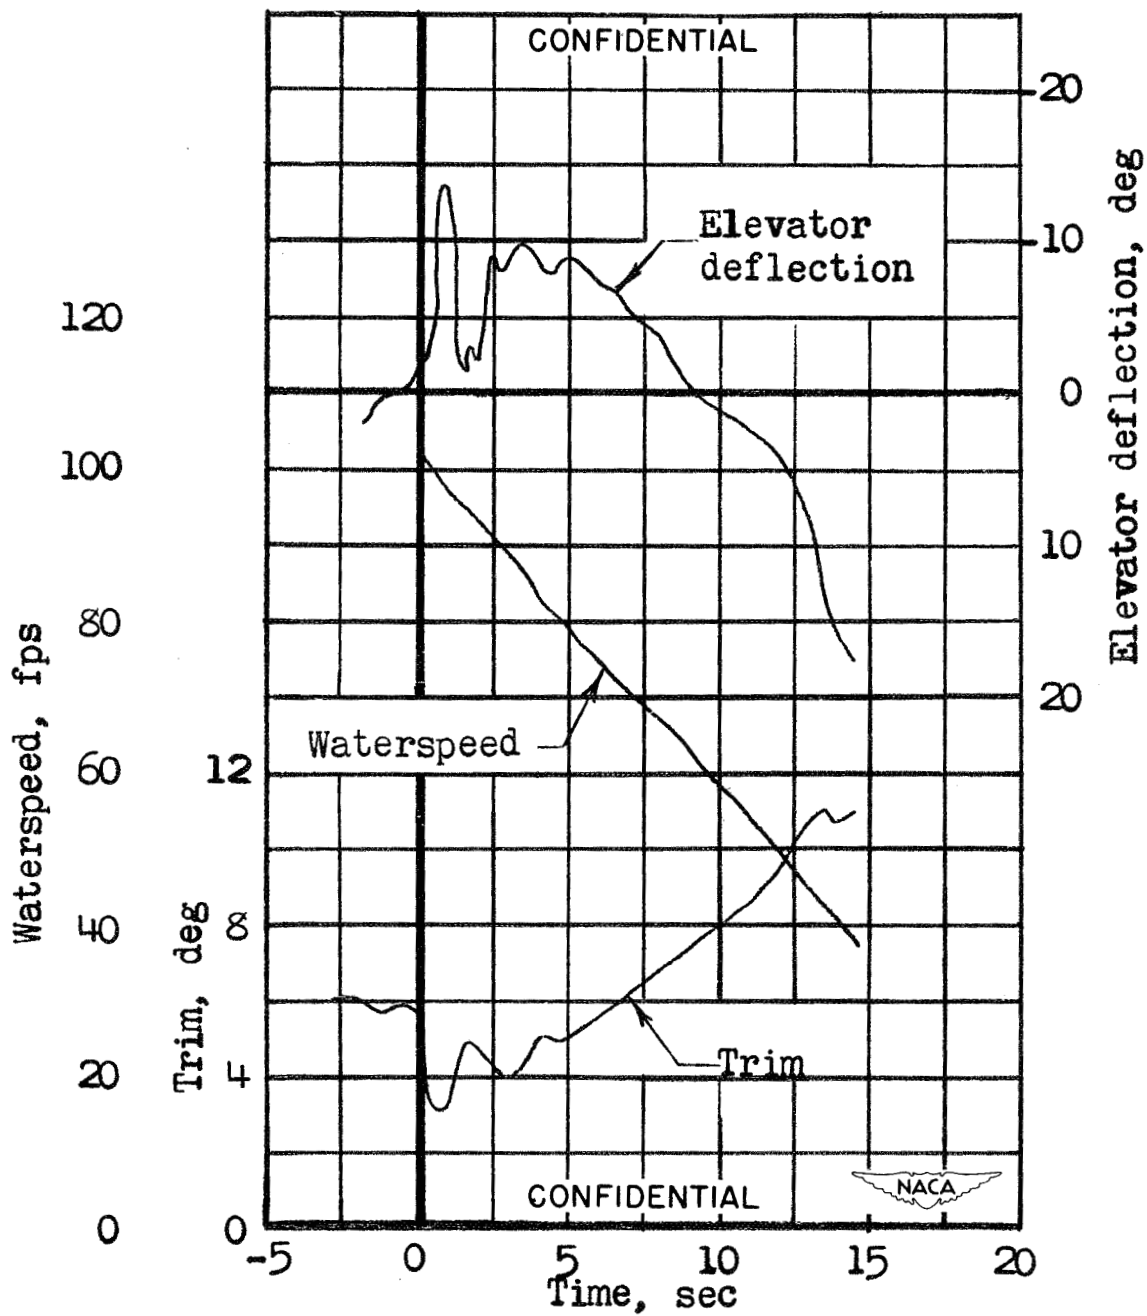
Figure 15.- Typical time history of a landing in smooth water.

The airplane had a tendency to trim down rapidly immediately after contact and required a rapid up-elevator movement to prevent the trim from becoming dangerously low. Occasionally this trimming down was accompanied by yawing. The tendency to trim down at contact was considered objectionable by all three of the pilots who flew the airplane. The time history of a typical landing (see fig. 15) illustrates this nosing-down tendency.

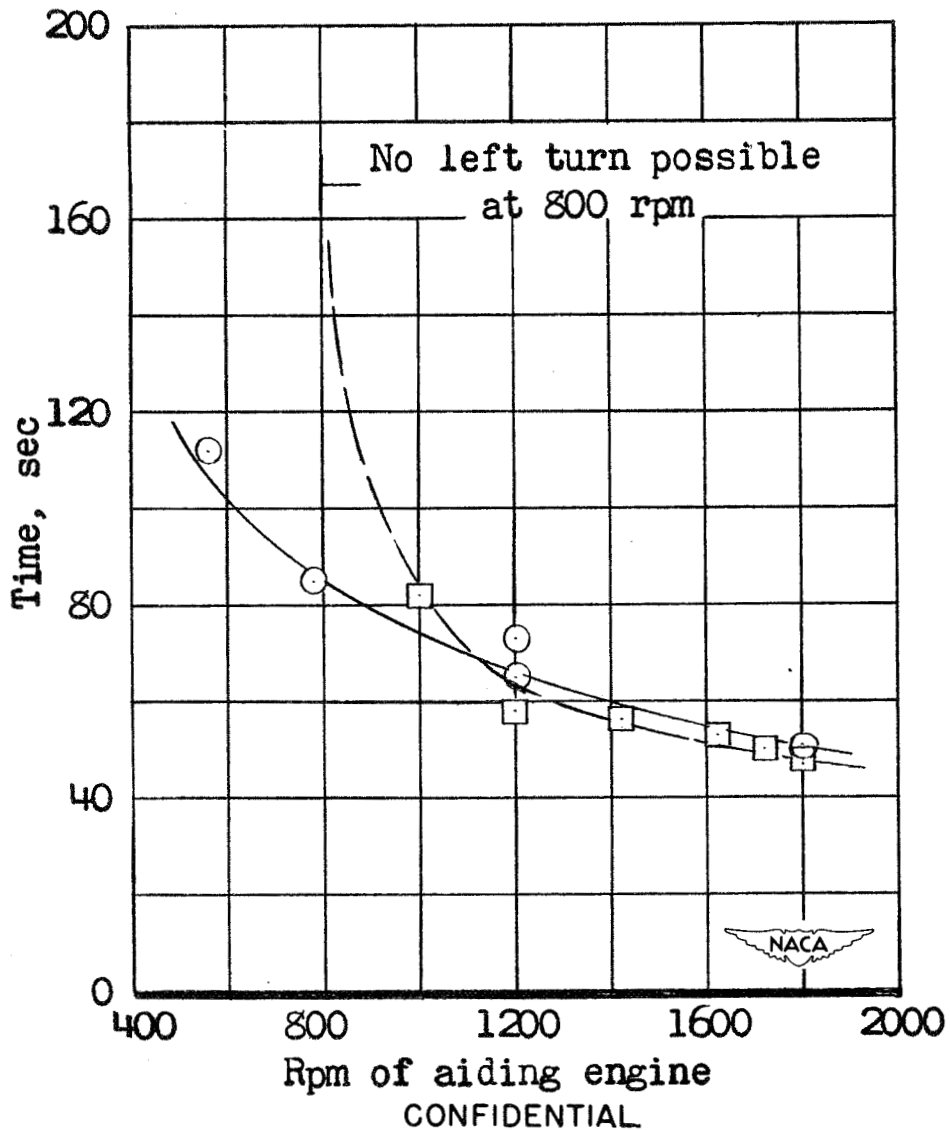
- Right turns
- Left turns

Figure 16.- Time to complete 360° turns at low water speeds.

Low-speed maneuverability. - The time to complete 360° turns is shown in figure 16. At the higher engine speeds there was no significant difference between turns made to the right or left. At low engine speeds, however, the data would seem to indicate an inherent tendency to turn right. Sufficient data were not obtained to definitely establish this tendency as the heading of the airplane relative to the wind at the start of the turn probably influenced the data. Regardless of this uncertainty, the time to complete a turn was long for all conditions that were investigated. Such a slow rate of turn might be expected with this long hull.

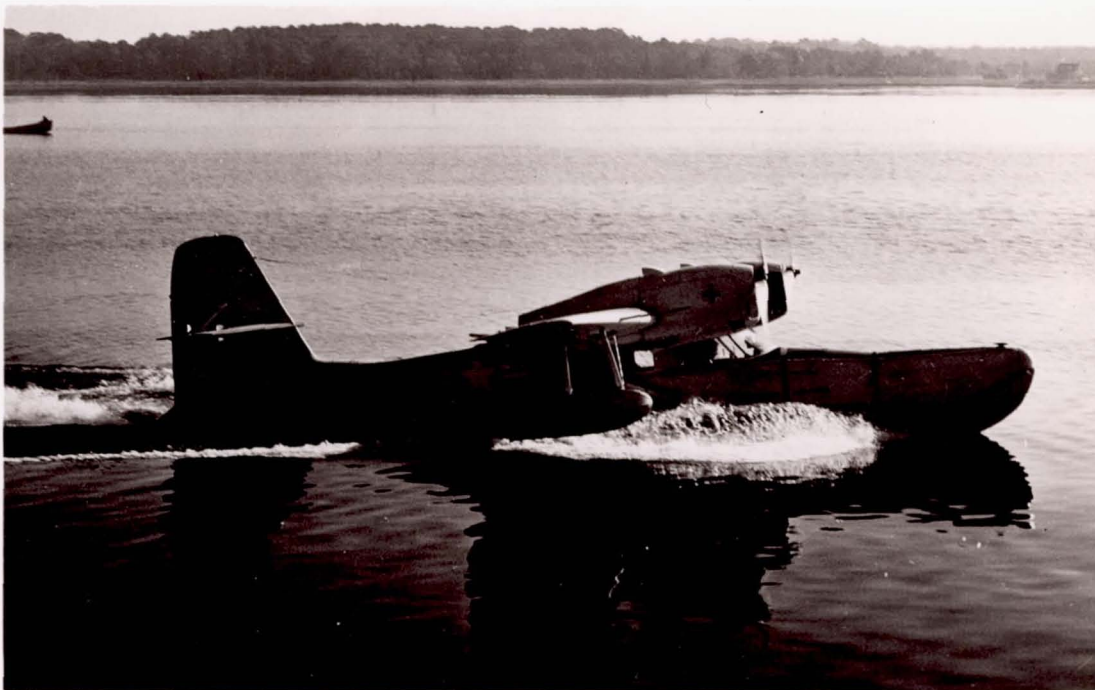
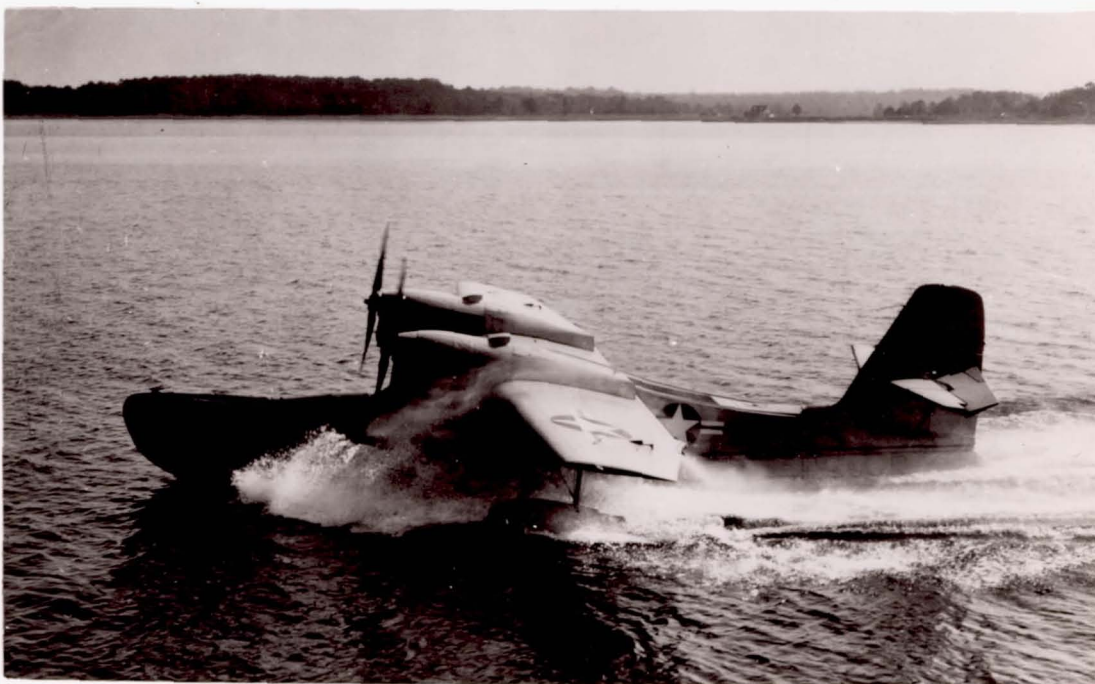
(a) Wing-high side; center of gravity, 25 percent M.A.C.

(b) Wing-low side; center of gravity, 20 percent M.A.C.

Figure 18.- Spray pictures. Speed, 19 feet per second; trim, 4.7° .

Spray characteristics.- Two typical spray photographs are presented in figure 18. Such photographs have been analyzed and the results are given in figure 19. The curves shown are drawn through the points representing the peaks of bow spray blisters at the various speeds. At low speeds, the pilot had no lateral control and the airplane heeled so that one or the other of the wing-tip floats was in the water. On the wing-high side no spray entered the propeller. On the wing-low side, although spray entered the propeller and struck the flap, this spray was considered moderate. The photographs of figure 18 show the difference in the spray on the two sides due to heel.
