Hypervelocity Impact Testing of IM7/977-3 with Micron-Sized Particles

J.G. Smith Jr.^{*}, D.C. Jegley[†], and E.J. Siochi[‡]
NASA Langley Research Center, Hampton, VA 23681-2199

Ground-based hypervelocity impact testing was conducted on IM7/977-3 quasi-isotropic flat panels at normal incidence using micron-sized particles (i.e. $\leq 100 \mu\text{m}$) of soda lime glass and olivine. Testing was performed at room temperature (RT) and 175°C with results from the 175°C test compared to those obtained at RT. Between 10 and 30 particles with velocities ranging from 5 to 13 km/s impacted each panel surface for each test temperature. Panels were ultrasonically scanned prior to and after impact testing to assess internal damage. Post-impact analysis included microscopic examination of the surface, determination of particle speed and location, and photomicroscopy for microcrack assessment. Internal damage was observed by ultrasonic inspection on panels impacted at 175°C, whereas damage for the RT impacted panels was confined to surface divets/craters as determined by microscopic analysis.

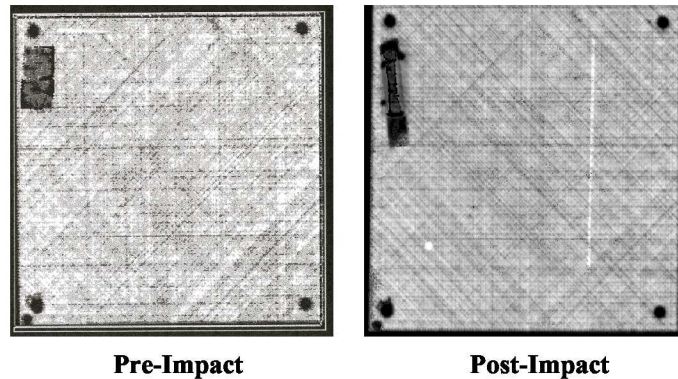
In order to establish a baseline, an impact test was performed at RT. Prior to testing, the panel was determined by Ultrasonic inspection to be well consolidated (Fig. 5). After HVI testing, gross visual analysis suggested no detectable damage. The post-impact panel C-scan image was found to exhibit no detectable difference (i.e. damage) compared to the pre-impact panel image (Fig. 5). The white vertical line observed in the post-impact image was due to a support bar in the water tank. Image analysis of the post impact panel under magnification revealed surface damage in the form of divets or craters with depths that were several times the crater diameter.

Figure 5. C-scan of pre- and post-impact RT SLG test panel.

location on the FRPC revealed no internal damage (i.e. delamination and microcracking) are shown in Fig. 7. This was further supported by the post-impact C-scan image shown in Fig. 5.

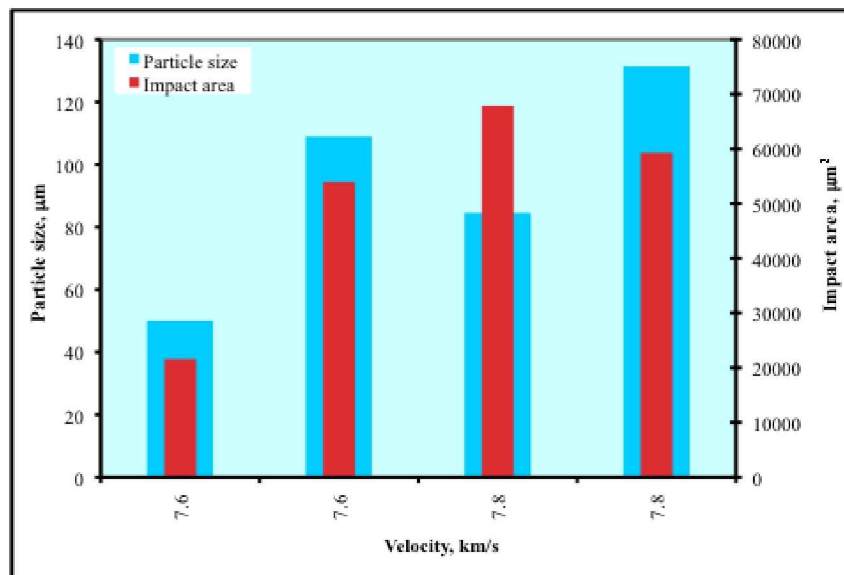
FRPC during the test (Table 5). The average calculated particle size was 102 μm compared to 68 μm in Table 2. The total calculated particle mass that impacted the panel was 2.99×10^{-5} g. No discernable trend was observed for particles of increasing size that were traveling at the same velocity with regards to impact area as shown in Fig. 8A. 2). It was observed though that as the velocity increased the impact area decreased for particles of approximately the

Figure 8A. Particle size and impact area vs. velocity.

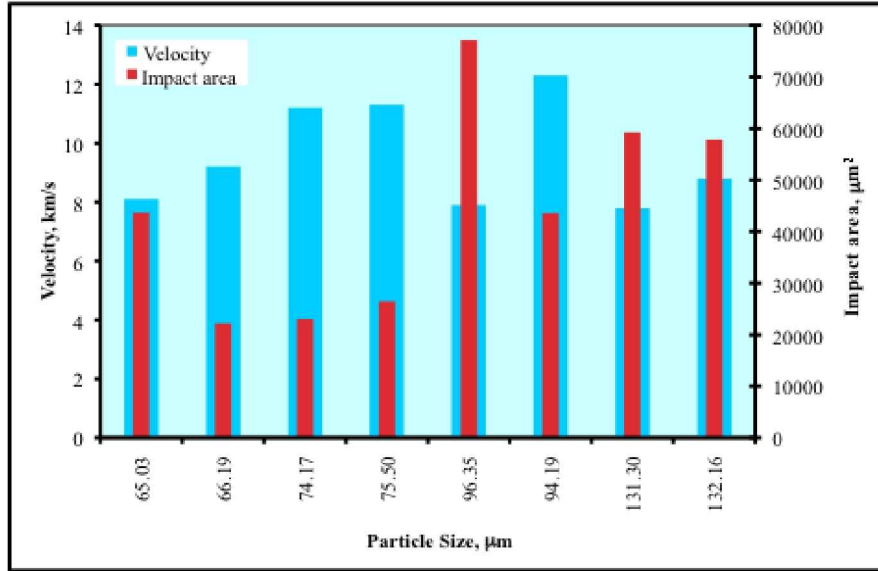
Figure 8B. Velocity and impact area vs. particle size.

same size shown in Fig. 8B. The impact area was comparable for particles that were approximately 75 μm in size traveling at similar velocities.

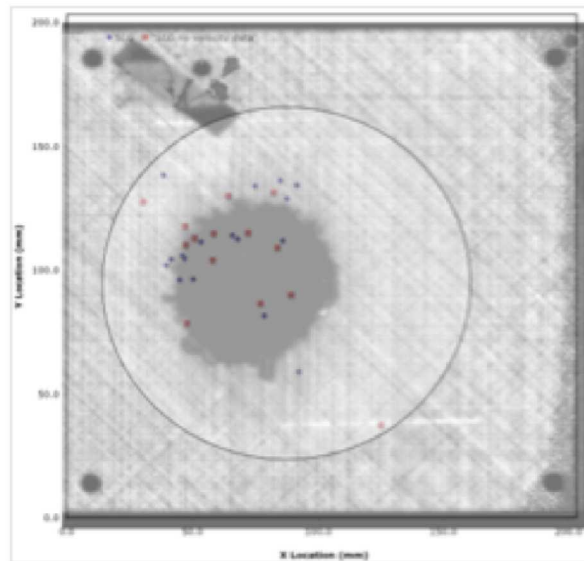
An overlay of the graphed impact locations in Fig. 11 over the post-impact C-scan image in Fig. 10 was made to view the SLG impacts in relation to the damage area (Fig. 12). The circular image in the overlay in Fig. 12 is a representation of the impact area centered on the bore of the gun barrel. The locations of SLG impactors with known

and unknown velocities identified in blue and red, respectively, are shown in Fig. 12. As seen in Fig. 12, a majority of the SLG impactors resided in the damage area detected by Ultrasonic inspection. A few of the impactors resided outside this area with no perceivable damage other than that observed under magnification. Given the reduction of composite properties at elevated temperature,¹⁵ it was speculated that the resultant damage may have been induced by the generated shock waves from each of the impacting particles through constructive and destructive addition. It has been reported that at elevated temperature the composite toughness of this system was higher, but a lower number of cycles were needed for delamination to occur and faster fatigue crack propagation was observed.¹⁶ This theory may aid in the explanation of the result seen here even though the FRPC was not cycled in this study.

Figure 12. Overlay of post-impact panel C-scan image over graphed SLG Impacts with known (blue) and unknown (red) velocities.

Another possible explanation for the damage observed in the post impact C-scan image is that it was caused solely by heat. The distance between the mounting of the silicon diodes and the heat lamps may have contributed to greater heating in the area in direct line of the illumination than was recorded by the data monitoring system. FRPCs are known to have low thermal conductance. Several diodes were mounted on the FRPC but the sensors were positioned away from the beam to minimize direct heating of the sensors. If the heating method did not achieve a uniform heating, then there may have been an overshoot in sample temperature. However a large damage area is not observed in Fig. 5 outside the impacted area. Therefore this explanation is not complete and requires further work to determine the exact cause of the observed delamination.

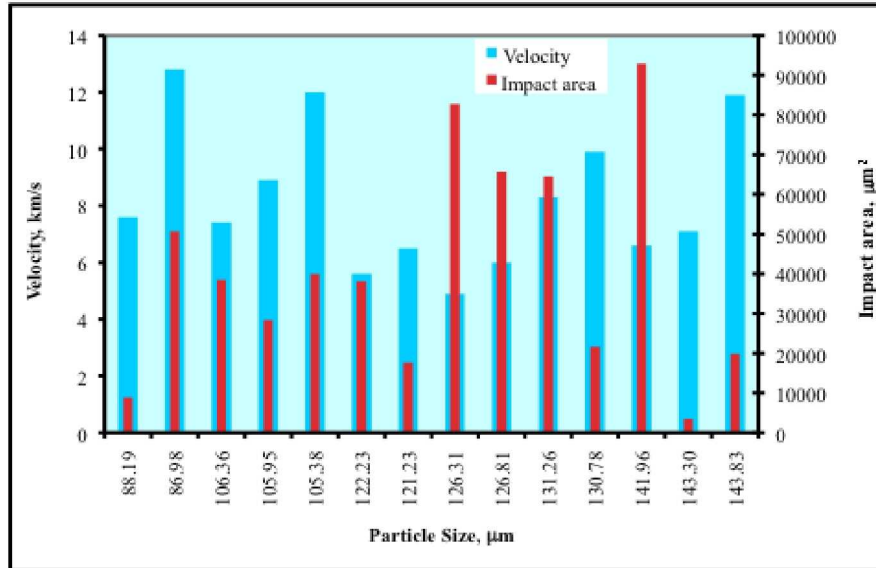
In general, particles that were approximately the same size in Table 6 exhibited a decrease in the impact area with increasing velocity. This result is shown in Fig. 14 and was similar to the RT SLG observation.

Figure 14. Particle size and impact area vs. velocity.

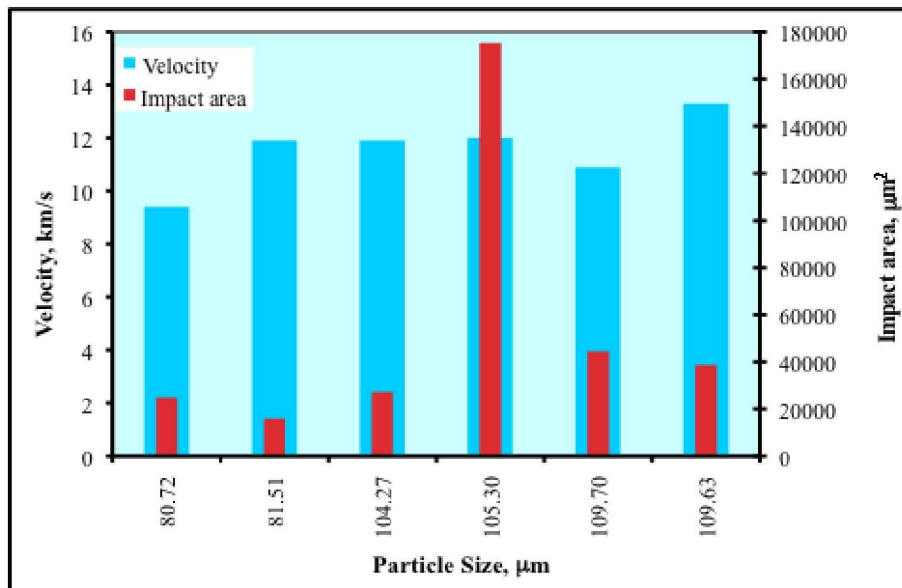
In general, particles of approximately the same size exhibited decreasing impact area with increasing velocity as shown in Fig. 18A. Similar results were observed for the SLG impactors. For particles that were approximately 105 μm in size with similar velocity, the impact areas differed markedly in contrast to the SLG RT results where the

Figure 18A. Velocity and impact area vs. particle size.

impact areas were comparable for similar particle size and velocity. Since the particle size is determined from the witness film, the OLV impactor could have fractured prior to impact resulting in a smaller particle size and thus may account for the different impact areas.

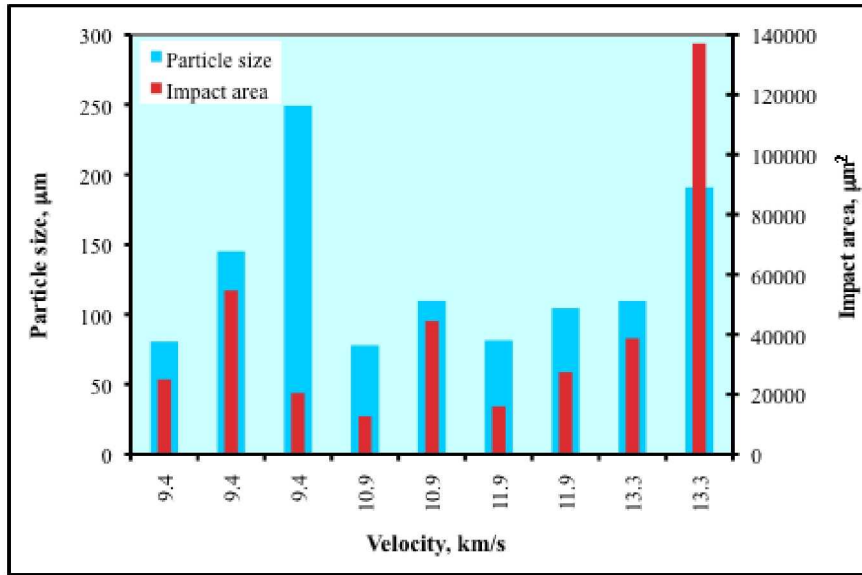
The impact area generally increased with increasing particle size for impactors traveling at the same velocity as shown in Fig. 18B. The lower impact area displayed by the particle size of 249 μm traveling at 9.4 km/s may be due to this particle fracturing prior to impact as cited above.

Figure 18B. Particle size and impact area vs. velocity.
