***Aircraft Emergencies:  
Challenge and Response***

**Barbara Burian, Ph.D., FRAeS**  
Human Systems Integration Division  
NASA Ames Research Center

**9<sup>th</sup> International Symposium of the Australian  
Aviation Psychology Association**

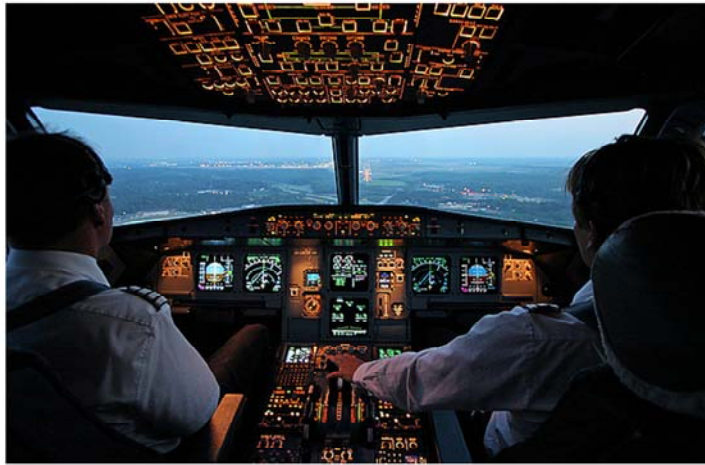
## Pack Trip

- Master Caution Alert sounds
- Crew Identifies that Pack has tripped off
- Crew completes 4 step procedure
- Flight proceeds normally

Illustration of range of situations – a pack trip is generally pretty benign and easily handled – not much increase in stress or workload – some pack trip checklists may have more than 4 items

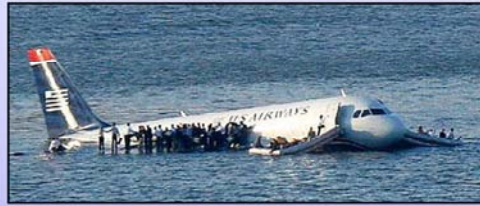
*US Airways 1549 - A320 Dual Engine Failure, Hudson River, NY  
January 15, 2009*

- During climb out from LGA the aircraft hit a flock of geese and lost the thrust in both engine
- CA took over as PF and called for the ENG DUAL FAILURE checklist
- This is a paper checklist (ECAM Exception)
- FO tries several time to start the engines - unsuccessful
- Approx. 3 min. after hitting the birds, CA performs a forced landing into the Hudson River

- ENG DUAL FAILURE checklist is three pages long
- Divided into three parts:
  - No fuel remaining vs. fuel remaining
  - Steps if restart is successful vs. unsuccessful
  - Forced landing or ditching anticipated
- Organized for dual engine failure at altitude
- Items expected to be completed in order presented
- Flaps configuration item at bottom of page 2 (For landing... Use FLAPS 3)
- Expectation that configuration for ditching will occur above 3,000 ft.
- "Ditching pb.....ON" item near the end of the checklist
