Design and Analysis of a Stiffened Composite Structure Repair Concept

A design and analysis of a repair concept applicable to a stiffened thin-skin composite panel based on the Pultruded Rod Stitched Efficient Unitized Structure is presented. Since the repair concept is a bolted repair using metal components, it can easily be applied in the operational environment. Initial analyses are aimed at validating the finite element modeling approach by comparing with available test data. Once confidence in the analysis approach is established several repair configurations are explored and the most efficient one presented. Repairs involving damage to the top of the stiffener alone are considered in addition to repairs involving a damaged stiffener, flange and underlying skin. High fidelity finite element modeling techniques such as mesh-independent definition of compliant fasteners, elastic-plastic metallic material properties and geometrically nonlinear analysis are utilized in the effort. The results of the analysis are presented and factors influencing the design are assessed and discussed.

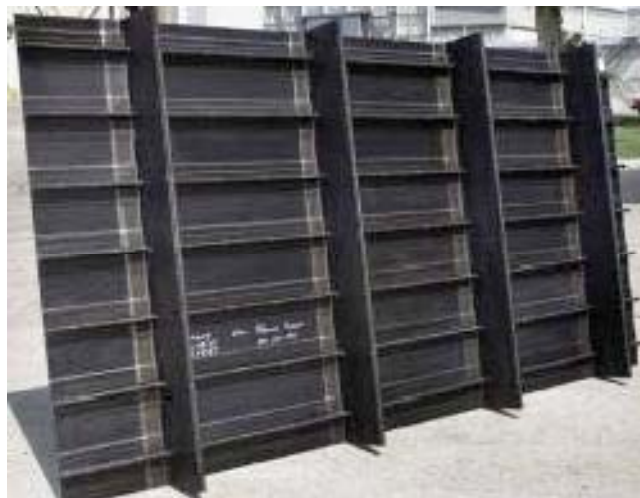
Figure 1a. PRSEUS flat panel.⁶

The structural concept being pursued as an important component of next generation airframe technology under the Environmentally Responsible Aviation Program at NASA¹⁻⁶ is the Pultruded Rod Stitched Efficient Unitized Structure (PRSEUS), illustrated in Figure 1. This concept is being developed in a partnership between NASA and The Boeing Company for application to future transport aircraft with the goal of developing lighter structure so that the aircraft will require less fuel and produce fewer pollutants. The PRSEUS structure is highly-integrated, weight-efficient and has crack-arresting capabilities. In this concept a stitched carbon-epoxy material system is used. By stitching through the thickness of a dry carbon-epoxy material system, the labor associated with panel fabrication and assembly can be significantly reduced. When stitching through the thickness of pre-stacked skin, stringers, and frames, the need for mechanical fasteners is almost eliminated. In addition, stitching reduces delamination and improves damage tolerance, allowing for a lighter structure with more gradual failures than traditional composites without through-the-thickness reinforcement. The PRSEUS concept consists of carbon-epoxy panels fabricated from dry components and then infused in an oven while subjected to vacuum pressure. Skins, flanges and webs are composed of layers of carbon material forms that are pre-kitted in multi-ply stacks. A single stack contains seven plies (+45, -45, 0, 90, 0, -45, +45) where the 0-degree plies are approximately twice the thickness of the ± 45 - and 90-degree plies, resulting in a 0.052 in. stack thickness with percentage of the 0°, 45° and 90° fibers equal to 44.9, 42.9 and 12.2, respectively. Several stacks of the pre-kitted material are used to build up the desired thickness and configuration. Stiffener flanges are stitched to the skin and no mechanical fasteners are used for joining. To maintain the panel geometry during fabrication, first stiffeners and then the skin are placed in a stitching tool for assembly prior to moving to a curing tool for consolidation in the oven. The stiffeners running in the axial direction consist of webs with unidirectional carbon fiber rods at the top of the web. AS4 carbon fiber overwraps surround the rod. The stiffeners in the lateral direction are foam-filled hats. Panels considered in the present study assumed 6-inch spacing for the rod-stiffeners and 20-inch spacing for the foam-filled hat frames. The manufacturing process is described in detail in reference 6.

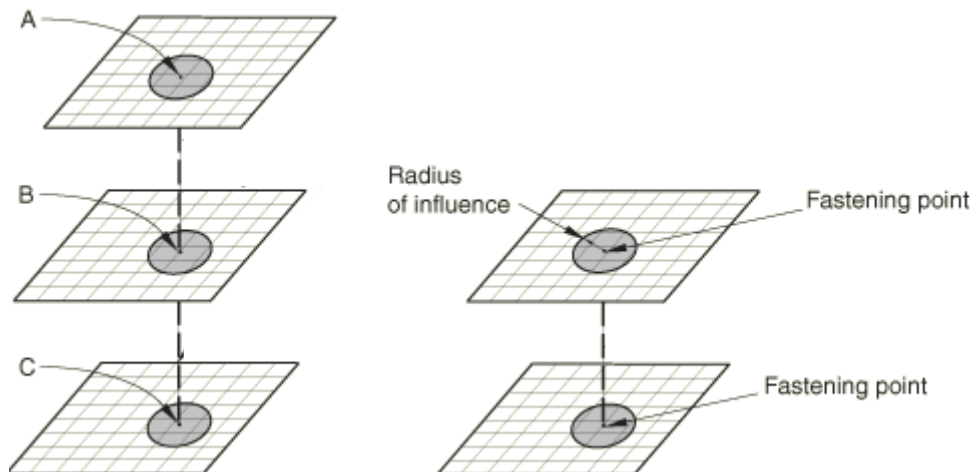
Figure 12. Fastener two- and three-part joint modeling in Abaqus FE code.⁸

As illustrated in Figure 12, the physical number of fasteners in the model is not necessarily equal to the number of the connector elements used to model them. When only two parts are connected with a fastener, one connector element represents one fastener, as seen on the right hand side of Figure 12. Such a configuration is the case, e.g., for the top row of 0.16-in. fasteners above the pultruded rod joining together the two upper repair pieces, shown in Figure 10a. When a single fastener is attaching together three parts, two connector elements are needed in a FE model, each connecting the two parts located next to each other, as seen on the left hand side of Figure 12 where one connector element attaches fastening points A and B and one connector element attaches fastening points B and C. Such a configuration is the case, e.g., for the row of 0.19-in. fasteners connecting the two upper repair pieces and the web in between them, shown in Figure 10a.

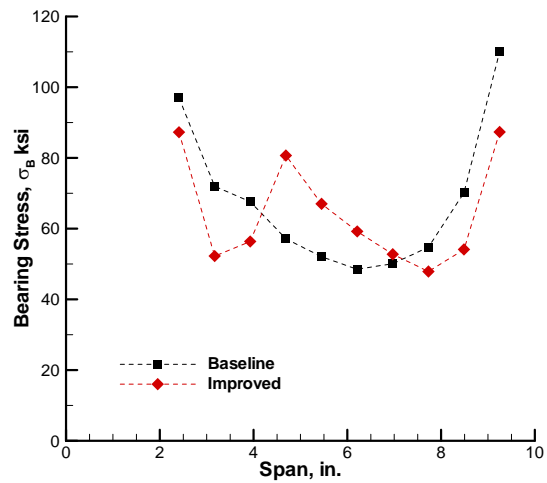
Figure 24. Bearing stress comparison between baseline and improved designs.

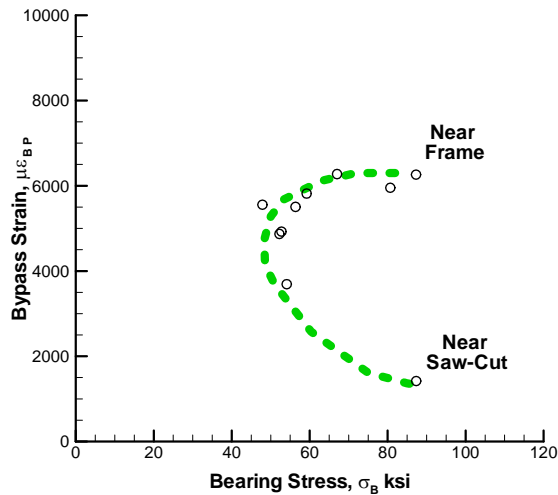
Figure 25. Bearing stress-bypass strain analysis at the center web.

Figure 25 presents the results from Figure 23 in the format of Figure 14. While the spatial distribution information is lost, this representation of the results enables assessment of the structural integrity of the design based on test data allowables illustrated in Figure 14. Allowable values representative of the dashed blue and green trend lines from Figure 14 are not plotted in Figure 25 since these values are proprietary. Note, that the points in Figure 25 form a pattern highlighted by a green dashed line with its limits established by the two end fastener locations near the frame and the saw-cut.
