Investigation of Hygro-Thermal Aging On Carbon/Epoxy Materials for Jet Engine Fan Sections

INVESTIGATION OF HYGRO-THERMAL AGING ON CARBON/EPOXY MATERIALS FOR JET ENGINE FAN SECTIONS

Lee W. Kohlman (The University of Akron, NASA GRC)
 Gary D. Roberts, Sandi G. Miller, and J. Michael Pereira (NASA GRC)

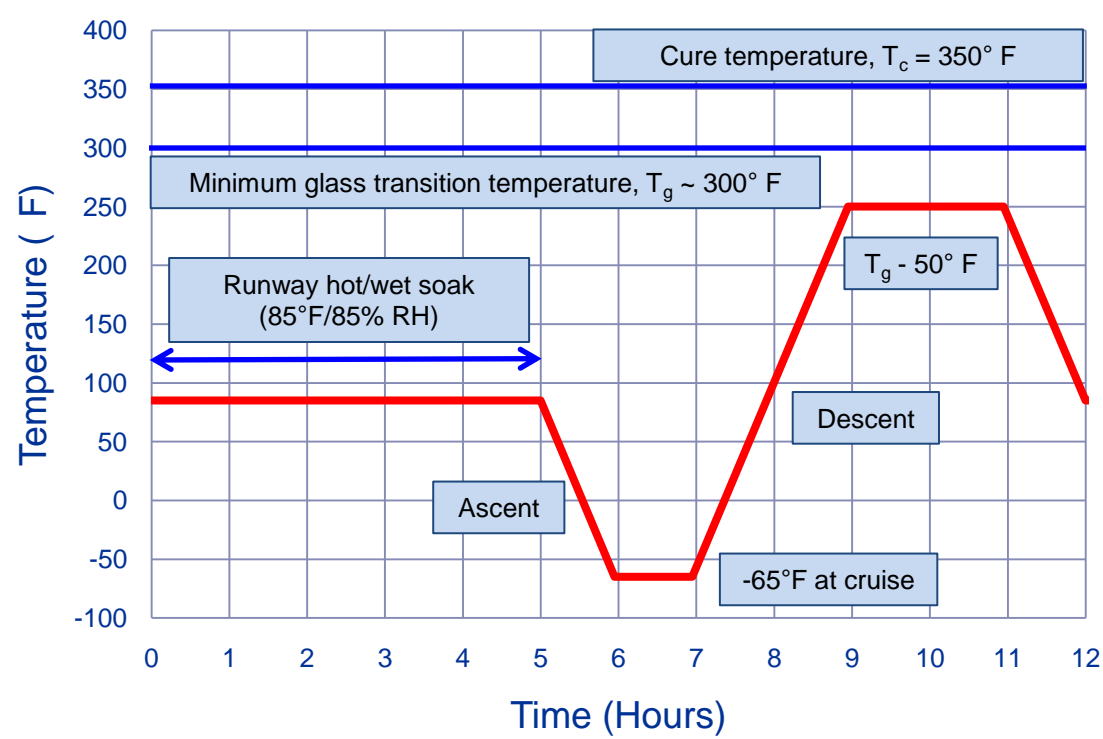
Aging Cycle Set-Points

An aging cycle was chosen to represent a possible set of environmental conditions that could be present in an engine fan section. The set-points of the chosen cycle are shown above.

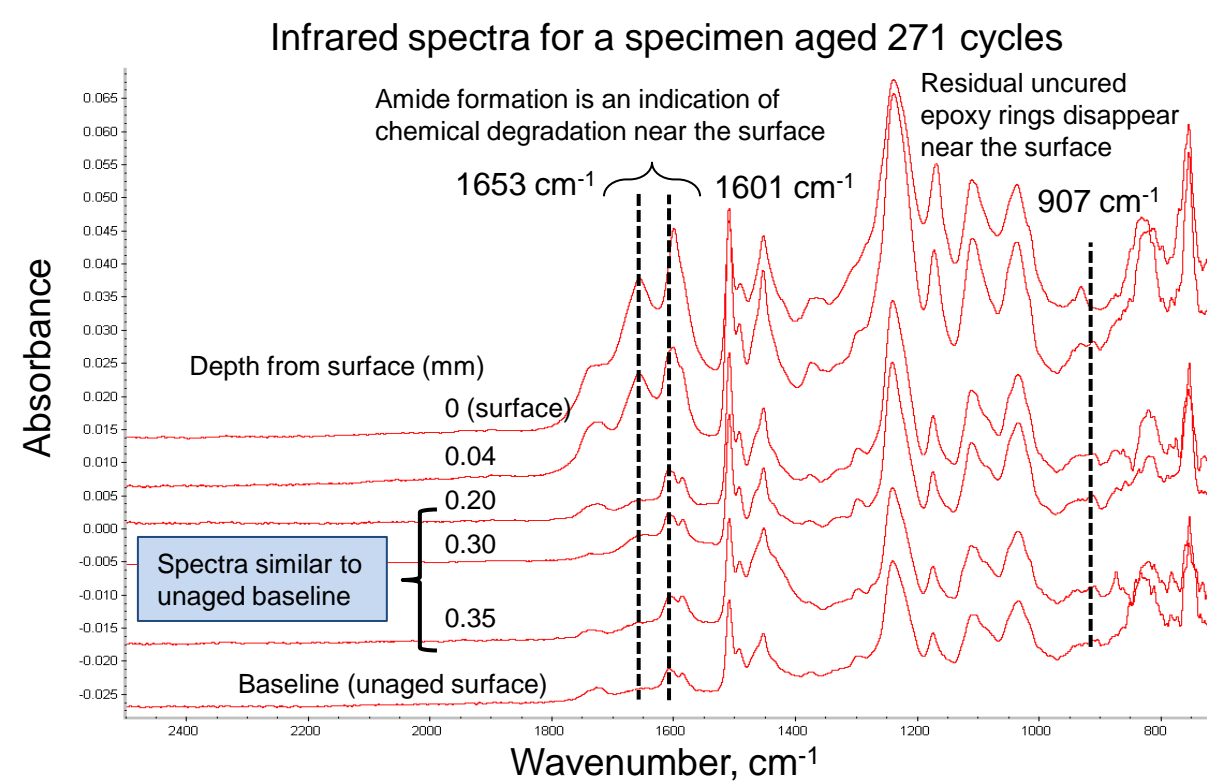
Resin Chemical Aging

Aging effects that change the chemistry of the resin are confined to the surface of the material. The resin used for the results presented here are Epon® E862 with W hardener.

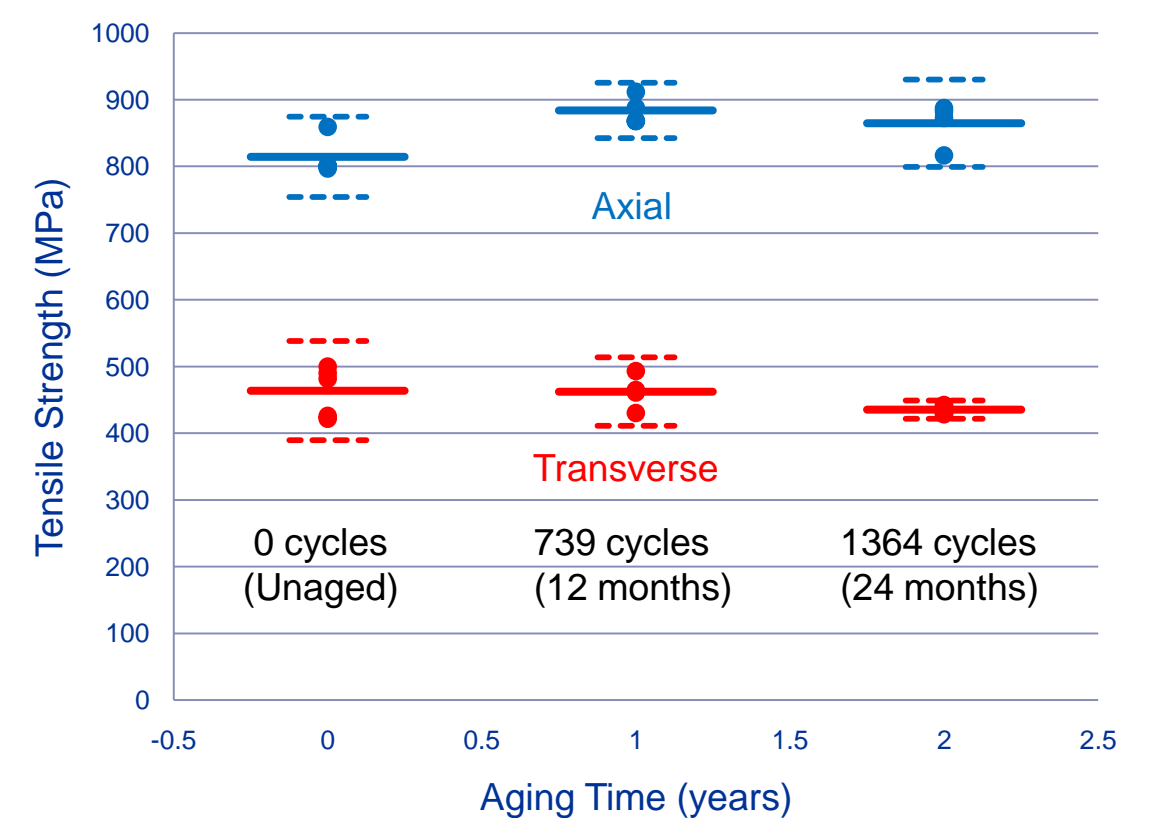
Composite Tension Results

Tension failure stress is plotted for 3 different aging conditions. No significant trend is observed up to 2 year of aging. Note that the transverse tension test is known to produce lower than expected results because of test method deficiencies. This is being investigated separately. Solid lines are the mean and dashed lines are two standard deviations from the mean.

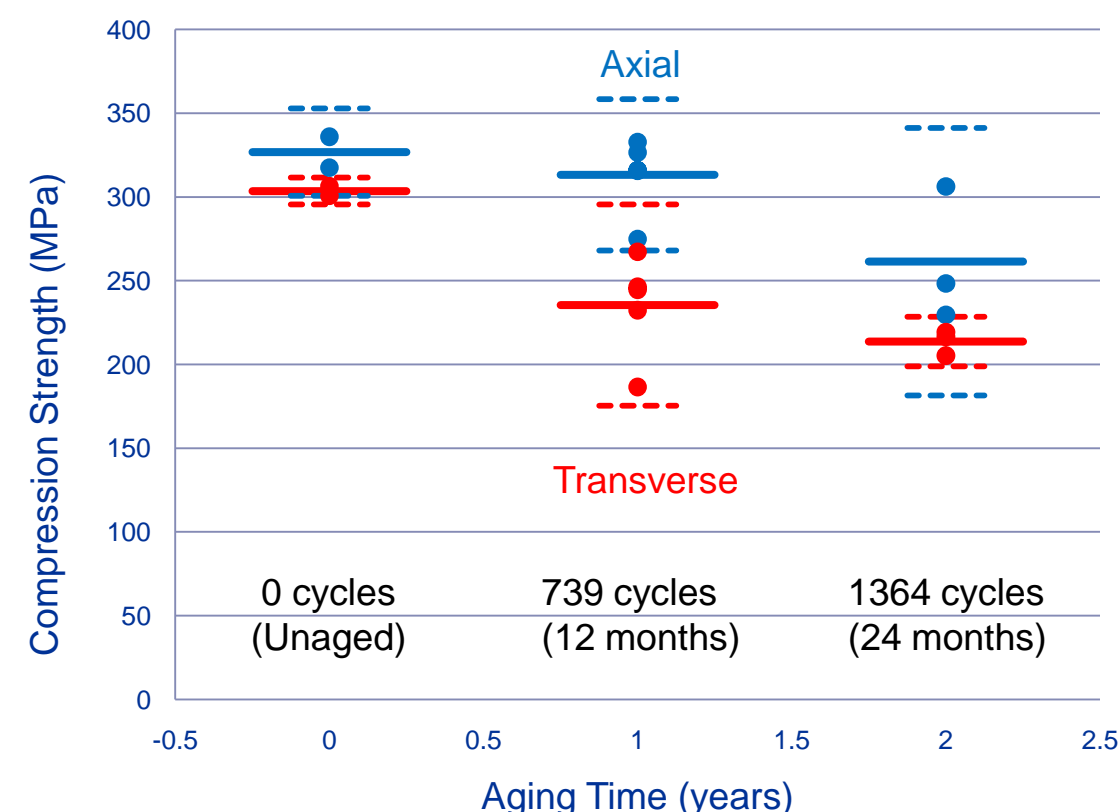
Composite Compression Results

Compression failure stress is plotted for 3 different aging conditions. A trend toward strength reduction may be present but due to limited material availability and scatter, a statistically significant conclusion can not be drawn. This matter is being investigated separately. Solid lines are the mean and dashed lines are two standard deviations from the mean.

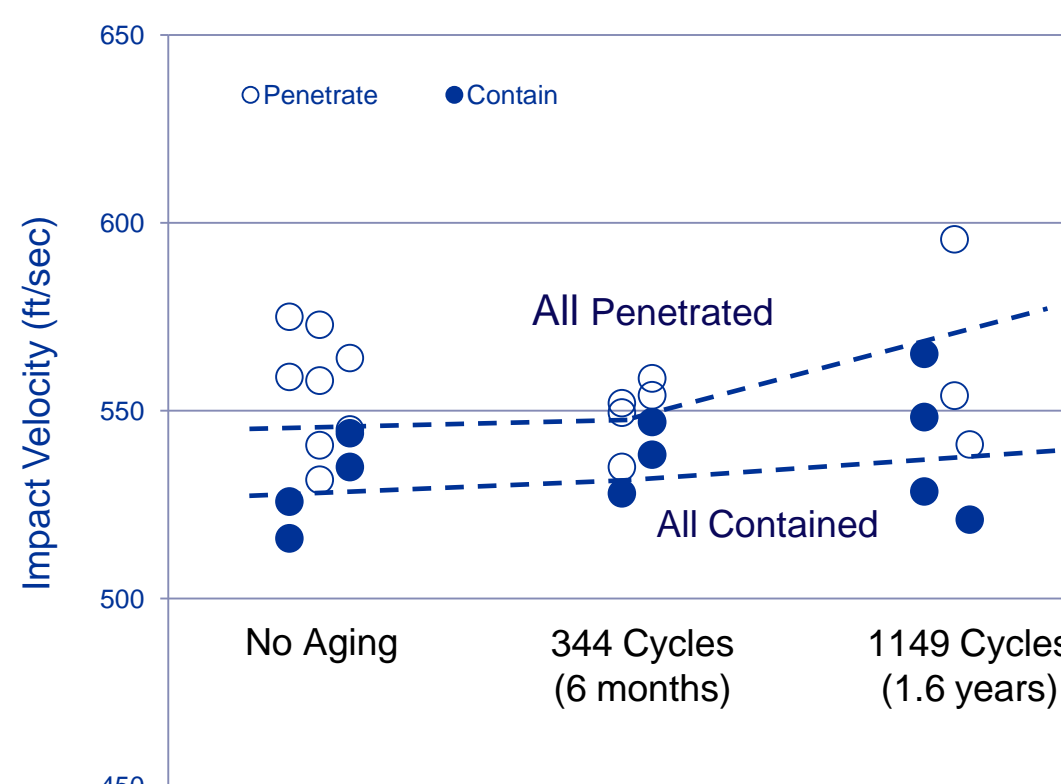
Impact Results

The threshold for impact penetration shows no significant change after 1.6 years of aging. Penetrated panels are shown with open circles, and non-penetrated with filled circles. The test method utilizes a blunt projectile and a circular, fixed boundary condition.
