Repair Concepts as Design Constraints of a Stiffened Composite PRSEUS Panel

Adam Przekop¹

Analytical Services and Materials, Inc., Hampton, VA, 23666

A design and analysis of a repair concept applicable to a stiffened thin-skin composite panel based on the Pultruded Rod Stitched Efficient Unitized Structure is presented. The concept is a bolted repair using metal components, so that it can easily be applied in the operational environment. The damage scenario considered is a midbay-to-midbay saw-cut with a severed stiffener, flange and skin. In a previous study several repair configurations were explored and their feasibility confirmed but refinement was needed. The present study revisits the problem under recently revised design requirements and broadens the suite of loading conditions considered. The repair assembly design is based on the critical tension loading condition and subsequently its robustness is verified for a pressure loading case. High fidelity modeling techniques such as mesh-independent definition of compliant fasteners, elastic-plastic material properties for metal parts and geometrically nonlinear solutions are utilized in the finite element analysis. The best

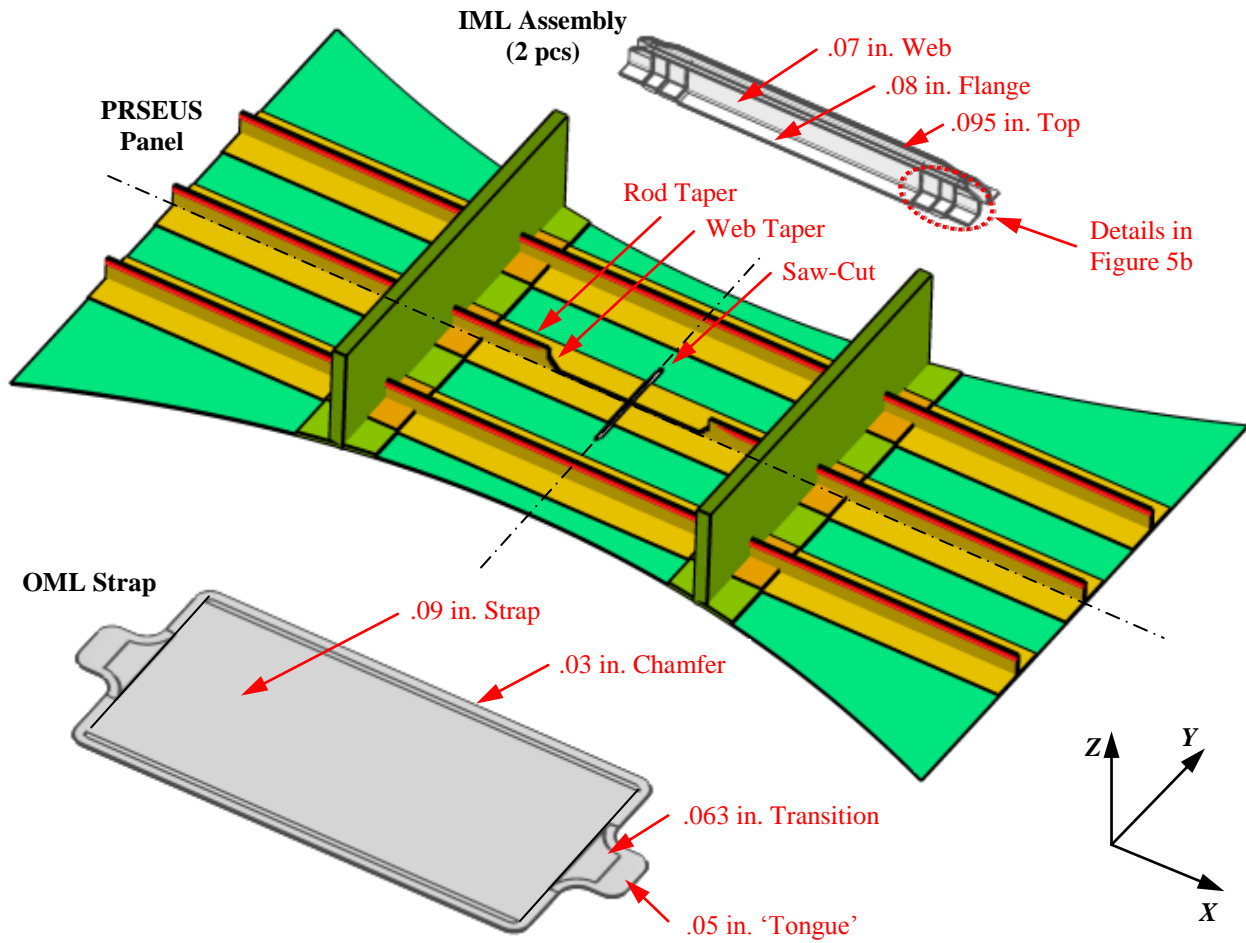
Figure 4. Exploded view of the saw-cut tension PRSEUS panel with Mohawk-type repair.

An exploded plot of the proposed repaired panel is presented in Figure 4. The panel was subjected to some preparation before installing the repair assembly. This preparation can be regarded as a part of the repair design, since it was intended to improve the way the repair assembly itself accepts and bears a desired portion of the panel's loading. The details of the panel prepared for installation of the repair assembly are shown in Figure 4. Panel preparation includes tapering the panel's center web and pultruded rod in the vicinity of the saw-cut damage. All the other sections of the panel remain unchanged with respect to the configuration used in the damage arresting demonstration test. The originally assumed simulated damage, i.e. 6-in. long and 1/4-in. wide midbay-to-midbay saw-cut, as seen in Figure 3b, remained unchanged only in the skin and flange sections of the panel. The web section, including the pultruded rod, is machined on both sides of the saw-cut such that the web is completely terminated above its bottom stitch line (refer to dashed lines in Figure 1b for locations of the stitch lines) over the span of 3.8 in. from the center, followed by 45-degree taper extending to the bottom of the pultruded rod. The rod itself is further tapered at 15-degree angle, i.e. over the additional distance of approximately 1.4 in. While FE modeling discussion is reserved for section IV.B, two remarks helpful in understanding of Figure 4, which is based on the FE model, are warranted here. First, note that the rod taper would have a different shape in the actual repair but it was simplified to be axially symmetric in the FE model. Also note, that rod overwrap sections of the webs are not explicitly modeled as the beam elements rendered in red are visible.

The most efficient repair assembly design selected from several configurations analyzed within the course of the study is presented in Figure 4 as the grey-colored parts. Aluminum alloy 7075-T6 was used for all the inner- and outer-mold line (IML and OML) components of the repair assembly except titanium alloy Ti-6Al-4V fasteners. The thicknesses of the main sections of the machined repair assembly parts are labeled in red. General cross-section thicknesses of the repair parts were dictated primarily by ensuring that the yielding stress level is not exceeded at the limit loading and the ultimate strength is not exceeded at the ultimate loading +10%. Thinner OML strap ends were designed to reduce bearing stress peaking in the panel in the vicinity of the end fastener joints (to be discussed momentarily). In addition to this requirement, end sections of the IML repair pieces were tailored such that the PRSEUS panel IML thickness variations in the vicinity of the flange-frame cap intersections can be accommodated.

As presented in Figure 4, only the 50-in. center section of the repaired panel, away from the installation lugs was modeled, as the original pristine panel was designed to produce a uniform in-plane displacement across the panel width at the ends of this section. Consequently, force distribution across the panel width at its end stations could not be known a priori. Thus, by constraining one end of the repaired panel and applying a uniform in-plane displacement at the other end, and interrogating the resultant reaction force at the boundary, the desired enforced in-plane displacements were determined in the iterative fashion. For the three prescribed loadings levels of 119.1 kip, 178.7 kip and 196.5 kip discussed before, the corresponding uniform in-plane displacements of 0.2042 in., 0.3048 in. and 0.3353 in. were found, respectively.

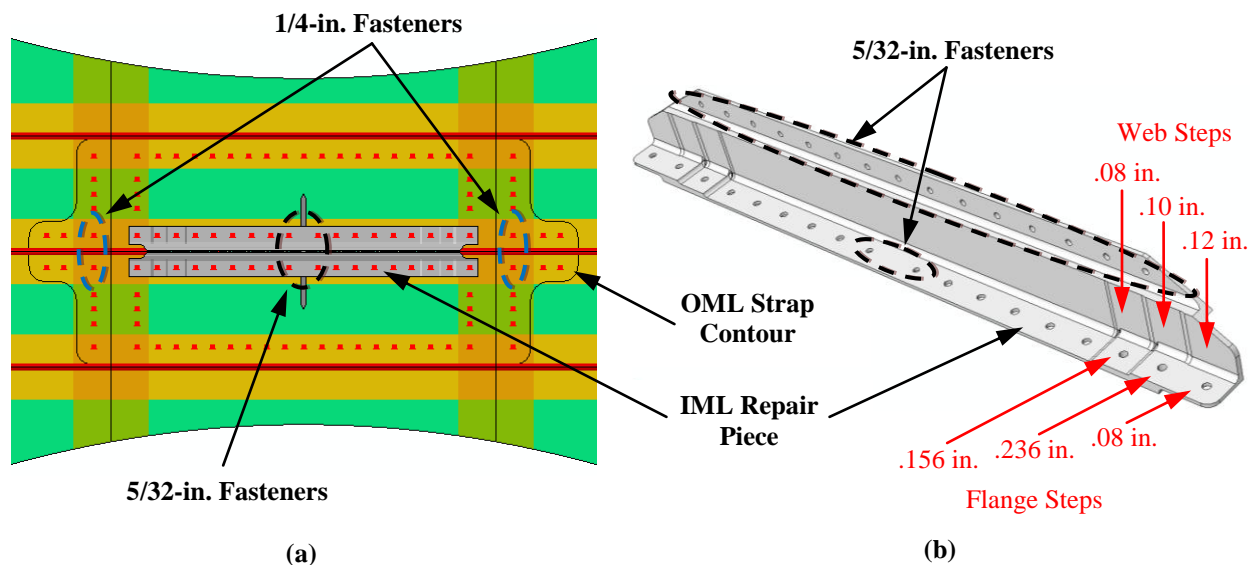
Figure 5. Location of fasteners (a) top view, including IML assembly and OML strap contour with 1/4-in. and 5/32-in. fasteners circled, (b) IML piece with fastener holes and 5/32-in. fasteners circled.

Fastener patterns used to install the repair assembly are shown in Figure 5a with the red squares. Locations of some of the fasteners installed in the IML repair pieces which are not visible in Figure 5a are presented in Figure 5b. Due to a smaller size of the IML pieces of the repair assembly in Figure 4, its more detailed representation is also offered in Figure 5b. Most of the fasteners used to install the repair assembly are 3/16-in. diameter lockbolts, unless otherwise noted in Figure 5. Specifically as shown in Figure 5a, to take advantage of the thicker flange-frame cap

intersection of the panel (six stacks, 0.312 in.-thick) four 1/4-in. fasteners are used at the locations circled with a blue dashed line. Their increased stiffness permits larger load being transferred from the panel to the repair without exceeding allowable bearing stress levels in the composite. Note, that some of the effect of the increased fastener stiffness, and therefore higher loading, is compensated by the increased bearing area as the bearing stress

relates the bearing force P_B to the bearing area calculated as a composite shell thickness t_s multiplied by fastener diameter d . In contrast, to reduce the loading and, therefore, bearing stress peaks in the direct vicinity of the simulated damage, the four fasteners closest to the saw-cut are 5/32-in. diameter to make them more compliant. Opposite to the larger diameter fastener argument presented above, a portion of the bearing stress reduction originating from a reduced loading in a more compliant fastener is diminished by a reduced bearing area. The 5/32-in. fasteners are also used above the PRSEUS panel stringers to attach together the two IML repair pieces. A smaller fastener diameter is selected for that location due to minimal loading that this row of fasteners is carrying. All 5/32-in. fastener locations are circled with a dashed black line in Figures 5a and 5b. Finally note, that fasteners seen in Figure 5a over the grey area of the IML repair assembly are double-shear fasteners as each penetrates the IML repair piece, PRSEUS panel and OML strap. All other fasteners are single shear fasteners as they penetrate only the PRSEUS panel and the OML strap, as seen in Figure 5a, or two IML repair pieces through the top row of fasteners, as seen in Figure 5b. A total of 129 fasteners is used in the repair, including 106 3/16-in., 19 5/32-in. and four 1/4-in. diameter fasteners. Per composite structure design guidelines,¹¹ the fasteners are spaced no closer than the quadruple of their diameter apart, and no closer than triple of their diameter plus 0.06 in. from any free edge, e.g., from the saw-cut damage.

The 6 in. by 1/4 in. midbay-to-midbay saw-cut damage was modeled as in the tension panel, i.e., in the middle of the center stringer which is the eighth stringer counting from either edge of the panel. The same panel preparation for the repair assembly installation as for the tension panel was assumed, i.e., the web and pultruded rod tapers were introduced as illustrated in Figure 4. Also unchanged were the locations and sizing of all the fasteners attaching the repair assembly, as illustrated in Figure 5.

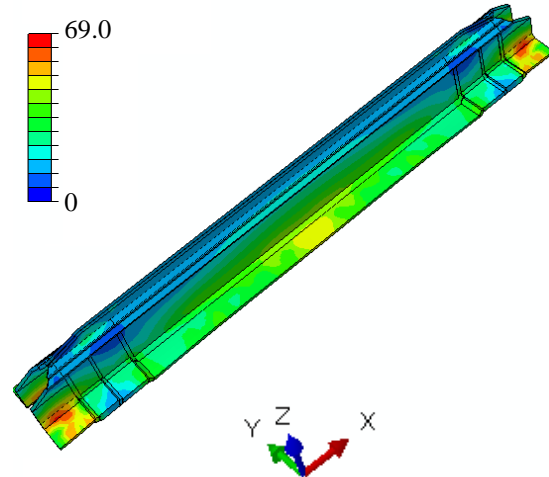
Figure 9. IML repair assembly maximum principal stress (ksi) at limit loading of 119.1 kip.

Maximum principal stress fields in the OML repair strap and the IML assembly are presented in Figure 8 and Figure 9, respectively. It is seen that the repair assembly does not exceed the allowable yielding stress level of 69 ksi. The maximum stress levels in the OML strap are found to be 50.5 ksi and are located in the ‘tongue’ areas of the strap near the fastener joints. The maximum stress levels in the IML assembly are higher, reaching 63.3 ksi, and occur at the ends of the IML repair pieces in the fillets between the flange and web sections of the repair. Note, that the design of this section of the IML assembly exemplifies a compromise between the two conflicting factors inherent to this repair design. On one hand, increased thickness of the end sections of the IML repair piece allows distribution of a load over an increased cross section area, and therefore may reduce stress levels. At the same time, increased thickness means increased stiffness and results in higher loads being transferred into the IML assembly from the damaged panel. Consequently, passed certain thickness value, stress level reduction may be diminished or even not achievable. This in turn, not only adversely affects the repair assembly itself, but also may lead to undesirably high fastener loads and/or fastener-generated bearing stress levels in the composite holes accommodating these fasteners. Furthermore, over-stiff repair assembly alters the overall load paths in the repaired panel, potentially making them very different from those of the pristine panel.

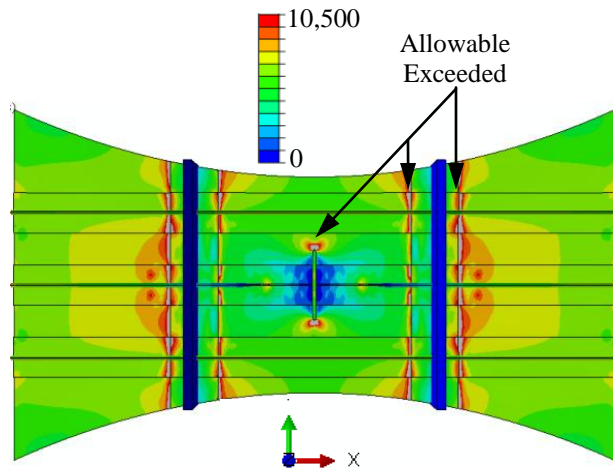
Figure 11. Maximum axial strain ($\mu\epsilon$) at ultimate loading of 178.7 kip.

Results obtained at the ultimate loading level (178.7 kip) for the panel and the ultimate loading +10% level (196.5 kip) for the repair assembly are illustrated in Figure 10 through Figure 15. The in-plane displacement field for the entire repaired panel is presented in Figure 10. Similar to in-plane displacement field obtained for the limit load level presented in Figure 6, a smooth and uniform panel displacement field across-the-width was obtained in the section between the frames. Maximum axial strain in the panel is presented in Figure 11 where again, the repair assembly is not plotted. The color bar legend in this plot is terminated at the stack 0-degree tension ultimate allowable strain of 10,500 $\mu\epsilon$, therefore all the locations exceeding this value are plotted in grey. Again, similar to the results presented before in Figure 7, it is seen that only small areas in the vicinity of the frame cap edges and at the tips of the saw-cut are exceeding allowable values. Per argument presented before when discussing Figure 7, strain levels in these areas are judged to be likely overestimated, and should not cause a premature failure of the panel.

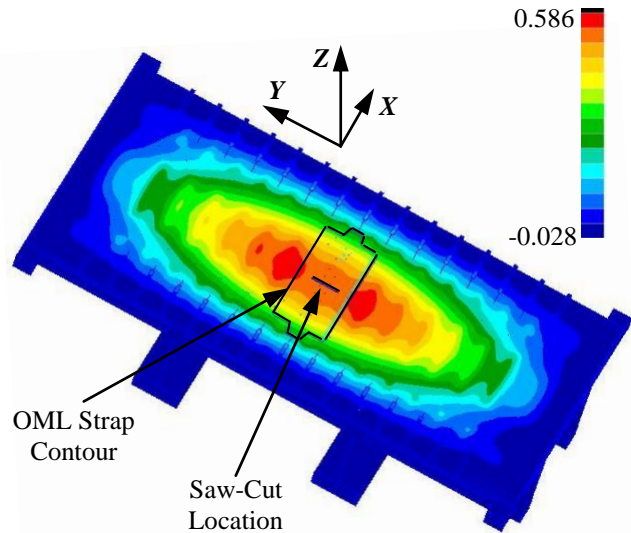
Figure 17. Repaired pressure panel out-of-plane displacement (in.) under ultimate loading of 18.4 psi.

Results obtained at the ultimate loading level of 18.4 psi are illustrated in Figure 17 through Figure 19. The out-of-plane displacement field for the entire repaired panel is presented in Figure 17, where the location of the OML repair strap and the contour of the saw-cut damage are identified. It is seen that a smooth displacement field was obtained and no excessive disruption of the displacement field occurs due to the presence of the repair assembly. Small displacement variations corresponding to substructure spacing are visible (so called ‘pillowing’) and a slight

suppression of the out-of-plane displacement within the area covered by the OML strap is also noticeable. Consequently, the maximum out-of-plane displacement of 0.586 in. occurs to the side of the OML strap while for the pristine panel⁷ the maximum out-of-plane displacement occurred in the area now covered with the OML strap and had a slightly higher value of 0.608 in.⁷ It is worth mentioning that while no significant geometrically nonlinear behavior was noted for the tension panel, a stiffening nonlinearity was identified under the pressure loading. This nonlinearity was expected since pressure loading acting on a thin-walled structure typically has a potential for producing out-of-plane displacements that are large enough to cause appreciable in-plane stretching, which in turn tends to suppress the out-of-plane deformation. For the maximum loading level considered (i.e., the ultimate loading +10% of 20.24 psi) and after verifying that no plastic response regime was present, a linear solution (Nastran solution 101) yielded the maximum out-of-plane displacement of 0.734 in, whereas the nonlinear solution (Nastran solution 106, used throughout the repaired pressure panel analysis) resulted in the maximum displacement of 0.639 in. Thus, the linear out-of-plane displacement solution was overestimated by 14.9%. Note, that for the pristine panel under 18.4 psi loading, the linear and nonlinear maximum out-of-plane displacements were found to be 0.666 in. and 0.608 in., respectively.⁷ Thus, the linear out-of-plane displacement solution was overestimated by 9.5%. Considering a slightly different loading levels and locations of the maximum out-of-plane displacement, the effect of nonlinearity can be regarded as comparable for the pristine and repaired panels. Finally, as expected, when inspecting the displacement results no appreciable deformation of the pressure vessel was noted.

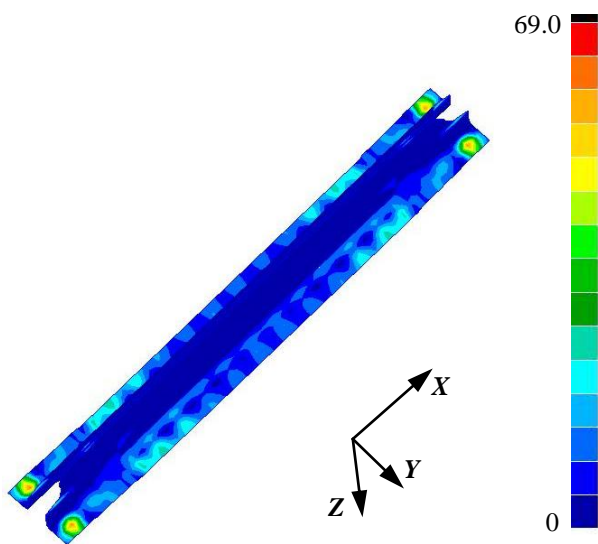
Figure 20. IML repair assembly maximum principal stress (ksi) at ultimate + 10% loading of 20.24 psi.

Maximum and minimum principal stress fields in the IML repair assembly at the ultimate loading +10% level of 20.24 psi are presented in Figure 20 and Figure 21, respectively. It is seen that the repair assembly does not exceed the yielding stress level of 69 ksi, therefore remains in the elastic regime. The maximum principal stress levels in the IML pieces are found to be 61.9 ksi and are located in the vicinity of the end fasteners, as seen in Figure 20. The minimum principal stress levels are found to be -63.6 ksi and are located close the ends of the IML pieces in fillet areas between the flange and web sections of the repair pieces, as seen in Figure 21. The maximum principal stress levels in the OML strap at the ultimate loading +10% level of 20.24 psi are presented in Figure 22.

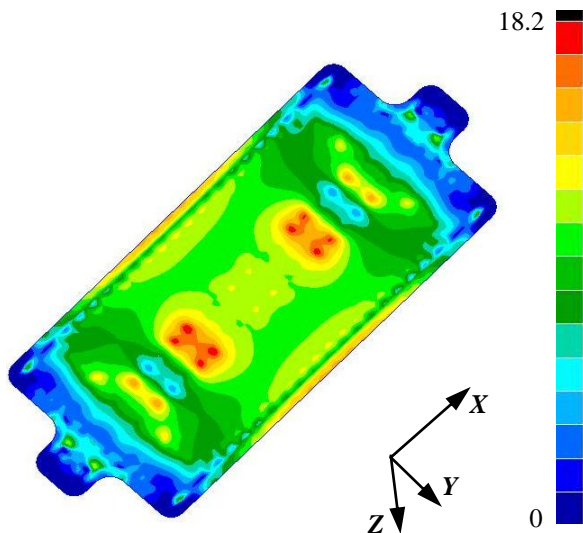
Figure 22. OML strap maximum principal stress (ksi) at ultimate + 10% loading of 20.24 psi.

Very modest maximum stress levels of 18.2 ksi are identified in the area where the fourth and fifth rows of the center flange fasteners are installed (when counting them from the saw-cut location). The minimum principal stress levels in the OML strap were found even less significant when compared with the maximum principal stress levels, and for brevity are not presented.
