# ELEVATED TEMPERATURE, RESIDUAL COMPRESSIVE STRENGTH OF IMPACT-DAMAGED SANDWICH STRUCTURE MANUFACTURED OUT-OF-AUTOCLAVE<sup>†</sup>

Brian W. Grimsley<sup>1</sup>, James K. Sutter<sup>2</sup>, Eric R. Burke<sup>1</sup>,  
Genevieve D. Dixon<sup>1</sup>, Thomas G. Gyekenyesi<sup>2</sup>, and Stanley S. Smeltzer<sup>1</sup>

<sup>1</sup> NASA Langley Research Center, Hampton, VA 23681

## ABSTRACT

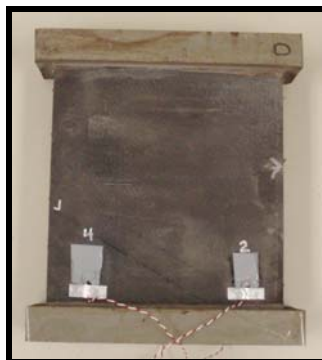
Figure 2. Front-view photograph of potted EWC and/or CAI test coupon.

The 20.32 cm x 15.24 cm curved EWC and CAI specimens were potted using Henkel® Hysol EA934NA epoxy potting compound following the supplier recommended bonding procedures. This resulted in a solid block of potting at each end of the specimen having dimensions of 17.8 cm x 5.4 cm x 1.6 cm. Photographs of the front-view and side-view of the potted coupon are displayed in Figure 2 and Figure 3, respectively. After the potting material cured at 25°C for 7 days, the ends of each potted specimen were machined to remove 3.175 mm from each end to ensure that the CFRP facesheets were flush with the surface of the potting material and that the potted ends were parallel to each other within +/-0.0254 mm. A photograph of the top-view of the potted specimen is shown in Figure 4.

Following the recommendation in ASTM C364 [26], all 100 EWC and CAI test coupons were instrumented using CEA-XX-187UW-350, 4.75 mm uniaxial strain gages supplied by Vishay Micro-Measurements<sup>®</sup>, Raleigh, NC. As indicated in Figure 2, two gauges were used on each side of the coupons, each located in the lower corners, 2.54 cm above the potting and 2.54 cm from the vertical edge of the coupon. These 4 gauges on each coupon were monitored during compression testing to ensure parallel loading and inhibit bending. The 27 coupons intended for ambient testing were gauged at LaRC according to procedures specified by the gauge supplier.

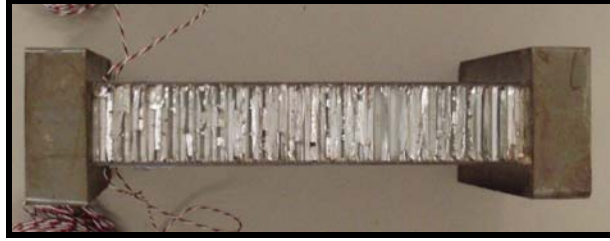
Figure 3. Side-view photograph of potted EWC and/or CAI test coupon.

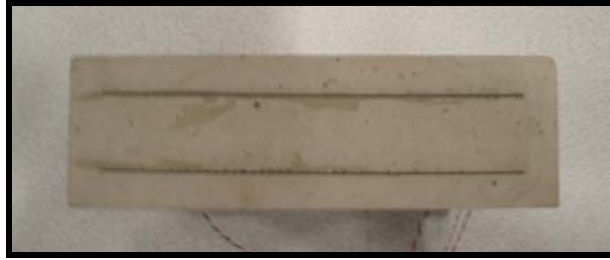
Figure 4. Top-view photograph of potted EWC and/or CAI test coupon.

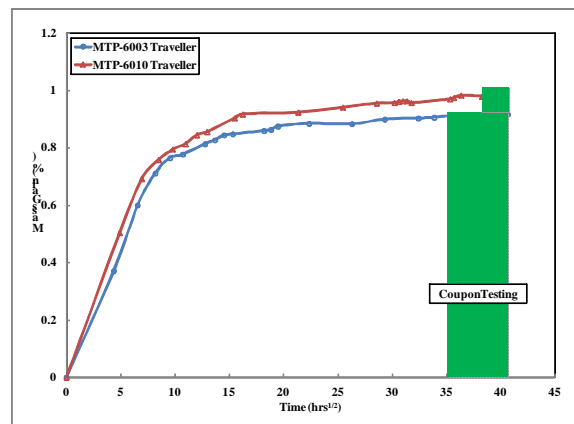
Figure 8. Moisture mass gain in witness panels from MTP-6003 and MTP-6010.

The 35 EWC and CAI coupons from MTP-6003 and the 17 EWC and CAI coupons from MTP-6010 intended for ETW testing were divided into two groups and conditioned in a chamber. Each set of coupons was accompanied by a witness panel consisting of a 10.2 cm x 5.1 cm portion of the larger 2.0 m x 2.4 m sandwich panel. The witness panels accompanied the coupons throughout the conditioning process and were used to measure the moisture absorption of the test coupons while in the conditioning chamber. Figure 8 shows the moisture mass gained during conditioning by one of the MTP-6003 witness panels in comparison to that of the MTP-6010 witness panel. Also shown in the figure are the starting and ending points of coupon testing following the conditioning process. As shown in Figure 8, the MTP 6003 witness panel reached a mass gain of 0.912% at the beginning of coupon compression testing and was at a level of 0.916% at the end of the two weeks required to test all of the coupons from this set. Likewise, the change in mass during the six working days required to test the MTP-6010 coupons resulted in a measured mass gain of 0.001%. In comparing the moisture absorption behavior of the two different material sets, it was observed that the OOA processed MTP-6010 sandwich CFRP witness panel initially absorbed moisture at a higher rate and to a higher level than the autoclave processed MTP 6003 witness panel. The difference in mass gain between the two witness panels during testing was <0.1%.

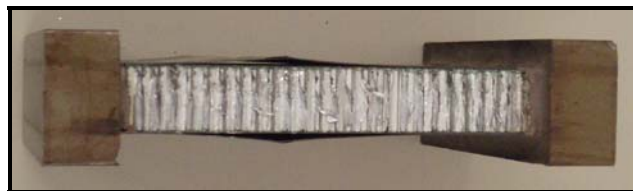
Figure 9. Photograph of ETW EWC from MTP-6003 showing typical valid failure mode including facesheet delamination and outward buckling on both the convex and concave sides.

The 44 undamaged coupons from both MTP-6003 and MTP-6010 that were available for EWC testing at the time of this publication exhibited the same two types of failure modes during testing. The predominant failure mode, or final damage state, was combined ply-delamination and fiber buckling/ breakage in the facesheets within the valid failure region as specified by ASTM C364 (2.54 cm above and below the top and bottom potted ends of the coupon). The failure of these coupons was denoted by a single loud pop with both facesheets typically failing at the same time across the 15.24 cm width of the coupon. Visual inspection of the failure indicated that the outer plies of each 6-ply facesheet delaminated from the inner plies, with the outer plies buckling outward and the inner plies buckling slightly inward. This was the typical failure mode for approximately 70% of the EWC coupons tested regardless of material type or test condition and is displayed in Figure 9. The other 30% of the EWC failures occurred in the same manner but within an inch of the sharp stress concentration created at the potting–coupon interface. According to the ASTM standard these are invalid failures even though the load at these invalid failures was often within the scatter of the valid failures. Due to these invalid failures, the amount of data used to calculate the average failure strength was limited; however, each test condition completed in this study contains at least two valid failures. The resulting number of coupons available after discounting the invalid failures is explained below in Section 3.4.

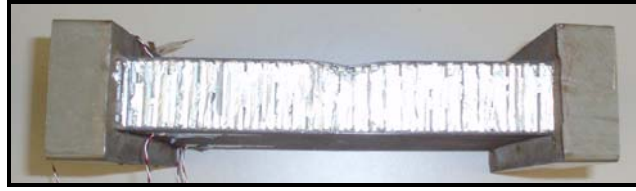
Figure 10. Photograph of ETW CAI from MTP-6010 showing typical facesheet buckling and core crushing valid failure mode.

With the exception of two invalid failures, all 38 of the BVID CAI failed by facesheet buckling inward across the width emanating from the impact region. The majority of these failures occurred in the impacted facesheet only, as indicated in Figure 10. In two MTP-6003 coupons and one from MTP-6010, failure was observed in both facesheets. In these three cases the damaged facesheet buckled inward and the undamaged facesheet delaminated with the outer plies buckling outward and the plies closest to the core buckling inward into the Al core. The two invalid failures experienced during the CAI testing were by delamination of the potting material at the ends. Both of these failures occurred in CAI coupons from MTP-6010 tested at 105°C. Up to 80 coupons were tested in the study at the various ETW conditions before a failure of this type occurred, however, once these two invalid failures occurred in succession, it was assumed that any future coupons would have been potted without adequate surface preparation and therefore would require clamping fixtures. Testing of MTP-6010 was suspended at this point while clamping fixtures were fabricated to accommodate clamping of the potted ends of the coupons. Therefore, the data set for MTP-6010 reported below was collected using no end-clamping fixture, in identical arrangement as that of the MTP-6003 data reported.

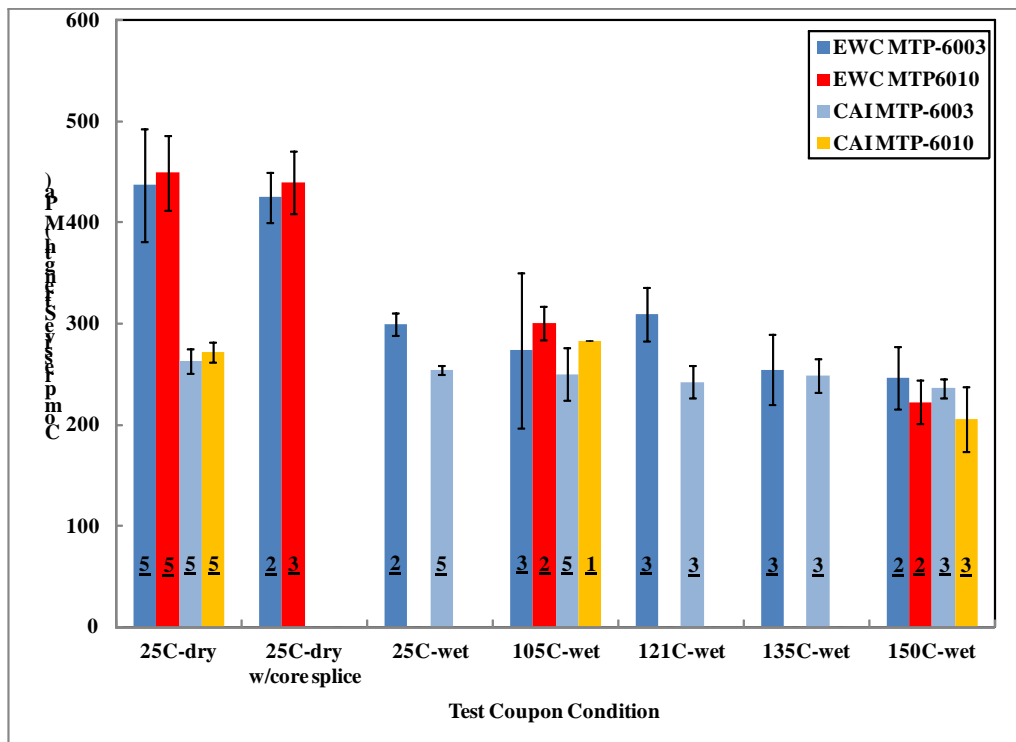
Figure 11. EWC and CAI strength of sandwich coupons tested from the autoclave processed panel MTP-6003 and the OoA processed panel MTP-6010.

The results of the EWC testing of undamaged sandwich coupons and the CAI testing of BVID sandwich coupons from both MTP-6003 and MTP-6010 panels are charted together for comparison in Figure 11. The number of valid coupon failures associated with each data column is denoted in the chart by the underlined numeral printed on each column.

The response of the sandwich coupons to compressive loads at the 25°C–dry condition for both material systems was as expected based on the literature; the BVID in the CAI coupons resulted in a retention of strength of  $60\% \pm 1\%$  and these results are based on five valid failures for each test set at 25°C-dry. Therefore, the compressive failure strength of the MTP-6003 and the MTP-6010 sandwich coupons in both the undamaged and BVID state are statistically equivalent at 25°C-dry. The core splice located at the center height of seven of the coupons tested at 25°C from both material sets had no significant effect on the undamaged strength for the quantity of

coupons tested in this study. Also, as expected, the moisture content at 25°C resulted in a 32% knockdown in axial compressive strength of the undamaged MTP-6003 sandwich coupons. In addition, the combination of moisture and elevated temperature resulted in a significant reduction in compressive strength of the undamaged coupons from both material systems. At the 150°C ETW testing condition, both materials have reached the level of 50% reduction in ambient undamaged compressive strength; the MTP-6003 autoclave coupons retained 56.4±7% and the MTP-6010 OoA coupons retained 50±5% of the ambient compressive strength based on the limited number of valid failures reported at the time of this publication. The most interesting results found in this study pertain to the ETW CAI coupons from panel MTP-6003. As shown in Figure 11, the failure strength at each condition from 25°C-dry BVID to 150°C BVID are statistically the same based on the standard deviation in CAI strength observed for these MTP-6003 sandwich coupons. There is no significant knockdown for the BVID coupons vs the undamaged EWC coupons at the ETW conditions. The same is true for the MTP-6010 coupons at 25°C-dry and 105°C-wet. At the 150°C-wet condition, the BVID CAI strength for the OoA material is reduced to 76% of the 25°C-dry result. These results suggest that the damage present at the BVID level is the dominant factor in the failure strength of the sandwich composite regardless of moisture absorption or thermal environment. Comparison of the average failure strength of undamaged and damaged coupons at each ETW condition from the MTP-6003 and the MTP 6010 panels indicates that the autoclave processed sandwich CFRP is equivalent in mechanical performance to the OoA processed sandwich CFRP.
