[Other] Relation between toughness, infinite fatigue life and microstructure in large blooms for automotive plastic molds

### RELATION BETWEEN TOUGHNESS, INFINITE FATIGUE LIFE AND MICROSTRUCTURE IN LARGE BLOOMS FOR AUTOMOTIVE PLASTIC MOLDS.

A. Ghidini Lucchini Sidermeccanica S.p.A. GRUPPOLUCCHINI

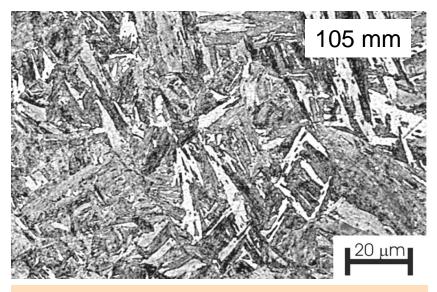
Lower bainite modified by tempering, retained austenite transformed during tempering
