# CADAM - Stability drawing

Project: Diploma  
 Dam: Moste  
 Owner:

Dam location: Kavčke  
 Date: 23.8.2012

Analysis performed by:  
 Project engineer: Mateja Klun

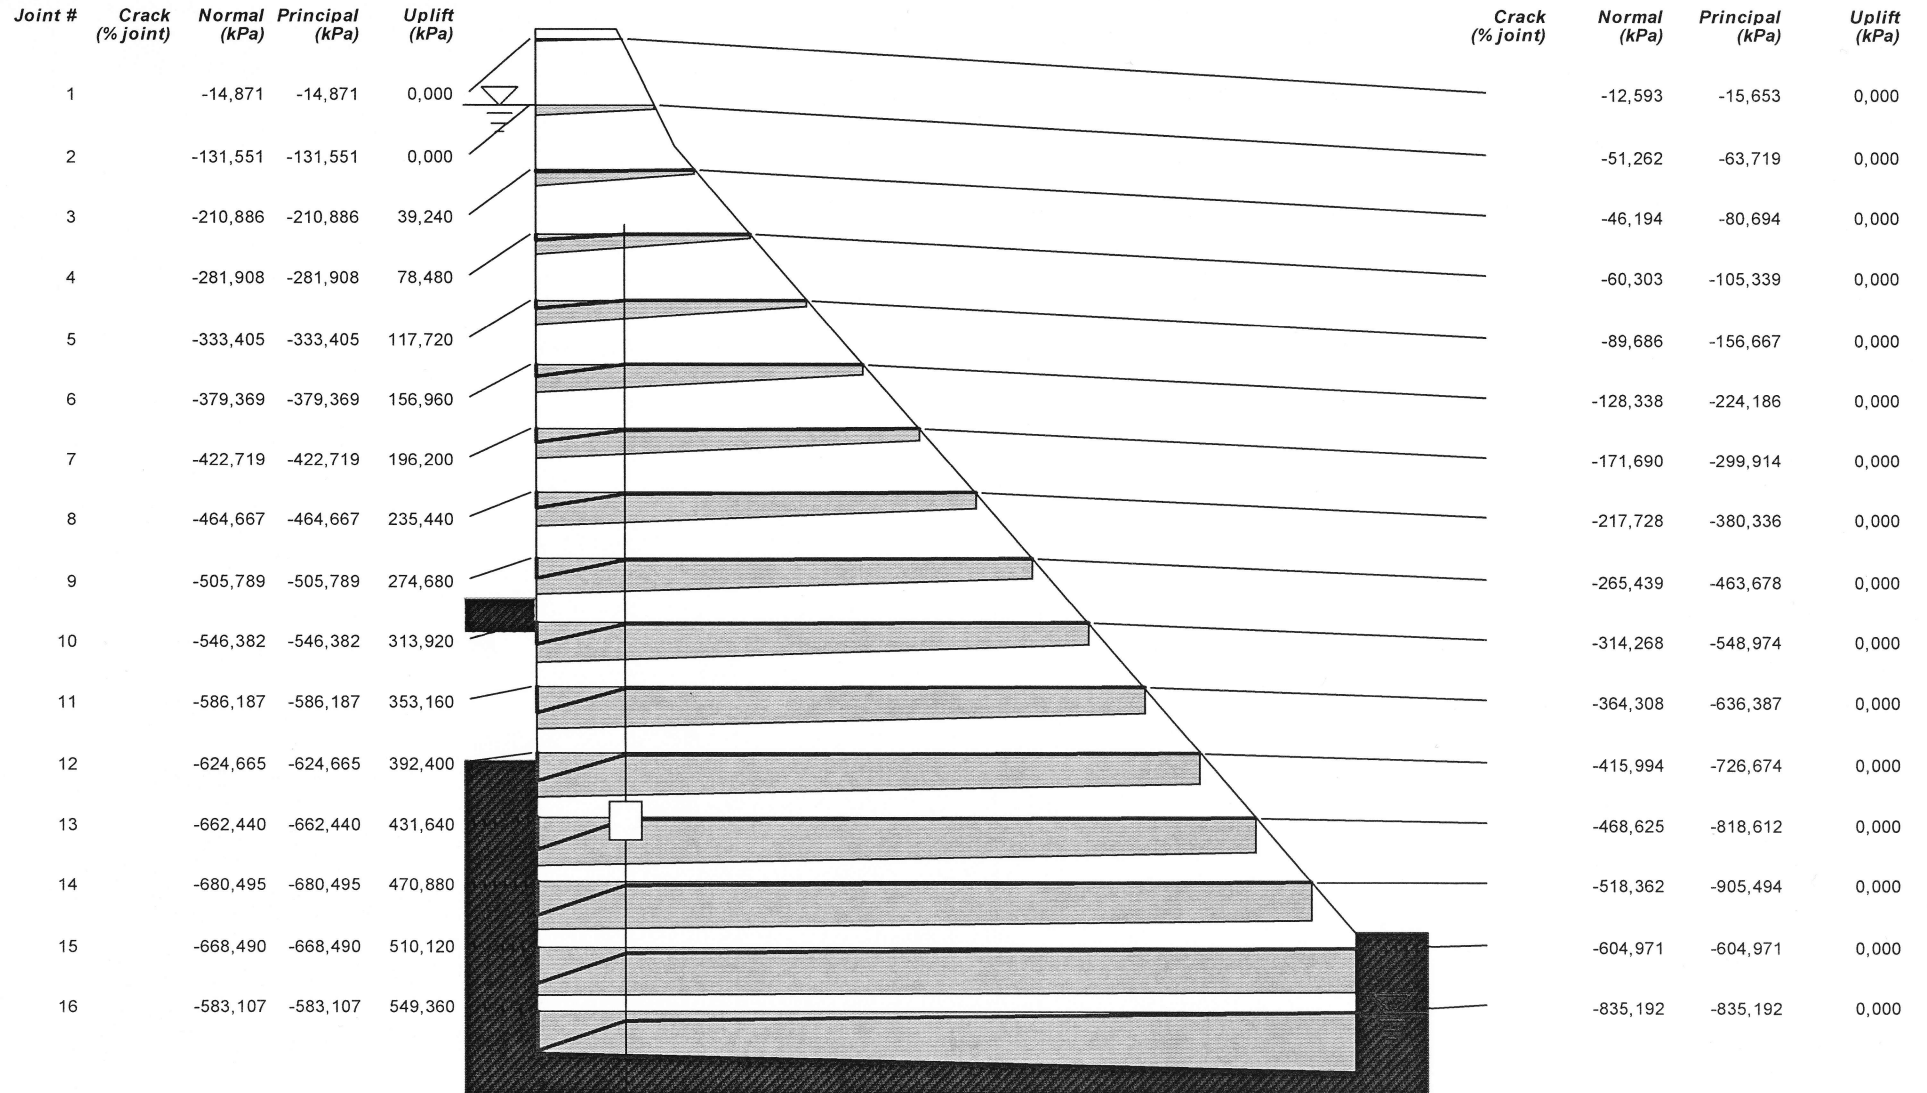
## Usual combination (effective stress analysis)

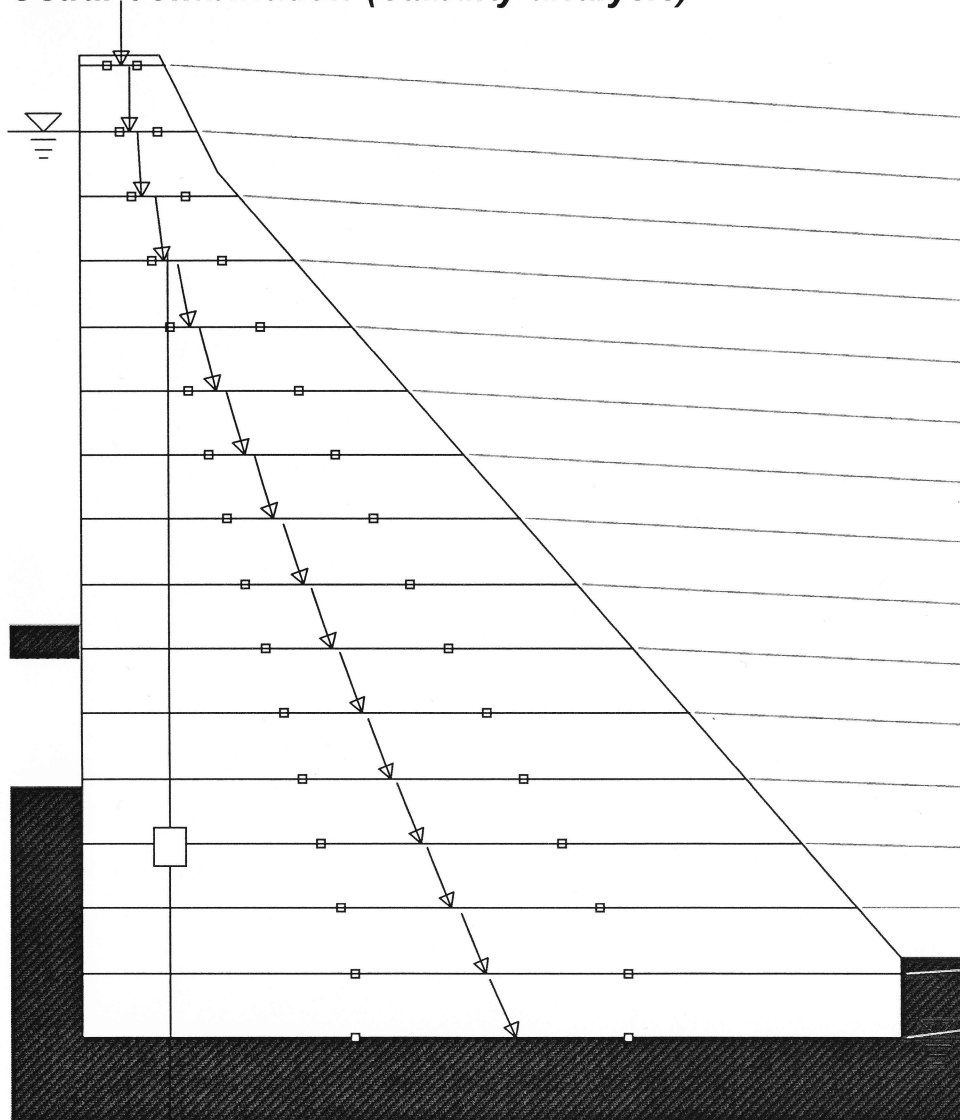
## Usual combination (stability analysis)

Joint #	SSF (peak)	SSF (residual)	OSF (U/S <)	OSF (-> D/S)	USF	Normal (kN)	Shear (kN)	Moment (kN-m)	Res. Pos. (% joint)
1	> 100	> 100	> 100	> 100	> 100	-72,7	0,0	-5,3	48,617
2	> 100	> 100	> 100	> 100	> 100	-664,3	0,0	-353,4	42,680
3	43,522	32,493	8,729	6,504	7,551	-1259,2	78,5	-1317,1	39,323
4	17,886	14,629	17,170	5,972	9,427	-2267,7	313,9	-3243,6	39,207
5	11,584	10,090	20,050	5,156	9,564	-3534,9	706,3	-5670,9	40,399
6	8,849	8,088	23,338	4,722	10,065	-5119,4	1255,7	-8507,7	41,759
7	7,275	6,946	26,535	4,450	10,683	-7021,0	1962,0	-11674,3	42,961
8	6,294	6,184	29,475	4,264	11,336	-9239,7	2825,3	-15090,8	43,969
9	5,635	5,618	32,111	4,129	11,993	-11775,5	3845,5	-18677,5	44,806
10	5,158	5,158	34,447	4,026	12,638	-14628,4	5027,1	-22352,2	45,505
11	4,765	4,765	36,520	3,942	13,265	-17798,3	6416,2	-25933,1	46,109
12	4,435	4,435	38,374	3,867	13,870	-21285,3	8025,0	-29099,4	46,658
13	4,229	4,229	40,022	3,803	14,452	-25089,4	9692,2	-31788,6	47,144

14	4,011	4,011	26,072	3,535	11,899	-28665,3	11497,2	-30897,7	47,746
15	3,787	3,787	17,883	3,187	9,465	-32154,9	13459,2	-13498,9	49,169
16	3,986	3,442	15,516	2,802	8,313	-35812,1	15578,2	53573,3	52,962
	<b>3,000</b>	<b>1,500</b>	<b>1,200</b>	<b>1,200</b>	<b>1,200</b>

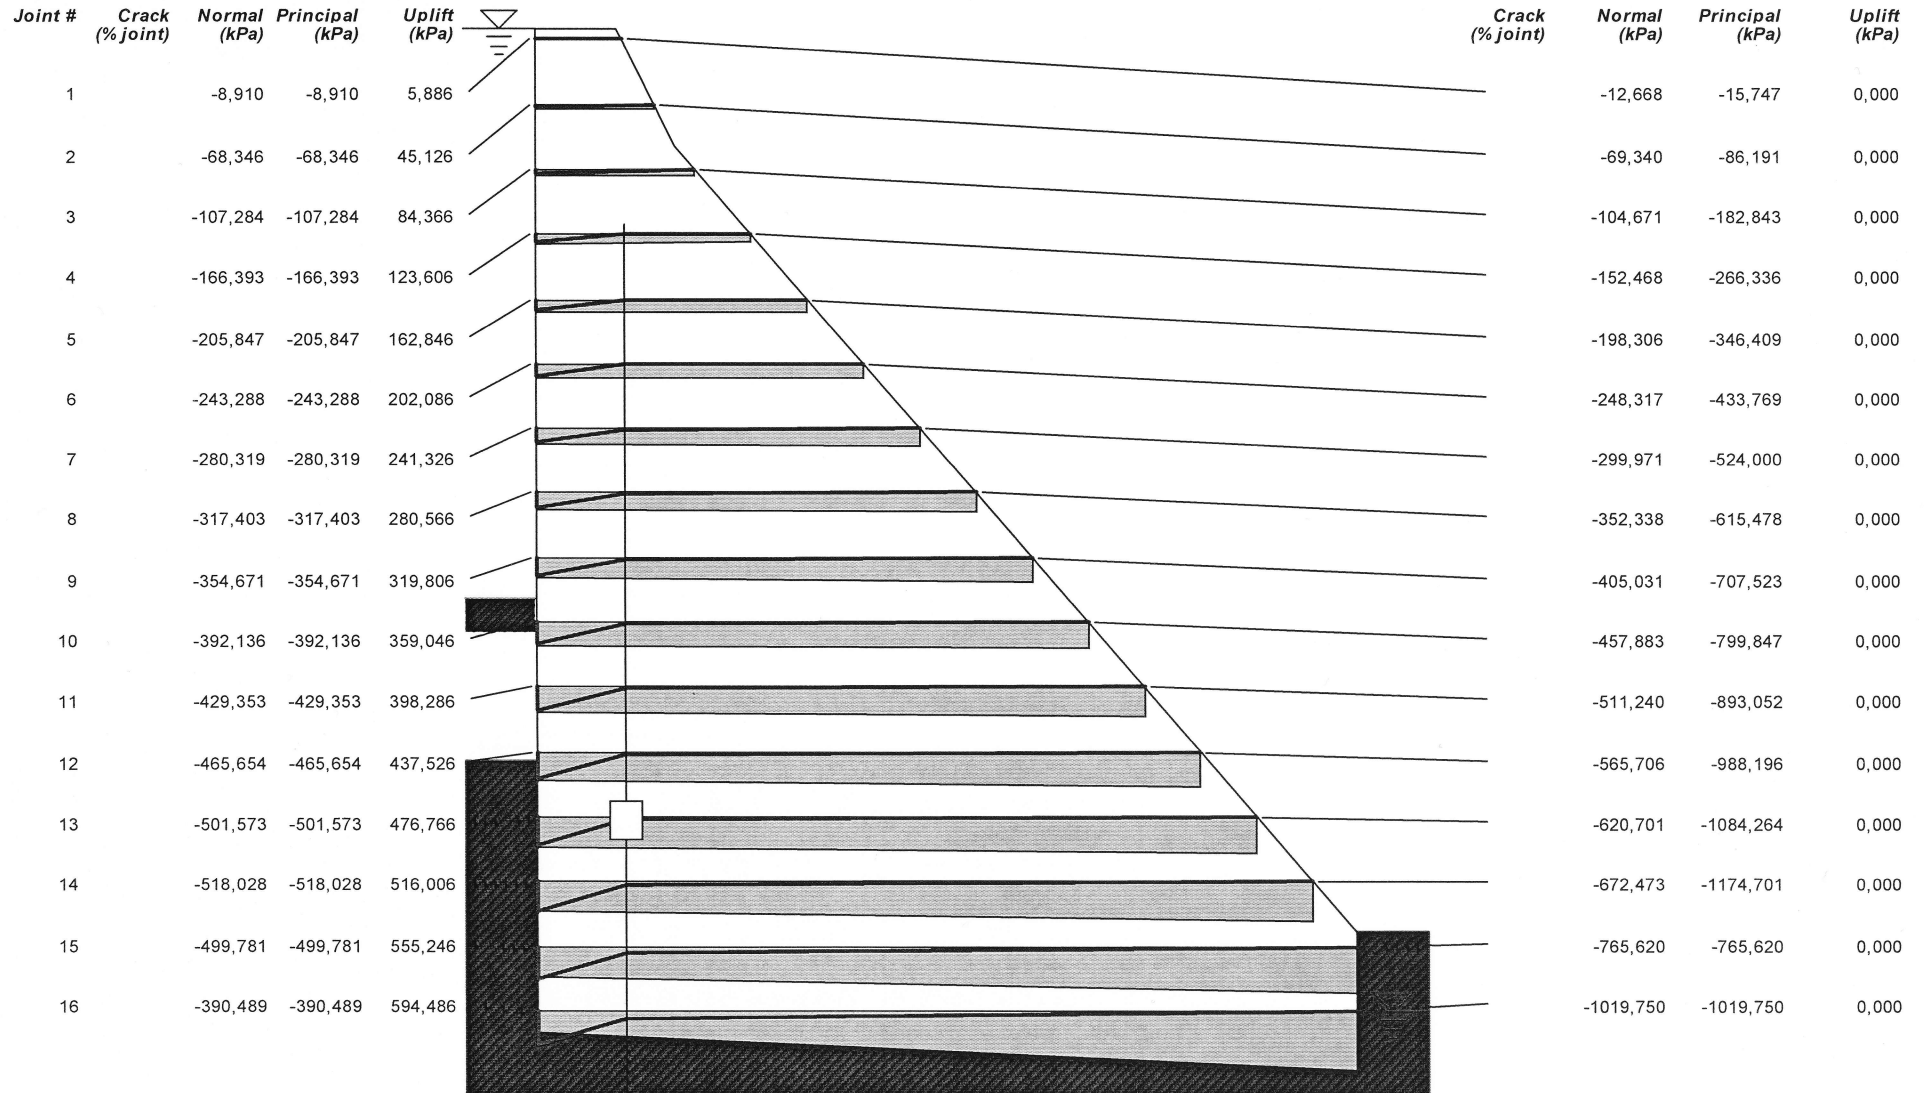
## Flood combination (effective stress analysis)

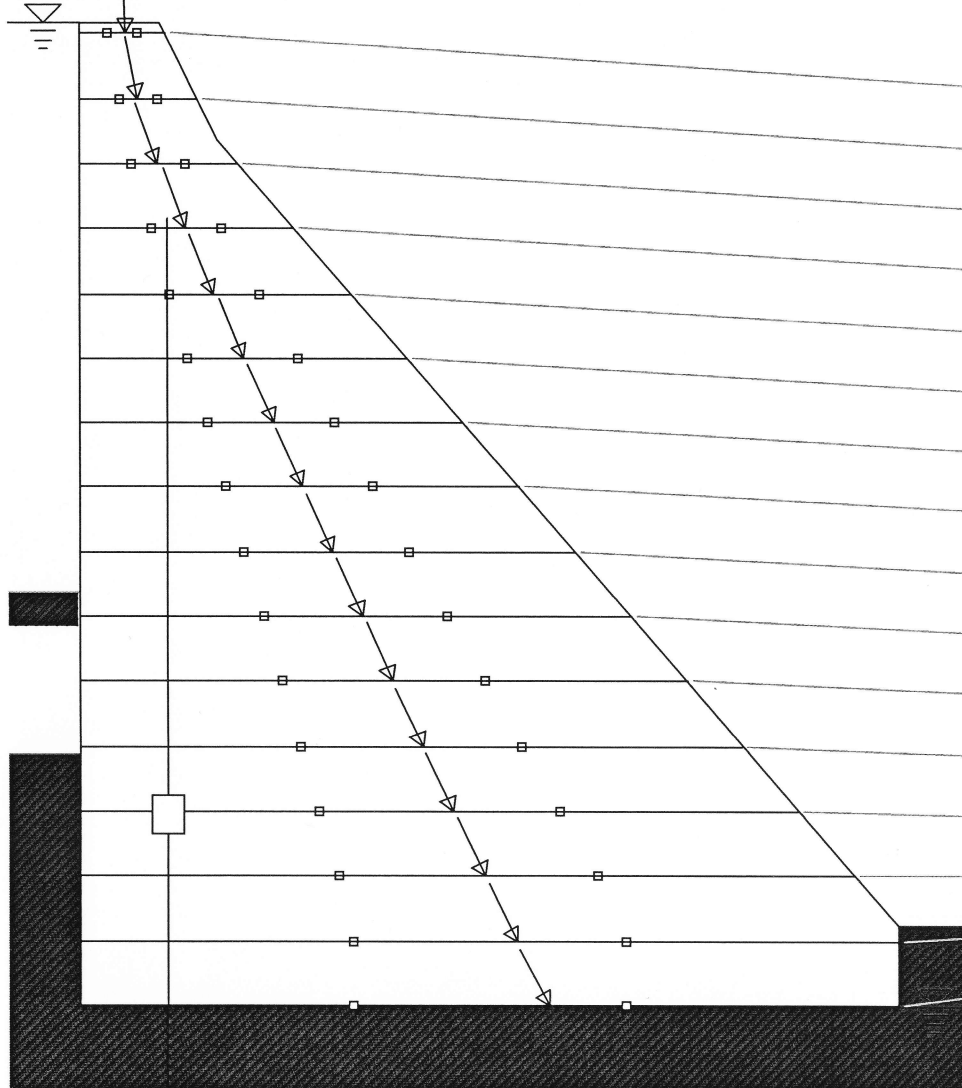
## Flood combination (stability analysis)

Joint #	SSF (peak)	SSF (residual)	OSF (U/S <)	OSF (-> D/S)	USF	Normal (kN)	Shear (kN)	Moment (kN·m)	Res. Pos. (% joint)
1	92,489	65,525	6,818	3,573	4,666	-57,1	1,8	8,8	52,903
2	13,779	9,762	5,588	2,902	4,051	-500,3	103,8	4,4	50,120
3	8,180	5,795	4,753	2,366	3,512	-1038,2	362,8	-20,9	49,795
4	7,488	5,495	13,022	2,835	5,985	-2112,9	778,7	-203,8	49,272
5	6,068	5,059	17,180	2,857	6,914	-3376,7	1351,6	-175,5	49,689
6	5,260	4,823	21,184	2,882	7,818	-4957,0	2081,5	170,4	50,170
7	4,742	4,676	24,854	2,907	8,685	-6854,2	2968,3	913,9	50,564
8	4,381	4,381	28,132	2,931	9,513	-9068,4	4012,1	2135,0	50,869
9	4,116	4,116	31,022	2,953	10,301	-11599,5	5212,8	3913,4	51,105
10	3,911	3,911	33,554	2,972	11,049	-14447,7	6575,0	6331,4	51,289
11	3,727	3,727	35,778	2,988	11,762	-17612,9	8144,5	9570,8	51,451
12	3,560	3,560	37,750	2,998	12,439	-21095,1	9933,8	13952,4	51,617
13	3,460	3,460	39,493	3,006	13,084	-24894,4	11781,5	19538,7	51,769

14	3,333	3,333	26,655	2,873	11,059	-28465,5	13767,1	29432,8	52,162
15	3,189	3,189	18,617	2,658	8,984	-31951,4	15909,6	56496,5	53,501
16	3,394	2,932	16,257	2,373	7,981	-35608,5	18209,0	133731,1	57,437
	<b>2,000</b>	<b>1,300</b>	<b>1,100</b>	<b>1,100</b>	<b>1,100</b>

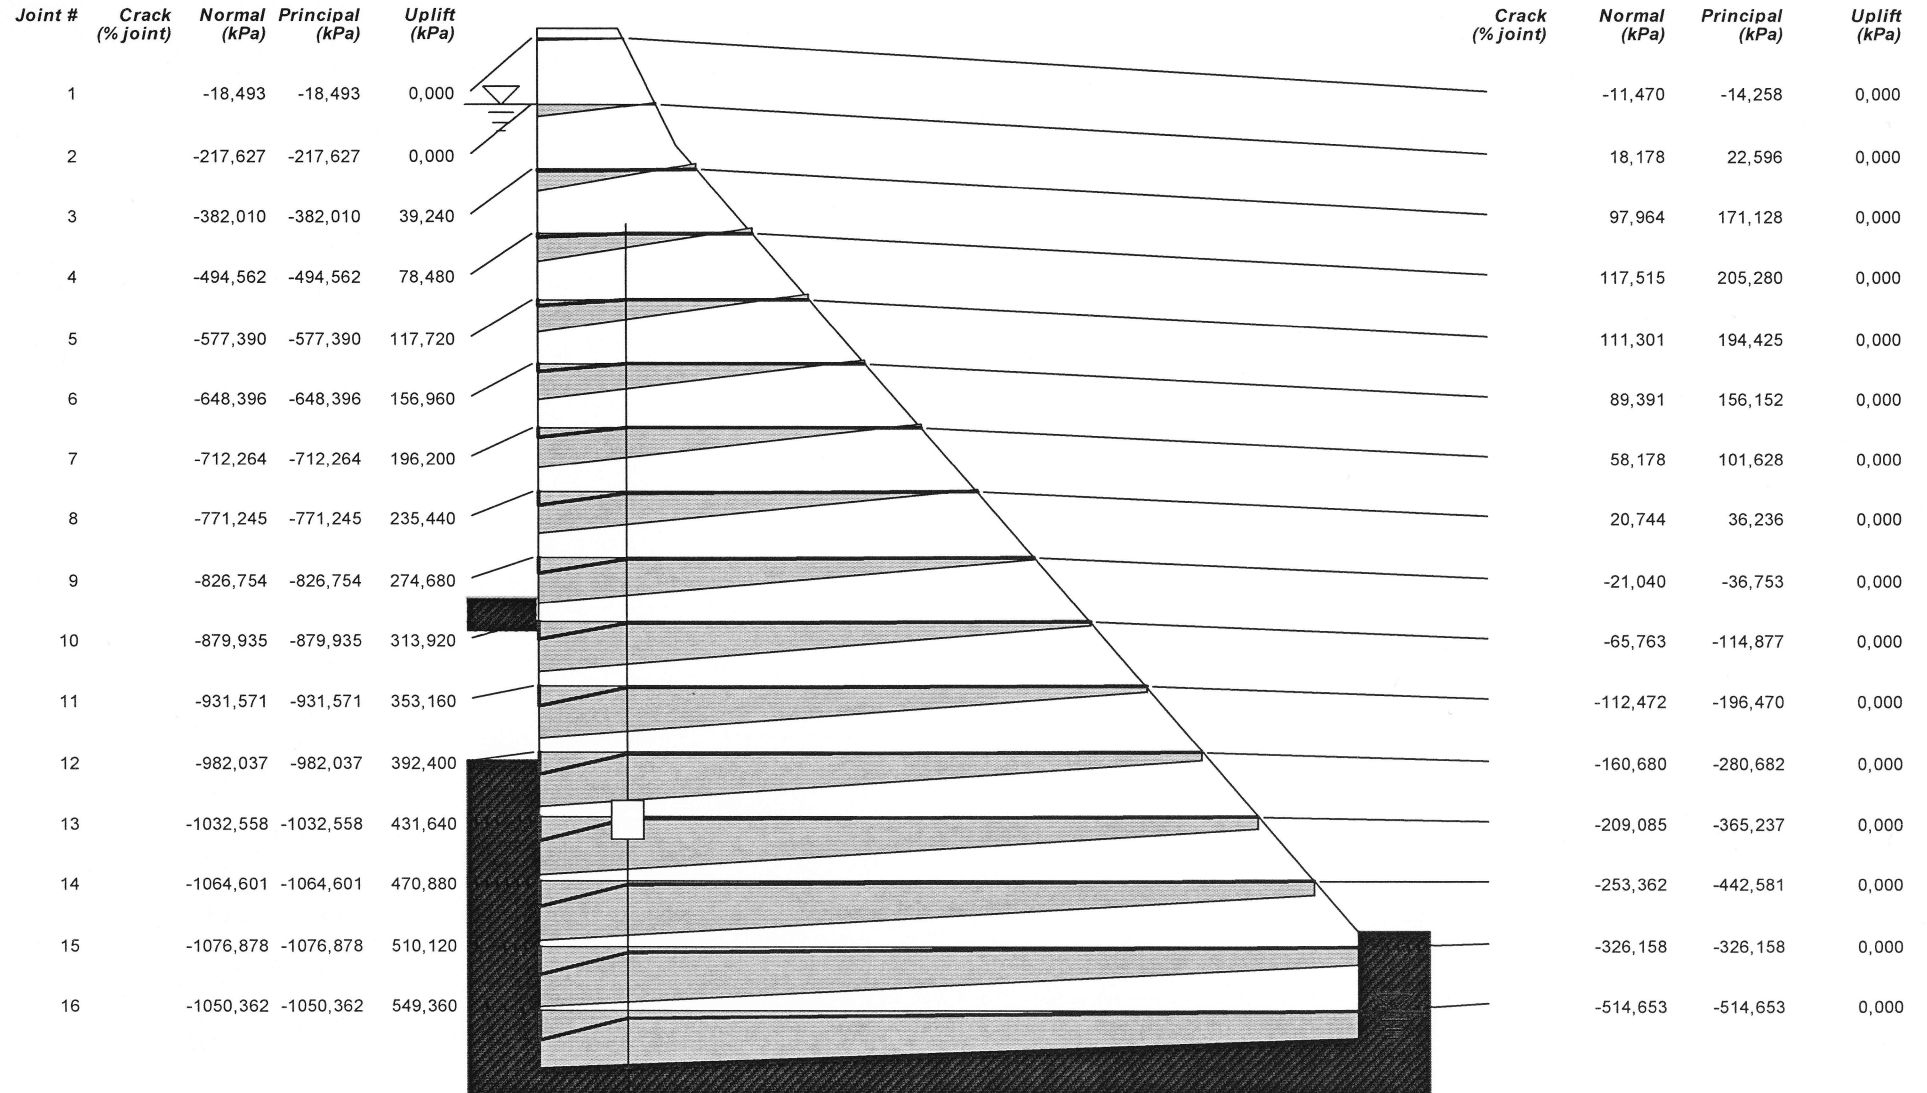
## Seismic #1 combination - Peak accelerations (stress analysis) (effective stress analysis)

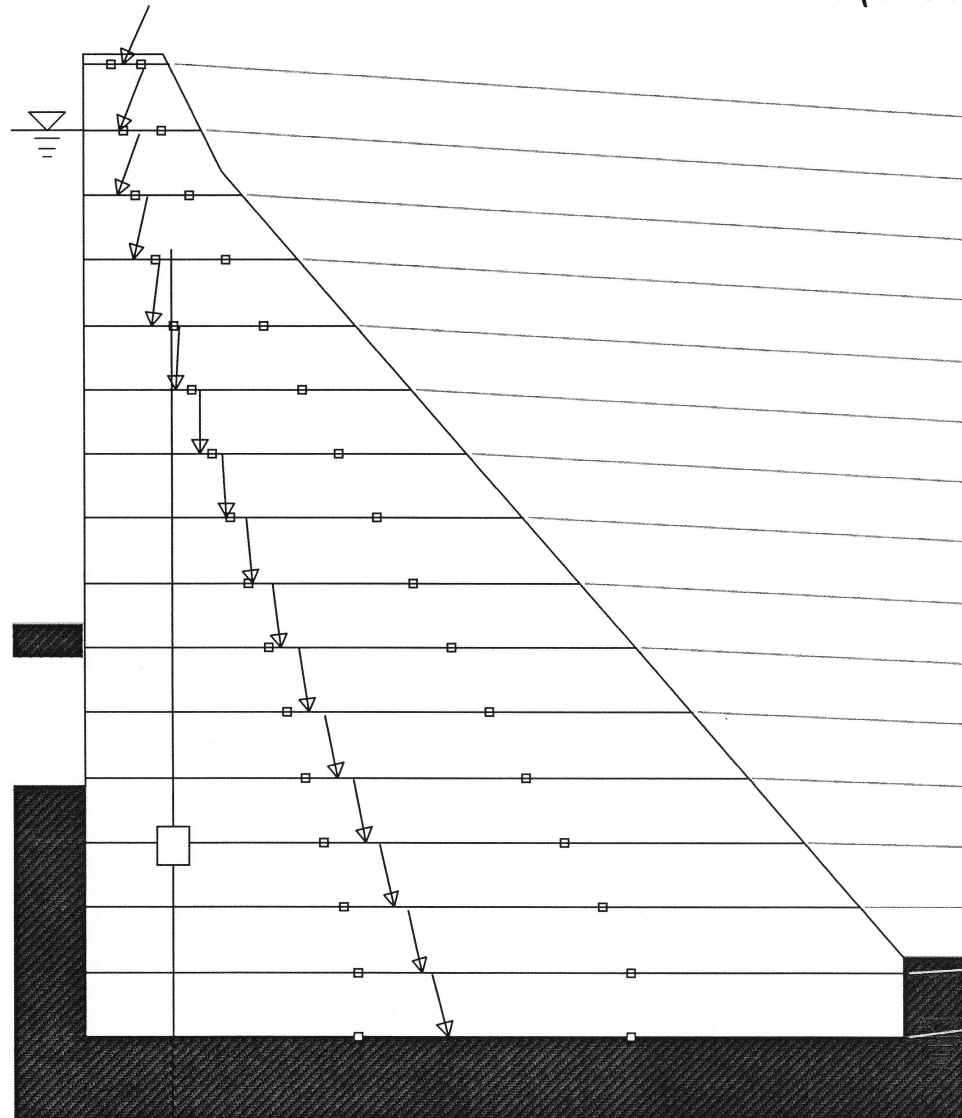
## Seismic #1 combination - Peak accelerations (stress analysis) (stability analysis)

Joint #	SSF (peak)	SSF (residual)	OSF (U/S <-)	OSF (-> D/S)	USF	Normal (kN)	Shear (kN)	Moment (kN·m)	Res. Pos. (% joint)
1	6,393	4,529	19,268	> 100	> 100	-79,3	-35,5	-16,4	46,094
2	6,785	5,109	3,446	> 100	> 100	-724,8	-289,3	-1037,9	30,295
3	6,535	5,760	1,995	8,834	8,239	-1391,3	-493,4	-3838,5	21,837
4	9,195	8,484	2,271	7,943	10,285	-2498,5	-570,8	-8959,0	22,944
5	15,193	14,294	2,553	6,733	10,434	-3894,1	-506,0	-16024,7	25,373
6	37,019	35,236	2,906	6,066	10,981	-5636,6	-287,3	-25004,5	28,003
7	> 100	> 100	3,293	5,635	11,655	-7725,9	92,2	-35829,9	30,368
8	28,494	27,482	3,703	5,331	12,368	-10161,9	633,9	-48399,7	32,412
9	16,909	16,381	4,131	5,103	13,084	-12944,6	1332,8	-62611,4	34,161
10	12,576	12,251	4,569	4,927	13,788	-16073,9	2179,4	-78403,5	35,651
11	10,209	10,016	5,008	4,783	14,472	-19550,0	3194,2	-95735,5	36,924
12	8,688	8,596	5,433	4,658	15,132	-23372,8	4383,1	-114539,3	38,020
13	7,834	7,801	5,832	4,554	15,767	-27542,3	5605,3	-135062,1	38,946

14	7,167	7,159	5,716	4,213	12,982	-31513,1	6908,6	-154598,3	39,741
15	6,609	6,609	5,414	3,793	10,326	-35426,7	8302,2	-159543,6	41,082
16	6,873	5,920	5,279	3,354	9,069	-39516,6	9804,8	-113849,3	44,295
	<b>1,300</b>	<b>1,000</b>	<b>1,100</b>	<b>1,100</b>	<b>1,100</b>

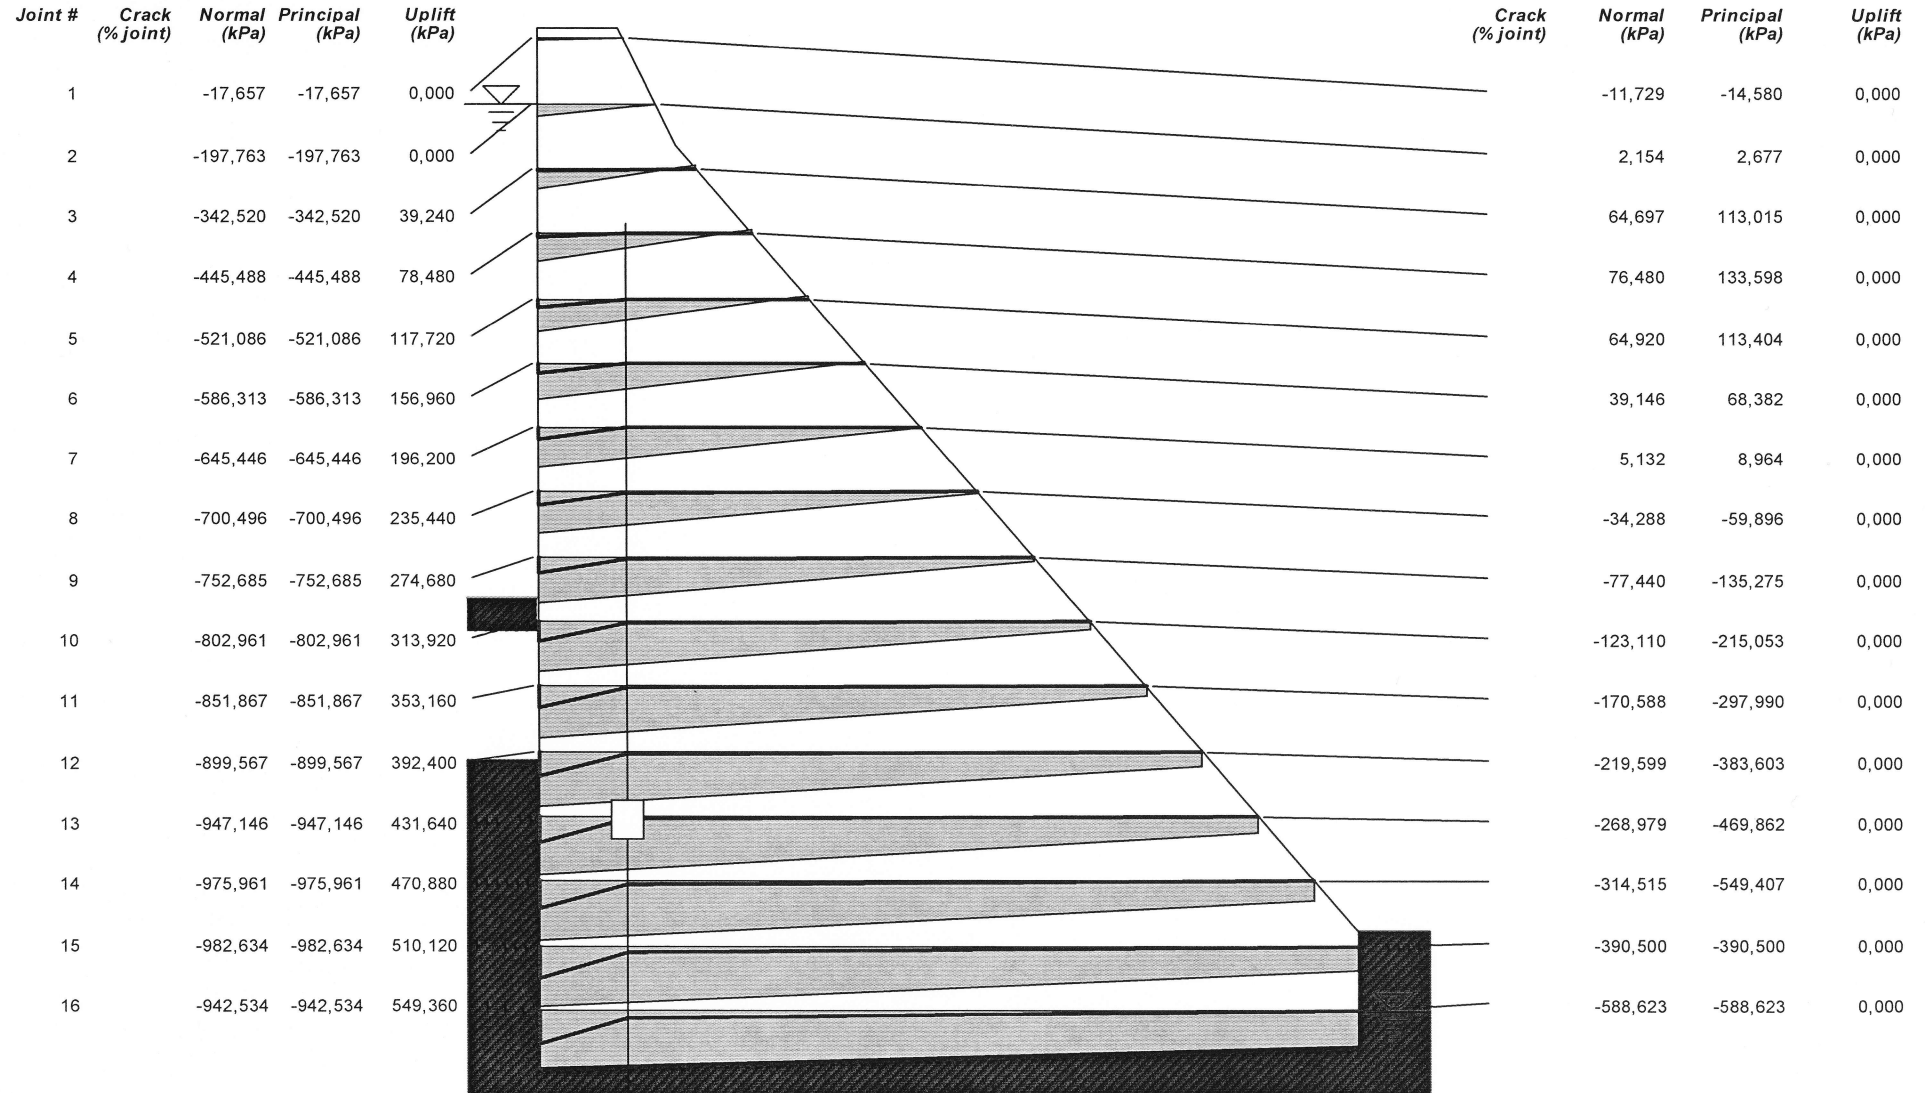
## Seismic #1 combination - Sustained accelerations (stability analysis) (effective stress analysis)

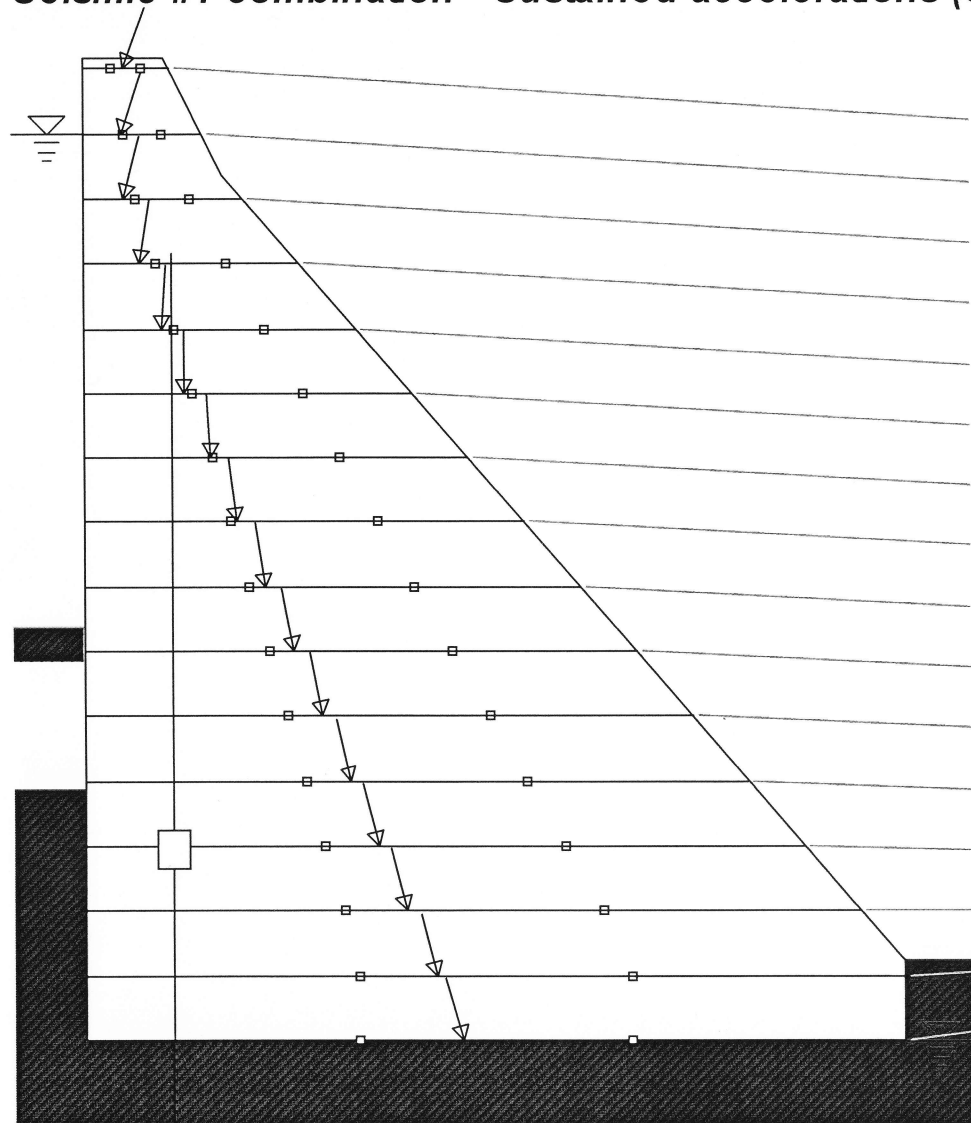
## Seismic #1 combination - Sustained accelerations (stability analysis) (stability analysis)

Joint #	SSF (peak)	SSF (residual)	OSF (U/S <-)	OSF (-> D/S)	USF	Normal (kN)	Shear (kN)	Moment (kN-m)	Res. Pos. (% joint)
1	8,151	5,775	24,566	> 100	> 100	-77,8	-27,3	-13,9	46,638
2	8,821	6,469	4,394	> 100	> 100	-710,8	-222,5	-879,9	32,966
3	8,938	7,691	2,394	8,296	8,080	-1360,8	-361,4	-3256,6	25,571
4	14,361	13,063	2,797	7,488	10,087	-2445,2	-366,7	-7640,1	26,425
5	34,128	31,765	3,150	6,369	10,233	-3811,2	-226,3	-13635,4	28,589
6	> 100	> 100	3,591	5,756	10,770	-5517,3	68,8	-21197,6	30,949
7	27,101	25,801	4,071	5,362	11,431	-7563,2	523,7	-30255,5	33,066
8	15,947	15,296	4,578	5,085	12,130	-9949,1	1139,6	-40713,1	34,889
9	11,785	11,401	5,104	4,879	12,832	-12674,8	1912,6	-52472,8	36,443
10	9,598	9,379	5,640	4,719	13,523	-15740,4	2836,6	-65468,6	37,765
11	8,172	8,075	6,175	4,589	14,193	-19145,8	3937,7	-79627,2	38,895
12	7,180	7,149	6,693	4,476	14,840	-22891,1	5223,6	-94822,4	39,874
13	6,603	6,599	7,177	4,381	15,463	-26976,2	6548,4	-111229,8	40,706

14	6,116	6,116	6,898	4,057	12,732	-30855,9	7967,5	-126052,0	41,457
15	5,686	5,686	6,393	3,654	10,128	-34671,6	9492,3	-125841,0	42,813
16	5,941	5,120	6,174	3,227	8,895	-38661,7	11137,1	-75213,3	46,148
	<b>1,300</b>	<b>1,000</b>	<b>1,100</b>	<b>1,100</b>	<b>1,100</b>
