Quantifying Pilot Contribution to Flight Safety during Drive Shaft Failure

This paper details the results and analysis of one of six non-normal events tested – a generator drive shaft failure.

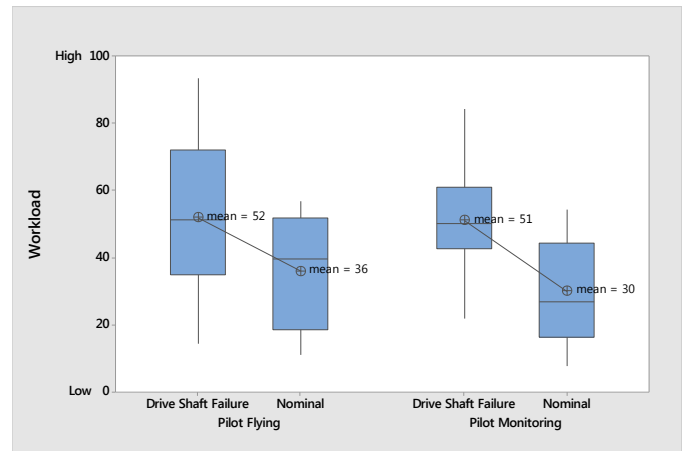
Fig. 1. Overall TLX pilot-flying and pilot-monitoring ratings for drive shaft failure and nominal runs

Not surprisingly, independent analyses revealed significant differences between the nominal and drive shaft failure runs for both pilot-flying (PF) ($F(1,34)=5.98$, $p=0.02$) and pilot-monitoring (PM) ($F(1,28)=6.46$, $p=0.017$) TLX ratings (Fig. 1). [The boxplots show the median ratings, with the 25th and 75th percentile spread in the data; the maximum and minimum values; and mean ratings (connected by a line).] For the drive shaft failure runs, pilots rated their overall workload as being moderate, as reflected in the PF (mean rating=52) and PM (mean rating=51) TLX ratings.

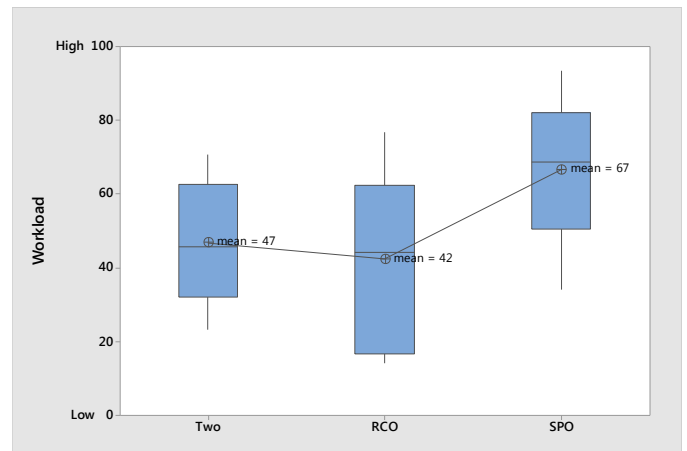
Fig. 2. Overall TLX ratings for pilot-flying drive shaft failure runs by crew configuration

There were no significant ($p>0.05$) crew complement differences for PF overall TLX ratings or PF subscale TLX ratings during a drive shaft failure run. Single pilot operations were rated as having moderately high workload (mean=67) while crewed operations were rated as having moderate workload (Fig. 2).

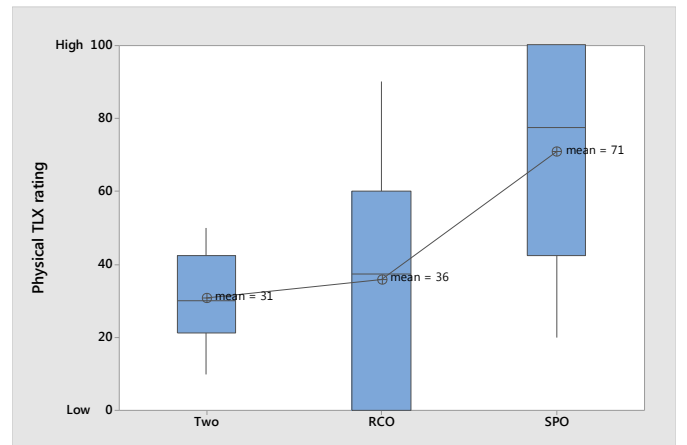
Fig. 3. Physical TLX ratings for pilot-flying drive shaft failure runs by crew configuration

Although the differences are not statistically significant, the physical workload TLX rating data highlights the significant change in the physical demands placed on the pilot-flying during Two-Crew and RCO conditions to SPO operations (Fig. 3).

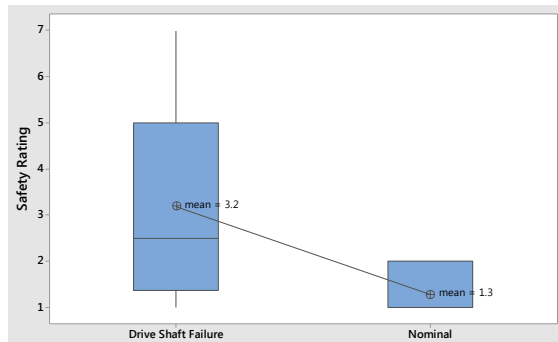
Fig. 4. Perceived safety of flight ratings for pilot-flying drive shaft failure and nominal runs collapsed across crew configuration

An ANOVA revealed significant differences ($F(1,34)=15.57$, $p<0.001$) between the nominal runs (median=1) and drive shaft failure runs (median=2.5) for PF Perceived Safety of Flight ratings. Fig. 4 illustrates these differences, where from an overall perceived level of safety for the PF compared to normal flight, this failure was difficult for some pilots as indicated by the large spread in data.

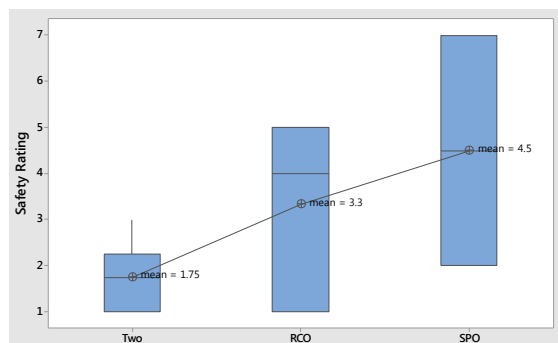
Fig. 5. Perceived safety of flight ratings for pilot-flying drive shaft failure runs by crew configuration

An ANOVA showed significant crew complement differences ($F(2, 15)=3.75$, $p=0.048$) for PF perceived safety of flight ratings. Fig. 5 shows the PF rating for each crew complement configuration. Pilots viewed the safety of this failure as unacceptable during single pilot operations (median rating=4.5) where the pilot had to simultaneously maintain flightpath control, communicate with ATC/Dispatch, and perform checklists. PF ratings indicated safety of flight was acceptable for this failure in the Two-Crew configuration.
