NASA KSC – Internship Final Report

Development of Guidelines for In-Situ Repair of SLS-Class Composite Flight Hardware

Thomas P. Weber, Jr.

John F. Kennedy Space Center

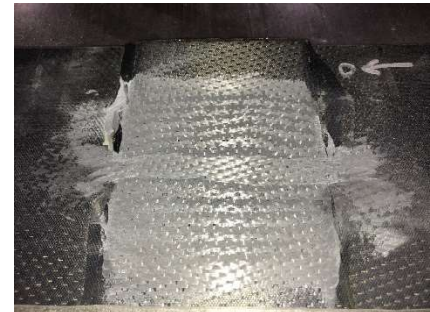
The next important step working towards the development of a repair procedure was to consider different repair methods and to develop a plan for testing these repair methods. The initial plan for repair was to scarf away damage in the doubler and apply a repair patch accordingly. Scarfing methods included tapered or stepped repairs. Practicing of these methods was conducted at the PDL using handheld disc sanders. An example of a tapered scarf practice panel with visible plies in the doubler is show in Fig. 5. After evaluating cross section views of the impact test samples and observing damage mainly in the facesheet, however, additional repair options needed to be considered. Revised repair options that were considered included bonding a repair doubler over the existing damaged doubler, scarfing away damage only in the doubler and applying a patch, and removing and replacing all of the damage in the doubler, facesheet, and honeycomb core.

Figure 5. Tapered Scarfing on Test Panel Doubler
