# **Composite Bonded Joint: Repair Development**

Daniel Perez

NE-L4 Engineering Fall Session

# Composite Bonded Joint: Repair Development

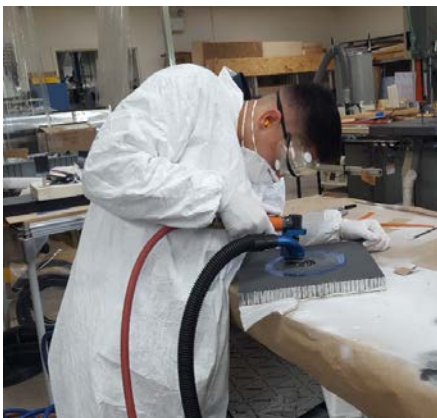
**Figure 2a. Panel Scarfing.** Pneumatic orbital hand sander and vacuum port used for scarfing.

The first steps of panel scarfing include pneumatic orbital hand sander and vacuum preparation. The main pressure valve was manually turned clockwise to close off pressure. The air supply line was connected to the main pressure line. Once that was complete, the pneumatic orbital hand sander and vacuum ports were connected to the air supply. The hand sander was also connected to the vacuum using a larger, corrugated tube, as shown in Figure 2a. An additional vacuum was suggested to collect any airborne particles not collected by the hand sander vacuum. Before starting panel scarfing, 2 inches were marked and tapped out from the edge of the 1 inch center hole. Eight 0.25 inch increments were marked from the edge of the hole to account for each ply cutout. The face sheet was taper scarfed using 80 – 120 grit sand paper. The process was a tedious technique; therefore, the removal of individual layers was closely watched to avoid cutting core/adhesive level. An important note to keep in mind is since the panel is co-cured, dimpling starts to occur from the core a couple of plies in. Also, due to it being fiber placement, thin plies make it more challenging to expose layer by layer during the scarfing process. The approach was to be very gentle scarfing the closer it got to the last layer. Once the last layer is reached, all layers are smoothed out by brushing over the tapered scarf in a circular motion. The final product is shown in Figure 2b.

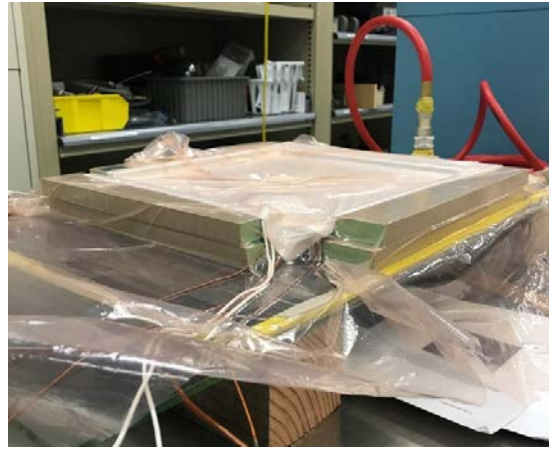
**Figure 5. Cure Cycle.** Panel was cured using hot bonder heater blanket

The first steps of the cure cycle were similar to the debulk process. All materials that cannot withstand high temperature cure were removed. Foam blocks were placed around the sandwich panel in order to prevent the vacuum bag from pulling down on the edges of the panel. Thermocouples were placed adjacent to the patch and on the panel. The perforated film adhesive was placed over the part and secured with flash breaker tape. Once that was done, a non-perforated film adhesive was placed over the laminate. A breather cloth was placed over the part and the vacuum port was placed on top of the breather cloth. High temperature tacky tape was applied to the tool around the breather, ensuring that the tape does not contact the breather. One continuous sheet of vacuum bagging (high temperature Nylon) was placed over the part and secured with tacky tape. A small slit was cut in the vacuum bag material over the vacuum port in order to securely attach the top component of the vacuum. Any open edges were sealed with tacky tape, especially around the thermocouple wires, to ensure there were no leaks. Once that was complete, 25-28 inHg of vacuum was applied over the part until the leak rate was less than 2inHg over 5 minutes. The cure cycle started on the hot bonder using a preset program. The hot bonder ramped up to 250°F at 3°F per minute. Once it reached that temperature, it held for 3 hours then ramped up to 350°F at 3°F per minute. At 350°F, it held for 2 hours then ramped down to 100°F at 3°F per minute. Once the curing cycle was complete, the hot bonder was turned off and the part was debagged.

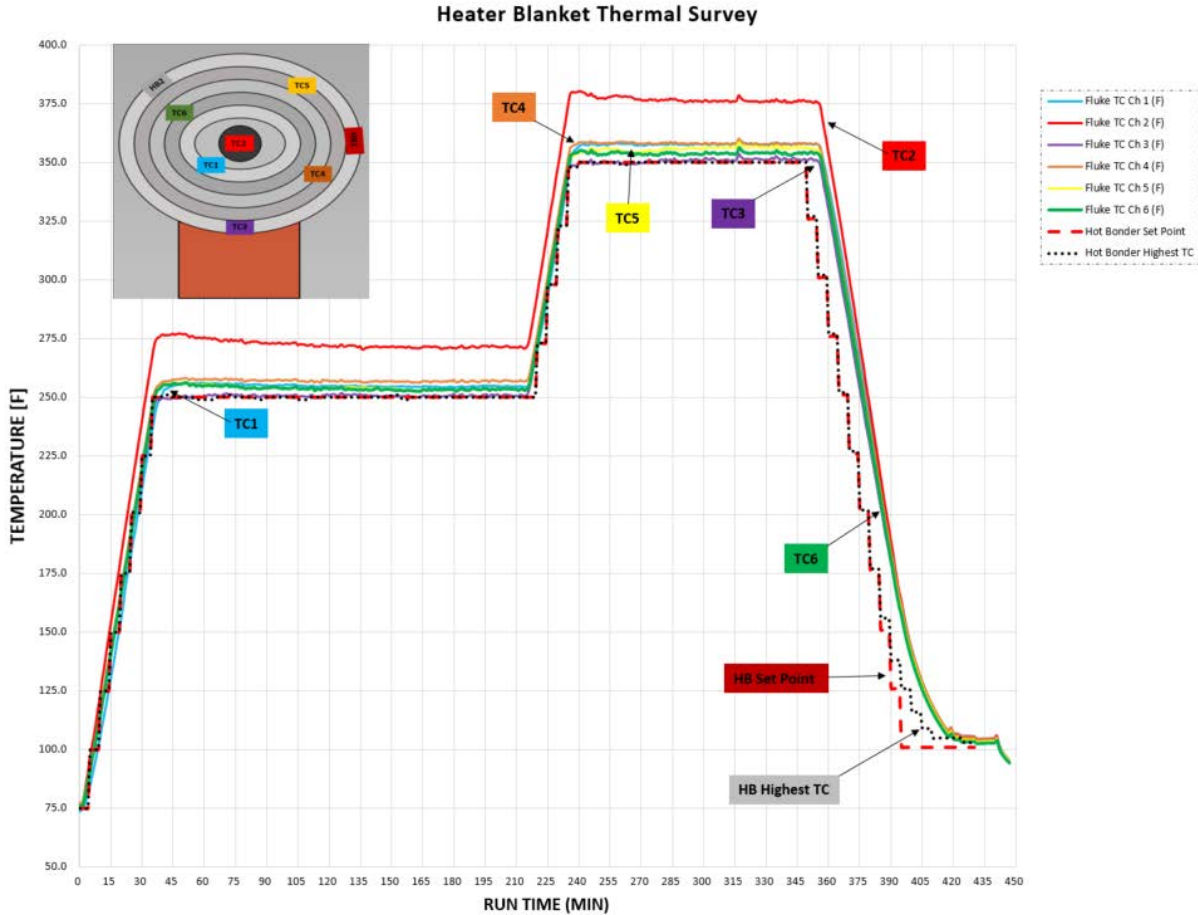
Figure 6. Thermal Survey. Results of cure cycle.

A thermal survey was performed to determine differences in the heating across the blanket. The data of the cure cycle was recorded through the thermocouple readings on the Fluke Data Acquisition. There were a total of six thermocouples connected to the Fluke and two thermocouples connected to the hot bonder. The data was recorded and shown on Figure 6. This figure also displays the locations of the thermocouples on the part. It was observed that Fluke Thermocouple Ch. 2 experienced the highest temperature reading of about 375°F. This could have been due to the center placement of the thermocouple on the part. The second and third highest thermocouple readings were Fluke Thermocouple Ch. 1 and Fluke Thermocouple Ch. 4. These were relatively close to the center as well, which justifies a reasoning that higher temperatures are experienced closer to the center of the heater blanket. Hot bonder thermocouples were also used in this experiment to show differences between the set temperature point and the highest thermocouple. Based on the graphed data, it can be seen that the hot bonder set point is closely similar to the highest hot bonder thermocouple reading. However, when compared to the highest fluke thermocouple reading (Ch.2), the difference is 25°F. This large difference could have been due to the fact that the hot bonder thermocouples were placed furthest away from the center of the heater blanket.
