NASA/TM—2018-220008

Fatigue Life of a NiCr-Coated Powder Metallurgy Disk Superalloy After Varied Processing and Exposures

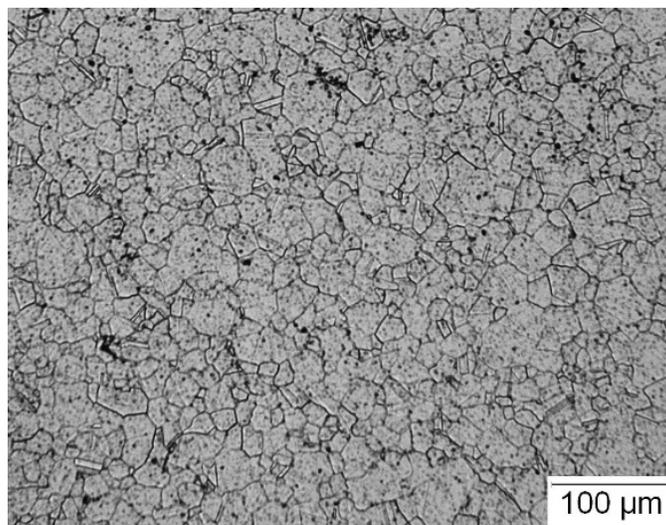
Figure 1.—Microstructure of powder metallurgy superalloy LSHR.

The low solvus high refractory (LSHR) powder metallurgy disk superalloy test material had the composition listed in weight percent of 3.54Al-0.027B-0.045C-20.4Co-12.3Cr-0.1Fe-2.71Mo-1.49Nb-0.02O-0.012Si-1.52Ta-3.45Ti-0.01V-4.28W-0.049Zr-bal. Ni. The LSHR superalloy powder was atomized in argon, consolidated by hot isostatic pressing, extruded, and isothermally forged into flat disks. Extracted rectangular blanks about 14 mm square and 55 mm long were consistently supersolvus solution heat treated at 1171 °C for 2 h and subsequently aging heat treated at 855 °C for 4 h, followed by 775 °C for 8 h. The resulting LSHR microstructure (Fig. 1) had an average linear intercept grain size of about 15 μm .

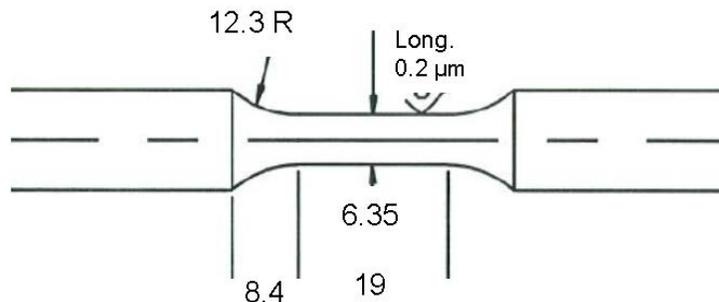
Figure 2.—Fatigue specimen gage section, with dimensions in mm.

Fatigue specimens having uniform gage sections 6.4 mm in diameter were then machined to the dimensions shown in Figure 2. The test specimens were all machined by low stress grinding, followed by longitudinal polishing with abrasive paper to a root mean square roughness of less than 0.2 μm . However, before coating, the gage surfaces of all specimens were “pre-conditioned”. A large group of specimens were pre-conditioned by grit blasting, using –220 mesh alumina grit. The surfaces of a smaller group were later pre-conditioned by wet blasting, using 15% of –300 mesh silica glass beads. A third small group of specimens had the grit blasting followed by the wet blasting treatments.

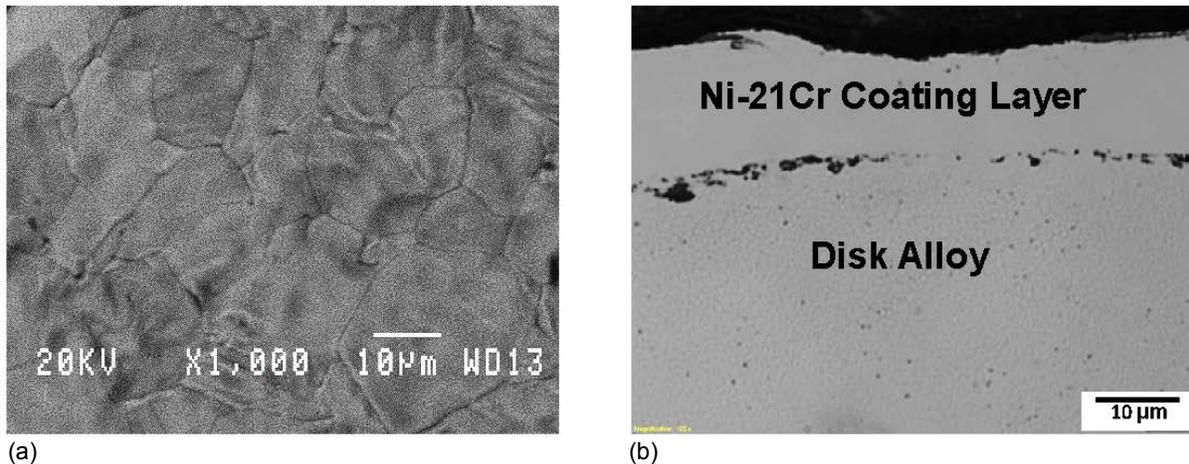
Figure 3.—Coated superalloy. (a) As-coated surface. (b) Cross-section of coated plus shot peened plus heat treated fatigue specimen.

samples. Four bars were thereby coated during a single coating run. Several coating runs were performed using the same process settings. The typical microstructure of the coating after application and subsequent shot peening at 16 N-200% and heat treatment is shown in Figure 3. The black inclusions at the coating/substrate interface are embedded alumina grit particles, which will be discussed later. The coating composition was measured by electron dispersive spectroscopy (EDS) in a scanning electron microscope (SEM) to be Ni-21Cr in weight percent. The coating had a mean thickness of 23.1 μm with a 95% confidence interval of $\pm 2.2 \mu\text{m}$ for the unexposed specimens, using measurements of their fracture surfaces adjacent to the failure initiation point. It consisted of a single nickel-rich γ phase. The mean linear intercept grain size of the coating measured normal to the specimen surface and environment was 12 μm .

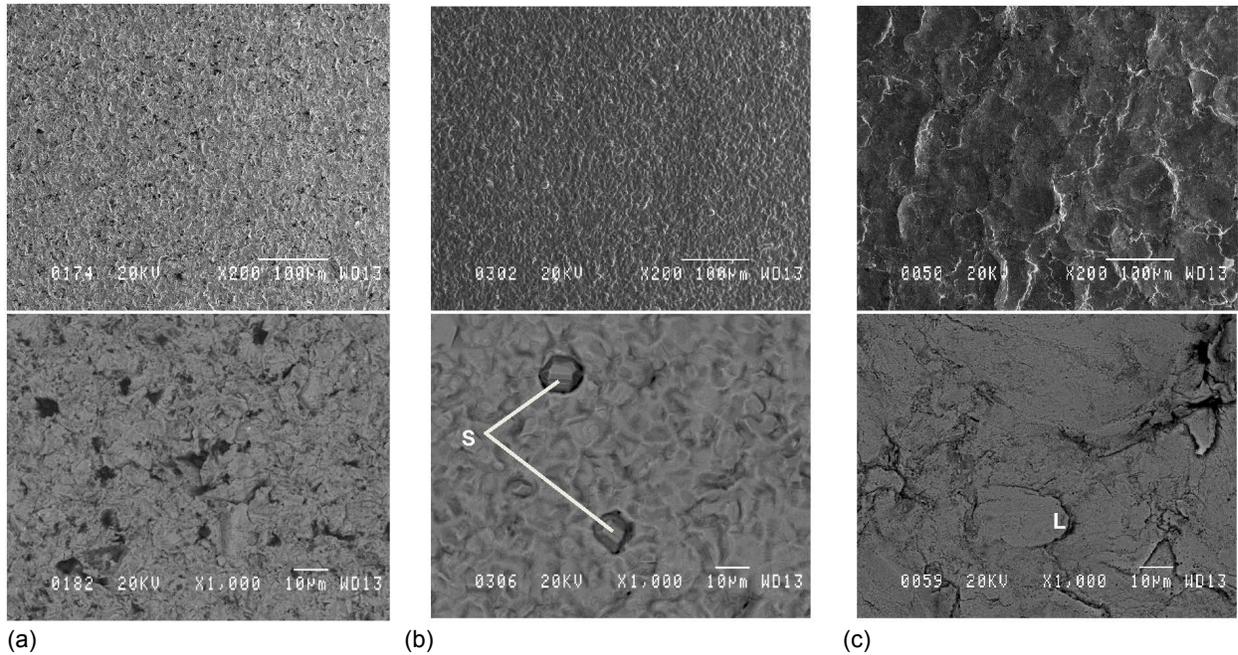
Figure 4.—Effects of baseline specimen preparation steps on surface conditions. (a) Grit blast, showing embedded alumina grit (black particles). (b) Coated, showing spits (S). (c) Shot peened 16 N-200% and heat treated 760 °C for 8 h, showing laps (L). The fatigue loading direction is oriented vertically.

Uncoated specimen gage surfaces after grit blasting are shown in Figure 4(a). The grit blast surface had a finely textured, roughly scalloped appearance. An area fraction of 0.034 alumina grit particles up to 10 µm in diameter was embedded in the grit blast surface. Deposition of the coating gave a fine texture that was generally nodular, shown in Figure 4(b). More prominent nodules known as spits were also observed, sometimes produced during this coating process. The shot peened and heat treated surfaces were more fairly uniform, with the formerly grooved and nodular surface textures mostly eliminated, being replaced with an undulating, dimpled texture, as shown in Figure 4(c). Shot peening of the coated surface flattened the spits, and resulted in folds of metal ("laps") sometimes occurring at the edges of dimples created by the impact of shot. As shown in Figure 5, both measured average roughness and peak-valley roughness increased between grit blasting and the final coated, shot peened, and heat treated condition. While the coating had a mean thickness of 23.1 µm for the unexposed specimens, measurements of fracture surfaces adjacent to the failure initiation point indicated the coating thickness typically varied with a 95% confidence interval of 2.2 µm around the mean, due in part to the shot peening.

It was noted that the shot peening at 16 N-200% significantly increased roughness and compressive residual stresses in the coating, through plastic deformation at the surface, evident in Figure 4. Yet, this could have produced significant deformation damage in the formerly ductile coating, to lower the coating's resistance to fatigue cracking. Therefore, a less intense shot peening process after the coating application was investigated.

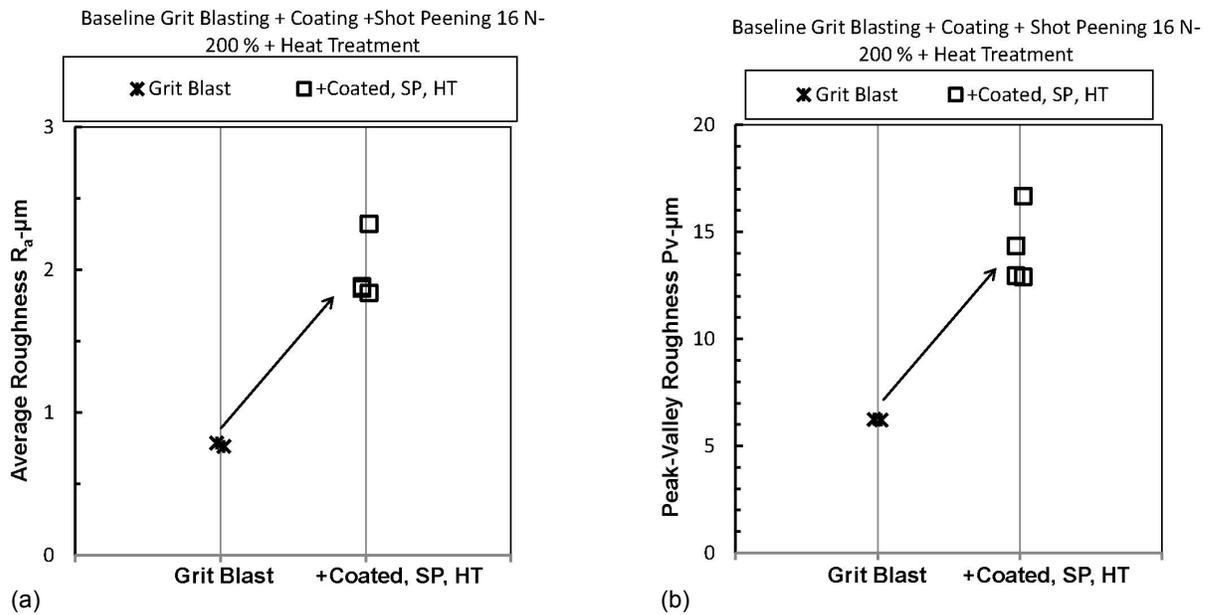
Figure 5.—Roughness after grit blasting, and after subsequent coating, shot peening, plus heat treatment. (a) Average roughness. (b) Peak-valley roughness. The hollow symbols are for coated specimens.

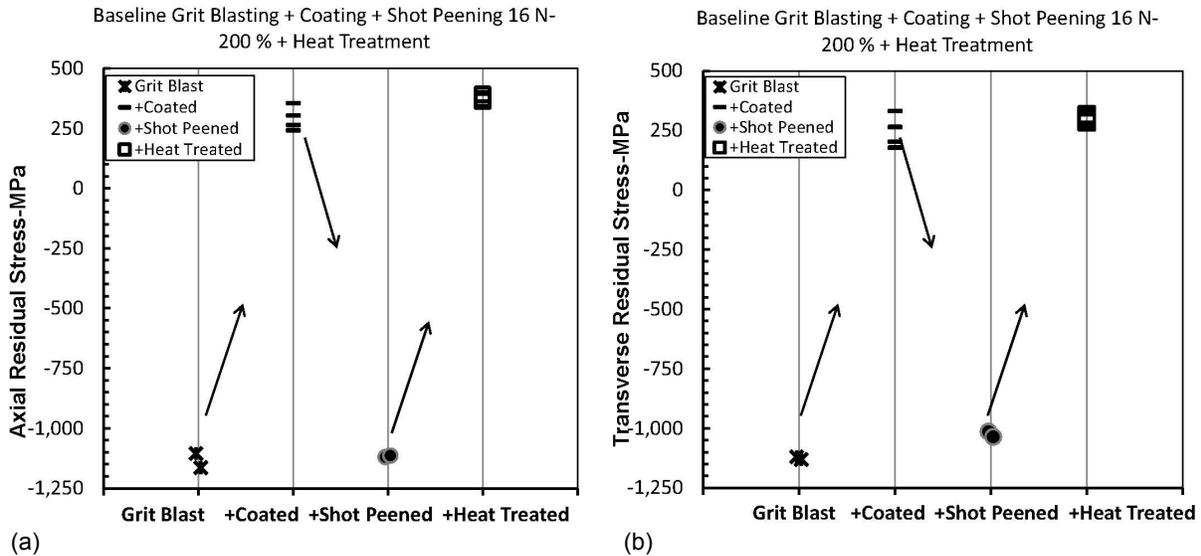
Figure 6.—Residual stresses measured at the surface after successive baseline processing steps. (a) Axial direction parallel to the fatigue load. (b) Transverse direction.

Residual stresses measured at the surfaces are shown in Figure 6. Residual stresses changed significantly for each processing step between grit blasting and final heat treatment. Uncoated grit blast surfaces had compressive residual stresses exceeding -1,100 MPa. But the applied coating had a low tensile residual stress near 250 MPa. Shot peening at 16 N-200% restored the compressive residual stress at the coated surface to initial grit blast levels. Yet, the final step of heat treatment at 760 °C for 8 h relaxed the compressive residual stresses at the coated surface, back to the low tensile levels previously measured as-coated. The generation of compressive residual stresses in the coating by shot peening has been described for MCrAlY coatings applied on superalloys in general by several processes (Ref. 20) and for NiCr coatings on disk superalloys (Ref. 21). The complete relaxation in the coating of these compressive stresses during subsequent heat treatment at the high temperature used in the present study had been previously observed for a Ni45CrY $\gamma + \alpha$ phase coating applied on LSHR (Ref. 22). This response of such coatings appears to be related to their low stress relaxation resistance.

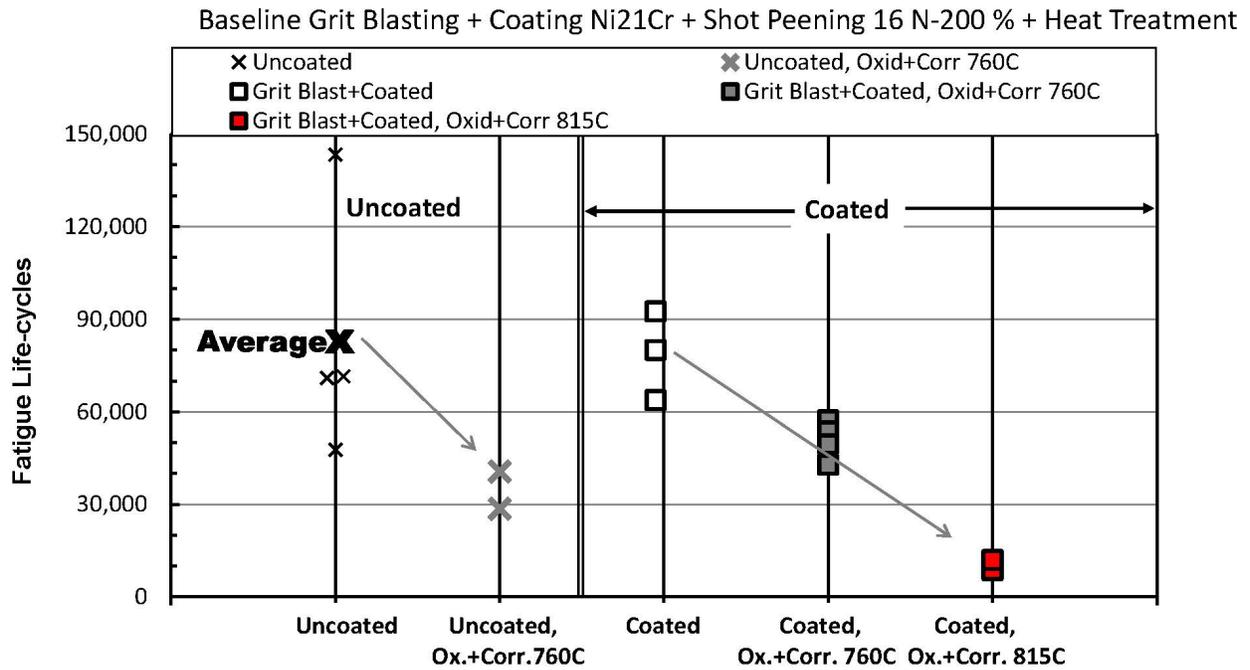
Figure 7.—Comparison of fatigue lives for uncoated versus coated specimens prepared using the baseline process.

Fatigue lives are compared for uncoated specimens and those coated using the baseline process, before and after combined oxidation plus corrosion exposures, in Figure 7. Coated specimens prepared using the baseline process had comparable mean fatigue lives to uncoated specimens. However, the combined oxidation plus corrosion exposures significantly reduced fatigue life for both uncoated and coated specimens. The coating using the baseline process gave a modest benefit in life over uncoated specimens after oxidation plus corrosion at 760 °C. However, exposures at 815 °C reduced coated fatigue lives from near 50,000 cycles after exposures at 760 °C, to about 10,000 cycles after exposures at 815 °C.

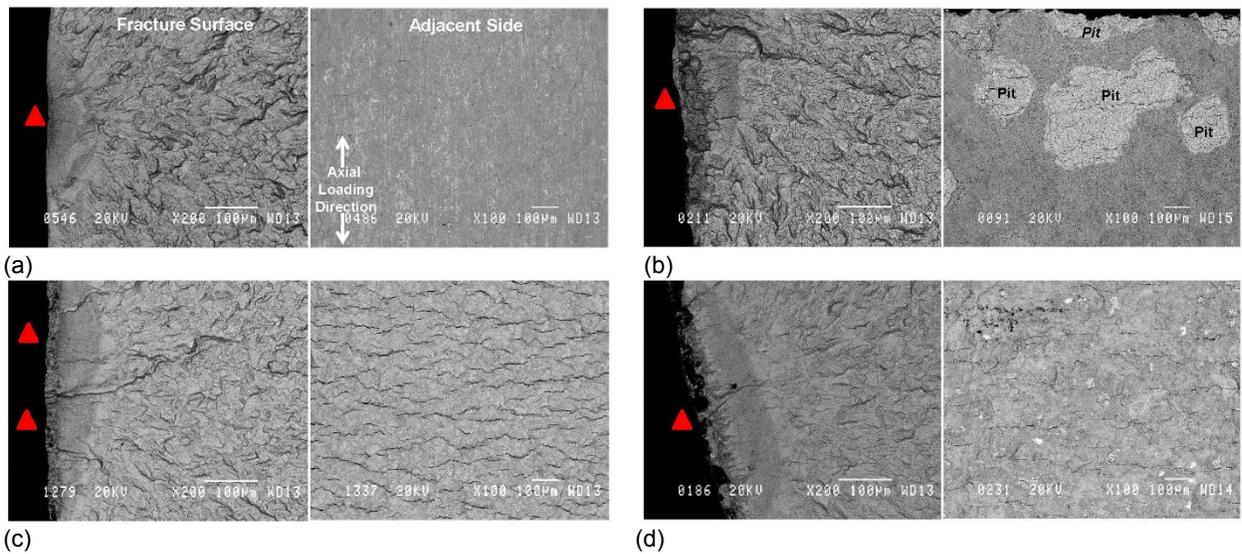
Figure 8.—Fatigue failure modes for uncoated versus coated specimens prepared using the baseline process. (a) Uncoated, unexposed. (b) Uncoated, oxidized plus corroded. (c) Coated, unexposed. (d) Coated, oxidized plus corroded.

The associated failure modes are compared in Figure 8. Uncoated specimens that were not exposed failed from single transgranular cracks initiated at the surface from shot peened dimples, or initiated internally at nonmetallic inclusions. Only a very few fatigue cracks less than 15 μm wide were observed on the side of the gage surface adjacent to the main fatigue crack causing failure. Coated specimens that were not exposed usually failed from multiple transgranular fatigue cracks initiated in the coating along the shot peened surface. A dense network of fatigue cracks that were typically 50 to 350 μm wide were observed on the side of the coated gage surface adjacent to the main fatigue crack causing failure.

The effects of combined oxidation plus corrosion on failure mode varied between uncoated and coated specimens. Uncoated specimens that were oxidized 500 h plus corroded 50 h at either 760 °C or 815 °C failed from multiple intergranular surface cracks initiated at corrosion pits. The corrosion pits initiating cracks on the fracture surface had widths of 15 to 75 μm, and depths of 10 to 30 μm. However, some cracks also initiated where two adjacent pits joined or were very closely separated, as observed in prior similar studies (Ref. 11). Additional intergranular fatigue cracks were observed to initiate on the side of the gage surface adjacent to the main fatigue crack causing failure, at other corrosion pits.

Coated specimens did not have corrosion pits exposing the substrate superalloy. Yet, some surface oxidation and corrosion of the coating was apparent, and fatigue failures still initiated from multiple elongated cracks initiated at the surface of the coating. The cracks initially grew with a mixed intergranular-transgranular mode in the LSHR, but transitioned to a predominantly transgranular crack growth mode after growing less than about 20 μm. These side cracks often occurred where darker patches imaged in backscatter SEM images indicated deeper oxidation and corrosion of the coating.

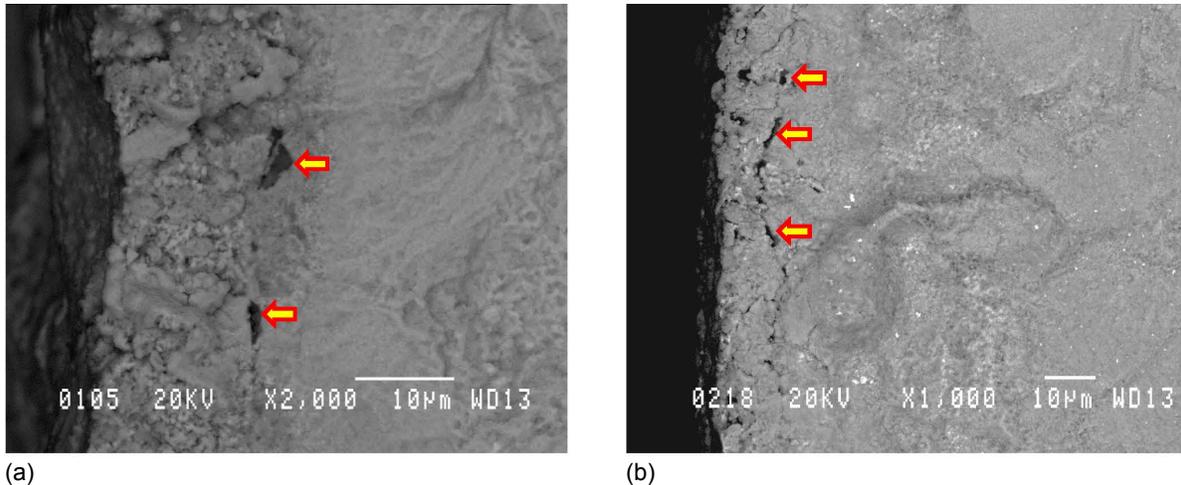
Figure 9.—Cracks on the fracture surfaces of coated specimens, with arrows showing exposed alumina grit blasting particles embedded at the coating-substrate interface. (a) Unexposed. (b) Oxidized plus corroded.

It was noted that cracks on the fracture surface sometimes uncovered alumina particles located at the coating-substrate interface, as shown in Figure 9. It was apparent that these particles had been embedded during the grit blasting process before coating, as shown in Figure 4(a). The role of these alumina particles in encouraging fatigue crack initiation in the tested specimens was unclear, as they were not always observed at fatigue cracks on the fracture faces examined. Yet, these particles at the coating-substrate interface have been reported to initiate fatigue cracks in disk superalloys (Ref. 13), and could be considered as potential contributors to the enhanced fatigue cracking of the coating. Hence, an alternative pre-treatment before coating that reduced or eliminated such contamination was investigated.

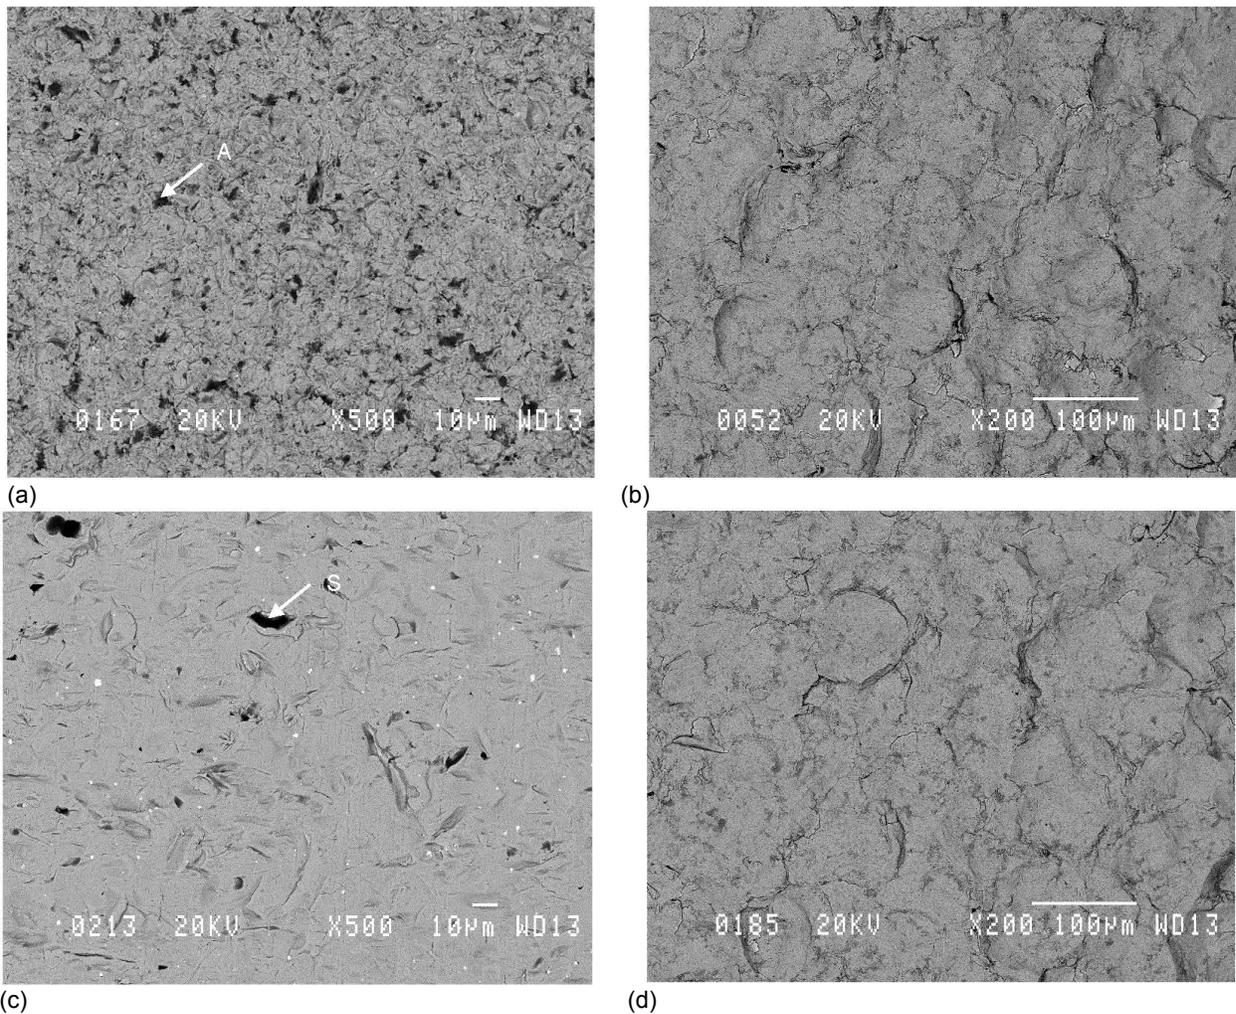
Figure 10.—Comparison of specimen surfaces for baseline grit blast to alternative wet blast pre-treatments. (a) Grit blast with 3.4 area percent of embedded aluminum oxide (A) particles. (b) Grit blast, coated, shot peened 16 N-200%, and heat treated. (c) Wet blast with 0.6 area percent of embedded silica (S) particles. (d) Wet blast, coated, shot peened 16 N-200%, and heat treated. The fatigue loading direction is oriented vertically.

“Wet blasting” also directs abrasive particles in a pressurized stream to abrade a surface, but uses water as a carrying fluid to potentially give more uniform flow of the particles and soften the impacts of abrasive particles (Ref. 23). Depending on process conditions, this process could affect the amount of particles embedded in the surface, surface finish, and residual stresses in comparison with the baseline grit blasting. Hence, additional fatigue specimens were wet blast using 15% of 300 mesh silica glass beads at a pressure of 550 kPa. Typical fatigue specimen surfaces are compared in Figure 10 after wet blasting or baseline grit blasting, both as-blasted and after subsequent coating, shot peening, and heat treatment. The wet blast surface clearly had a lower extent of embedded particles than for the baseline grit blasting. Wet blast surfaces had 0.6 area percent of embedded silica particles up to 12 μm in maximum exposed dimension, versus 3.4 area percent of embedded alumina grit particles up to 10 μm in diameter

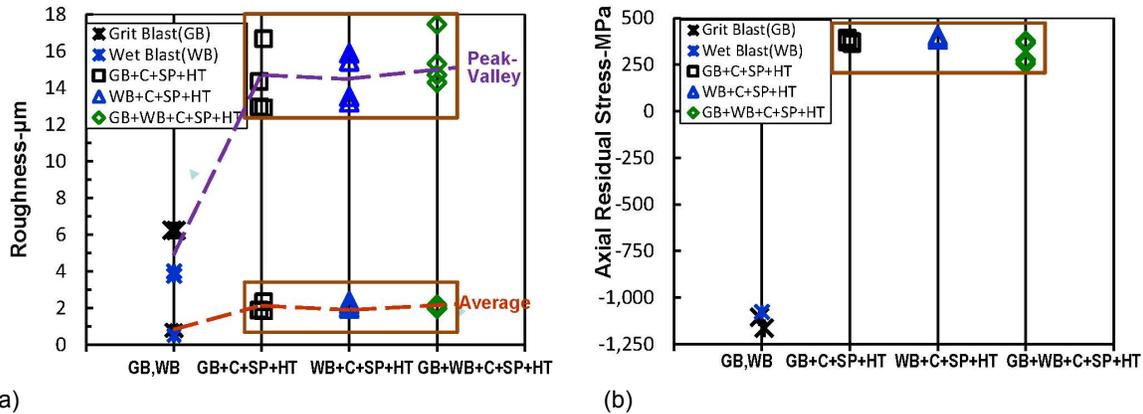
Figure 11.—Comparison of specimen surfaces'. (a) Roughness. (b) Axial residual stress for baseline grit blast and alternative wet blast pre-treatments: grit blast (GB); grit blast, coated, shot peened 16 N-200%, and heat treated (GB+C+SP+HT); wet blast (WB); wet blast, coated, shot peened 16 N-200%, and heat treated (WB+C+SP+HT).

measured for grit blasting. The wet blast surfaces also had a lower average roughness R_a of $0.51 \mu\text{m}$ in comparison to $0.77 \mu\text{m}$ for the baseline grit blast surfaces, shown in Figure 11(a). Yet, axial residual stresses measured on the blasted surfaces were comparable, as shown in Figure 11(b). Ultimately, the wet and grit blast specimen surfaces were indistinguishable, after coating, shot peening at 16 N-200%, and heat treatment at $760 \text{ }^\circ\text{C}$ for 8 h, also compared in Figures 10 and 11. Surface appearance, average roughness, and axial residual stresses were not significantly affected by the alternate pre-treatment of wet blasting. Several other fatigue specimens were subjected to grit blasting followed by wet blasting, in search of additive effects. These “grit+wet blast” specimens also had appearance, roughness, and surface residual stress values indistinguishable from the above specimens, after coating, shot peening, and heat treatment.

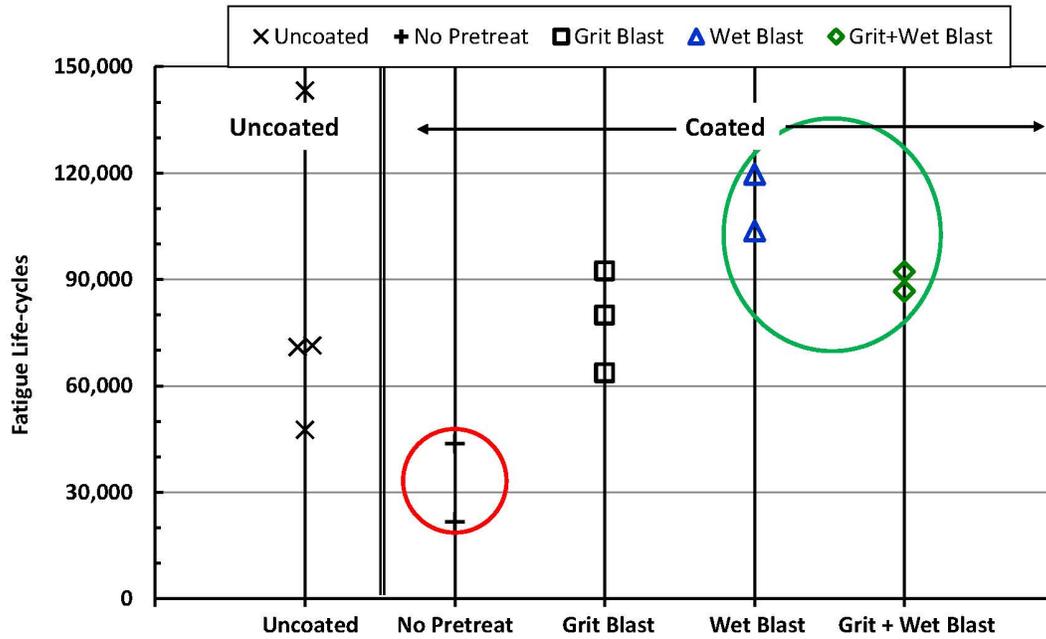
Figure 12.—Uncoated fatigue life versus coated fatigue lives after different pre-treatments, with no subsequent oxidation plus corrosion.

Fatigue lives are compared in Figure 12 for grit blast, wet blast, and grit+wet blast specimens that were subsequently coated, shot peened 16 N-200%, heat treated at 760 °C for 8 h, and then fatigue tested, without oxidation plus corrosion exposures. Specimens prepared using only the wet blasting pre-treatment before coating had highest mean fatigue life.

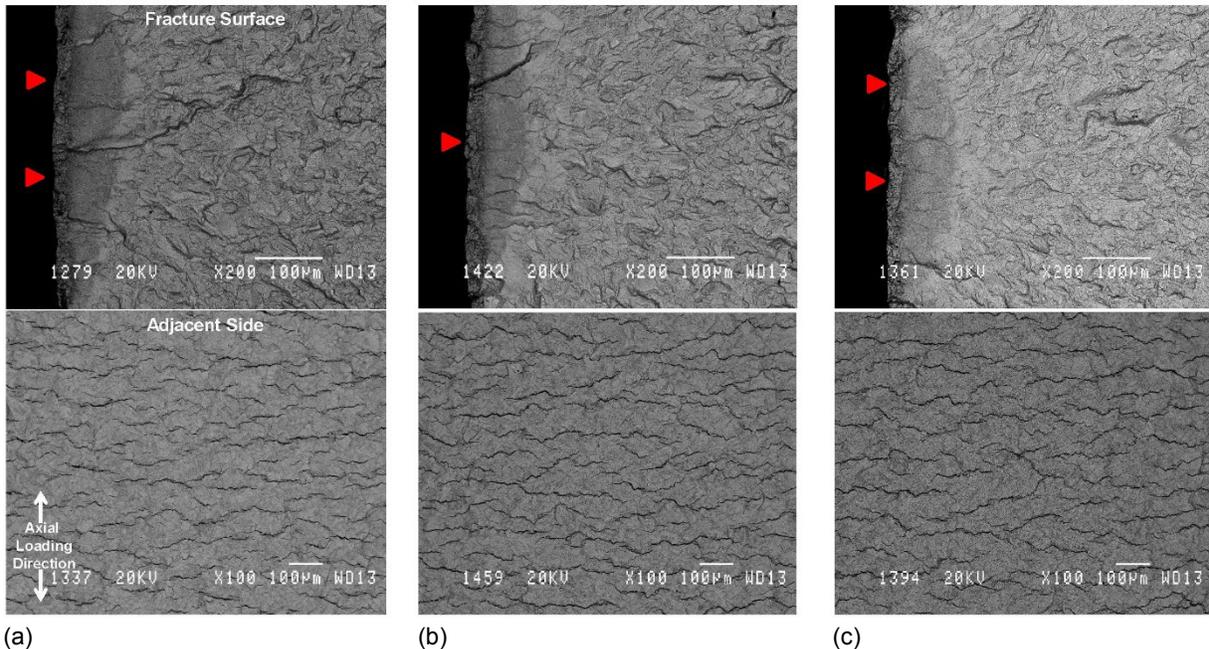
Figure 13.—Associated fatigue failure modes of coated specimens after different pre-treatments, no subsequent oxidation plus corrosion. (a) Grit blast. (b) Wet blast. (c) Grit plus wet blast. Coating crack density is comparable for the three cases.

The associated failure modes are compared in Figure 13. Coated specimens usually failed from multiple transgranular fatigue cracks initiated in the coating along the shot peened surface, for all of the pre-treatments applied. A dense network of fatigue cracks that were typically 28 to 424 μm wide were again observed on the side of the coated gage surface adjacent to the main fatigue crack causing failure.

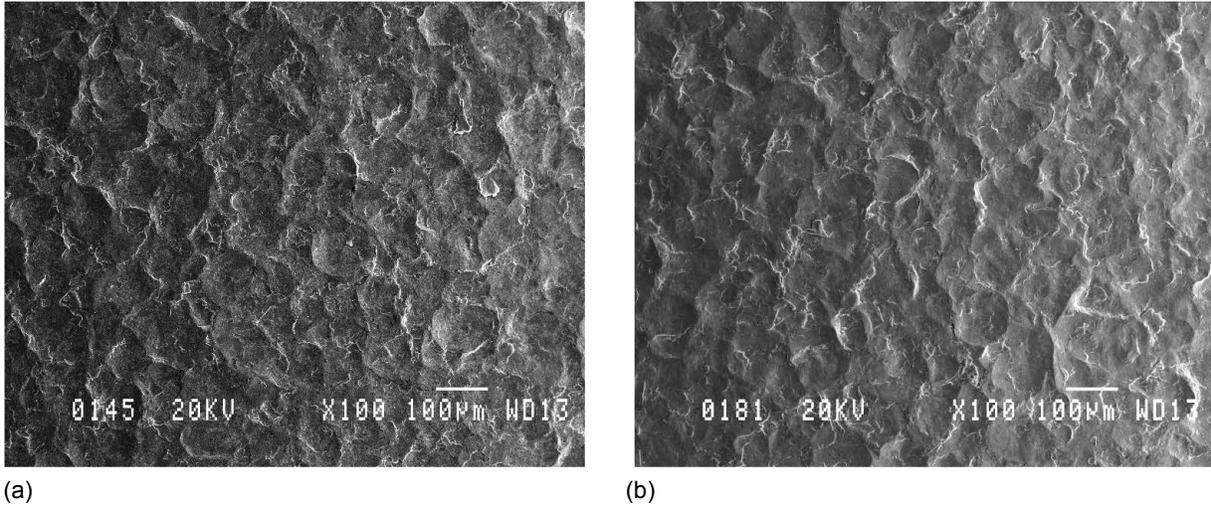
Figure 14.—Images of coated specimens after different post-coating shot peening treatments, no subsequent oxidation plus corrosion. (a) 16 N-200%. (b) 8 N-150%. The fatigue loading direction is oriented vertically.

The surface conditions are compared in Figure 14 for coated specimens shot peened at 8 N-150% versus the baseline 16 N-200%. These surfaces were generally similar in overall appearance, with an undulating, dimpled texture. Shot peening at 8 N-150% still produced dimples with laps. However, the lap heights and dimple depths were moderated in comparison to the baseline 16 N-200% condition. Average roughness and peak-valley roughness were each reduced about 40% for coated specimens given the alternative 8 N-150% shot peening conditions, as shown in Figure 15.

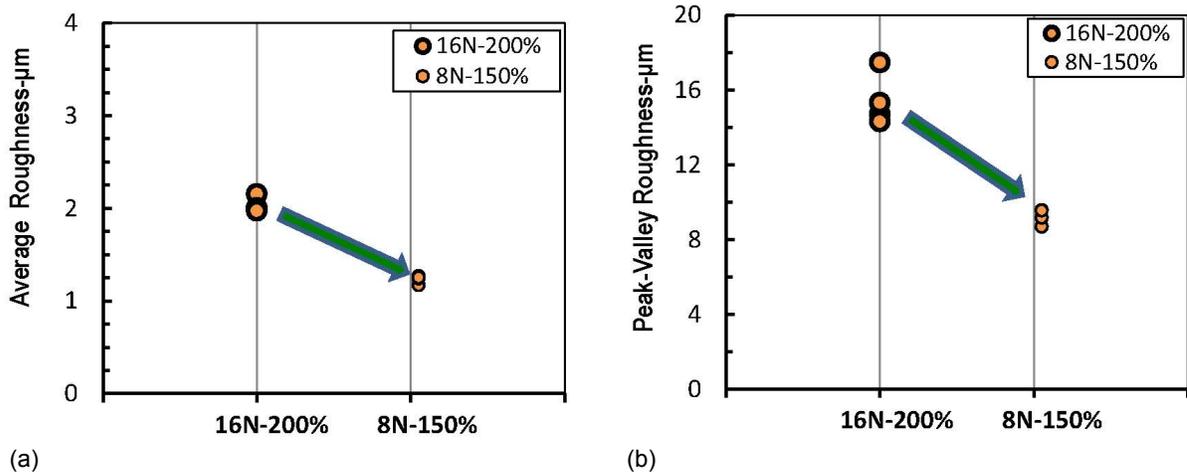
Figure 15.—Associated roughness measurements of coated specimens after different post-coating shot peening treatments, no subsequent oxidation plus corrosion. (a) Average roughness. (b) Peak-valley roughness.

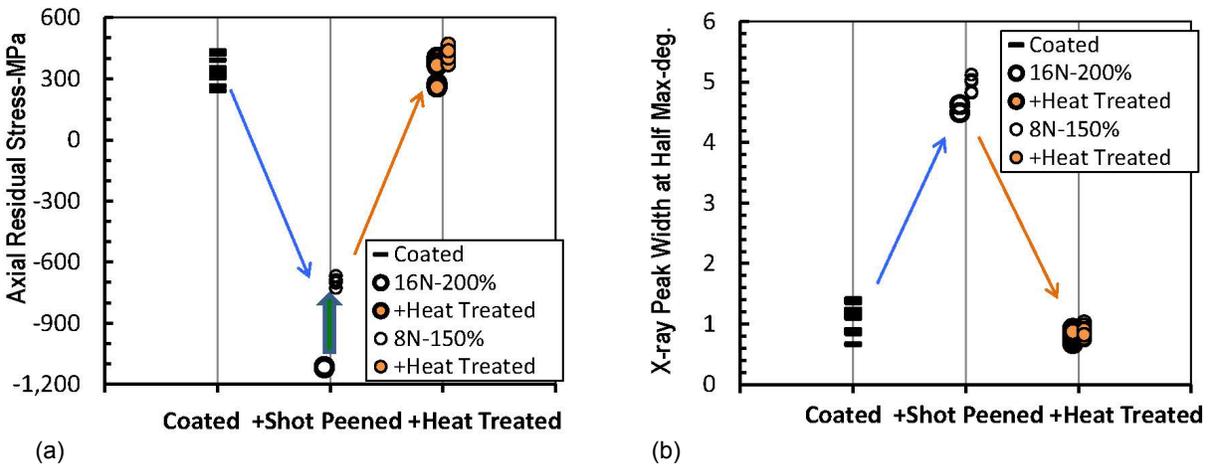
Figure 16.—Associated x-ray measurements of coated specimens after different post-coating shot peening conditions, no subsequent oxidation plus corrosion. (a) Axial residual stress, relaxed to low tensile values after heat treatment from either shot peening condition. (b) Peak width at half maximum intensity, indicating elimination of shot peening's cold work after heat treatment from either shot peening condition.

The axial residual stresses measured at the surface are compared in Figure 16. Shot peening at 8 N-150% gave a 35% lower magnitude of axial compressive residual stress on the coated surface, in comparison to the baseline 16 N-200% condition. The corresponding X-ray peak width has often been related to the plasticity (cold work) generated by shot peening (Refs. 14 and 18). This was therefore measured, and was curiously found to be slightly higher after 8 N-150% shot peening condition than for the baseline 16 N-200% condition. This implied slightly higher plasticity generated by shot peening at 8 N-150% than for 16 N-200%.

Nevertheless, final heat treatment at 760 °C for 8 h relaxed compressive surface residual stresses and corresponding peak width for both shot peening conditions to comparable levels at the coated surfaces, Figure 16. Heat treated coated specimens had modest tensile residual stresses of 350 to 450 MPa at the surface for both shot peening conditions. The generation of compressive residual stresses in the coating by shot peening has also been described for MCrAlY coatings applied by various processes (Ref. 20) and for NiCr coatings on superalloys (Ref. 21). Yet, evaluations of residual stress for a similar NiCrY coating with the baseline 16 N-200% shot peening and heat treatment indicated that significant compressive residual stresses of over -400 MPa remained at depths of up to 150 μm in this superalloy beneath the coating (Ref. 22). Therefore, the overall mechanics of the residual stress response at the surface can be

Ranking these influences is more difficult, but can be aided by further considering the plasticity introduced by shot peening. Corresponding x-ray peak width was also greatly reduced by the heat treatment as shown in Figure 16. Peak width was reduced to actually equal that measured after only applying the coating. This implied the shot peening-induced plasticity had been largely eliminated by the heat treatment, through an enhanced recovery process occurring in the coating. Prior tensile stress relaxation tests of Nichrome specimens having a composition quite close to the coating indicated very low strength and accelerated stress relaxation of this alloy and coating (Ref. 22). So of the influences listed above, the impressive relaxation of compressive residual stresses in such NiCr coatings appears largely attributable to the low strength and an enhanced recovery – stress relaxation process in the coating at temperatures near 760 °C. The higher thermal contraction also previously measured (Ref. 22) for this alloy may then generate the low tensile stresses during cooling to room temperature, where residual stress measurements were conducted by x-ray diffraction.

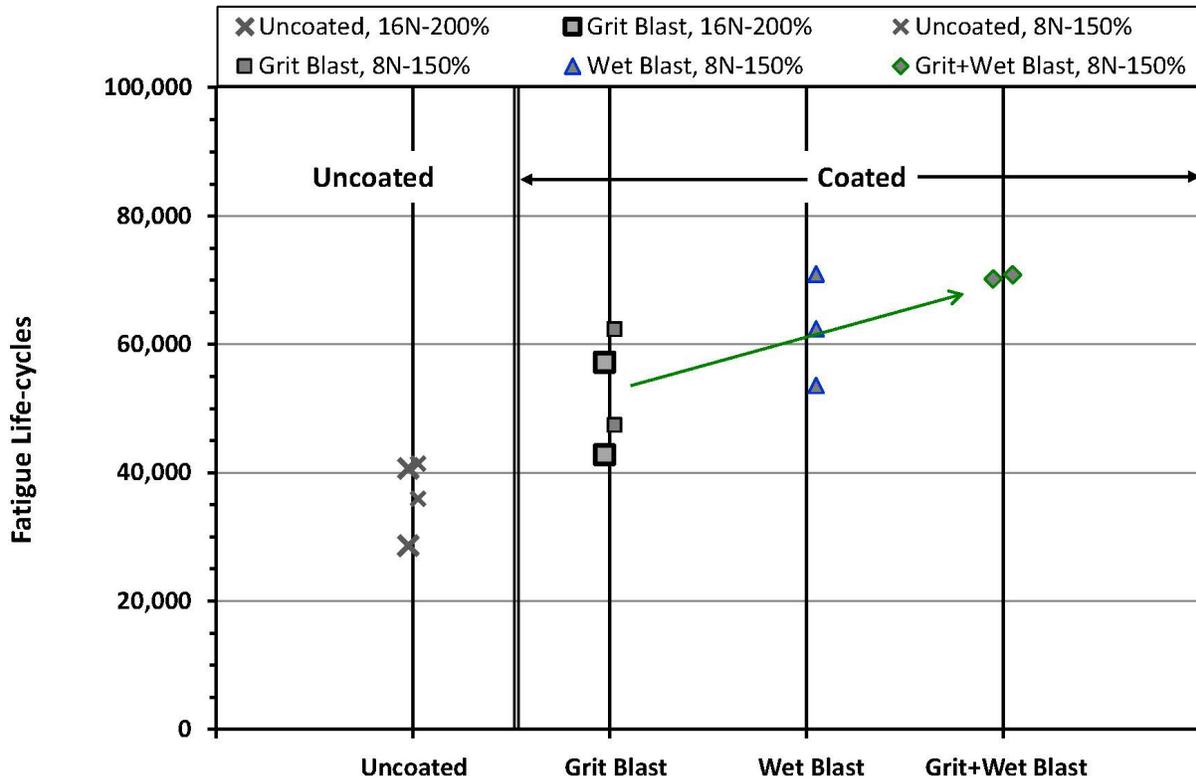
Figure 17.—Comparison of fatigue lives for alternative pre-coating and post-coating treatments, after oxidation plus corrosion. Larger symbols indicate baseline (16 N-200%) post-coat shot peen treatment, while smaller symbols indicate alternative (8 N-150%) post-coat shot peen treatment.

Fatigue lives are compared in Figure 17 after varied pre-treatments, coating, 8 N-150% shot peening, heat treatment, and finally the combined oxidation plus corrosion exposures at 760 °C. The alternative pre-coating and post-coating treatments gave modestly improved coated fatigue lives after subsequent oxidation plus corrosion. Nevertheless, the coating could still be considered successful with the alternative conditions, enabling twice the fatigue life of uncoated specimens after combined oxidation and hot corrosion. Specimens with a final wet blasting treatment before coating and shot peening at 8 N-150% performed most favorably.

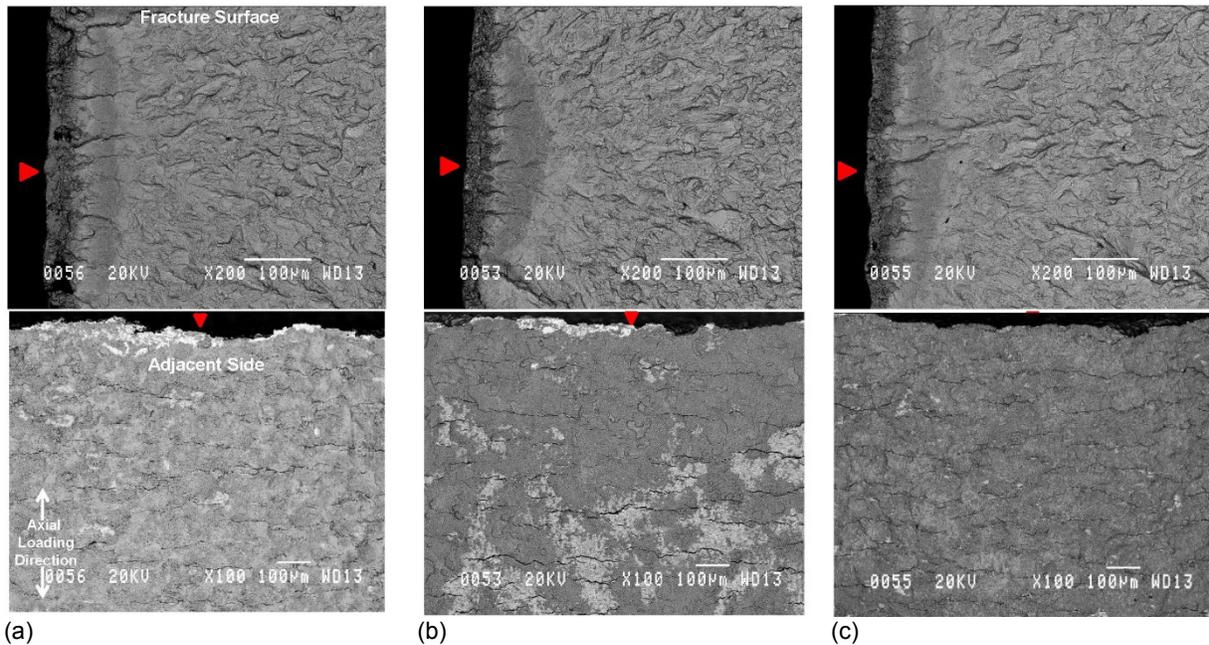
Figure 18.—Comparison of fatigue failure modes for alternative pre-coating and post-coating treatments, after oxidation plus corrosion. (a) Grit blast. (b) Wet blast. (c) Grit plus wet blast. Shot peened 8 N-150%.

Typical images of the fracture surfaces for these fatigue failures are shown in Figure 18. Surface cracks initiated fatigue failures in all cases. Examination of the gage sides adjacent to the main failure initiation points indicated increased surface cracking in the coating still predominated, after pre-coating treatments of grit blasting and/or wet blasting and post-coating shot peening at 8 N-150% plus the standard heat treatment. The hot corrosion attack did not appear to form pits to expose the substrate for coated specimens with any combination of the pre-coating and post-coating treatments. However, patches of oxide were observed on the coating, and these patches sometimes had evidence of spallation and cracking.

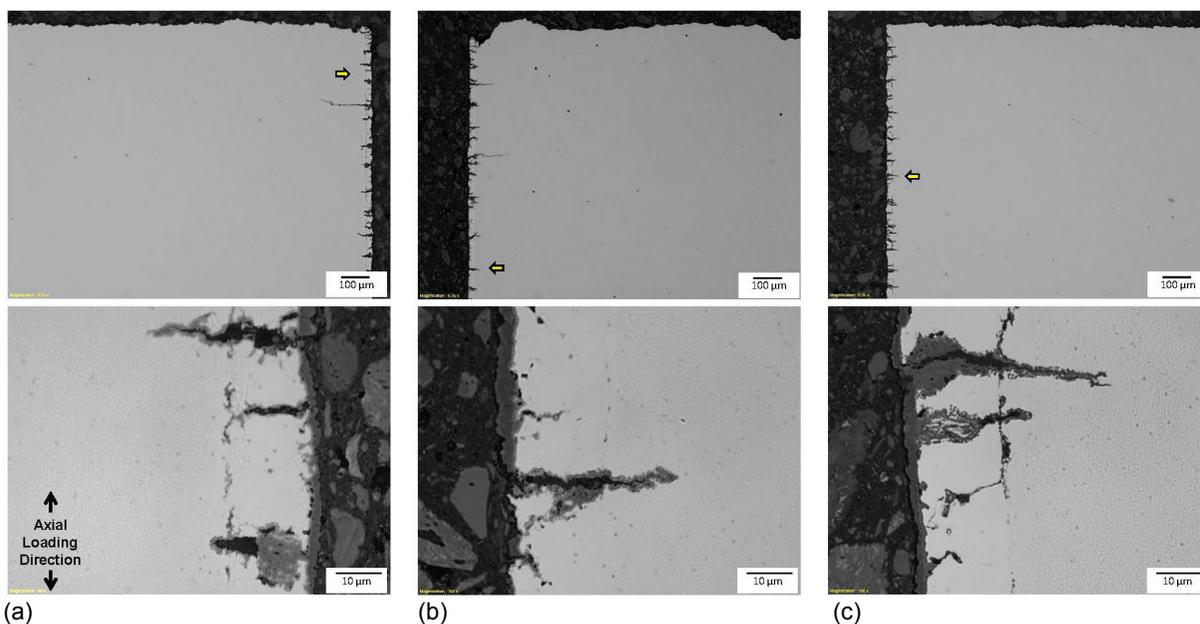
Figure 19.—Comparison of metallographically-prepared longitudinal sections for the failure initiation sites with alternative pre-coating and post-coating treatments, after oxidation plus corrosion. (a) Grit blast. (b) Wet blast. (c) Grit plus wet blast. All were coated, then shot peened 8 N-150% + heat treated 760 °C/8 h/low pO₂ + oxidized 760 °C/500 h + hot corroded 760 °C/50 h before fatigue at 760 °C.

Metallographically prepared longitudinal cross-sections of these specimens are shown for comparison in Figure 19. The polishing plane for these test specimens was parallel to the loading direction. Multiple secondary fatigue cracks grew through the coating, but a majority did not extend into the underlying superalloy. The coating is still adhered well to the substrate, and is not lifted away at the cracks. Therefore, these cracks do not appear associated with “rumpling” of the coating due to excessive compressive creep there, as reported for plasma-sprayed MCrAlY overlay coatings on airfoil superalloys (Ref. 12). Rather, they appear to simply be tensile cracks in the weak NiCr coating. No corrosion pits penetrating through the coating to the substrate were found in these sections. Therefore, the coating did appear to protect the substrate superalloy from corrosion attack and pit formation after extended oxidation exposures, while preserving fatigue life when favorably pre-treated with wet blasting, then shot peened and heat treated after coating.

and for 35,000 cycles as shown in Figure 20. Yet, these fatigue cracks in the coating are clearly impeded from growing into the substrate, for specimens that had been coated, shot peened at either 16 N-200% (Ref. 17) or 8 N-150% (Fig. 19), and then heat treated, oxidized, and corroded. While no intact coated specimens of the present study remained for measuring residual stress as a function of depth, the evidence strongly suggests that axial compressive residual stresses remained in the superalloy substrate adjacent to the coating, to again suppress fatigue crack growth there.

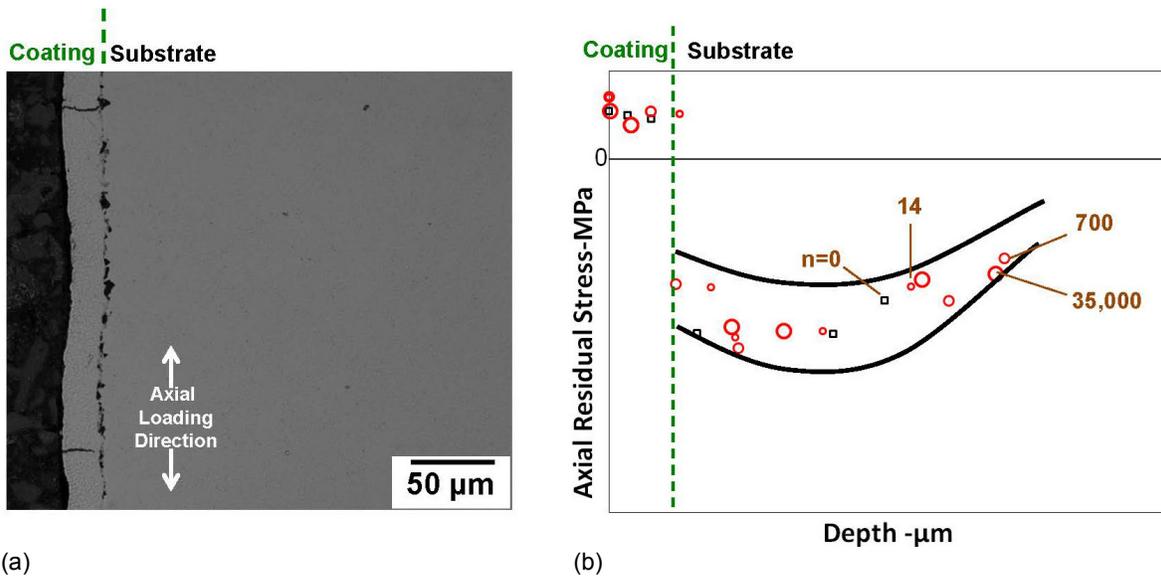
Figure 20.—Ni45CrY-coated LSHR fatigue specimen (baseline process) tested at 760 °C/35,000 cycles. (a) Longitudinal section, showing fatigue cracking of the coating. (b) Measured axial residual stresses versus depth for specimens interrupted after up to 35,000 cycles (n) (Ref. 22) Baseline process used grit blast plus Ni45CrY coating plus shot peen 16 N-200% plus heat treat 760 °C for 8 h in low pO_2 .

It is apparent that a very similar situation could exist for the present NiCr-coated specimens. In spite of applying a more ductile single phase γ coating, using varied pre-treatments before coating, and varied shot peening conditions after coating, increased fatigue cracking continued to occur in the coating. This is consistent with the comparable tensile residual stresses measured in the coating after final heat treatment, which remained so for coated specimens not oxidized or corroded but fatigue tested for 700 fatigue cycles
