Full-Scale Drop Test of a Fokker F28 Wingbox Fuselage Section

J. D. Littell¹

¹NASA Langley Research Center, Research Directorate, Structural Dynamics Branch, Mail Stop 495, 14 West Bush Road, Hampton, VA 23681; PH (757) 864-5195; FAX (757) 864-8547; email: Justin.D.Littell@nasa.gov

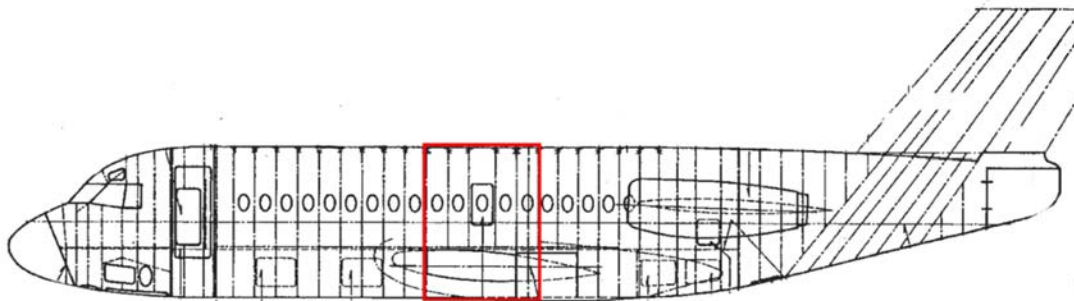
Figure 1 - Fokker F28 station diagram with Wingbox Section highlighted

The F28 Wingbox Section was cut between fuselage frame sections (FS) 9805 and 12405 from a F28 MK4000 full fuselage. Figure 1 shows a schematic of a F28 fuselage with the removed section highlighted. Note the schematic shows the F28 MK1000 variant, which is slightly smaller than the MK4000. The major difference for current purpose is the diagram consists of only a single emergency exit, whereas the test article (the MK4000 variant) contains two emergency exits. However, the location on the test article is identical.

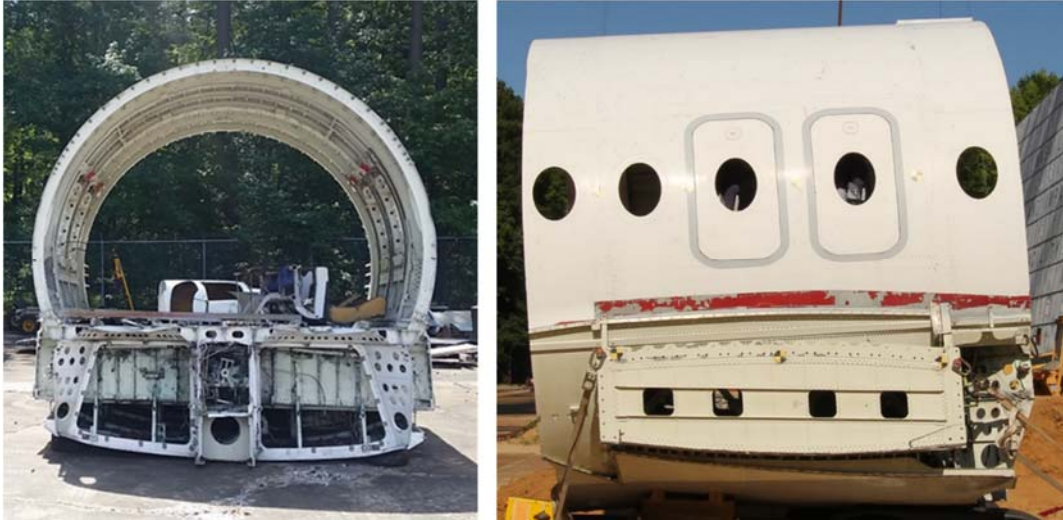
Figure 2 – Un-Instrumented F28 Wingbox Section aft view (left), and port side view (right)

The interior electronics, lighting, paneling and overhead bins were removed such that only the outer skin, frame and other structural components of the airframe remained. The floors and seats were removed for storage, and while the original floors were reinstalled and reused for test, the original seats were discarded. The wings were removed at the wingbox attachment points, and all fluids were drained from the remaining hydraulic lines that were still present in the wing truss structure and lower cavity below the wing truss structure. Two views of the test article are shown in Figure 2. The test article is in its original, un-instrumented condition.

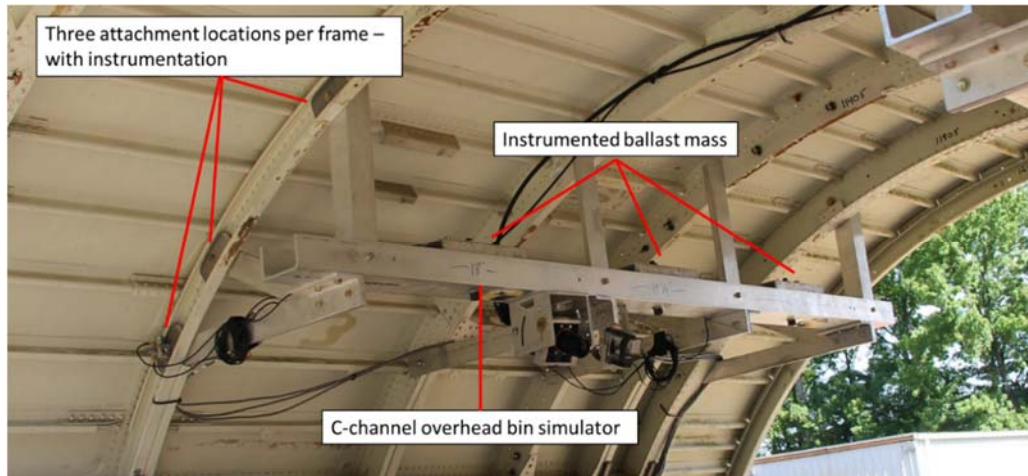
Figure 3 - Overhead bin simulators with ballast

Overhead bins were simulated by adding lead ballast to aluminum c-channel sections, giving a total weight of approximately 11.34 kg (25 lb) per linear foot for a total of approximately 52.62 kg (116 lb) on each side. Aluminum c-channels were attached to the existing overhead bin location attachment points on the frames and spanned between FS 10305 and FS 11905. Accelerations were measured at the bin-frame attachment points on FS 10305 and FS 11405, and on the most forward and most aft lead ballast on each side. Figure 3 shows a close up of the overhead bins.

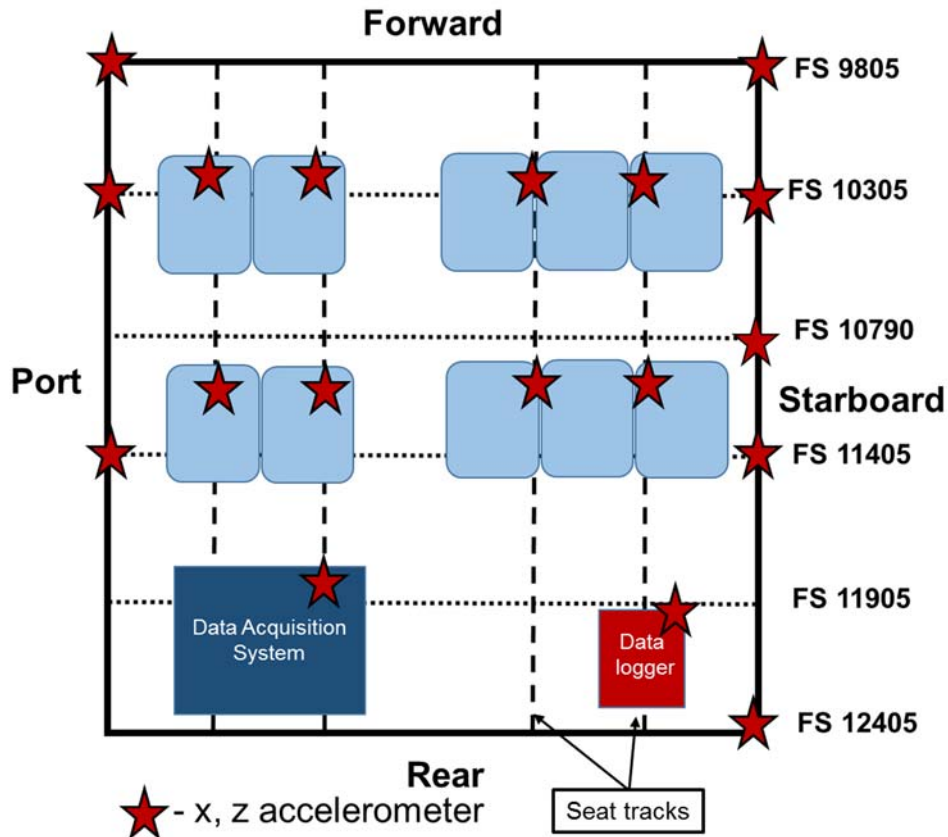
Figure 4 - Test article diagram showing seat configuration and floor level accelerometer locations

Instrumentation included a suite of accelerometers to measure accelerations in the horizontal (x) and vertical (z) directions at critical points on the airframe. Accelerometers were located on the floor/frame section junctions, seat tracks, overhead lead ballast, overhead ballast/frame attachment points, and under the wingbox truss structure, near the cavity at the bottom of the test article. There were also two rotational rate sensors, one in the front and one in the aft, to measure the pitch rotation of the test article. All measurements were collected via a ruggedized onboard data acquisition system (DAS) sampling at 10 kHz. Additionally two standalone 500 g acceleration data loggers were added at two positions in the aft of the test article. The first was placed on a plate mounted on the inner seat track near the aft starboard side of the test article, and the second was placed on an unsupported span in the lower aft starboard cavity, near the bottom skin. These data recorders were set to initiate data logging via sensing a g-threshold limit, set at 20 g, and would record three axis accelerations at 10 kHz for 10 seconds once initiated. An additional 6000-g shock recorder was also placed on the seat track at the aft starboard inner location, however this recorder did not trigger, so measurements were not collected. Figure 4 shows the instrumentation, seat and data system location for the test.

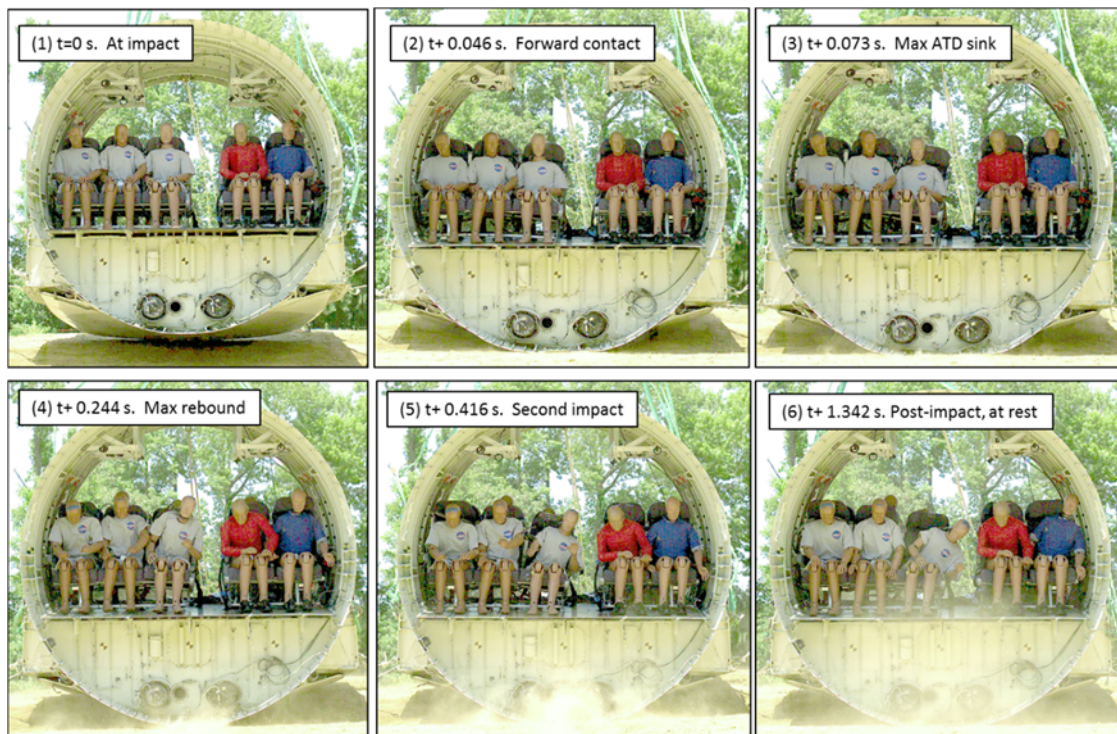
Figure 5 - Sequence of test events

An image series showing significant events which occurred during the test is depicted from the south high speed camera view in Figure 5.

The initial contact of the aft portion of the test article onto the sloped soil surface was considered to be the initial impact, and is depicted in the top left image of Figure 5. It can also be noted that at initial impact, the forward portion of the test article is still in the air. Between impact and $t+0.046$ s, the test article rotated about the rear impact point, terminating with the forward portion of the test article initiating ground contact at $t+0.046$ s, which is depicted in the top middle image. No sliding between impact at $t+0.046$ s was evident from the videos, so the horizontal acceleration between these two times was presumed to be from the test article rotation only. The next notable time occurred when the onboard ATDs experienced their maximum downward vertical motion, also known as their maximum sink position, which occurred at $t+0.073$ s, only slightly lagging the forward contact time. The test article and ATD appeared to exhibit uniform motion between $t+0.073$ s and $t+0.244$ s, which was the time when both test article and ATD rebounded to their maximum unloaded positions. There was a second impact of the test article that occurred at $t+0.416$ s. During the second impact, the test article uniformly contacted the soil surface without rotational motion present. The test article came to rest shortly thereafter. A final position of the test article depicted in the lower right portion of Figure 5 shows the test article at rest, at a time well beyond where the final motion occurred during the test.

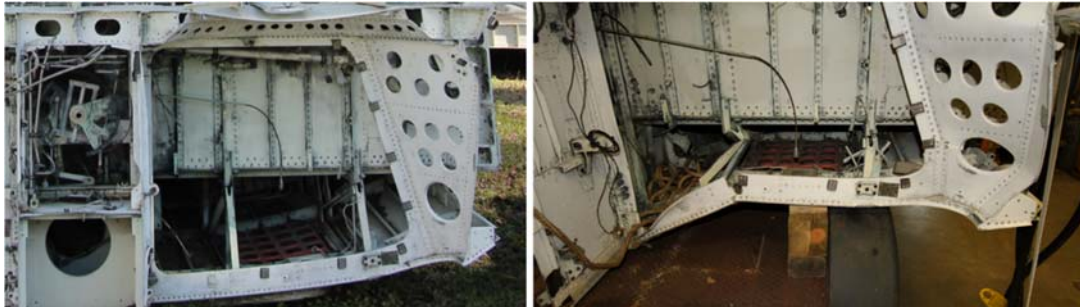
Figure 6 - Lower aft cavity. Before test (left) and damage post-test (right)

Other than the aft lower cavity, the test article did not show noticeable signs of structural damage. Additionally, all four emergency exit doors opened nominally post-test, indicating no signs of deformation or warpage on the skin or frames at the mid-cabin height. Figure 6 shows a close-up view of the aft lower cavity, pre- and post-test, which experienced the vast majority of the deformation during the test.

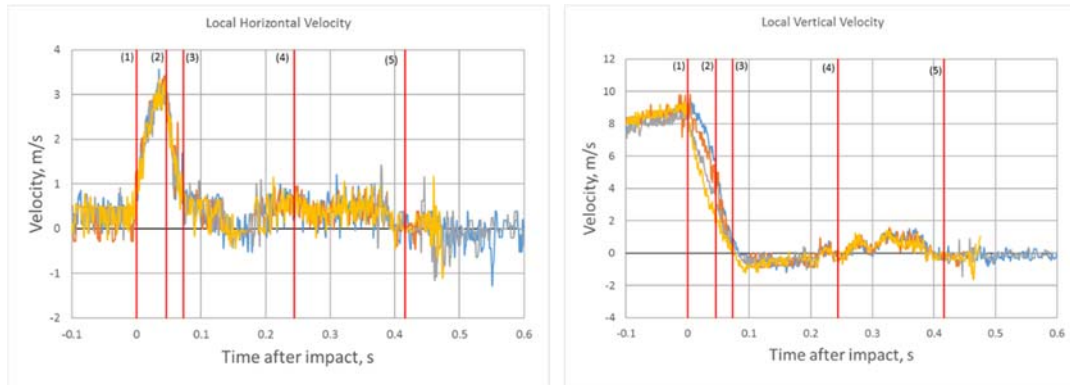
Figure 7 - Horizontal velocity results (left) and vertical velocity results (right) in the local coordinate system

The velocity results were resolved from a series of four black and yellow bowtie targets placed on the port and starboard sides between the window openings at mid-cabin height. The target data showed the aft portion of the test article impacted the soil surface first at a pitch as determined from the floor of 2.9 degrees nose down with a vertical velocity of 8.99 m/s (29.5 ft/s) as viewed from a global coordinate system. The pitch down in combination with the sloped soil created induced local vertical and horizontal velocities. The four velocity traces were translated into the test article local coordinate system using calculations based on the pitch angle time history, and are shown in Figure 7, noting that positive horizontal velocity indicates motion of the test

article forward, and positive vertical velocity indicates motion of the test article downward. The velocities were smoothed using a 5 point moving average, however no filtering was used. The individual velocity traces follow the same general trends, so the data were taken as a whole, with individual traces averaged together for reporting. The numbered vertical bars correspond to several image times shown in Figure 5.

The local vertical velocity was 8.87 m/s (29.1 ft/s) downward and the local horizontal velocity is 0.34 m/s (1.1 ft/s) forward at initial impact. The rotation of the test article after impact caused the local horizontal velocity to reach a peak of 2.92 m/s (9.6 ft/s) in the forward direction, which occurred before forward test article contact at 0.046 s. Both the horizontal and vertical velocities approached zero at the maximum ATD sink at 0.073 s, after which the vertical velocity averaged 0.49 m/s (1.6 ft/s) in the upward direction during the rebound ending with the test article at maximum rebound position at 0.244 s after impact. The second impact occurred with a forward velocity of 0.40 m/s (1.3 ft/s) and a vertical velocity of 0.46 m/s (1.5 ft/s), when examining averaged data between 0.244 s and 0.416 s. After the second impact, the test article came to rest. Local horizontal accelerations measuring in the test article longitudinal direction are next plotted in Figure 8. These results, along with all acceleration data presented, were filtered in accordance to SAE J211 filtering schemes (Society of Automotive Engineering 1995).

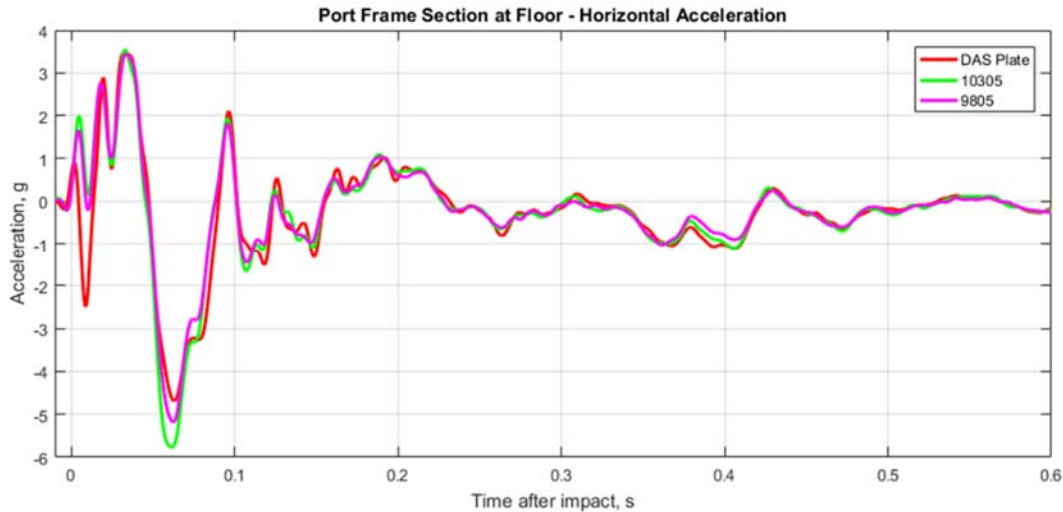
Figure 8 - Port floor level horizontal accelerations

The accelerometer at FS 11405 did not function during the test, so an accelerometer on the DAS plate, near FS 12405, was used in its place. Acceleration traces for all accelerometers closely matched throughout most of the impact event, with minor differences experienced in the negative peaks occurring at 0.64 s. Positive acceleration peaks of 3.5 g occurred during the test article rotation up until initial forward impact at 0.046 s, at which the acceleration responses fall back to crossing the zero g mark. The acceleration trace then went negative, reaching between -4.7 g on the DAS plate to -5.7 g on FS 10305 until it crossed the zero g position again at 0.084 s after initial impact. The large negative accelerations were resultant from the fuselage inertia resisting further tip over due to the rotation at impact. As shown in the velocity data, a rebound occurred between 0.073 s and 0.244 s after impact, during which the accelerations headed in the positive direction toward a maximum of approximately 1 g at 0.192 s after impact, which was in the middle of the rebound motion. After 0.416 s, the horizontal accelerations crossed the zero g position, which marked the beginning of the second impact. After the second impact, the accelerations oscillated about a zero g condition until motion stopped.

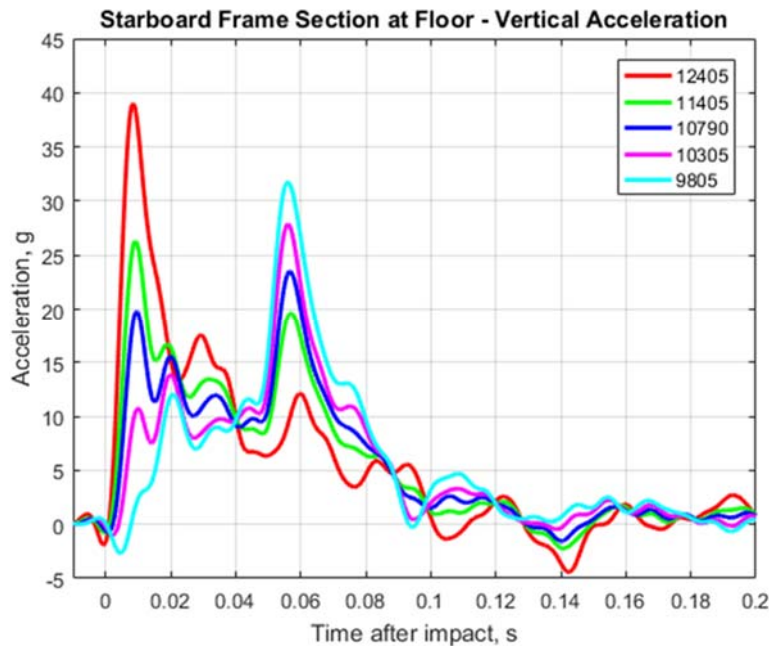
Figure 12 - Starboard frame section vertical acceleration

The starboard accelerations at the floor/frame junctions are shown in Figure 12. The data are filtered using a CFC 60 class filter and reported in the local aircraft coordinate system by measuring accelerations normal to the floor. In general, the pulse shape was trapezoidal in nature, having a total duration of approximately 0.100 to 0.120 s and an average plateau value of between 9.8 g and 12.2 g for times between 0.02 and 0.05 s after impact. The initial peak occurred at approximately 0.008 s after initial test article/soil contact. The peak values were greatest at the aft of the test article and decayed as the location moved toward the front. The highest peak of approximately 39.0 g occurred at FS 12405, which was followed by a peak of 26.3 g at FS 11405. The accelerations decayed until the forward-most section, FS 9805, was reached, in which there was no discernable peak exhibited 0.008 s after impact.

The second peak occurred approximately 0.055 s after impact, which was shortly after the time the forward portion of the test article made contact with the soil surface due to the rotation of the test article at impact. In contrast to the trend observed in the initial peaks in the response, the greatest magnitude in the second peak occurred in locations at the front of the test article. Specifically, the highest magnitude peak occurred at FS 9805 which exhibited an acceleration magnitude of approximately 31.7 g, and decreased rearward, until a peak of approximately 12.1 g was observed at FS 12405.

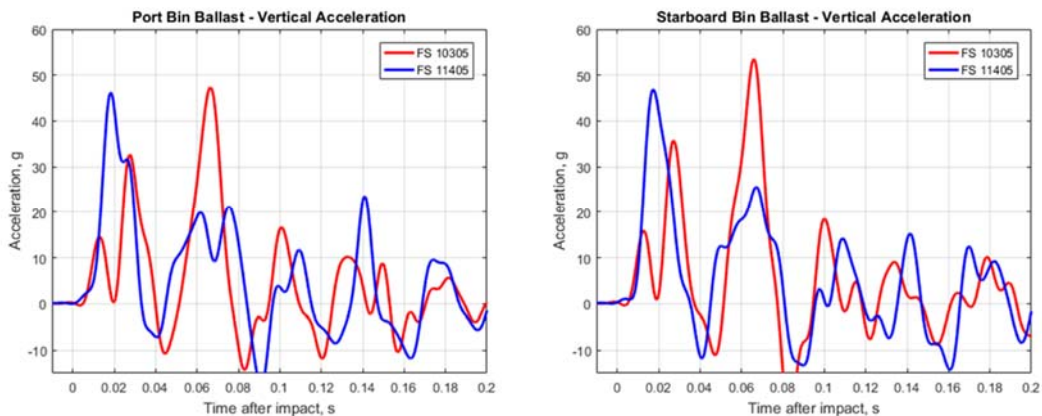
Figure 14 - Overhead bin ballast vertical accelerations. Port side (left) and starboard side (right)

Accelerations recorded on the overhead bin ballast mass were of higher magnitude than either the bin attachment or floor accelerations. They also did not exhibit a trapezoidal pulse shape, but rather, showed an oscillatory response of between 26.6 and 27.2 Hz for all locations centered about zero g. The oscillations were a result the bin ballast masses and c-channels cantilevered off of the end of the attachment bars. The accelerations did however follow the general trend that the aft-most locations exhibited an initial peak during the initial contact, while the forward-most locations exhibited this peak after the front contact. The magnitudes for the peaks were 45.9 g and 46.8 g for the port and starboard FS 11405 locations, respectively, and 47.3 g and 53.5 g for the port and starboard FS 10305 locations, respectively, and are shown in Figure 14.
