Fatigue Life of a NiCr-Coated Powder Metallurgy Disk Superalloy After Varied Processing and Exposures

Tim P. Gabb¹, J. A. Nesbitt¹, D. Hass², J. Telesman¹, S. L. Draper¹, B. J. Puleo¹, R. B. Rogers¹, R. A. Miller³

1. NASA Glenn Research Center, 2. DVTI, Inc., 3. Vantage Partners, LLC

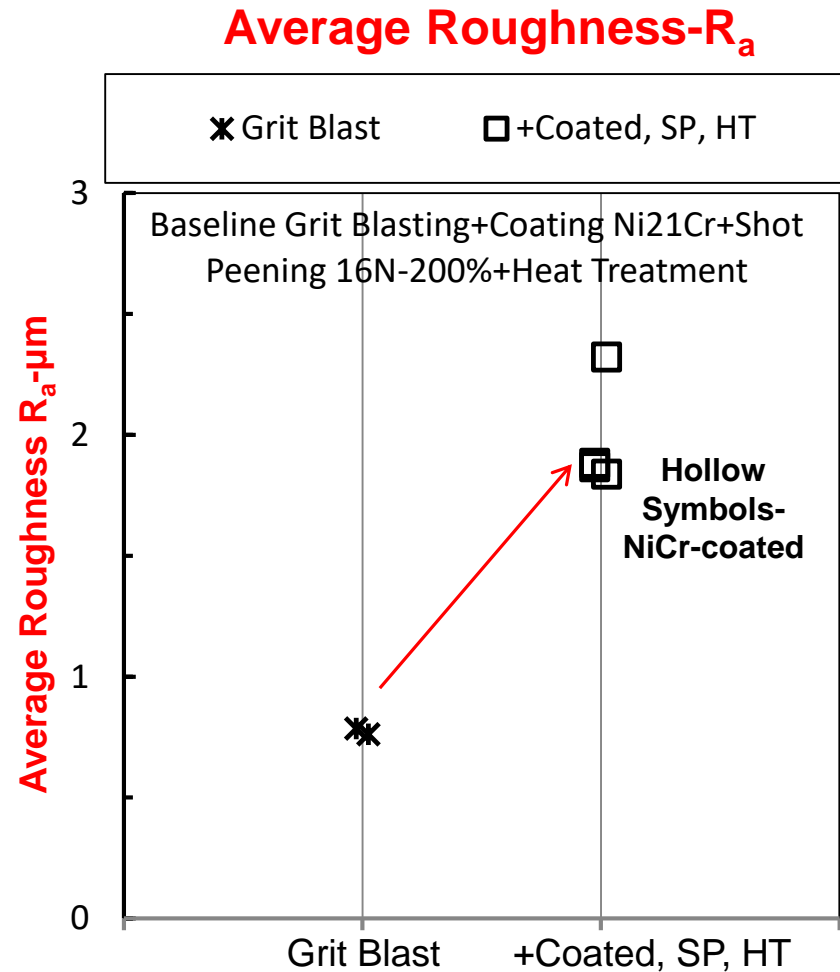
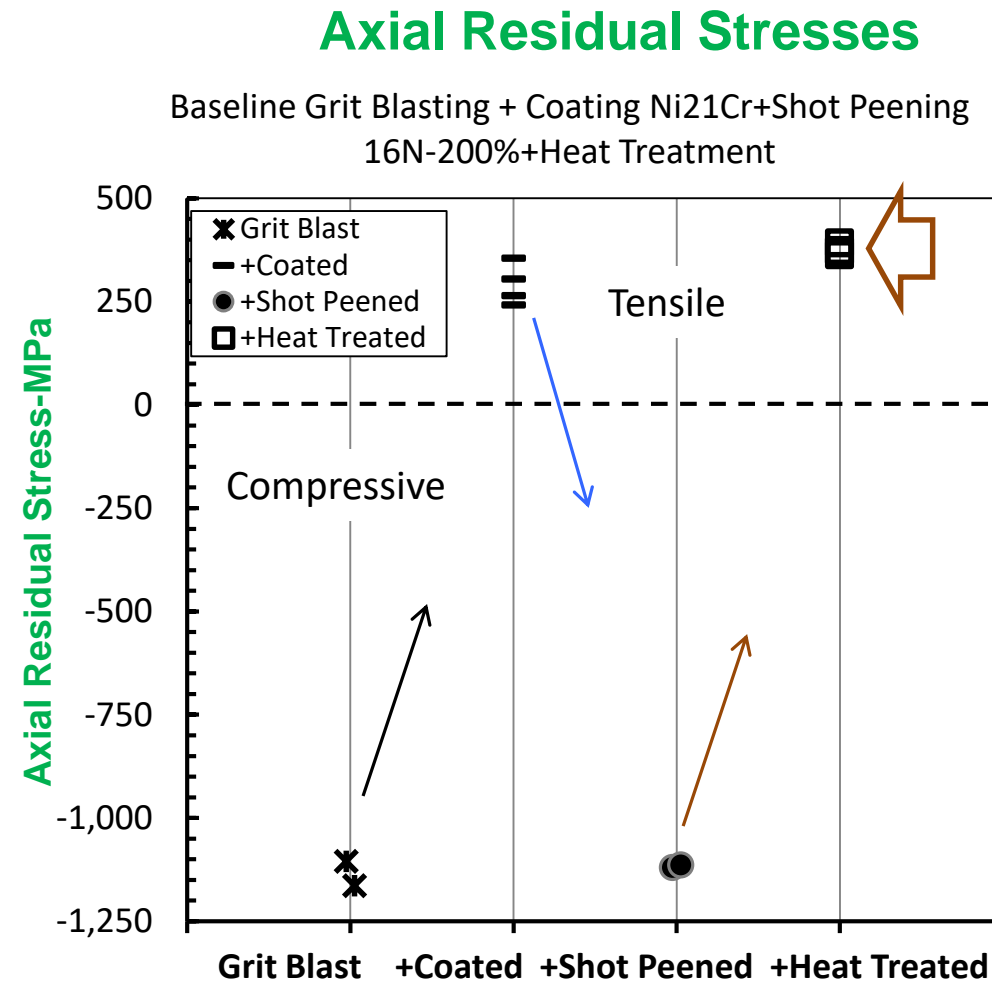
Surface Roughness Was Increased After Coating + Shot Peen + Heat Treat

(A) Baseline Processing: Pre-coat Grit Blast + Coating + Shot Peen + Heat Treat

- The coating was in tension, but shot peening produced large compressive residual stresses at the surface of the coating.
- Heat treatment at 760 °C for 8 h relaxed out the compressive residual stresses, resulted in tensile stresses at the surface.

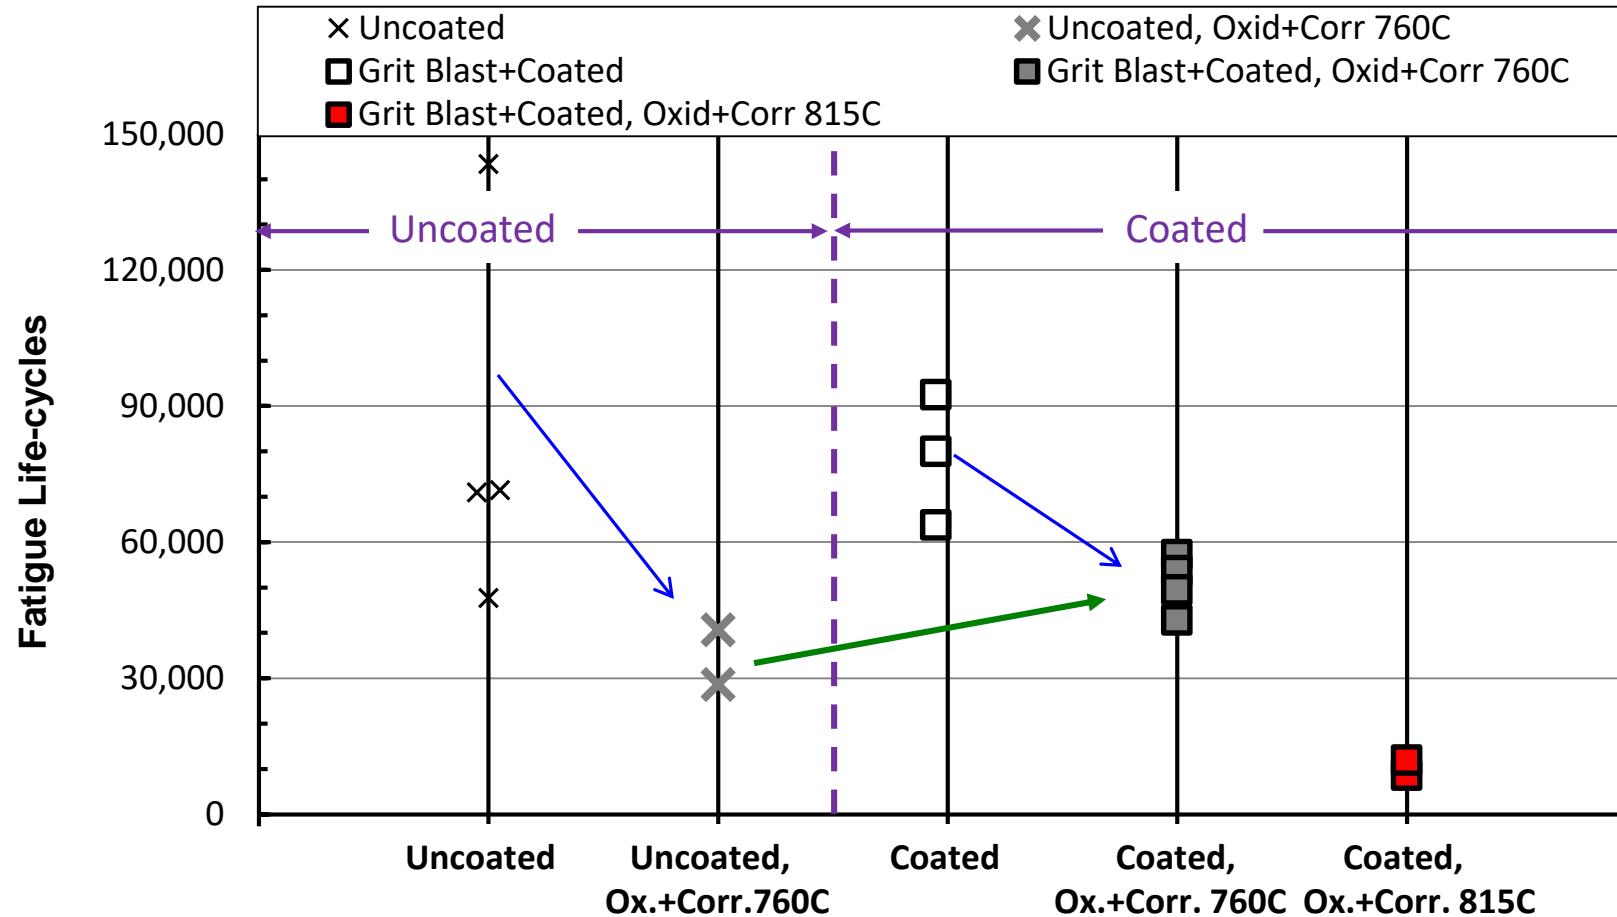
Comparison of Fatigue Lives For Uncoated Versus Coated Specimens Prepared Using the Baseline Process

(A) Baseline Process = Pre-Coat Grit Blast + Coated Ni21Cr + Shot Peened 16N-200% + Heat Treated 760 °C/8h/low pO₂

- Combined oxidation plus corrosion exposures reduced fatigue lives for uncoated and coated specimens.
- Coating gave a modest benefit after oxidation + corrosion

- Coated and uncoated specimens were fatigue tested at 760 °C, after oxidation plus hot corrosion exposures:
 - Uncoated specimens- fatigue cracks initiated from corrosion pits to reduce life.

- Coated specimens- no deep corrosion pits were formed, so life improved.Increased surface cracking occurred in this ductile coating.
- Alternative pre-coating surface pre-treatments were screened:

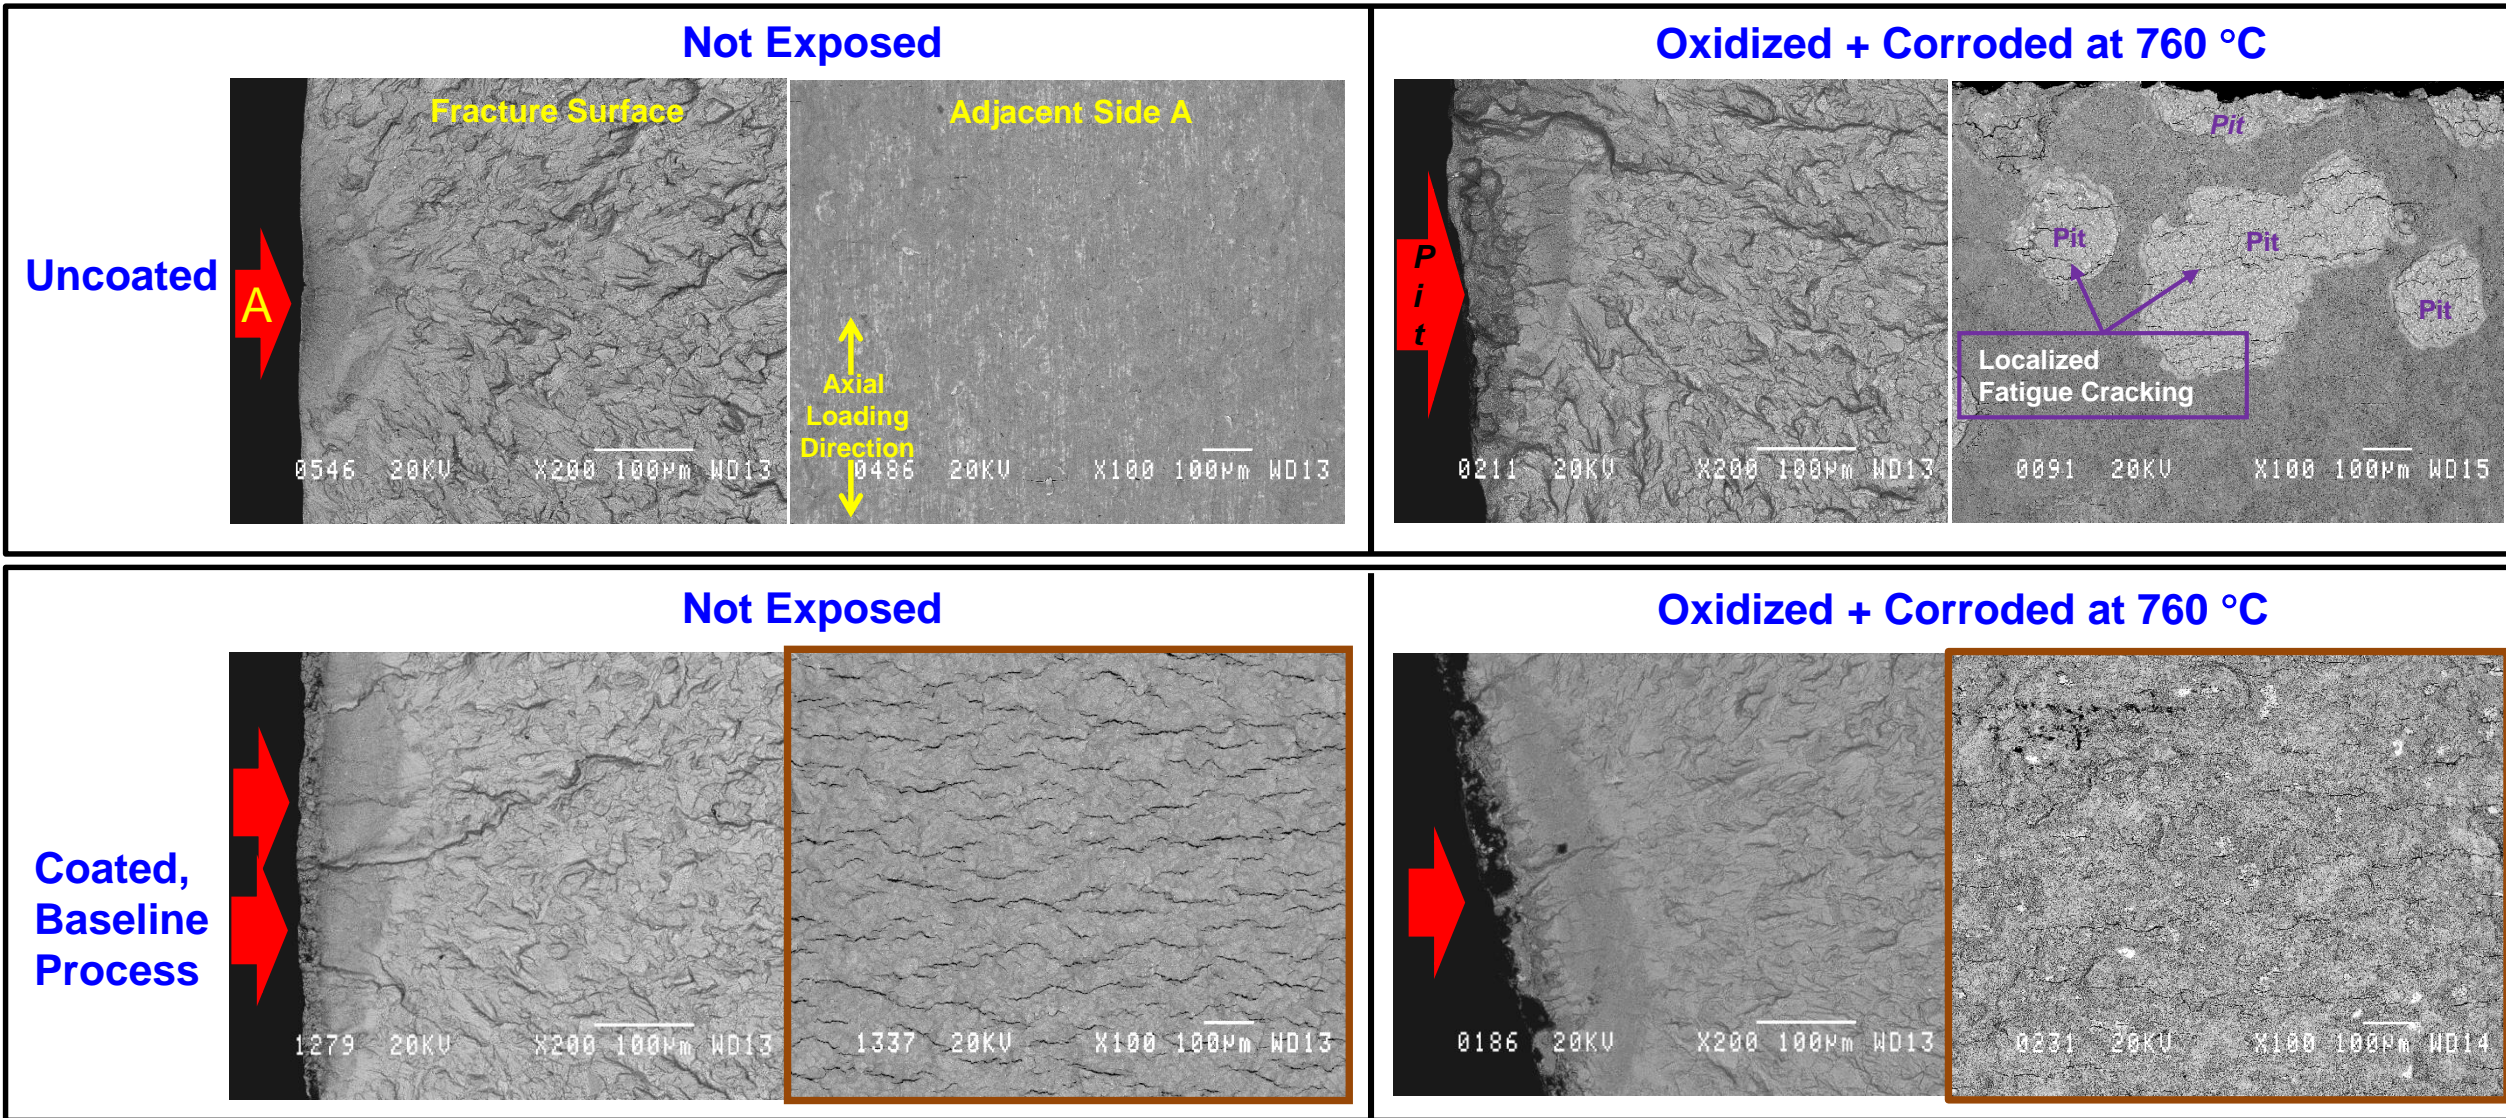
Fatigue Failure Modes Were Shifted By the Exposure and By the Coating

-Uncoated specimens had localized fatigue cracking at corrosion pits.

-The surfaces of coated specimens did not display distinct corrosion pits, yet had increased fatigue cracking, even without oxidation plus corrosion at 760 °C.

➤ A more ductile coating did not eliminate the increased surface cracking, at the coating.

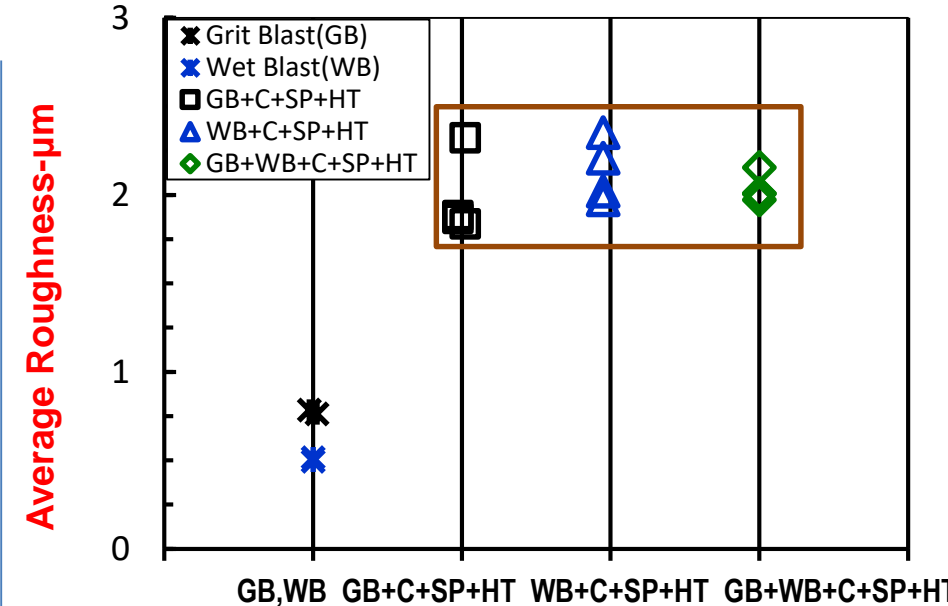
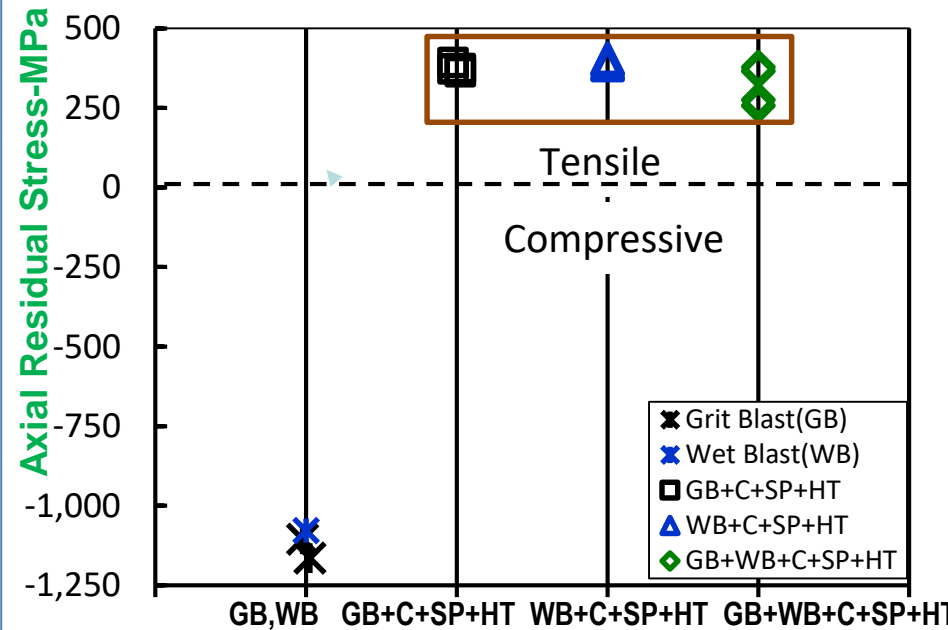
- After baseline coating (C), shot peening (SP), and heat treatment (HT) processes, similar tensile residual stresses were measured at the surface for all conditions.

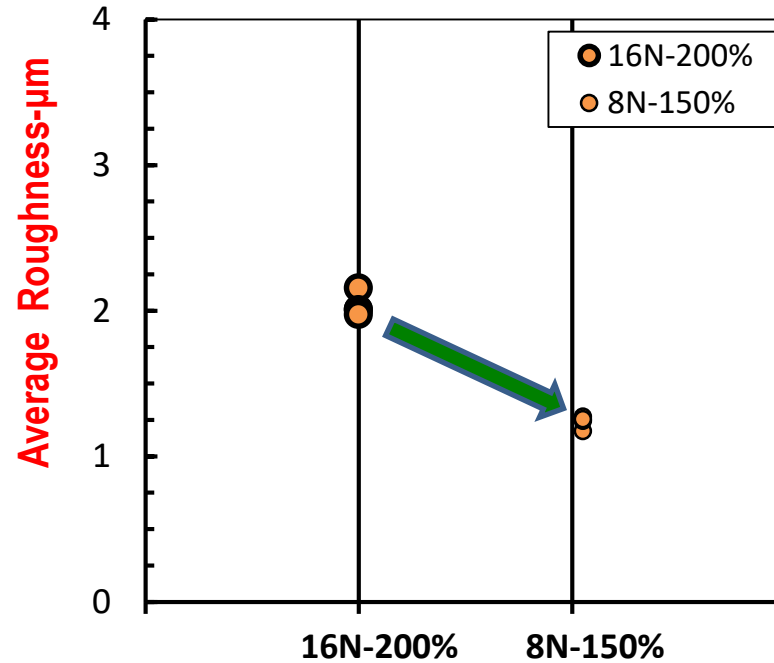
-Average roughness after shot peening reduced about 40 %.

- Alternative post-coating shot peening conditions were screened:
 - Gentler shot peening gave lower roughness, comparable residual stresses after heat treatment, moderately improved fatigue life after exposures.Increased surface cracking of coating still remained.

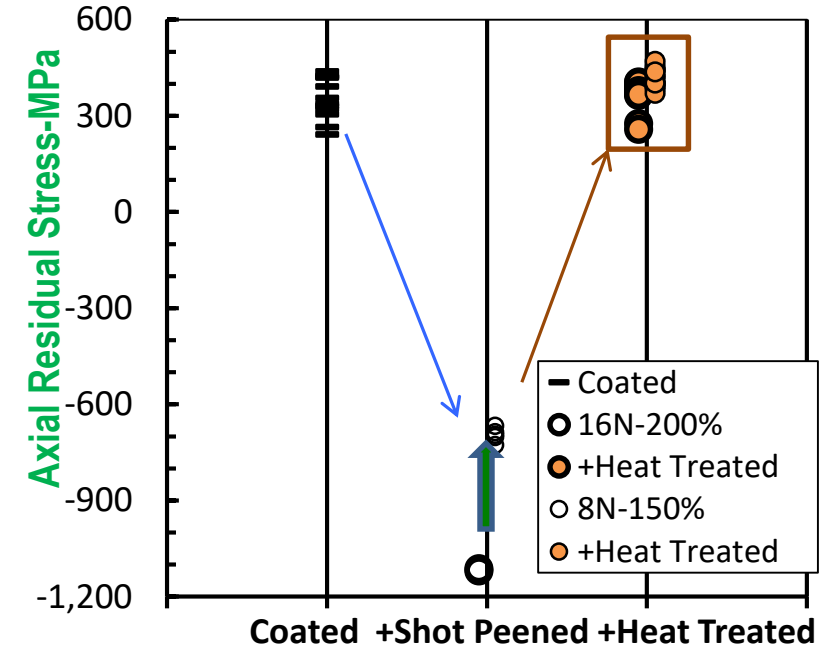
-Magnitude of axial compressive residual stress from shot peening reduced about 35 %.

- Alternative post-coat shot peen treatment reduces roughness and compressive residual stress.

- Yet, heat treatment still relaxed residual stresses to comparable values.

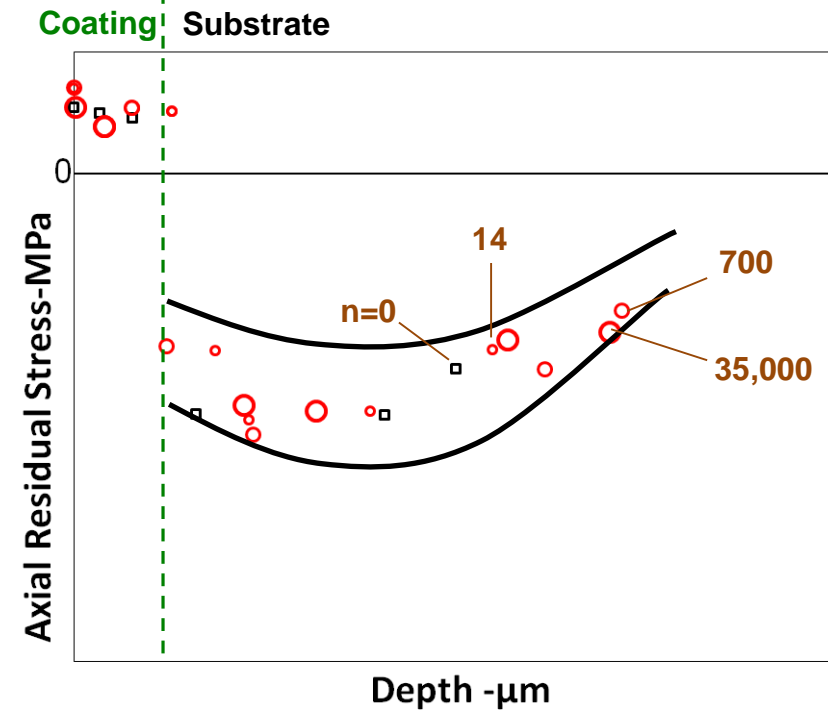
Residual Stresses in NiCrY-Coated Specimens, After Various Numbers of Fatigue Cycles - *n*

- Cracks can begin to form sooner in these weak coatings, where no compressive residual stresses from shot peening remain at 760 °C.

- Yet, the adjacent substrate can retain sufficient stable compressive residual stresses to resist most crack growth there, enabling good fatigue life.

- **Why can there be increased fatigue cracking of the coating, yet good fatigue lives:**
 - **Cracks can form sooner in NiCr γ phase and $\gamma + \alpha$ phase coatings, where no compressive residual stresses from shot peening remain at 760 °C.**

- **Yet, the adjacent superalloy substrate can still retain some compressive residual stresses, to help suppress crack growth there.**
