Fatalities of repair, maintenance, minor alteration, and addition works in Hong Kong.

Safety Science, 51(1), pp. 85-93.

Fatalities of repair, maintenance, minor alteration, and addition works in Hong Kong

Carol K.H. Hon^{*}, Albert P.C. Chan

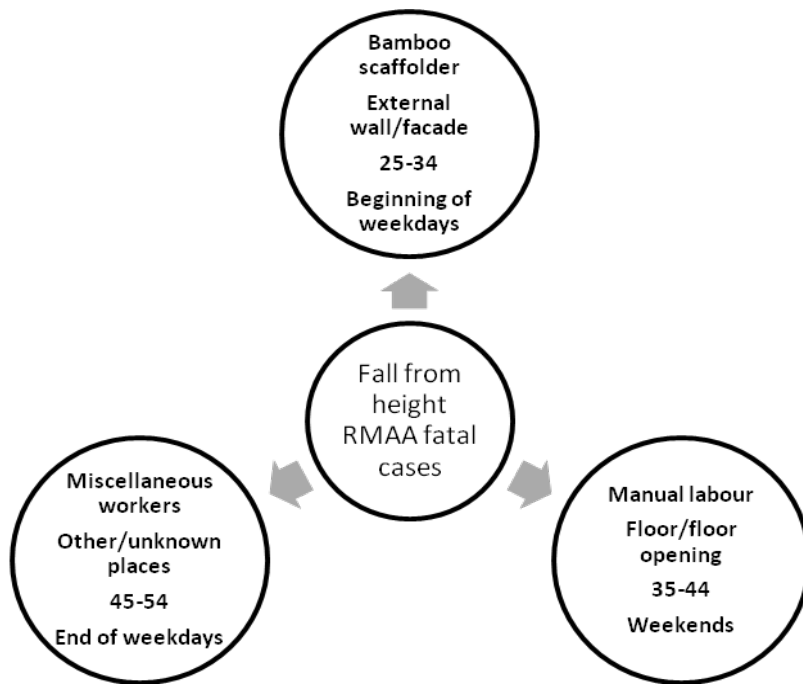
Fig. 4. Three clusters of fall from height RMAA fatal cases.

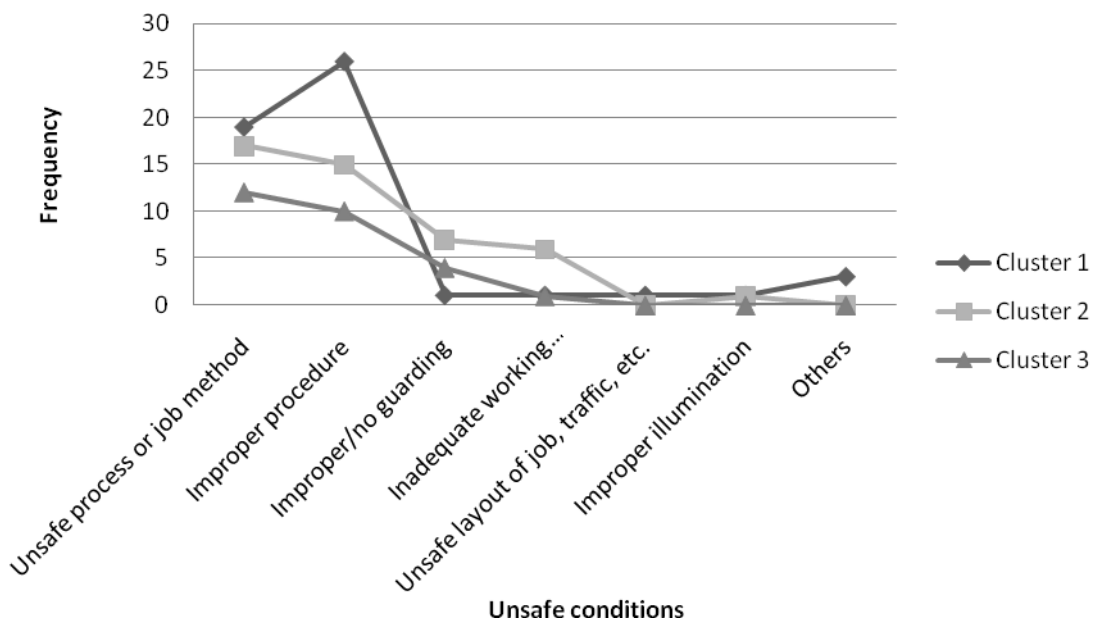
Fig. 5. Frequency of different types of unsafe conditions with respect to each cluster.

Improper procedure ($n = 51$, 72%) and unsafe process or job method ($n = 48$, 68%) were the top two unsafe conditions (Fig. 5) whereas failure to use safety belt/harness was the top unsafe action ($n = 50$, 70%) (Fig. 6) found in the fall from height RMAA fatalities. Cluster one accounted for most of the improper procedure, unsafe process, and failure to use safety belt/harness, implying that younger bamboo scaffolders tended to pay less attention to the safety practices than the more experienced ones. More safety training and supervision should be given to the younger bamboo scaffolders.

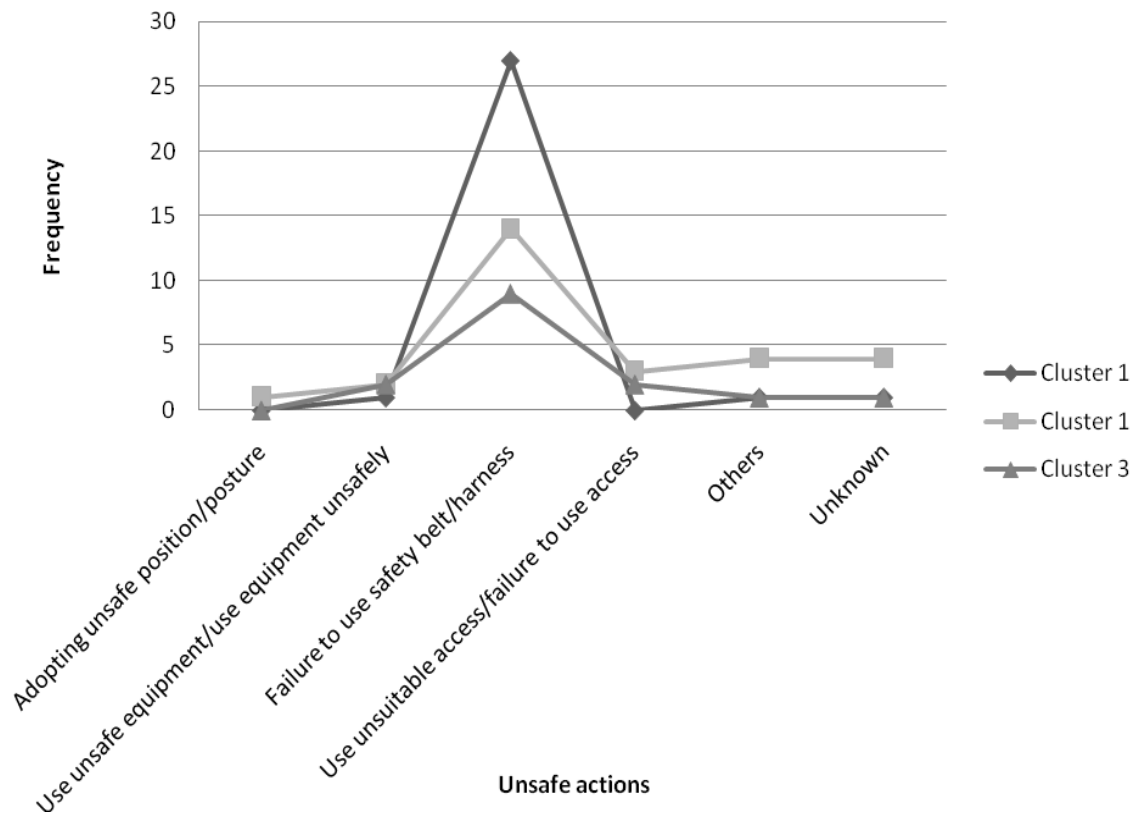
Fig. 6. Frequency distribution of unsafe actions with respect to each cluster.
