**IOWA STATE HIGHWAY COMMISSION**

**R-262**

***Bridge Deck  
Waterproofing  
Membrane Study***

**December, 1974**

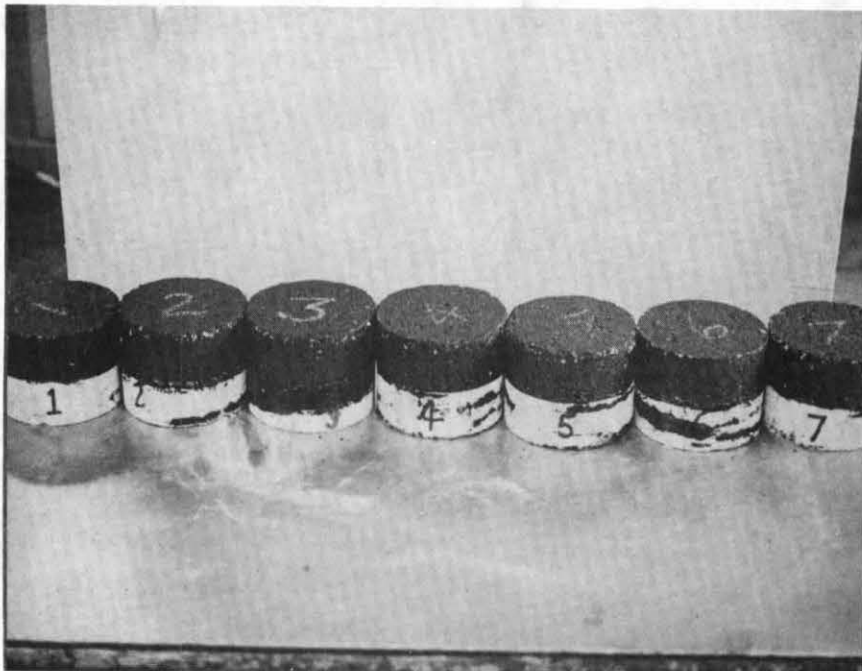
Figure 9

Shear test specimens with membrane system and asphaltic concrete applied
