STRAY VOLTAGE PROBLEMS WITH DAIRY COWS

R. D. Appleman and H. A. Cloud

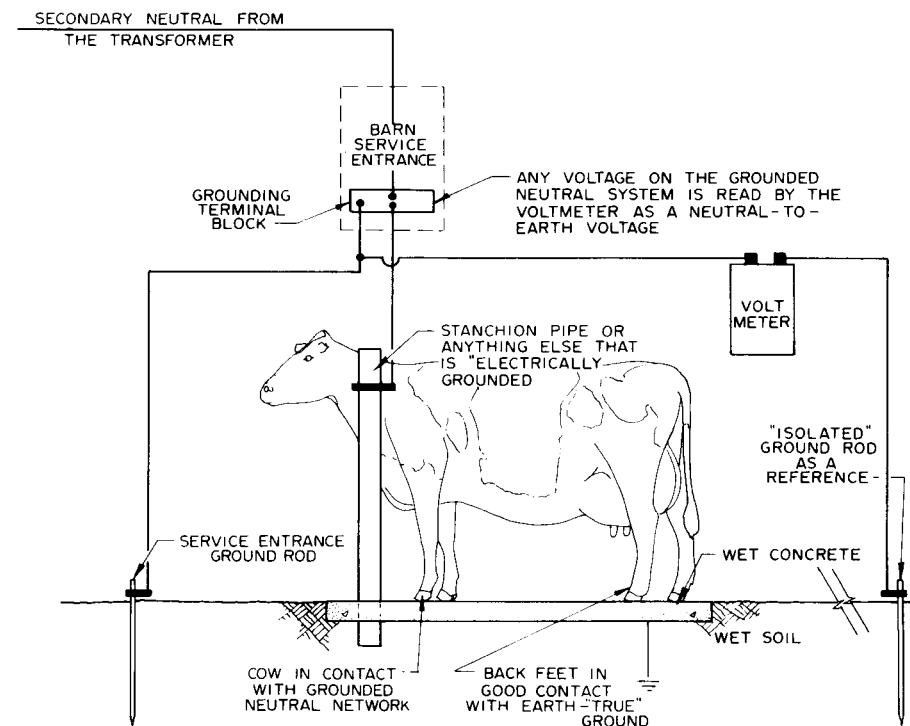
Figure 2. A dairy cow subjected to a neutral-to-earth (N-E) voltage

crete, feeder, etc. She may be subjected to the same N-E voltage read by the voltmeter in figure 2. This voltage causes a current to flow through her body and can result in serious problems when it is high enough to cause discomfort.

grounded neutral system and an isolated or true ground (see figures 2 and 3).

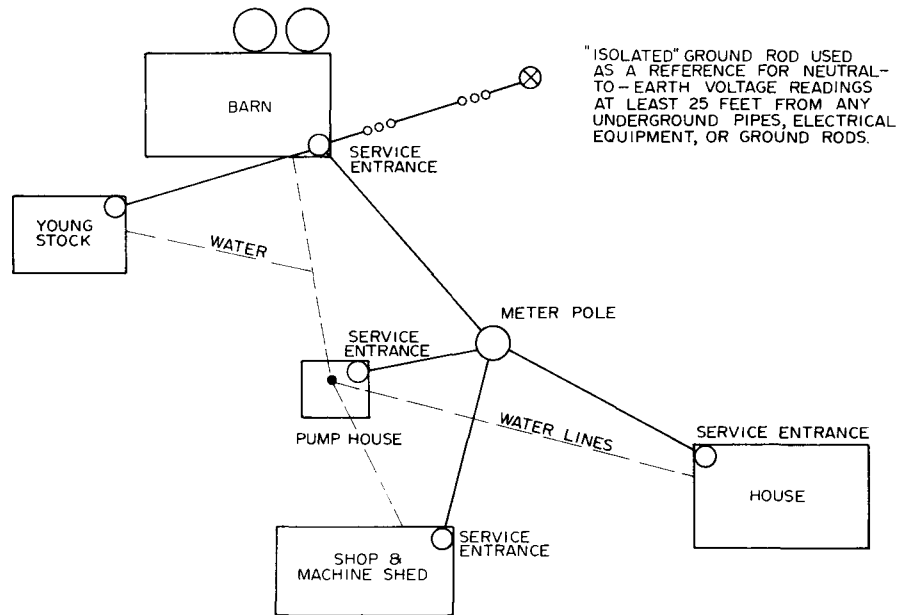
Figure 3. Location of an "isolated" ground rod used as a reference in neutral-to-earth voltage measurements

The following examples show several N-E voltage conditions and will help develop a better understanding of the problem. Figure 3 shows the location of an "isolated" ground rod used as a reference when measuring N-E voltages. If one lead of a voltmeter is attached to the service entrance ground of the barn, as shown in figure 2, and the other lead is attached to the "isolated" ground rod, it will read the N-E voltage existing on the network at this location. The location and use
