Spillway model study for two lick creek dam, February 1968, Project Report 54

SPILLWAY MODEL STUDY FOR TWO LICK CREEK DAM

Project Report No. 54

Gilbert Associates, Inc.

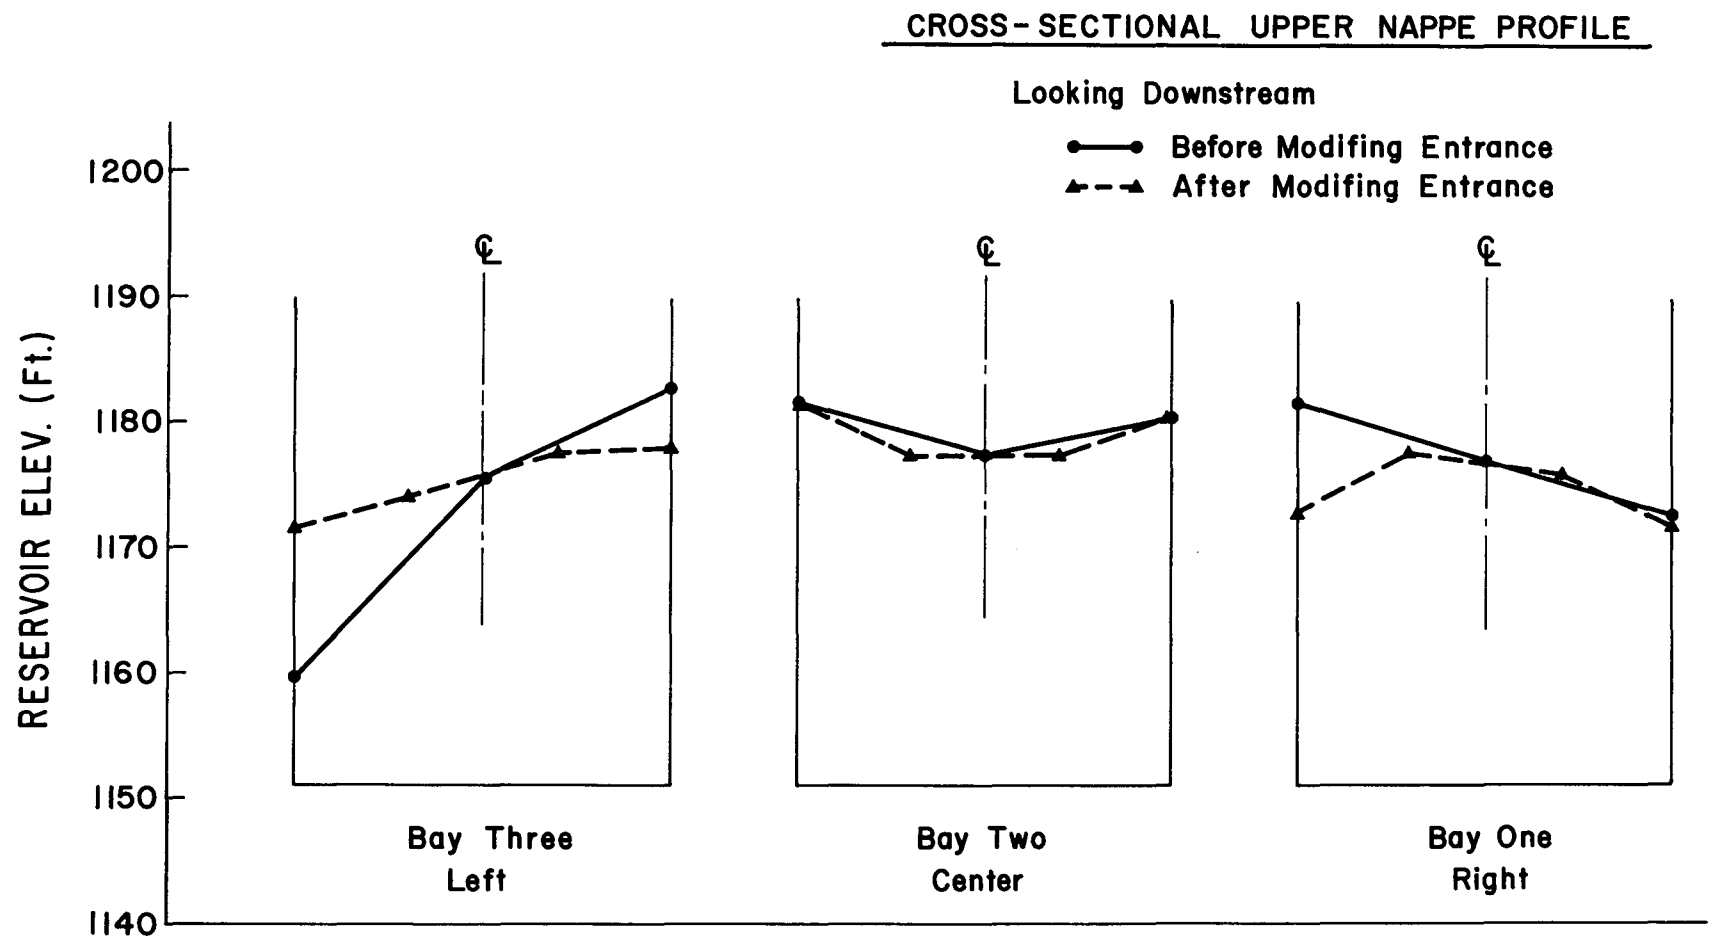
Fig. 9 Surface Profiles Along Crest

The model tests resulted in several design changes to better equalize flow between the three bays. These modifications are shown in Fig. 9 and included:

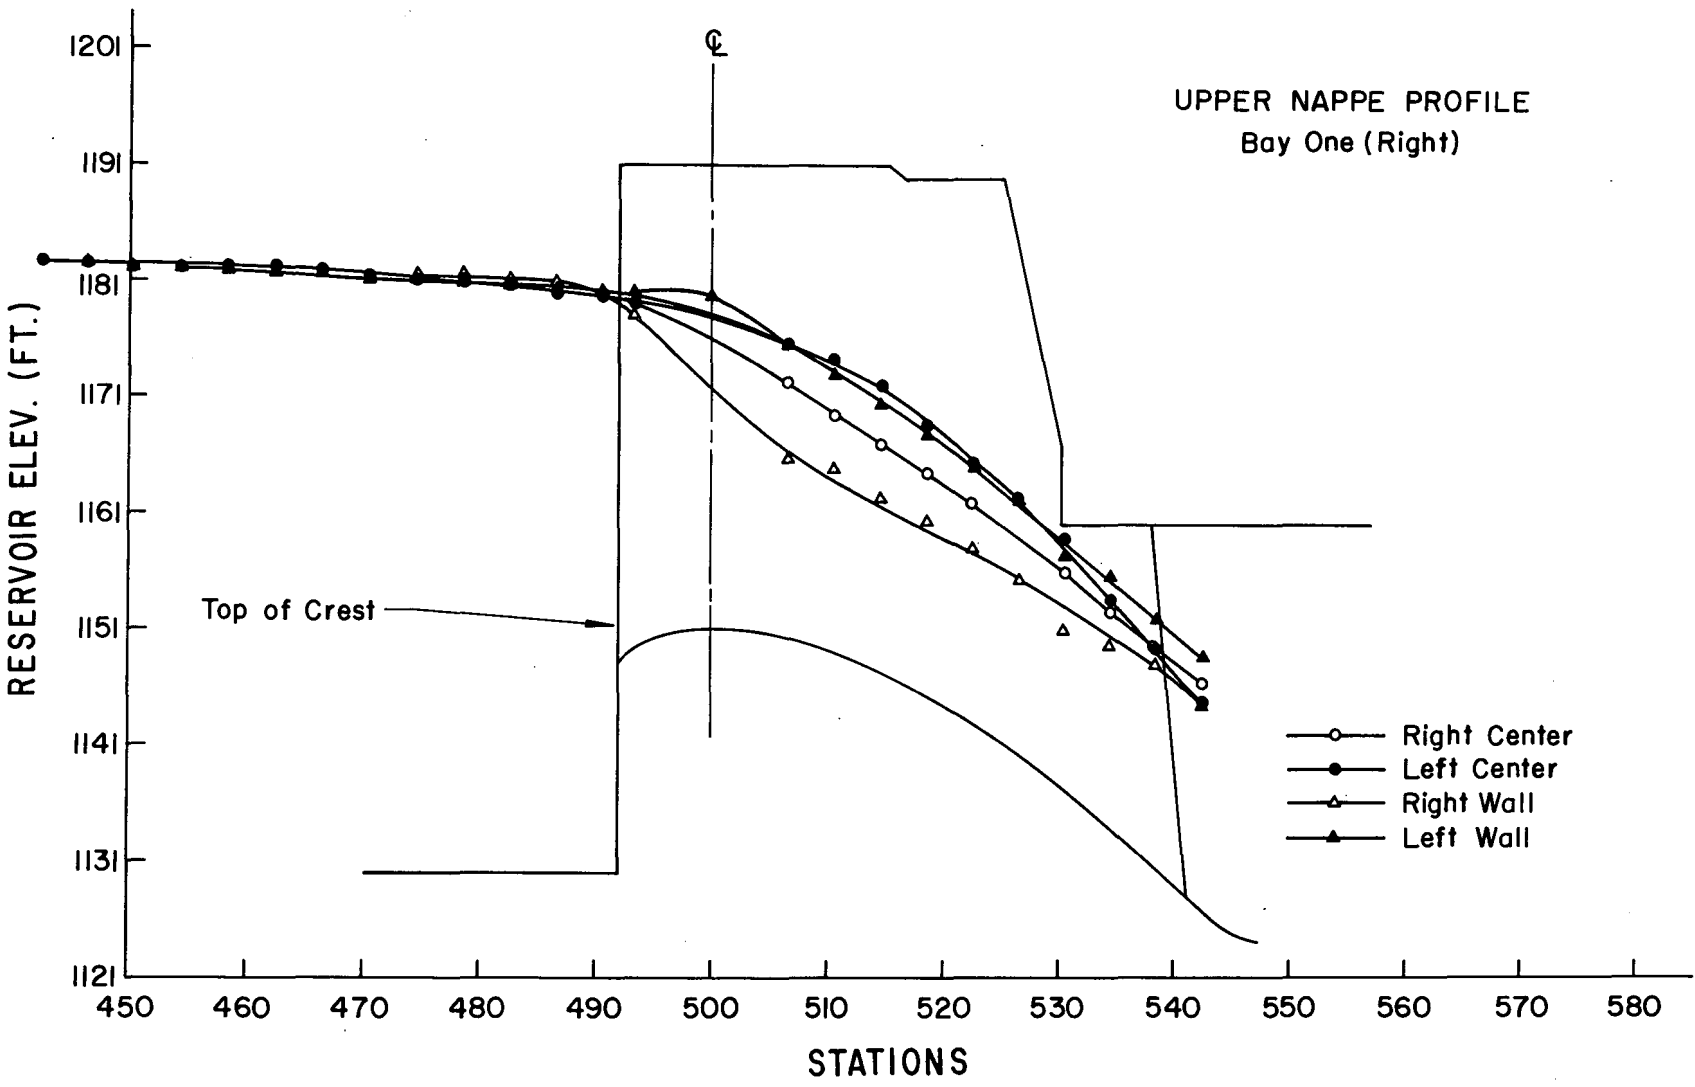
Fig. 10 Surface Profiles - Bay 1

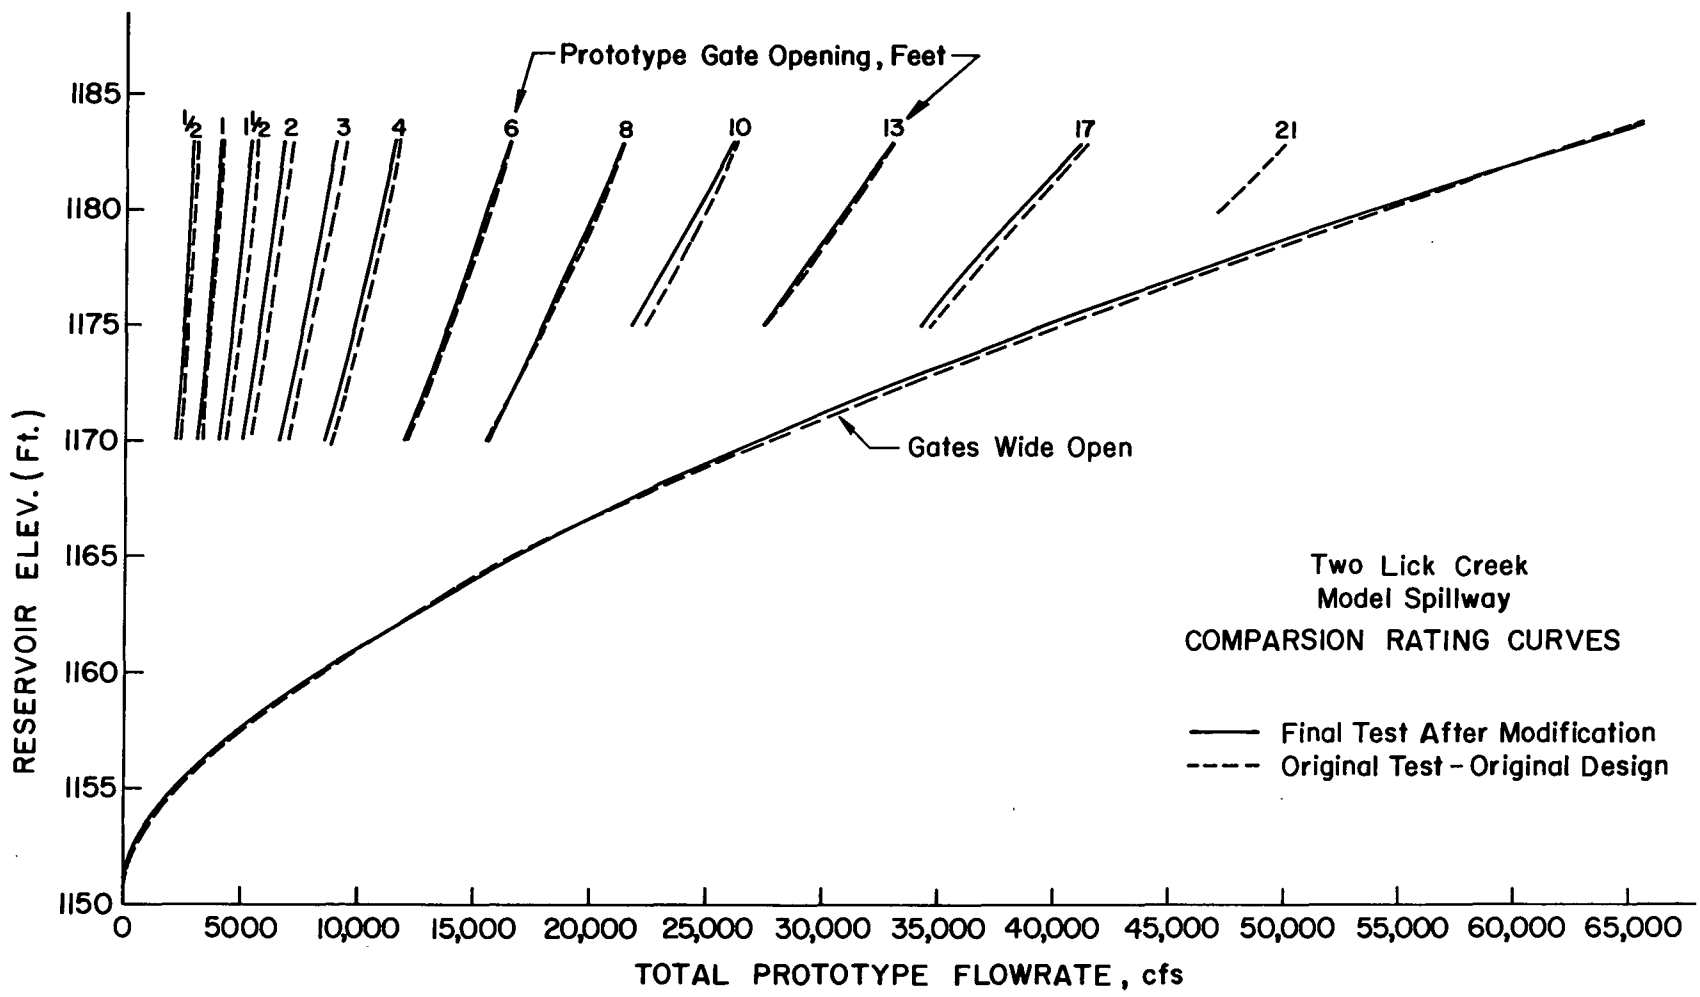
Fig. 13 Spillway Rating Curve
