# Report on Field Measurements and Uncontrolled Load Testing of the Lehigh River Bridge (SR-33)

**Report on Field Measurements and  
Uncontrolled Load Testing of the  
Lehigh River Bridge (SR-33)**

**Phase II**

**ATLSS Report No. 06-12**

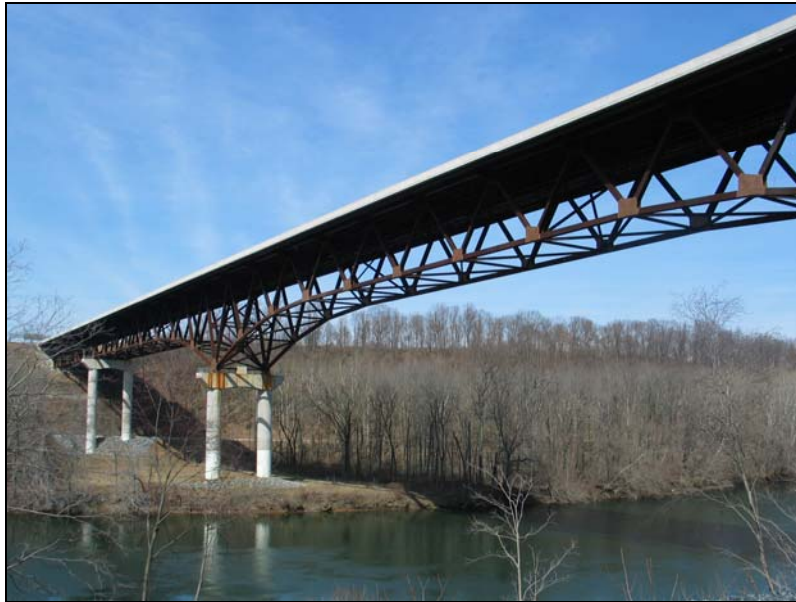
Figure 1.1: Photograph of the SR-33 Lehigh River Bridge looking northeast at the west face of the bridge

This Final Report discusses the findings of the long-term monitoring and uncontrolled live load testing of the SR-33 truss bridge as of March 21, 2005. The bridge carries traffic over the Lehigh River, the Lehigh Canal, and a double set of Norfolk Southern railroad tracks. A view of the bridge looking northeast is shown in Figure 1.1. The purpose of the testing was to study the overall influence of temperature on the truss, determine the long-term effects of concrete creep and shrinkage on the instrumented members, and verify the behavior of selected truss members under vehicular live load. Additional instrumentation of the bridge was installed in July 2003 and vehicular live load data were collected for periods of time throughout 2004 and 2005.

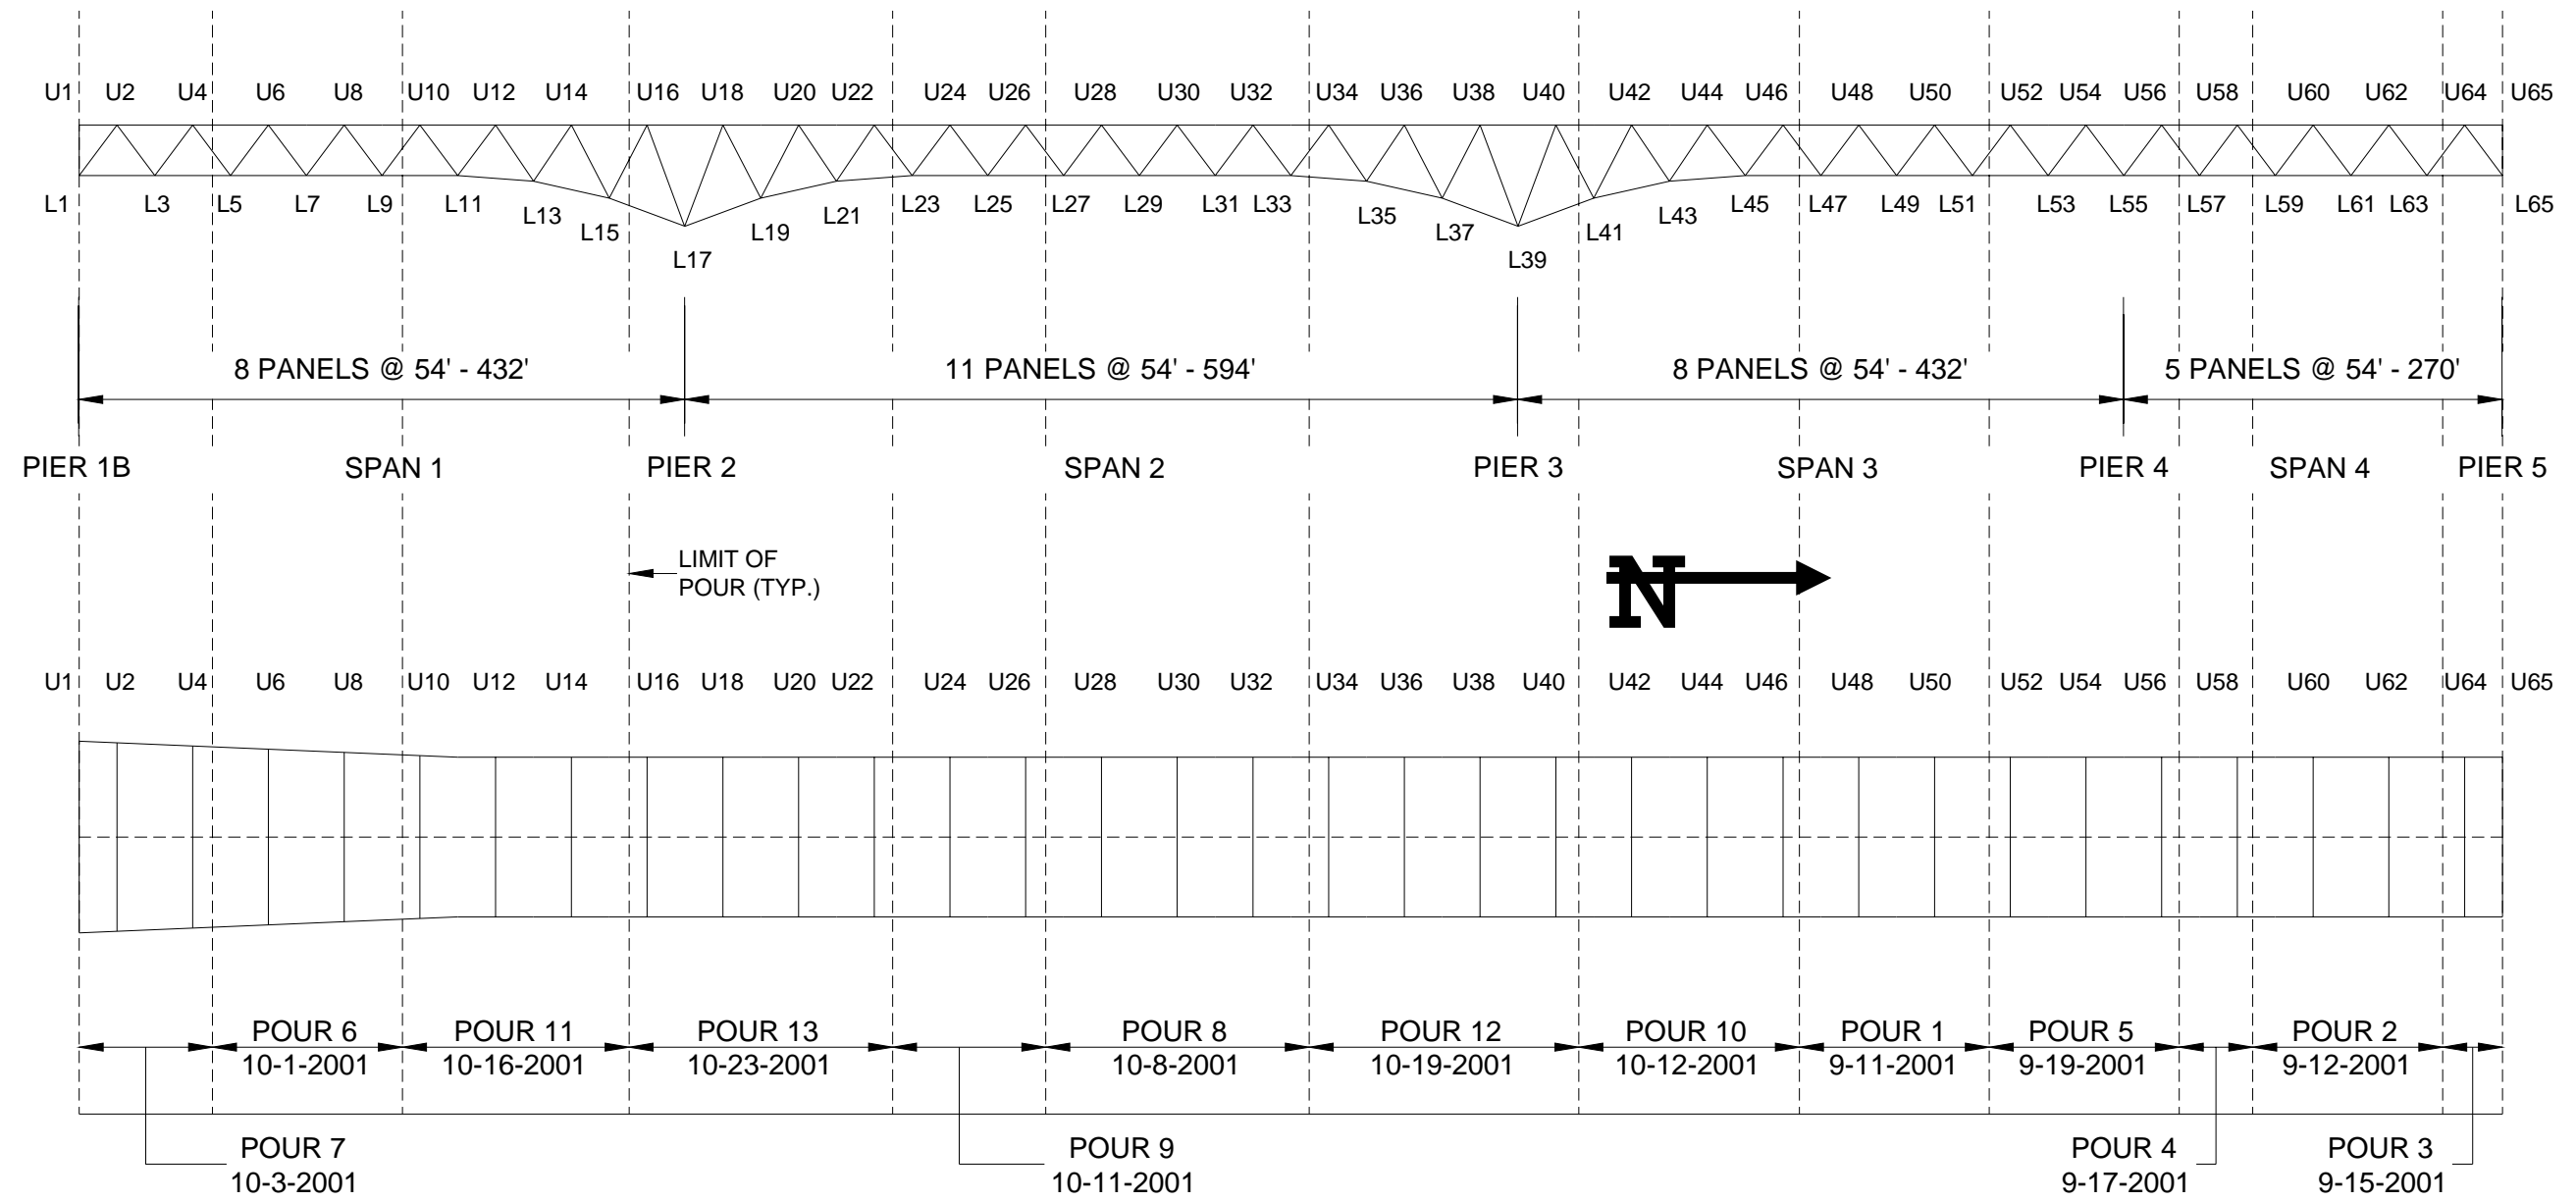
See pages 27-37 and 42-43 for gage locations

Figure 1.2 - Elevation view of Lehigh River Bridge and illustration of deck pours

The bridge is a four-span continuous haunched steel deck truss that is fully composite with the reinforced concrete deck. The main truss members (i.e., upper chords, lower chords and diagonals) are fabricated from structural steel plates into box or “H” shapes. The steel stringers, sway bracing, and cross bracing members are all rolled “W” shapes. The bridge is unique in that the reinforced concrete deck is not only composite with the longitudinal stringers and transverse floorbeams, but also with the upper chord members of the truss. It is the only fully composite deck truss bridge in Pennsylvania and quite possibly in the United States. An elevation view of the bridge with sequence of concrete deck pours is shown in Figure 1.2 and a typical cross-section at midspan of the main river span is shown in Figure 1.3.

Placement of the concrete deck was completed on October 23, 2001. A sequence of the pours is shown in Figure 1.2. Members that were directly in contact with the concrete such as the stringers and the upper chords, responded differently to changes in temperature after the concrete deck was placed. Figure 2.3 shows a comparison of temperatures on selected truss members. A vertical line indicates when placement of the concrete was completed. The data are from the period September 28, 2001 through November 23, 2001.

The concrete deck was placed in thirteen different steps (Figure 1.2) that began on September 11, 2001 and ended on October 23, 2001. The effects from the first five pours had very little effect on the instrumented members of span 2. Also, some pours by themselves had very little effect. Therefore, the effects of pours 6 and 7 were grouped together and pours 10, 11 and 12 were grouped together to see a noticeable change in stress in the members.

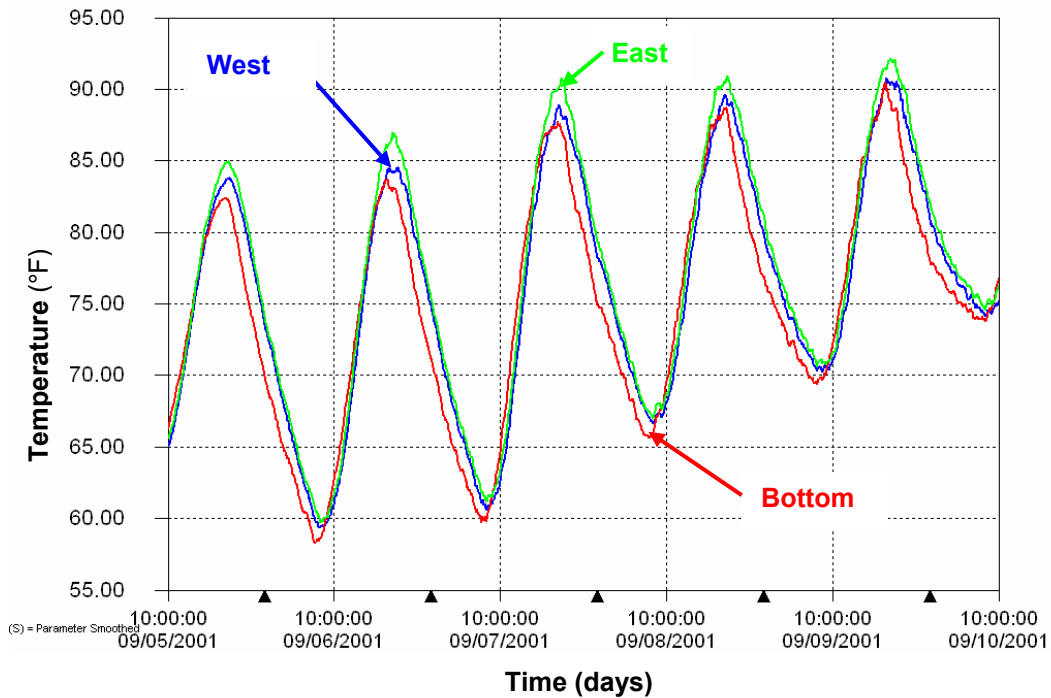
Figure 2.1: Comparison of measured temperature on east upper chord (U16-U18 East) during early September 2001

Figure 2.1 shows the comparison of measured temperatures on the east upper chord (U16-U18 East). The figure shows that the temperature of the upper chord remained fairly uniform within the member. The bottom gage remained cooler by only a few degrees. Similar temperature distributions were observed for both upper chords.

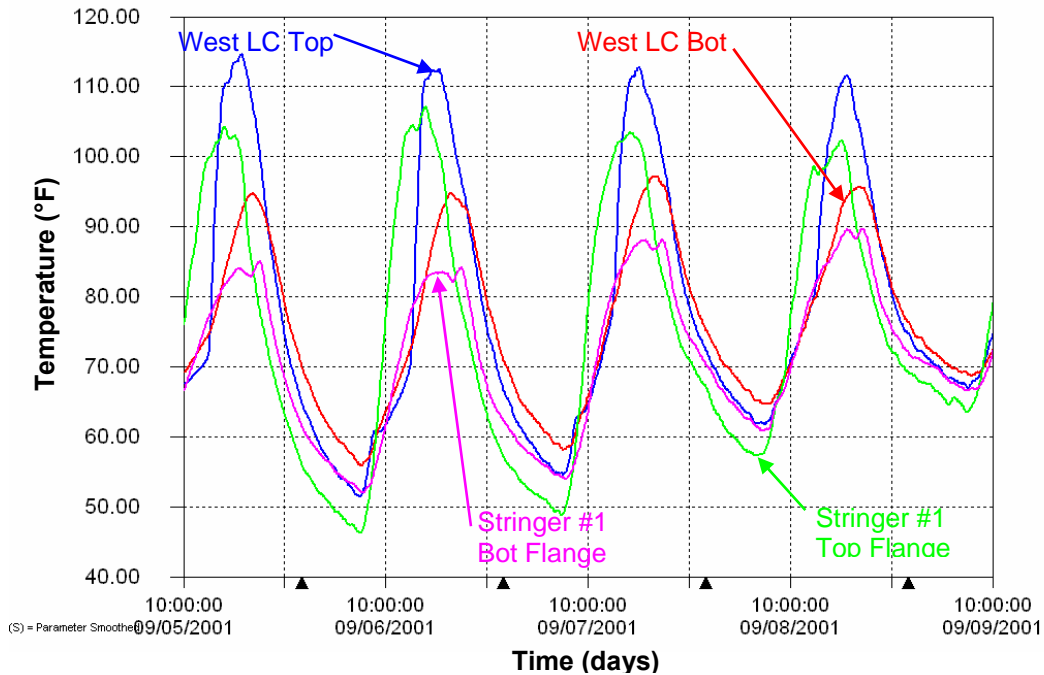
Figure 2.2: Comparison of measured temperature on top and bottom surface of west lower chord L25-L27 and stringer 1 between U16 and U18 during early September

Figure 2.2 indicates the temperatures of the top and bottom surfaces of the west lower chord (L25-L27 West). Also, the temperatures for the top and bottom surfaces of

stringer 1 are presented. As expected, the temperature of the top surface of the members reaches a much higher temperature than the bottom surface. Temperatures are a minimum between 6 AM and 8 AM in the morning. Overall, the data indicates that temperatures on the east and west face of a member remain relatively uniform throughout the day. However, temperatures on the top and bottom surfaces of a member are quite different due to the exposure of the top surface to the sun.

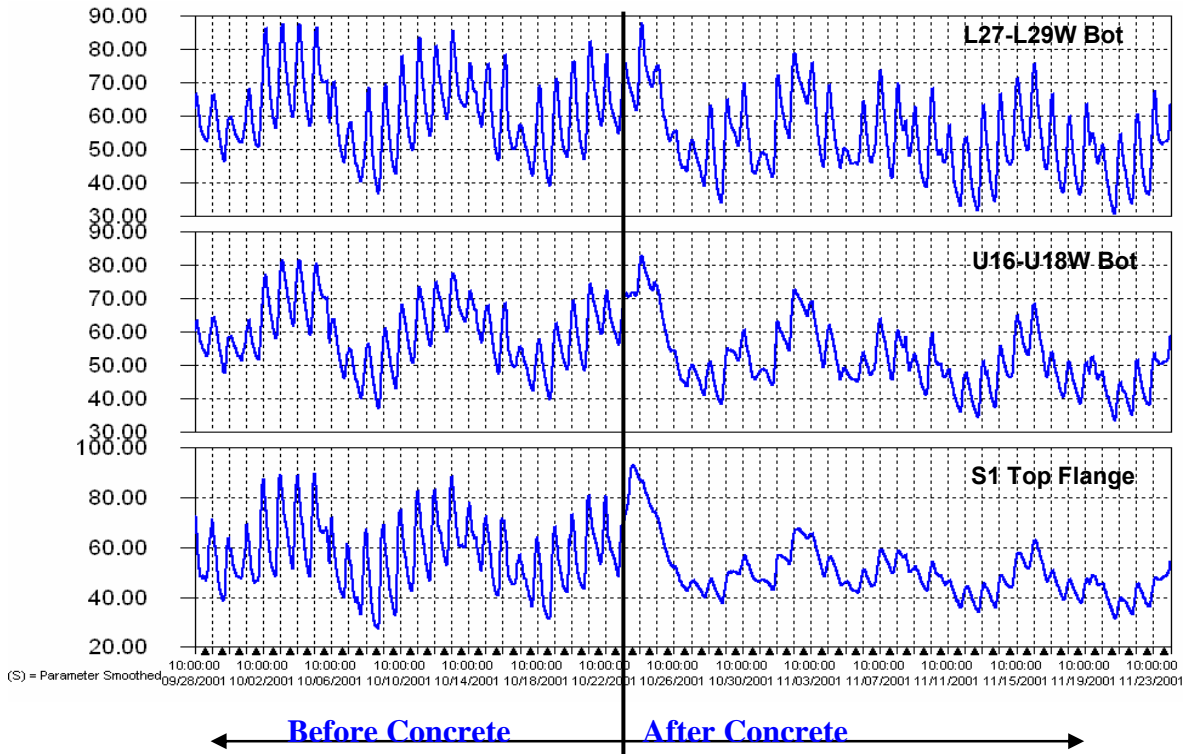
Figure 2.3: Comparison of temperatures of selected truss members

There is an increase in temperature in the upper chord and stringer as a result of the concrete placement. It should be noted that the temperature remains above 70 degrees for about two days and then gradually cools. This is due to the increase in temperature of the concrete from the hydration process. After placement of the deck was completed on October 23, the amplitude of the daily temperature cycles in the upper chord and stringer are greatly reduced. This is due to the fact that the members are shaded by the deck and that the thermal mass of the system was greatly increased by the addition of the concrete. Hence, the upper chords and stringers are not as sensitive to changes in temperature.

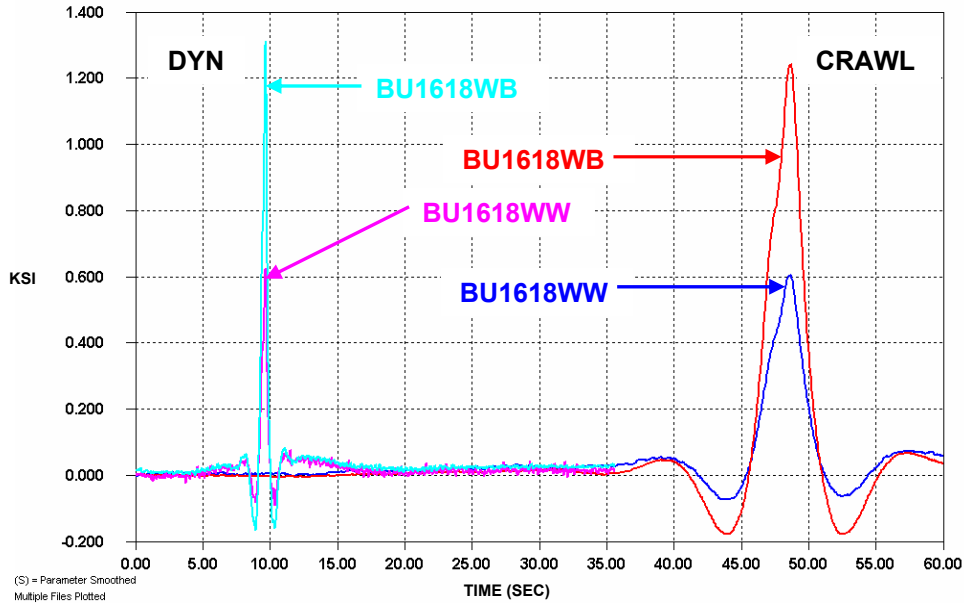
Figure 2.9: Comparison of crawl and dynamic tests in lane 2  
(Truck #80 headed north)

Dynamic tests were run in each lane at approximately 45 mph. A comparison of the response of the west upper chord to a dynamic and crawl test run in lane 2 is shown in Figure 2.9. The figure clearly shows that there is little dynamic amplification factor (approximately 3% to 5%). The dynamic amplification factor is the ratio of stress caused by a dynamic test to the stress caused by a crawl test. It should be noted that the relatively low dynamic amplification factor observed is due to the quality of the concrete deck at the time of the testing. Deterioration of the wearing surface would increase the dynamic amplification factor. The primary response of the upper chord to the crawl and dynamic tests was local member bending.

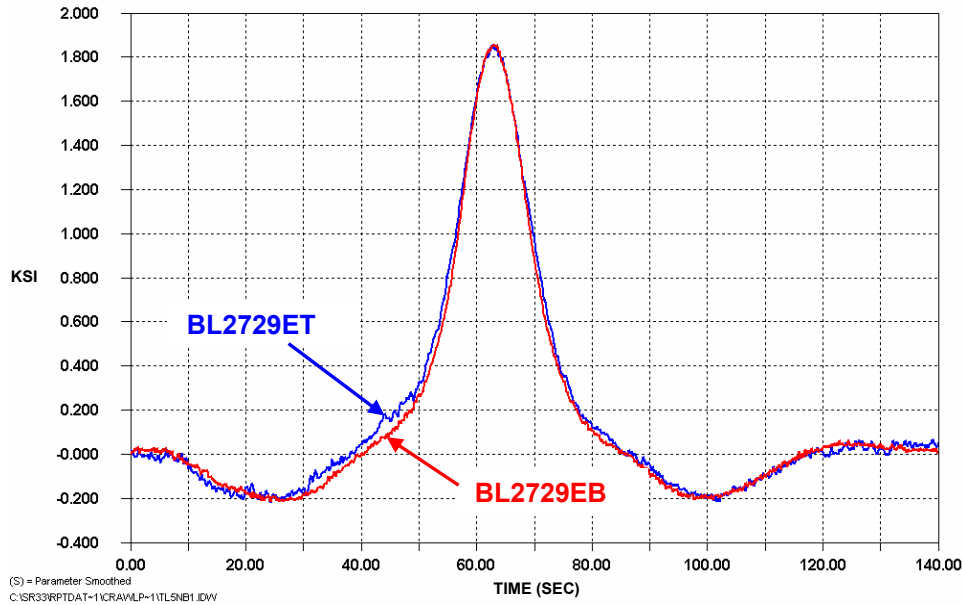
Figure 2.10: Typical lower chord response  
(Truck “train” in lane 5)

Figure 2.10 represents the largest single stress cycle measured in the lower chord L27-L29. This test was performed with all three trucks bumper to bumper forming a train of trucks. This particular arrangement was used to show that the lower chords primarily behave globally and axially. The stress plots from the top and bottom gages are essentially identical. This means there is little bending, if any, in the member. A similar test for the upper chord would have shown three distinct stress cycles compared to one stress cycle observed in the lower chord.

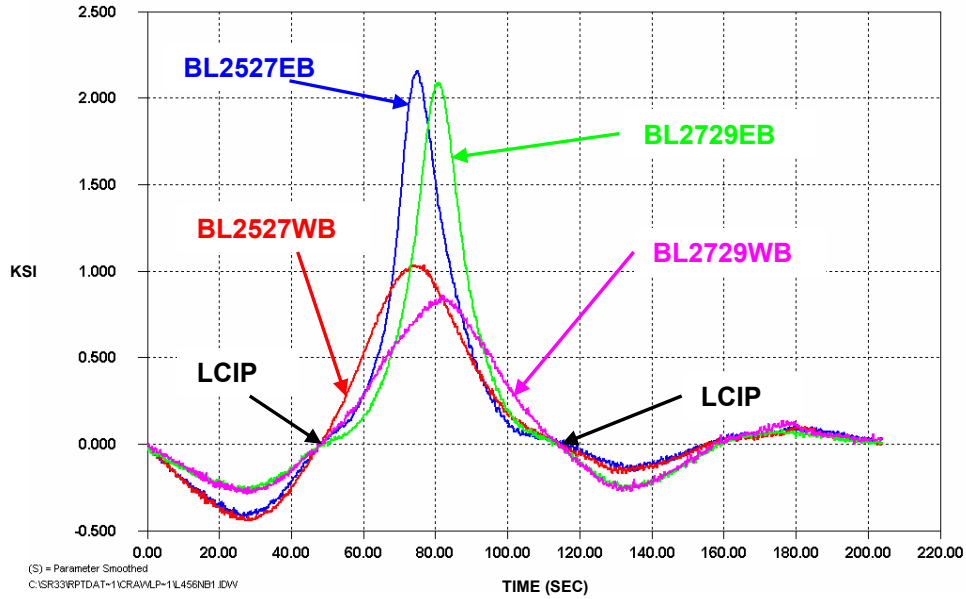
Figure 2.11: Typical lower chord response for adjacent lower chord members

Figure 2.11 describes the behavior of all four bottom gages on the lower chords with trucks in lanes 4, 5 and 6 traveling northbound. A few important conclusions can be drawn from this plot. The first point to be noted is that the lower chord members experience small stress reversals as the trucks cross the piers. The lower chord inflection point (LCIP) on the left marks where the trucks cross pier 2 and the LCIP on the right marks where they cross pier 3. Simple calculations were shown that the trucks traveling at approximately 6 mph would have crossed the piers where the lower chord inflection points occur. The peak stresses in the members occur when the trucks are directly over the gages. Also, the figure shows that when the load is outside of the span between piers 2 and 3, the lower chords of the two trusses act together more equally. When the main span is loaded however, the chords on that side of the bridge carry most of the load. Overall, the lower chords responded in a global and axial manner.

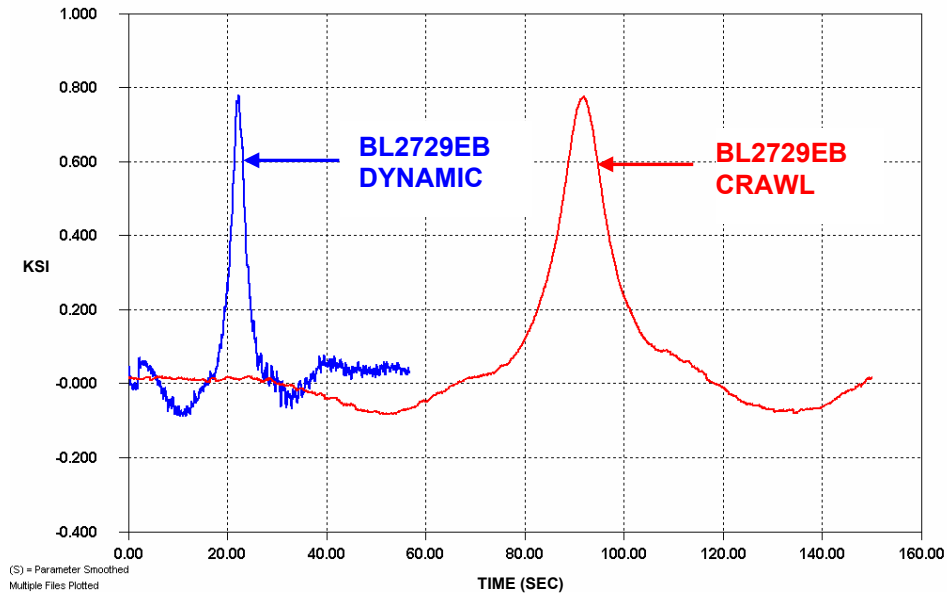
Figure 2.12: Typical dynamic vs. crawl amplitude for the lower chord (Truck #80 in lane 5)

As expected, the lower chords exhibited very little dynamic amplification factor as seen in Figure 2.12. This was expected since the truss acted in a global manner as described by the crawl test data. The response of the lower chords to dynamic testing was comparable to crawl testing. The lower chords remained as global and axial members.

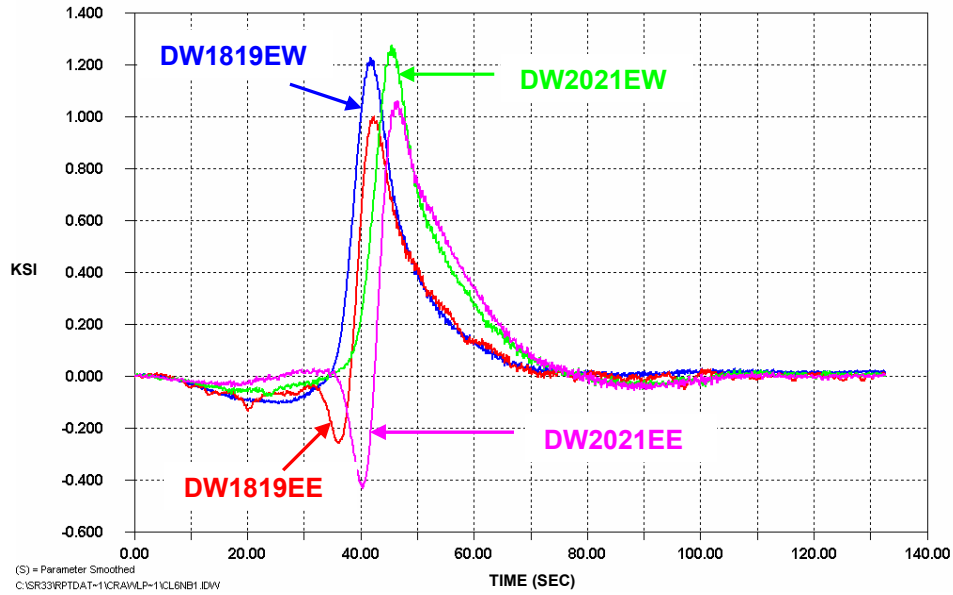
Figure 2.13: Typical east diagonal response to a crawl test in lane 6  
(Truck #80 headed north in lane 6)

The response of diagonals U18-L19 and U20-L21 on the east truss is shown in Figure 2.13. This figure represents the largest stress cycle caused by a single truck in lane 6. The diagonals primarily exhibit an axially behavior which would be expected.

However, the figure below illustrates a noticeable bending component from the stress reversal on one side of the member and the absence of this reversal on the other side. This out of plane bending was most noticeable when the shoulder (lane 6) was loaded. Nevertheless, this out of plane bending was consistent with expected behavior since lane 6 is cantilevered outside of the truss. Similar behavior would be expected on the west truss diagonals if lane 1 were loaded.

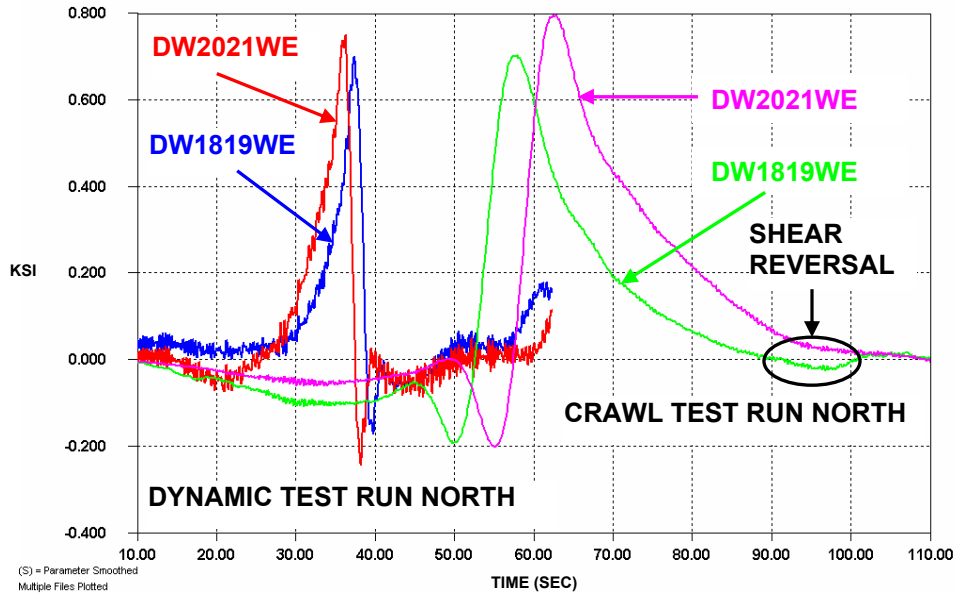
Figure 2.14: Typical dynamic amplification of stress response in west diagonal members (Truck #80 in lane 3)

As with the upper chords, the validity of superposition holds for the diagonal members. Stresses could be added for individual tests in separate lanes to achieve the result from a test conducted in two lanes at once. Little dynamic amplification was expected for the diagonal members since they exhibit a global and axial response much like the response of the lower chords. Figure 2.14 plots the response of the strain gages on the east flange of the west diagonals for crawl and dynamic tests. The figure clearly shows that there is little, if any, dynamic amplification factor for the diagonals. Overall, the response of the diagonals to dynamic testing was comparable to the response due to crawl testing. The diagonals exhibited primarily a global and axial response.

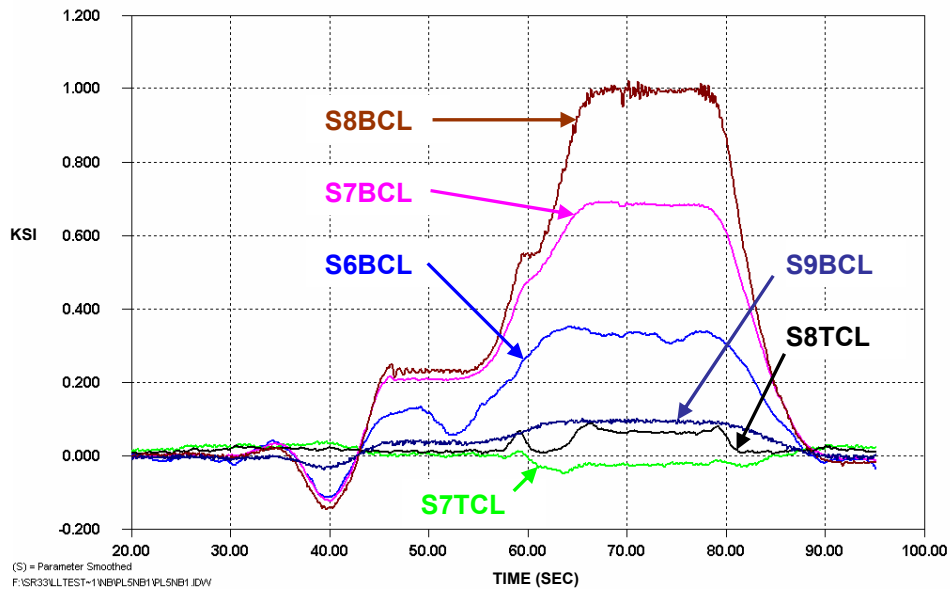
Figure 2.15: U16-U18 centerline of stringer response to a park test in lane 5 (Truck #80 headed north in lane 5)

Figure 2.15 shows the typical stringer responses to a park test in lane 5. The figure exhibits the two-plateau formation discussed earlier. Also, the neutral axis of the stringers lies close to the steel-concrete interface as seen in the near zero stress read by the top flange gages (S7TCL and S8TCL).

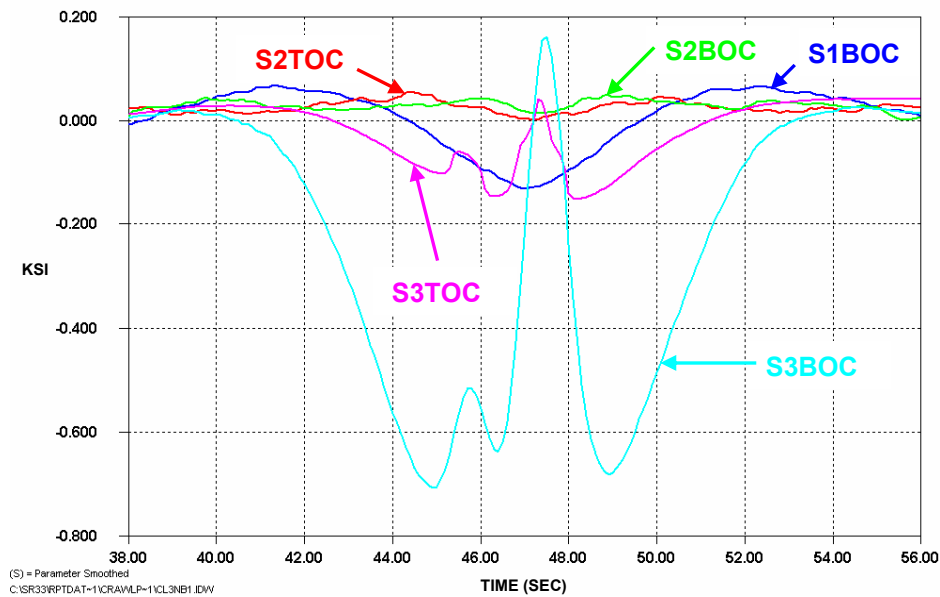
Figure 2.16: Typical crawl response of west stringers (near U16 floorbeam interface)  
(Truck #80 in lane 3 headed north)

The difference in behavior between the gages located near the ends of the stringers and near midspan can be seen in the next two figures. Figure 2.16 plots the response of the gages near the floorbeam at U16 to a crawl test in lane 3. It can be seen that the composite action of the deck affected the response of the stringer. Instead of behaving as a beam with a hinged end connection, there is significant compression stress in the bottom flange at the ends of the members. This indicated that the connection is behaving more like a rigid connection due to the addition of the composite deck. Also, the figure reiterates that the neutral axis of the stringers is near the top flange, which is typical behavior of composite beams.

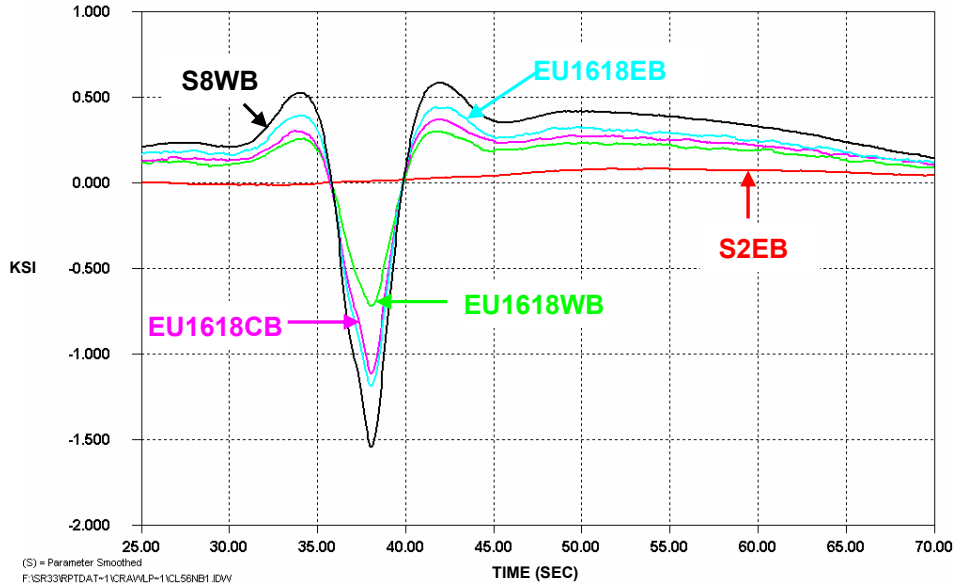
Figure 2.20: Typical response of instrumented reinforcing bars to a crawl test (Truck #80 in lane 6 and truck #67 in lane 5 headed north)

The response of the deck reinforcement to a crawl test in lane 5 is shown in Figure 2.20. As with previous instrumented members, the validity of superposition holds for the deck reinforcement. Therefore, tests in individual lanes can be added together to form the response of a test in multiple lanes. Figure 2.21 compares the response of the deck reinforcement during a crawl test to its response during a dynamic test. The figure clearly shows the dynamic amplification of stress caused by the increase in vehicle speed. The increase in the dynamic stress cycle was between 20% and 35% greater for the dynamic test.

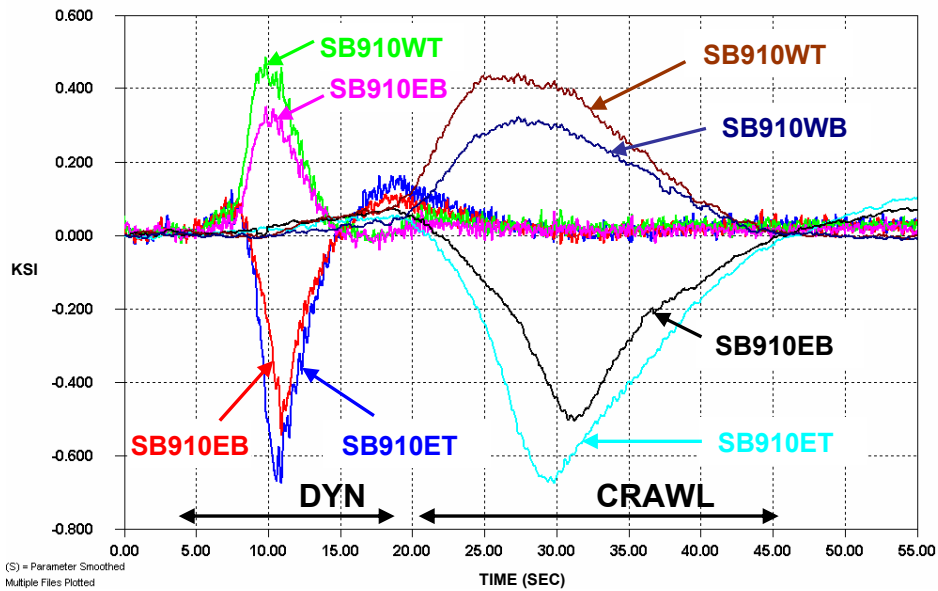
Figure 2.23: Typical dynamic vs. crawl data for sway bracing (Truck #80 headed north in lane 5 for both tests)

meaning there is a small bending component present. However, the responses are very similar in magnitude and axial compression or tension is the dominant behavior. The comparison between a crawl and a dynamic test in lane 5 is shown in Figure 2.23. In general, the dynamic stress cycle amplification was between 10% and 20% greater than the crawl test. All conclusions regarding the sway bracing between L9 and U10 are valid for the sway bracing between U24 and L25.

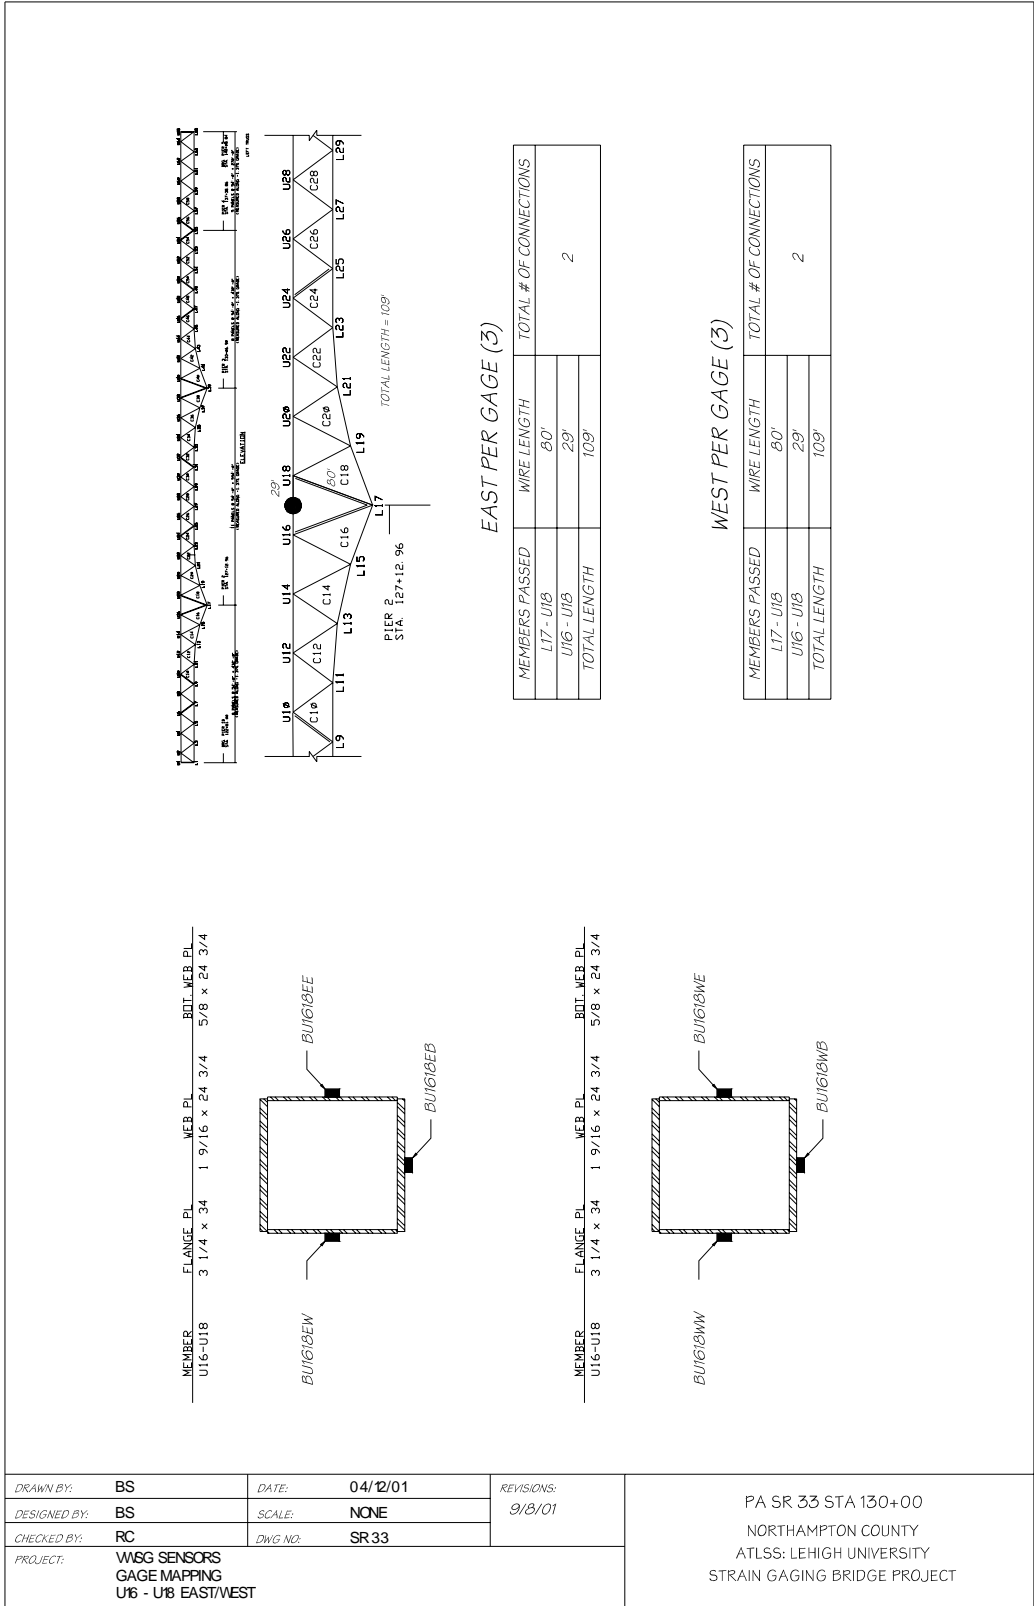
Figure 3.3: Strain gage layout on the upper chord between U16 and U18

The locations of all strain gages instrumented during the summer of 2001 are presented in Figure 3.3 through Figure 3.11 and summarized in Table 3.1. Each gage location is named according to the location in reference to the nodes of the truss and the type of structural member to which it is mounted. For example, the gage location BU1618EW indicates it is on a box member (B) located on the upper chord (U) between nodes 16 and 18 (1618) on the east truss of the bridge (E) and on the west side of the member (W). All other gages are named in a similar fashion.

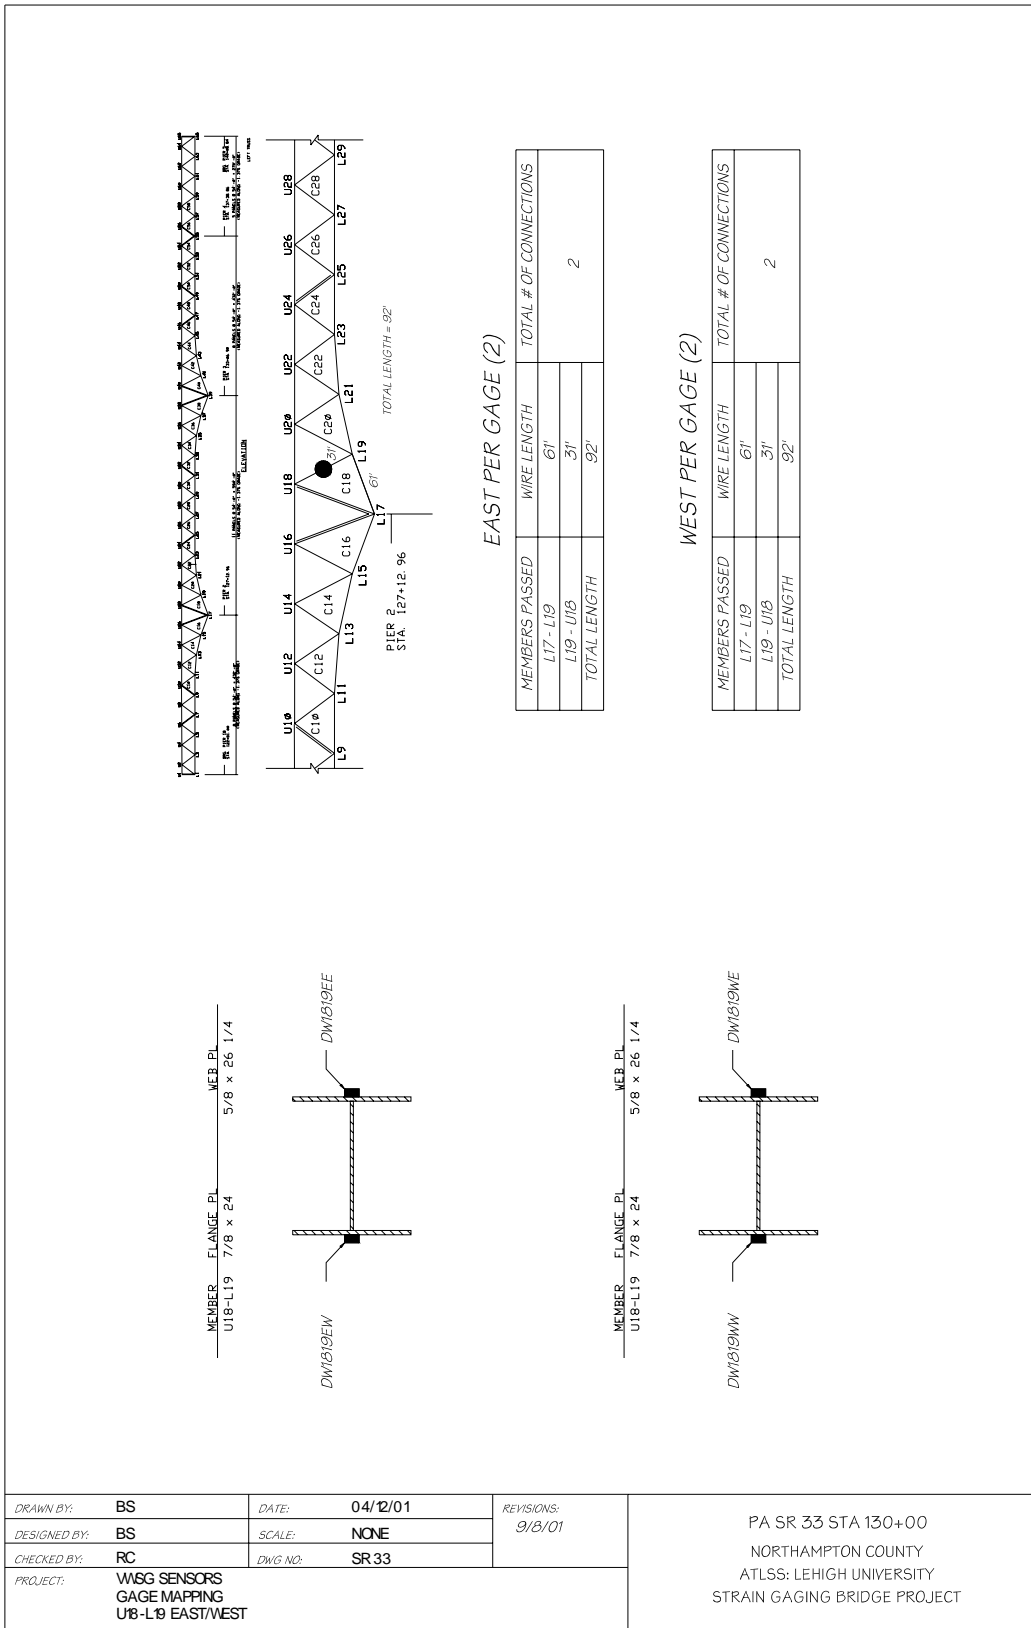
Figure 3.4: Strain gage layout on the diagonal between U18 and L19

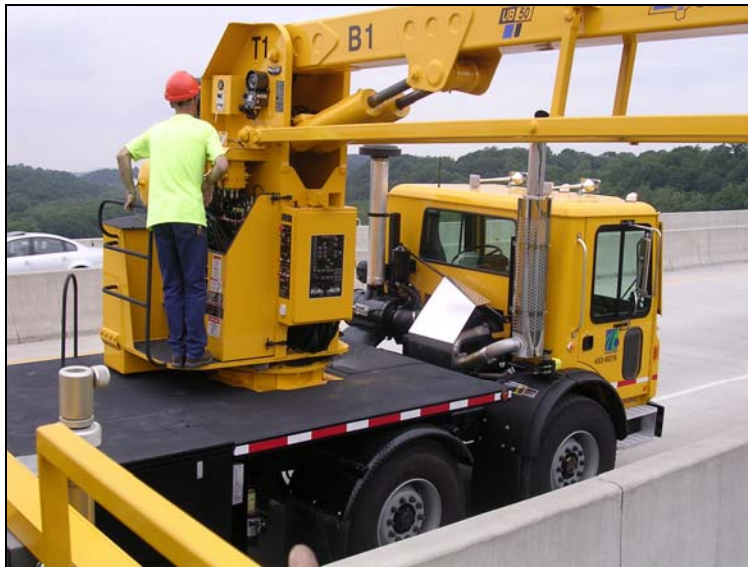
Figure 3.15: Aspen Aerial UB50 snooper used for instrumentation of bridge

An Aspen Aerial UB50 snooper with a 50' boom was used to install the additional sixteen gages. A photograph of the snooper is shown in Figure 3.15.

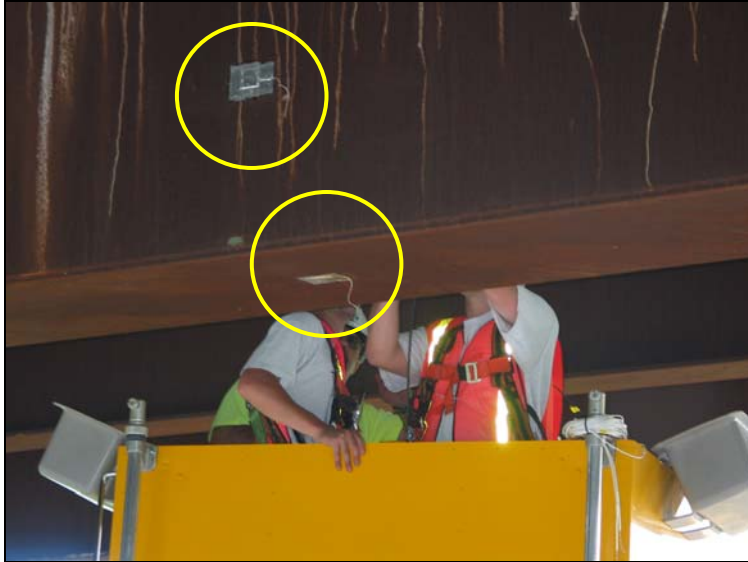
Figure 3.16: Instrumentation of the east upper chord (U26-U28 East)

The same spot weldable uniaxial resistance strain gages used during Phase I were selected. These were Measurements Group type LWK-06-W250B-350. As previously stated, these gages are fully temperature compensated. All gages installed on the two upper chords and five stringers between panel points U26 and U28 of the truss were instrumented in the same fashion as during Phase I for members of the same type. A total of three gages were placed on each upper chord, one on each side flange plate and one on the bottom web plate. A photograph of typical instrumentation installed on an upper chord location with gages circled in yellow is shown in Figure 3.16.

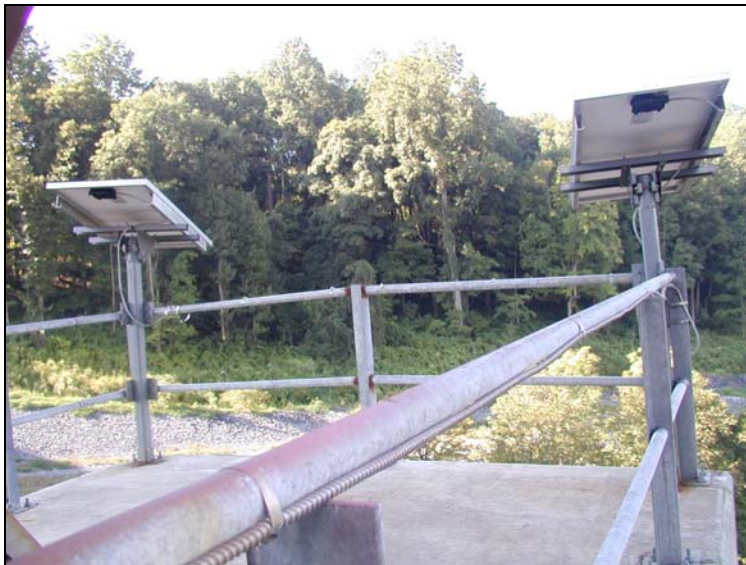
Figure 3.20: View of solar panels on pier 2 looking west

A second solar panel was installed on pier cap 2 in order to supply additional power during the daylight hours for uncontrolled live load testing. A picture of the solar panels is shown in Figure 3.20. In addition, a second weather-tight box was installed to house the CR9000 data logger for uncontrolled live load monitoring of traffic on the bridge. This unit is independent of the box housing the CR5000 long-term monitoring unit described in the previous section. A picture of the box and the CR9000 data logger is shown in Figure 3.21.

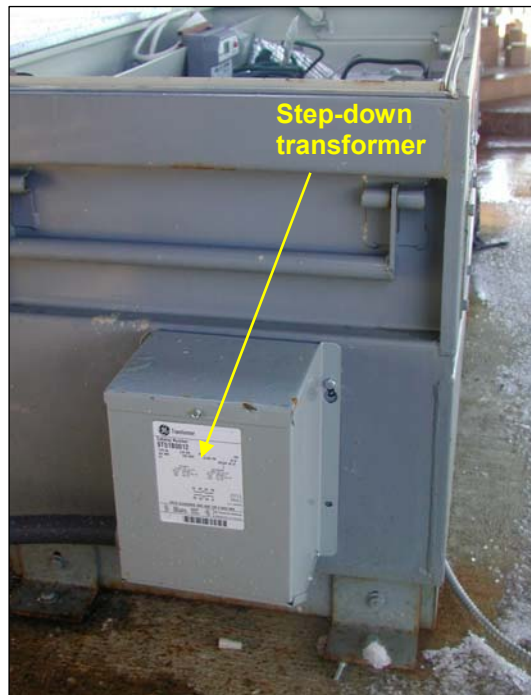
Figure 3.22: Step-down transformer mounted on east face of battery box

In order to enable the long-term monitoring system (CR9000) to run for extended periods of time, an additional power source was required to charge the batteries during the night (The approximate power draw of the CR9000 and all of the high-speed wireless communication devices is approximately 8.5 amps DC). The source of this power comes from a light pole mounted on the abutment wing wall near the southwest end of the bridge and was fully operational in early February, 2004. Power lines were run to the catwalk, through existing conduit above the catwalk, and down to the pier cap. A step-down transformer (240V/120V) was mounted on the east face of the box housing the 12-volt marine batteries. A picture of the step-down transformer is shown in Figure 3.22.

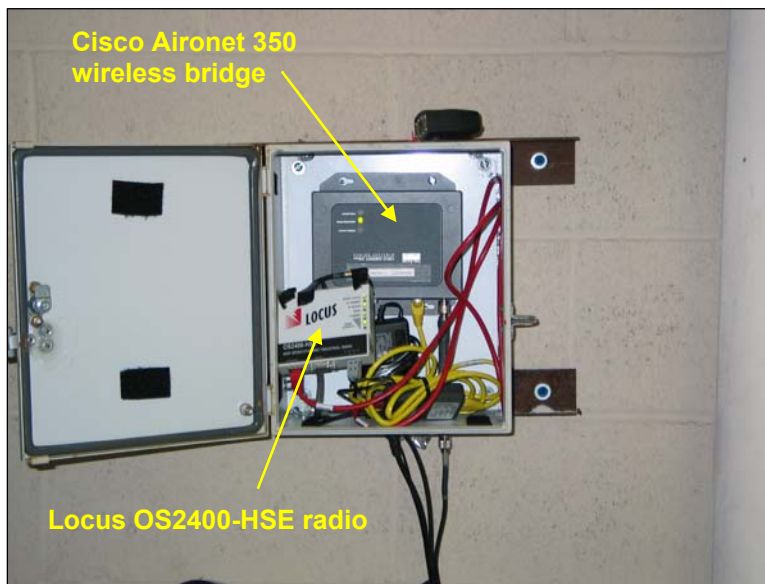
Figure 3.25: Wireless bridge and radio installed on roof of Martin Tower

A high-speed internet connection was initiated between the ATLSS Laboratory on Lehigh University's Mountaintop Campus and the Lehigh River Bridge. This internet connection was made possible through the use of high-speed wireless bridges and directional antennas. The horizontal distance from ATLSS to Martin Tower is approximately 2.75 miles as shown in Figure 3.24. Two (2) Cisco Aironet 350 Series wireless bridges were used to establish the connection from ATLSS to Martin Tower. A view of one of the Cisco wireless bridges installed on Martin Tower is shown in Figure 3.25. A 24 dBi directional parabolic grid antenna was mounted on the roof of ATLSS and directed towards a 14 dBi yagi directional antenna located on Martin Tower (see Figure 3.26). The distance between Martin Tower and the Lehigh River Bridge is approximately 6.07 miles (see Figure 3.24). It was difficult to establish a strong and robust connection between these two locations using the Cisco wireless bridges. Therefore, two (2) Locus OS2400-HSE High Speed Ethernet radios were utilized. One radio was installed on a catwalk landing leading down to pier 2 of the bridge and the other was located on top of Martin Tower (see Figure 3.25). Two (2) 24 dBi directional parabolic antennas were used to communicate between the bridge and Martin Tower. A photograph of the antenna installed on the roof top is shown in Figure 3.26. This connection made it possible to view the data in real time, retrieve data files wirelessly, and make any changes to the programs running the data loggers from the ATLSS Laboratory.

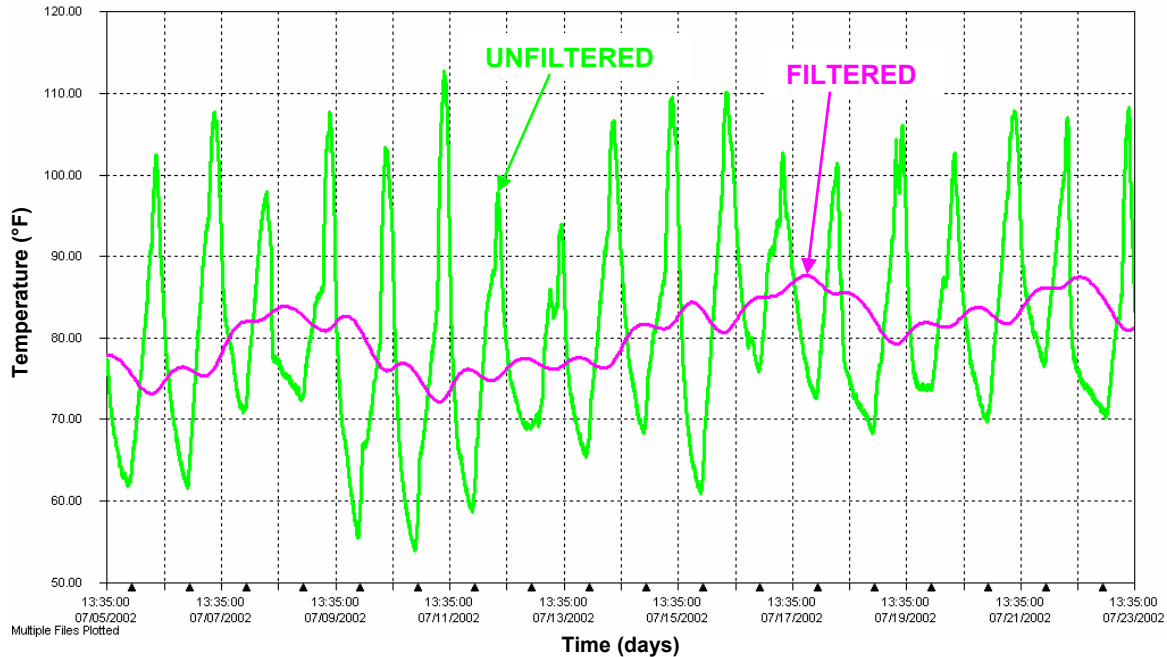
Figure 4.2: Close up view of a portion of unfiltered and filtered temperature data for west gage of U18-L19 West (TDW1819WW)

A Chebyshev filter is used to separate one band of frequencies from another (Smith, 1999). Essentially, it removes unwanted frequencies above or below a specified frequency. In this case, a low-pass filter was used to remove the unwanted high frequency inherent in the daily cycles (over the 38-month period, the daily cycles can be thought of as high frequency cycles). A comparison of the unfiltered raw temperature data to the filtered temperature data for the west gage of U18-L19 West can be seen in Figure 4.1 for a portion of the data collection period. A closer view of the filter eliminating the inherent daily cycles in the data can be seen in Figure 4.2 for the same gage. Filtering was performed on all of the long-term temperature and strain gages.
