# Report on Field Measurements and Uncontrolled Load Testing of the Lehigh River Bridge (SR-33)

**Report on Field Measurements and  
Uncontrolled Load Testing of the  
Lehigh River Bridge (SR-33)**

**Phase II**

**ATLSS Report No. 06-12**

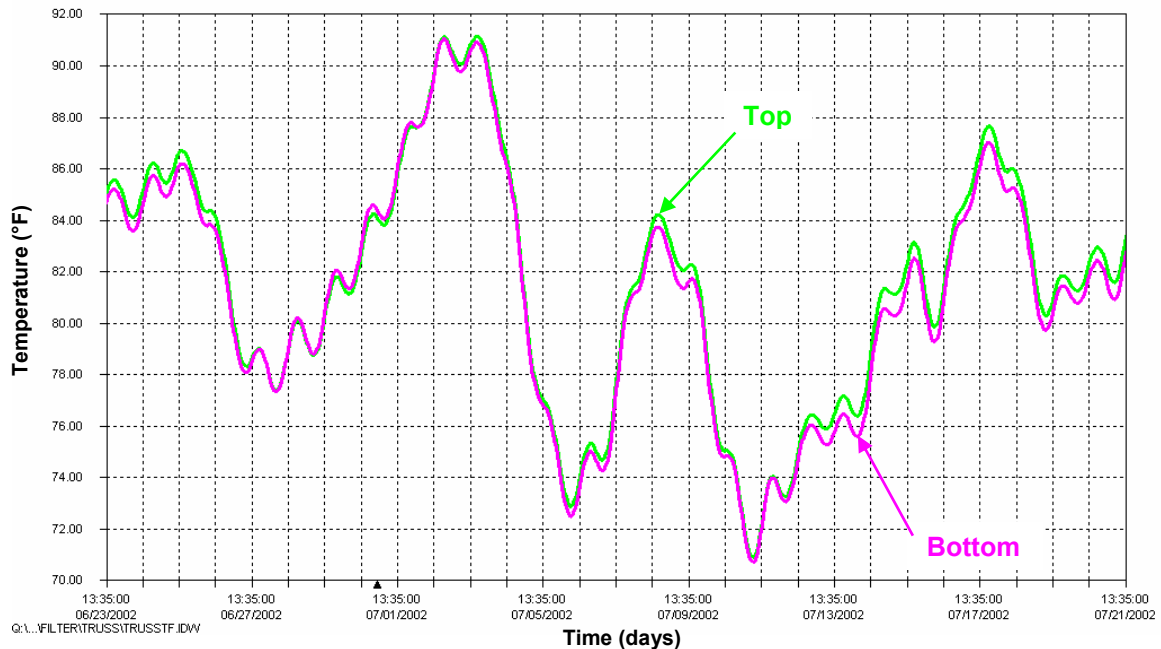
Figure 4.25: Portion of temperature response of both gages on the horizontal strut L9-L9

The responses of both the top and bottom gages of the horizontal strut L9-L9 are shown in Figure 4.25. The figure indicates that the top and bottom face of the member exhibit nearly the same temperature response. The top gage is slightly warmer at some points due to greater sunlight exposure, but overall the behavior is the same. The member L9-L9 (W14 x 61) is much smaller than the lower chord members previously discussed. The temperature distribution would be expected to remain more uniform in a smaller member such as L9-L9 than in a larger box section (i.e., L25-L27). This behavior was also verified for the west cross of sway brace L9-U10. It could not be shown for the east cross of sway brace L9-U10 or any sway bracing members at U24-L25 due to the number of temperature gages that are not functioning properly (see Table 4.11). Hence, accurate conclusions could not be made for these members. However, it is reasonable to assume the temperature behavior of the sway bracing at U24-L25 is comparable to the sway bracing at L9-U10.

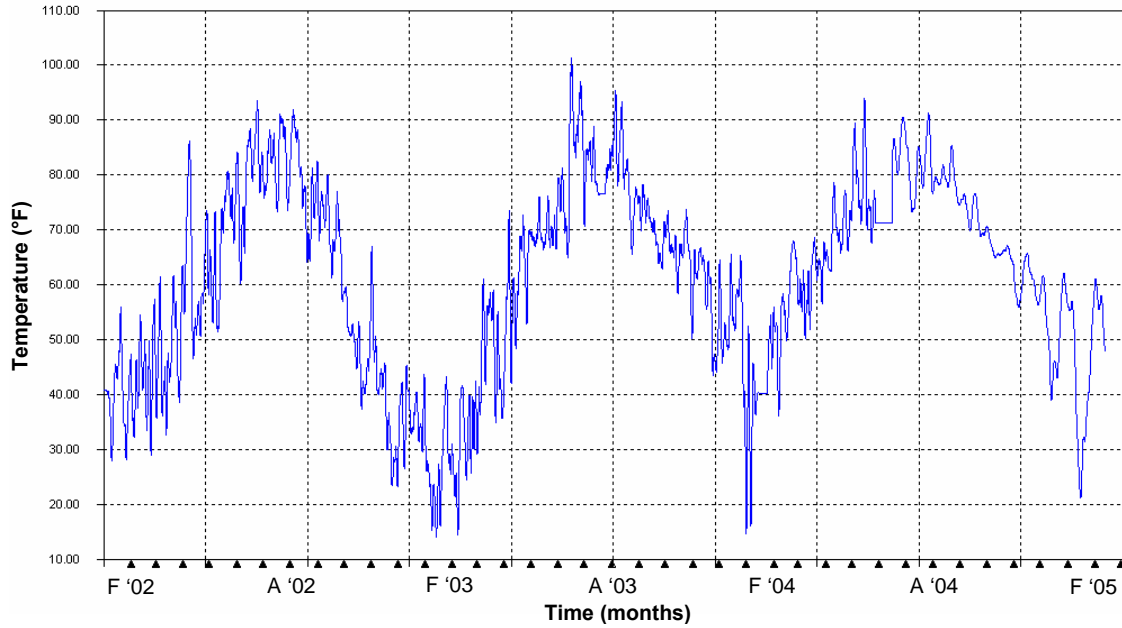
Figure 4.30: Temperature response of top gage of stringer 8 at midspan between U16 and U18 (TS8TCL)

The temperature response of a typical stringer gage is shown in Figure 4.30. Specifically, the top gage response of stringer 8 at midspan between U16 and U18 is plotted versus time. The gage behaves as anticipated with the member experiencing warmer temperatures in the summer and colder temperatures during the winter. Overall, the summer to summer temperature values and winter to winter readings are comparable. The rapid increase in temperature near June 20, 2003 is visible in Figure 4.30 and is typical of all functioning temperature gages on the stringers. This increase was also noticeable in almost all of the lower chords and all sway bracing members.
