# **Field Study of the SR 1045 Hares Hill Road Bridge over French Creek in Chester County, Pennsylvania**

## **Final Report**

**ATLSS Report No. 05-21**

**October 2005**

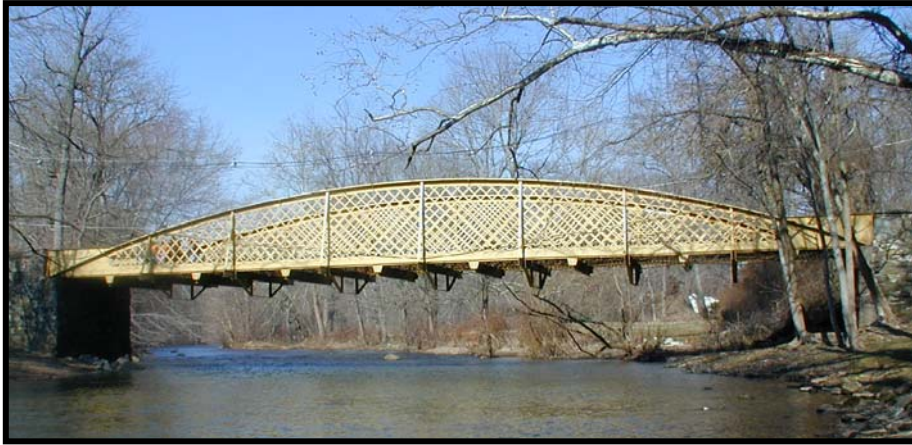
Figure 1.1 – Elevation view of the Hares Hill Road Bridge over French Creek  
(View looking west)

The Hares Hill Road Bridge is a single span wrought-iron tied arch with lattice infilling (truss members). It was built in 1869 in Chester County, Pennsylvania by Moseley Iron Bridge and Roof Company and it is the only known surviving example of its kind. The bridge crosses French Creek connecting Kimberton and Spring Cities. Figure 1.1 shows an elevation view of the bridge over French Creek.

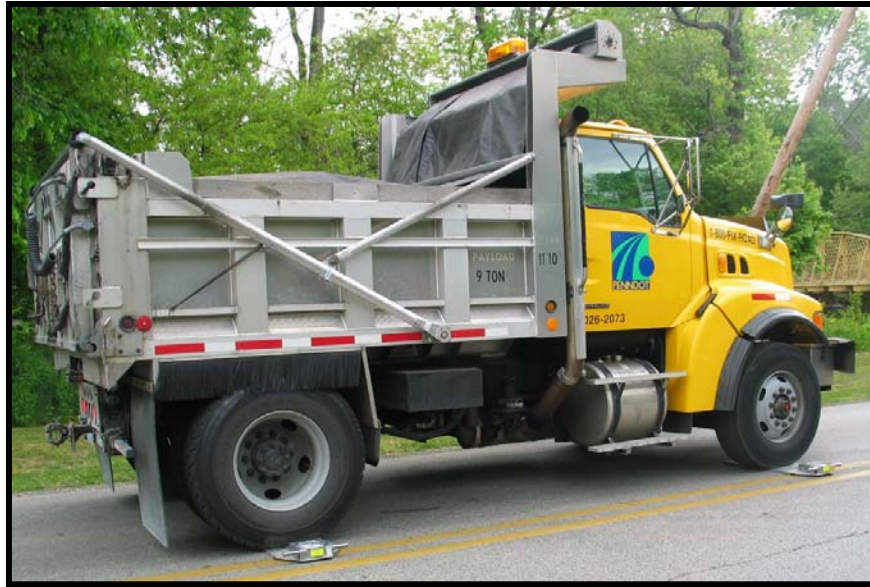
Figure 3.1 – The single axle truck (lighter truck) used in the controlled load testing

A series of controlled load tests were conducted using a single axle truck (lighter truck) and a tandem axle truck (heavier truck). Both test trucks were fully loaded with gravel. The gross vehicle weight (GVW) of the lighter truck and the heavier truck was 35,300 pounds and 51,450 pounds, respectively. Figure 3.1 shows the lighter truck, while Figure 3.2 shows the heavier truck. Also shown in the figures are the portable scales, which are under the tires, used to weigh the truck(s) axles on site. The geometry and the axle load data of the single axle truck are listed in Table 3.1 and Table 3.2, respectively. Similarly, the geometry and the axle load data of the tandem axle truck are listed in Table 3.3 and Table 3.4, respectively.

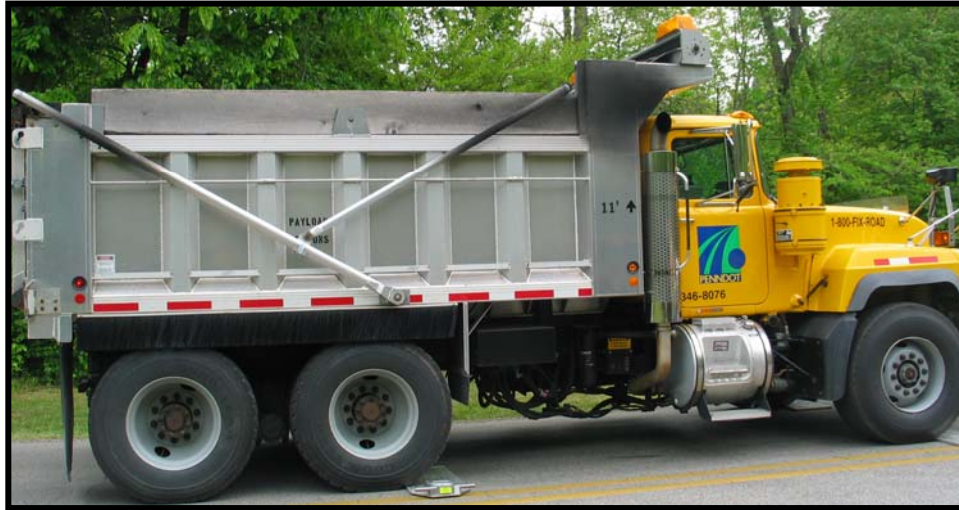
Figure 3-2 – The tandem axle truck (heavier truck) used in the controlled load testing

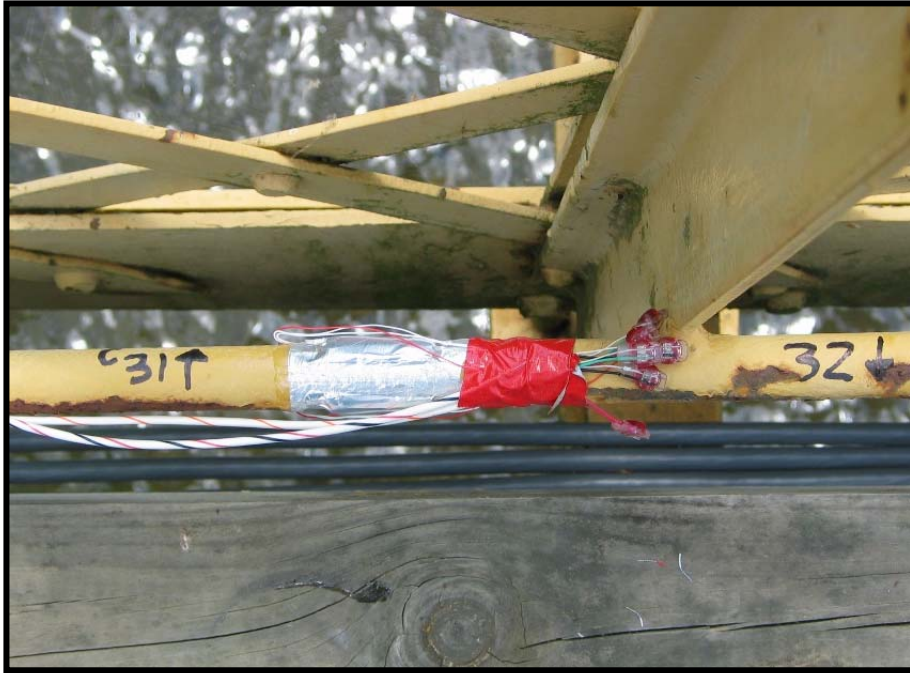
Figure 4.11 – CH\_31 and CH\_32 installed on the east and west faces, respectively, of the diagonal tension bar, which ties the east Z-Bar arch near floorbeam 2 to the bottom end of the vertical T-shape member at floorbeam 8. The gages were installed at a diagonal distance of approximately 11'-6" away from the end of the bar at floorbeam 8.

Two strain gages were installed on the east diagonal tension bar, which ties the east Z-Bar arch near floorbeam 2 to the bottom end of the vertical T-shape member at floorbeam 8. Channel CH\_31 was installed on the east face of the bar, while CH\_32 was installed on the west face. The gages were installed at a diagonal distance of approximately 11'-6" away from the end of the bar at floorbeam 8. As shown in Figure 4.11, two gages were installed back-to-back on the rod to measure both the in-plane axial stresses and any the out-of-plane bending stresses that might exist.

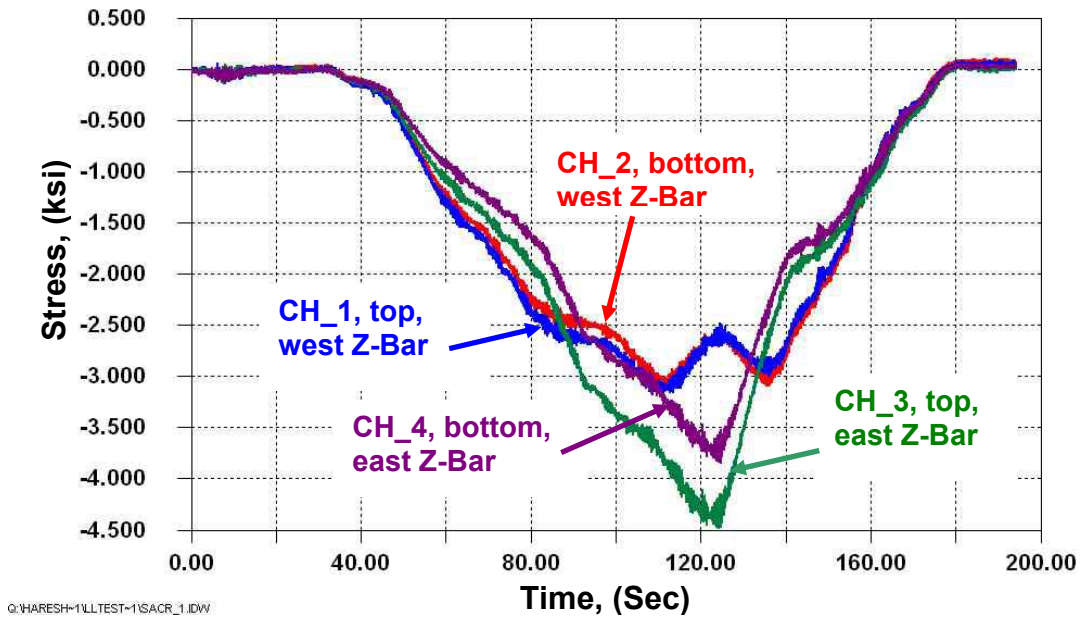
Figure 5.1 – Response of CH\_1 and CH\_2 installed on the top and bottom face, respectively, of the west Z-Bar on the east side of the bridge, and CH\_3 and CH\_4 installed on the top and bottom face, respectively, of the east Z-Bar on the east side of the bridge, as the single axle test truck passed over the bridge in the crawl test (SACR\_1) (All four channels were installed inch from the edge of the bar and approximately 3 inches south of floorbeam 8)

In general, the bridge responded as a beam such that the arch and the tie plates could be considered as the top and bottom flange of a beam, respectively, and the lattice infilling could be considered as the web of the beam. The analogy is made based on the out-of-plane bending behavior of the lattice infilling (Section 5.7) and the in-plane bending behavior, along with axial tension, of the lower and strengthening tie plates. The bridge also responded as a tied arch. Compressive stresses were measured in the steel arch members as the test truck(s) crossed over the bridge. Figure 5.1 presents the response of CH\_1 and CH\_2 installed on the top and bottom face, respectively, of the west Z-Bar on the east side of the bridge, and CH\_3 and CH\_4 installed on the top and bottom face, respectively, of the east Z-Bar on the east side of the bridge, as the single axle test truck passed over the bridge in the crawl test (SACR\_1). All four channels were installed 1 inch from the south end of the bar and approximately 3 inches south of floorbeam 8.

As seen in the figure, the response in CH\_1 and CH\_2 is almost identical, indicating that the stresses are in-plane (i.e. no vertical out-of-plane bending in the west Z-Bar member located on the east side of the bridge). It is important to mention that in all controlled tests, equal stresses were observed for CH\_1 and CH\_2 installed on the top and bottom face of the west Z-Bar located on the east side of the bridge. Similarly, equal stresses were observed for CH\_24 and CH\_25 installed on the top and bottom face on the east Z-Bar located on the west side of the bridge. Larger stresses were, however, measured in CH\_3 and CH\_4 installed on the top and bottom face of the east Z-Bar located on the east side of the bridge. In fact, the response of CH\_3 and CH\_4 was always higher than that of CH\_1, CH\_2, CH\_24, and CH\_25 in any of the controlled load tests suggesting lateral bending of the east arch under live load. Although the west arch on the west side of the bridge was not instrumented, lateral bending of the west arch may also be expected as a result of symmetry.

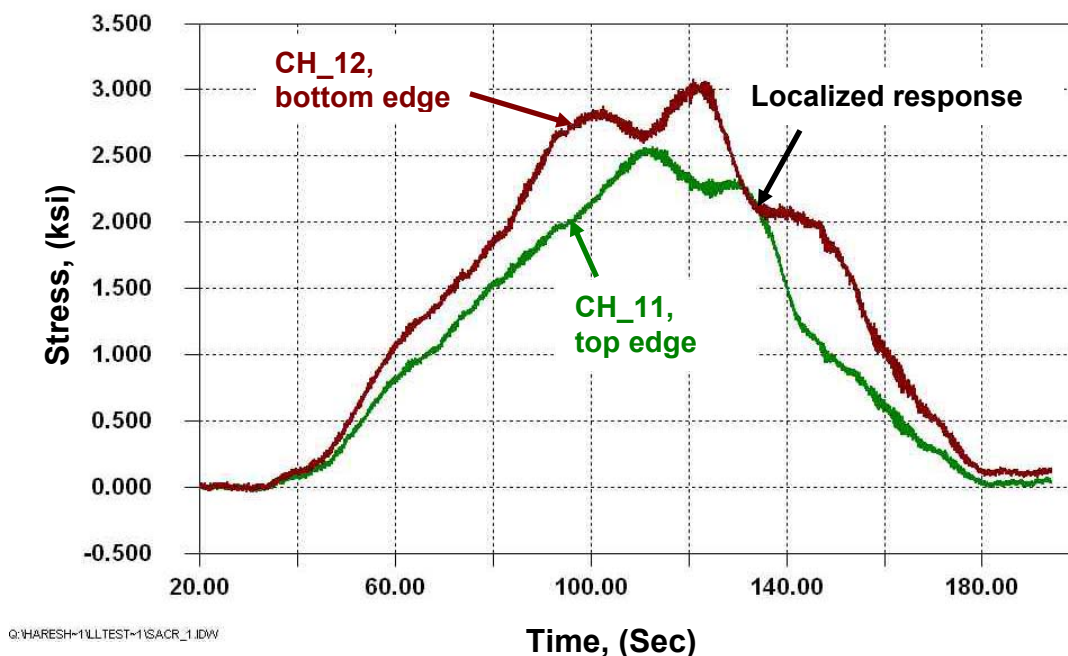
Figure 5.2 – Response of CH\_11 and CH\_12 installed on the top and bottom edges, respectively, of the lower tie plate on the east side of the bridge, as the single axle test truck passed over the bridge in the crawl test (SACR\_1).

Figure 5.2 shows the response of CH\_11 and CH\_12 installed on the top and bottom edge, respectively, of the lower tie plate on the east side of the bridge, as the single axle test truck passed over the bridge in the crawl test (SACR\_1). As shown in the figure and as expected, tensile stresses are present in both the top and bottom edges of the tie plate. The difference in the magnitude of the measured stresses in both channels is believed to be due to bending stresses in the tie plates (tensile bending stresses in the bottom edge and compressive bending stresses in the top edge), which are superimposed onto the axial tensile stresses resulting in the total final stresses shown in Figure 5.2. The bending stresses in the tie plates is most likely the result of a global bending in the plate due to crossing of the truck(s). The localized response shown in the figure is believed to be the point at which only axial stresses are present in the lower tie plate at the instrumented location (i.e. no bending stress component).

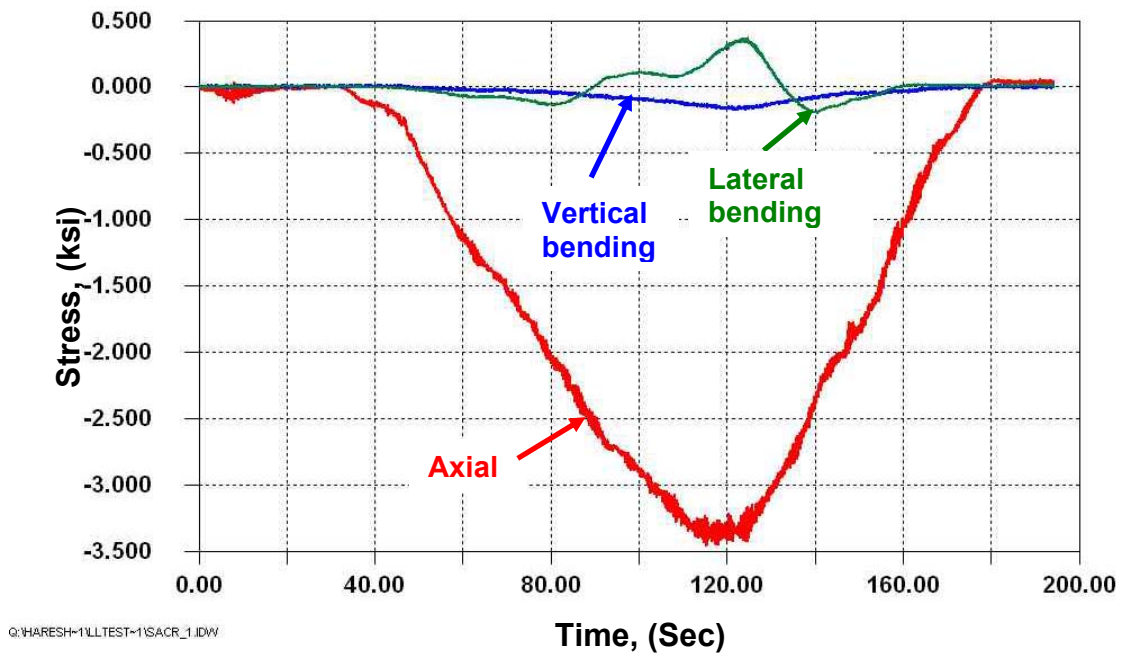
Figure 5.4 – Axial, vertical, and lateral stresses in the east arch as the single axle test truck passed over the bridge in the crawl test (SACR\_1).

As previously mentioned in Section 5.1, the response of CH\_3 and CH\_4 was always higher than that of CH\_1 and CH\_2, suggesting that lateral bending stresses are present in the east arch and therefore, could also be assumed to be present in the west arch due to symmetry. To understand the response of the east arch, rather than the response of individual Z-Bars, to moving load, the response of channels CH\_1 through CH\_4 shown in Figure 5.1 was resolved into axial stress component, vertical bending stress component, and lateral bending stress component acting on the east arch as shown in Figure 5.4. As shown in the figure, the response of the east arch to moving load is primarily axial compressive stresses. The arch experiences lateral bending as previously suggested. It is however unclear as to why the lateral bending stress changes its sign as the test truck crossed over the bridge. The figure also shows that the east arch experiences small magnitude of compressive vertical bending stresses.

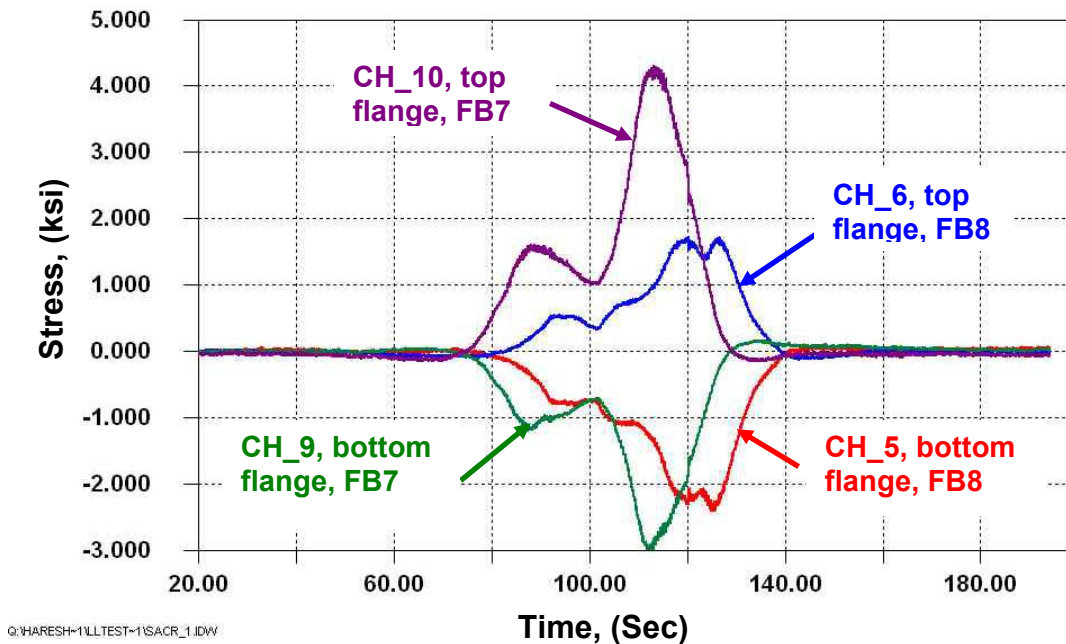
Figure 5.5 – Response of CH\_5 and CH\_6 installed on the bottom and top flange of floorbeam 8, respectively, and CH\_9 and CH\_10 installed on the bottom and top flange, respectively, of floorbeam 7 as the single axle test truck passed over the bridge in the crawl test (SACR\_1).

A typical response of the strain gages installed on the top and bottom flanges of floorbeam 7 and floorbeam 8 during the controlled load testing is shown in Figure 5.5. Channels CH\_5 and CH\_6 were installed on the bottom and top flange, respectively, of floorbeam 8 and CH\_9 and CH\_10 were installed on the bottom and top flange, respectively, of floorbeam 7. All four channels were installed at mid span of the floorbeams. As shown in the figure, tensile stresses were measured in the bottom flanges and compressive stresses were measured in the top flanges. The response of the strain gages installed on floorbeam 7 (added to the bridge) is higher than that installed on floorbeam 8 (existing floorbeam). A summary of the maximum and minimum stress values from the strain gages installed on the top and bottom flange of floorbeam 7 and floorbeam 8 in the crawl tests is presented in Table 5.2. It is clear from the table that altering the transverse position of the single axle test truck in the controlled crawl tests had very minimal effect on the magnitude of the measured stresses at a given strain gage (i.e. the response in CH\_1 is almost identical in all crawl tests regardless of the transverse position on the test truck). The table also shows that the stresses in the bottom and top flanges of floorbeam 8 are lower than that of floorbeam 7, suggesting that the vertical and diagonal queen posts of floorbeam 8 help in strengthening the floorbeam and participate in carrying of the vertical load imposed on the floorbeam.

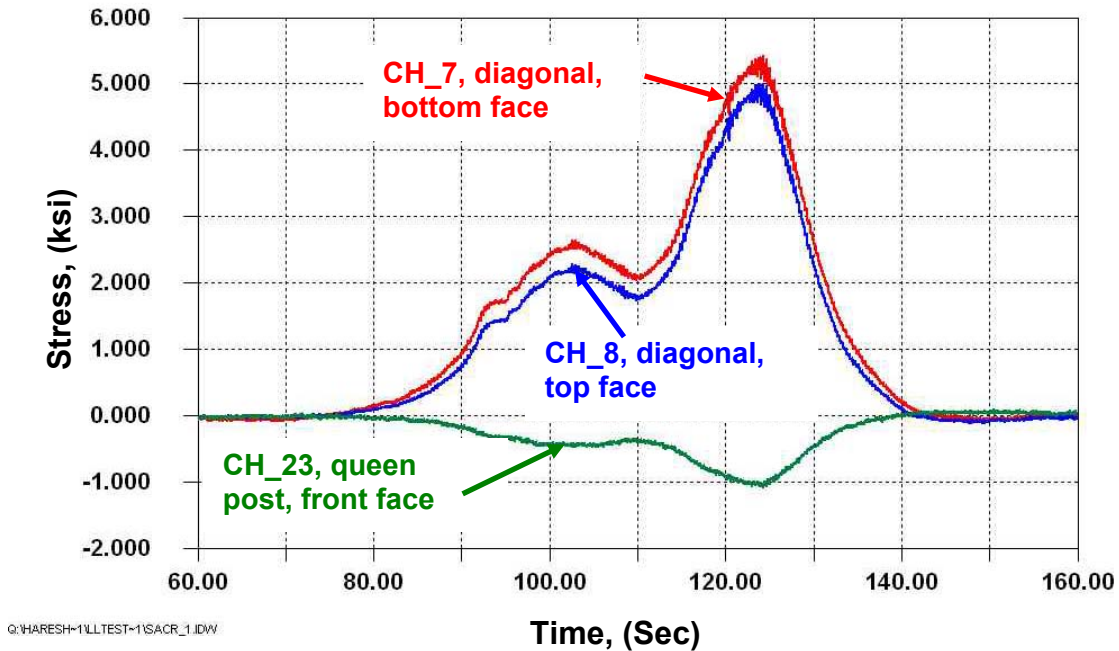
Figure 5.6 – Response of CH\_7 and CH\_8 installed on the bottom and top face of the diagonal member attached to floorbeam 8 and the response of CH\_23 installed on the front face of the queen post member attached to floorbeam 8 as the single axle test truck passed over the bridge in the crawl test (SACR\_1).

Channels CH\_7 and CH\_8 were installed on the bottom face and top face, respectively, of the diagonal strut attached to the bottom flange of floorbeam 8. The strain gages were installed back-to-back to measure any out-of-plane bending in the diagonal member. Tensile stresses of approximately equal magnitude were measured in both channels in the controlled load tests indicating that a very small out-of-plane bending was present in the diagonal strut. Figure 5.6 shows a typical response of CH\_7 and CH\_8 during the controlled load test (SACR\_1).

The response of the vertical strut to moving load is also shown in Figure 5.6. Channel CH\_23 was installed on the front face of the vertical strut attached to the bottom flange of floorbeam 8. Compressive stresses were measured in the vertical member during all tests. Table 5.3 lists a summary of the maximum and minimum stress values experienced by the channels installed on the diagonal and vertical strut of the queen post during the crawl tests. As the table indicates, the response in both the diagonal and vertical strut of the queen post was consistent in all crawl tests, indicating that changing the truck position in the crawl tests had a minimal effect on the response in the instrumented struts.

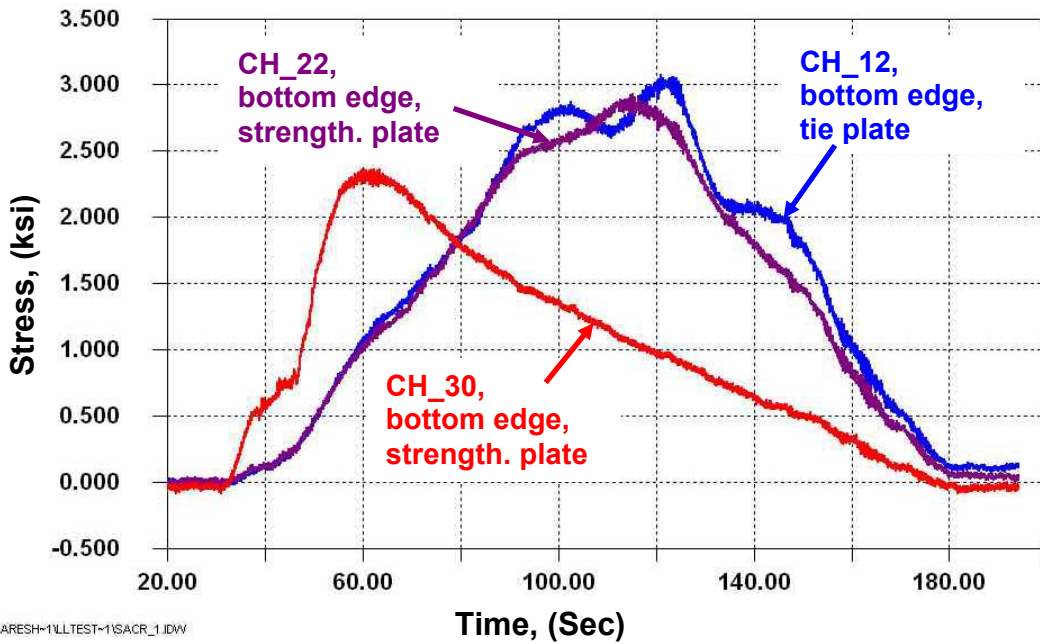
Figure 5.7 – Response of CH\_12 and CH\_22 installed on the bottom edge of the lower tie plate and the bottom edge of the strengthening plate, respectively, at mid distance between floorbeam 7 and floorbeam 8. Also shown is the response of CH\_30 installed on the bottom edge of the lower strengthening plate near the end of the bridge span. The response shown in the figure was during the crossing of the single axle test truck in the crawl test (SACR\_1).

Tensile stresses were measured in the top and bottom edges of the instrumented lower tie plate and strengthening plate, on the east side of the bridge. As shown in Figure 5.7 and in Table 5.4, equal stress values were measured in CH\_12 and CH\_22 installed on the bottom edges of the tie plate and the strengthening plate, respectively. The response of CH\_11 installed on the top edge of the tie plate was approximately 13%, on average, higher than that of CH\_21 installed on the top edge of the strengthening plate. It is practical to say that equal response was also observed in CH\_11 and CH\_21 installed on the top edge of the plates. However, it is important to point out that the measured stresses in the plates are due to the axial stress component resulting from the tie plates restraining the horizontal forces at the end of the arch and the bending component resulting from global bending of the plates as the truck (s) crossed over the bridge.

The measured stress value in CH\_30, installed on the bottom edge of the strengthening plate approximately 5'-4 1/2" from the south end of the strengthening plate, is lower than that measured in CH\_12 and CH\_22 (close to mid span). As mentioned previously, the total stresses in the tie plate and the strengthening plate is a result of superimposing the tensile bending stresses onto the tensile axial stresses. The lower measured value of stress in CH\_30 is believed to be due to the fact that bending tensile stresses in the plates is lower near the end of the span (i.e. end of the plate) than at mid span, resulting in total measured stresses being lower in CH\_30 than CH\_12 or CH\_22. Table 5.4 lists a summary of the maximum and minimum stress values experienced by the channels installed on the lower tie plate and the strengthening plate.

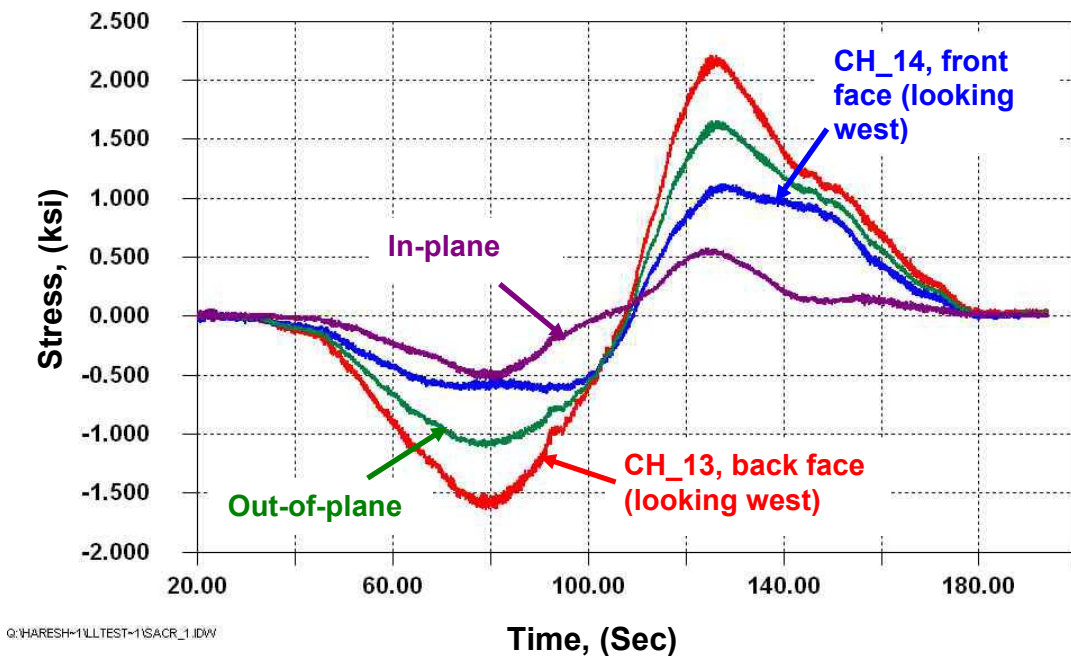
Figure 5.8 – Response of CH\_13 and CH\_14 installed on the front face and back face (looking west), respectively, of the lattice member located near mid span as the single axle test truck passed over the bridge in the crawl test (SACR\_1).

As previously mentioned, two channels (CH\_13 and CH\_14) were installed back-to-back on a lattice located near mid span to measure the response of a typical lattice member to moving load. The response of the instrumented lattice member is shown in Figure 5.8. The figure shows that the response in CH\_14 installed on the front face of the member (looking west) is higher than the response in CH\_13 installed on the back face of the member (looking west). Such observation is an indication of the existence of in-plane axial stresses as well as out-of-plane bending stresses in the instrumented lattice member. The out-of-plane bending stress in the instrumented lattice member suggests that the response of the bridge is similar to that of a beam such that the arch and the tie plates could be considered as the top and bottom flange of the beam, respectively, and the lattice infilling could be considered as the web of the beam. The in-plane and out-of-plane stresses in the member during the crawl test (SACR\_1) were calculated and graphed along with the measured stresses as shown in Figure 5.8. A summary of the maximum and minimum stress values experienced by CH\_13 and CH\_14, installed back-to-back on the front and back face (looking west) of a lattice member located near mid span, in the crawl tests is presented in Table 5.5.

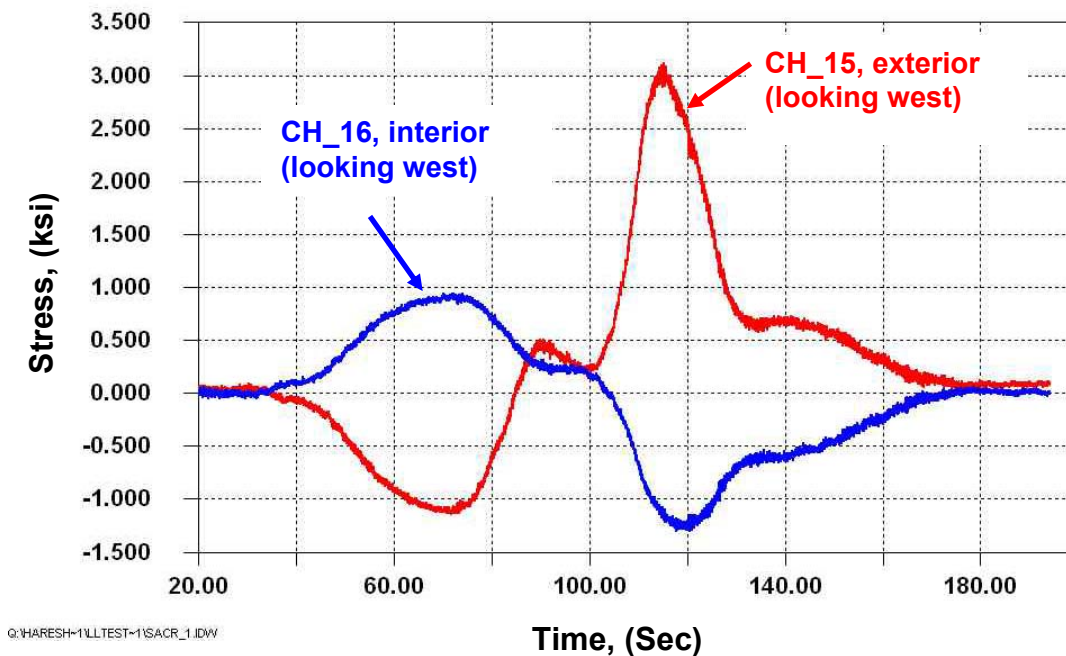
Figure 5.9 – Response of CH\_15 and CH\_16 installed on the front face and back face (looking west), respectively, of the connection plate used for connecting floorbeam 7 to the lower tie plate, as the single axle test truck passed over the bridge in the crawl test (SACR\_1).

Two channels, CH\_15 and CH\_16, were installed back-to-back on the exterior and interior face (looking west), respectively, of the connection plate used for connecting the lower tie plate to floorbeam 7. The response of the channels to moving load during the crawl test SACR\_1 is shown in Figure 5.9. As can be seen in the figure, opposite sign of stresses were observed in the channels (i.e. for a given truck location on the bridge, the stresses are positive in one channel and negative in the other). A summary of the maximum and minimum stress values experienced by CH\_15 and CH\_16, installed back-to-back on the front and back face of the connection plate connecting the lower tie plate to floorbeam 7, in the crawl tests is presented in Table 5.6. As shown in the table, the positive response in CH\_15 is significantly higher than that of CH\_16 in all crawl tests. However, the negative response in CH\_16 was always higher than that of CH\_15 in the same crawl test. Such behavior can not be explained due to the complexity of the system. Understanding the complex behavior of the connection plate detail requires either additional installation of instrumentation at the detail or the development of a detailed finite element model to capture the local response of the detail.

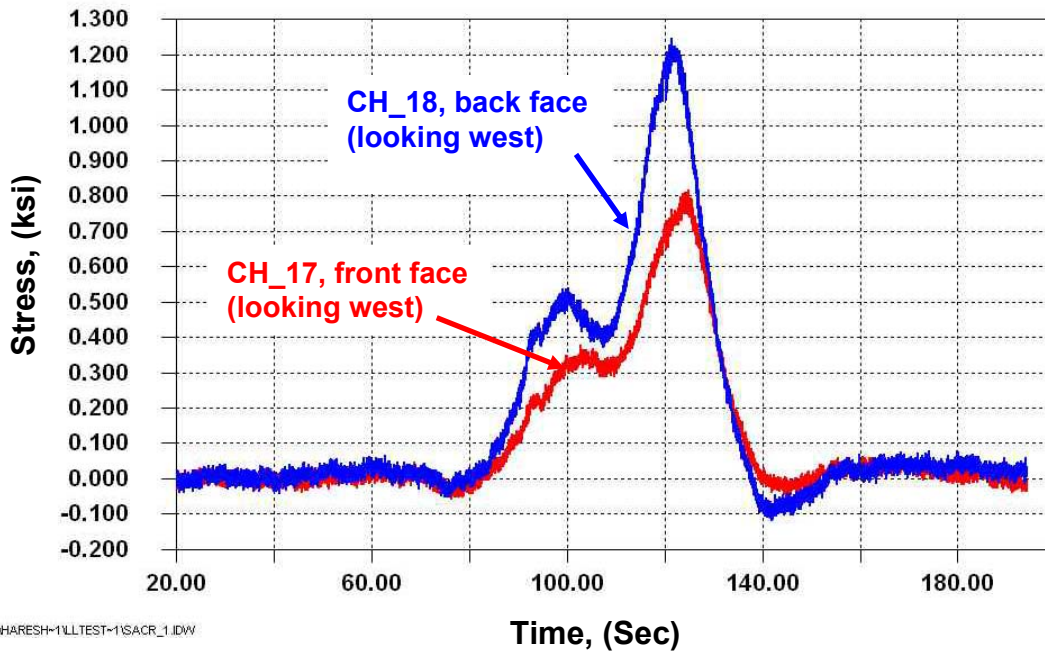
Figure 5.10 – Response of CH\_17 and CH\_18 installed on the front face and back face (looking west), respectively, of the connection rod used for connection floorbeam 8 to the lower tie plate, as the single axle test truck passed over the bridge in the crawl test (SACR\_1).

Channels CH\_17, CH\_18, CH\_19, and CH\_20 were installed on the two connection rods attaching the lower tie plate to floorbeam 8. Channel CH\_17 was installed on the connection rod south of the web of floorbeam 8 and CH\_18 was installed on the same rod directly behind CH\_17. Similarly, Channel CH\_19 was installed on the connection rod north of the web of floorbeam 8 and CH\_20 was installed directly behind CH\_19. As shown in Figure 5.10, positive stresses were measured in CH\_17 and CH\_18 installed back-to-back on the rod located south of the web of floorbeam 8. The response in CH\_18 is higher than that of CH\_17 indicating the existence of out-of-plane bending stresses in the rod. Similar behavior was observed in the rod instrumented north of the web of floorbeam 8. A summary of the maximum and minimum stress values experienced by CH\_17, CH\_18, CH\_19, and CH\_20 installed back-to-back on the front and back face of the connection rod located south and north of the web of floorbeam 8 in the crawl tests is presented in Table 5.7.

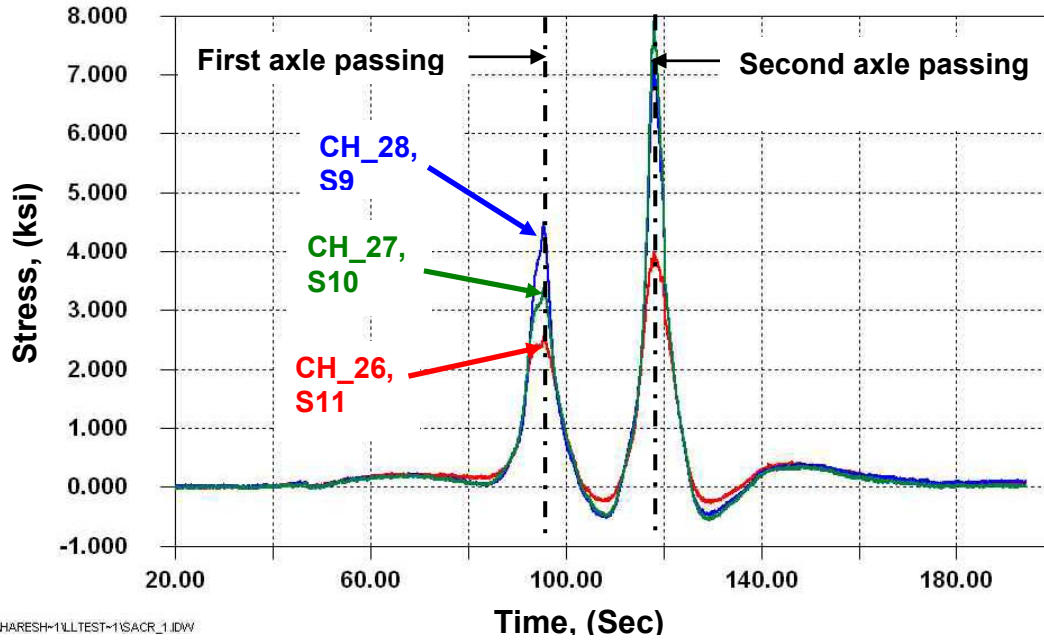
Figure 5.11 – Response of CH\_26, CH\_27, and CH\_28 installed on the bottom face of the bottom flange at centerline of the flange of stringers S11, S10, and S9, respectively, at mid distance between floorbeam 7 and floorbeam 8 as the single axle test truck passed over the bridge in the crawl test (SACR\_1).

As previously mentioned, CH\_26, CH\_27, and CH\_28 were installed on the bottom face of the bottom flange at centerline of the flange on stringers S11, S10, and S9, respectively, at mid distance between floorbeam 7 and floorbeam 8. The response of the channels to moving load in the controlled crawl test (SACR\_1) can be seen in Figure 5.11. As shown in the figure, positive stresses were in the bottom flange in all three channels. Also shown in the figure, is the peak response caused by the front axle of the single test truck being located directly over the channels. In such case, the response was higher in CH\_28 followed by CH\_27 and finally CH\_26. When the rear axle was located directly over the channels, the stresses were higher in CH\_27 followed by CH\_28 and finally CH\_26. It is unclear as to why the stresses were highest in CH\_28 as the front axle was directly located over the channel, while it was highest in CH\_27 when the rear axle was directly located over the channel. It is possible that such behavior is due to slight change in the transverse position of the truck as it was crossing the bridge.

In general, the response of the channels installed on the bottom flange of the stringers was very sensitive to the transverse location of the test truck(s) in the crawl tests. The sensitivity of the instrumented locations to the transverse position of the testing truck is shown in Table 5.8. The table shows that the response of CH\_26 to the passage of the single axle truck (lighter truck) during the crawl test (SACR\_5) is almost two times higher than the response of the same channel to the passage of the tandem axle truck (heavier truck) during the crawl test (TACR\_1). It is important to mention that with the exception of the channels installed on the bottom flange of the stringers, the response of any given channel to the passage of the tandem axle truck in the crawl test (TACR\_1) was higher than the response during the passage of the single axle truck in the seven crawl tests (SACR\_1 through SACR\_7). A summary of the maximum and minimum stress values experienced by CH\_26, CH\_27, and CH\_28 installed on the bottom face of the bottom flange of stringers S11, S10, and S9, respectively, in the crawl tests is presented in Table 5.8.

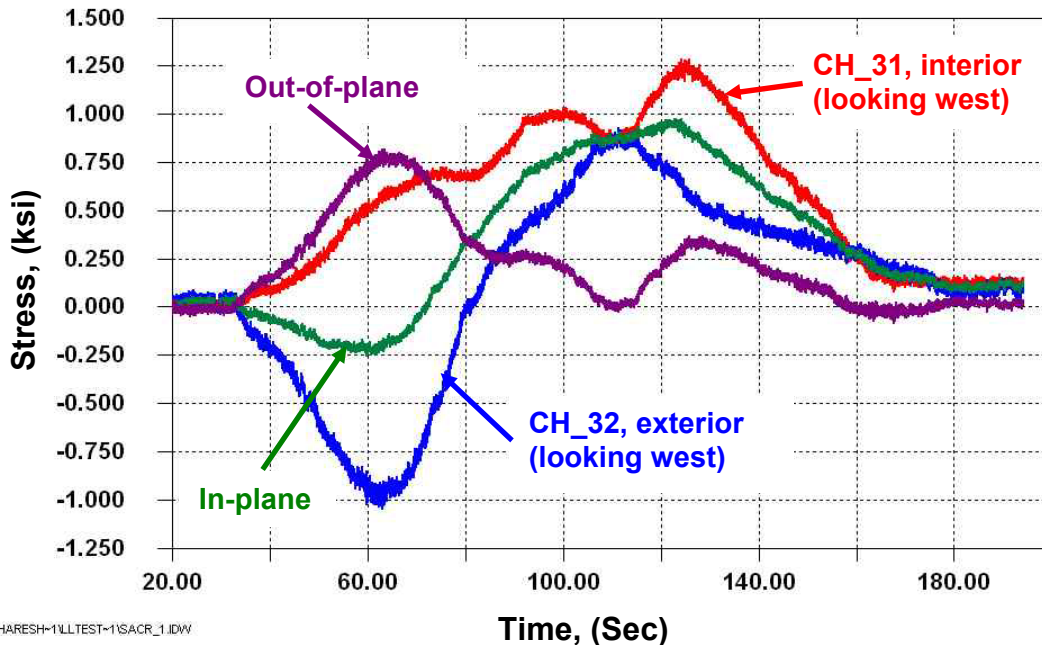
Figure 5.12 – Response of CH\_31 and CH\_32 installed on the east and west face, respectively, of the east diagonal tension bar at a diagonal distance of approximately 11'-6" away from the end of the bar at floorbeam 8 as the single axle test truck passed over the bridge in the crawl test (SACR\_1).

Channel CH\_31 was installed on the east face of the bar, while CH\_32 was installed on the west face. The gages were installed on the east diagonal tension bar at a diagonal distance of approximately 11'-6" away from the end of the bar at floorbeam 8. The bar ties the east arch Z-Bar near floorbeam 2 to the bottom end of the vertical T-shape member at floorbeam 8. The response of the two gages during the controlled load test (SACR\_1) is shown in Figure 5.12. The response of CH\_31 is shown to be positive during the entire time of the crawl test (SACR\_1), while the response of CH\_32 is shown to be negative for approximately 50 seconds of the test followed by positive response during the remainder of the test. As shown in the figure, during the first 50 seconds of the test, out-of-plane bending of the rod was the dominate behavior. After which, the behavior of the rod was mainly axial tension. A summary of the maximum and minimum stress values experienced by CH\_31 and CH\_32 installed on the east and west face, respectively, of the east diagonal tension bar at a diagonal distance of approximately 11'-6" away from the end of the bar at floorbeam 8 is presented in Table 5.9.

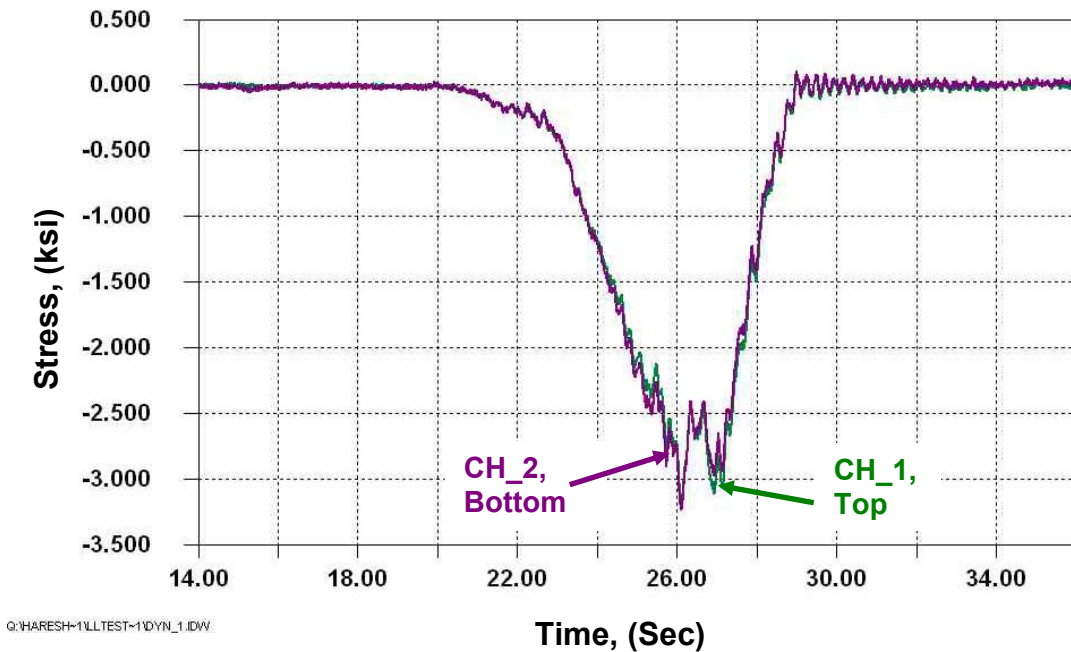
Figure 5.13 – Response of CH\_1 and CH\_2 installed on the top and bottom face, respectively, of the west Z-Bar on the east side of the bridge, 1 inch from the edge of the bar and approximately 3 inches south of floorbeam 8, as the single axle test truck passed over the bridge in the dynamic test (DYN\_1)

To gain a feel for the magnitude of dynamic amplification of stresses in the bridge, two dynamic load tests were conducted with the single axle test truck traveling north in the first test at a speed of approximately 15 mph and traveling south in the second test at a speed of 17 mph. Figure 5.13 contains a stress time-history for the east Z-Bar located on the east side of the bridge, during a dynamic test with the single axle test truck traveling north with a speed of 15 mph. This figure can be compared with Figure 5.1 above, which shows a similar stress history for the crawl test (SACR\_1). Also comparing both figures shows that more vibration was introduced in the east Z-Bar on the east side of the bridge during the dynamic test.

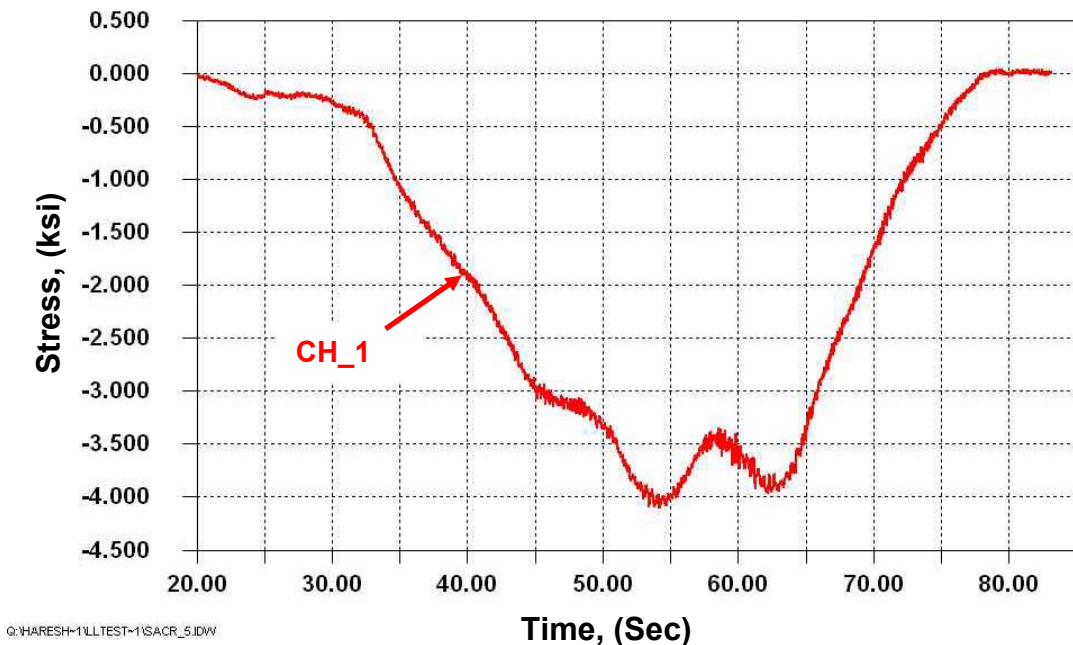
Figure 6.1 – Response of CH\_1 installed on the top face of the west Z-Bar on the east side of the bridge, 1 inch from the edge of the bar and approximately 3 inches south of floorbeam 8, as the single axle test truck passed over the bridge in the crawl test (SACR\_5)

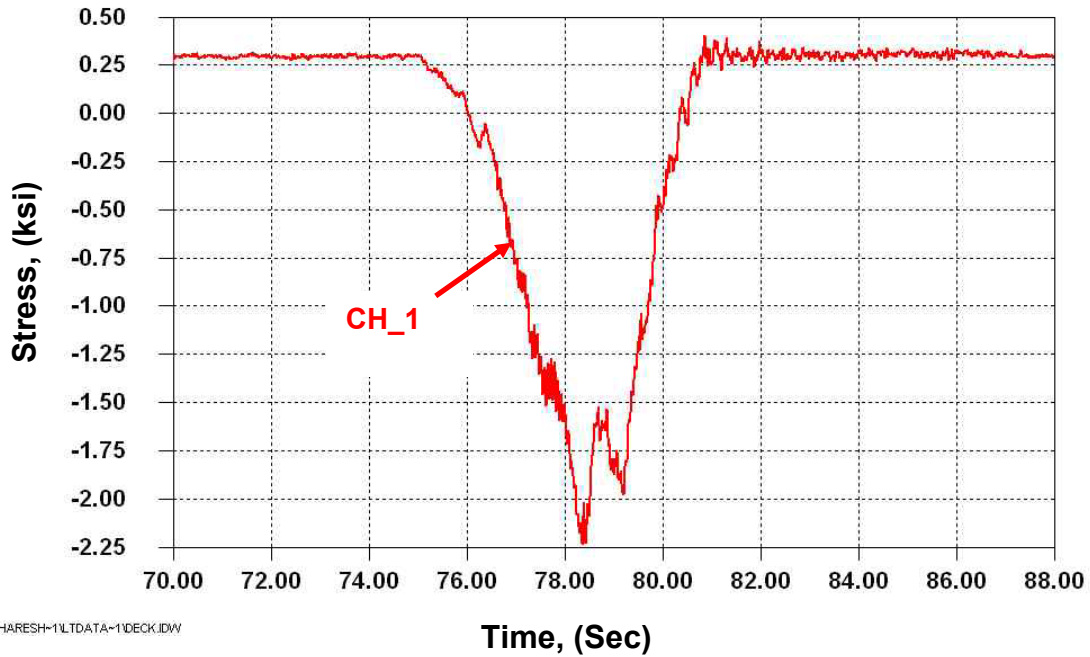
Figure 6.2 – Time history response of CH\_1 installed on the top face of the west Z-Bar on the east side of the bridge, 1 inch from the edge of the bar and approximately 3 inches south of floorbeam 8, during the long-term random monitoring of the channel. The response shown took place on May 18, 2005 at 3:24 PM

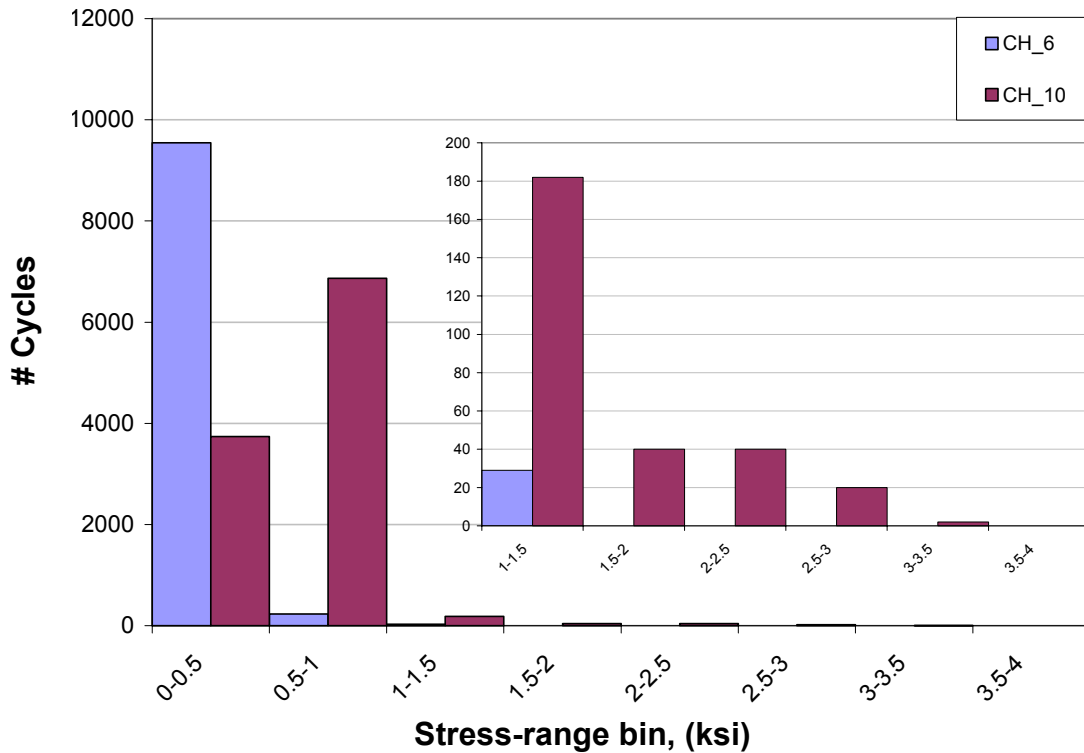
Figure 6.3 – Stress range histogram for CH\_6 installed on the bottom flange of floorbeam 8 and CH\_10 installed on the bottom flange of floorbeam 7

As previously discussed, CH\_6 and CH\_10 were installed on the bottom flanges of floorbeam 8 and floorbeam 7, respectively. The histograms were divided in 0.5 ksi bins. The stress-range histogram for both channels is shown in Figure 6.3. The maximum stress range recorded by CH\_6 is within the bin of 1.0 ksi – 1.5 ksi. An average maximum stress-range value of 1.25 ksi could therefore be assumed. For CH\_10, the average maximum stress-range value recorded by CH\_10 during the monitoring period is 3.25 ksi.

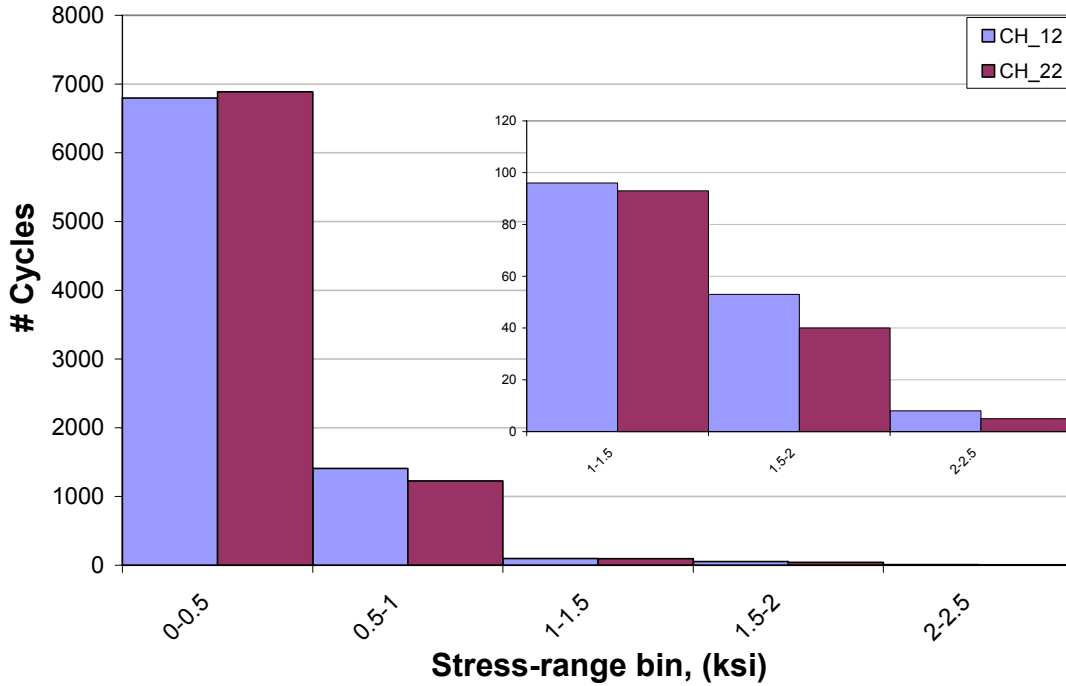
As mentioned in Chapter 4, six channels were installed on the lower and strengthening tie plates to measure their response to moving load. From the six channels installed, two channels were selected for the short-term monitoring, namely CH\_12 and CH\_22. Channels CH\_12 and CH\_22 were installed on the bottom edge of the lower tie plate and strengthening plate, respectively, at mid distance between floorbeam 7 and floorbeam 8. Figure 6.5 shows the stress-range histogram of both channels. The average maximum stress range recorded by both channels is 2.25 ksi.

Figure 6.5 – Stress range histogram for CH\_12 and CH\_22 installed on the bottom edge of the lower tie plate and strengthening plate, respectively, at mid distance between floorbeam 7 and floorbeam 8.

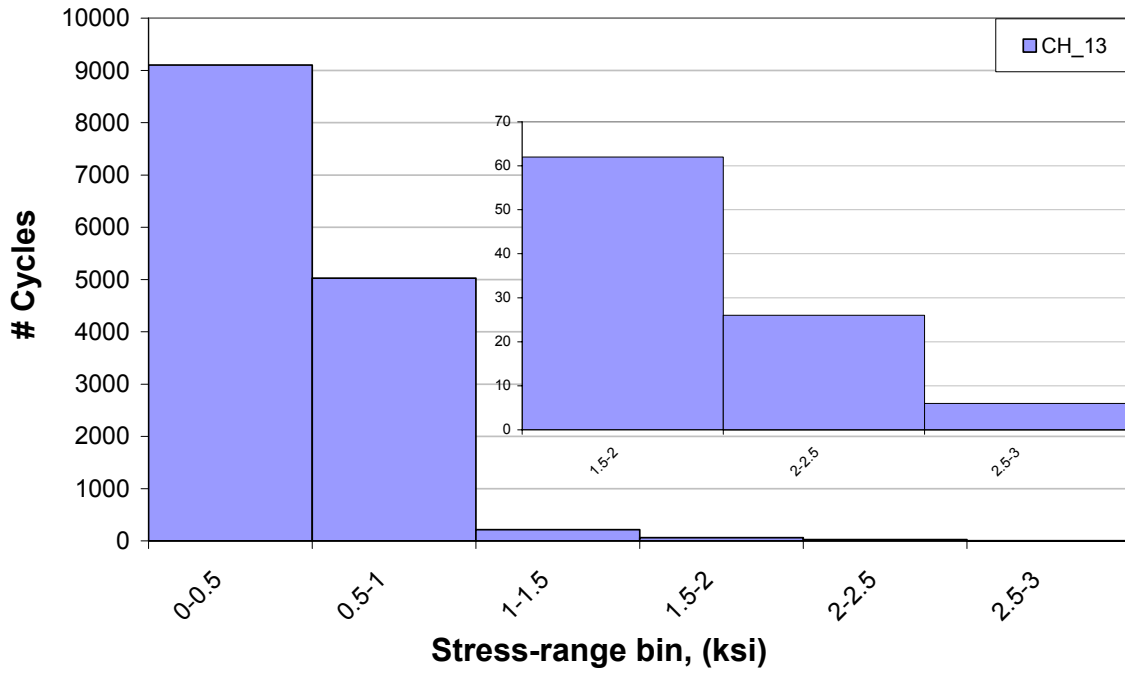
Channels CH\_13 and CH\_14, installed back-to-back on the front and back face of a lattice member located near mid span. Channel CH\_13 was selected for the short-term monitoring. Figure 6.6 shows the stress-range histogram of the channel. As can be seen in the figure, the maximum stress range recorded by the channel falls in the bin of 2.5 ksi – 3.0 ksi, with an average maximum stress of 2.75 ksi.

Figure 6.6 – Stress range histogram for CH\_13 and CH\_14 installed back-to-back on the front and back face of a lattice member located near mid span
