# CORROSION RESISTANCE OF AZ31 MAGNESIUM ALLOY INFLUENCED BY CONVENTIONAL CUTTING FLUID

This paper deals with the evaluation of cutting fluid impact on corrosion resistance of AZ31 magnesium alloy in aggressive environment containing chloride ions supported by photo documentation. Ground samples were immersed in the standard commercial cutting fluid for 5 minutes to simulate conditions during machining process at the temperature of  $22 \pm 2$  °C and subsequently cleaned and immersed in 0.1M NaCl solution at the temperature of  $22 \pm 2$  °C in order to measure electrochemical corrosion characteristics. Cyclic potentiodynamic polarization (CPP) tests were chosen as a testing method. The measured CPP curves of immersed samples and ground samples were analysed by Tafel extrapolation method. The values of obtained electrochemical characteristics show that the chosen cutting fluid has negative effect on corrosion resistance of AZ31 magnesium alloy in sodium chloride solution.

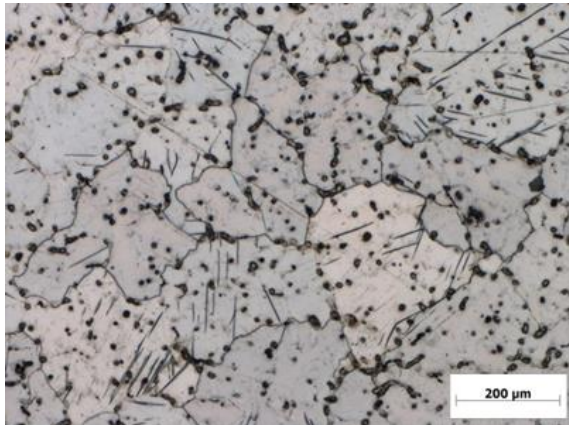
The microstructure of AZ31 magnesium alloy (Fig. 1) consists of polyedral grains of solid solution of aluminium, zinc and other alloying elements in magnesium. There are visible twins and areas of  $Al_{12}Mg_{17}$  intermetallic phase.

Fig. 1. Microstructure of AZ31 magnesium alloy. (full colour version available online)

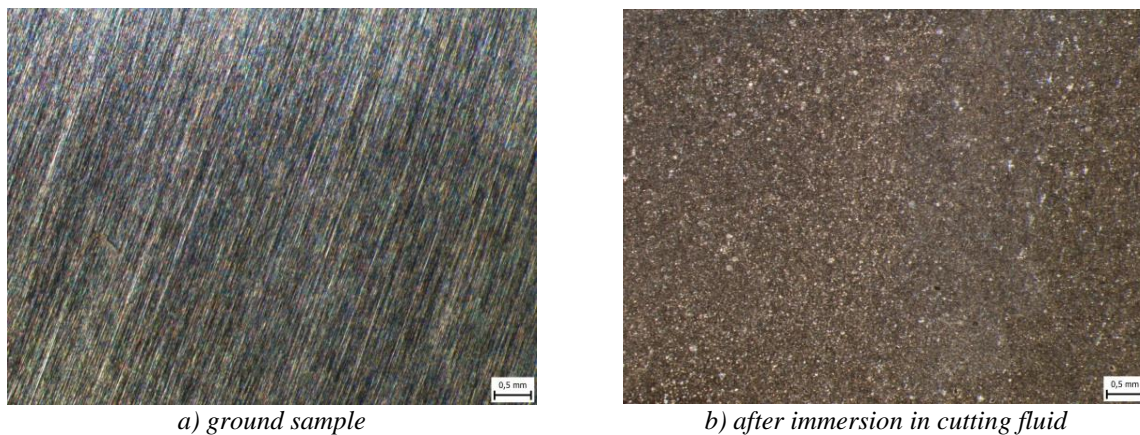
The surface of the ground AZ31 sample and sample after immersion is depicted in the Fig. 2. It can be seen that the immersion in cutting fluid leads to the creation of corrosion products layer due to the reaction of Mg sample with components contained in fluid. Another components are  $MgO$  and  $Mg(OH)_2$  probably formed on the surface due to the aqueous character of the fluid [18].

Fig. 2. Surface of the AZ31.  
(full colour version available online)

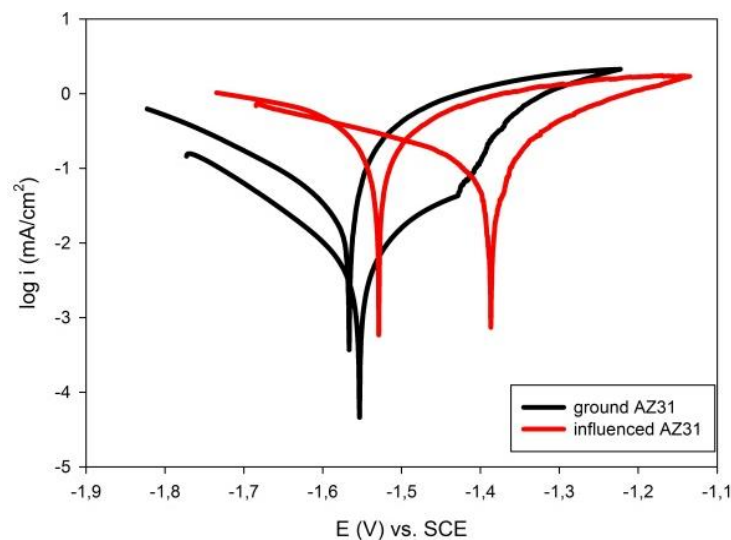
Measured CPP curves of AZ31 tested samples in 0.1M NaCl are shown in Fig. 3. The values of electrochemical characteristics obtained by the Tafel extrapolation method for both states are listed in Table 3. The samples in ground state have reached (in direct polarization) the corrosion potential  $E_{corr}$  value of -1561 mV and value of corrosion current density of  $5.3 \mu A \cdot cm^{-2}$ . It can be seen that after the backward polarization, ground AZ31 samples exhibit more negative corrosion potential and higher corrosion current density due to the breakdown of the surface film probably

consisting of  $Mg(OH)_2$  occurred at the pitting potential  $E_{pt}$  (-1429 mV). During the exposition in aqueous environment following reaction takes place:  $MgO + H_2O \rightarrow Mg(OH)_2$ . According the E-pH diagram for magnesium in water environment,  $Mg(OH)_2$  is stable only in strongly alkaline environments. The ground samples tented to corrode rapidly after the breakdown of the surface film due to its interaction with aggressive chloride ions  $Cl^-$  contained in the testing electrolyte [12]. As can be seen from electrochemical characteristics mentioned in Table 3, the samples influenced by the immersion in cutting fluid have reached more positive value of  $E_{corr}$  (-1391 mV) compared to the ground samples. On the other hand, the corrosion current density increased to the value of  $90.6 \mu A \cdot cm^{-2}$ . This value is more than 17-times higher in comparison with the  $i_{corr}$  of ground AZ31 samples. The part of CPP curve measured during the backward polarization shows the shift of  $E_{corr}$  to the more negative value and higher  $i_{corr}$ . It has to be noted that this backward  $E_{corr}$  is still more positive compared to the direct  $E_{corr}$  of the ground samples. The fact that the influenced samples exhibit more positive values of corrosion potential means that the presence of film created on surface during immersion in cutting fluid leads to the thermodynamically nobler behaviour of these samples. In terms of corrosion kinetics, the significantly higher corrosion current density values of influenced samples means that corrosion rate is higher compared to non-influenced ones as it is shown in Table 3. This fact is probably caused by the non-protective and highly soluble layer of corrosion products consisted of  $MgCl_2$  and  $Mg(OH)_2$  created on the AZ31 surface which are unstable when exposed to the  $Cl^-$  ions and such that provide poor corrosion protection to the magnesium substrate.

Fig. 3. Cyclic potentiodynamic polarization curves for the ground and influenced AZ31 Mg alloy in 0.1M NaCl.  
(full colour version available online)

the interaction of fluid components with Mg substrate. The performed CPP measurements in 0.1M NaCl shows that the cutting fluid positively influenced thermodynamic stability of samples as the values of corrosion potential have been more positive to the values

of the ground samples and it means that influenced samples are thermodynamically more stable. However, the corrosion current density increased 17-times after impact of cutting fluid. From the corrosion kinetics point of view, it means that the corrosion rate is higher after the immersion in cutting fluid as the corrosion current density is in direct proportionality with corrosion rate. This negative influence on corrosion behaviour in environment containing  $\text{Cl}^-$  could be overcome by the using of cutting fluid with more suitable chemical composition that does not react with the Mg surface or by the usage of proper removing technique of the created surface film.
