CONCRETE DAMS  
THEORY AND PRACTICE OF CONSTRUCTION

JACKSON HEATH WILKINSON  
B. S. University of Illinois, 1915

THESIS

IN CIVIL ENGINEERING

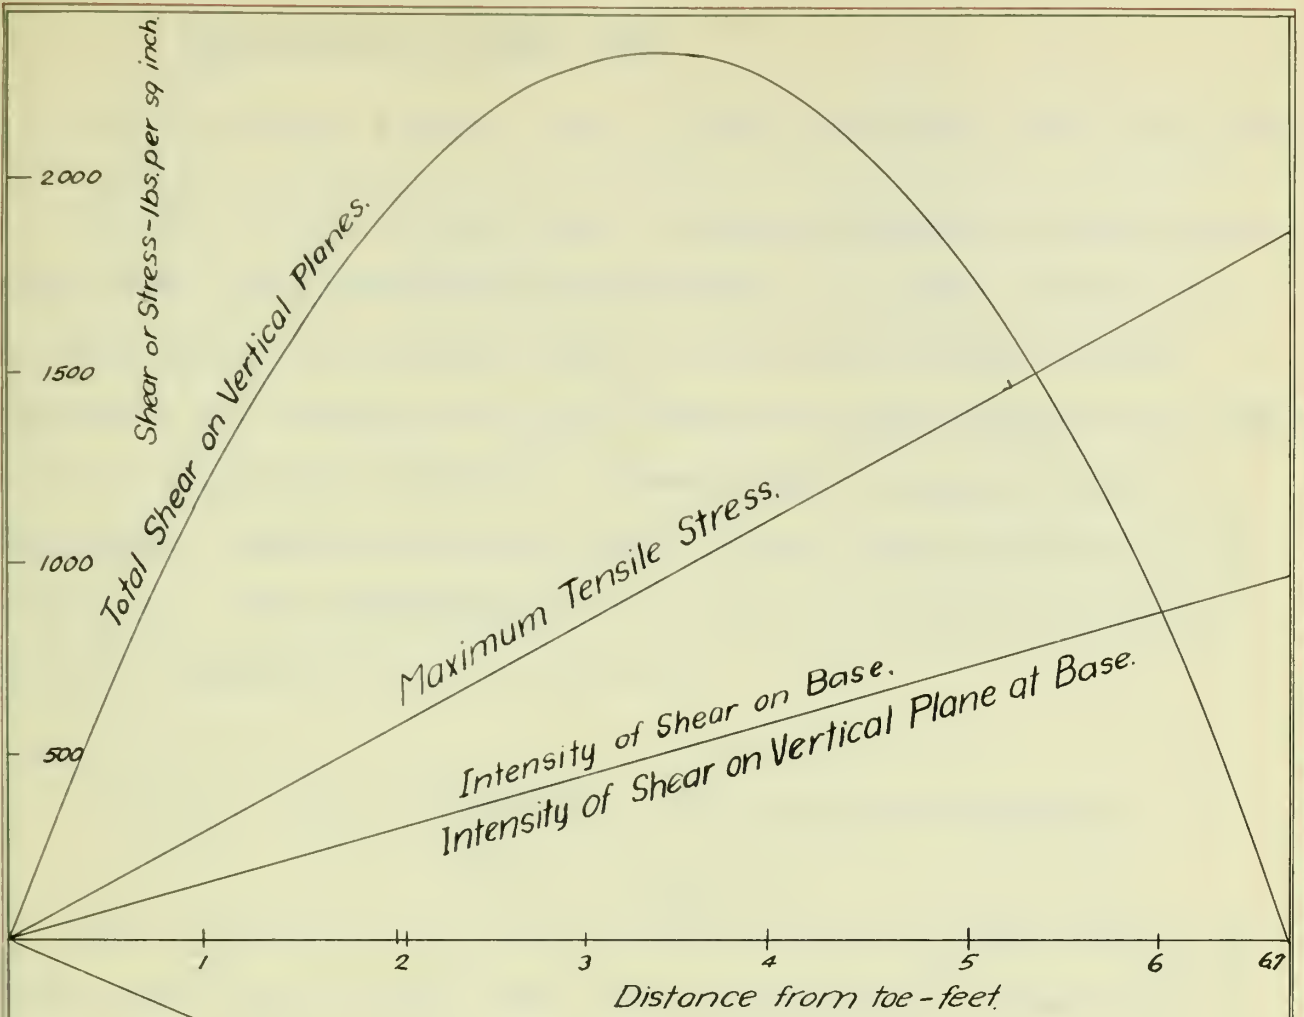
VARIATION OF  
SHEARS AND STRESSES

It is proven in mechanics that the horizontal shear at any point is equal to the vertical shear at that point. Therefore the intensity of shear on a horizontal section at any point is equal to
