Composites Part B

Experimental investigation on cyclic response of RC elements repaired by CFRP external reinforcing systems

This paper deals with the experimental results of an investigation aimed at studying cyclic response of half scaled RC specimens previously damaged and then repaired with externally bonded carbon fiber reinforced polymer sheets. The research involved the test of ten specimens. Two of them were tested without any external strengthening material in order to provide a reference for the response of repaired specimens. These latter were tested after a previous damaging procedure and a subsequent repair intervention with fiber reinforced polymer composites. The parameters under investigation were the level of initial damage, the strengthening configuration, and the level of axial load. Test results have pointed out effectiveness of the adopted strengthening systems, since repaired specimens exhibited better mechanical responses than the unstrengthened ones.

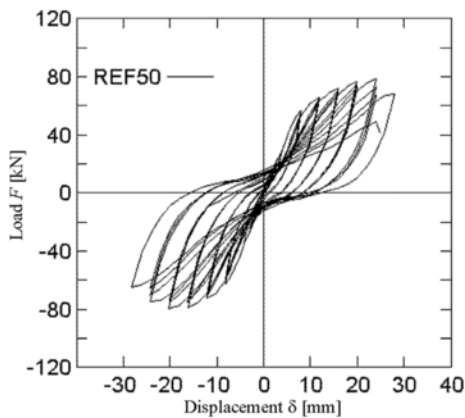
Fig. 8. Load-displacement curve of control specimen REF50 ($N = 50$ kN).

Figs. 8 and 9 show the load-displacement curves of reference unstrengthened specimens (REF50, $N = 50$ kN and REF100, $N = 100$ kN). Figs. 10 and 11 show details of the damage suffered by these specimens during the tests.

The cyclic response of specimen REF50 ($n = 9.2\%$) was characterized by sufficiently stable hysteresis loops up to the deformation level $\delta/L = 3.5\%$ (end of the 19th loading cycle) with a moderate strength degradation up to the 16th loading cycle. A higher strength degradation (13%) can be observed for the last three loading cycles (Fig. 8). The response curve presented a marked pinching due to the influence of the shear mechanisms on specimen pinching response. The failure of the specimen was attained at beginning of the 21st cycle because of the rupture of a longitudinal rebar. The examination of the speci-

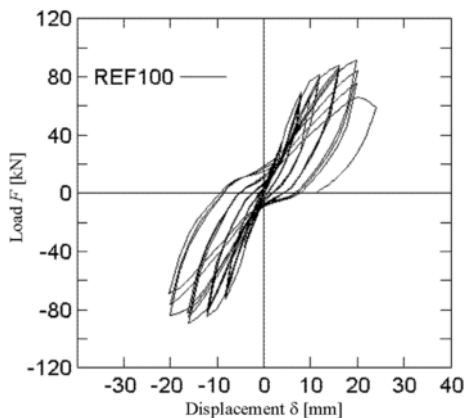
Fig. 9. Load-displacement curve of control specimen REF100 ($N = 100$ kN).

As expected, the unstrengthened specimen REF100 ($n = 16.7\%$) exhibited a greater strength and a lower deformation capacity than the specimen REF50. Hysteresis loops were less stable with considerable strength degradation, especially at high deformation levels (Fig. 9). Failure was reached at beginning of the 17th cycle due to the overall instability of the specimen caused, in turn, by the excessive concrete degradation and buckling of longitudinal bars at critical regions (Fig. 11).

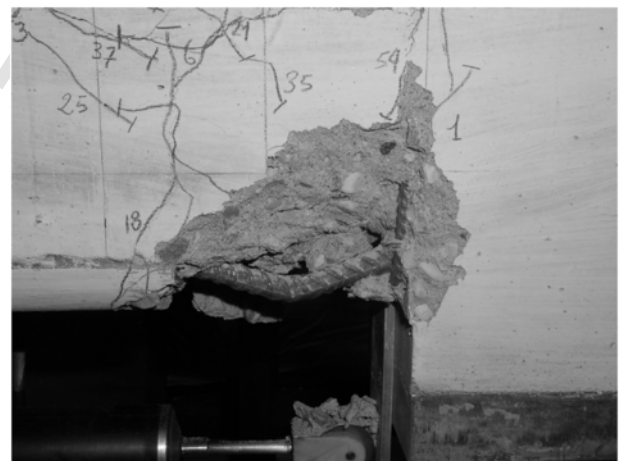
Fig. 11. Specimen REF100: buckling of a longitudinal bar at a critical region.
