Experimental Investigation on the effect of water ingress on the flexural and interlaminar properties of glass/vinyl-ester composite for marine applications

FIBRESHIP 3
INTEGRAL COMPOSITE SHIP

Marine Aging of Polymers, Brest
28-29 August 2019

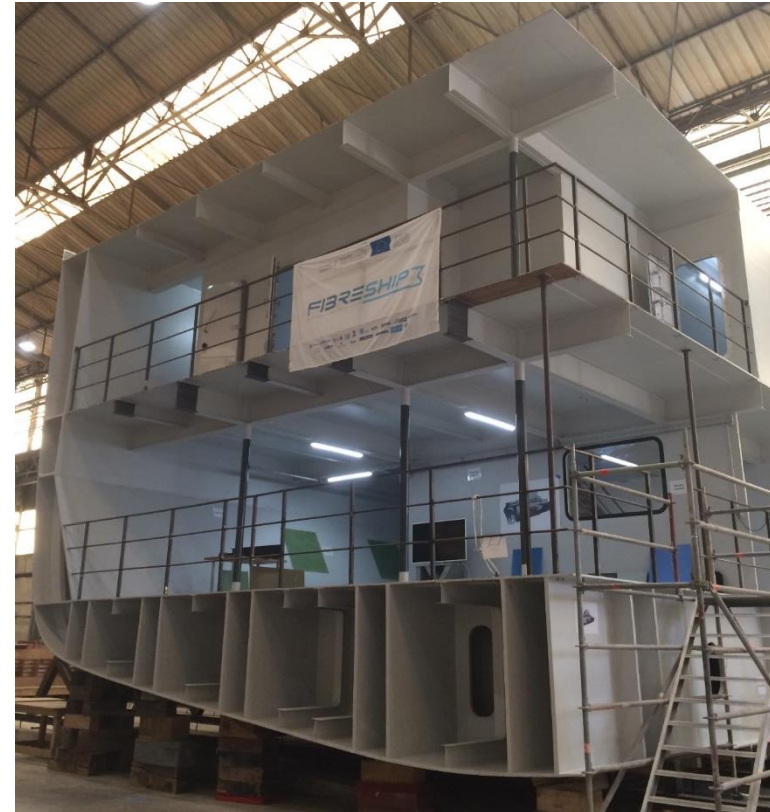
Ship Block Demonstrator
(iXblue Shipyard, La Ciotat, France)

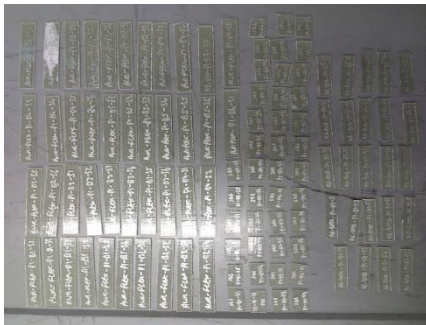
✓ Procedure 1

Oven for 5 hours at 45°C

Record the Mass

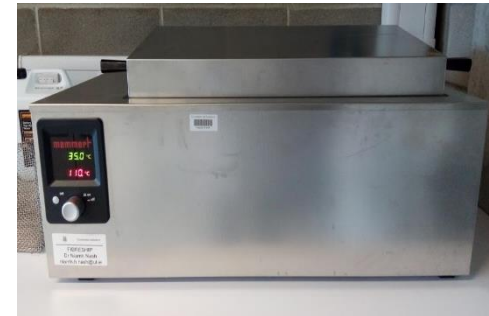
✓ Procedure 2

Immersion Bath (Deionised water @ 35 °C)

Record water uptake
(ASTM D5228)
