NASA/TM-2016-218972

The Behavior of a Stitched Composite Large-Scale Multi-Bay Pressure Box

*Dawn C. Jegley, Marshall Rouse, Adam Przekop, and Andrew E. Lovejoy
Langley Research Center, Hampton, Virginia*

April 2016

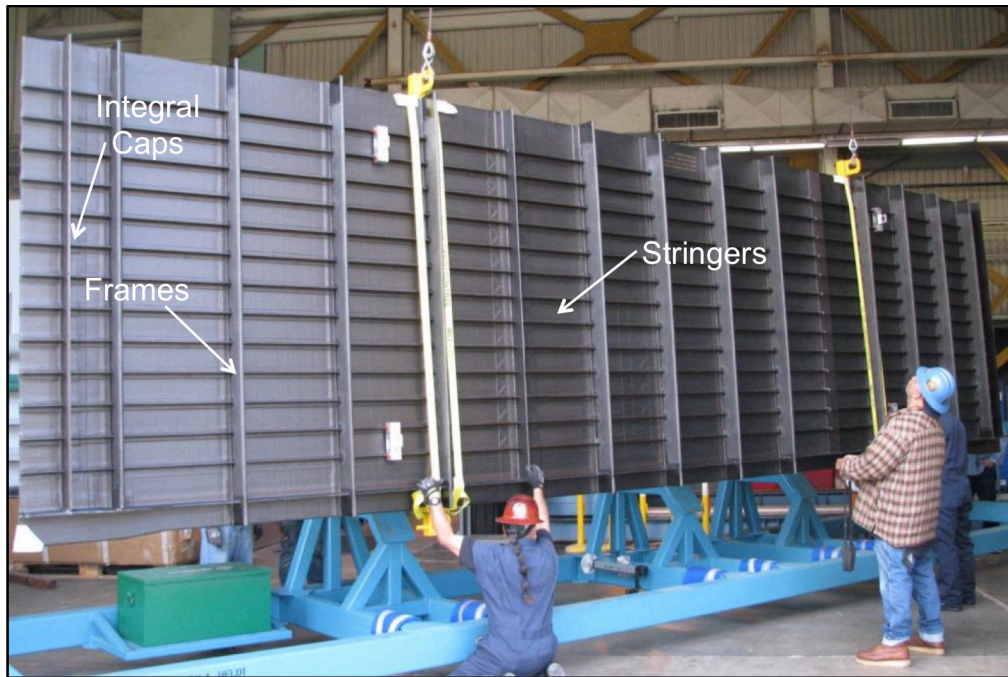
Figure 3. PRSEUS panel being prepared for assembly.

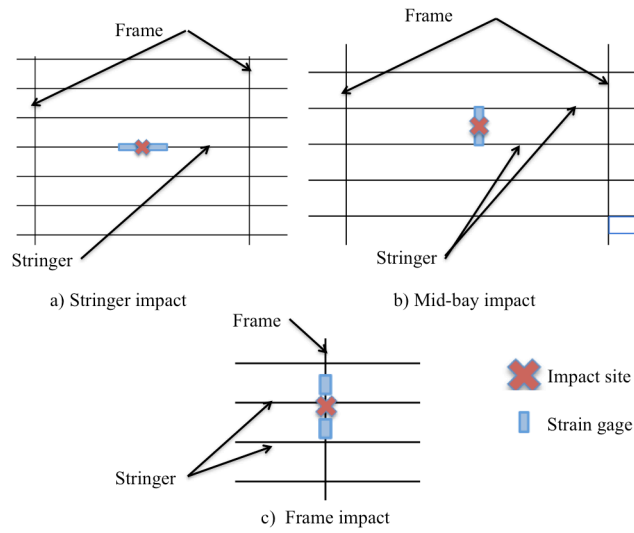
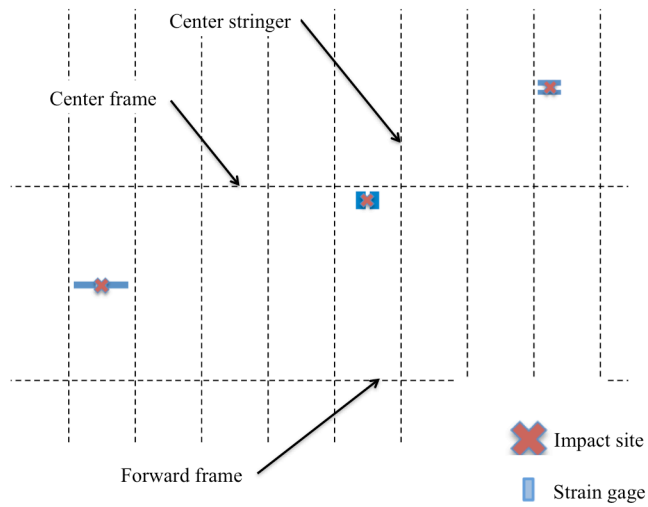
a-c) Interior on upper bulkhead

d) Exterior on center keel

Figure 14. Strain gauges associated with impact sites.

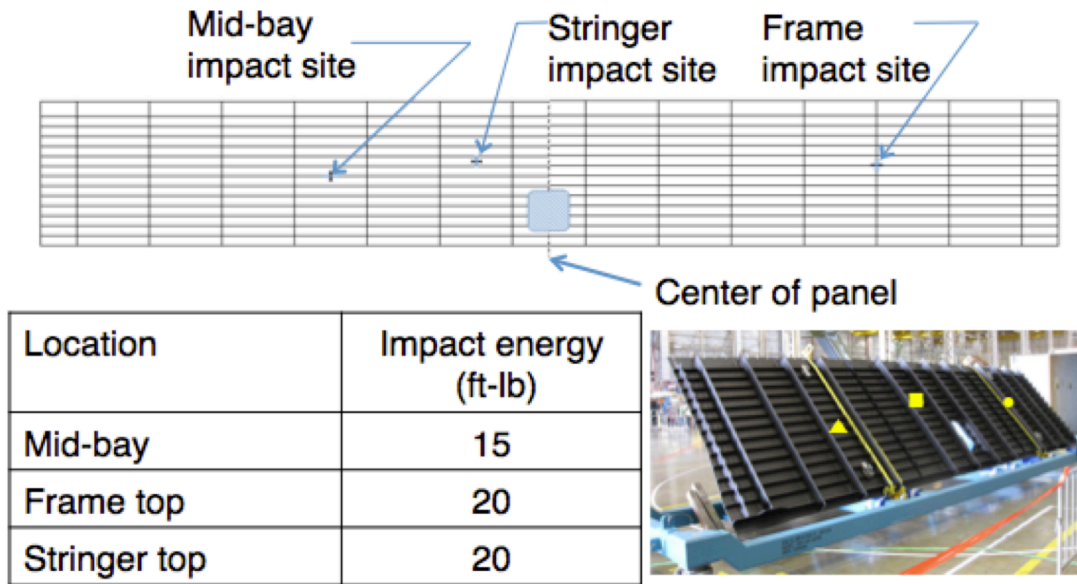
a) Interior impacts

b) Exterior impacts

Figure 17. Impact sites.

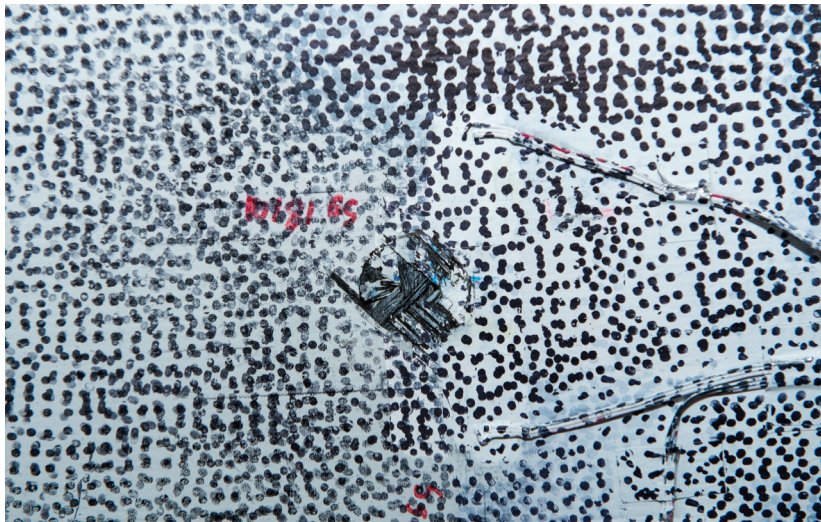
Figure 19. Impact causing a through-hole.

One of the exterior impacts was inflicted slightly away from the planned impact site. This impact was into the thin-skin region instead of at the adjacent flange. Therefore, the damage was more severe than intended. The damage was clearly visible from the exterior and interior and, in fact, a through-hole was created. A photograph of the damage from the exterior of the test article is shown in Figure 19. Evaluation of the damage at this location indicated that this damage would not reduce the ability of the structure to sustain mechanical load, but could reduce the ability of the structure to support internal pressure loads. Therefore, a non-structural patch was taped over the hole on the inside stiffened side of the center keel. Ultrasonic scans were conducted immediately before and immediately after the impacts, so that the extent of damage caused by the impacts could be quantified. These scans indicated that delamination occurred at the keel skin and flange impact sites, but was arrested at the closest stitch line to the impact site. Scans of the bulkhead stiffener impacts found no damage. Scans of

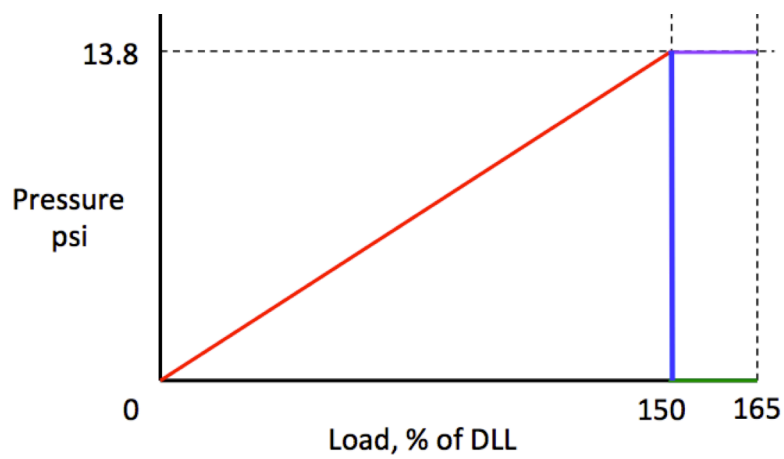
Figure 20. Loading to 110% DUL.

After the application of BVID, the DLL and DUL loadings were repeated, with the final BVID test to a load greater than DUL in the up-bending and up-bending plus pressure case. The loads were applied using the same methodology as in the earlier tests. A detailed description of the test sequence for the test to loading greater than DUL is shown in Figure 20. In this test, first, the load was ramped to DUL in the up-bending plus pressure condition, represented by the red line in the figure. Then, the pressure was held constant while the mechanical load was increased by 10%. Then, the mechanical load was decreased to DUL. The purple line in the figure represents the pressure-hold sections of the loading. Then, the mechanical load was held constant while the pressure load was removed, leaving the test article at DUL in the up-bending condition without pressure. This portion of the load sequence is represented by the blue line. Then, the mechanical load was increased to 10% greater than DUL, and held briefly. This portion of the load sequence is represented by the green line. Finally, the mechanical load was removed.

The last loading of the test article with BVID where it was required to support DUL was to a load of 10% greater than DUL in the up-bending and up-bending plus pressure load cases. The loading sequence is described in Figure 20, which shows the initial loading to DUL in the up-bending plus pressure condition, followed by an increase in mechanical load but no increase in pressure. Then, mechanical loading was reduced back to DUL and pressure was reduced to zero. Finally, the mechanical load was then increased to 10% greater than DUL. The strains at the impact sites for this test are shown in Figures 90 and 91 for the interior and exterior impact sites, respectively. Strains at the interior sites remain at less than 0.004 in./in. in magnitude.

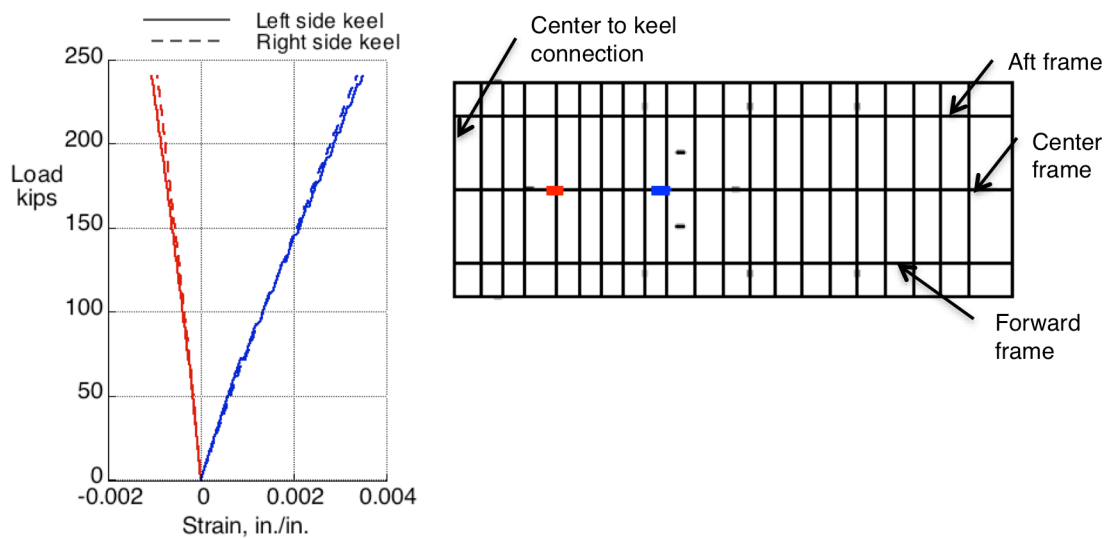
Figure 49. Strain on the top of the center frame in the side keels.

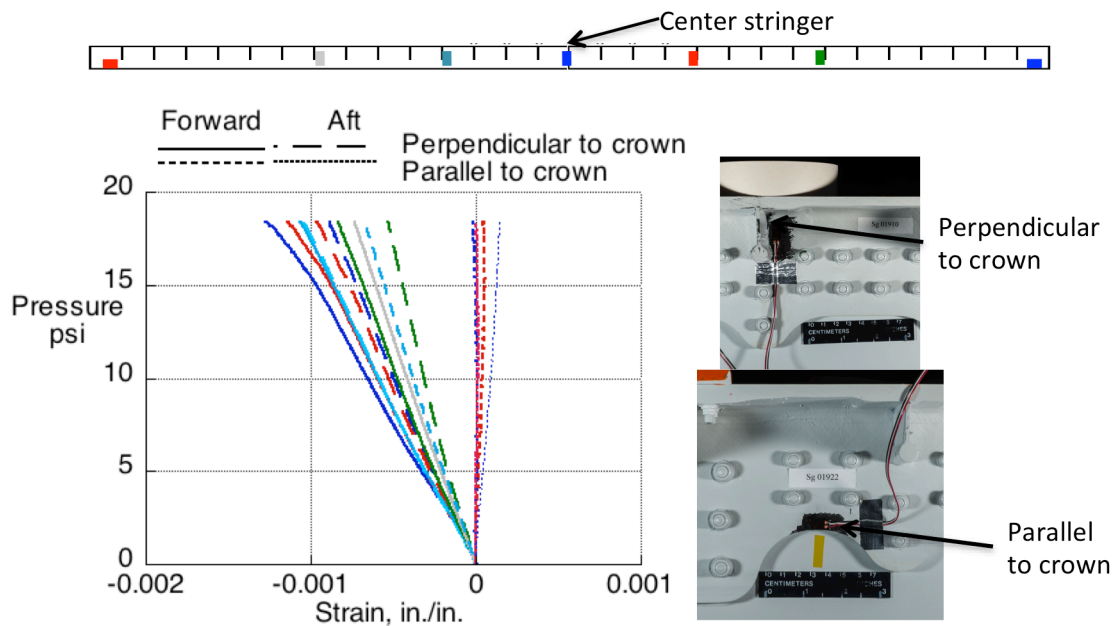
Figure 52. Strain on the exterior side of the crown T-caps.

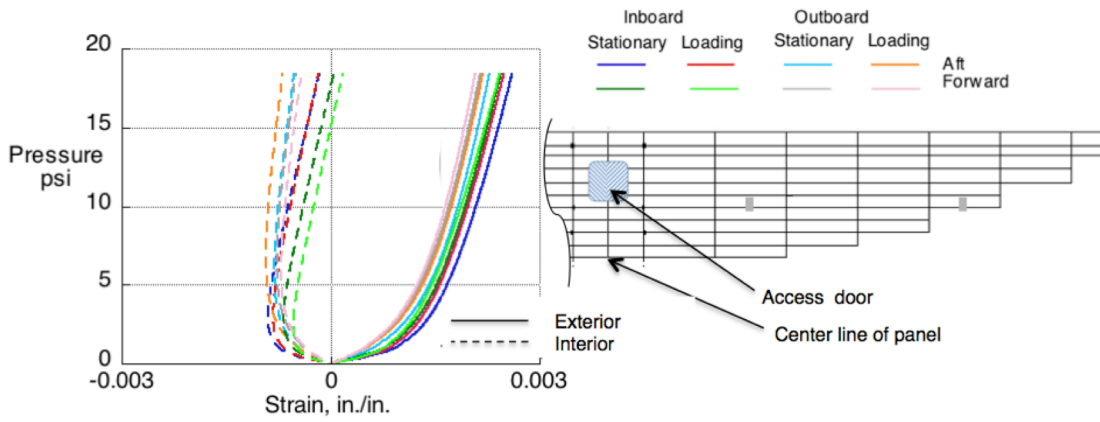
Figure 72. Strain in the lower bulkheads skin.

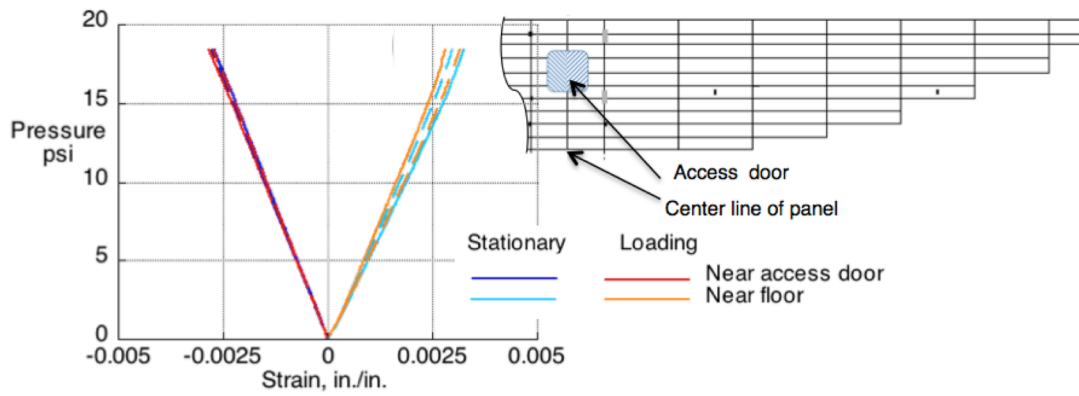
Figure 75. Strain on the top of stringers in the lower bulkhead.

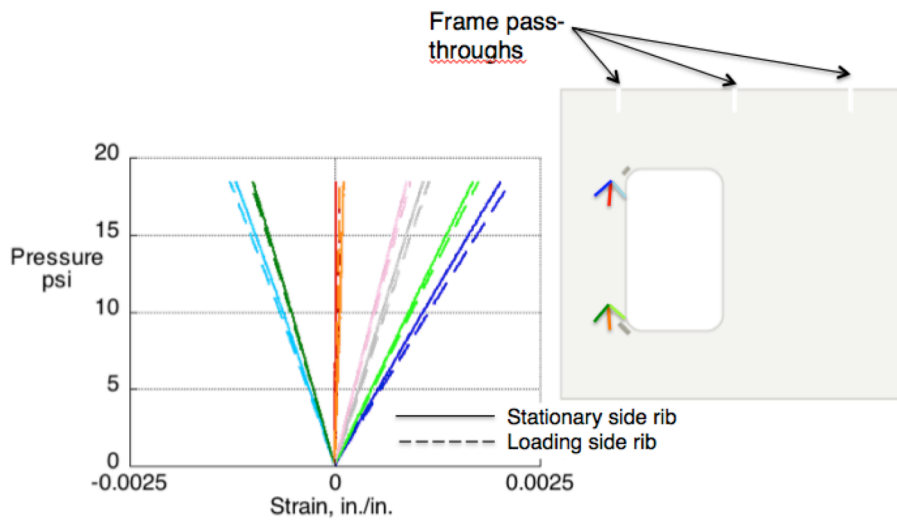
Figure 76. Strain in the upper inner ribs from rosettes strain gauges (Color indicates the arm of the gauge).

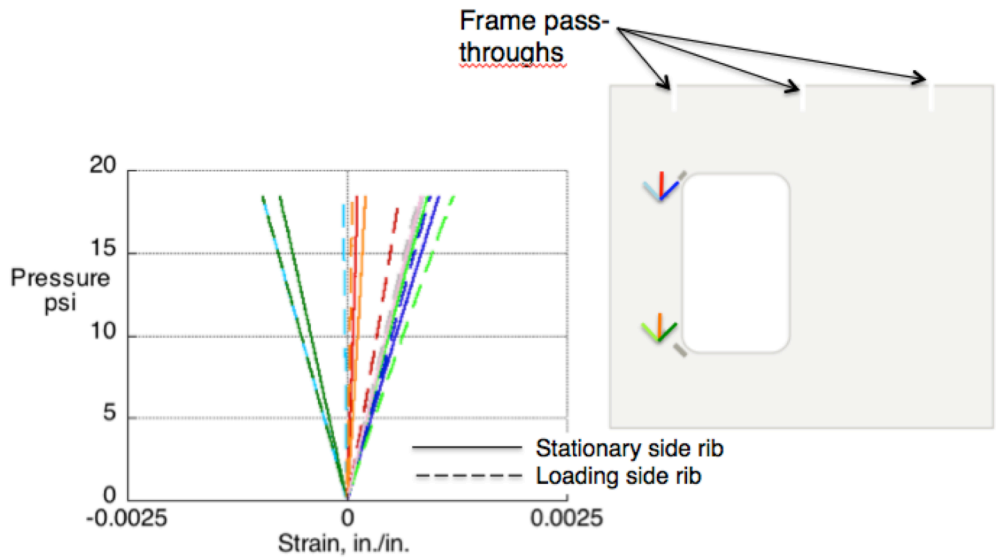
Figure 77. Strain in the lower inner ribs from rosettes strain gauges (Color indicates the arm of the gauge).

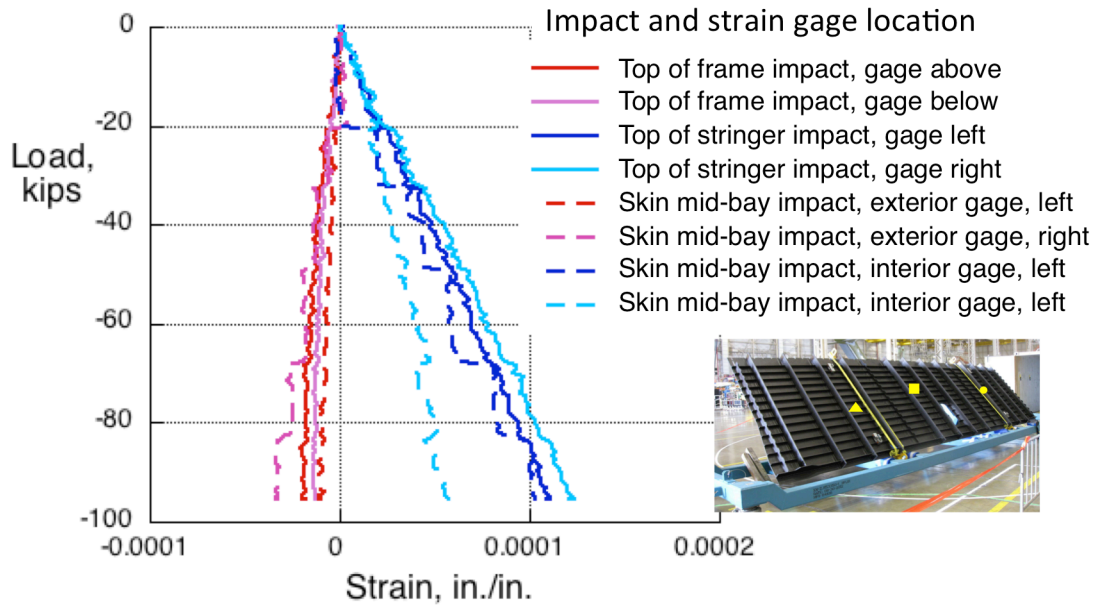
Figure 82. Strain at the interior impact sites for the down-bending load case.

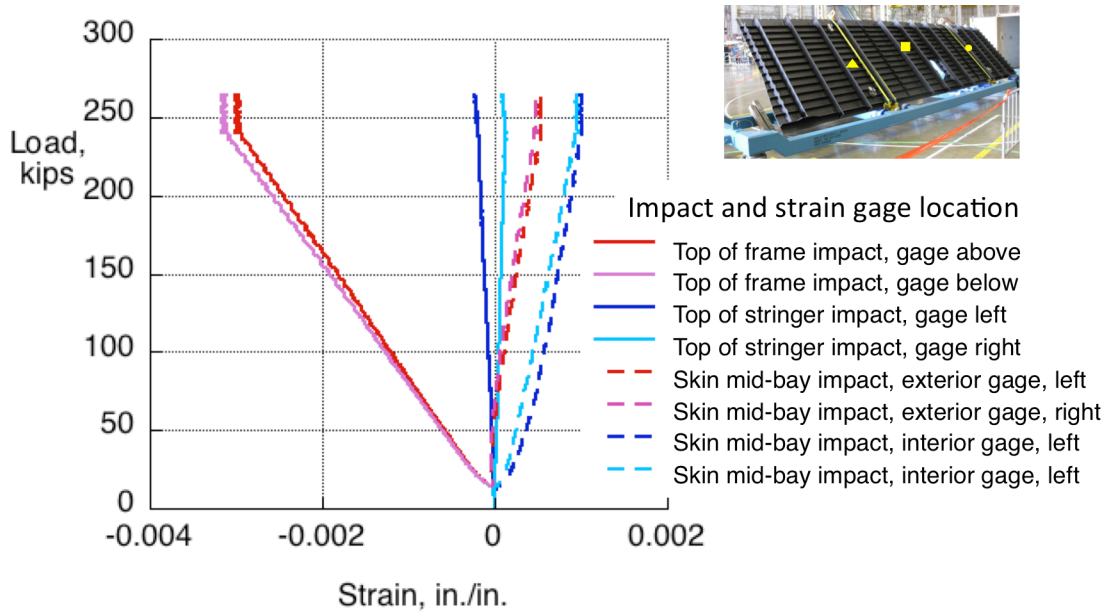
Figure 90. Strain at the interior impact sites for the up-bending with pressure load case.

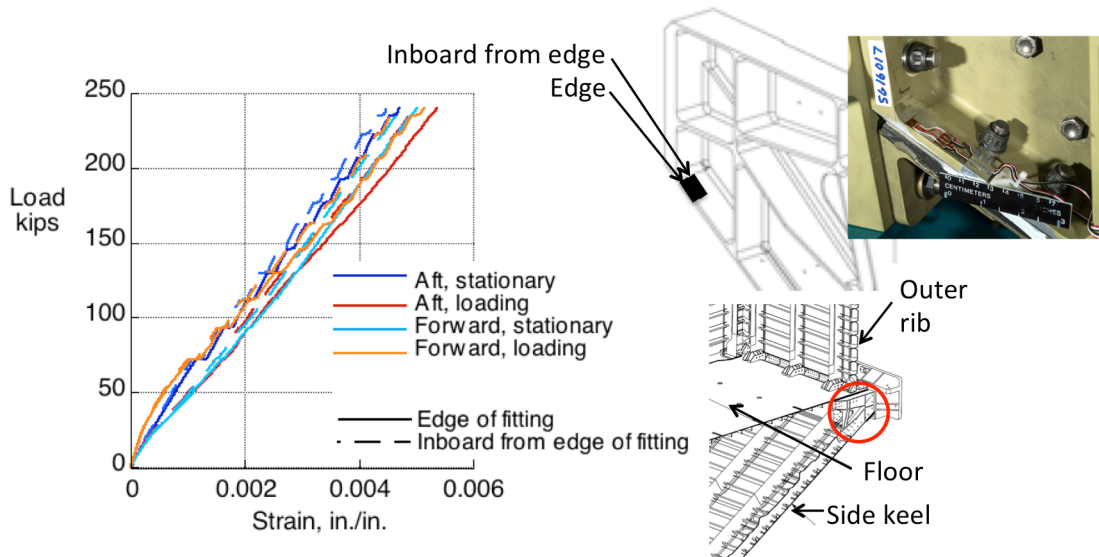
Figure 97. Strain in the external fitting at the lower load introduction structure (point B in Figure 13).

Two fitting types were potentially critical for the up-bending case; both were external fittings in the load introduction areas. Strains in the fittings at the crown-bulkhead connection at the corner where load is introduced into the test article, labeled A in Figure 13, are shown in Figure 96. Strains in the fittings at the floor-bulkhead connection at the corner where load is introduced into the test article, labeled B in Figure 13, are shown in Figure 97. In the upper load introduction fittings, the strain gauge was placed at the edge of the flange of the fitting. In the lower load-introduction fittings, one strain gauge was placed at the edge of the flange of the fitting and one strain gauge was placed immediately adjacent to that strain gauge to determine if there was a significant strain gradient in that region. None of these gauges in the upper fittings recorded strains with magnitude greater than 0.001 in./in. However, the gauges in the lower fittings recorded strains up to approximately 0.006 in./in. Nevertheless, the strains were not large enough to indicate any failures or plastic behavior.

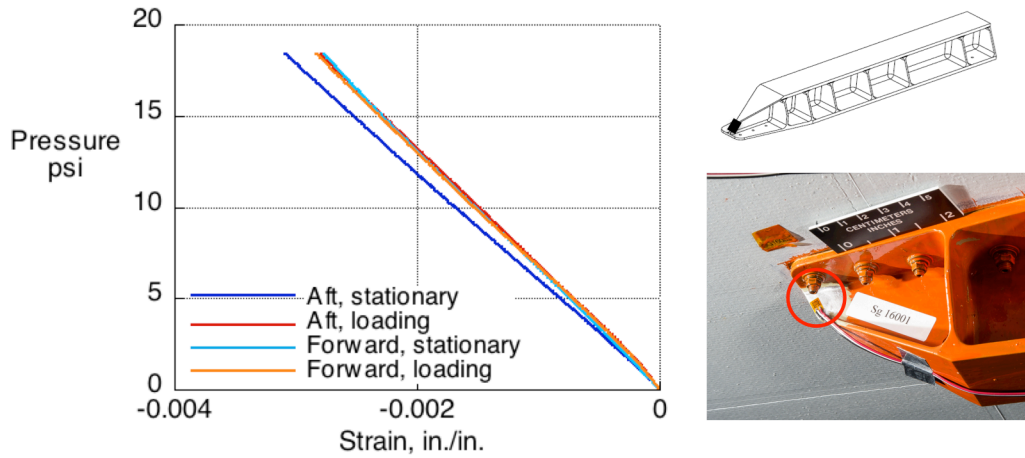
Figure 98. Strain in the external fitting at the edge of the third stringer from the center of keel (point C in Figure 13).

Two external fitting types were potentially critical for the pressure-only load case. These fittings were at the taper in the fitting on the unstiffened surface of the center keel, labeled C in Figure 13, and on the unstiffened surface of the crown labeled D in Figure 13, as shown in Figures 98 and 99, respectively. These fittings were the fittings closest to the center of the panels. Strains remained linear and did not exceed a magnitude of 0.004 in./in.
