NASA/TM-2016-219168

# Experimental Photogrammetric Techniques Used on Five Full-Scale Aircraft Crash Tests

*Justin D. Littell*  
*Langley Research Center, Hampton, Virginia*

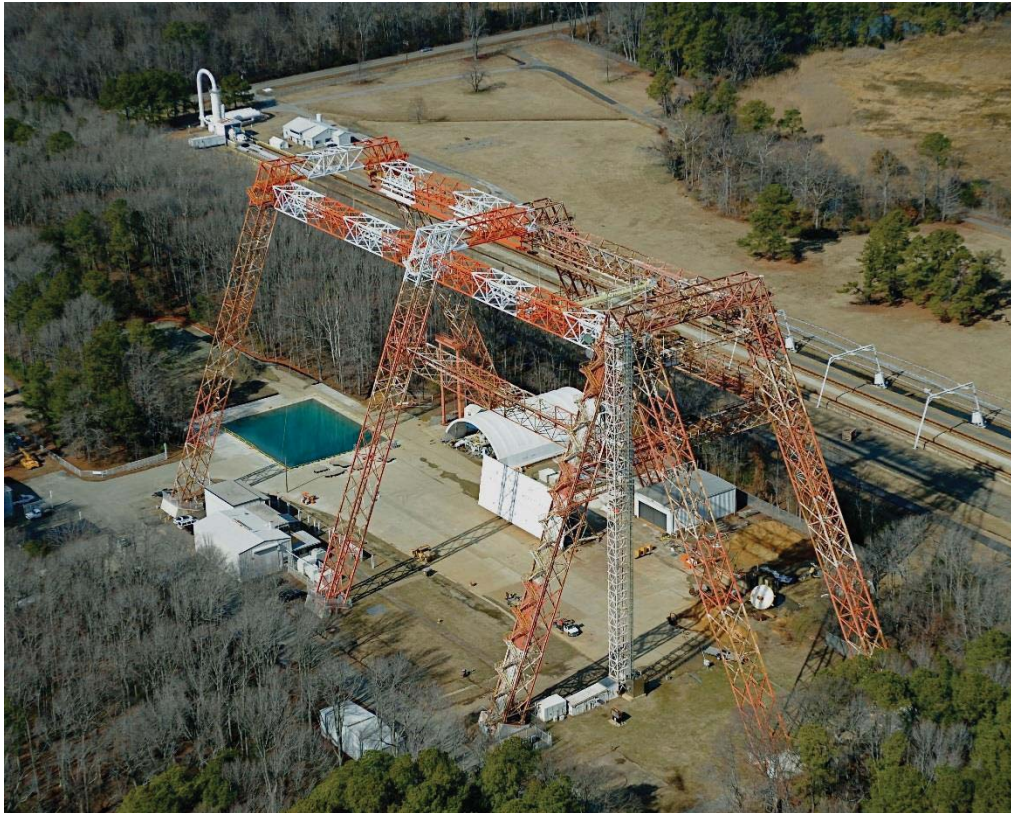
NASA Langley Research Center's (LaRC) Landing and Impact Research Facility (LandIR) has a long and rich history of full-scale aircraft crash testing. The facility, originally built in 1965 to train the Apollo astronauts for the moon landings, was converted into a full-scale crash test facility in 1972. It is a 240-ft. high, 400-ft. long steel A-frame gantry structure which uses a cabling system to pendulum swing test articles achieving various combinations of free flight and crash velocities [1]. Full-scale aircraft crash testing has been ongoing for 40+ years, with test articles ranging from small general aviation (GA) airplanes to large military transport helicopters. A partial history of testing up through the late 1990's is summarized in [2], with more recent tests summarized in references 3 through 7. Figure 1 shows the LandIR facility.

Figure 1 - LandIR facility

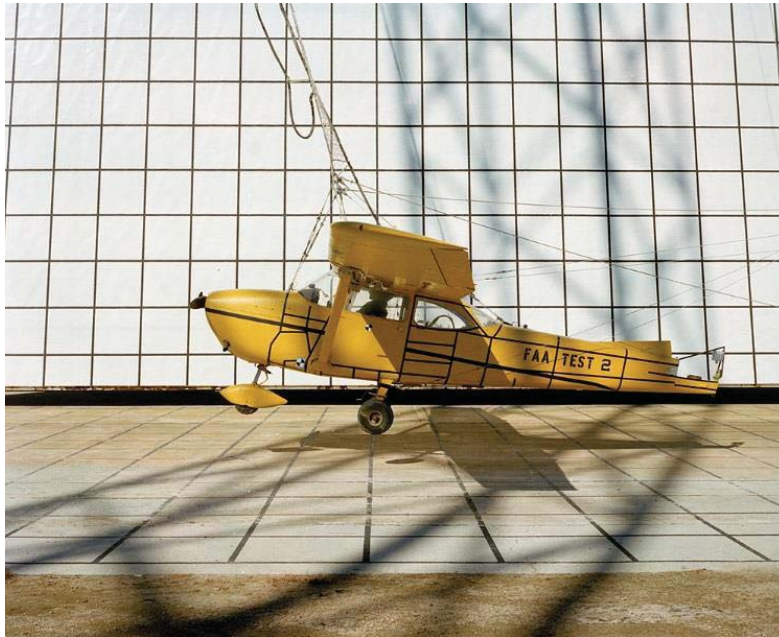
In order to obtain useful data from the crash tests, points of interest need to be identified in advance. Common ways are to highlight frames, stringers and longitudinal structural members of the aircraft to track deformation. Other times, discrete targets are placed at structural junctions, ATD limbs or other areas of interest to gather specific results at those locations. Figure 2 shows one example on a GA test conducted in 1977 where the test article was painted a light yellow, over which the stiffeners, frame sections and rivet line locations were painted with black lines. There are yellow and black (commonly called “bowtie”) stickers applied at the CG on the door and near the bottom of the firewall locations. No other types of tracking targets are visible.

Figure 2 - Historical painted patterns for use in tracking

Figure 2 also shows a white grid background, along with a grid pattern painted into the impact surface. The grid pattern in the background is located on a movable backboard (still in use) that can be placed behind the impact location specified by the test conditions. Both of these items were used to provide a reference

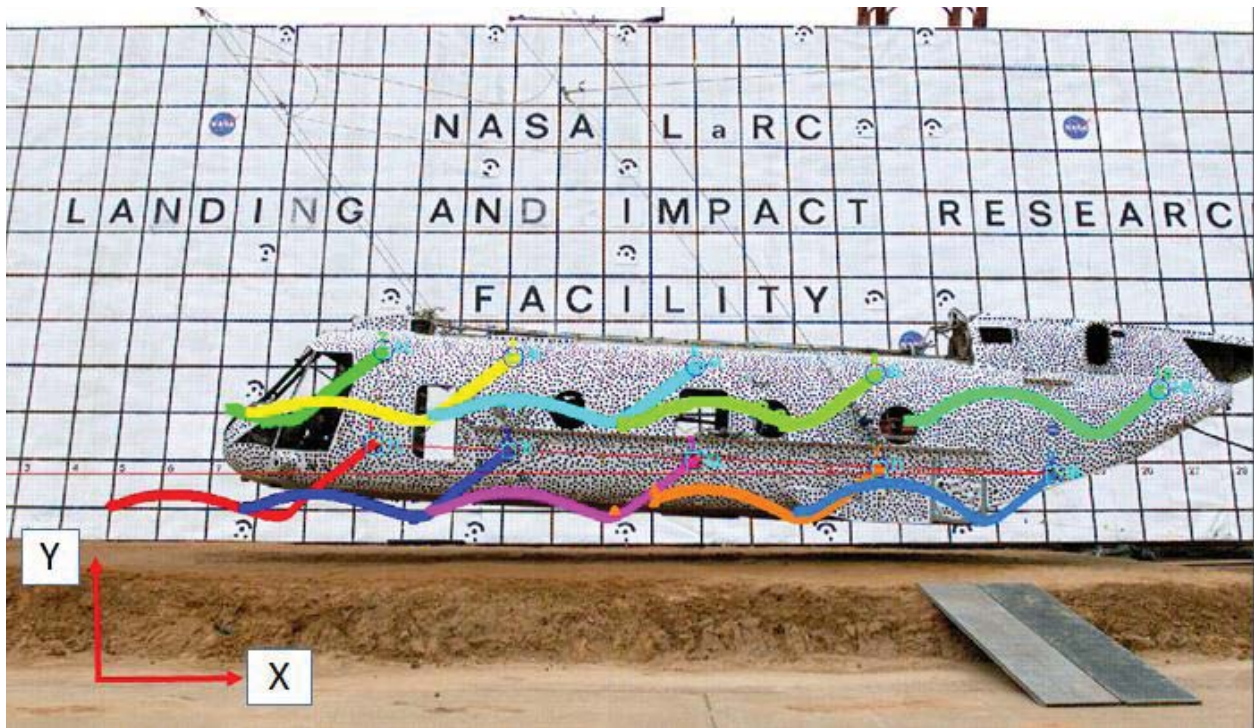
Target locations were measured prior to the test and these measurements established both a baseline target location, and also scaling factors needed in data processing. A coordinate system was established using the grid on the backboard, located behind the test article and visible in Figure 4. Figure 4 shows the created points, tracked through the time history during the crash, starting with the first tracked position, slightly before impact.

Figure 4 – TRACT 1 target tracking marker time history

The tracking algorithms used on the markers in Figure 4 started at the end of the swing, approximately 0.070 sec. prior to impact. During the final stages of the swing, the vehicle exhibited motion downward (negative Y direction) and leftward (negative X direction), which is the motion of the swing dynamics due to the pendulum swing. The markers reached a minimum, which represented the impact position, then exhibited upward and leftward motion, which represented the rebound. The distance between the minimum at impact and the relative max during the post impact arc was the maximum rebound position and grew larger when examining the data starting at the front of the airframe going to the rear. The vehicle came to rest shortly thereafter, and the location at rest is shown in Figure 4 at the final left-most point. Figure 5 shows the time history of the marker velocities, which is computed by taking the time differential of the marker positions.

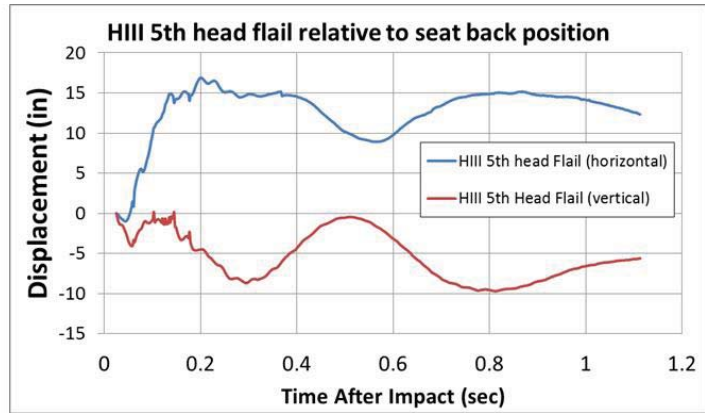
Using the tracked targets on the seat back, armrest, ATD head, right arm and right leg, the motion of the ATD was tracked and a flail envelope was established. Figure 10 shows the flail envelope of the head, which was found by determining the relative position between the seat back and the ATD head. Figure 10, left, shows the tracked markers, while Figure 10, right, shows the resolved data trace.

Figure 10 – Example ATD motion tracking during TRACT 1 test.

The maximum horizontal flail for the head was 16.5 in., which occurred 0.200 sec. after impact. The head then reached a relative minimum of 9.0 in. at 0.569 sec. after impact, and afterward proceeded toward a second maximum of 15.1 in. at 0.857 sec. after impact. In the vertical direction, the head reached a relative maximum downward displacement of 8.7 in. at 0.299 sec. after impact. The head nearly rebounded to an initial position of 0.5 in. at 0.515 sec. after impact. The largest tracked vertical motion of the head occurred at 0.802 sec. after impact, which reached a maximum downward vertical displacement of 9.62 in. The existence of the two peaks in both data sets is attributed to the initial impact of the airframe and the subsequent rebound and second impact. Similar analyses were performed on the other ATDs using the video acquired from the other onboard cameras.

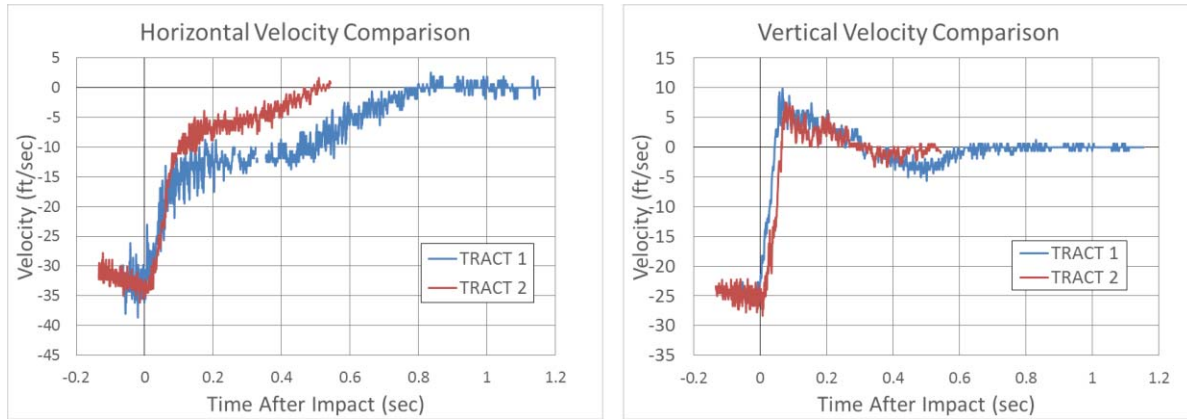
coming to rest at a time of 0.83 sec. after initial impact. These results correspond to post-test slide-out measurements. TRACT 1 exhibited approximately 96 in. of slide-out, while the TRACT 2 test article only exhibited 51 in. of slide-out. This difference in horizontal velocity time histories was important because it was the first indication that the horizontal deceleration on the test article was much higher for TRACT 2. Figure 16 shows a comparison of the velocities between the TRACT tests.

Figure 16 - TRACT 1 to TRACT 2 velocity comparison

Differentiation of the horizontal velocity data showed the average accelerations between 0.200 and 0.500 sec. after impact to be higher in TRACT 2 than in TRACT 1. In the vertical direction, the velocities matched well. The velocity results suggested that the dirt compression did not have a noticeable effect on the vertical motion, however the shearing motion of the test article on the dirt did affect the horizontal motion.

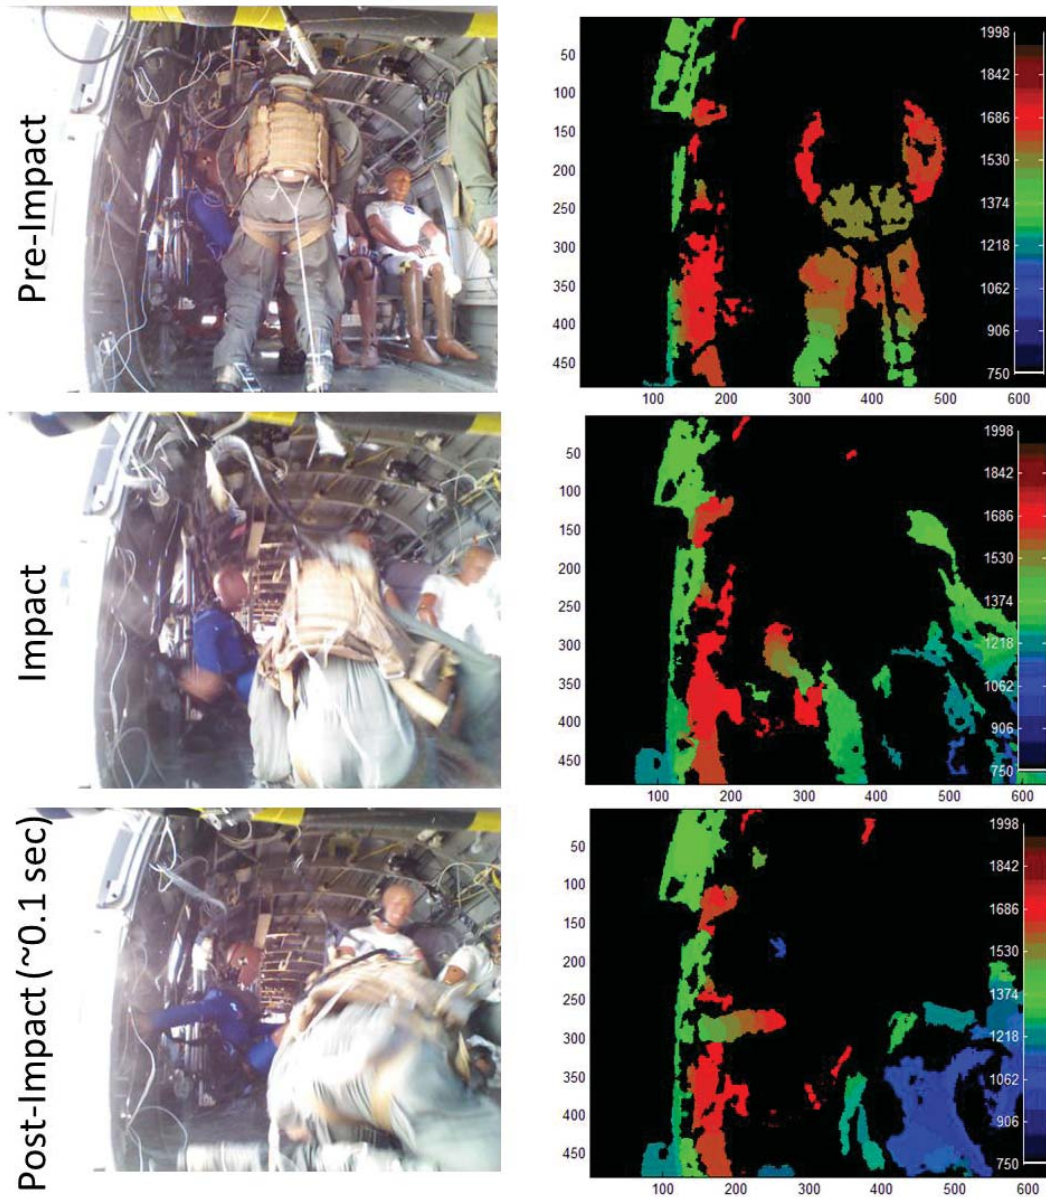
Figure 22 - TRACT 2 markerless tracking results. Visible image (left) and created depth data projection (right)

A similar setup from TRACT 1 was used for the markerless tracking sensor on TRACT 2. It was placed in a forward bulkhead, and focused on one of the standing ATDs. For TRACT 2, the standing ATD experiment called for the ATD to be facing backward, making the face not visible to the markerless tracking sensor. A cage was built around the sensor, and its mounting bracket was stiffened such that it could retain its field of view throughout the crash sequence. The acquired results are shown in Figure 22.

The markerless tracker acquired a larger time history of motion than TRACT 1, however data dropout was still persistent on the ATD. The sensor was able to obtain limited amounts of 3-D position information, however areas around the upper back where a backpack was located did not get tracked at all. The head also did not get tracked, mainly due to the backpack obscuring the grid projection onto the head. However, the arms and legs are clearly visible in the depth data. The wireframe overlay was also not able to be

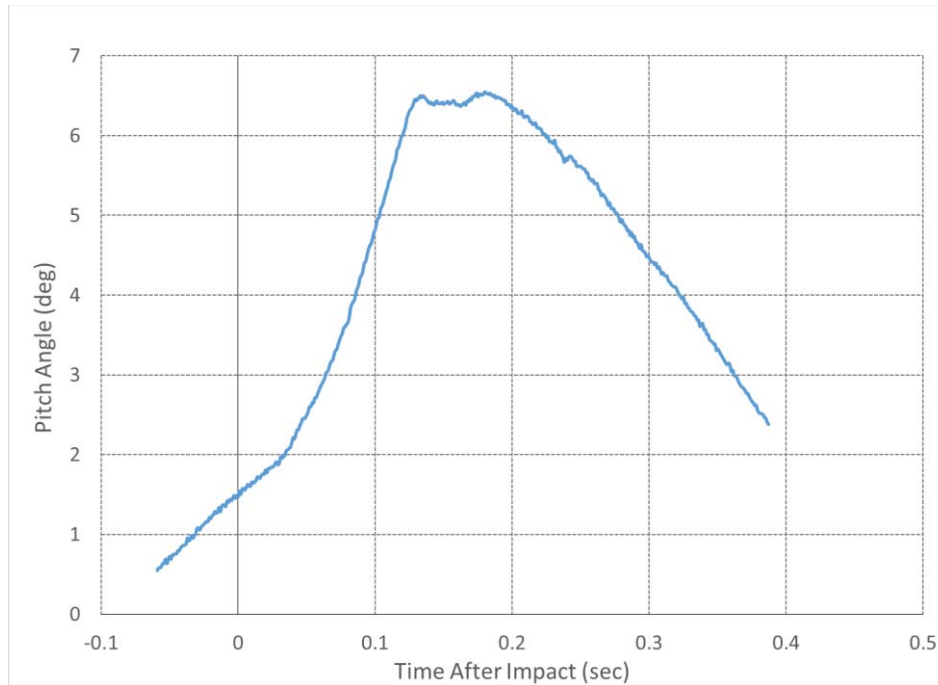
Figure 28 - ELTSAR Test 1 pitch angle

The pitch angle was found from the tracking software by tracking the horizontal angle between the CG and Engine targets throughout the impact event. Tracking starts at 0.054 sec. before impact and lasts through 0.387 sec. after impact. The first portion of the curve ranging between -0.054 sec. and + 0.03 sec. is linear. Taking the slope of this portion of the curve gives a rate of +16.5 deg./sec., indicating a rate causing the nose to pitch up. This rate is produced in the airplane due to the swinging via a single swing cabling system, and it is this rate which causes the velocities to not be identical at impact. The impact angle is 1.5 degrees, but the angle increases until it reaches a maximum of 6.5 degrees at 0.134 sec. after impact and retains this maximum value until 0.180 sec. after impact. It is during this time that the airplane crosses the zero vertical velocity mark and starts rebounding. After 0.180 sec., it starts heading back toward a level, 0 degree pitch condition.

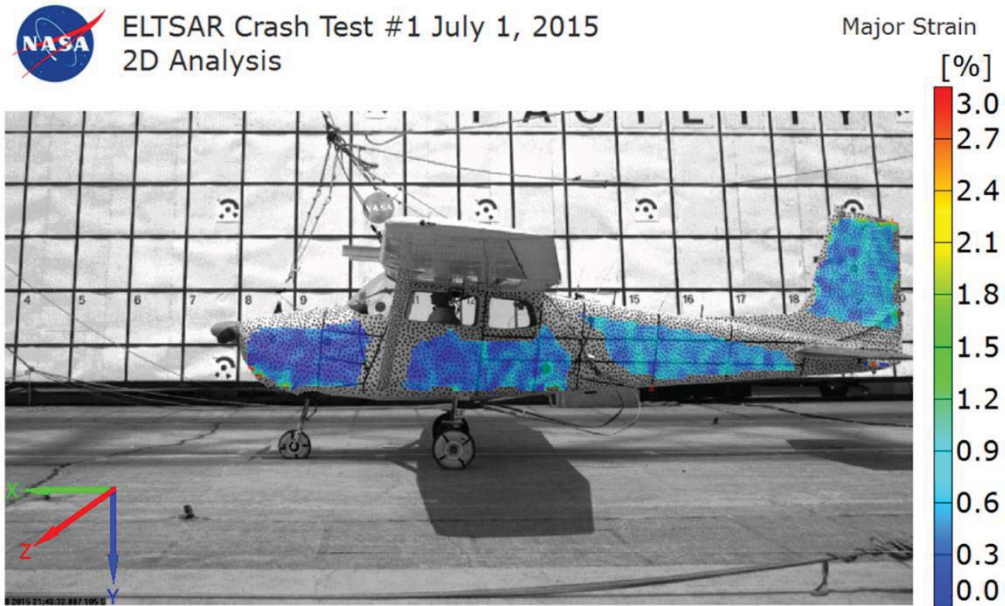
Figure 29 - Data set resolved for use in ELTSAR Test 1 analysis

The target-tracking analysis gave insight into the response of the airplane during the impact event. However, the digital image correlation results will next be examined to investigate airframe response further. After removing all perceived spurious data, there were only small portions of the airframe which gave data usable for analysis, shown in Figure 29. The four major areas where data were resolved on the

airplane were the engine compartment, the cabin, the mid-to-rear tail and the vertical stabilizer. The dot spacing used on the airplane gave a data point every 1.75 in. along the skin of the airplane.

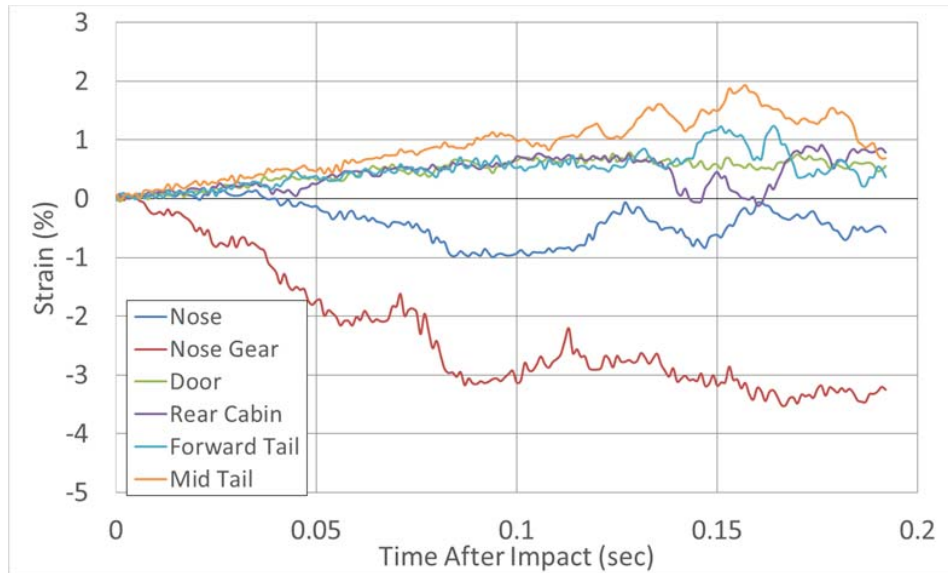
Figure 33 - Vertical (Y) strain time histories from ELTSAR Test 1

The area immediately adjacent to the nose gear experienced the most compression, which leveled off at approximately 3.5% compressive strain at just before 0.200 sec. after impact. At the 0.200 sec. time, the airplane started to rebound and some of this strain would have potentially dissipated, and the permanent strain due to the impact could have been determined. However, because the camera field of view did not capture the entire rebound, no further analyses was completed. Figure 33 also shows that the only other negative strain occurred on the skin of the nose. While Figure 32 shows negative strain around the main gear locations, this strain has dissipated when examining the strains on the door, which are slightly positive. The Mid Tail strains are the most positive, which shows almost 2% positive strain in tension due to the tail flexure.

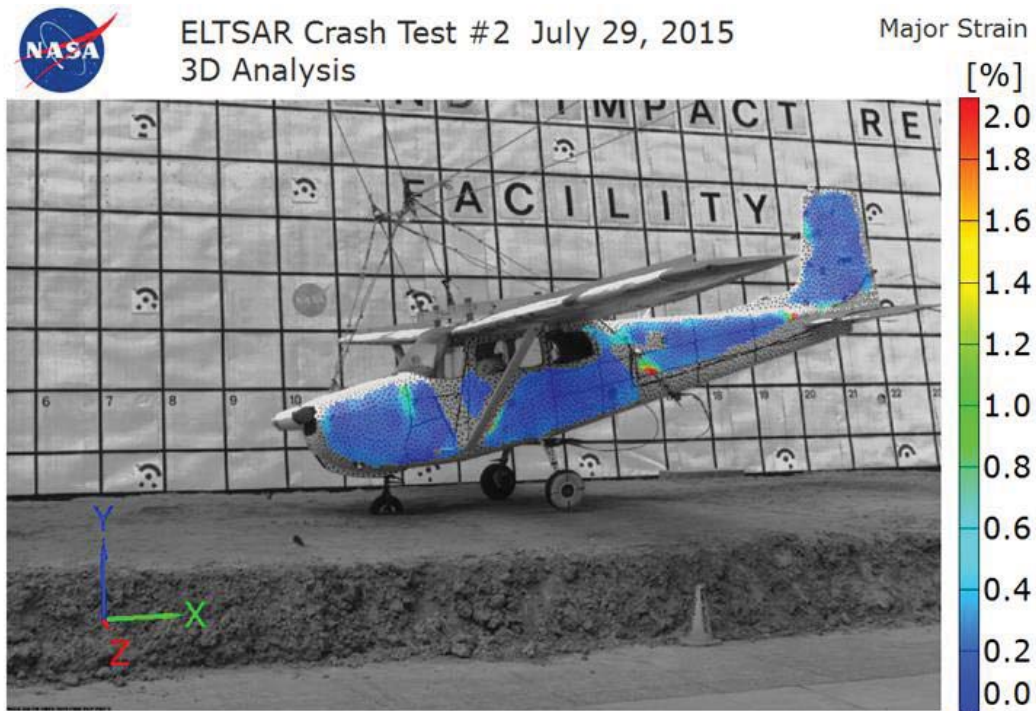
There was a substantial amount of damage on the airframe due to plowing and rotation. The strain on the skin was next examined in an attempt to quantify the deformation. Figure 38 presents major strain on the airframe approximately 0.021 sec. after initial nose gear to soil contact.

Figure 38 - ELTSAR Test 2 major strain at t+0.021 sec

Figure 38 also shows the erroneous data on the tail at the location of the DAS umbilical, which was also seen in ELTSAR Test 1. After ignoring these data, the major result is shown on the nose at the firewall location. The nose wheel has started to penetrate the soil, which creates a pivot point for the start of rotation. The strain developed at this location is the beginning of the deformation of the nose of the aircraft due to the rotation about the nose wheel, while the majority of the rest of the airframe is unaffected at this time. Figure 39 shows the major strain developed a short time later, at 0.063 sec. after impact, or 0.042 sec. after the data shown in Figure 38.

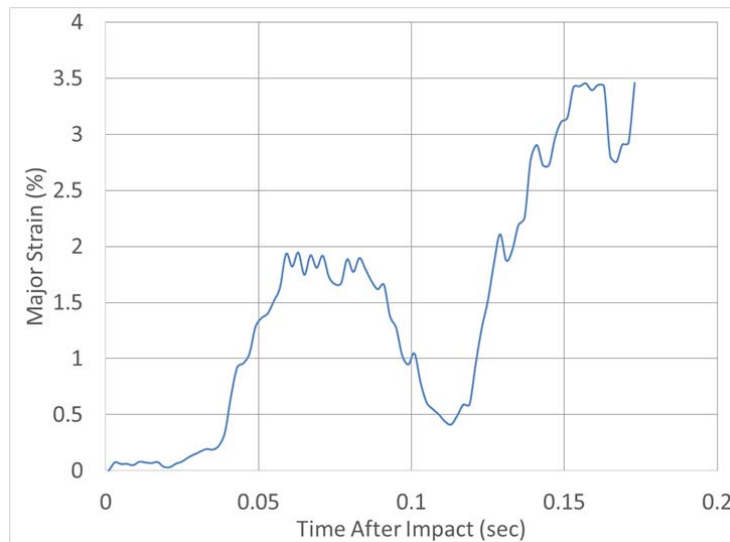
Figure 40 - ELTSAR test 2 door frame strain time history

The strain plotted in Figure 40 reaches an initial peak of 1.9% approximately 0.059 sec. after impact and plateaus for the next 0.024 sec. It then dips down to a minimum of 0.41% at 0.113 sec. after impact. It returns to almost 3.5% at 0.155 sec. after impact and stays at this value until the data are unable to be tracked further. The initial plateau and then minimum suggests a stress wave traveling through the airframe skin due to the initial impact at the nose. The strain reaches a minimum after the wave has passed, but then heads back to a permanent value of almost 3.5% when the airplane finally starts to flip over, suggesting that the flipping permanently deforms the airframe. Shortly after 0.150 sec., the extreme deformation of the aircraft obscures the majority of the dot pattern on the engine and cabin so tracking near the front of the airplane is not possible. However, the portion of the tail aft of the buckling deformation is a portion of the aircraft which is able to be tracked for the next 0.700 sec. Figure 41 shows a fringe plot, along with a time history of major strain on the portion of the tail capable of being tracked.

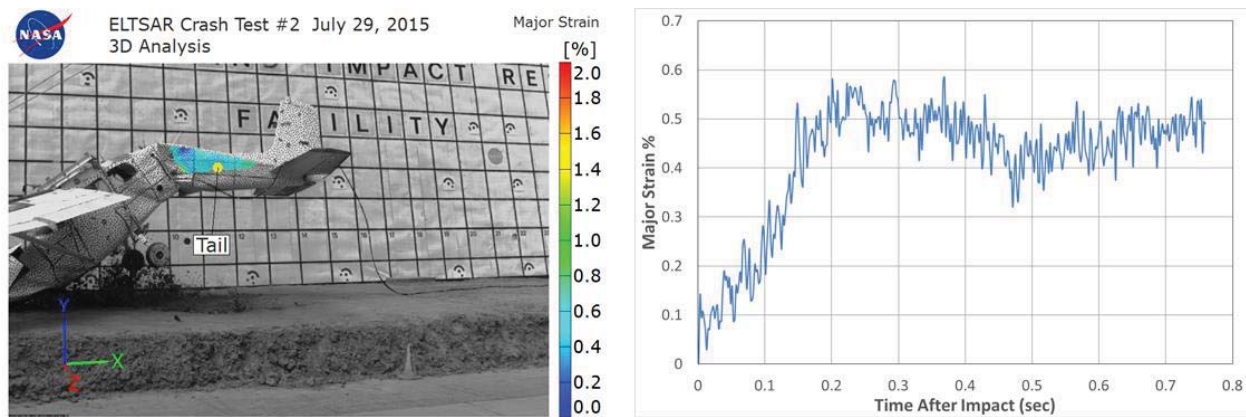
Figure 41 - ELTSAR Test 2 major strain on tail.

The deformation on the tail was able to be tracked late into the time history of the crash. It is important to note that the tail reached a maximum of almost 0.6% and sustained major strain of between 0.4 and 0.5%, which occurs 0.200 sec. after impact. Much like what was seen in the door frame data, it is at this time when the strain seen in the door also reaches its maximum sustained strain value due to the flipping of the airframe.

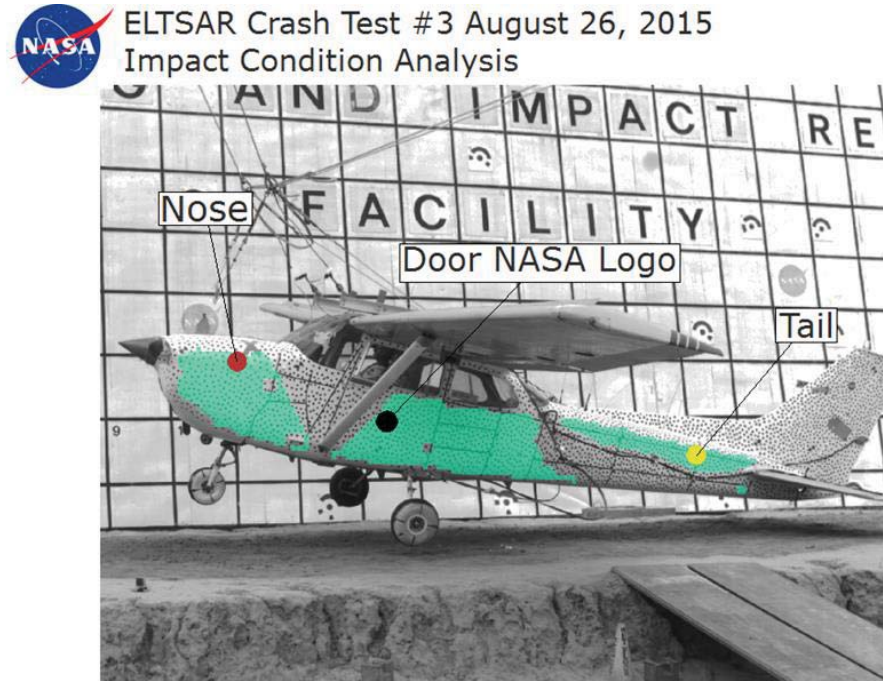
sticker locations as possible using the full-field grid. Impact angle was found using a 2-D analysis of the airplane orientation at the frame of impact. It was important that there were redundant cameras filming the impact and post-impact response, as the impact conditions would not be able to have been found if these were not present. Figure 42 shows the created tracking markers, as obtained from the 3-D deformation analysis.

Figure 42 - ELTSAR Test 3 tracked target locations

All of the bowtie markers used specifically for the 2-D impact condition analysis on the airplane were not able to be tracked with the 3-D deformation cameras due to data limitations outlined in the *Data Interpretation Limitations* section. The wing strut obstructed the view of the CG sticker, and therefore, the CG was tracked via the NASA logo sticker, which was applied approximately 6 in. below the CG sticker on the door. The two other locations used for the determination of impact velocities and attitudes were located on the front and rear of the airplane. In the front, the sticker on the nose near the firewall and battery cover was used. In the rear, the position near the sticker at the ST172 location was used. However, because the point picked was not at the exact ST172 location, it was generically called “Tail.” Figure 43 shows the time history of the three tracked points.

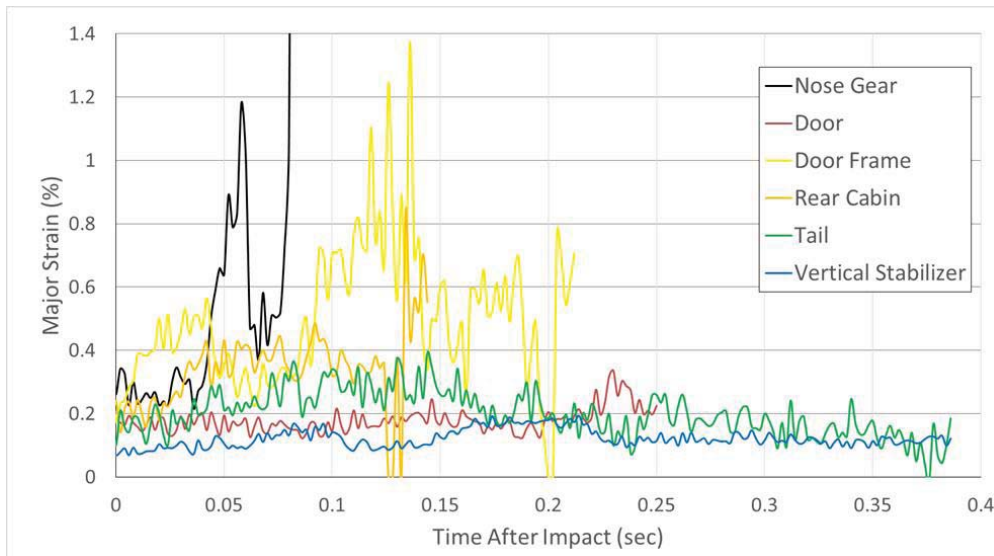
Figure 47 - ELTSAR Test 3 point major strain time histories

The data in Figure 47 shows high major strain mainly occurring in the nose gear, which peaks at 4.5% (not shown) at 0.084 sec. after impact. It is at this time where the maximum vertical displacement of the nose gear occurred, but before the airplane started to flip over. The high strain then moves to the door frame at approximately 0.125 sec. after impact, which is due to the airplane rotation. The high strain has moved from the nose, down the longitudinal axis of the airframe and impacted the cabin during this time. Similar to Tests 1 and 2, the door represented a discontinuity in the airframe skin and displayed high strains when compared to the surrounding airframe structure. Major strain data on the rear cabin also reached a peak sometime after 0.130 sec. after impact. It is near this location where the main structural failure occurred. The major strain in the tail reached a strain value of approximately 0.4% due to tail flexing before the failure, while the vertical stabilizer was largely unaffected from the crash. Its strain data reached peak values of below 0.2% strain.
