Real time fatigue damage growth assessment of a composite three-stringer panel using passive thermography

ABSTRACT

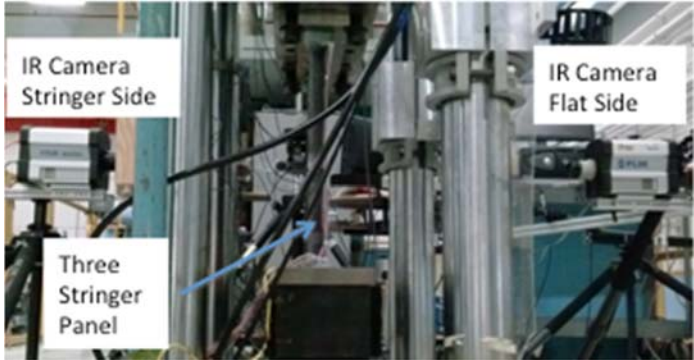
Figure 2. Three-stringer panel setup for passive thermography inspection of both flat and stringer sides.

The thermal measurement setup is shown in Figure 2. The basic system consists of two infrared (IR) cameras operating in the 3–5 micrometer infrared band and an image data acquisition computer. The infrared cameras were configured

with 25 mm germanium optics. The focal plane array sizes for the cameras were from 640x512 to 1024x1204. The passive inspection captured the thermal variations during the fatigue loading. The setup required a Plexiglas® shield to contain fragments if ultimate failure occurred. The IR cameras were located behind the shield with the lens positioned in front of a viewing hole. The added benefit of the shield is it also filters out spurious IR background sources. The cameras were triggered externally using the load signal from the test machine. The sinusoidal load signal was offset corrected and the zero crossover points were used to produce a TTL trigger signal. The trigger signal was converted to a series of pulses using a pulse generator. The infrared cameras were operated at a frequency range of 16 to 90 Hz depending on acquisition time duration. Higher frequencies were used to capture the damage progression as the panel approached ultimate failure. The image data are displayed in real time and stored directly to a hard drive with minimal frames dropped. This provides the capability to acquire frames for an extended period of time (hours if required).

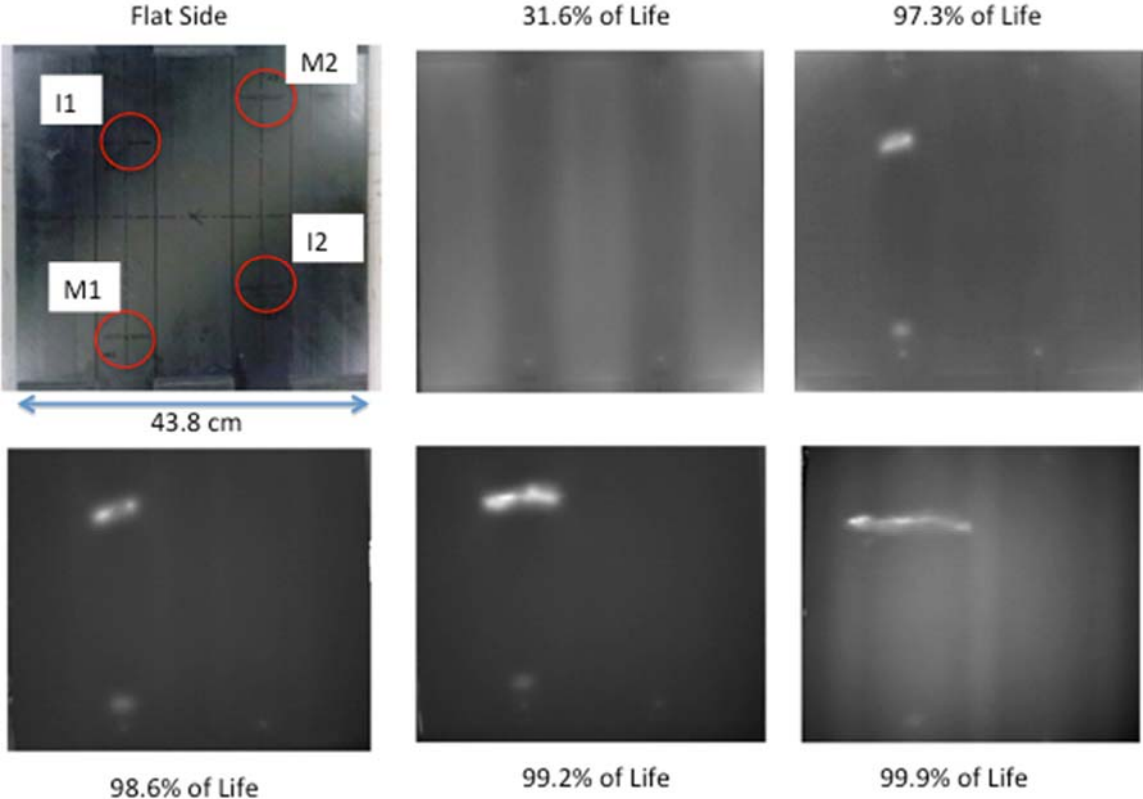
Figure 3. Flat side passive thermography unprocessed raw temperature images as a function of remaining fatigue life.

The passive inspection was performed without application of external heat. Any detectable heating was a result of thermoelastic heating, matrix cracks rubbing or delamination/disbond interfaces clapping or rubbing due to the applied load. Thermal data were both acquired and displayed in real time during cyclic loading. The infrared cameras were triggered simultaneously from the applied fatigue load signal. The real time display was used to allow the operator to watch the damage growth. If the heating area or intensity increased suddenly, then the applied load was stopped for detailed inspection using non-immersion ultrasound. This strategy allowed for controlled damage growth as a function of applied load. Example raw temperature images are shown in Figure 3. The raw unprocessed real time temperature images, shown as a function of remaining fatigue life, provide good contrast to track the increased areas of heating due to damage growth. The early load data as shown in Figure 3 for the 31.6% remaining life fatigue image does not show significant heating and therefore reveals minimal or no damage growth. Processing the images using an image

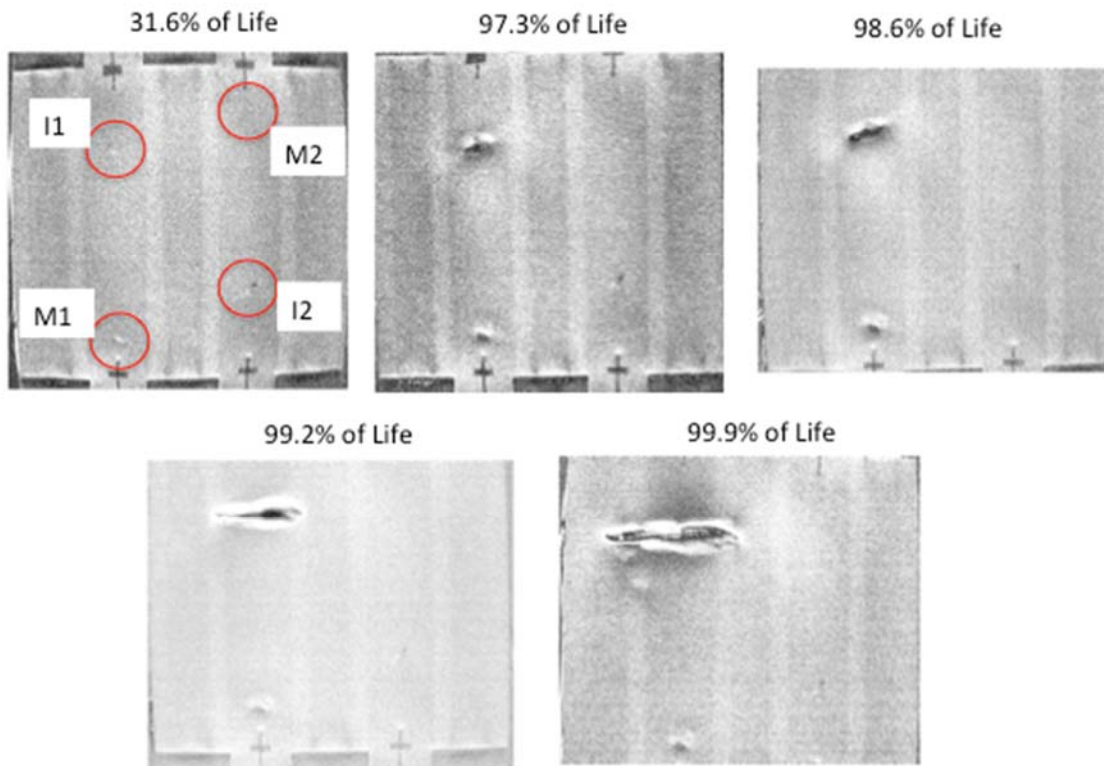
Figure 4. Difference thermography images of damage growth as a function of remaining fatigue life.

where k = number of images per cycle and i is the current acquired image number. Dividing k by 2 insures the maximum and minimum temperature images are subtracted, within a cycle, and this image provides the optimal contrast of the damaged areas. The difference images between the maximum and minimum temperature images for a given cycle are shown in Figure 4. The subtracted images reveal the damaged areas in greater contrast as compared to the raw unprocessed temperature images shown previously in Figure 3. The impact I1 is shown to clearly grow as a function % remaining life, and therefore real time difference processing is ideal for display during loading.

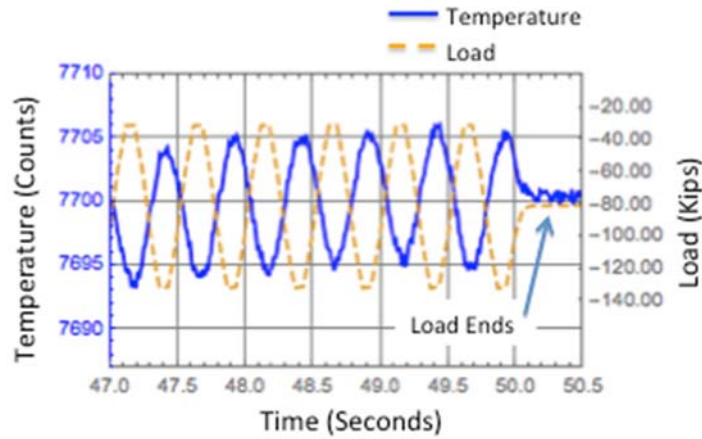
Figure 5. Averaged temperature over panel surface and applied load.

The image data are stored directly to a hard drive for processing. This provided the capability to acquire frames for an extended period of time (hours) if necessary. The stored data was subsequently analyzed to track the temperature increases in more detail. The temperature response was generated by averaging the temperature values (counts) over the panel. The average temperature and applied load are plotted in Figure 5 where the applied compressional loading increases the overall temperature and release of loading decreases the temperature. This is attributed primarily to the thermoelastic effect. For each cycle, the maximum and minimum temperature images were selected and subtracted. The difference images were then averaged over a given number of load cycles (typically around 50 cycles). Examples of the processed passive inspection results, showing detected damage, are shown in Figure 6 along with comparisons to non-immersion ultrasonic inspection results. Frictional forces or clapping of damaged areas during loading produce

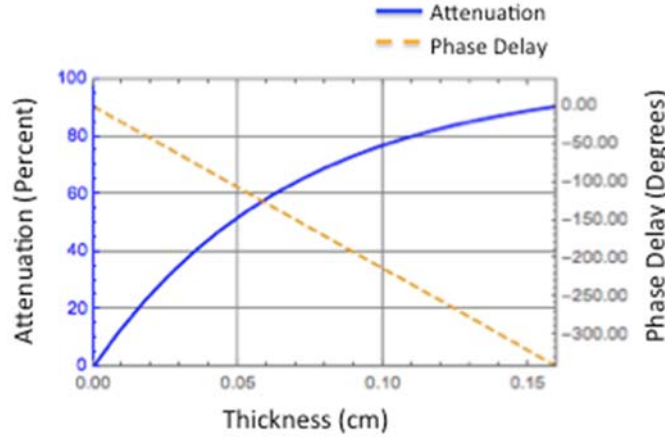
Figure 7. Comparison of attenuation and phase delay as a function of thickness.

The values of thermal diffusivity, *diff*, is estimated to be 0.0045 cm²/sec [8] and the frequency $Freq = 2.0$ Hz (fatigue frequency). The attenuation and phase delay are both plotted as a function of defect depth in Figure 7. Equation (2) provides a linear estimate of the phase difference between the temperature at the defect location (depth z) versus the measured surface temperature response. For near surface damage the phase delay will be small whereas for deeper defects the phase delay will be greater. Because the periodic thermal responses are highly damped, the measured defect depth is limited using phase, especially since the fatigue loading frequency is fixed at 2 Hz. To address this limitation, 2 infrared cameras were used to capture the thermal response on both the flat and stringer sides.

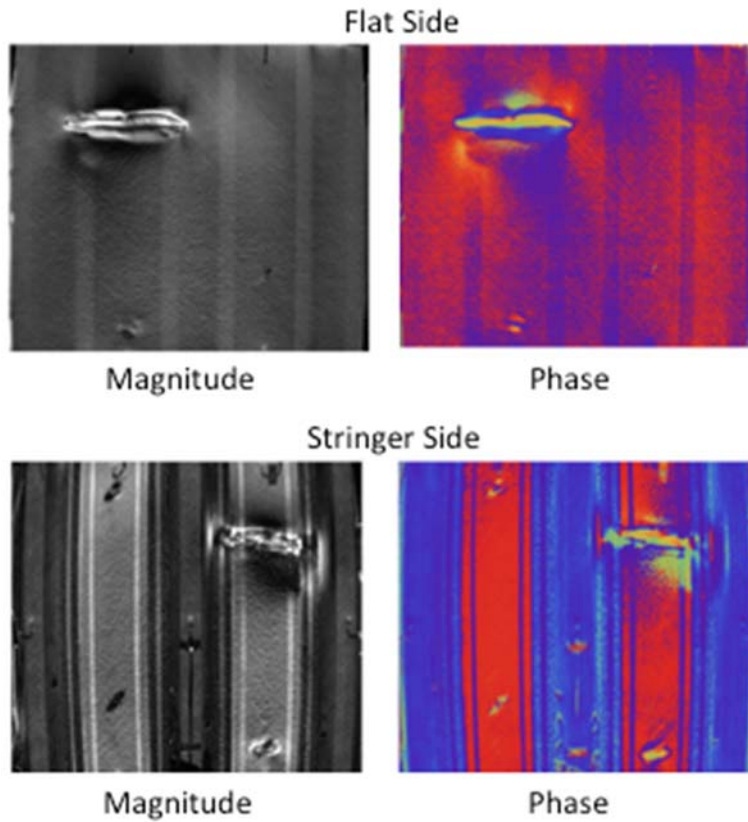
Figure 8. Magnitude and phase images (at 2 Hz) of both the flat and stringer sides.

The phase and magnitude images are calculated by taking the Fourier transform, pixel by pixel, of an image data cube [9,10]. The magnitude and phase images (representing 10 load cycles) at the frequency of loading (2 Hz) of both flat and stringer sides are shown in Figure 8. These images represent damage to within several cycles before ultimate failure. The phase delay image is used to estimate damage depth using equation 2. The phase delay is determined by subtracting the corrected loading phase with the phase within the image. The loading phase is corrected by 180 degrees and this defines the surface phase temperature response (confirmed by Figure 5). Defects at the surface will have a phase delay of zero and deeper defects will have an increasing phase delay. This is shown in Figure 9 where the ultrasonic through-the-thickness results are compared to the thermal phase delay image for defect I1. There appears to be good qualitative agreement for the near surface defects to ultrasonic images a and b. The ultrasonic inspection results for c and d are barely detectable in the thermal phase image since the periodic thermal response is highly damped for deeper defects.

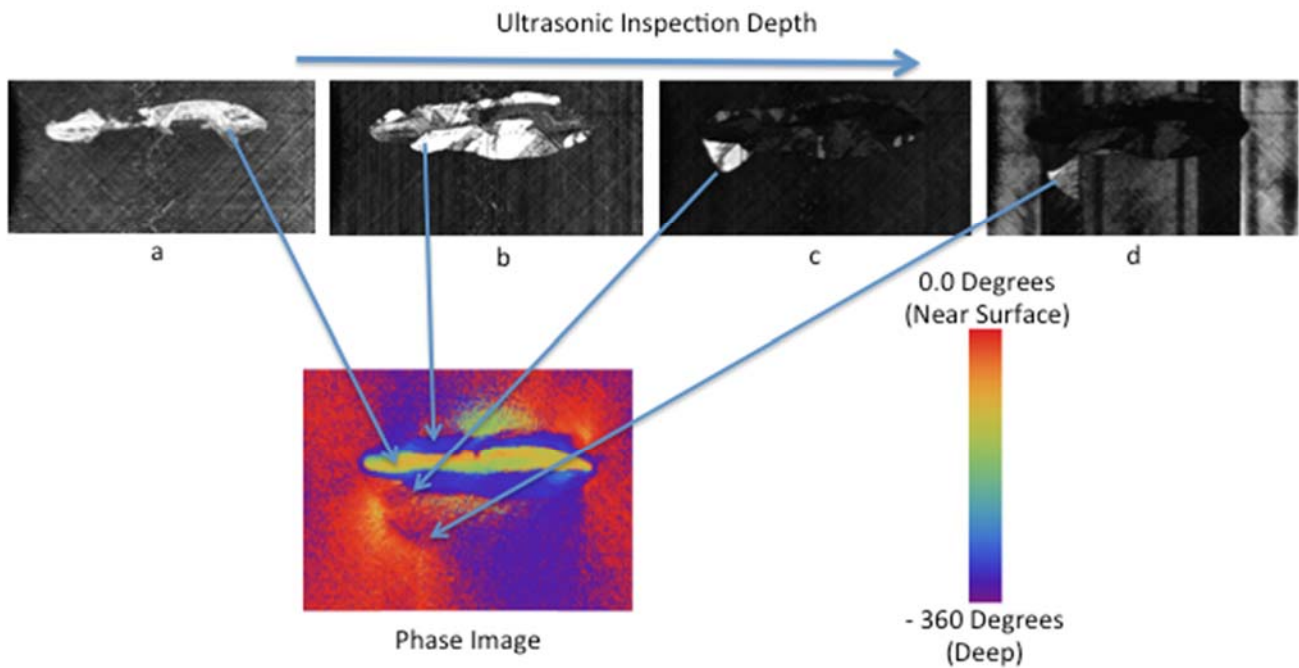
Figure 9. Comparison of phase image to ultrasonic inspections showing damage at multiple interfaces.

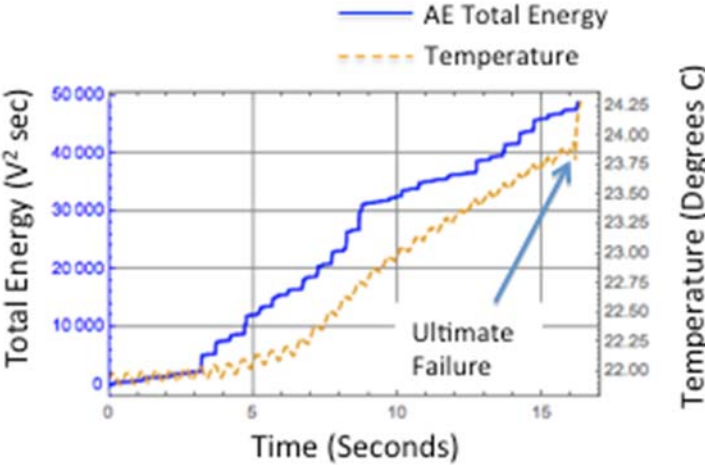
Figure 10. Comparison of total acoustic emission energy to temperature.

where V_i is the signal voltage, i is the time reference point, n is the number of time points in the signal, Δt is the sampling time per point. The total event energy is calculated by summing the SE values for all the acoustic emission sensors (Figure 10). Also in Figure 10 is the averaged measured temperature over defect II, calculated from the thermal camera image data. Trends of the energy over time, or released thermal energy perhaps can be used to identify and track damage development. For example, the release of the acoustic energy can be used to trigger the infrared camera acquisition [12]. Sudden increases, as shown in Figure 10, of both thermal and released acoustic energy show potential to predict ultimate failure. This would allow removal of load to inspect using non-immersion ultrasound before panel loss.

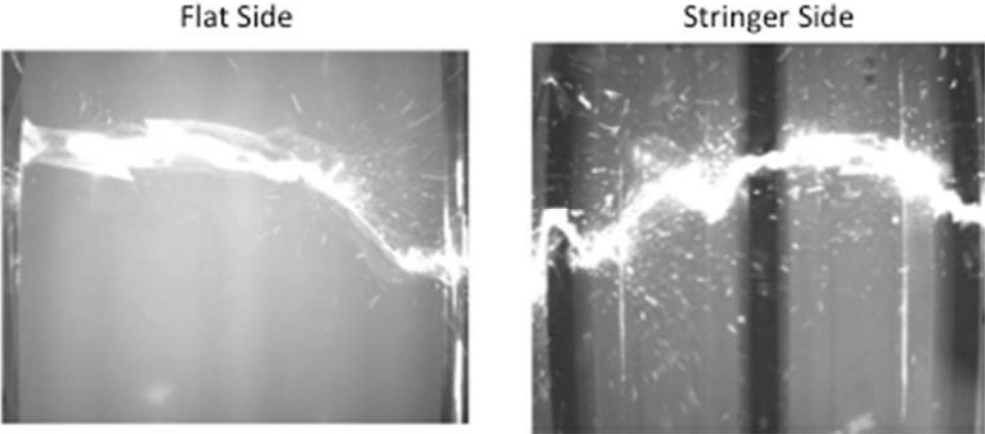
Figure 11. Thermal images showing panel ultimate failure.

Figure 11 shows the flat and stringer side images where the acquisition of the thermal image is timed with the catastrophic failure of the composite structure. These images can be used to determine the final failure mechanism. In this panel, the growing delamination II initiated a disbond between the stringer flange/skin. The growing disbond between the stringer flange/skin was final failure mechanism.
