# Correlation of electrical resistance to CMC stress-strain and fracture behavior under high heat-flux thermal and stress gradients

**Matthew Appleby\* †, Gregory Morscher\*, Dongming Zhu†**

39th International Conference and Exposition on  
Advanced Ceramics and Composites. Daytona Beach, FL

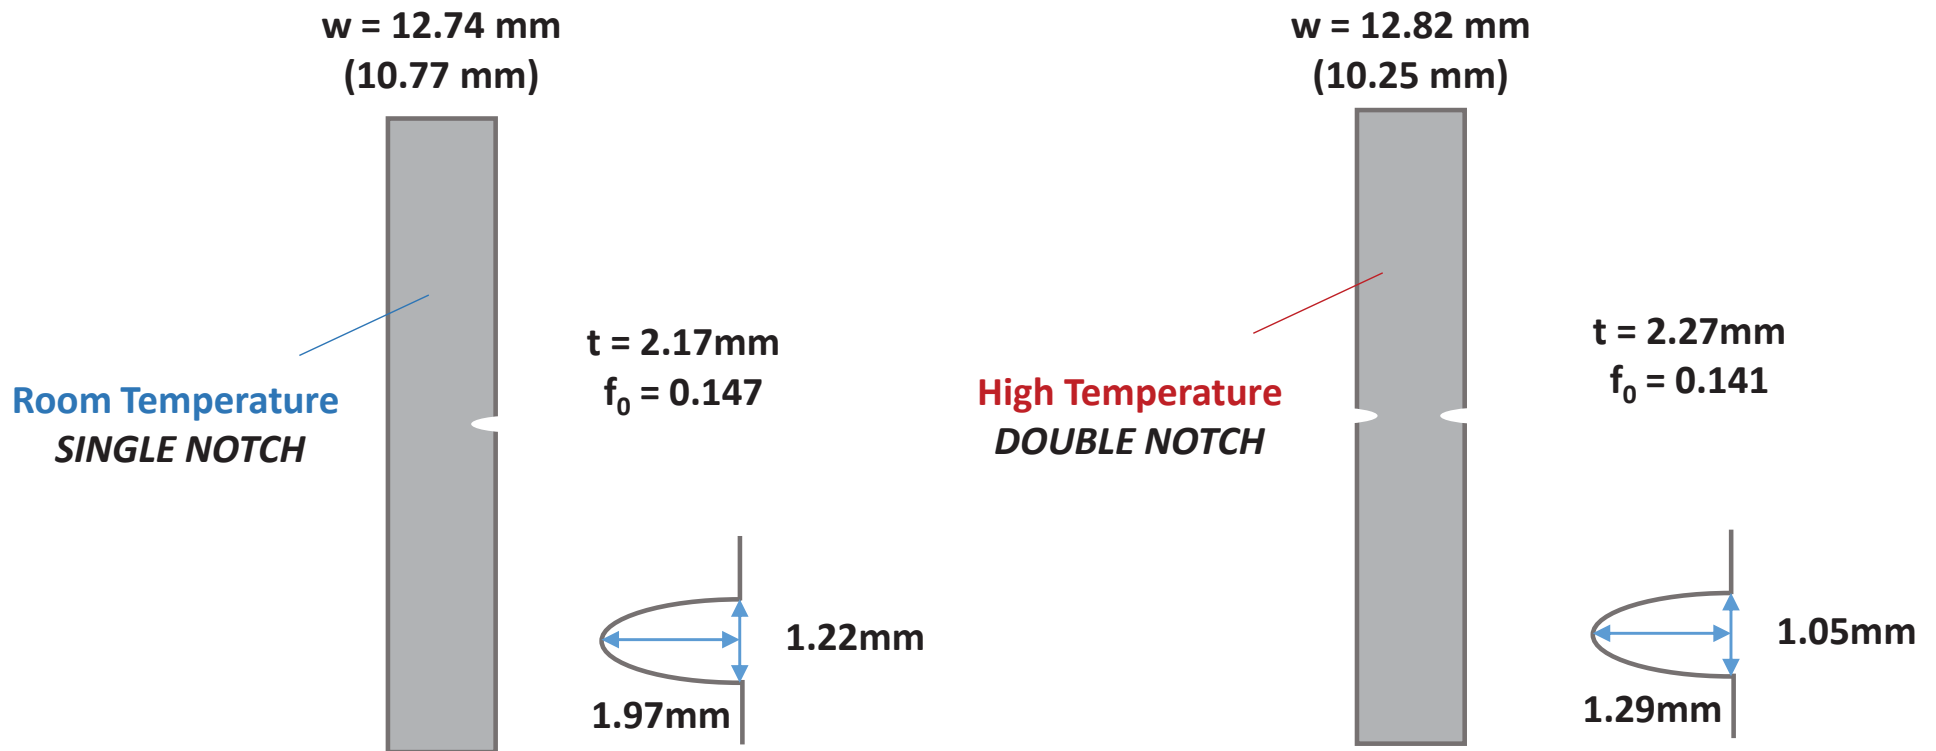
- SiC/SiC CMC material (Hyper-Therm HTC)
  - 8 plies, balanced 5 harness satin 2D woven 0°/90°, SiC/BN/SiC
  - Hi-Nicalon Type-S fiber reinforced
  - Produced by molten silicon melt infiltration (MI)
  - Machined into 6 in. tensile bars

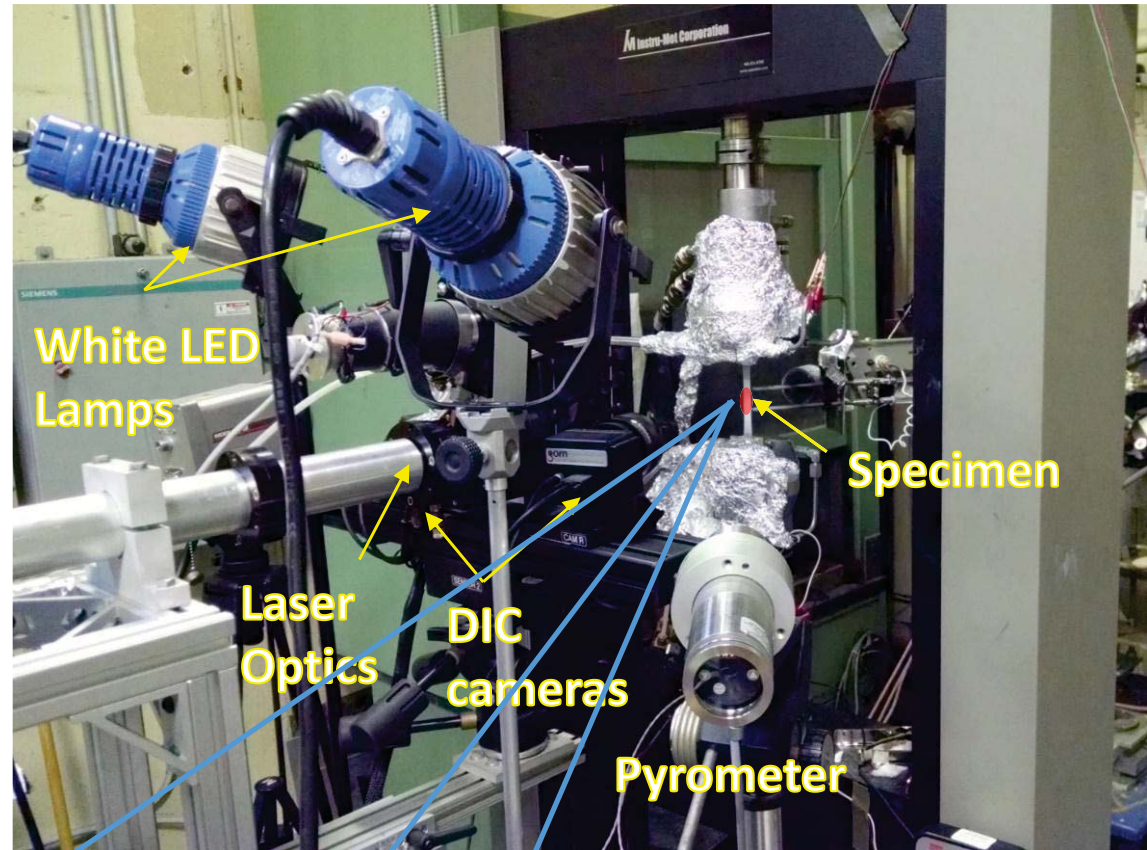
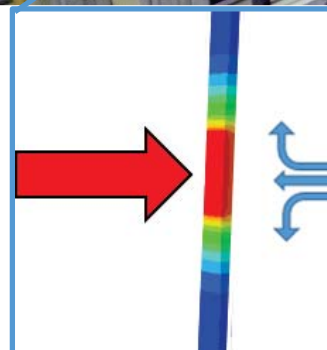
- Specimens are loaded in uni-axial tension rig
- Digital Image Correlation (**DIC**) is used to determine localized strain fields
- Nominal strain measurements are taken from using a 25.4 mm extensometer with a  $\pm 0.5$  mm travel
- **High temperature testing:**
  - Face of specimen gage-section heated by a 3.5kW CO<sub>2</sub> high heat-flux laser
  - Asymmetrical heating by laser generates thermal gradients (thru thickness and longitudinal)
  - Thermal gradients can be increased by the addition of active back side air-cooling
  - Front and back temperatures of the heated region are monitored by optical pyrometers

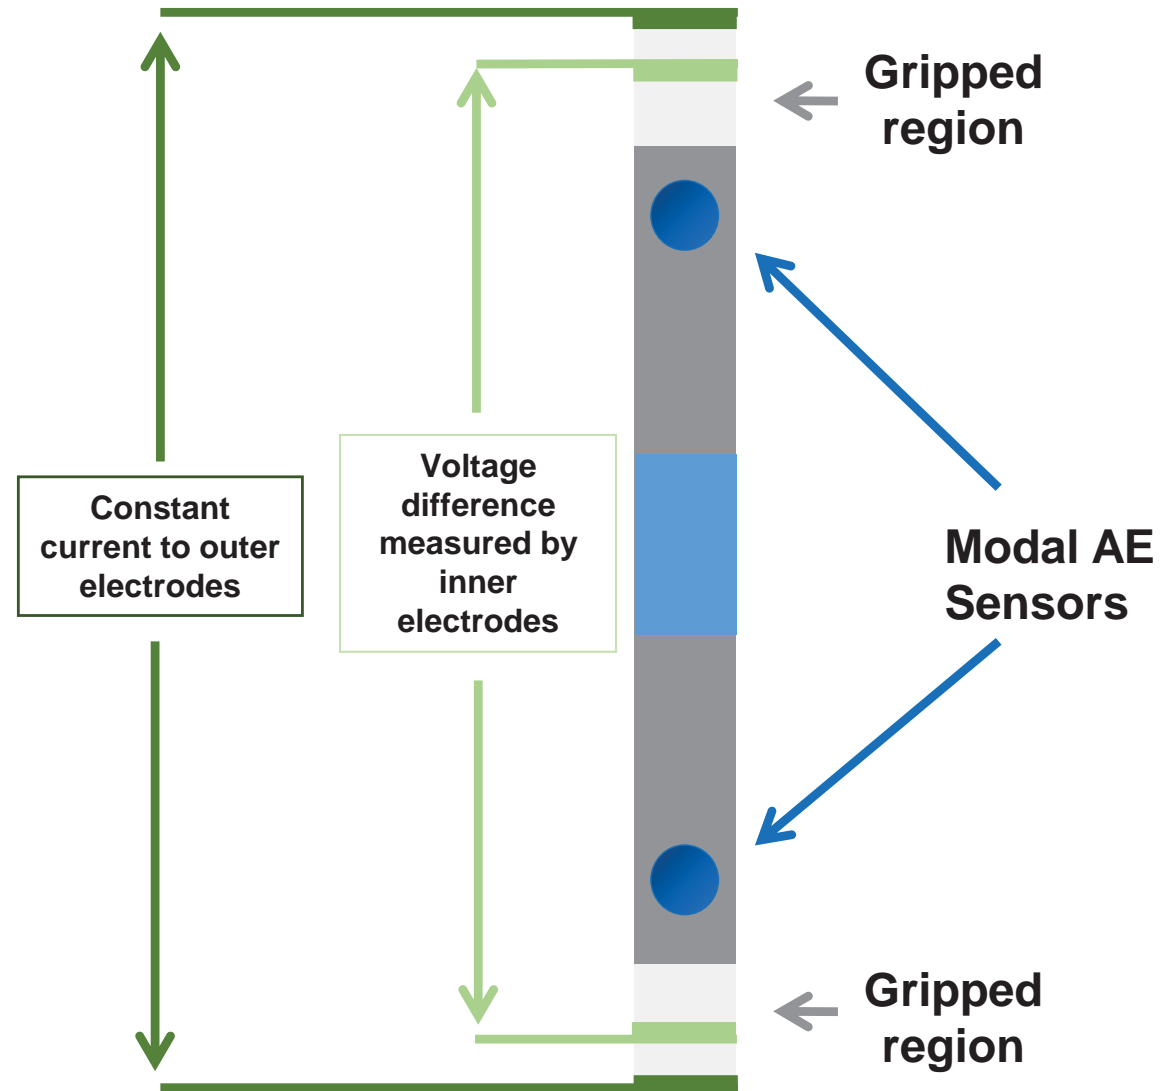
- Electrical Resistance (**ER**) measured by four-point probe method
- In order to avoid high temperature exposure during laser heating, **ER** leads for in-situ measurement are attached within the gripped areas
- Acoustic Emission (**AE**) sensors are attached  $\pm 40$  mm from center
- Post-test **ER** “inspection” is performed by taking discrete measurements along the specimen length

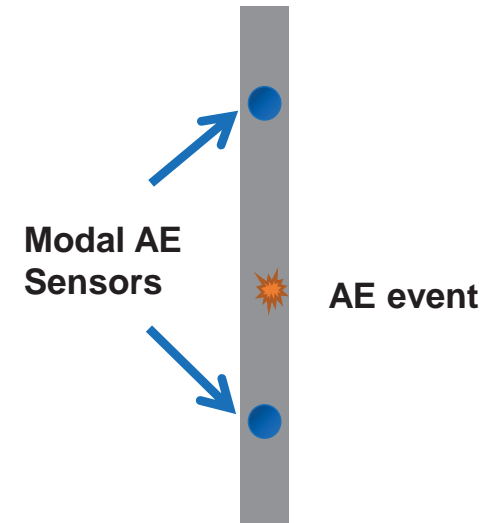
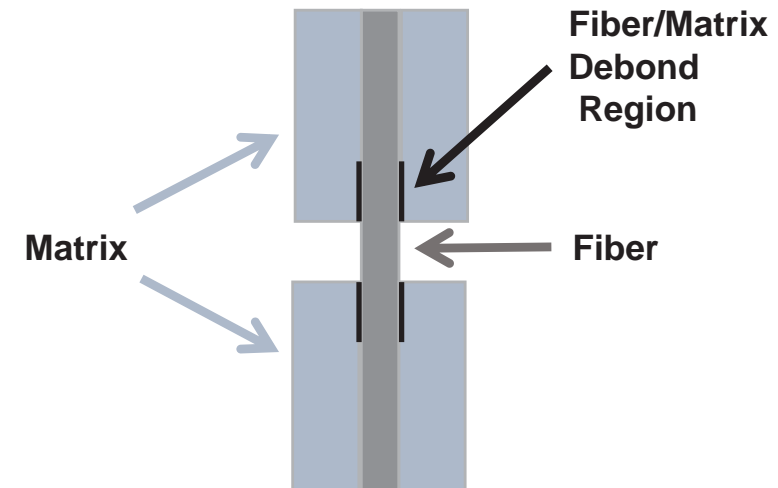
- Fracture energy of solids released as elastic waves which are detected by the use of wide-band sensors in order to quantify stress-dependent cracking initiation and accumulation.
- Location of AE events estimated by the difference in arrival times of AE signals

$$x = \frac{v}{2} (t_{bottom} - t_{top})$$

- Damage in the form of matrix cracks and associated fiber debonding/sliding increase the overall electrical resistance of the composite specimen
- Matrix cracking of MI SiC/SiC is especially sensitive due to the highly conductive matrix formed from excess silicon deposits left from processing

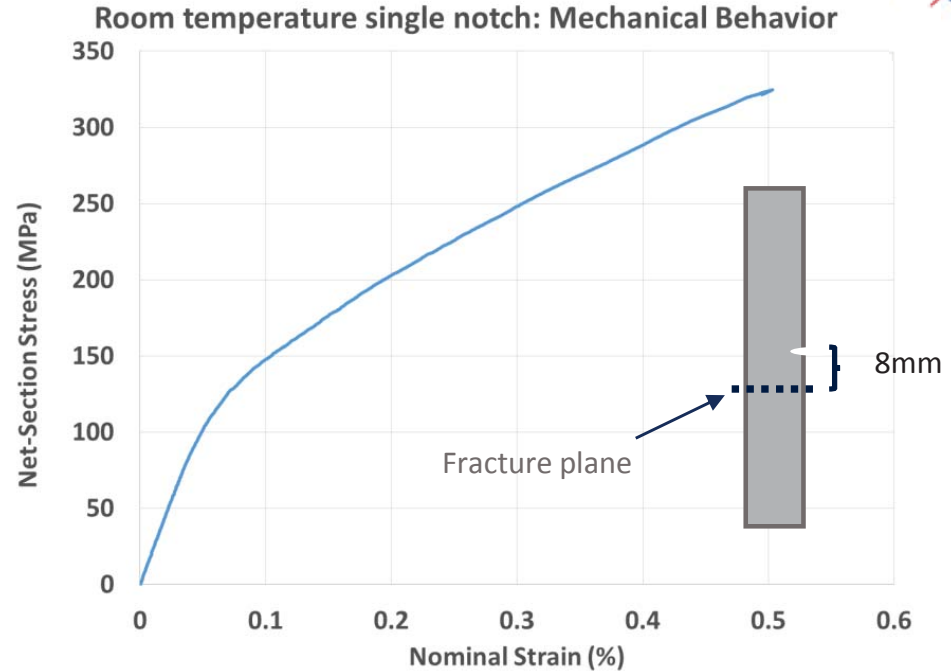
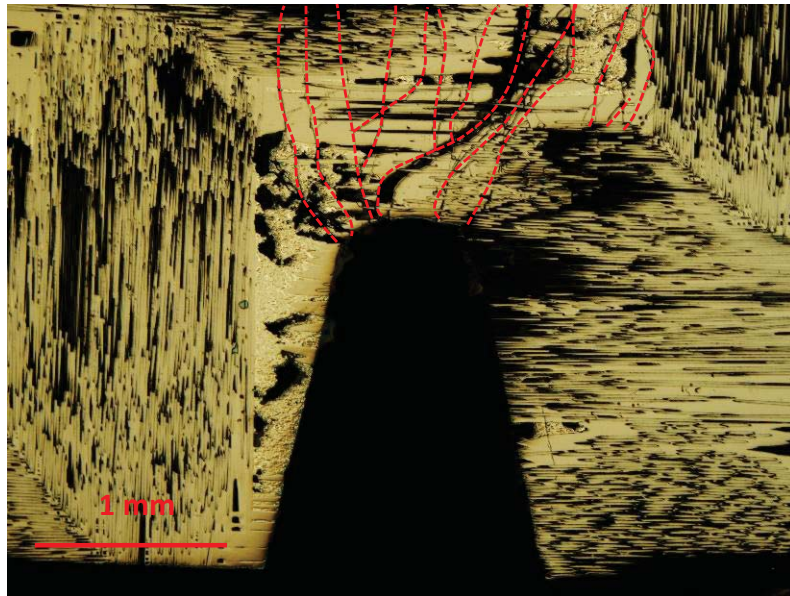
# Room Temperature – Single Notch

- Post-test microscopy revealed high crack densities in the vicinity of the notch, as would be expected from locally increased stress.
- However, due to a large density of porosity, another localized strain field was produced, leading to the ultimate failure location

Crack densities were therefore calculated for the notched region and the far-field regions

-12.7mm < x < -5mm	± 5mm	5mm < x < 12.7mm
Crack Density, mm <sup>-1</sup>	2.1	2.5	1.70
(far-field/notch)	(0.85)	1	(0.68)

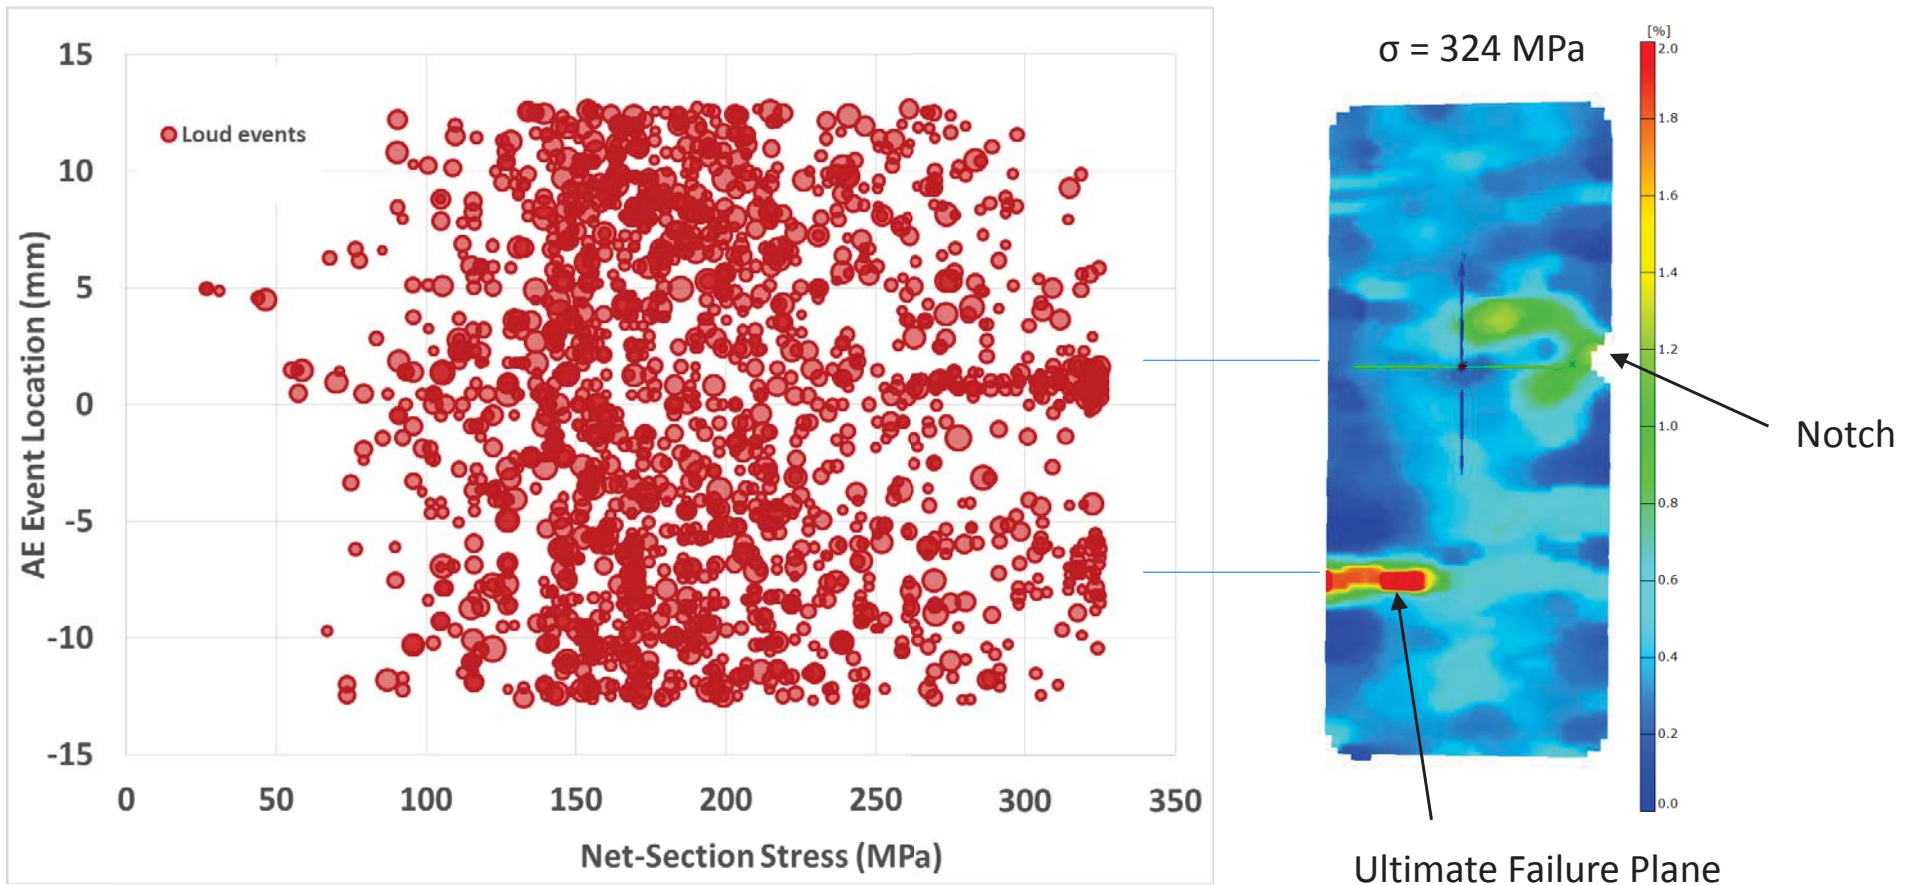
# Damage Location

- Damage location determined from AE events in good agreement with DIC strain-field mapping of gage section at peak load

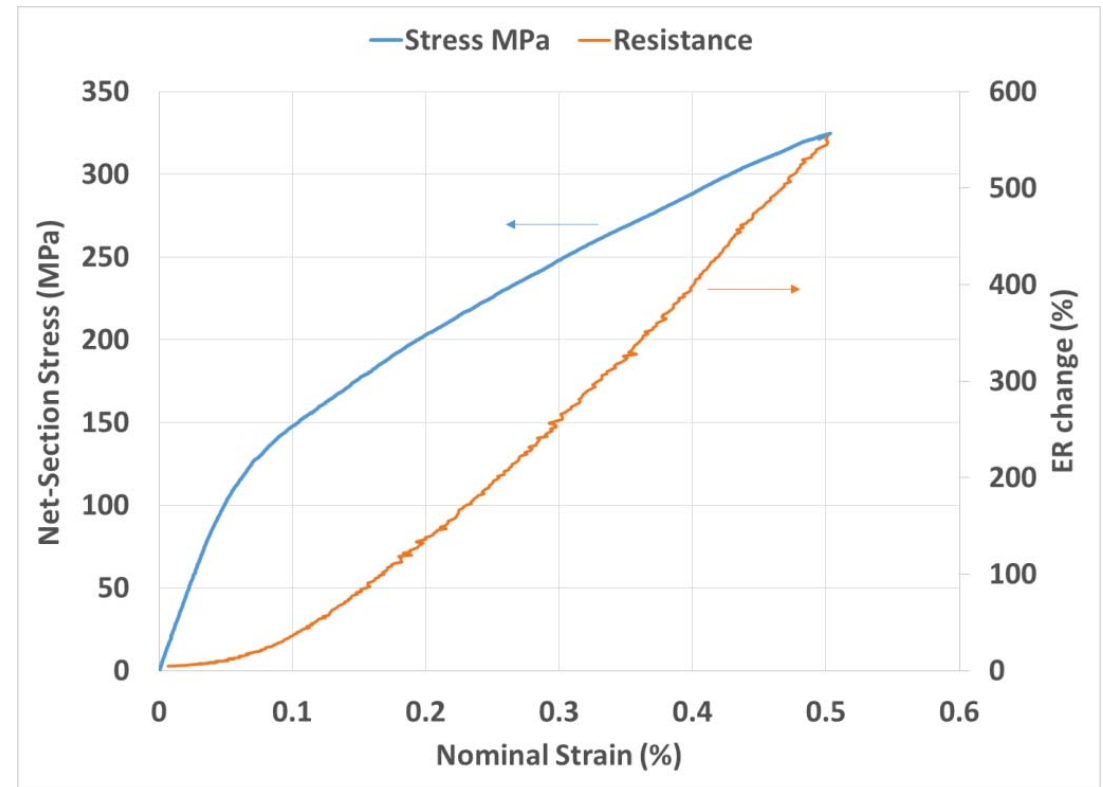
- While the elastic region shows little increase, ER begins to increase rapidly with damage onset.
- The electrical resistance of the entire specimen increases over 500% with an increase in nominal strain of the gage section of 0.5% at failure.
- ER is monitored over the entire specimen showing both the contribution to localized and far-field damage (including all matrix crack and fiber sliding)
- However, as previously noted, the damage accumulation is being dominated by the stress concentration region

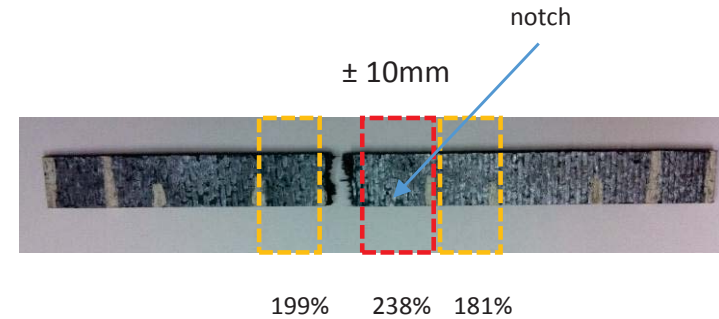
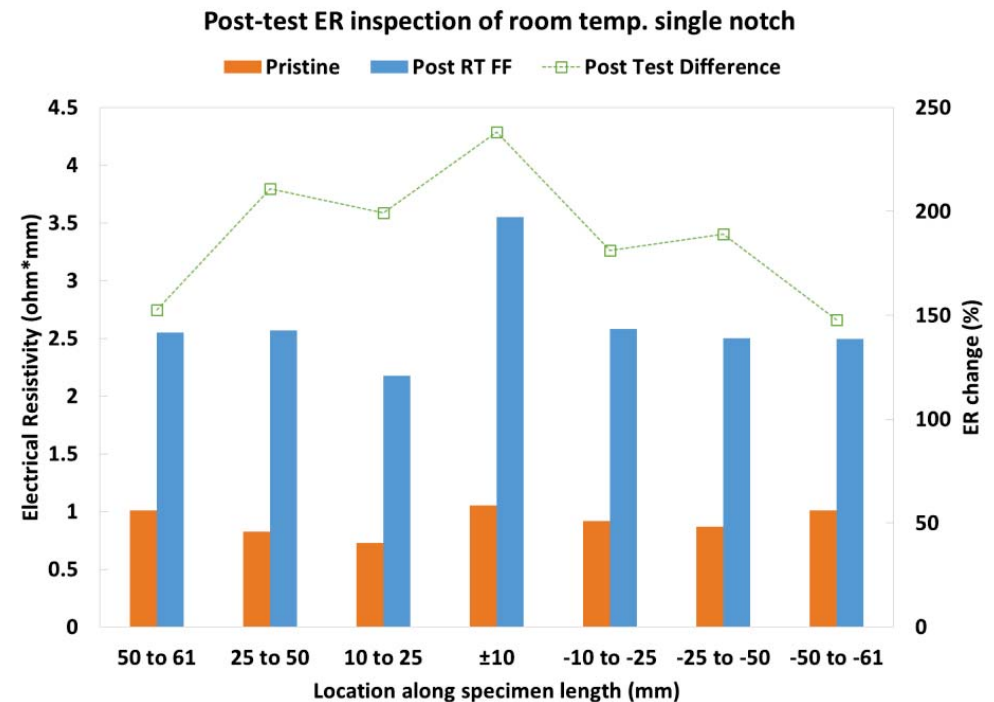
# Post-test ER inspection

➤ In order to determine the contribution of ER increase from the gage region vs. the rest of the specimen, discrete ER measurements were taken along the length of the sample for the “pristine” and “post fracture” cases.

➤ As expected, the results show that the highest ER increase corresponds to the area of increased damage in the gage section

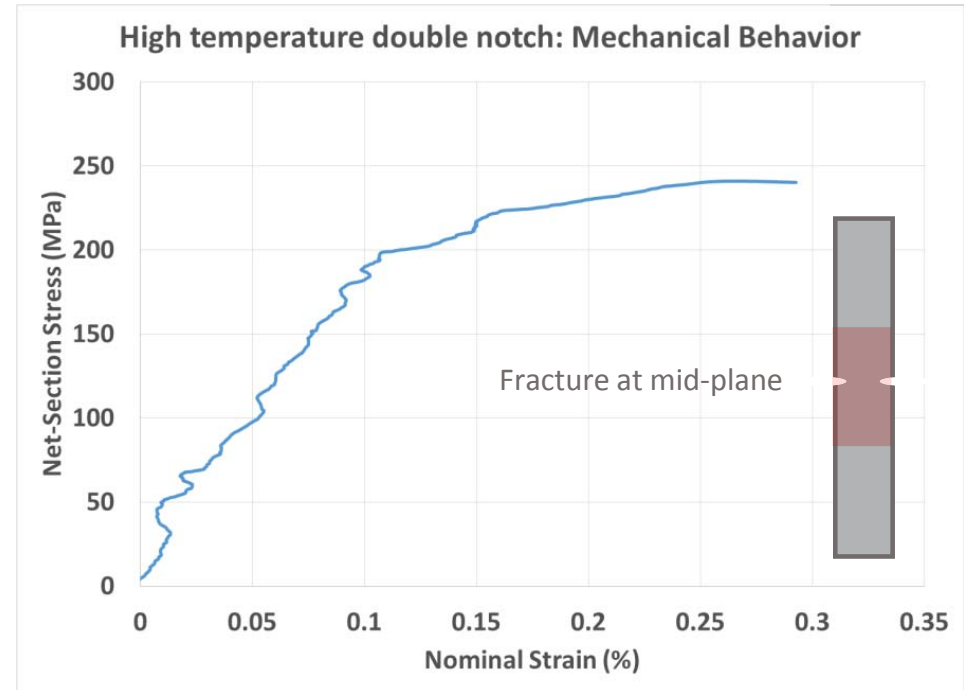
➤ Laser-heated gage section

$$T_{\text{surface}} = 1230^{\circ}\text{C}$$

$$T_{\text{back}} = 1000^{\circ}\text{C}$$

➤ 0.53% nominal strain increase from thermal loading, with an addition 0.29% nominal mechanical strain to failure

➤ Specimen failed along notch plane, with post-test microscopy showing increased crack density in notch region

➤ Specimen exhibits far less damage accumulation than room temperature (single notch) specimen

± 5mm	± 5mm < x < ± 12.7mm
Crack Density, mm <sup>-1</sup>	1.0	0.81
(far-field/notch)	1	(0.81)

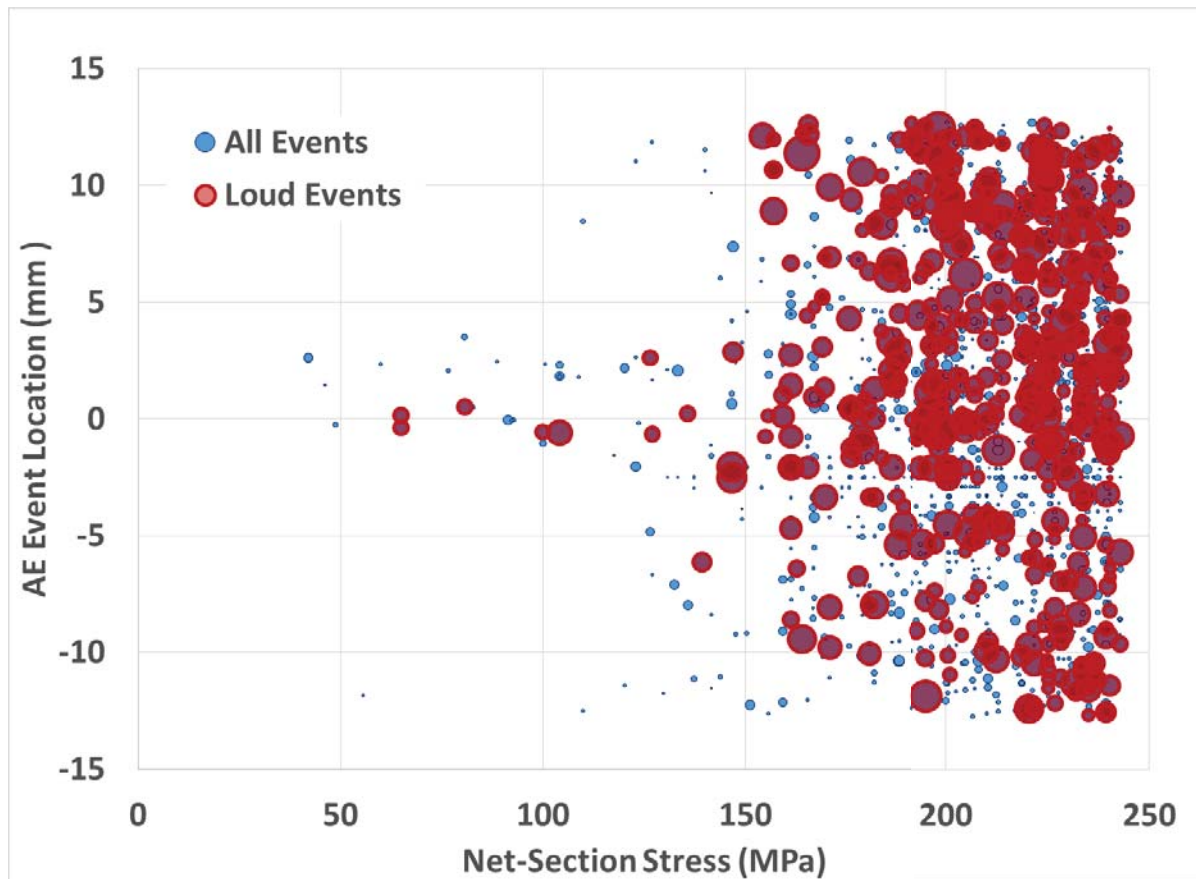
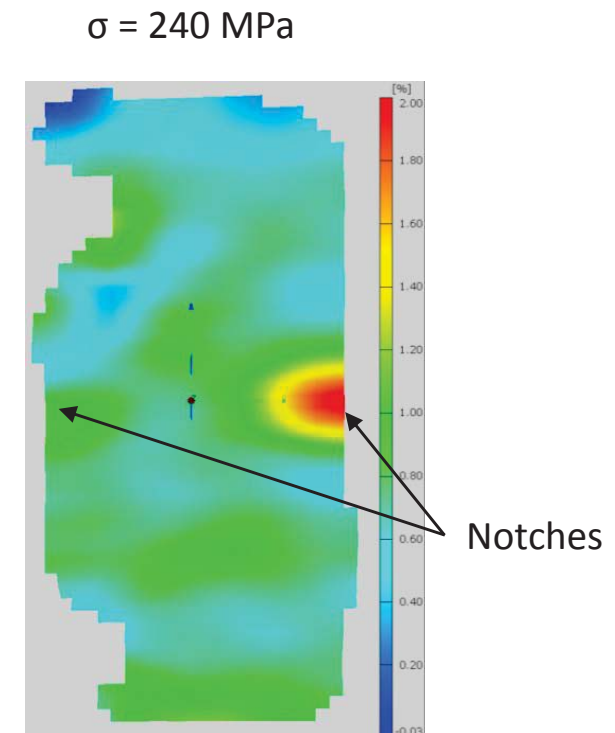
- Once again damage location determined from AE events in good agreement with DIC strain-field mapping of gage section at peak load
- At low stresses, AE activity occurs only in the notch region ( $\pm 5\text{mm}$ ), while only becoming significant in the far-field above 150 MPa

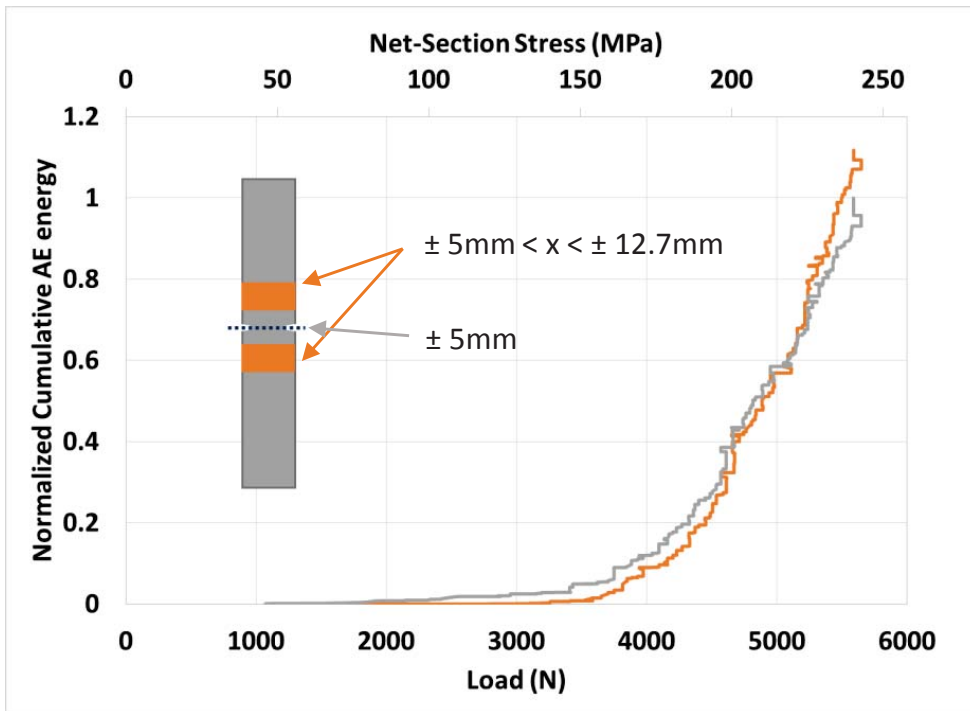
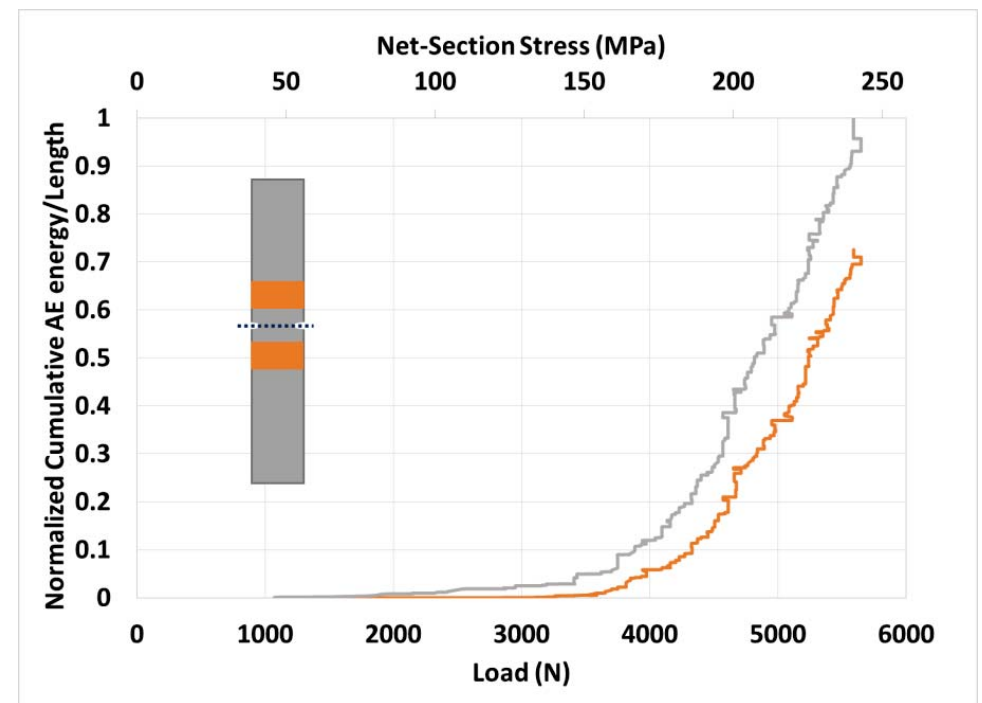
# High Temperature - Damage Growth: Notch vs. Far-Field

- Similar to the room temperature specimen the area around the notch sees an increase in AE energy at a lower load level
- However, this sample does not reach matrix crack saturation, leading to the decreased values in matrix crack density in both the notched and far-field regions (as compared to room temp. test)
- Normalizing by their respective lengths you can see that the region outside the notch has a lower energy density (73% of notch region), which is in good agreement with the reported crack density measurements

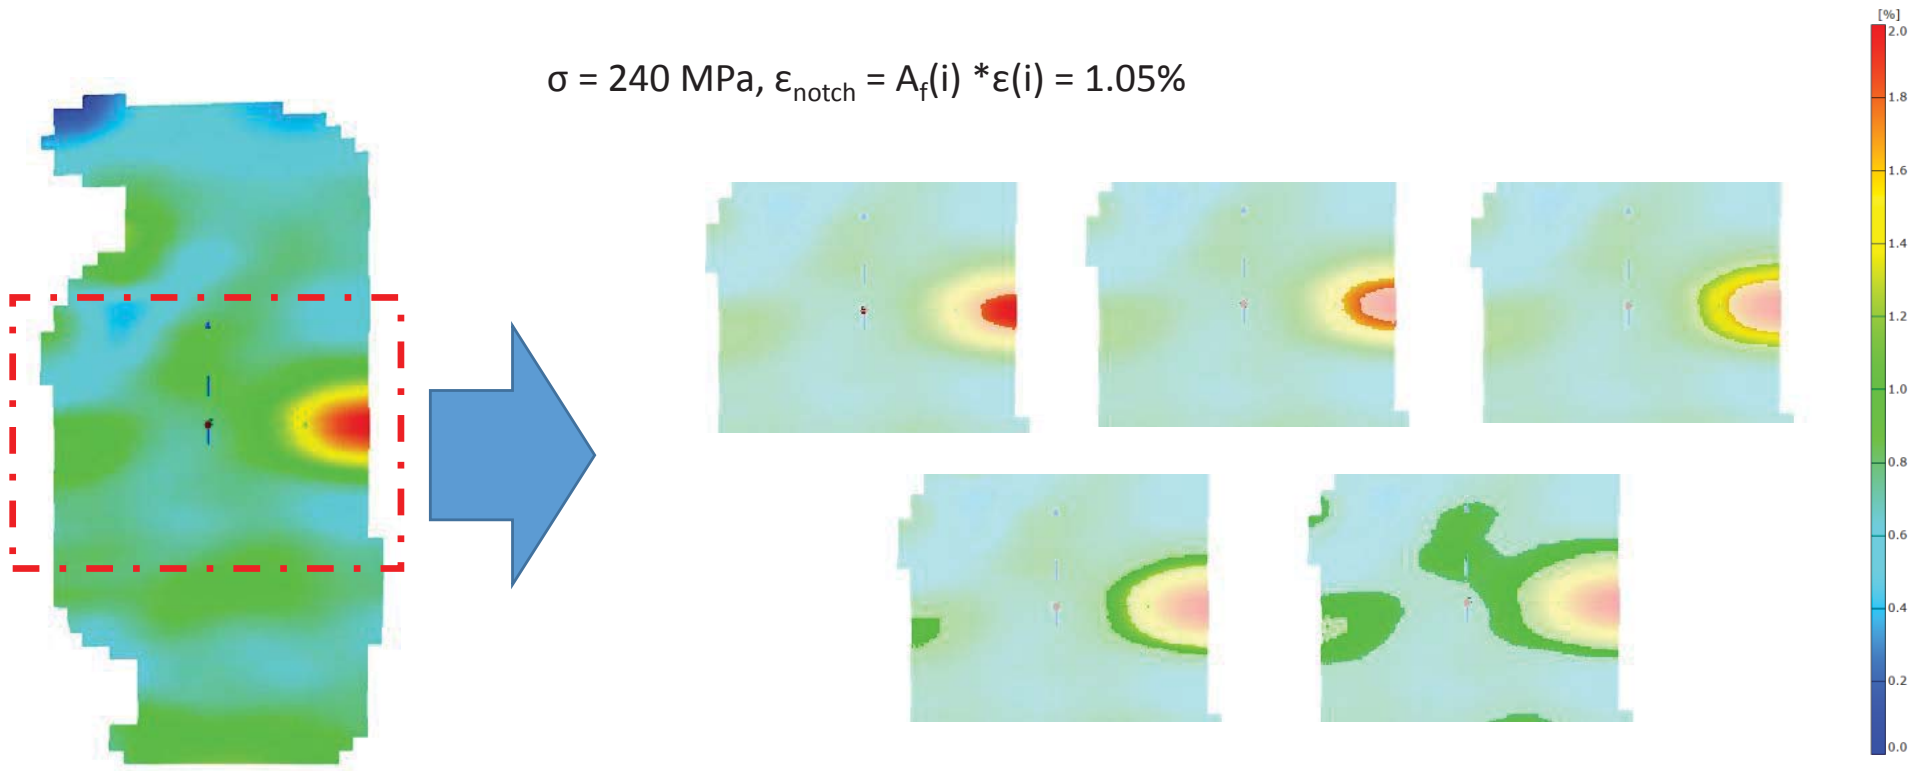
# Notch strain decomposition

- In an effort to further investigate the contribution of the stress concentration region surrounding the notch area with ER increase, the increased strain fields in the notch region were isolated (based on color thresholds) using image analysis software
- The area fractions of each of these strain values is then used to determine the weighted average of elevated strain in the notch region for a given applied stress

$$\sigma = 240 \text{ MPa}, \epsilon_{\text{notch}} = A_f(i) * \epsilon(i) = 1.05\%$$

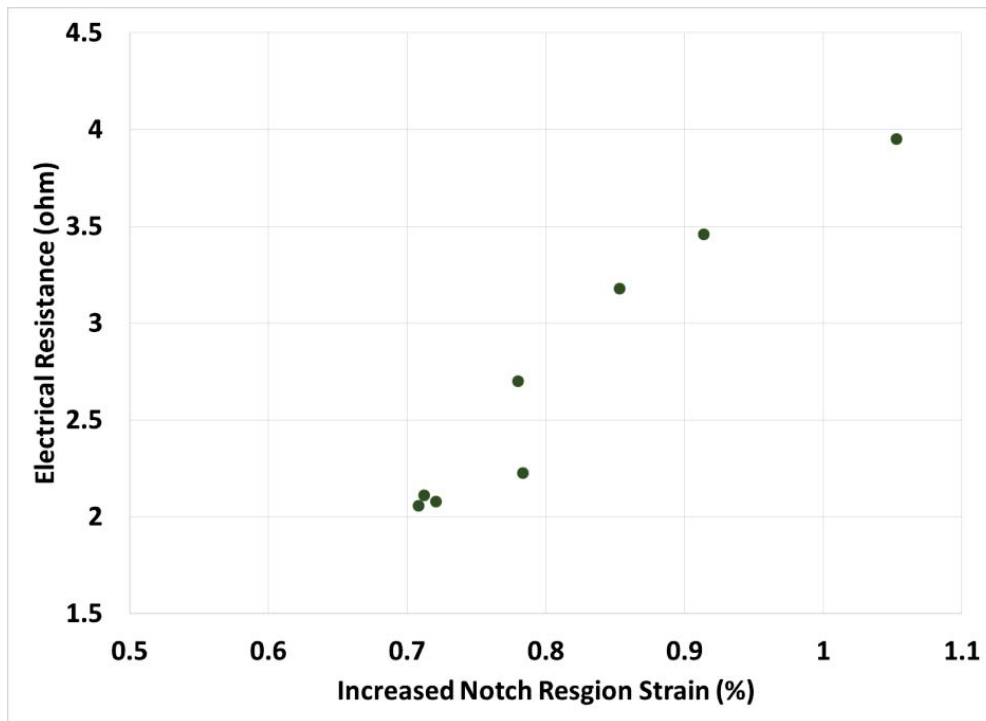
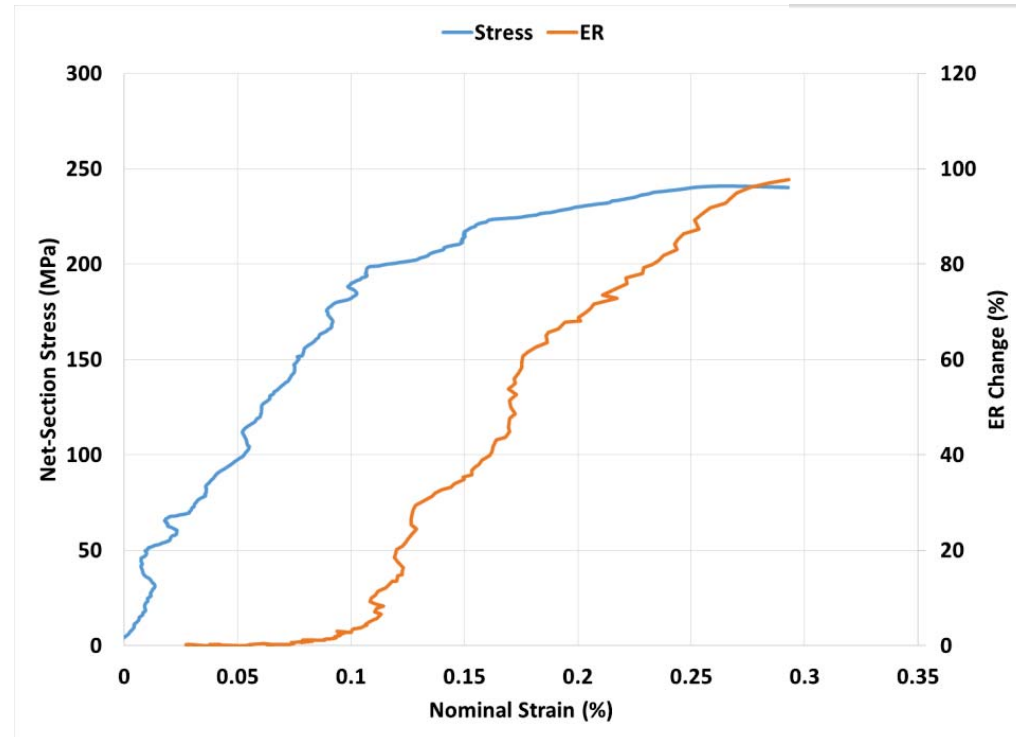
- **Notch strain decomposition** analysis was performed on images of 103, 132, 151, 172, 200, 217, 226, and 240 MPa (net-section stress) respectively

- The values of increased strain in the notch area appears to correlate well with the increase in total ER of the sample; suggesting notch area ER dominance

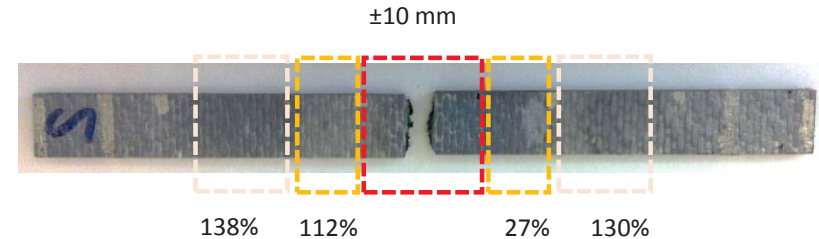
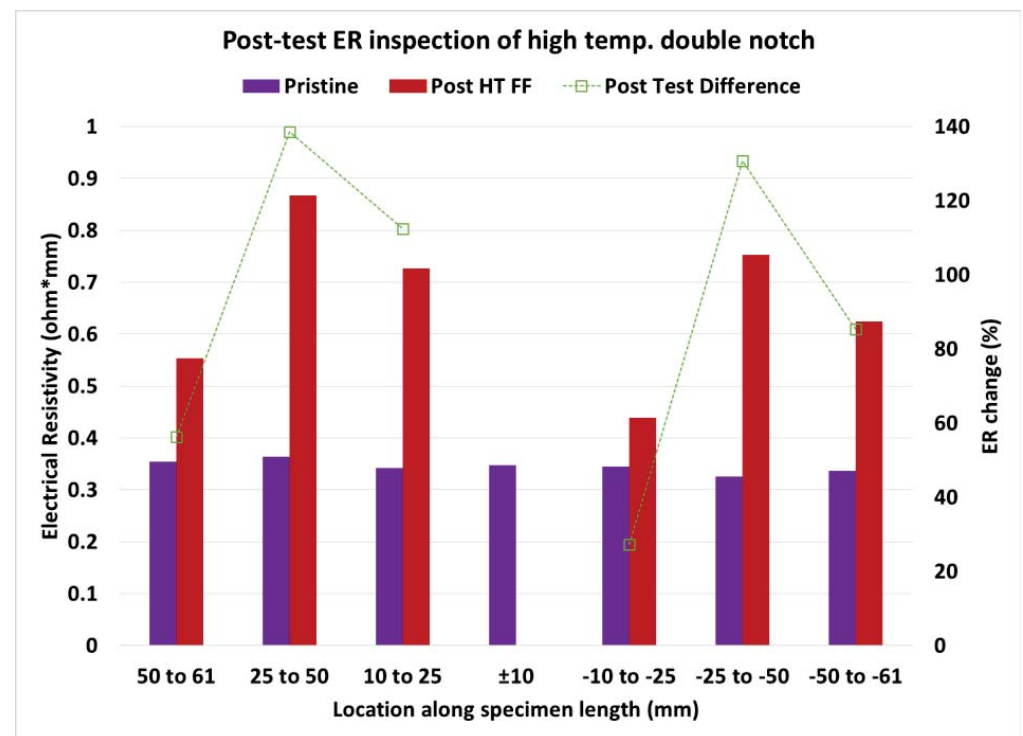
- Room temperature inspection of high-temperature tests
- The post high-temperature fast-fracture ER inspection analysis did not demonstrate the highest ER increase around the notch region as expected
- This seemingly anomalous behavior was further examined by observing the ER response to laser-heating only (i.e. no mechanical loading) to similar temperatures

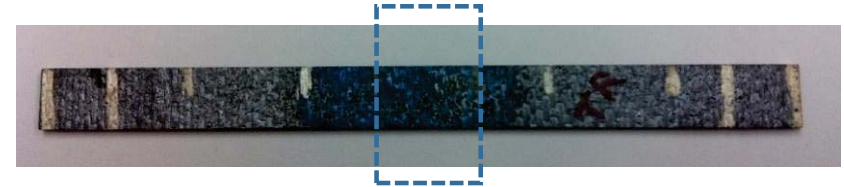
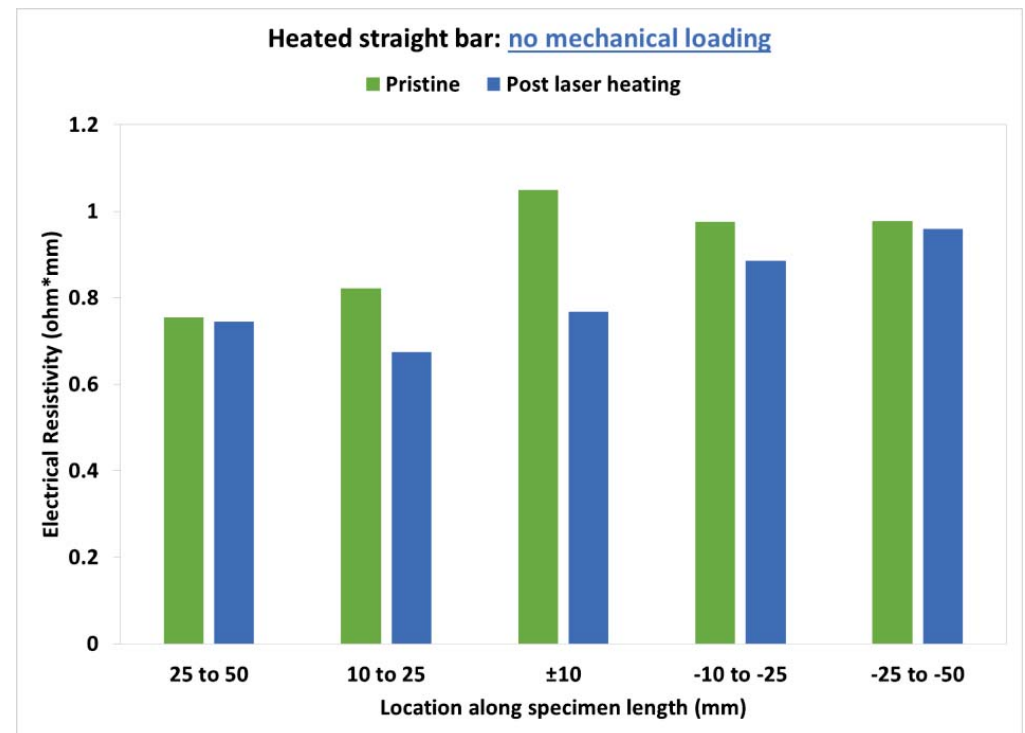
- Post-heat only data shows an increase in electrical conductivity of the heated zone upon cooling back to room temperature
- Clearly more needs to be understood about high temperature microstructural changes in the matrix (relief of residual stress, diffusion of impurities, etc..)
- Competing factors between high temperature exposure and damage could lead to good area for further development
