## Experimental Evaluation of Fatigue Damage Progression in Postbuckled Single Stringer Composite Specimens

Authors: Chiara Bisagni Carlos G. Dávila Cheryl A. Rose Joseph N. Zalameda

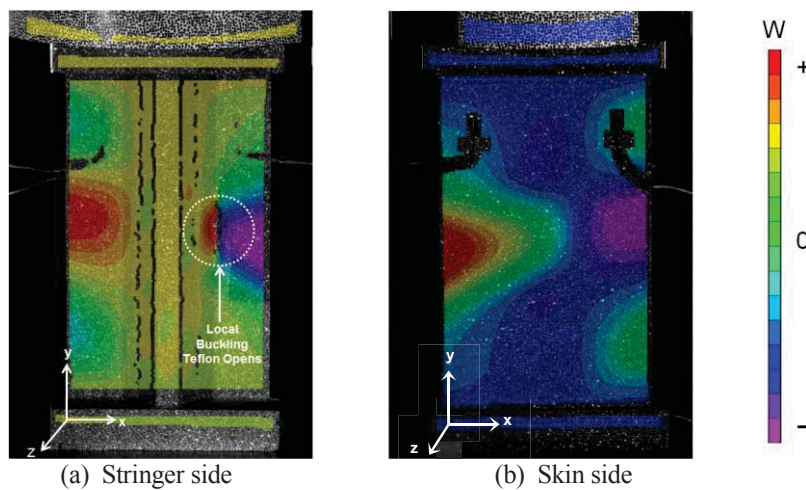
Figure 5. Postbuckling out-of-plane displacements after opening of the Teflon-induced defect. Load=24.65 kN.

Failure produced a sudden opening of the delamination between the stringer flange and skin at the Teflon insert, along with an extension of the initial delamination defect, which caused the load to drop to 24.65 kN. The postbuckling deformations reported on the stringer and skin side of the specimen after the initial defect extension are shown in Figures 5a and b, respectively. The shape of the deformation on the side of the Teflon insert changed significantly compared to the deformation before the growth of the initial defect. The magnitude of the out-of-plane displacements of the skin reached 6.3 mm in the direction opposite to the stringer (positive z-direction as viewed from skin side).

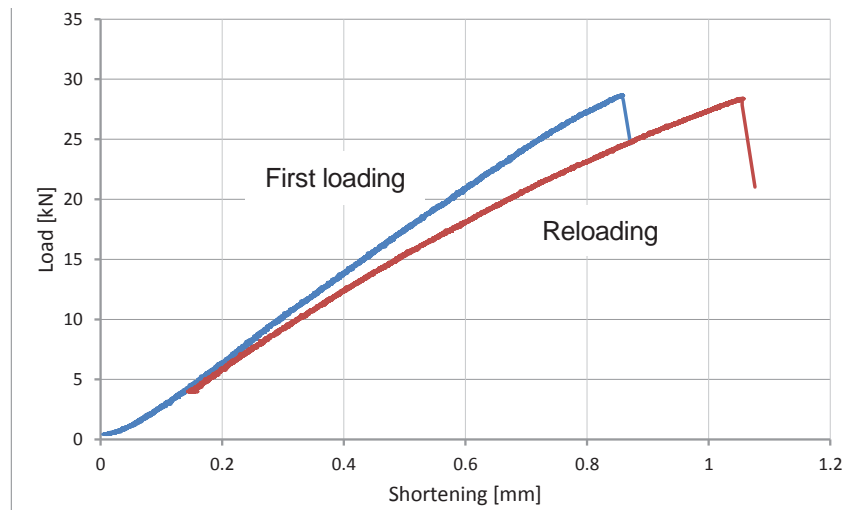
Figure 7. Load-shortening curves of the quasi-static SSC specimen test.

The load-shortening curves for the static test are shown in Figure 7. The blue curve corresponds to the first compressive loading of the specimen. The peak of the blue curve corresponds to the load at which the Teflon-induced defect snapped open and extended from 40 mm to approximately 100 mm. The red curve corresponds to a reloading of the specimen, and its peak corresponds to the initiation of stringer detachment from the skin, forming a tunnel under the stringer. The reduced stiffness during reloading suggests that the extension of the initial defect at the Teflon insert caused a non-negligible loss of stiffness.

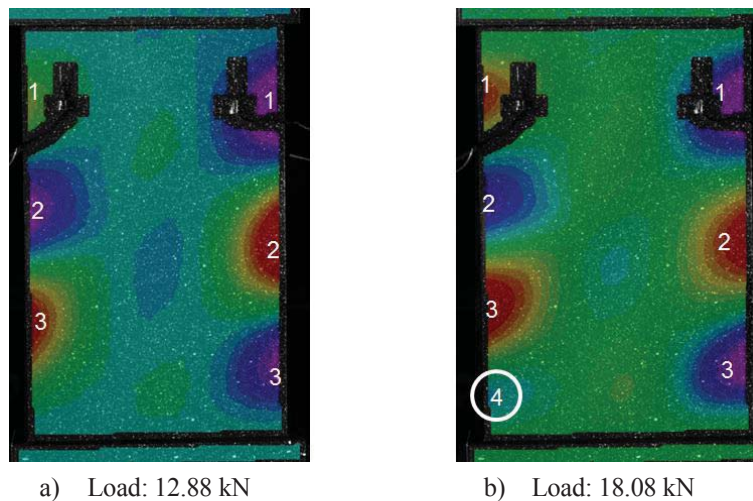
Figure 8. Evolution of postbuckling mode during cycle #10 of fatigue testing of the first fatigue SSC specimen.

Two images captured by the digital image correlation system on the skin side of the panel during one of the first load cycles applied to the first SSC specimen are shown in Figure 8. The postbuckling deformation initiated as three half-waves in the skin (Figure 8a) and then, during the same cycle, a smaller fourth half-wave formed in the skin on the side of the specimen with the Teflon insert (Figure 8b). Small waves also developed in the central area of the skin under the stiffener but cannot be seen in Figure 8b.

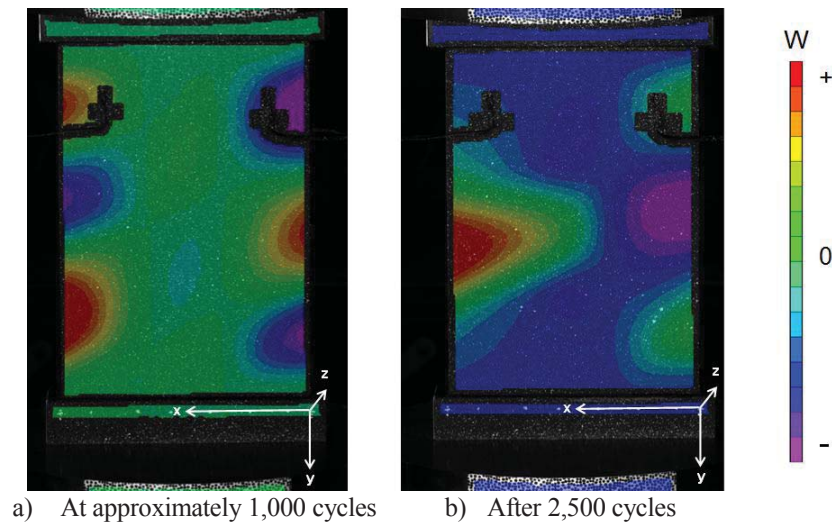
Figure 12. Postbuckling mode before and after opening and extension of the initial defect at the Teflon insert, second fatigue SSC specimen.

Fatigue testing of the second SSC specimen was initiated using the same loading parameters as used in testing of the first fatigue specimen. At approximately 2,000 cycles, the Teflon-induced defect opened suddenly. Results from a UT scan indicated that the initial defect at the Teflon insert had extended from the initial 40 mm length to a length of 50 mm. The out-of-plane deformation obtained with the digital image correlation just before and after the extension is shown in Figure 12.
