International Space Station (ISS) Soyuz Vehicle Descent Module Evaluation of Thermal Protection System (TPS) Penetration Characteristics

Hypervelocity Impact Technology Group

February 2013

**International Space Station (ISS) Soyuz Vehicle
Descent Module Evaluation of Thermal Protection
System (TPS) Penetration Characteristics**

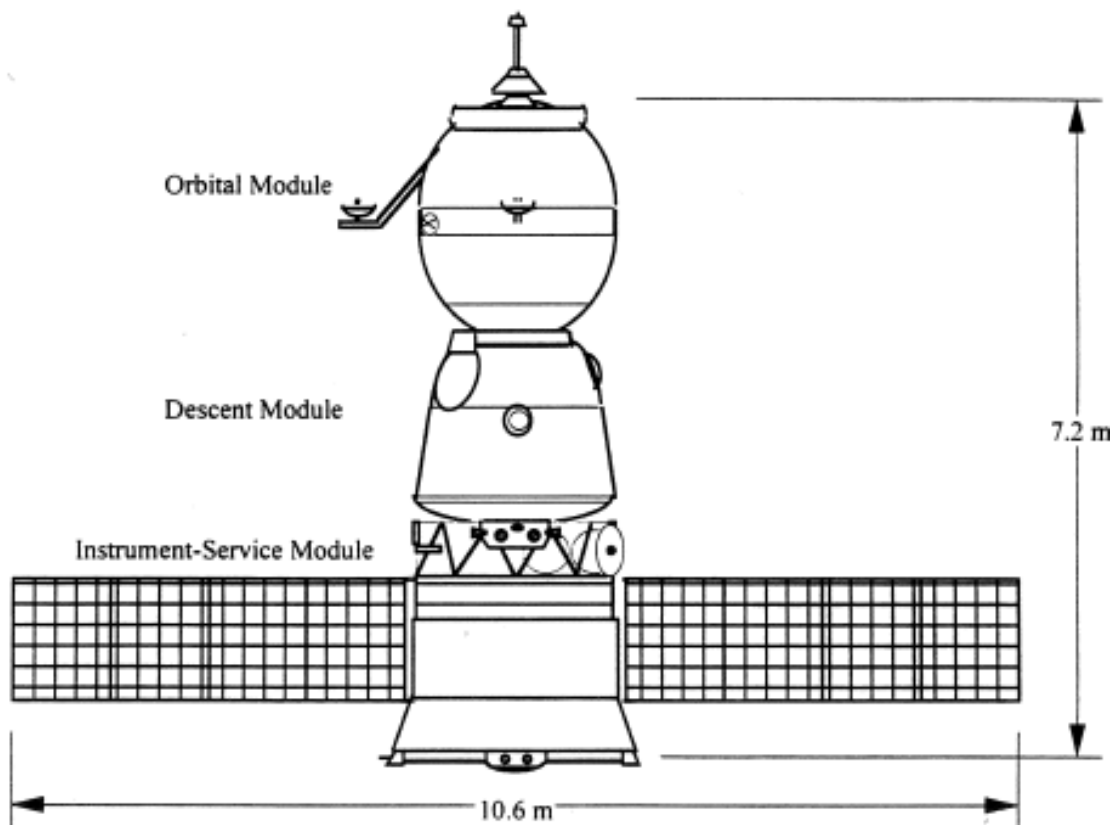
Figure 1 Soyuz vehicle

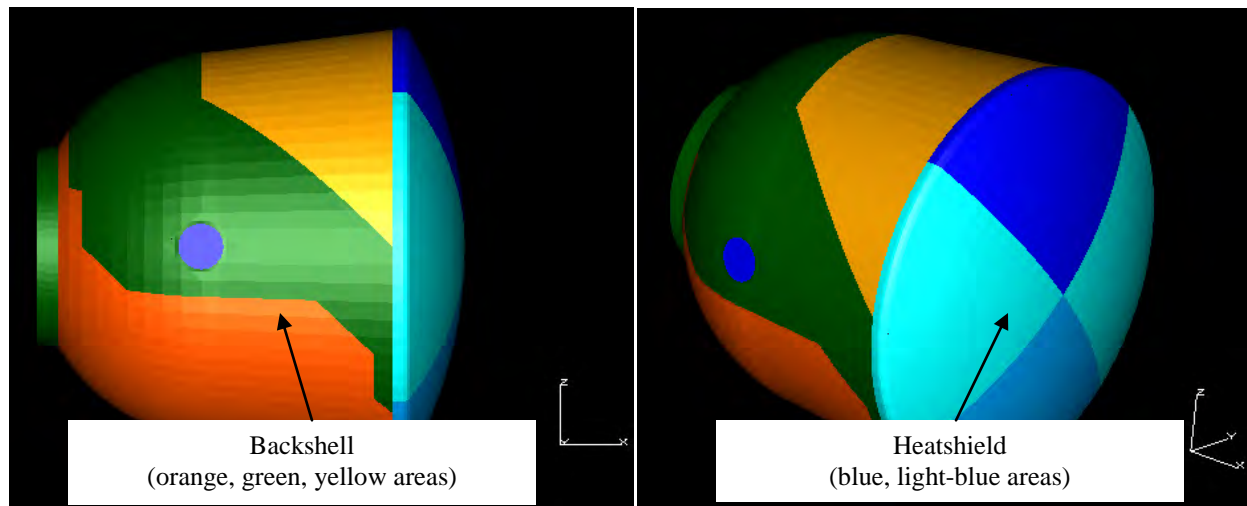
Figure 2 Soyuz Descent Module

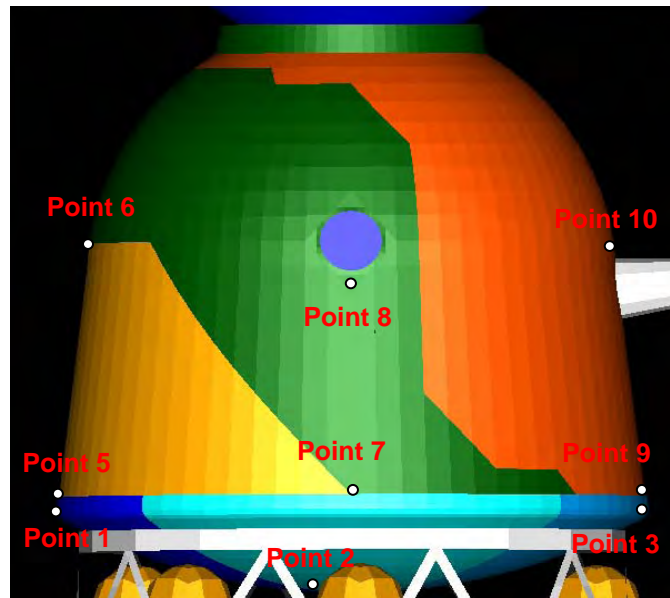
Soyuz Descent Module - Thermal Protection Material Thickness (mm)				
Descent Module Point Number	PKT-11K-FL ПКТ-11К-ФЛ $\rho=1200-1400 \text{ kg/m}^3$, 1.30 g/cm^3 (average)	Ftorlon (FT) $\rho=1800-1900 \text{ kg/m}^3$, 1.85 g/cm^3 (average)	TSP-F-N ТСП-Ф-Н $\rho=1600-1650 \text{ kg/m}^3$, 1.625 g/cm^3 (average)	VIM-2 ВИМ-2 $\rho=140-150 \text{ kg/m}^3$, 0.145 g/cm^3 (average)
1	28.0			8.0
2	24.0			8.0
3	21.0			8.0
4 (unused)	-	-	-	-
5		5.5	4.0	28.0
6		4.2	4.0	28.0
7		1.5	3.2	28.8
8		1.0	3.2	28.8
9		1.0	2.5	29.5
10			2.5	29.5

- (1) ПКТ-11К-ФЛ – a laminate plastic ($\rho=1,200-1,400 \text{ kg/m}^3$) based on a silicon dioxide/Capron fabric and a phenol/formaldehyde adhesive
- (2) ВИМ-2 – a fibrous material ($\rho=140-150 \text{ kg/m}^3$) based on super-thin silicon-dioxide fibers and an organosilicon adhesive
- (3) ТСП-Ф – volume-reinforced fiberglass ($\rho=1,600-1,650 \text{ kg/m}^3$) based on stitched silicon dioxide fabric and a phenol/formaldehyde adhesive, with a sub-layer of ВИМ-2 thermal insulating material
- (4) ftorlon (ФТ) – layer of sublimating material ($\rho=1,800-1,900 \text{ kg/m}^3$)

Figure 3 Soyuz Descent Module TPS materials

Figure 3 indicates the type of TPS materials that protect the descent module, and the thickness of these materials. The heat shield materials are represented by points 1-3, whereas the backshell materials correspond to points 5-10. The Soyuz descent module has an offset center of gravity, and the stagnation point during reentry is shifted to one side of the vehicle. That is, one side of vehicle leads during reentry and is the “windward” side of the vehicle, whereas the opposite side trails during reentry and is referred to as the “leeward” side of the vehicle. The windward side of the descent module is exposed to higher heating during reentry, and the TPS materials are therefore thicker on the windward side of the descent module, compared to the leeward side. The backshell TPS is at higher risk of penetration from MMOD impacts, and is the focus of this impact test program. The backshell TPS consists of an ablator (Ftorlon) bonded to a fiberglass substrate. In some places on the backshell (leeward side), no Ftorlon is used. Elsewhere, the Ftorlon thickness varies from 1.0mm to 5.5mm. The backshell substrate is 2.5mm to 4.0mm thick reinforced fiberglass and is attached 41mm to 60mm from the 2.0mm thick aluminum AMG-6 pressure shell (41mm on the windward side, 60mm on the leeward side). There is 28-30mm of VIM (low density silica fibrous insulation) between the backshell substrate and pressure shell (the VIM is attached to the back of the substrate). Although not part of this test plan, the heat shield consists of 21mm to 28mm thick ablator (glass-phenolic composite) which is held by brackets approximately 15mm from the 3.5mm thick aluminum AMG-6 substrate.

VIM low-density silica fibrous insulation (8mm thick) is contained in the gap between the heat shield ablator and aluminum substrate. The 2.0mm thick aluminum AMg-6 pressure shell is approximately 25mm-35mm from the back of the substrate.

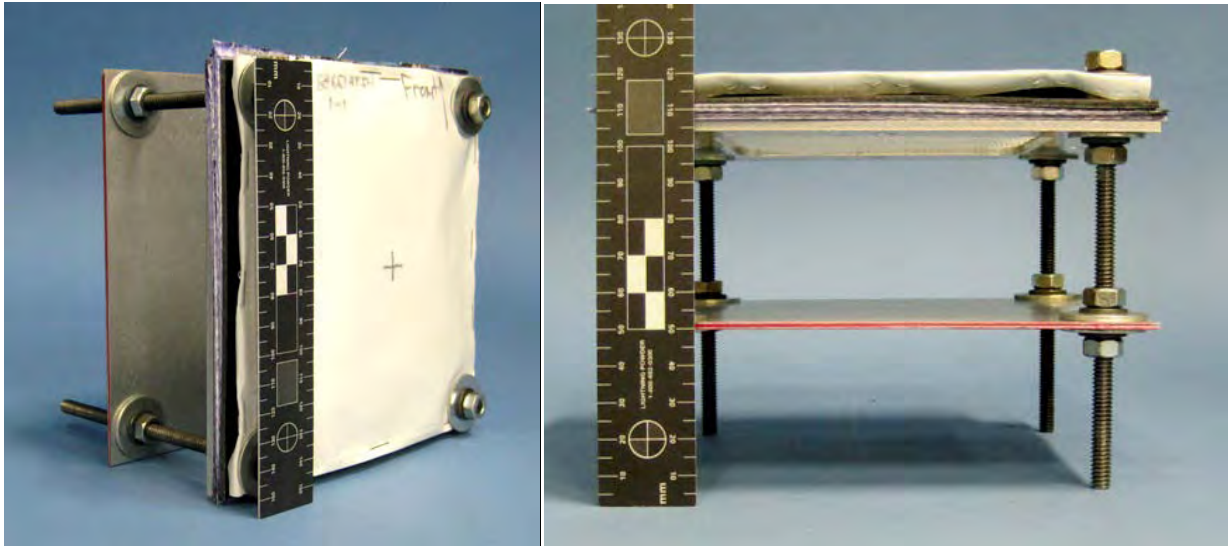
Figure 1 Overall oblique and side view of test article configuration (typical)

Figures 1 and 2 illustrate the typical test article configuration for all configurations. Figure 2 shows how the MLI package is being secured using two 0.125” thick shims (0.25” total) at each corner of the target between the MLI and TPS. This allows the MLI to rest on top of the TPS with minimal compression of the thermal blanket. The test article is secured at each of the four corners by means of all-thread, Belleville spring washers and nuts which maintain the standoff between TPS and rear wall during the testing process.

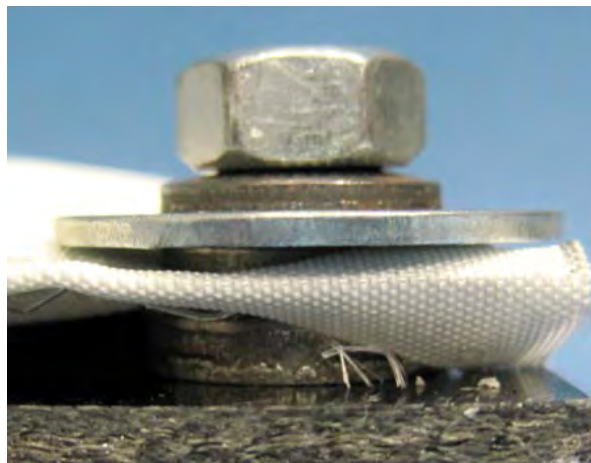
Figure 2 Close-up of method securing MLI to TPS (typical)

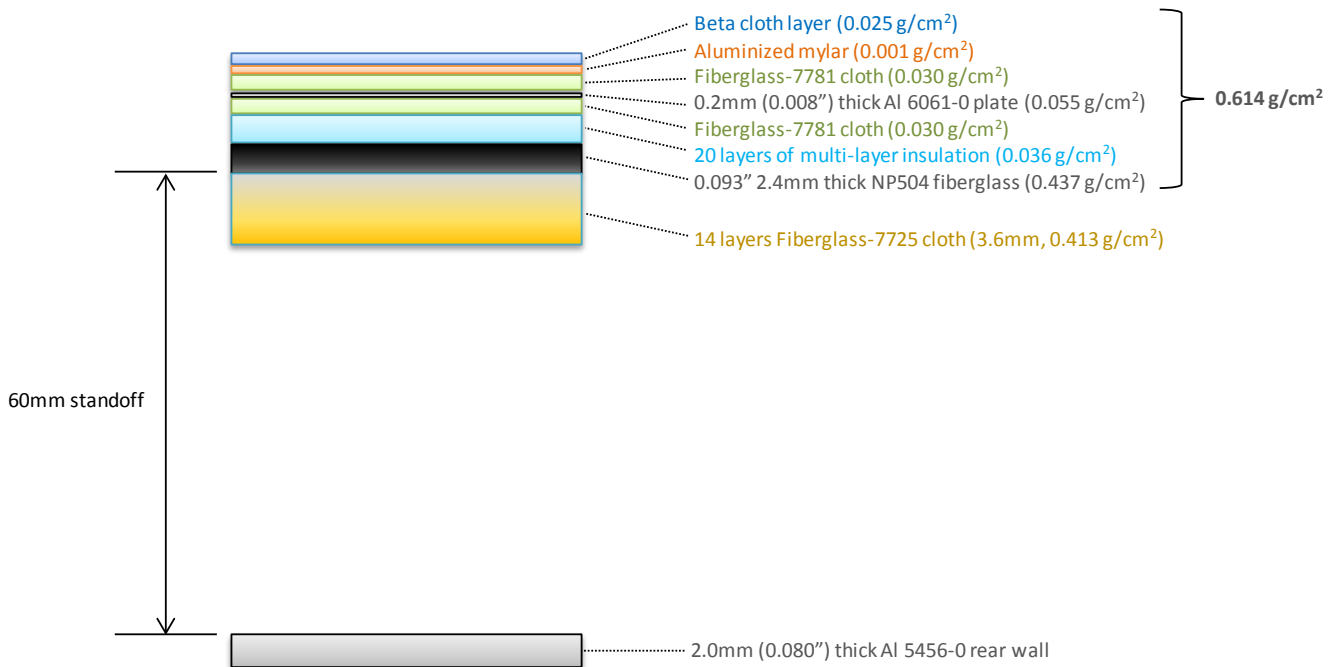
Figure 3 Type 1 test article, representing thin TPS region of the Soyuz DM

Type 1 test article represents the thin leeward backshell TPS region, with no Ftorlon. The type 1 test article is described in Figure 3, and compared to the Russian configuration in Figure 4 and Table 1. Table 2 lists the materials used in the targets, as well as the total number of targets of each type in the current test matrix.

The US configuration uses fiberglass NP504 in place of TSP-F fiberglass substrate material. NP504 is a high performance composite manufactured by Norplex-Micarta from a woven glass fabric with high-temperature Phenolic resin system. NP504 offers high temperature resistance, as well as good flexural, compressive, and impact strength at elevated temperatures. In addition, the Phenolic resin system gives the product excellent creep resistance. This thermoset composite does not melt or become soft with heat. NP504 complies with the requirements of MIL-I-24768/18, Type GPG. NP504 has a density of 1.85 g/cm^3 , and a tensile strength (0.125" thickness) of 42,000 psi (290 MPa) lengthwise, and 34,000 psi crosswise (234 MPa). The NP504 material is manufactured by a company called Norplex-Micarta ([www.norplex-micarta](http://www.norplex-micarta.com)), see [Appendix E](#) for property data sheet on this product.

The US configuration uses fiberglass 7725 cloth (14 layers, 54x18 count, 2x2 twill weave) in place of VIM2 insulation. The total fiberglass areal density (mass per unit area) was made similar to the reported VIM2 areal density. Fiberglass cloth is made from silica fibers, whereas VIM2 is a low-density fibrous silica material.

The multi-layer insulation (MLI) used in the US version contains 20 layers of 0.00025" aluminized kapton with 0.006" thick Dacron scrim between Kapton layers (i.e., the MLI contains 39 layers including scrim).

The 0.2mm (0.008") thick Al 6061-0 plate is bent on the edges to make the insulation thicker. Each edge of the plate is bent 90degrees with a 0.125" (3.2mm) wide bend. Adjacent sides of the plate are bent in opposite directions, leaving two edges bent upward and two edges bent downward. This makes the effective thickness of the 0.008" plate close to 0.25" thick.

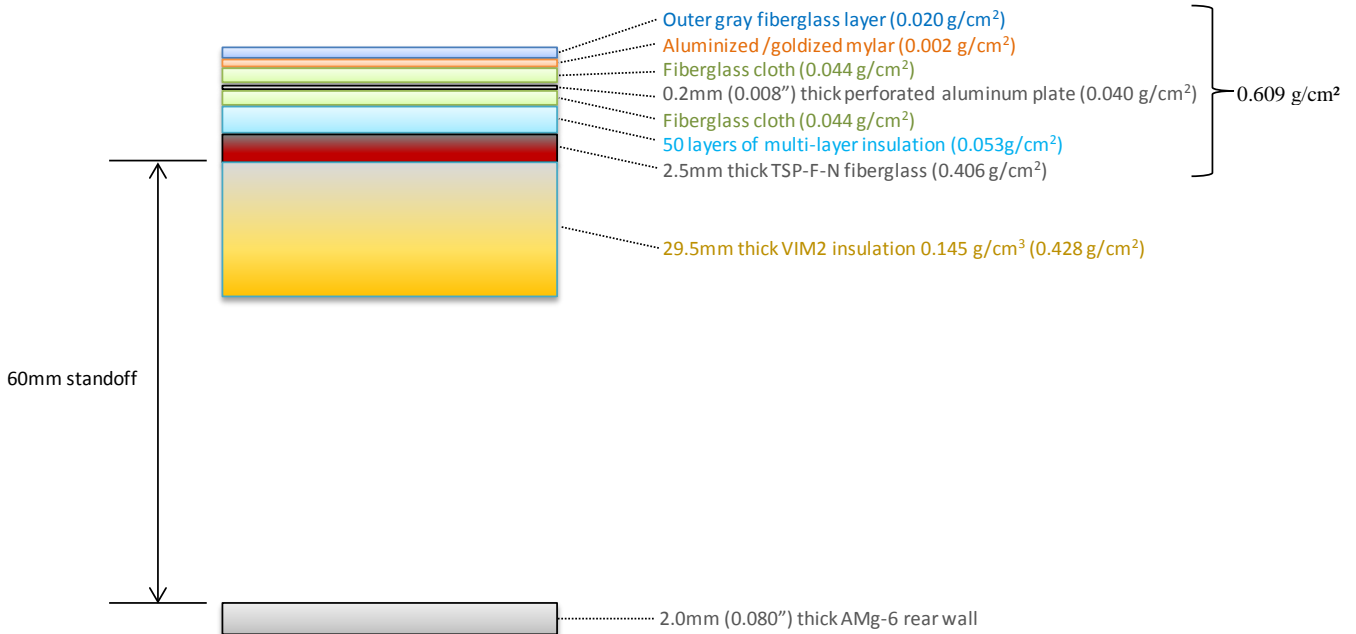
Figure 4 Thin TPS leeward backshell region of Soyuz DM

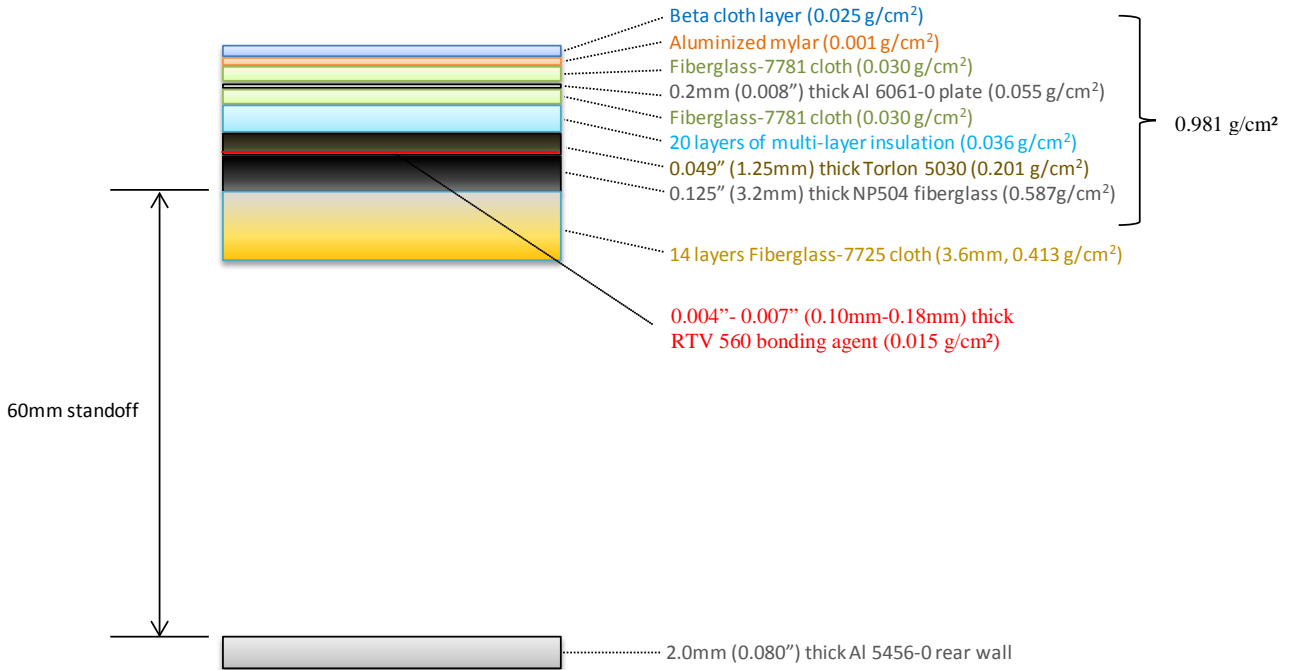
Figure 5 Type 2 test article, representing the average medium thickness TPS region

Type 2 test article is representative of the medium backshell TPS region (average thickness). Figure 5 illustrates the type 2 test article. Figure 6 and Table 1 provides a comparison to the Russian configuration for this region of the vehicle. The US configuration uses Torlon 5030, in place of Ftorlon. Torlon 5030 is a high-strength, 30% glass-filled polyamide-imide polymer. Typical properties of this material include high stiffness, high strength, good retention of stiffness at high temperatures, and very low creep. The density of this material is 1.61 g/cm^3 and the tensile strength is 29.7 ksi (205 MPa). The Torlon 5030 material is manufactured by a company called Drake Plastics (www.drakeplastics.com), see [Appendix E](#) for property data sheet on this product. RTV 560 is used to bond the Torlon 5030 to the NP504 fiberglass plate. The RTV 560 has an application thickness range of 0.004" – 0.007" and an average mass per unit area of 0.015 g/cm^2 .

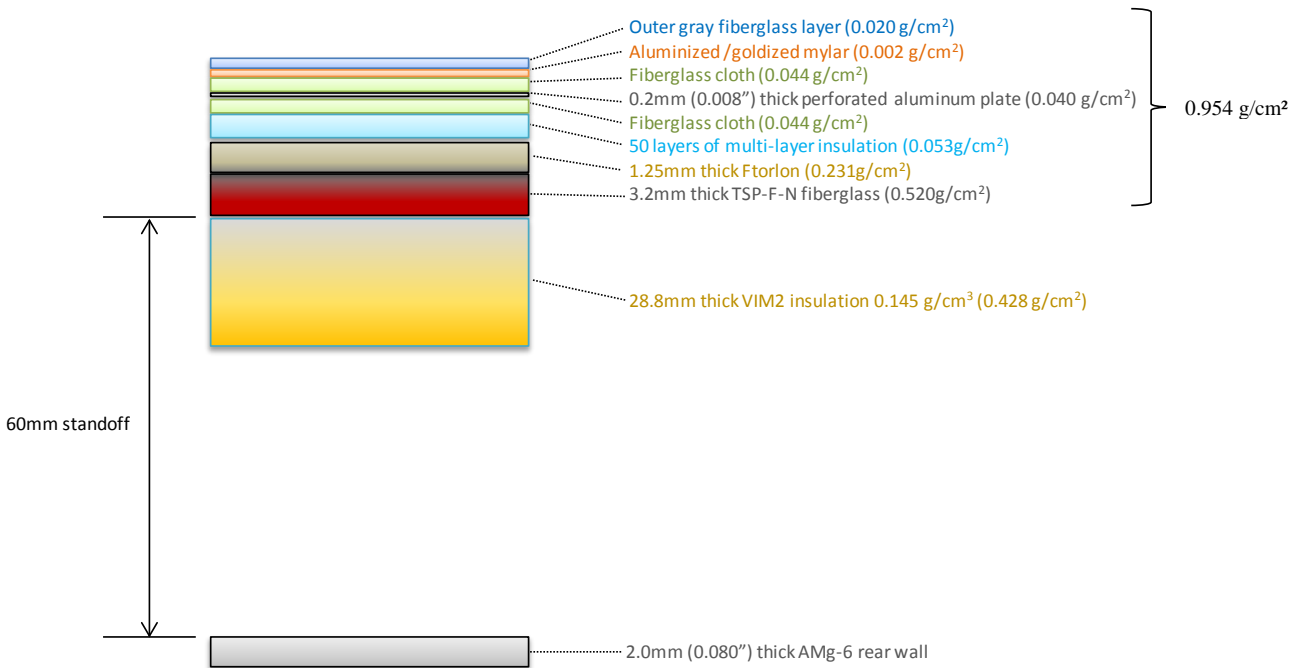
Figure 6 Average medium TPS region of Soyuz DM

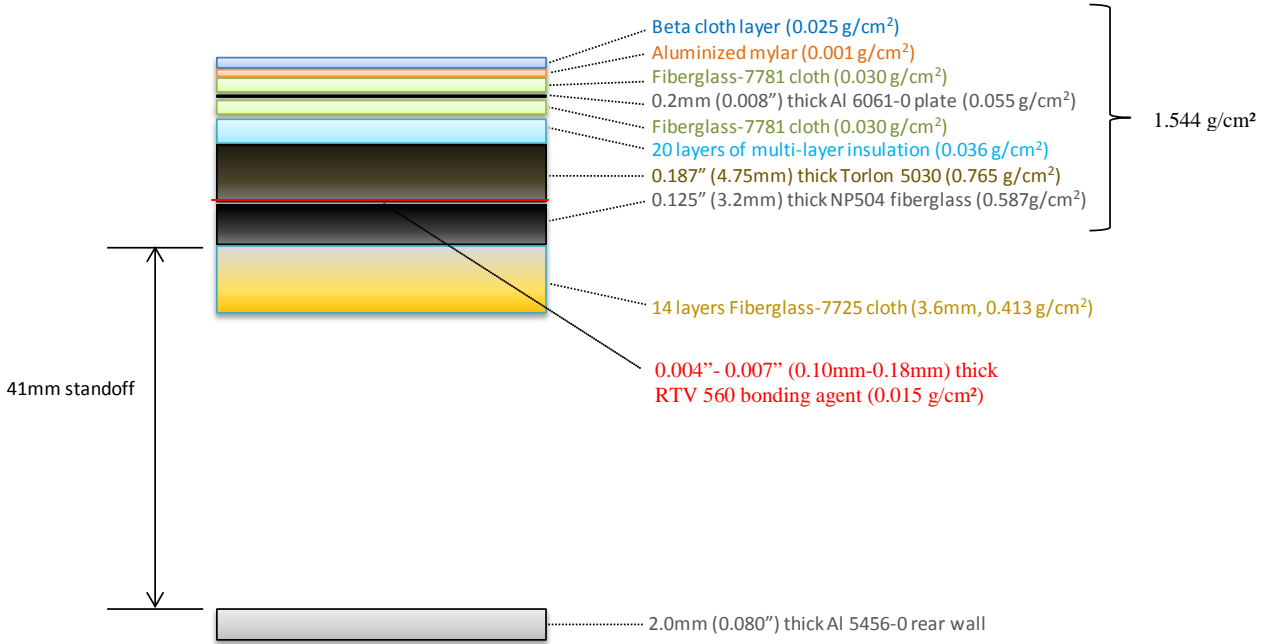
Figure 7 Type 3 test article, representing the average thick area of the TPS

Type 3 test article is representative of the thickest backshell TPS region (average thickness), in the windward area of the vehicle's backshell. Figure 7 illustrates the type 3 test article. Figure 8 and Table 1 provides a comparison to the Russian configuration for this region of the vehicle. RTV 560 is used to bond the Torlon 5030 to the NP504 fiberglass plate. The RTV 560 has an application thickness range of 0.004" – 0.007" and an average mass per unit area of 0.015 g/cm².

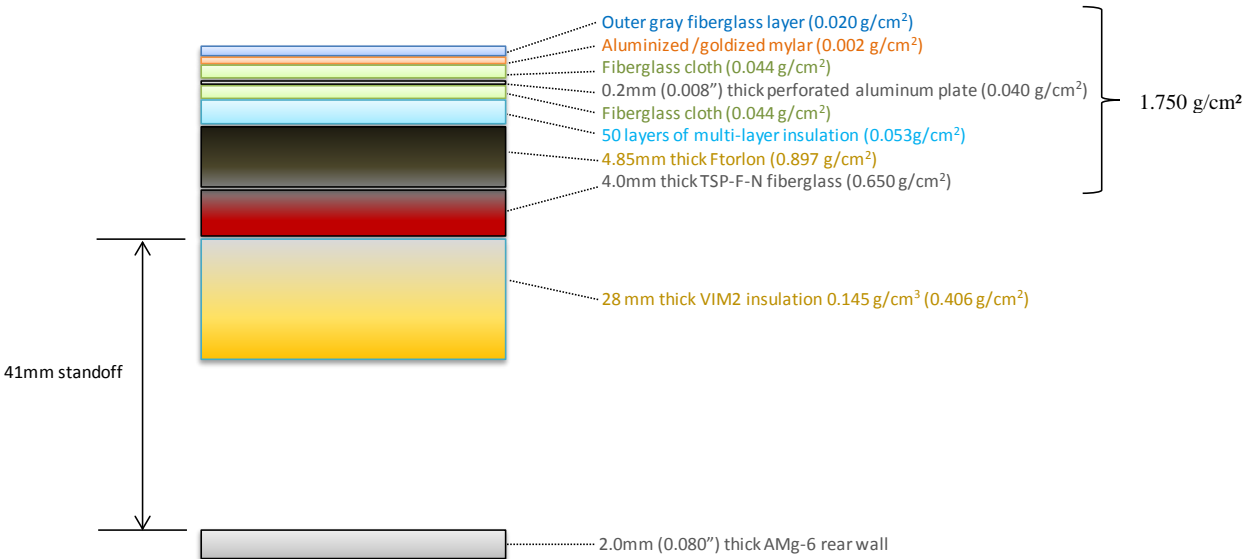
Figure 8 Average thick TPS region of Soyuz DM

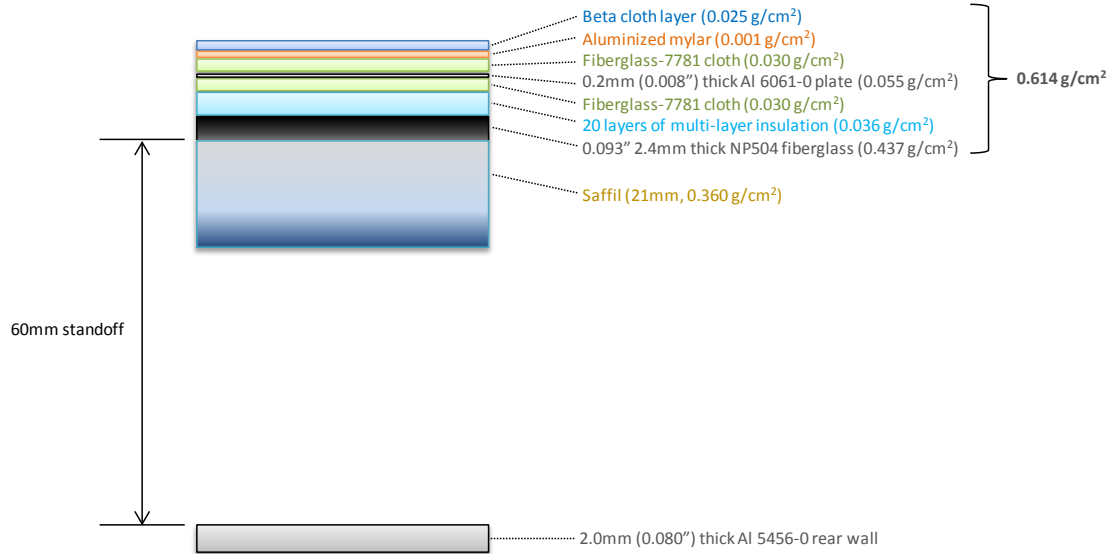
Figure 9 Type 4 test article, thin TPS region of Soyuz DM with Saffil insulation

Type 4 test article is similar to Type 1 test article, representative of the thin TPS region in the leeward area of the vehicle’s backshell, but containing Saffil insulation behind the NP504 fiberglass instead of fiberglass 7725 cloth. This target will be used for assessments of rear wall penetration ballistic limits. Saffil is considered a better material choice to represent the VIM-2 insulation, but was not available for early testing. Figure 9 illustrates the type 4 test article. The Saffil used in this application is Ecoflex E200LB, which is a densified polycrystalline fiber mat (97% alumina and 3% silica). The Saffil is 21mm thick with a density of 0.171 g/cm³. In addition, a 0.04” (1mm) thick Al 2024-T3 witness plate is included 2” (5.08cm) behind the 2mm thick Al 5456-0 rear wall.

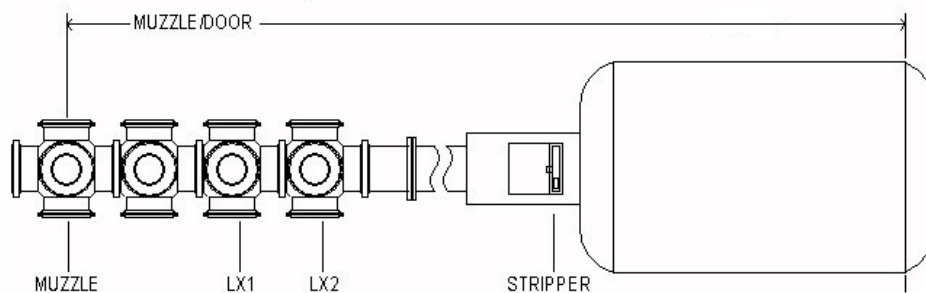
Typical Range Diagnostics Configuration Schematic

Note: The door is considered the primary point of reference from which to measure back to the impact face of the installed test article.

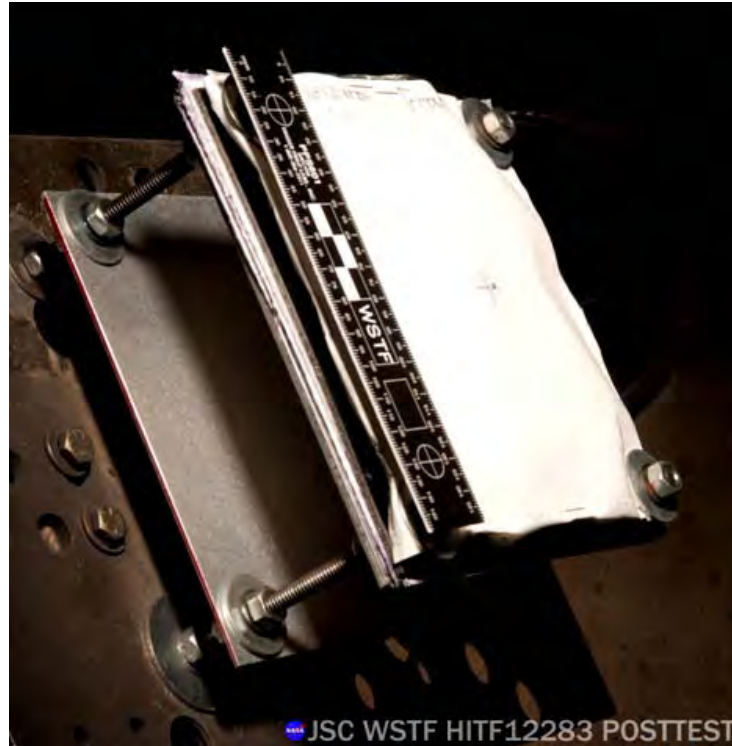
HITF12283 / Test #1

Figure 8 Overall View of Sample in the Target Tank (post-test)

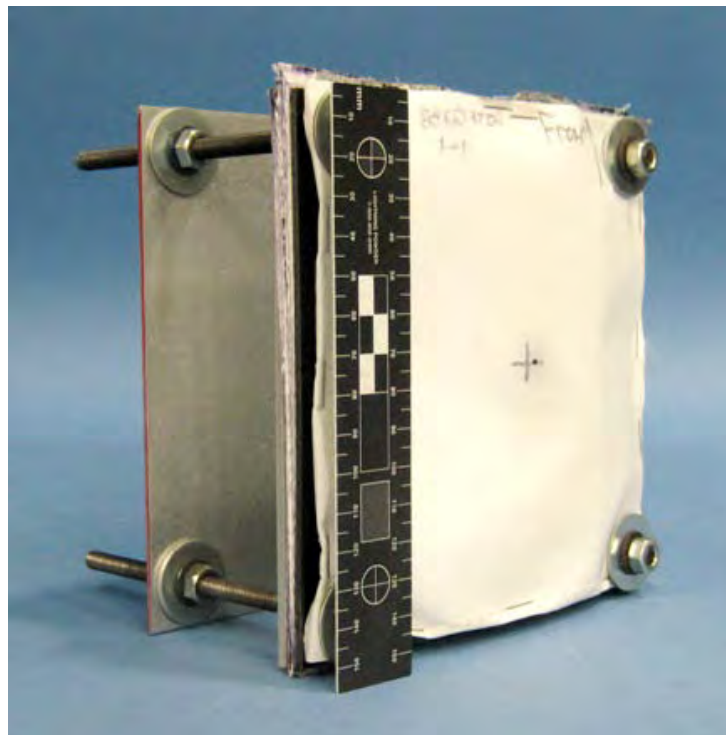
Figure 9 Overall Front Oblique View of Sample (scale in 5mm increments)

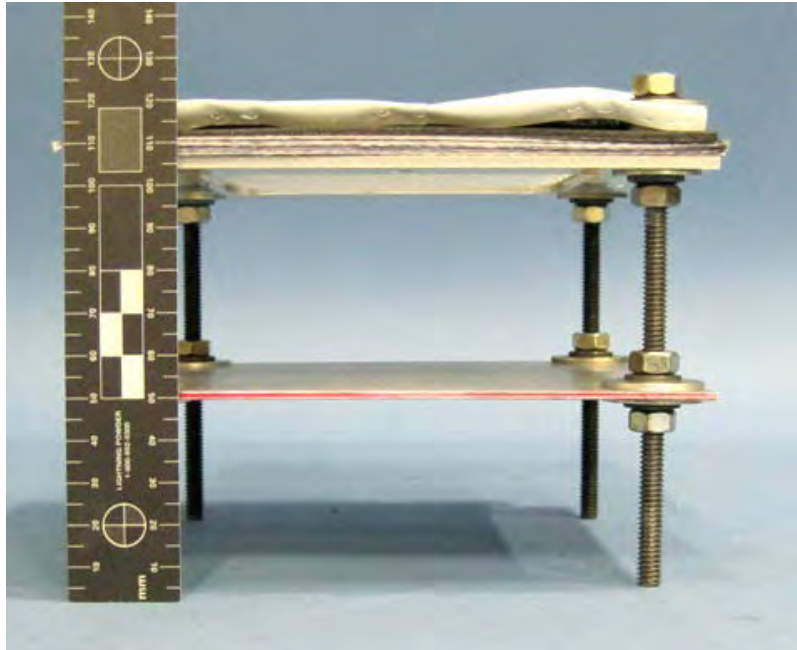
HITF12283 / Test #1 (continued)

Figure 10 Overall Side View of Sample (scale in 5mm increments)

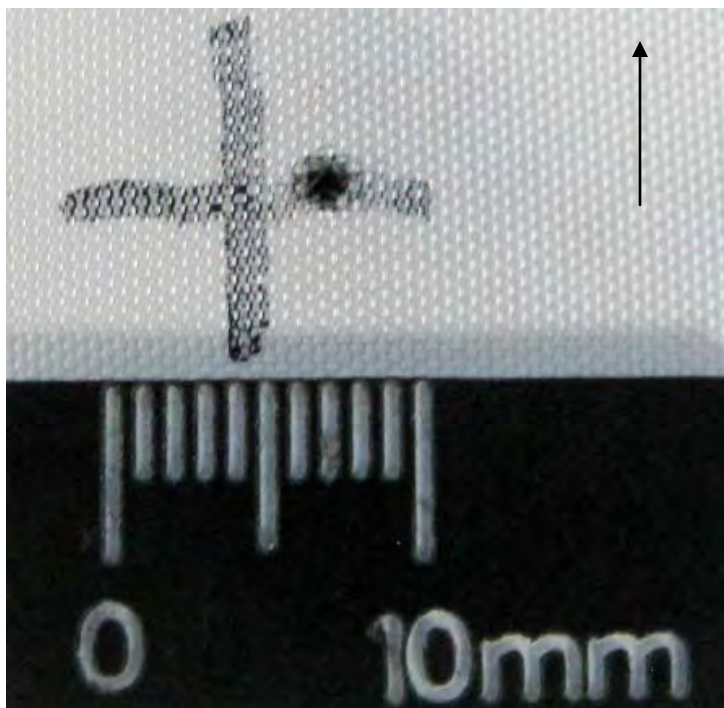
HITF12283 / Test #1 (continued)

Figure 12 Close-up View of Damage to Front of MLI (scale in 1mm increments / black arrow indicates flight path of projectile)

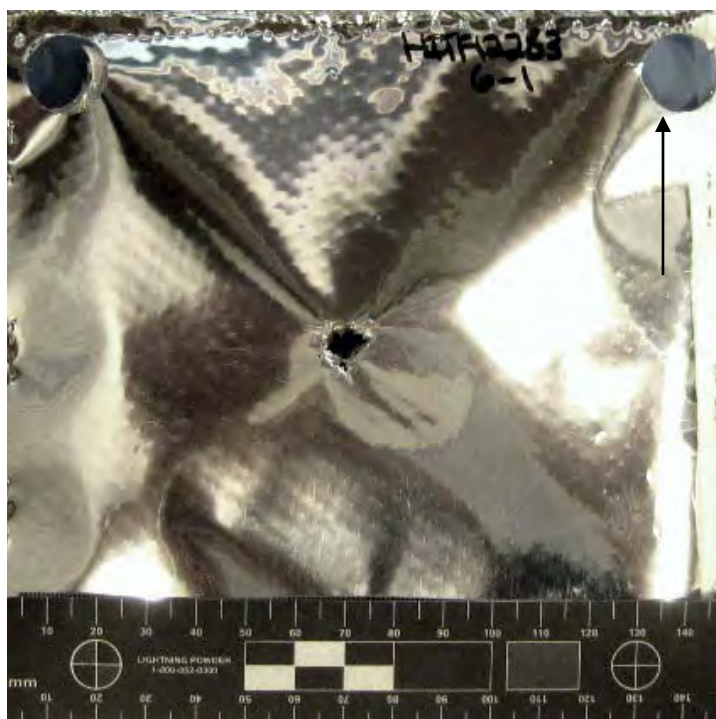
Figure 13 Overall View of Damage to Back Side of MLI (scale in 5mm increments / black arrow indicates flight path of projectile)

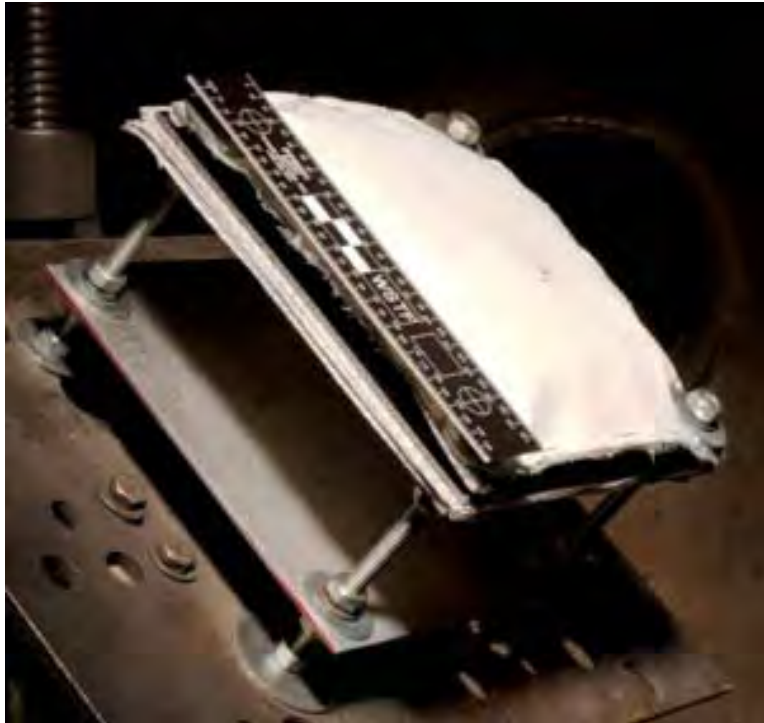
HITF12284 / Test #2

Figure 21 Overall View of Sample in the Target Tank (post-test)

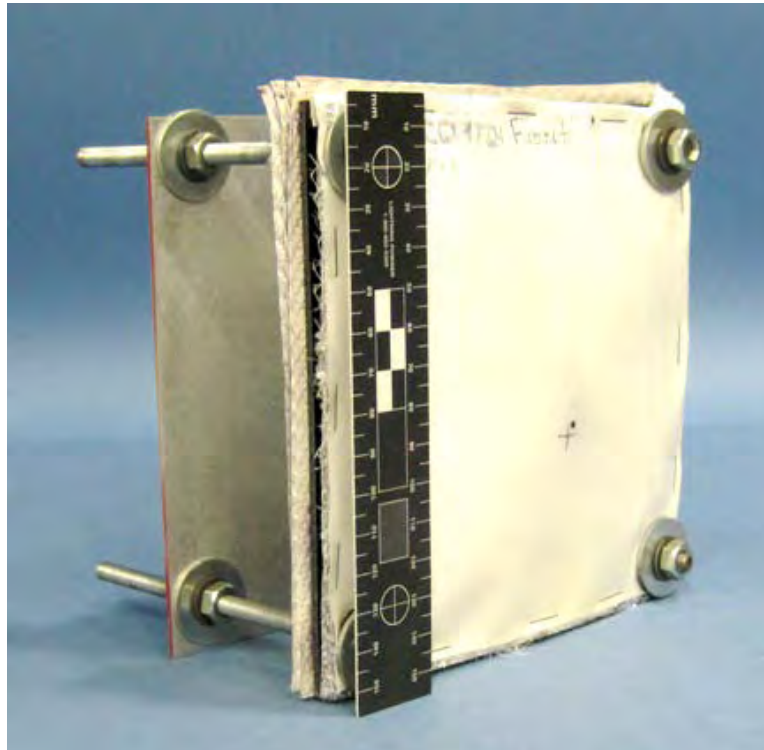
Figure 22 Overall Front Oblique View of Sample (scale in 5mm increments)

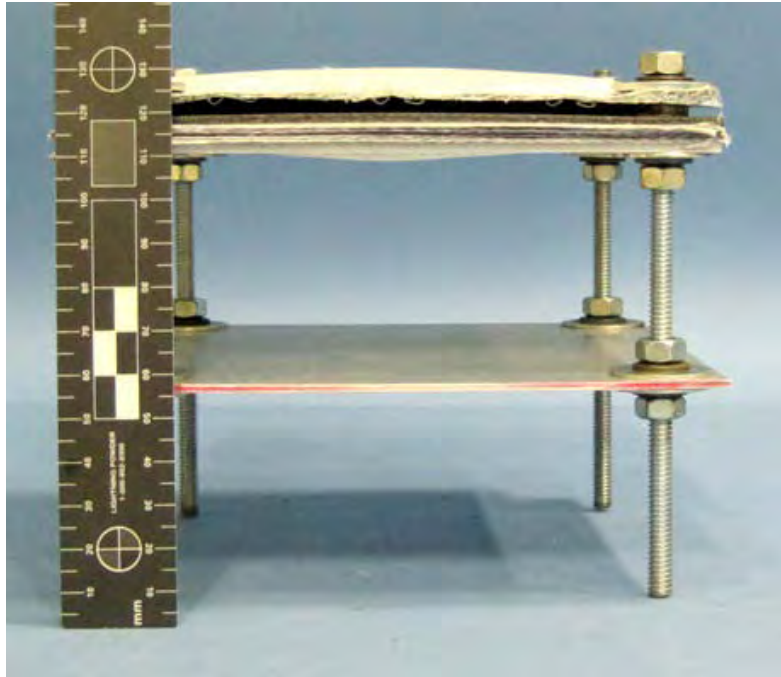
HITF12284 / Test #2 (continued)

**Figure 23** Overall Side View of Sample (scale in 5mm increments)

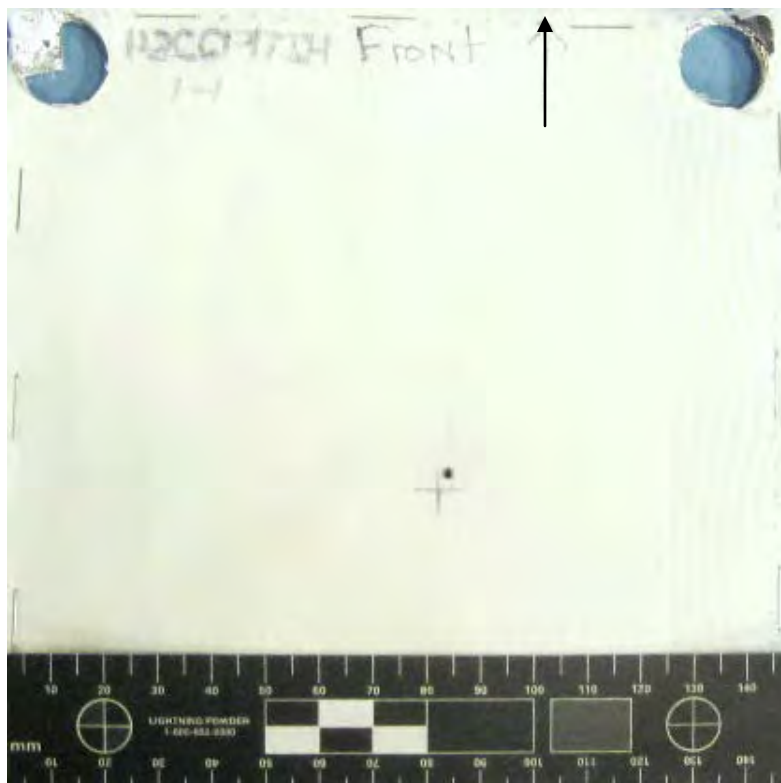
**Figure 24** Overall View of Damage to Front of MLI (scale in 5mm increments / black arrow indicates flight path of projectile)

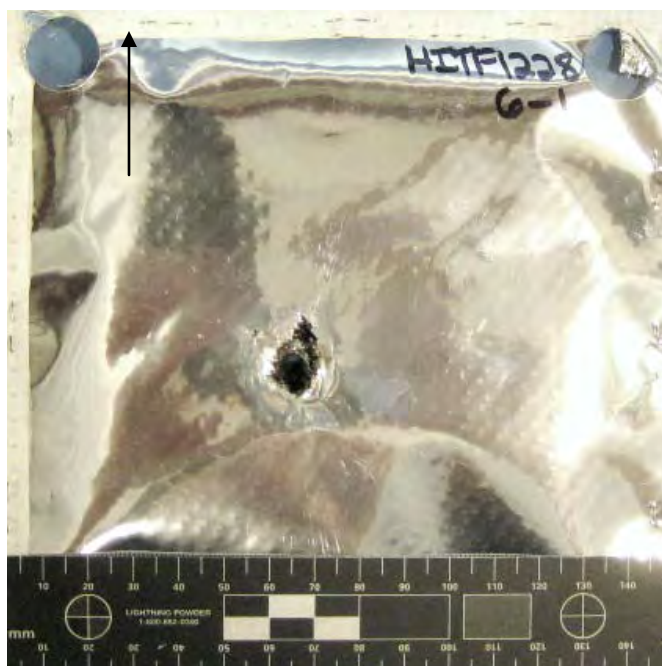
HITF12284 / Test #2 (continued)

Figure 26 Overall View of Damage to Back Side of MLI (scale in 5mm increments / black arrow indicates flight path of projectile)

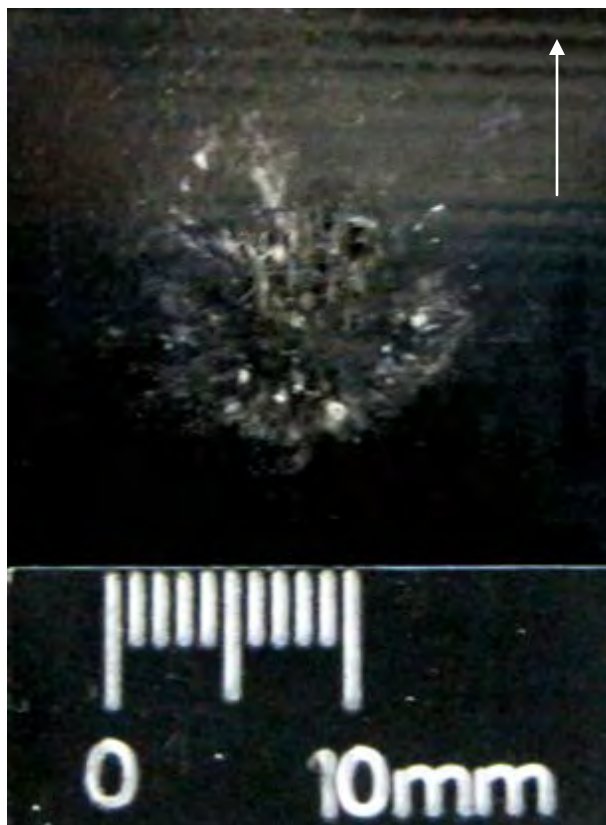
HITF12284 / Test #2 (continued)

Figure 29 Close-up View of Damage to Front of NP 504 Substrate (scale in 1mm increments / white arrow indicates flight path of projectile)

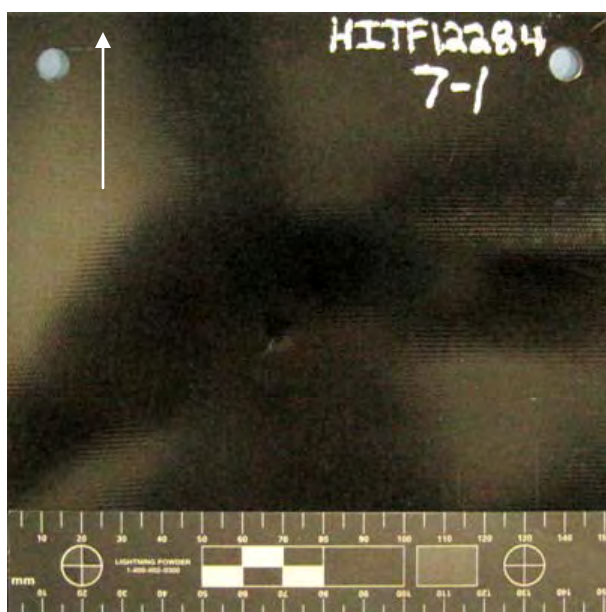
Figure 30 Overall View of Damage to Back Side of NP 504 Substrate (scale in 5mm increments / white arrow indicates flight path of projectile)

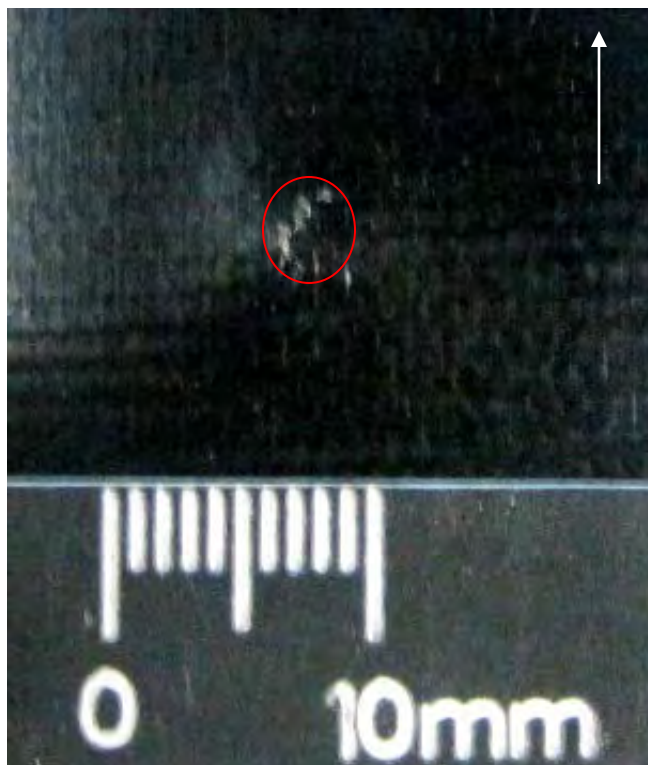
HITF12284 / Test #2 (continued)

Figure 31 Close-up View of Damage to Back Side of NP 504 Substrate (scale in 1mm increments / white arrow indicates flight path of projectile)

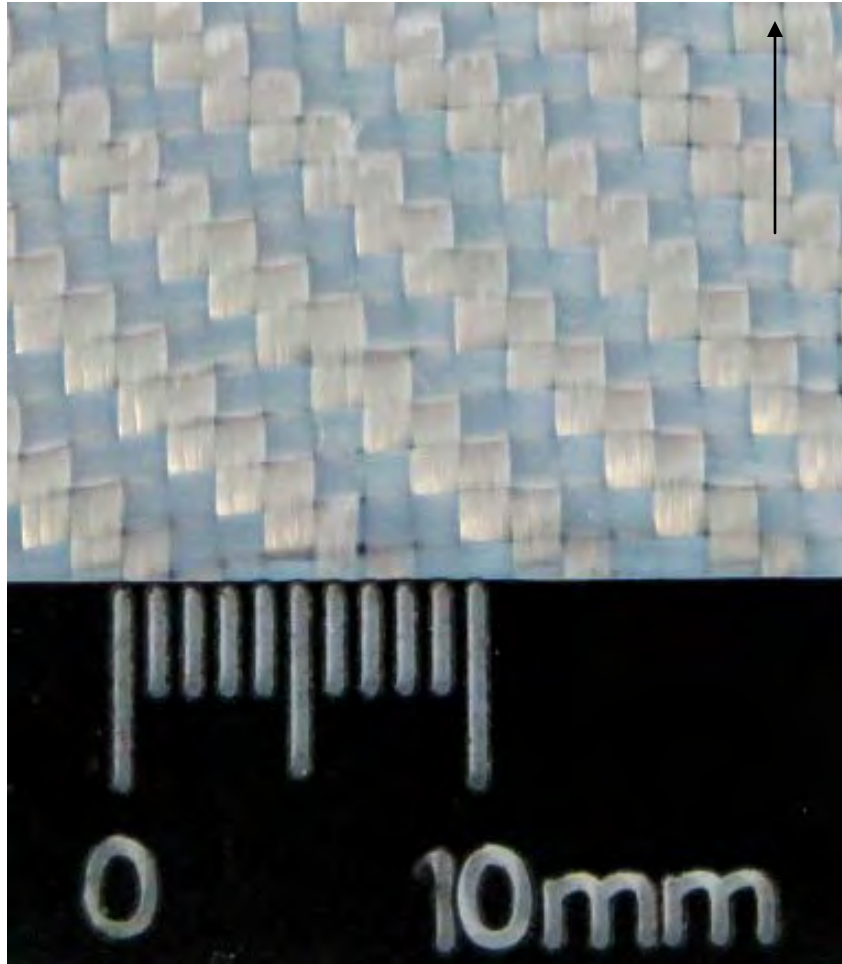
HITF12284 / Test #2 (continued)

Figure 35 Close-up View of Damage to Back Side of 1st Fiberglass Layer (scale in 1mm increments / black arrow indicates flight path of projectile)

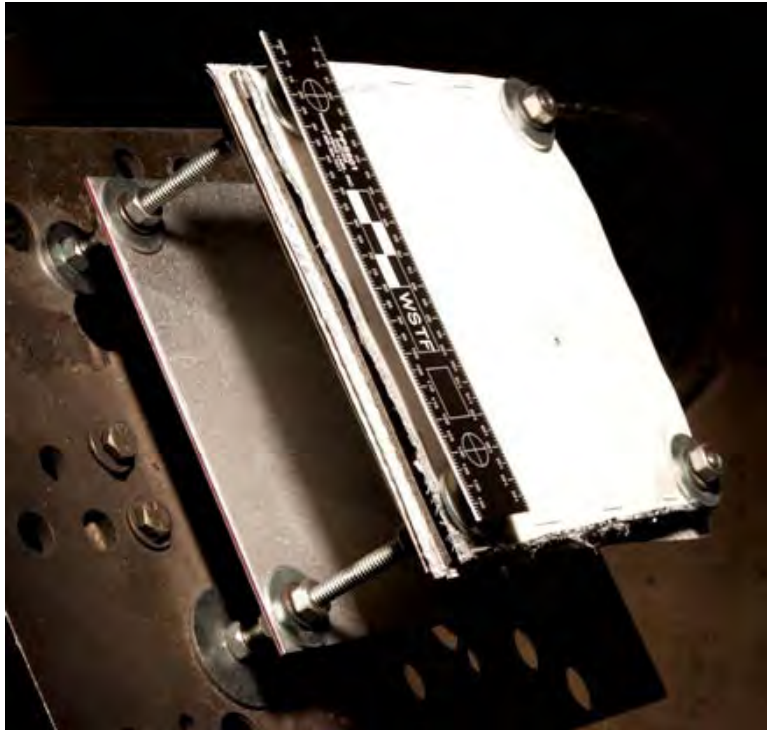
HITF12285 / Test #3

Figure 36 Overall View of Sample in the Target Tank (post-test)

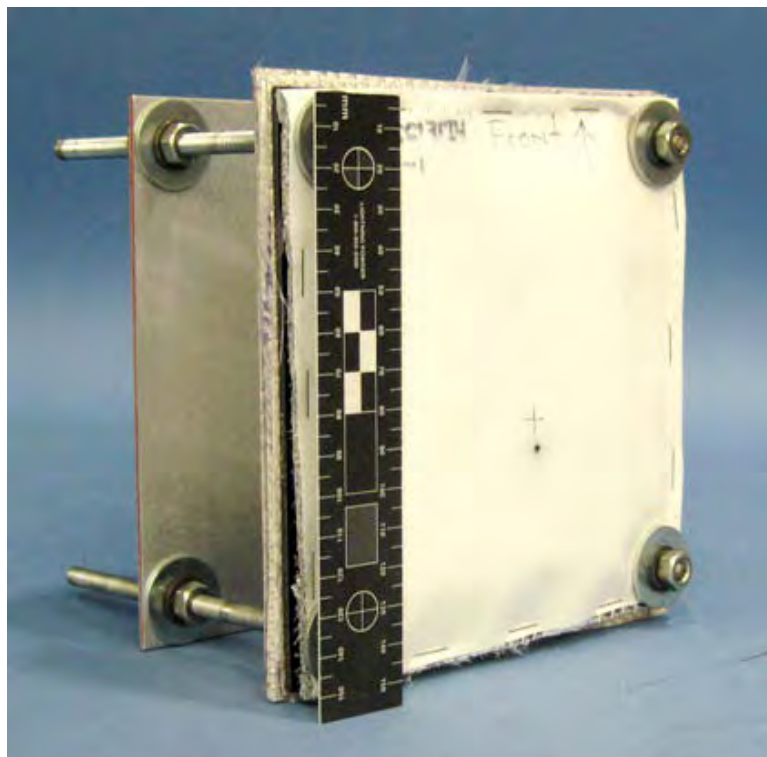
Figure 37 Overall Front Oblique View of Sample (scale in 5mm increments)

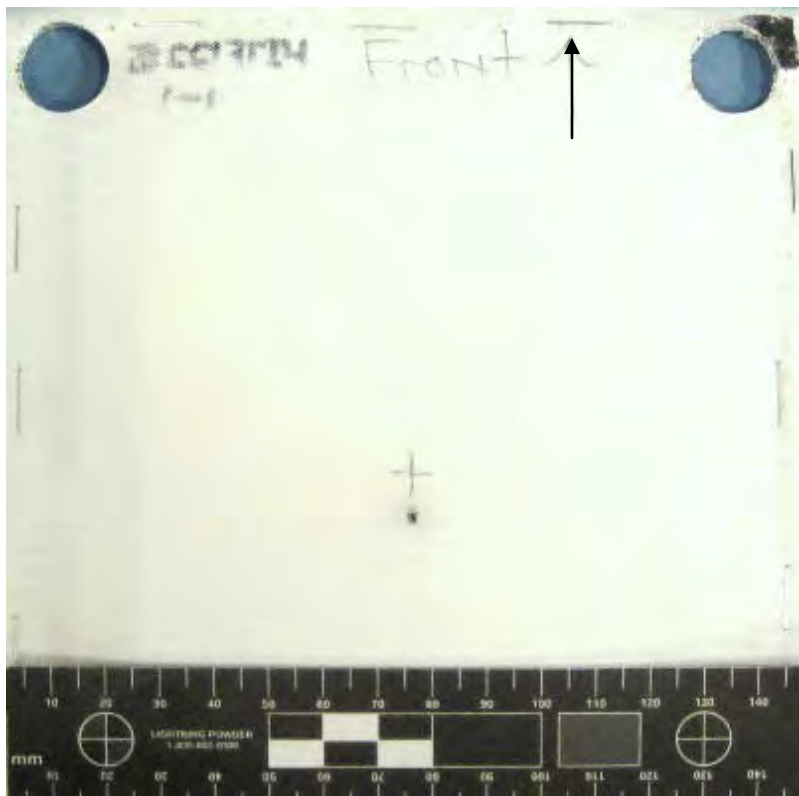
**Figure 39** Overall View of Damage to Front of MLI (scale in 5mm increments / black arrow indicates flight path of projectile)

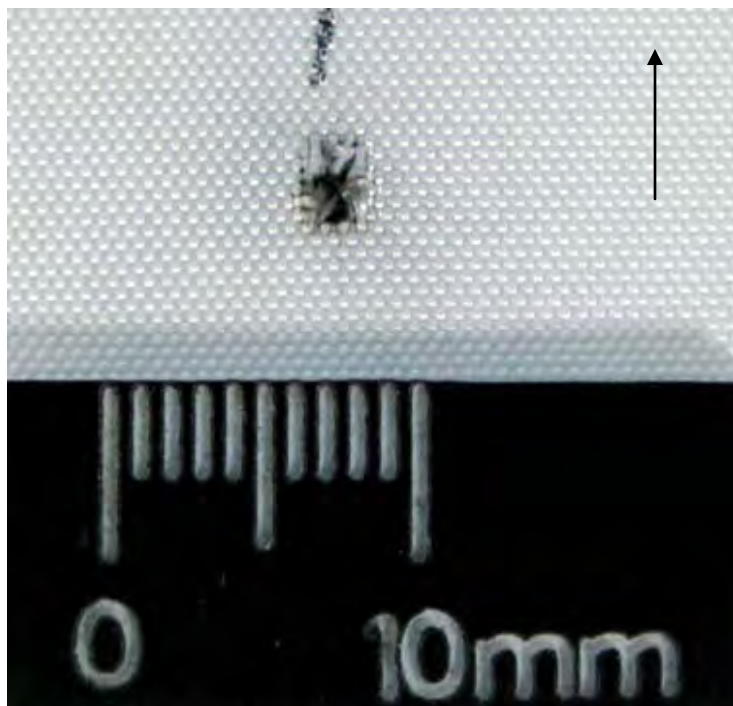
Figure 40 Close-up View of Damage to Front of MLI (scale in 1mm increments / black arrow indicates flight path of projectile)

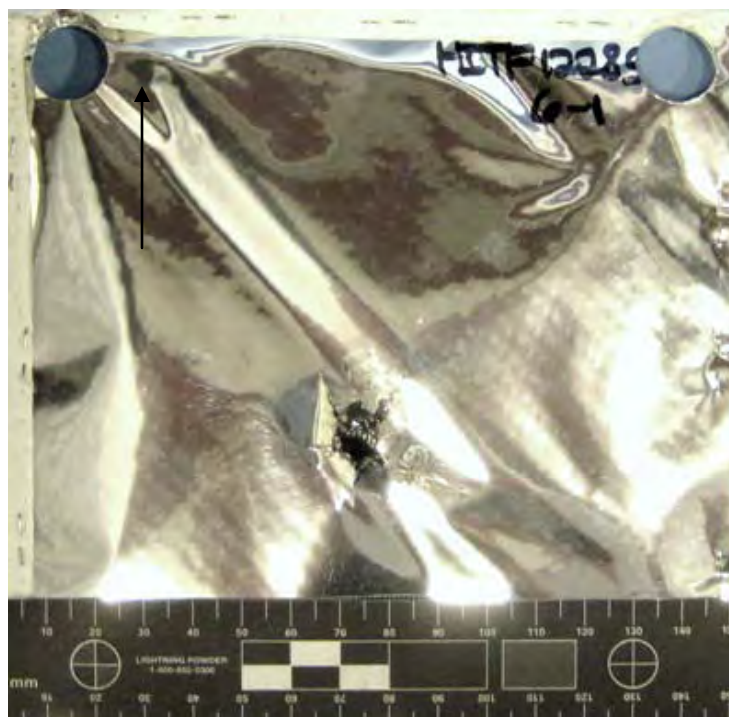
Figure 41 Overall View of Damage to Back Side of MLI (scale in 5mm increments / black arrow indicates flight path of projectile)

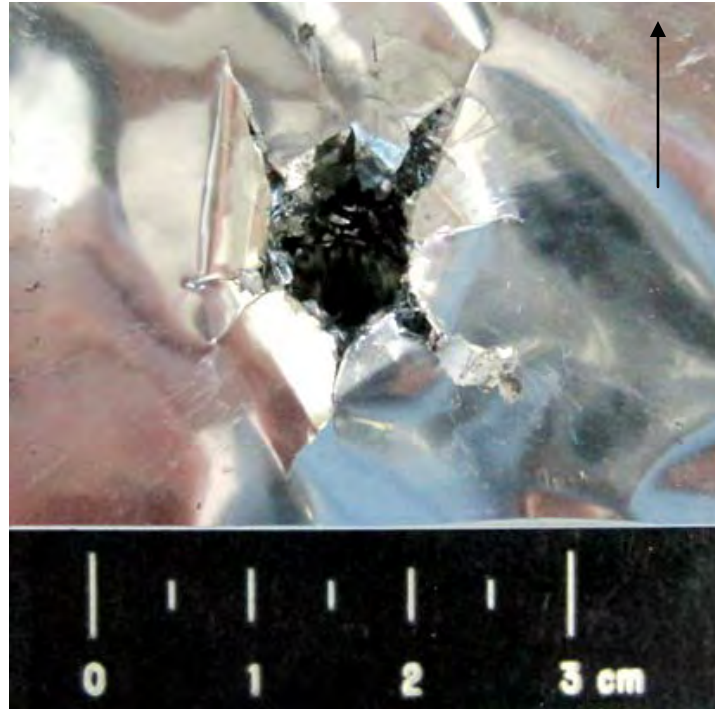
Figure 42 Close-up View of Damage to Back Side of MLI (scale in 5mm increments / black arrow indicates flight path of projectile)
