International Space Station (ISS) Soyuz Vehicle Descent Module Evaluation of Thermal Protection System (TPS) Penetration Characteristics

Hypervelocity Impact Technology Group

February 2013

**International Space Station (ISS) Soyuz Vehicle
Descent Module Evaluation of Thermal Protection
System (TPS) Penetration Characteristics**

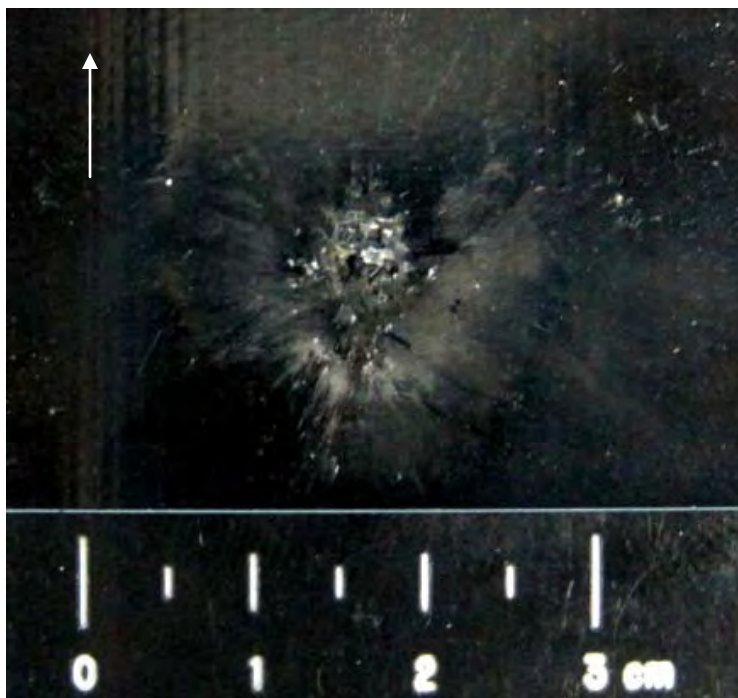
Figure 44 Close-up View of Damage to Front of NP 504 Substrate (scale in 5mm increments / white arrow indicates flight path of projectile)

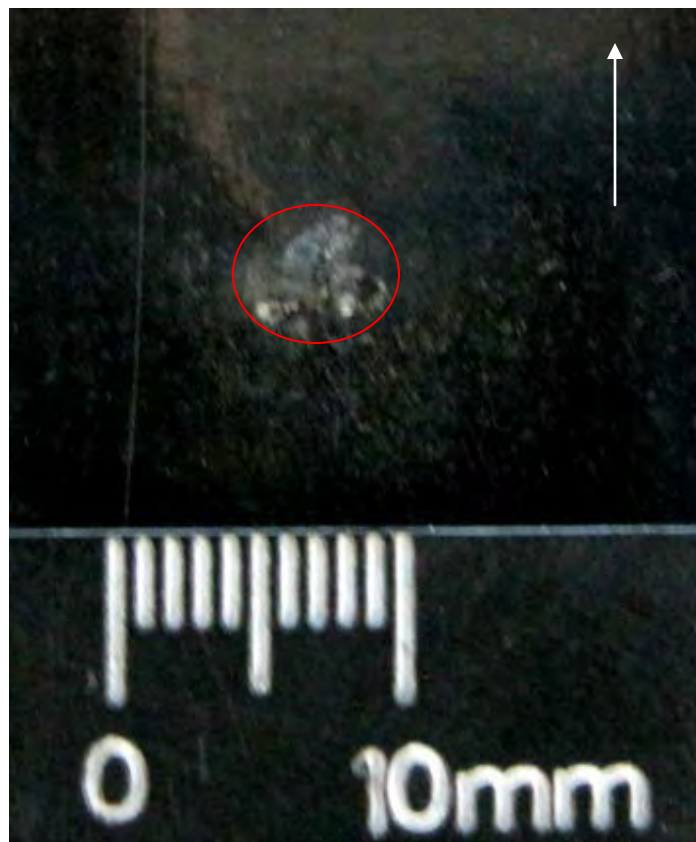
Figure 46 Close-up View of Damage to Back Side of NP 504 Substrate (scale in 1mm increments / white arrow indicates flight path of projectile)

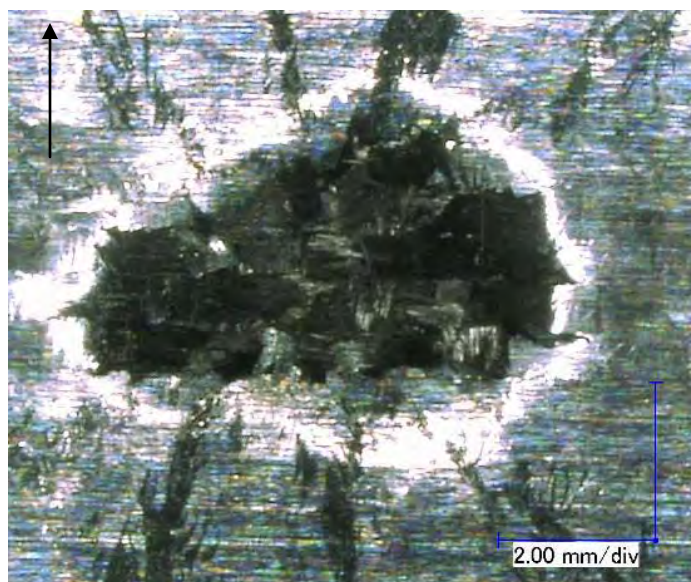
Figure 47 Close-up View of Most Significant Damage to Back Side of NP 504 Substrate (black arrow indicates flight path of projectile / damage within red circle in Figure 46)

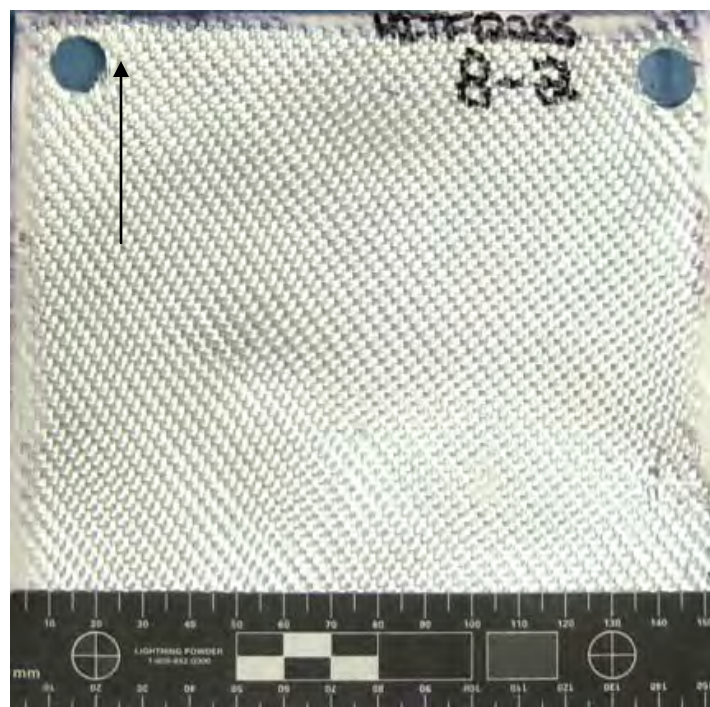
Figure 49 Overall View of Damage to Back Side of 2nd Fiberglass Layer (scale in 5mm increments / black arrow indicates flight path of projectile)

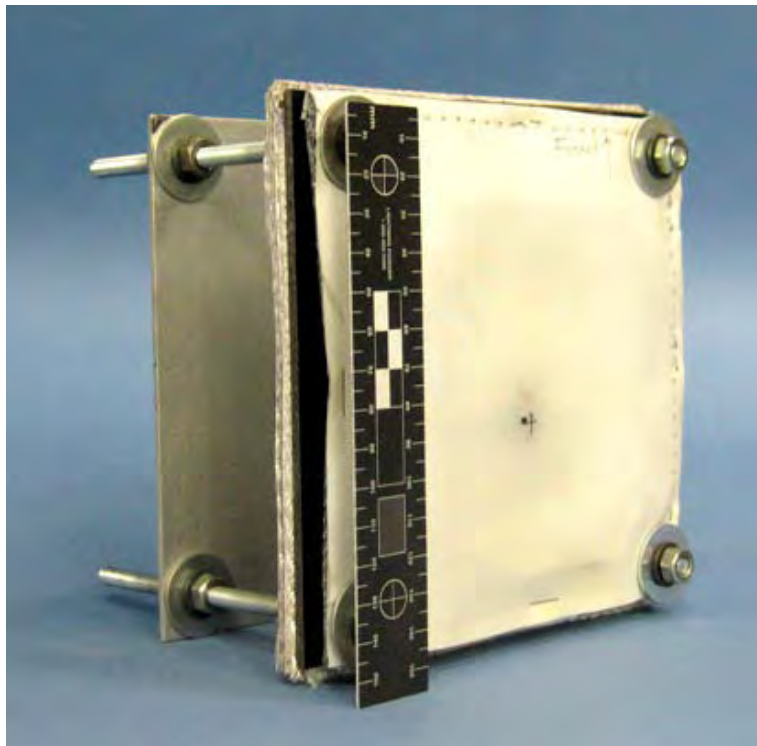
Figure 52 Overall Front Oblique View of Sample (scale in 5mm increments)

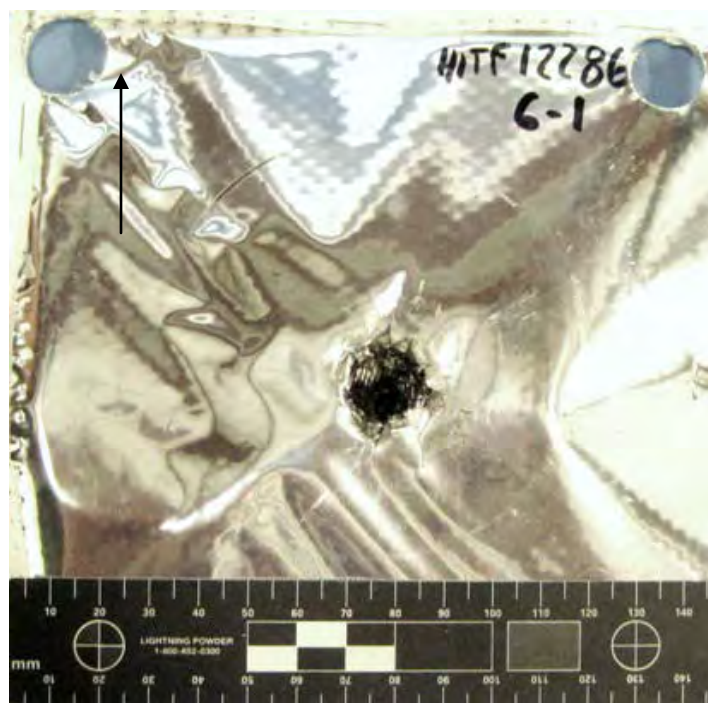
Figure 56 Overall View of Damage to Back Side of MLI (scale in 5mm increments / black arrow indicates flight path of projectile)

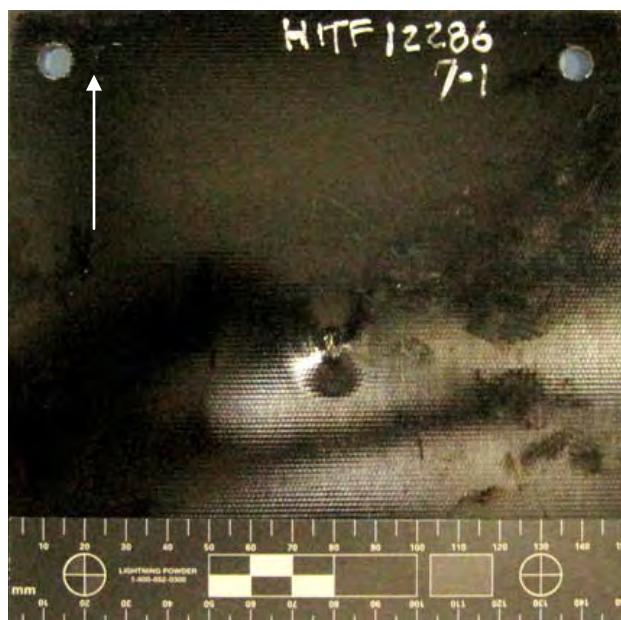
Figure 60 Overall View of Damage to Back Side of NP 504 Substrate (scale in 5mm increments / white arrow indicates flight path of projectile)

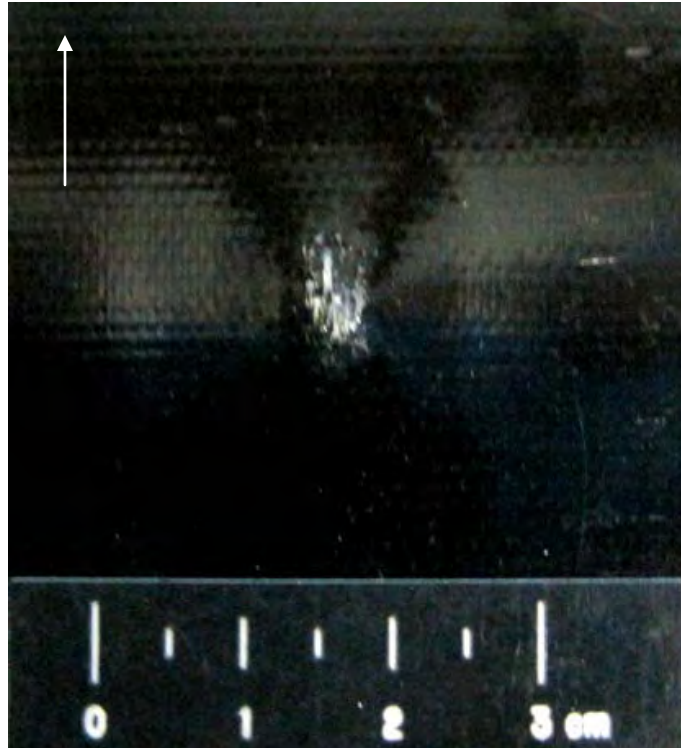
Figure 61 Close-up View of Damage to Back Side of NP 504 Substrate (scale in 5mm increments / white arrow indicates flight path of projectile)

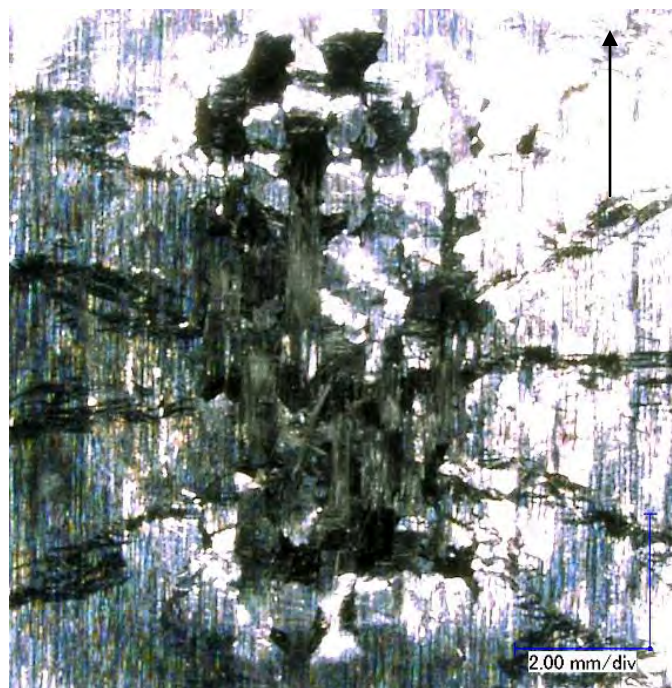
Figure 62 Close-up View of Most Significant Damage to Back Side of NP 504 Substrate (black arrow indicates flight path of projectile / damage within red circle in Figure 61)

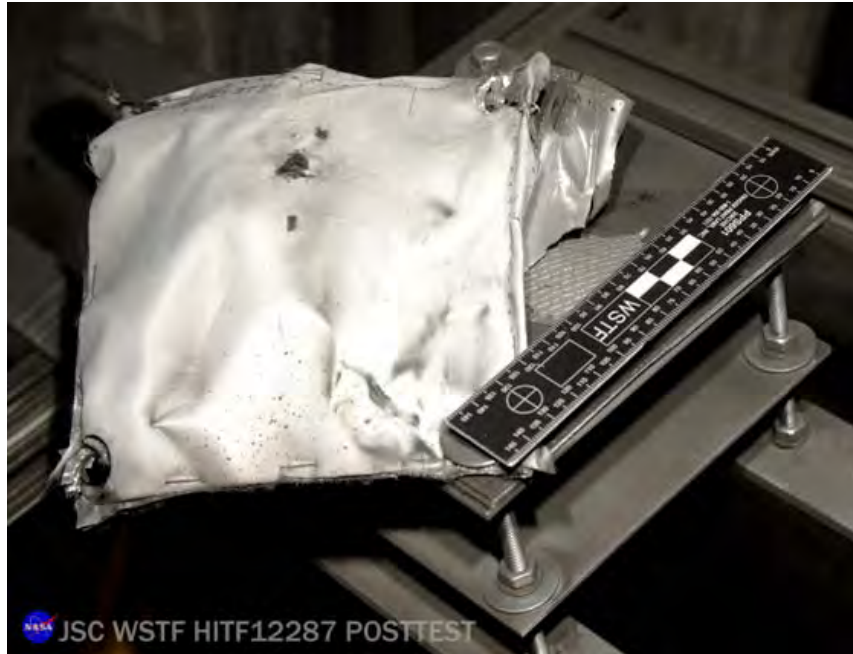
Figure 66 Overall View of Sample in the Target Tank (post-test)

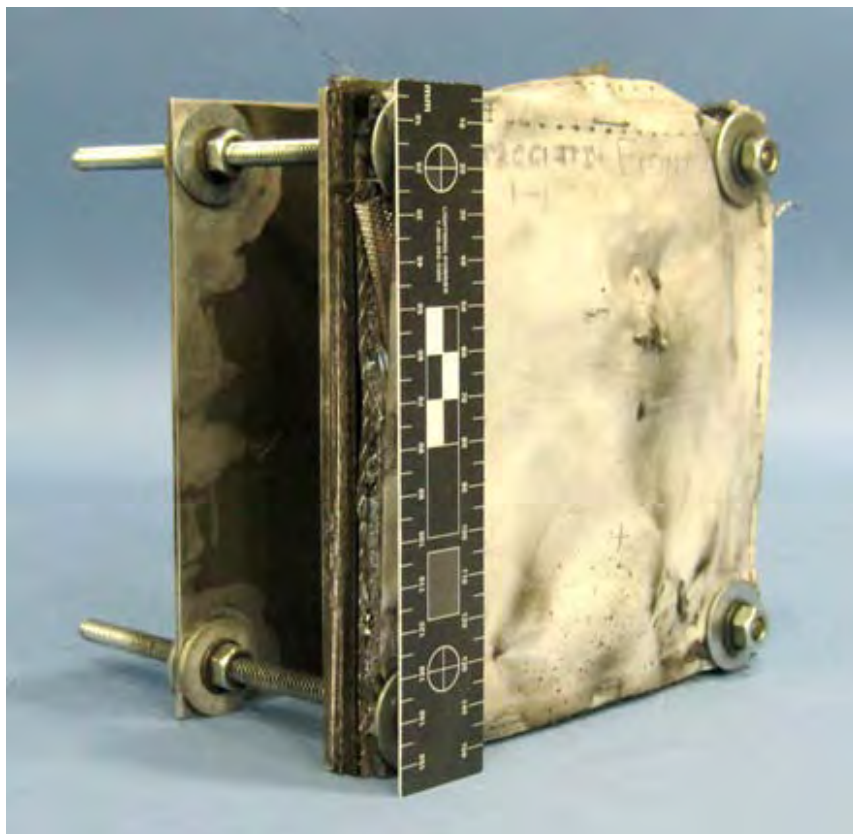
Figure 67 Overall Front Oblique View of Sample (scale in 5mm increments)

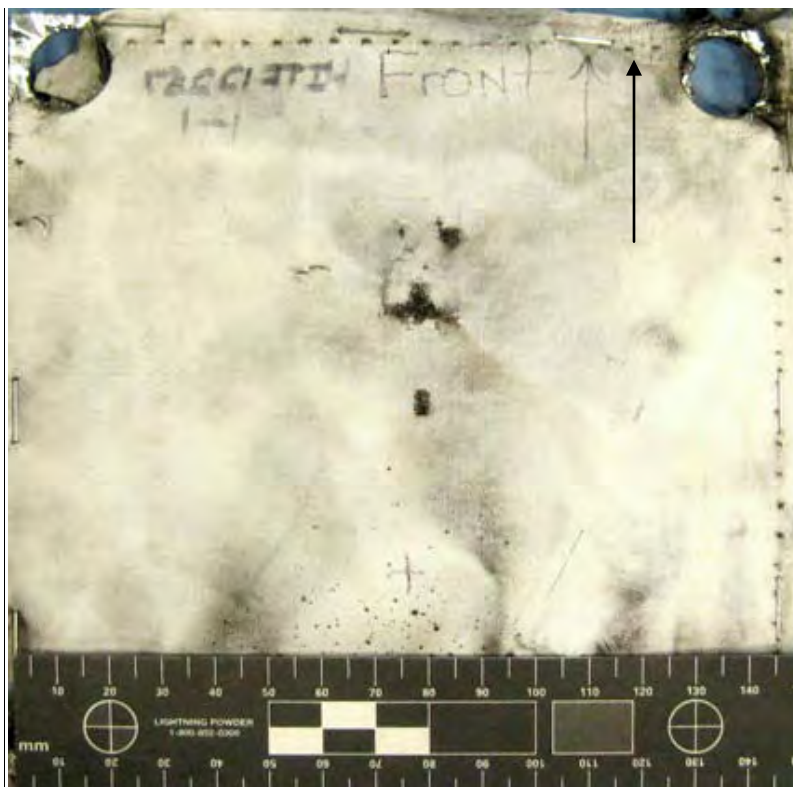
Figure 69 Overall View of Damage to Front of MLI (black arrow indicates flight path of projectile / scale in 5mm increments)

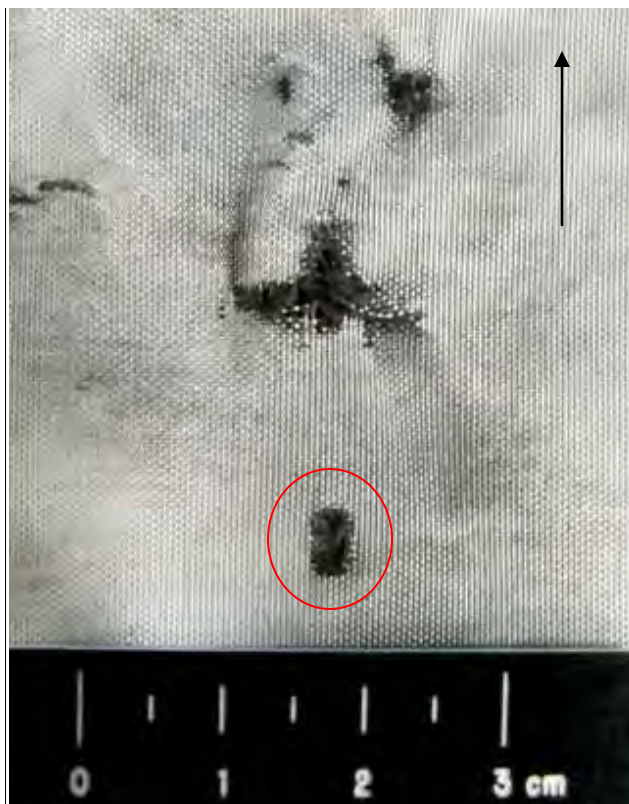
Figure 70 Close-up View of Damage to Front of MLI (scale in 5mm increments / black arrow indicates flight path of projectile / projectile impacted within red circle)

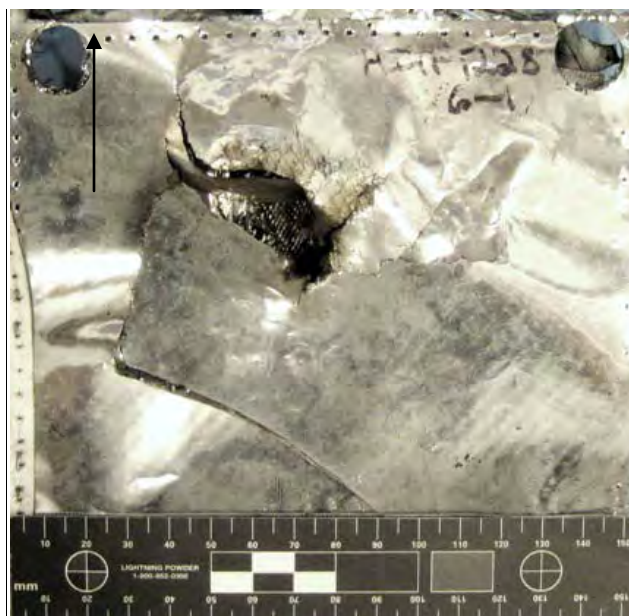
Figure 71 Overall View of Damage to Back Side of MLI (scale in 5mm increments / black arrow indicates flight path of projectile)

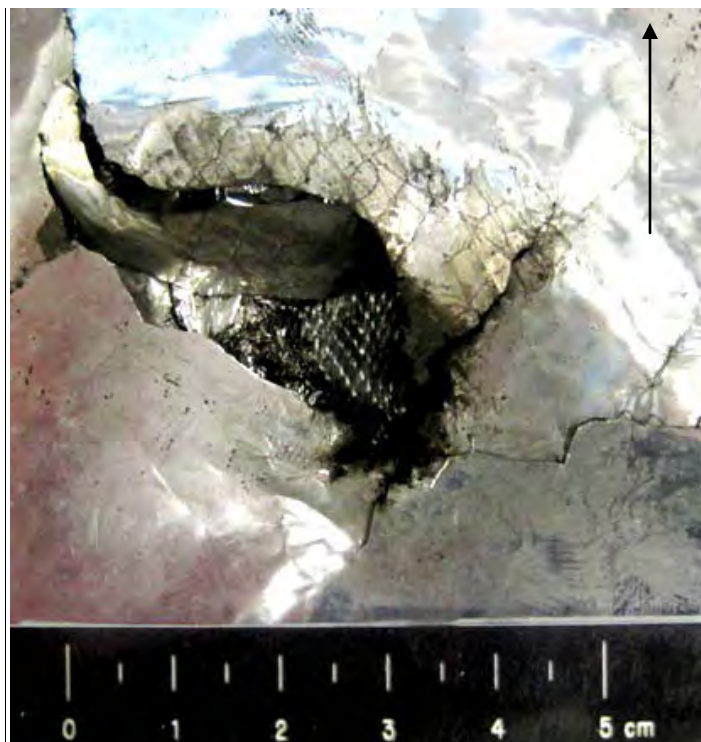
Figure 72 Close-up View of Damage to Back Side of MLI (scale in 5mm increments / black arrow indicates flight path of projectile)

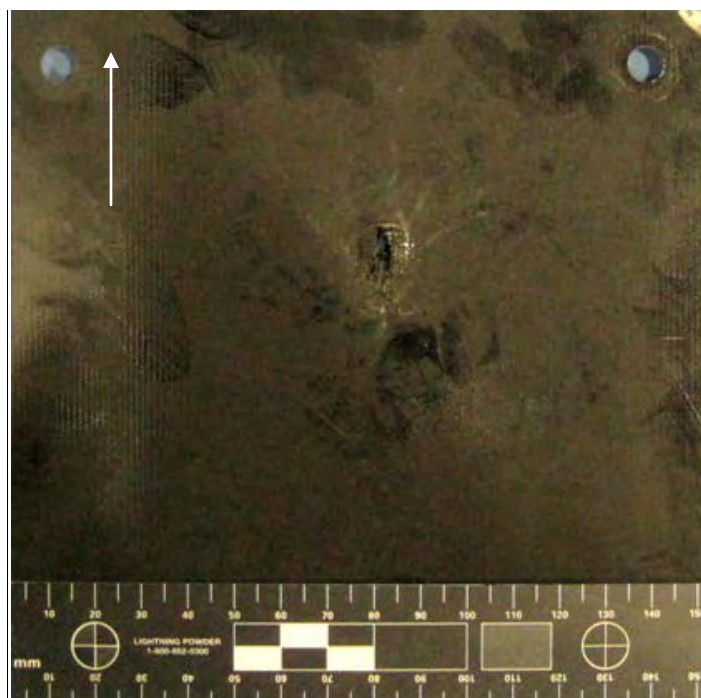
Figure 73 Overall View of Damage to Front of NP 504 Substrate (scale in 5mm increments / white arrow indicates flight path of projectile)

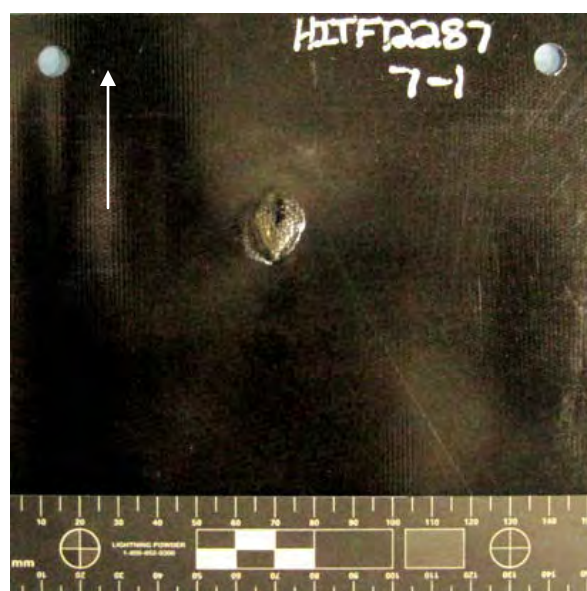
Figure 75 Overall View of Damage to Back Side of NP 504 Substrate (scale in 5mm increments / white arrow indicates flight path of projectile)

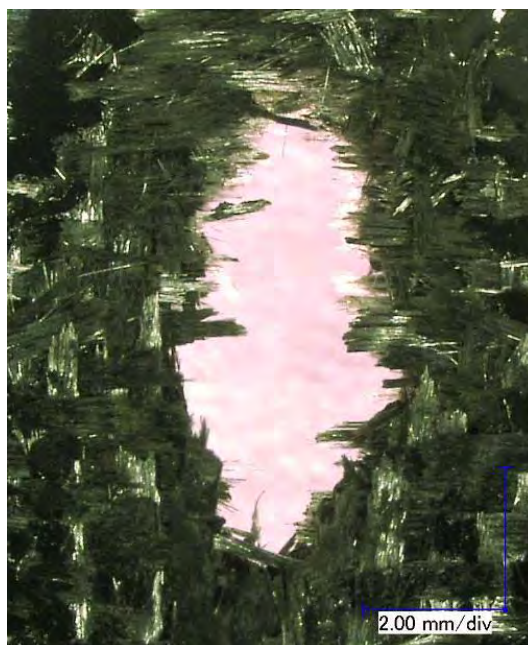
Figure 77 Close-up View of Most Significant Damage to Back Side of NP 504 Substrate (black arrow indicates flight path of projectile / damage within red circle in Figure 76)

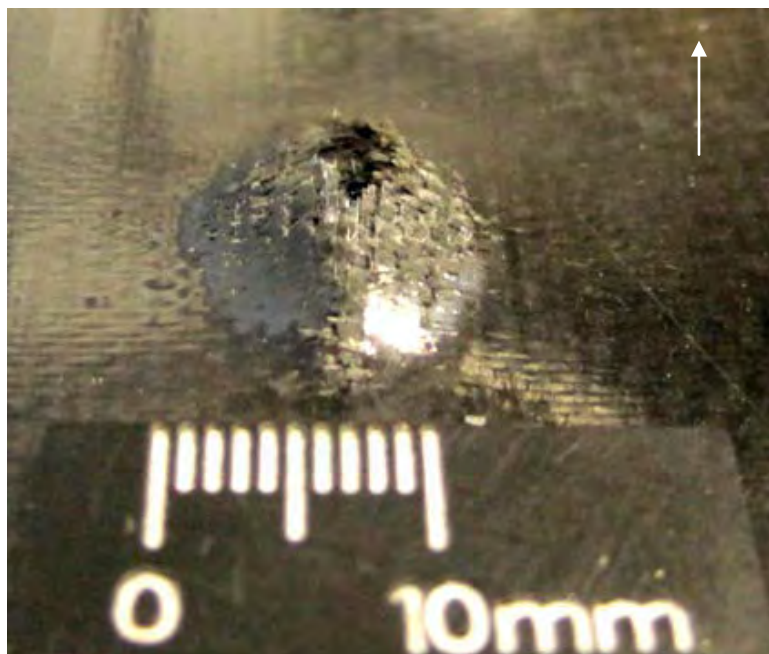
Figure 78 Close-up Oblique Side View of Damage to Back Side of NP 504 Substrate (scale in 1mm increments / white arrow indicates flight path of projectile)

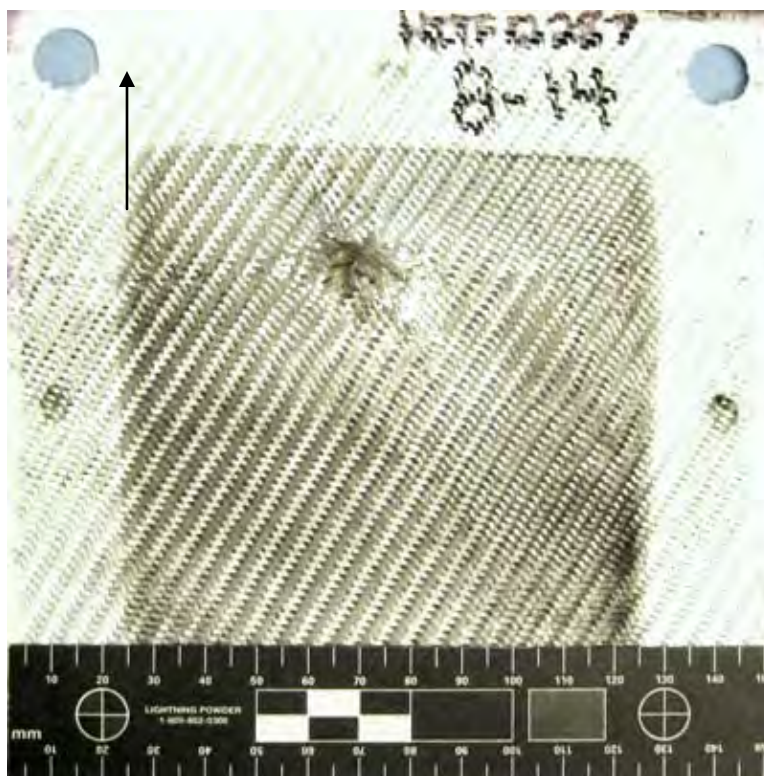
Figure 79 Overall View of Damage to Back Side of Last Fiberglass Layer (scale in 5mm increments / black arrow indicates flight path of projectile)

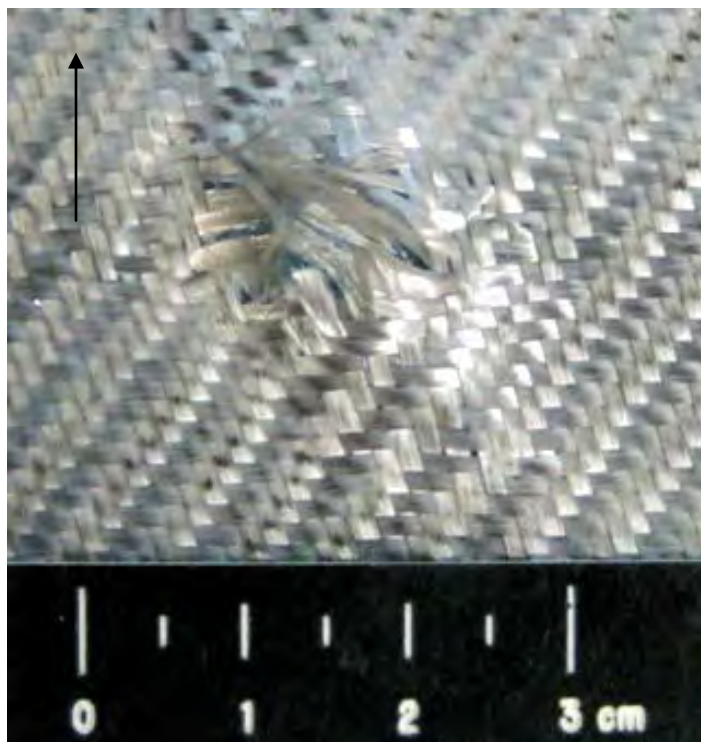
Figure 80 Close-up View of Damage to Back Side of Last Fiberglass Layer (scale in 5mm increments / black arrow indicates flight path of projectile)

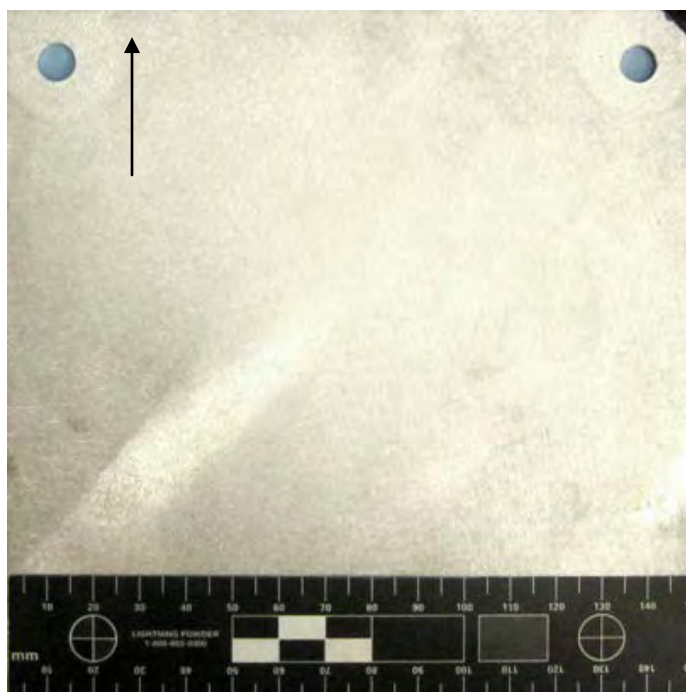
Figure 81 Overall View of Damage to Front of Rear Wall (scale in 5mm increments / black arrow indicates flight path of projectile)

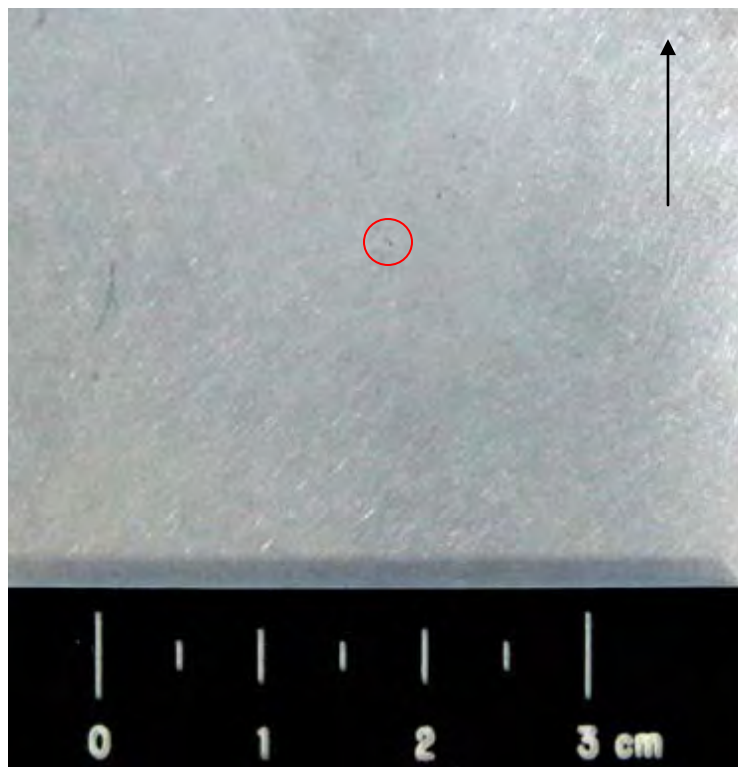
Figure 82 Close-up View of Damage to Front of Rear Wall (scale in 5mm increments / black arrow indicates flight path of projectile)

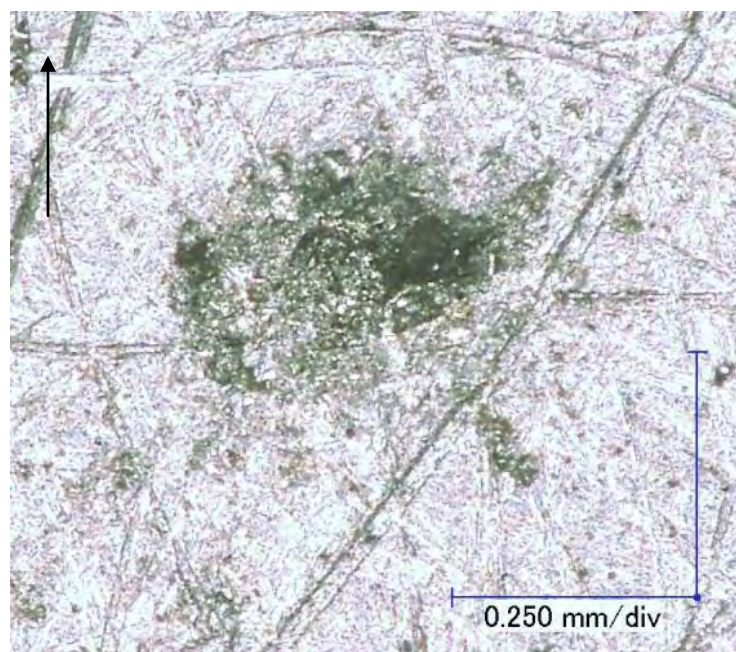
Figure 83 Close-up View of Most Significant Damage to Front of Rear Wall (black arrow indicates flight path of projectile / damage within red circle in Figure 82)

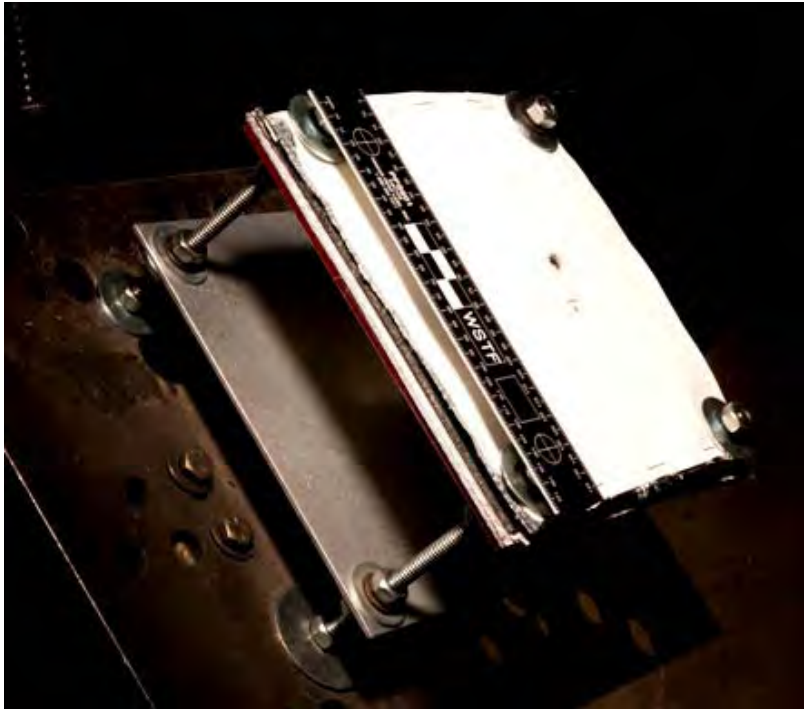
Figure 85 Overall View of Sample in the Target Tank (post-test)

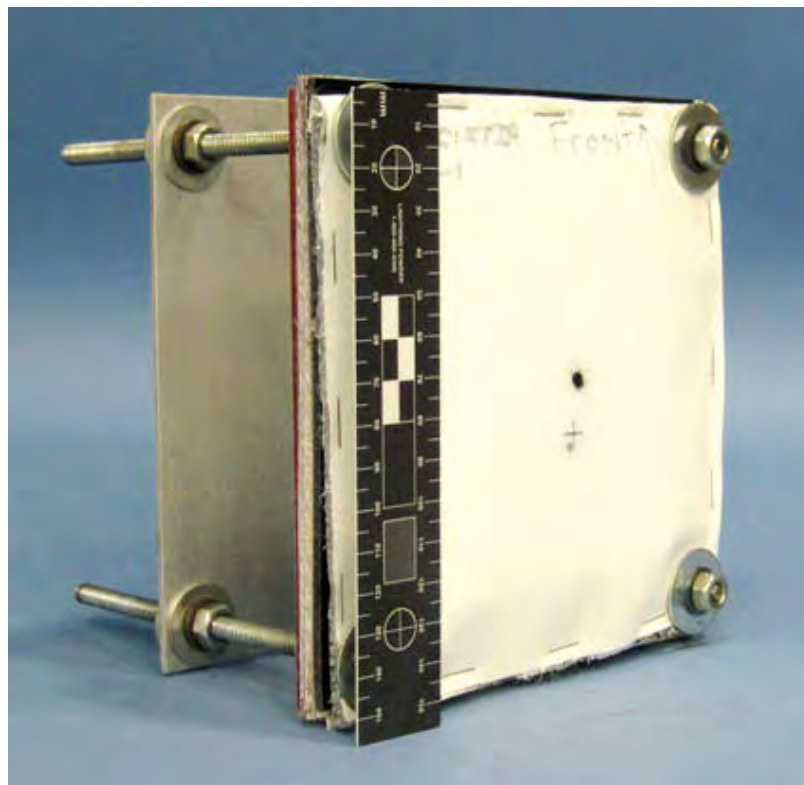
Figure 86 Overall Front Oblique View of Sample (scale in 5mm increments)

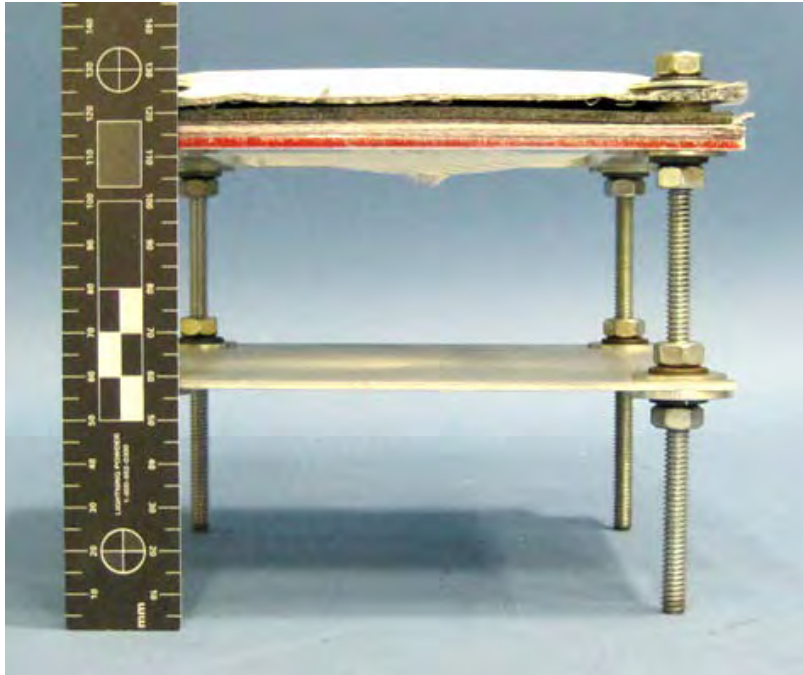
**Figure 87** Overall Side View of Sample (scale in 5mm increments)

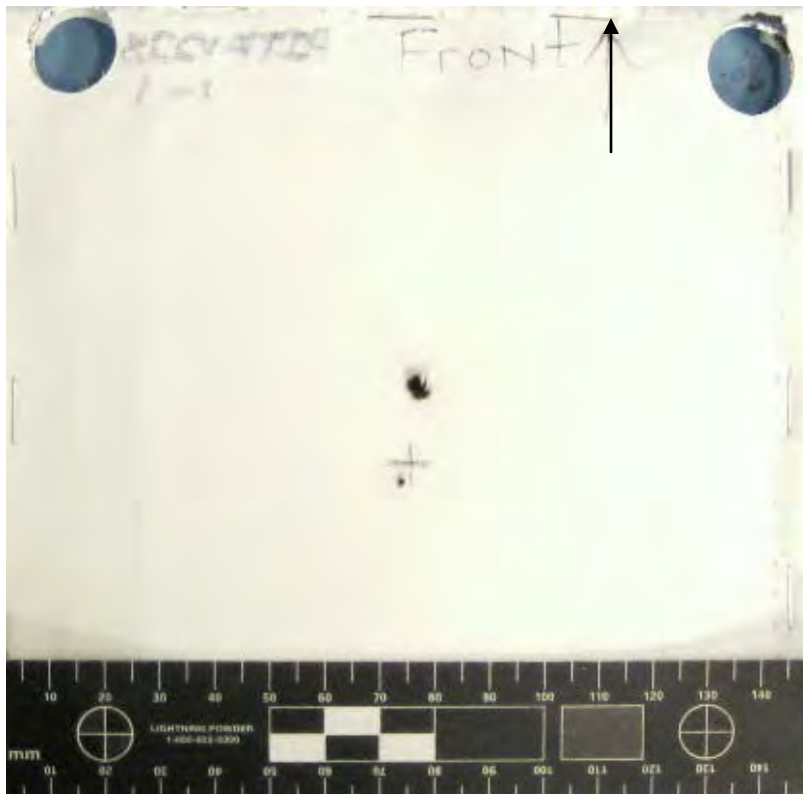
**Figure 88** Overall View of Damage to Front of MLI (scale in 5mm increments / black arrow indicates flight path of projectile)

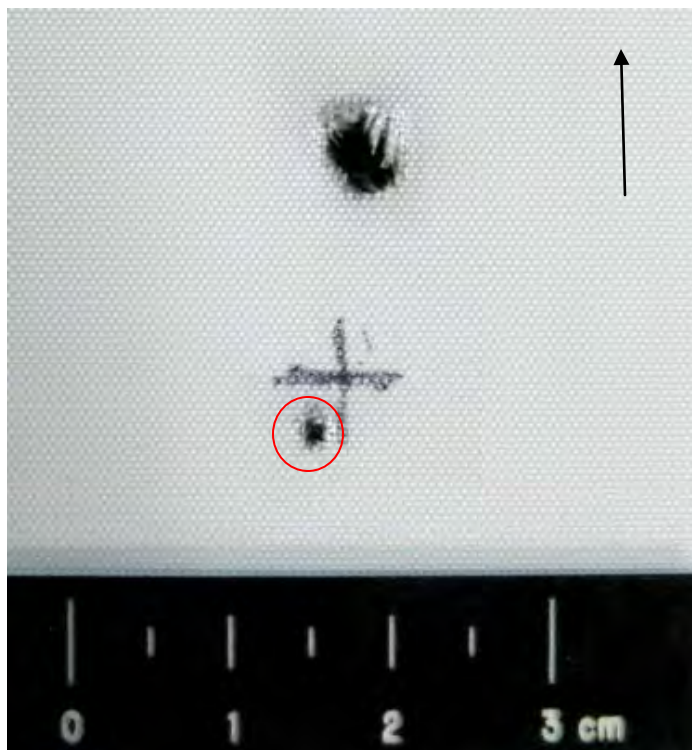
Figure 89 Close-up View of Damage to Front of MLI (scale in 5mm increments / black arrow indicates flight path of projectile / projectile impacted within red circle)

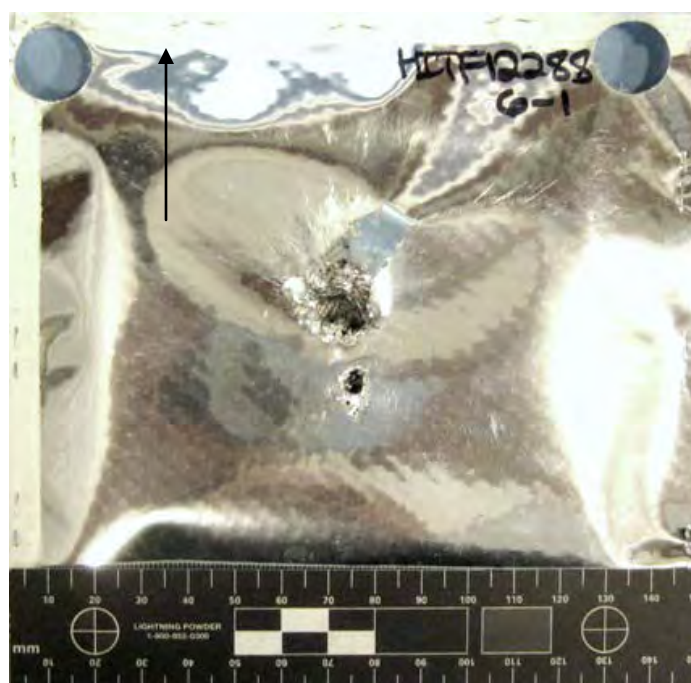
Figure 90 Overall View of Damage to Back Side of MLI (scale in 5mm increments / black arrow indicates flight path of projectile)

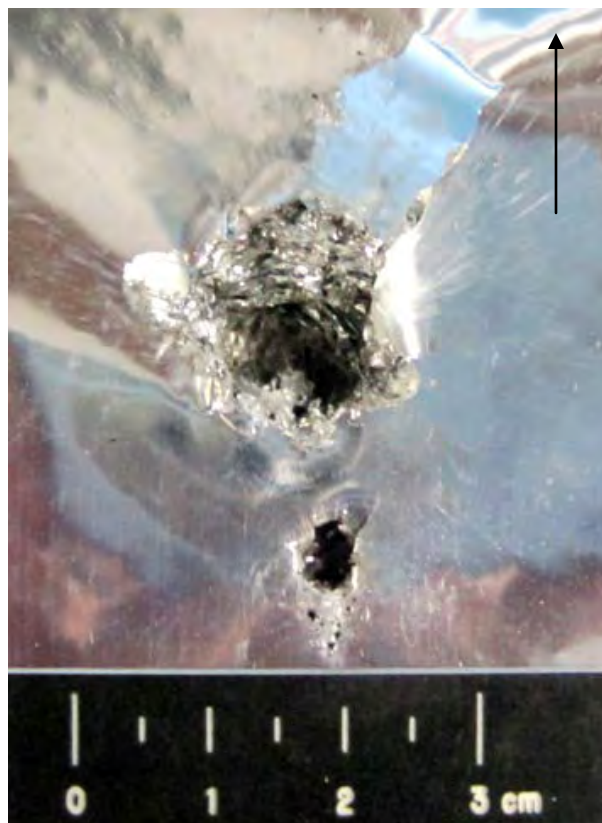
Figure 91 Close-up View of Damage to Back Side of MLI (scale in 5mm increments / black arrow indicates flight path of projectile)

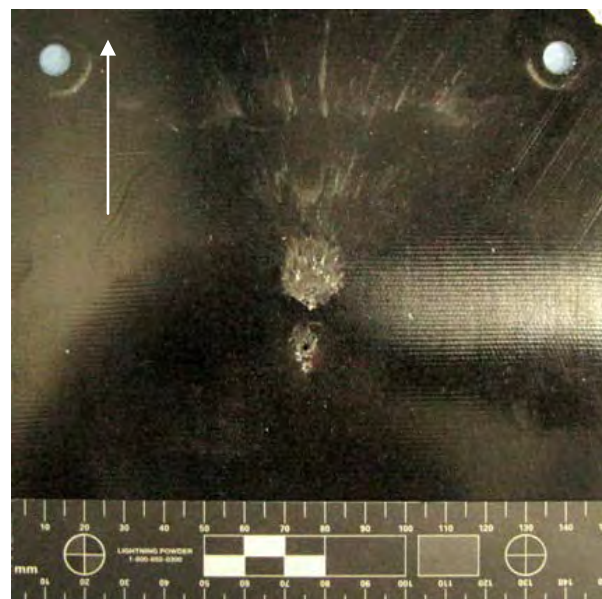
Figure 92 Overall View of Damage to Front of NP 504 Substrate (scale in 5mm increments / white arrow indicates flight path of projectile)

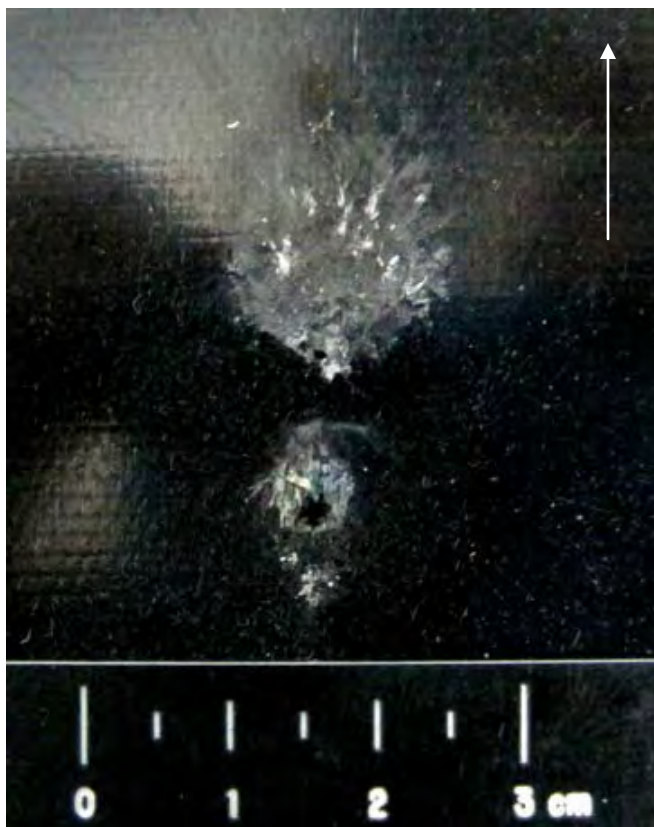
Figure 93 Close-up View of Damage to Front of NP 504 Substrate (scale in 5mm increments / white arrow indicates flight path of projectile)

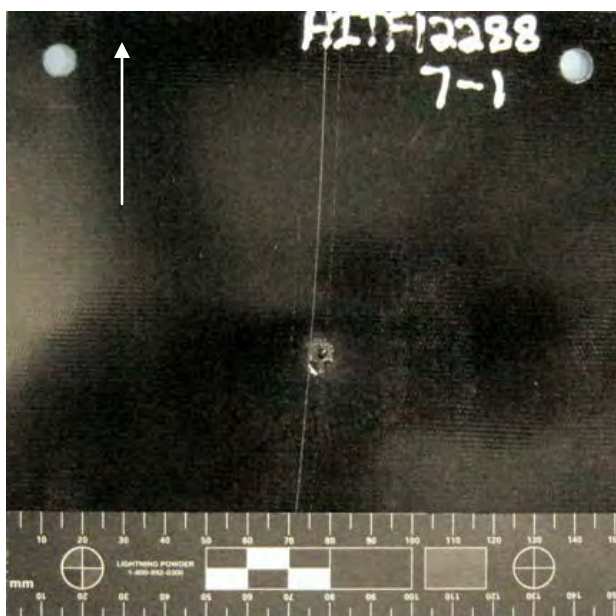
Figure 94 Overall View of Damage to Back Side of NP 504 Substrate (scale in 5mm increments / white arrow indicates flight path of projectile)

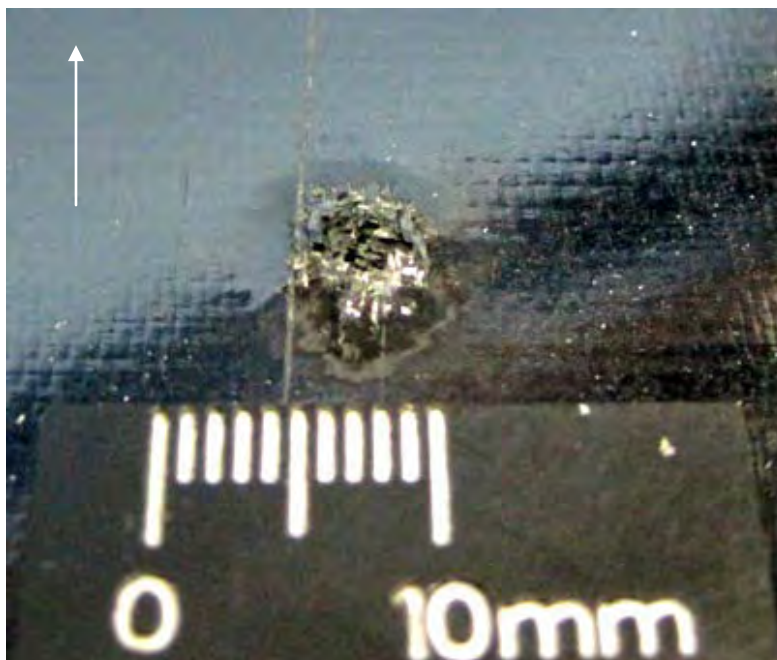
Figure 97 Close-up Oblique Side View of Damage to Back Side of NP 504 Substrate (scale in 1mm increments / white arrow indicates flight path of projectile)

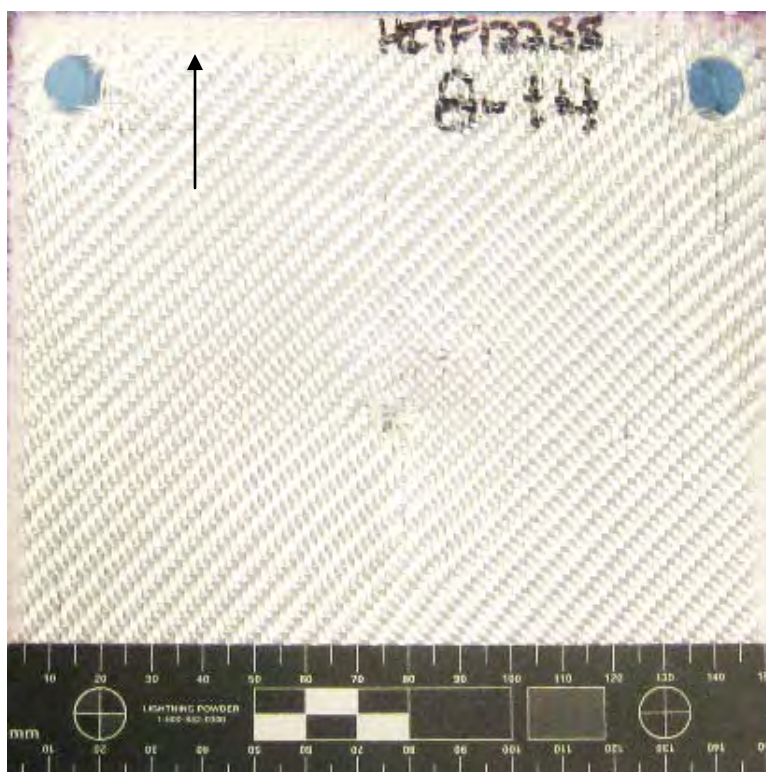
Figure 98 Overall View of Damage to Back Side of Last Fiberglass Layer (scale in 5mm increments / black arrow indicates flight path of projectile)

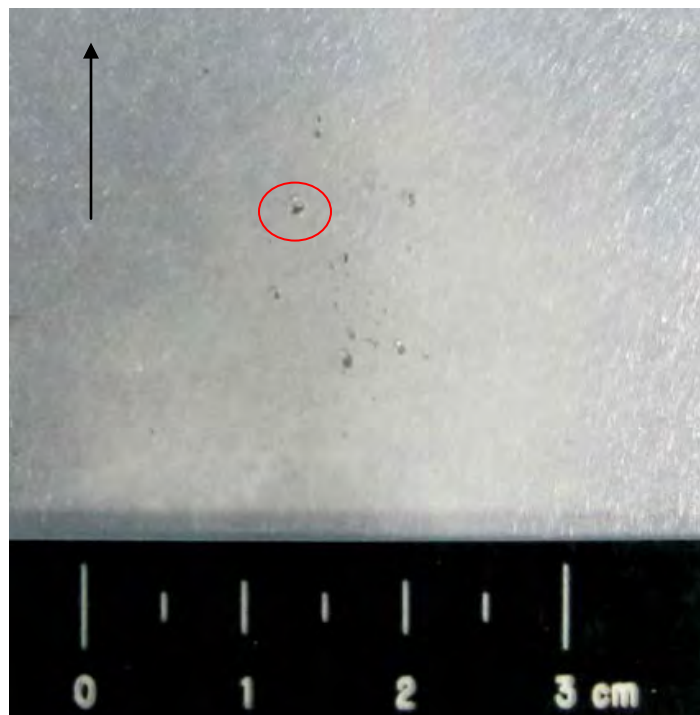
Figure 101 Close-up View of Damage to Front of Rear Wall (scale in 5mm increments / black arrow indicates flight path of projectile)

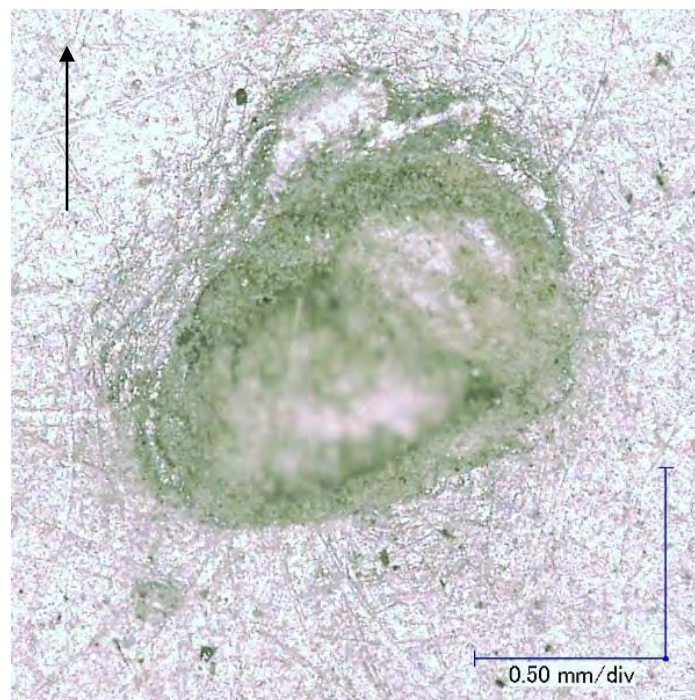
Figure 102 Close-up View of Most Significant Damage to Front of Rear Wall (black arrow indicates flight path of projectile / damage within red circle in Figure 101)

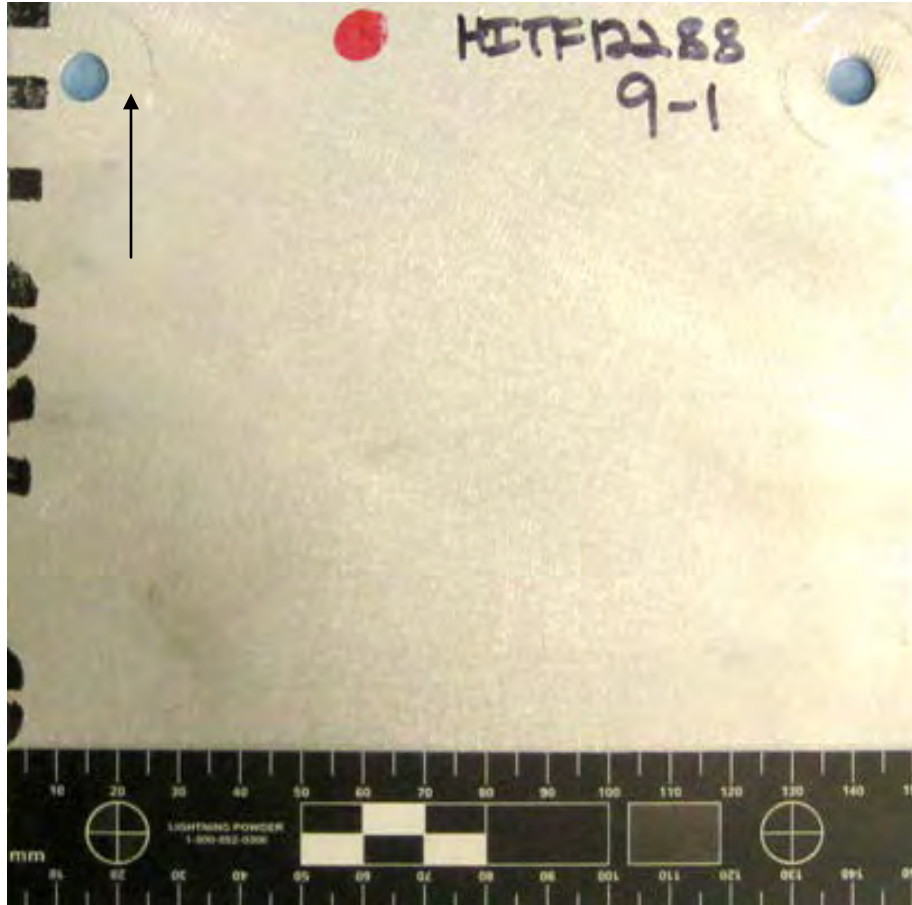
Figure 103 Overall View of Damage to Front of Rear Wall (scale in 5mm increments / black arrow indicates flight path of projectile)

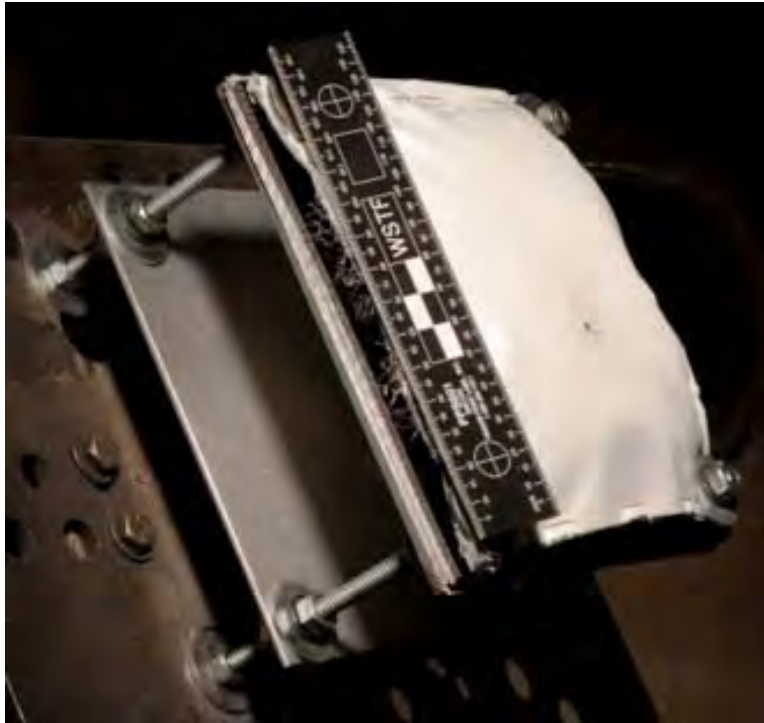
Figure 104 Overall View of Sample in the Target Tank (post-test)

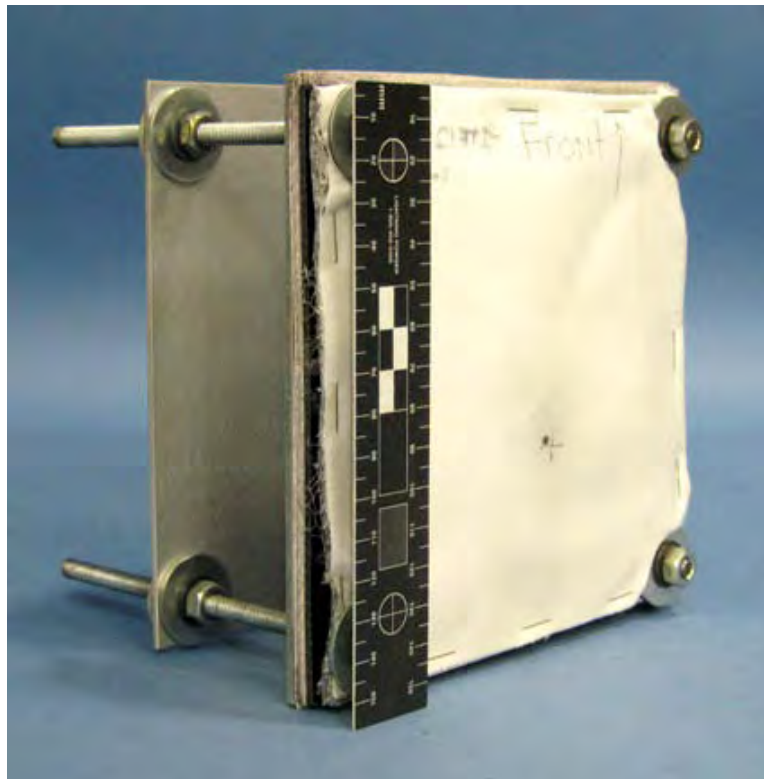
Figure 105 Overall Front Oblique View of Sample (scale in 5mm increments)
