International Space Station (ISS) Soyuz Vehicle Descent Module Evaluation of Thermal Protection System (TPS) Penetration Characteristics

Hypervelocity Impact Technology Group

February 2013

**International Space Station (ISS) Soyuz Vehicle
Descent Module Evaluation of Thermal Protection
System (TPS) Penetration Characteristics**

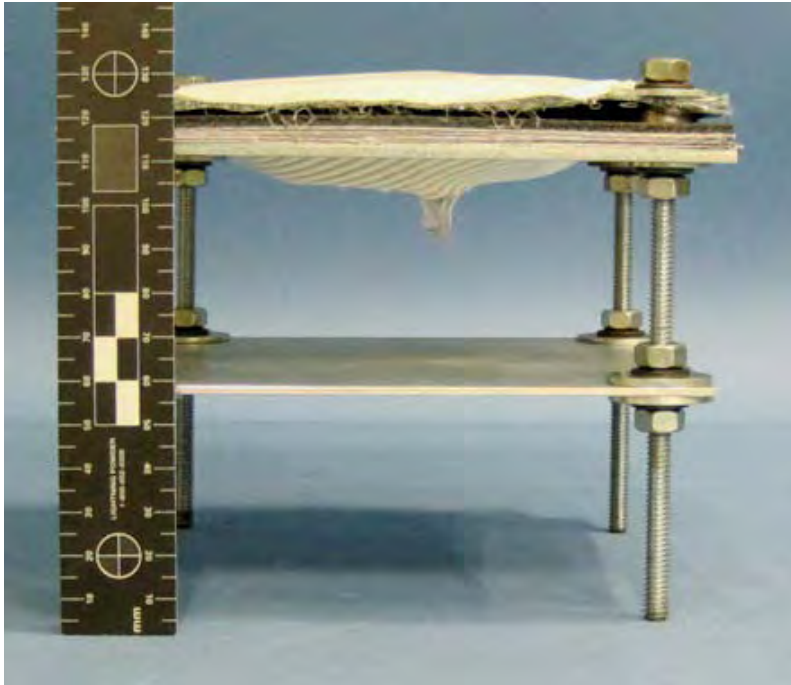
Figure 106 Overall Side View of Sample (scale in 5mm increments)

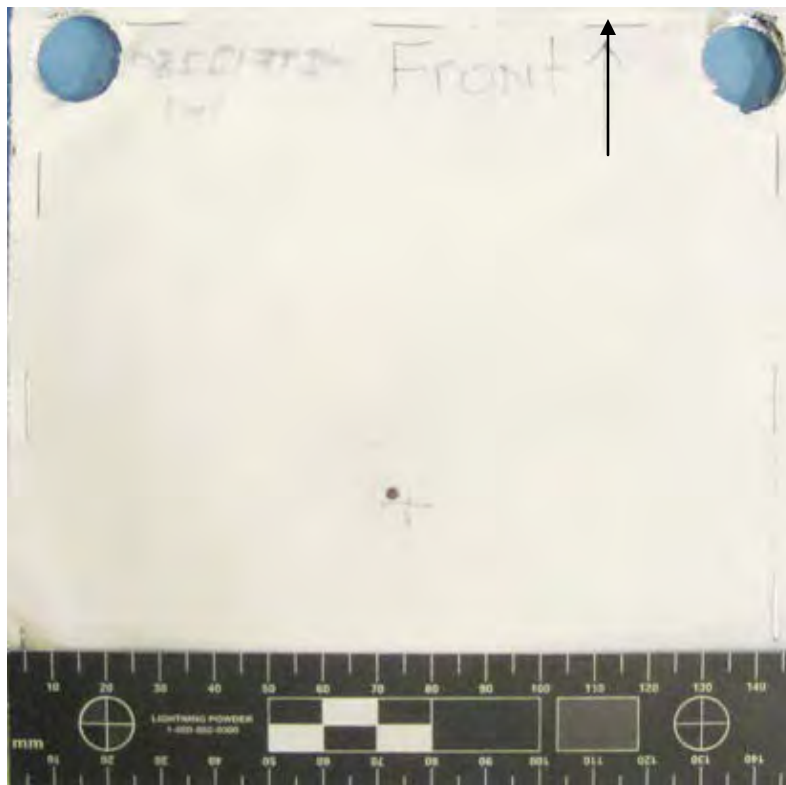
Figure 107 Overall View of Damage to Front of MLI (scale in 5mm increments / black arrow indicates flight path of projectile)

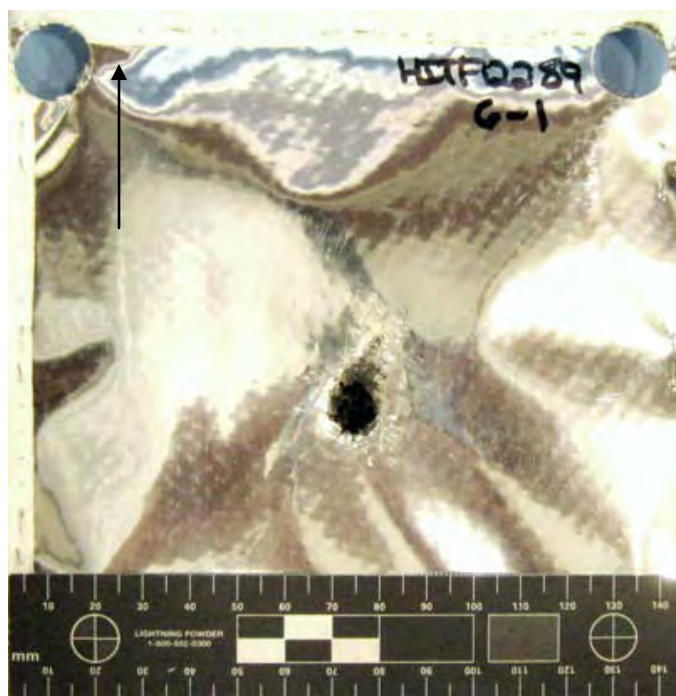
Figure 109 Overall View of Damage to Back Side of MLI (scale in 5mm increments / black arrow indicates flight path of projectile)

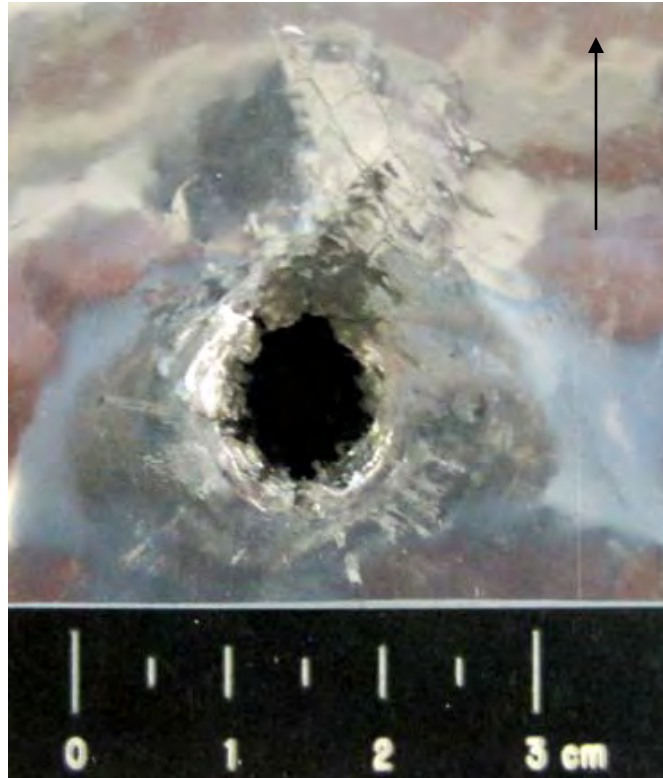
Figure 110 Close-up View of Damage to Back Side of MLI (scale in 5mm increments / black arrow indicates flight path of projectile)

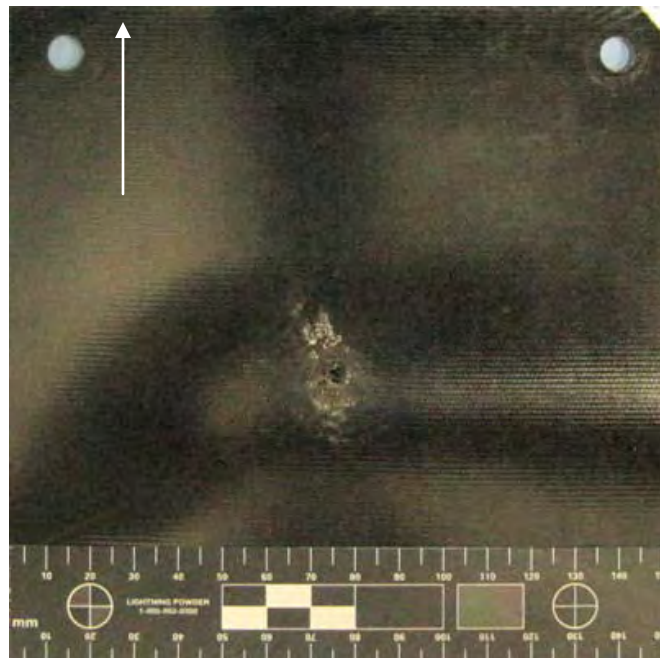
Figure 111 Overall View of Damage to Front of NP 504 Substrate (scale in 5mm increments / white arrow indicates flight path of projectile)

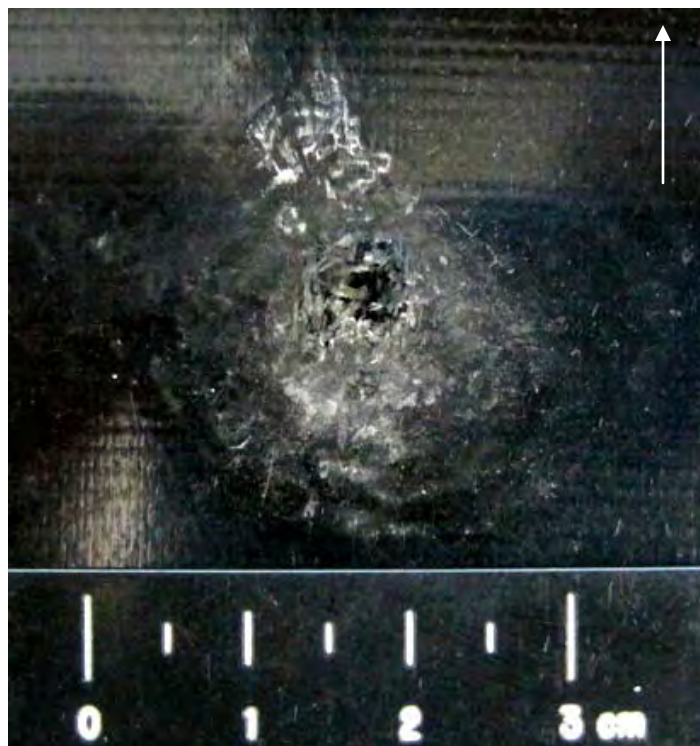
Figure 112 Close-up View of Damage to Front of NP 504 Substrate (scale in 5mm increments / white arrow indicates flight path of projectile)

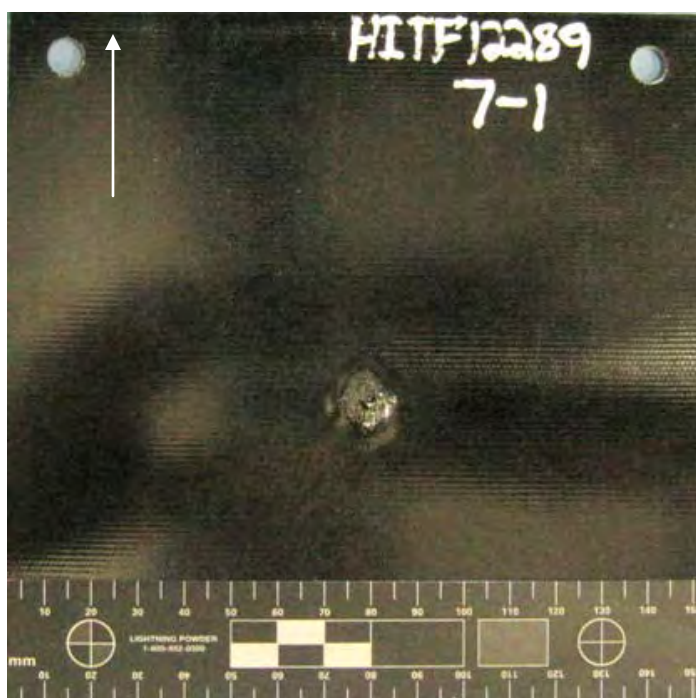
Figure 113 Overall View of Damage to Back Side of NP 504 Substrate (scale in 5mm increments / white arrow indicates flight path of projectile)

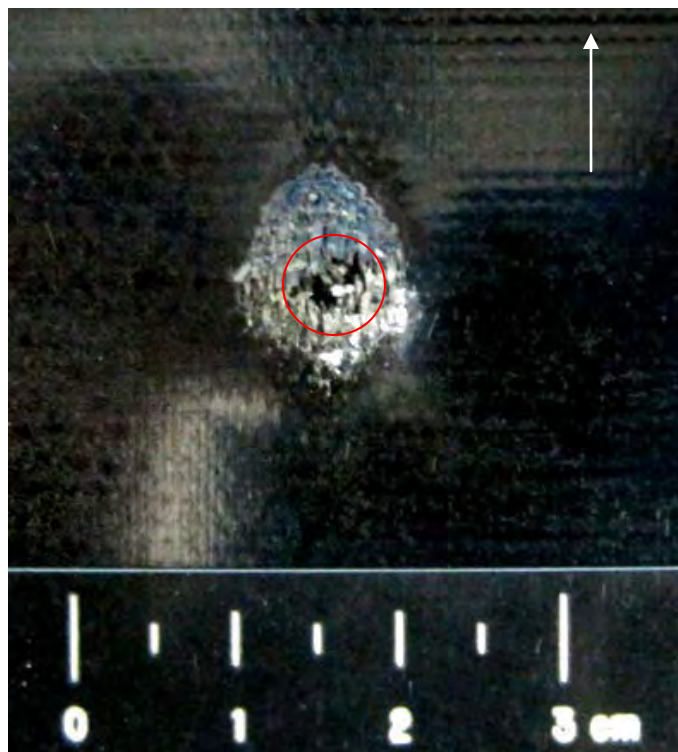
Figure 114 Close-up View of Damage to Back Side of NP 504 Substrate (scale in 5mm increments / white arrow indicates flight path of projectile)

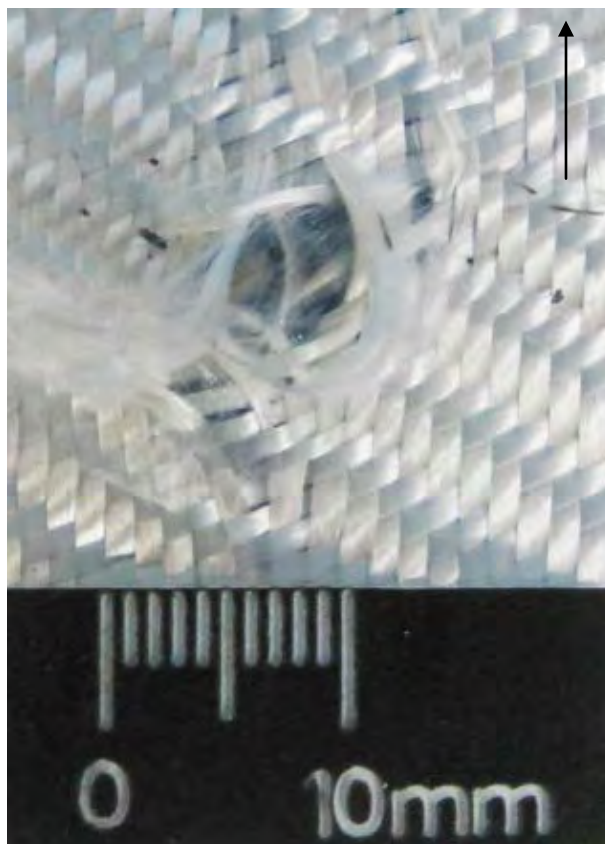
Figure 118 Overall View of Damage to Back Side of Last Fiberglass Layer (scale in 1mm increments / black arrow indicates flight path of projectile)

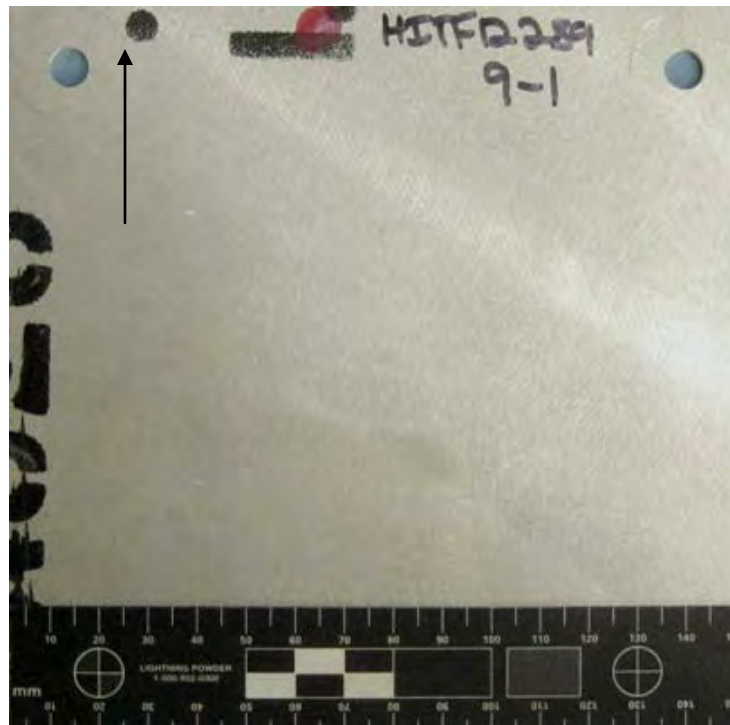
Figure 121 Overall View of Damage to Front of Rear Wall (scale in 5mm increments / black arrow indicates flight path of projectile)

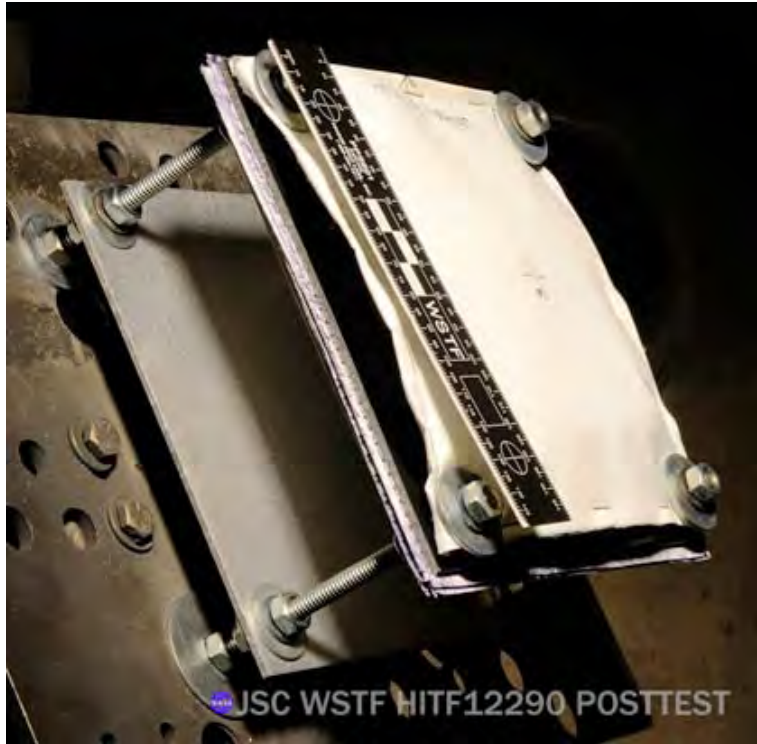
Figure 122 Overall View of Sample in the Target Tank (post-test)

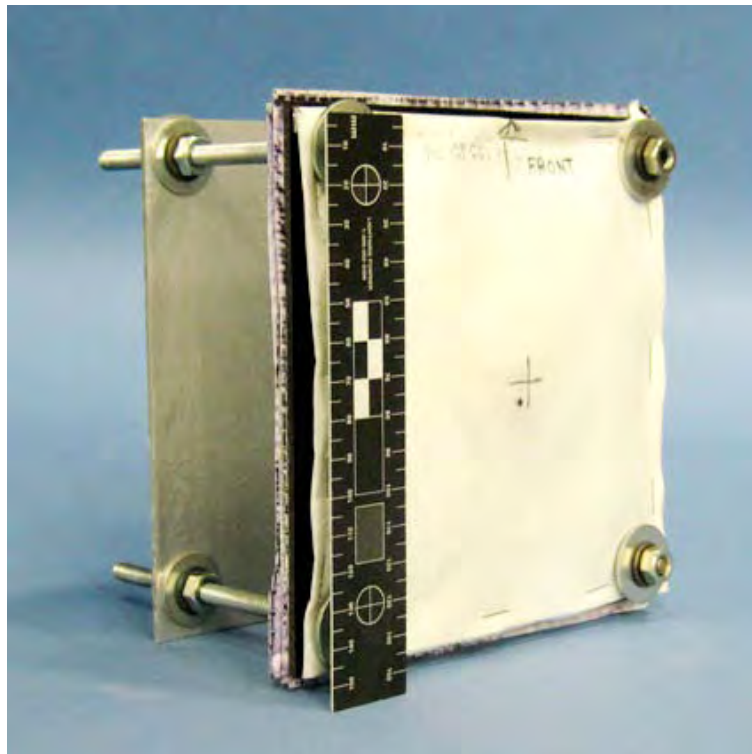
Figure 123 Overall Front Oblique View of Sample (scale in 5mm increments)

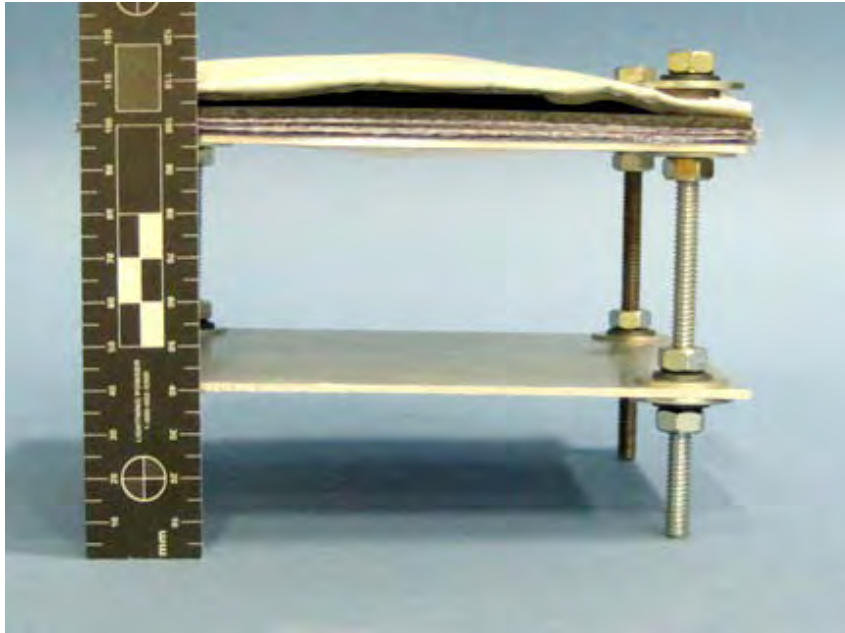
Figure 124 Overall Side View of Sample (scale in 5mm increments)

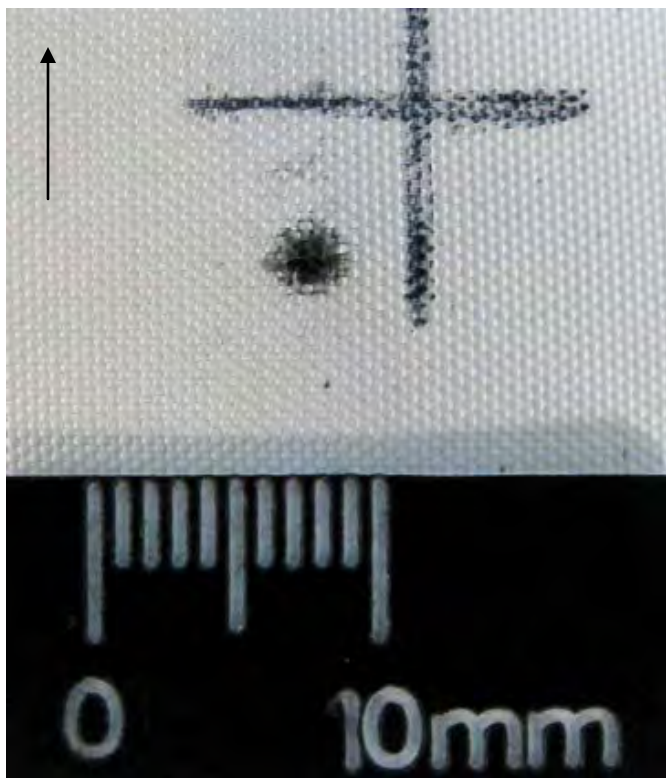
Figure 126 Close-up View of Damage to Front of MLI (scale in 1mm increments / black arrow indicates flight path of projectile)

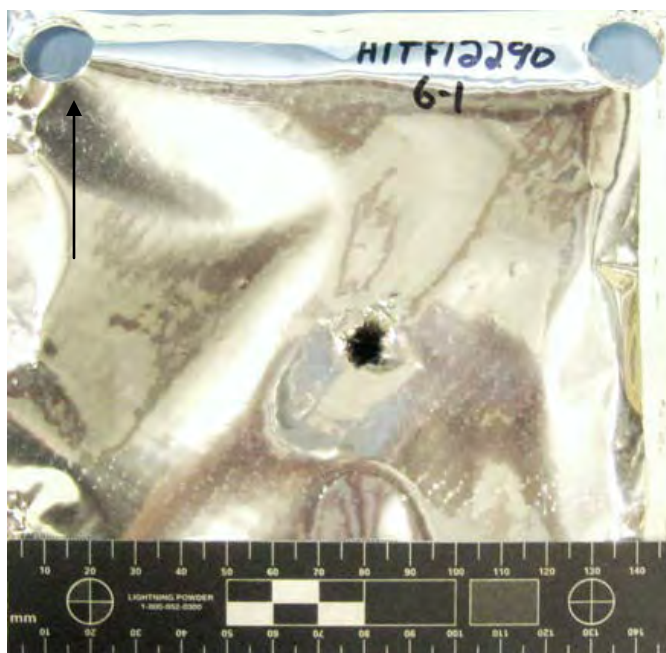
Figure 127 Overall View of Damage to Back Side of MLI (scale in 5mm increments / black arrow indicates flight path of projectile)

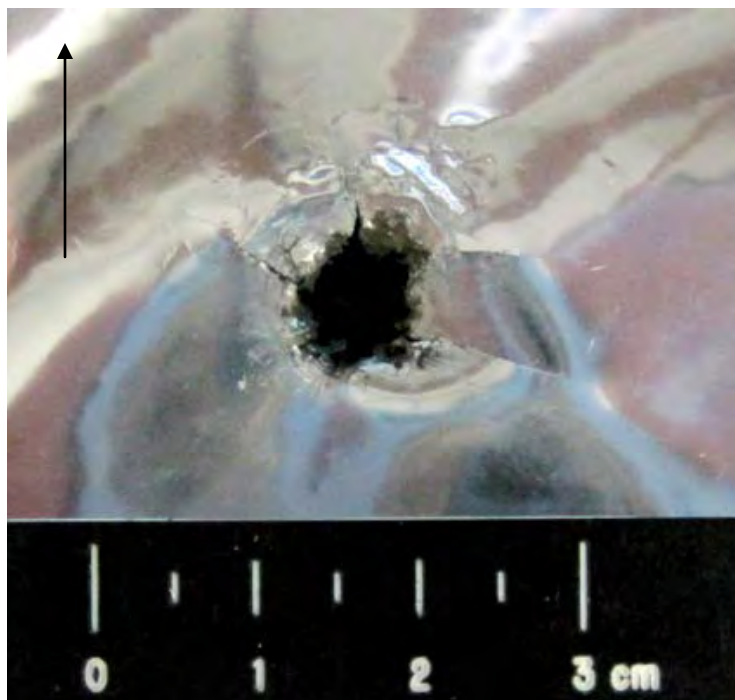
Figure 128 Close-up View of Damage to Back Side of MLI (scale in 5mm increments / black arrow indicates flight path of projectile)

Figure 316 Close-up View of Damage to Front of NP 504 Substrate (white arrow indicates flight path of projectile / damage within red circle in Figure 128)

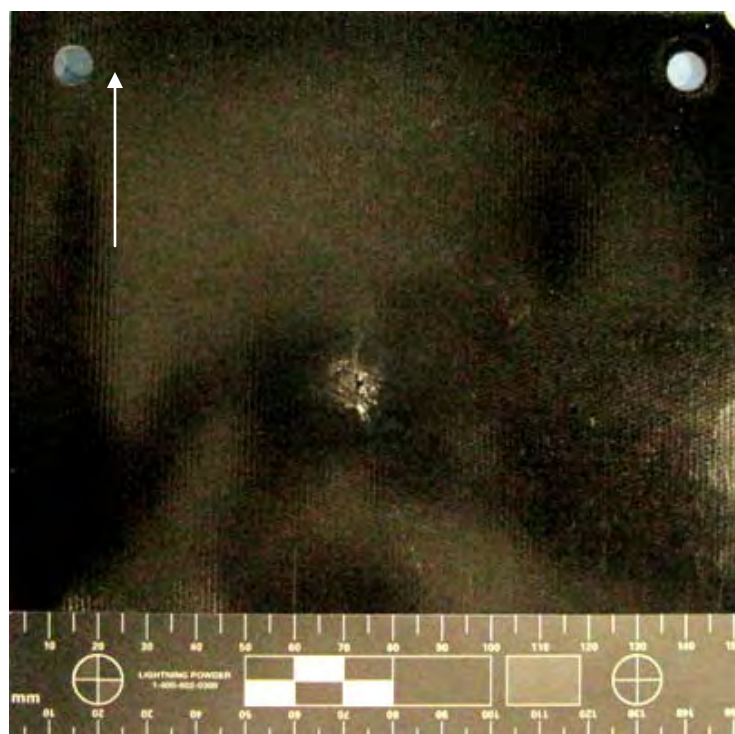
Figure 129 Overall View of Damage to Front of NP 504 Substrate (scale in 5mm increments / white arrow indicates flight path of projectile)

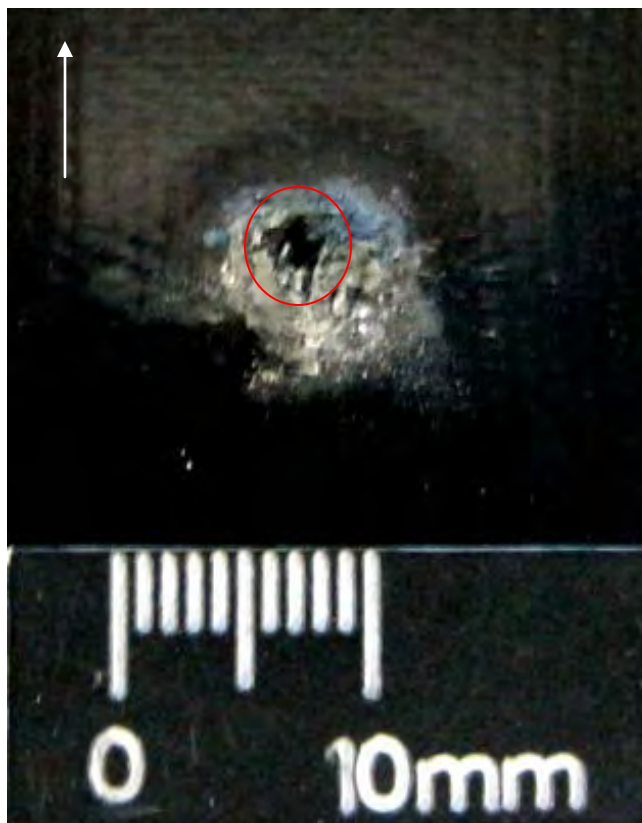
Figure 132 Close-up View of Damage to Back Side of NP 504 Substrate (scale in 1mm increments / white arrow indicates flight path of projectile)

Figure 133 Close-up View of Most Significant Damage to Back Side of NP 504 Substrate (white arrow indicates flight path of projectile / damage within red circle in Figure 132)

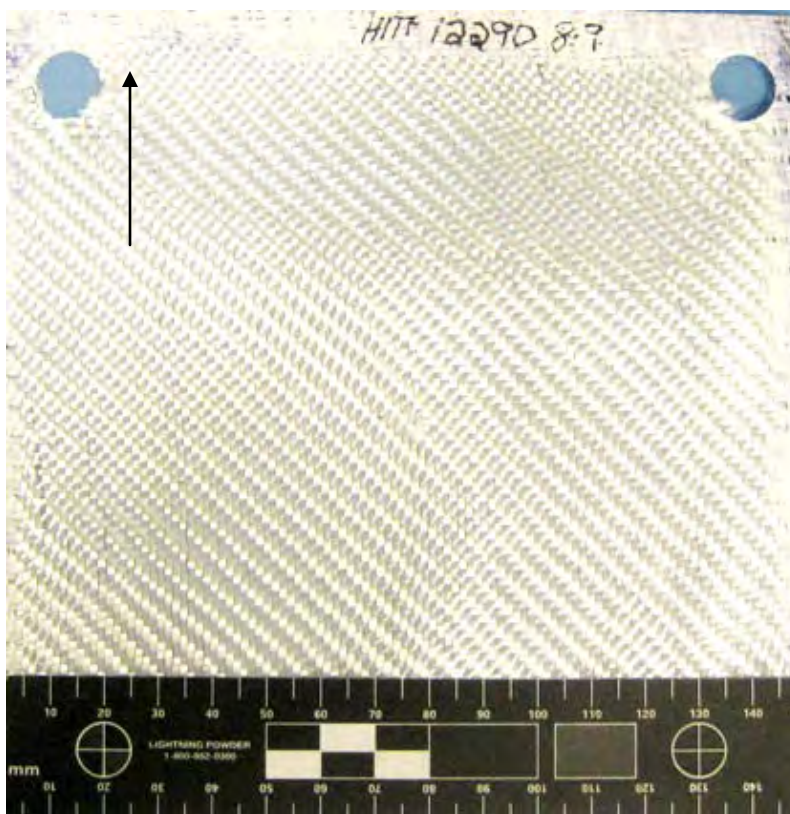
Figure 135 Overall View of Damage to Back Side of 7th Fiberglass Layer (scale in 5mm increments / black arrow indicates flight path of projectile)

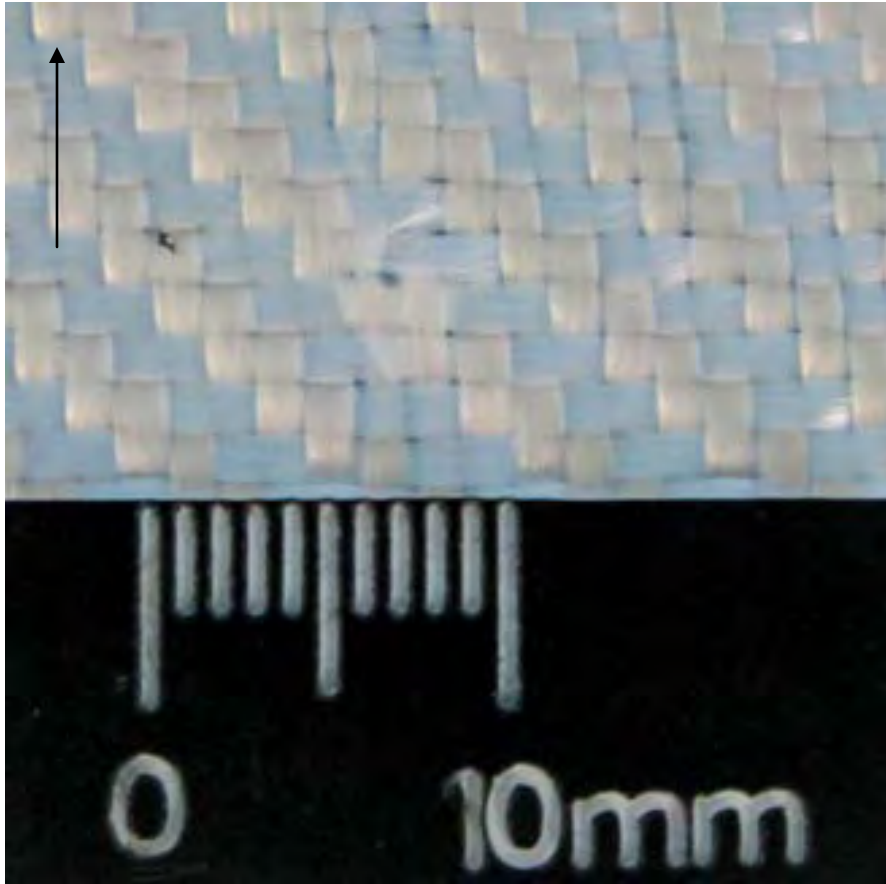
Figure 136 Close-up View of Damage to Back Side of 7th Fiberglass Layer (scale in 1mm increments / black arrow indicates flight path of projectile)

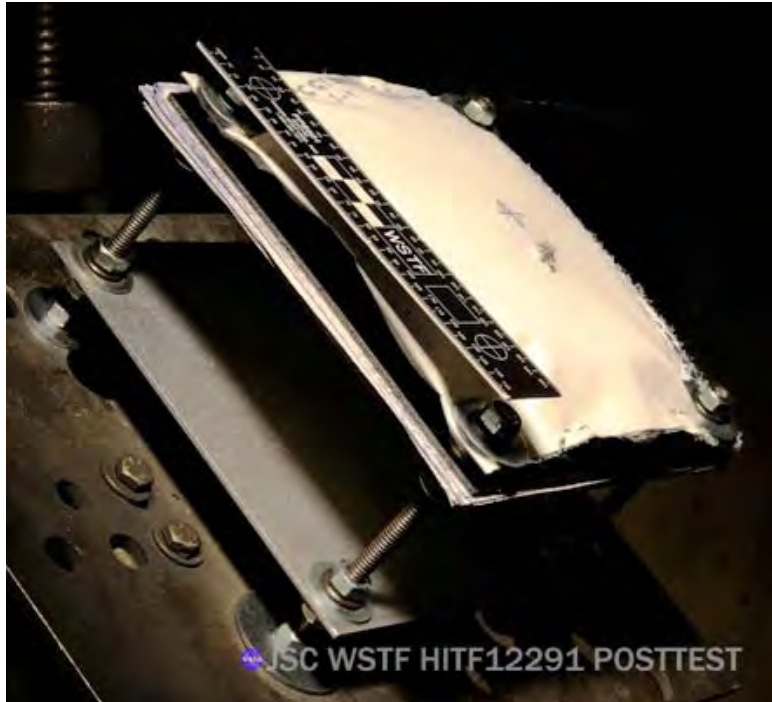
Figure 137 Overall View of Sample in the Target Tank (post-test)

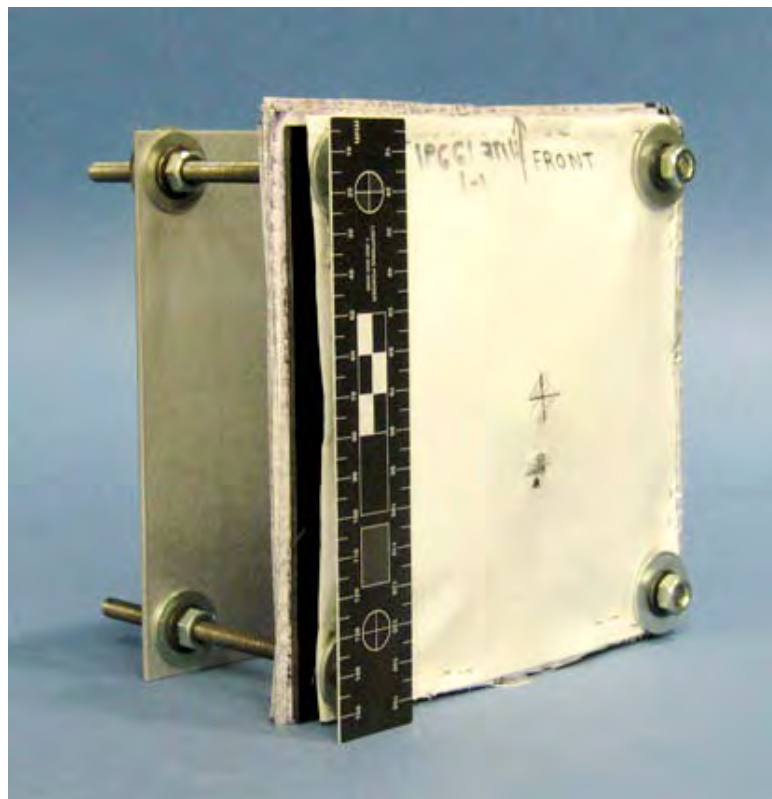
Figure 138 Overall Front Oblique View of Sample (scale in 5mm increments)

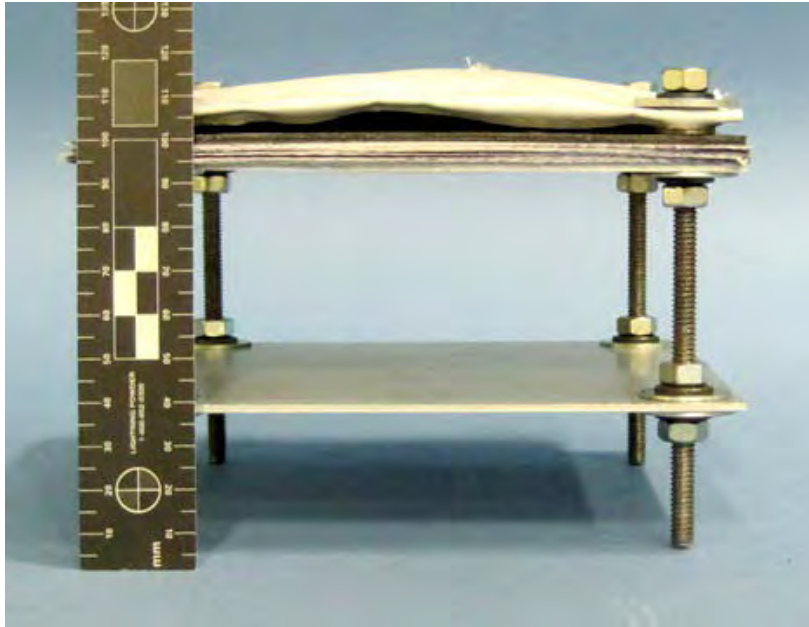
**Figure 139** Overall Side View of Sample (scale in 5mm increments)

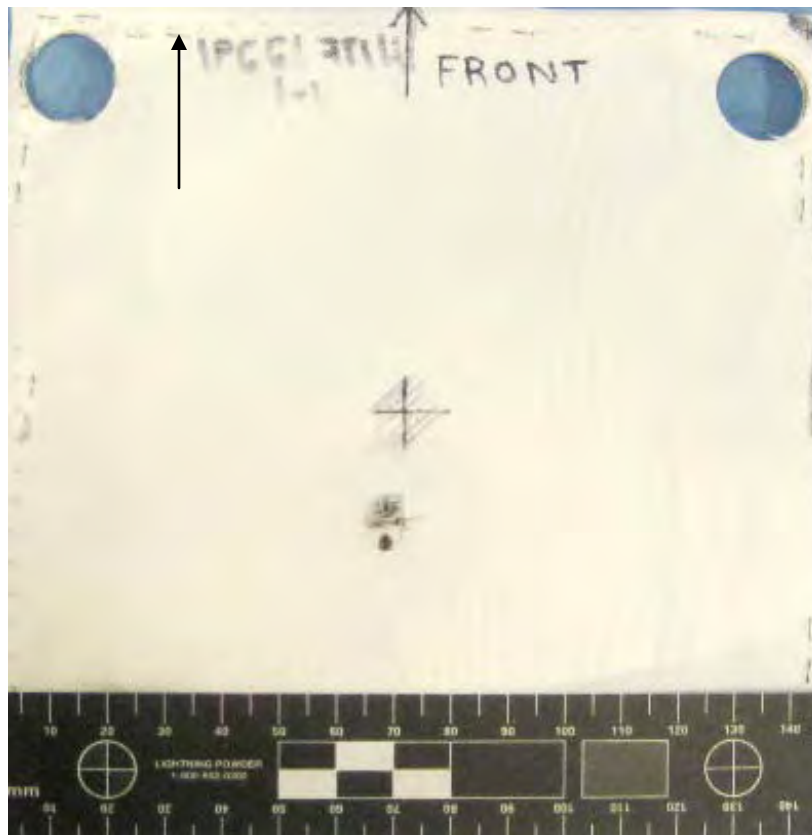
**Figure 140** Overall View of Damage to Front of MLI (scale in 5mm increments / black arrow indicates flight path of projectile)

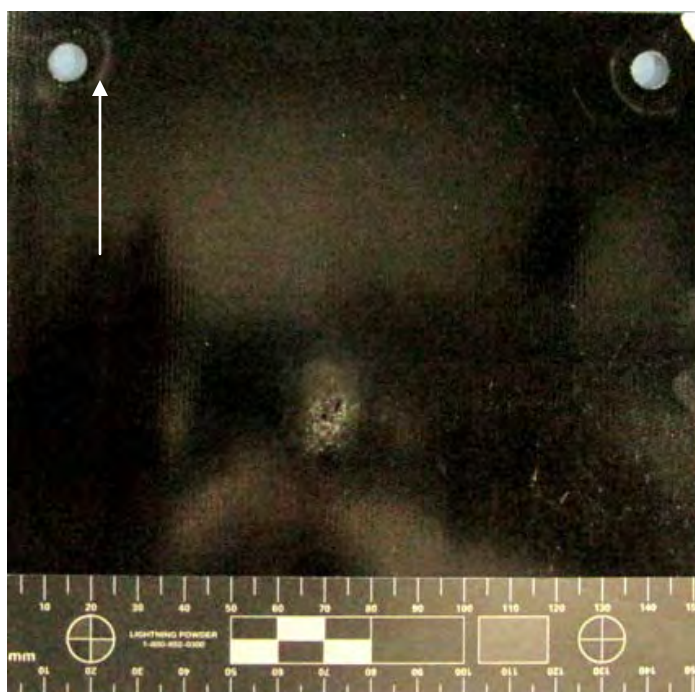
Figure 144 Overall View of Damage to Front of NP 504 Substrate (scale in 5mm increments / white arrow indicates flight path of projectile)

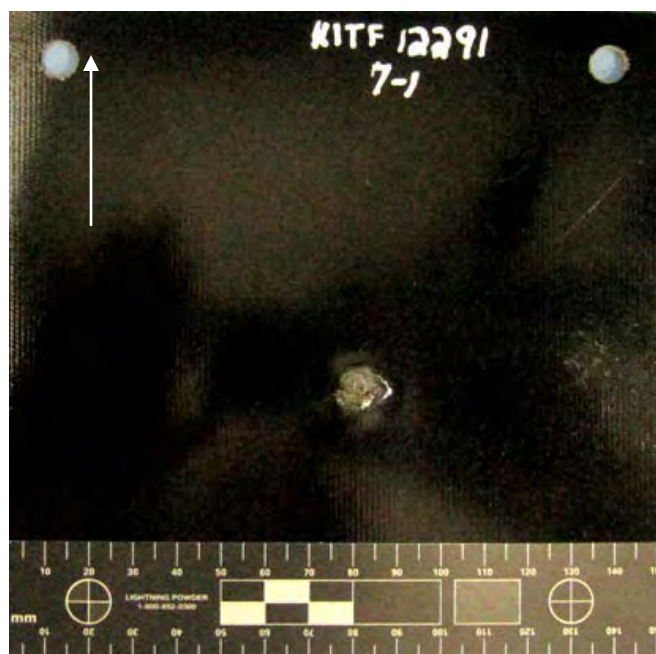
Figure 146 Overall View of Damage to Back Side of NP 504 Substrate (scale in 5mm increments / white arrow indicates flight path of projectile)

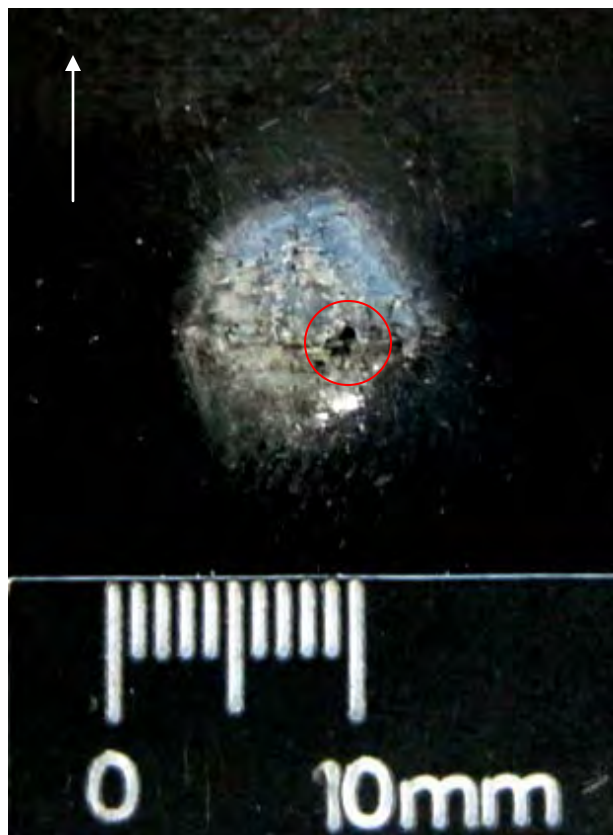
Figure 147 Close-up View of Damage to Back Side of NP 504 Substrate (scale in 1mm increments / white arrow indicates flight path of projectile)

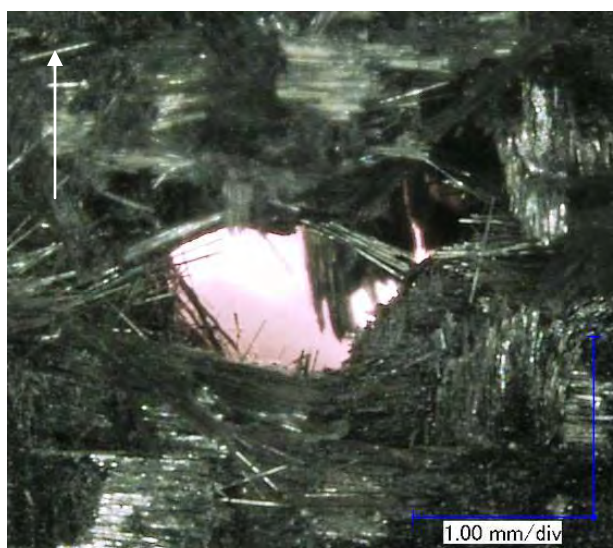
Figure 148 Close-up View of Most Significant Damage to Back Side of NP 504 Substrate (black arrow indicates flight path of projectile / damage within red circle in Figure 155)

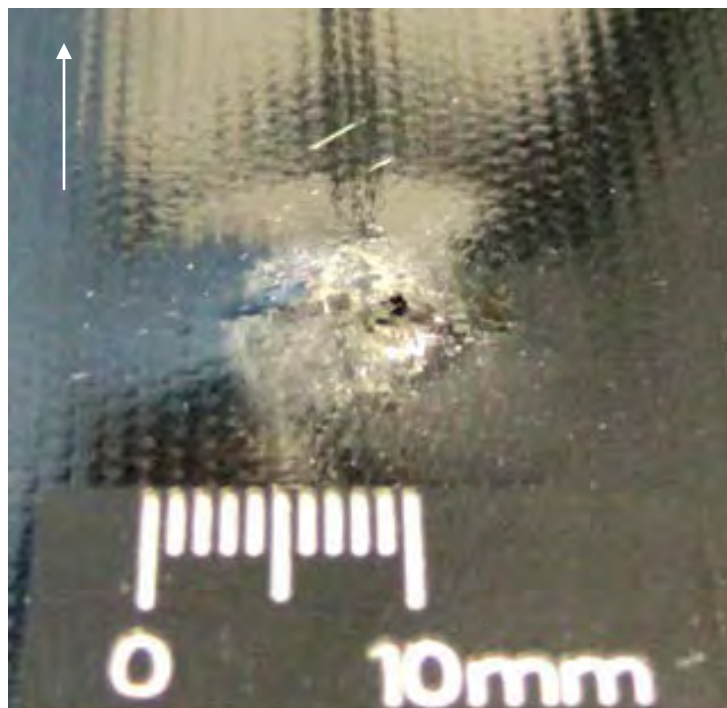
Figure 149 Close-up Oblique Side View of Damage to Back Side of NP 504 Substrate (scale in 1mm increments / white arrow indicates flight path of projectile)

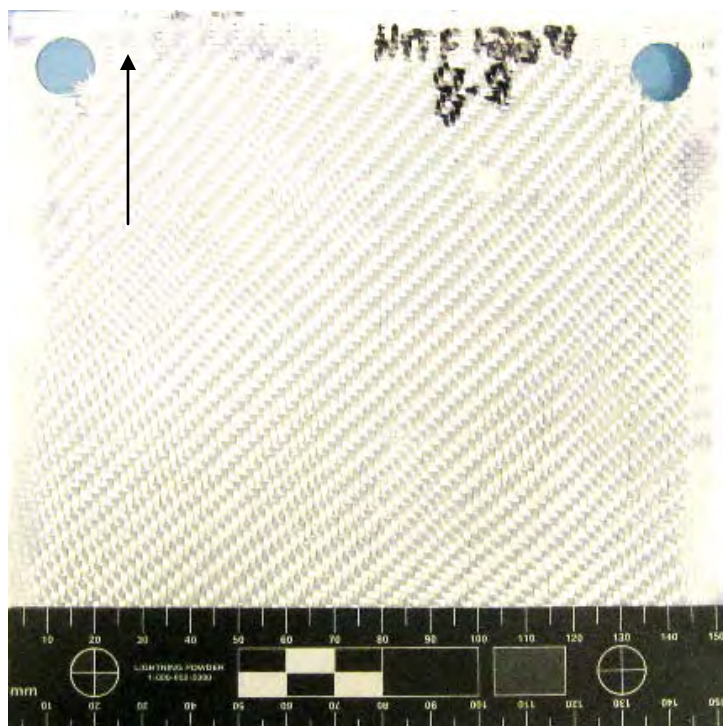
Figure 150 Overall View of Damage to Back Side of 8th Fiberglass Layer (scale in 5mm increments / black arrow indicates flight path of projectile)

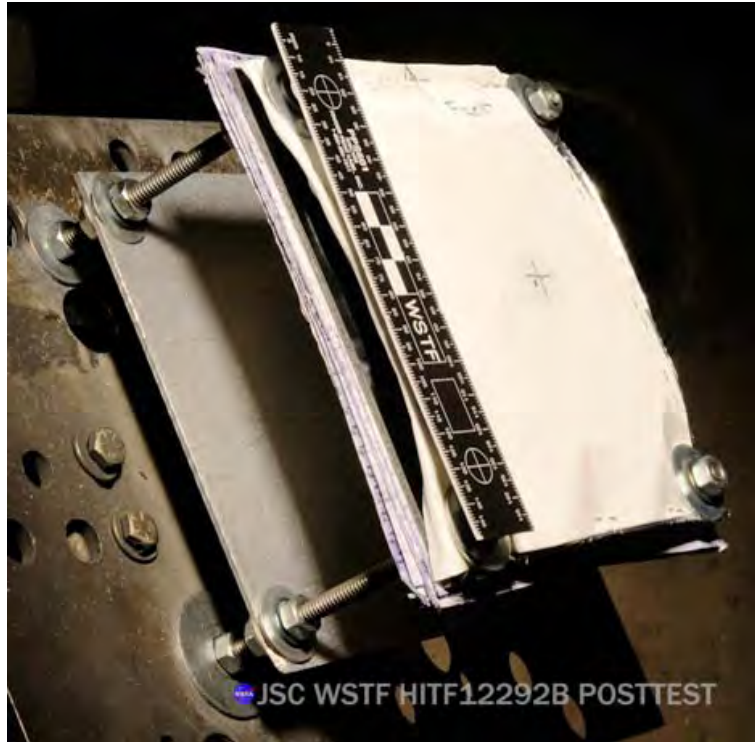
Figure 152 Overall View of Sample in the Target Tank (post-test)

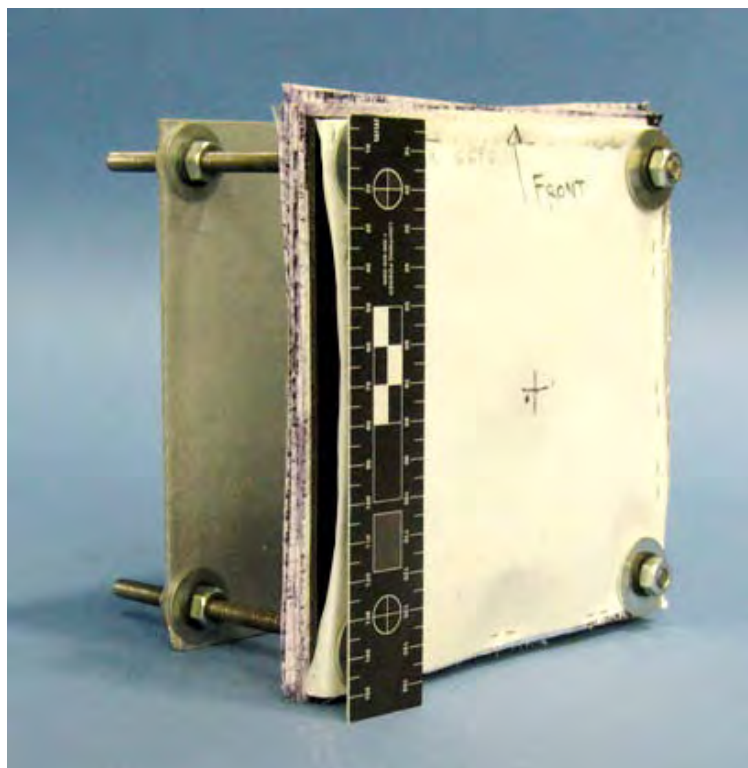
Figure 153 Overall Front Oblique View of Sample (scale in 5mm increments)

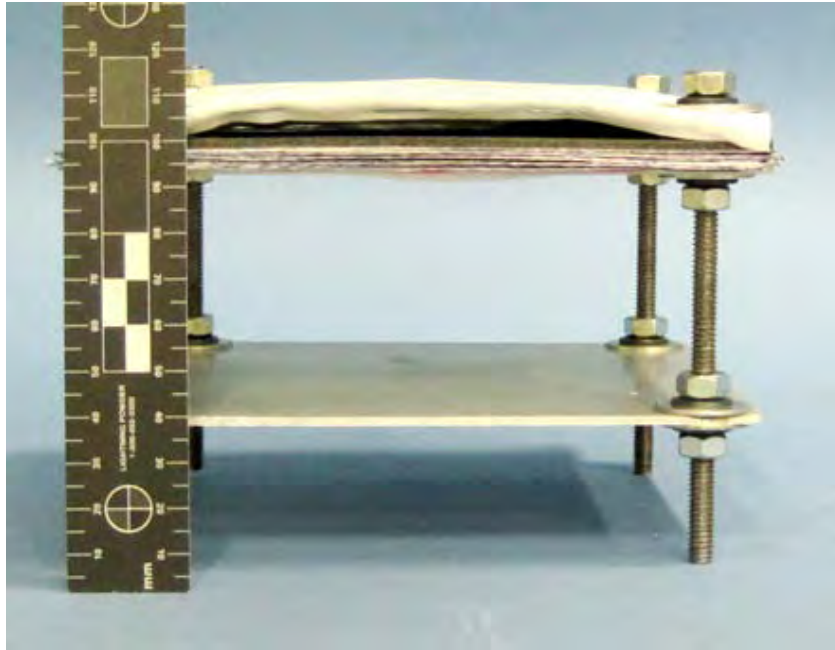
Figure 154 Overall Side View of Sample (scale in 5mm increments)

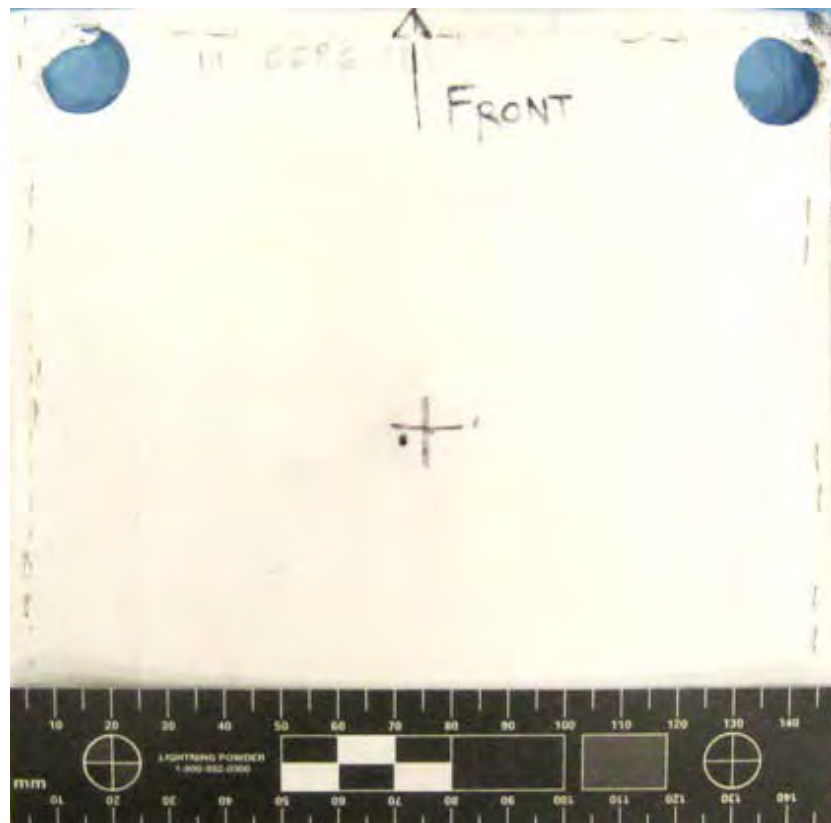
Figure 155 Overall View of Damage to Front of MLI (scale in 5mm increments / black arrow indicates flight path of projectile)

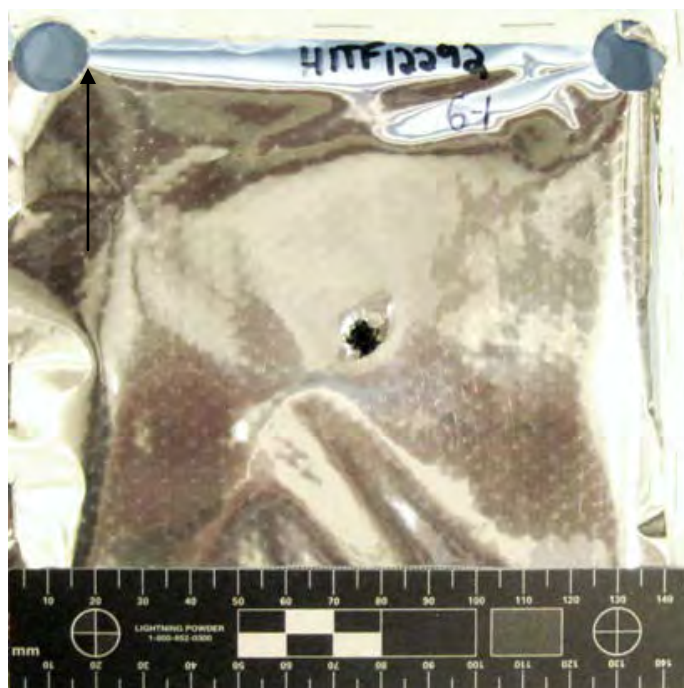
Figure 157 Overall View of Damage to Back Side of MLI (scale in 5mm increments / black arrow indicates flight path of projectile)

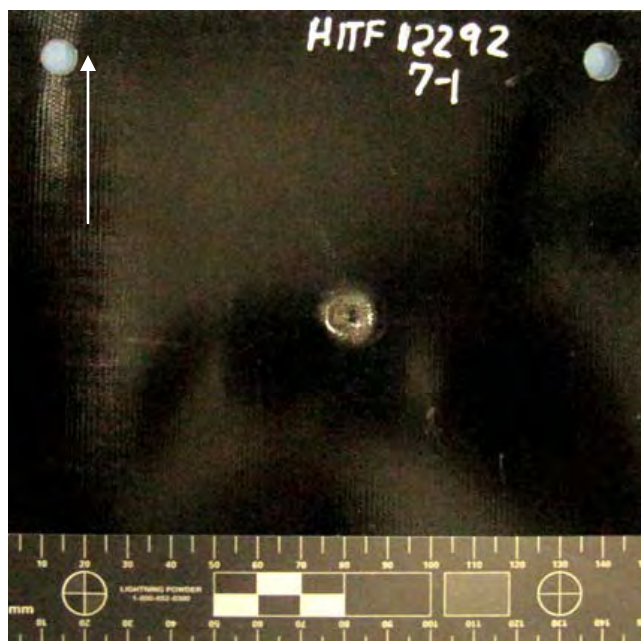
Figure 161 Overall View of Damage to Back Side of NP 504 Substrate (scale in 5mm increments / white arrow indicates flight path of projectile)

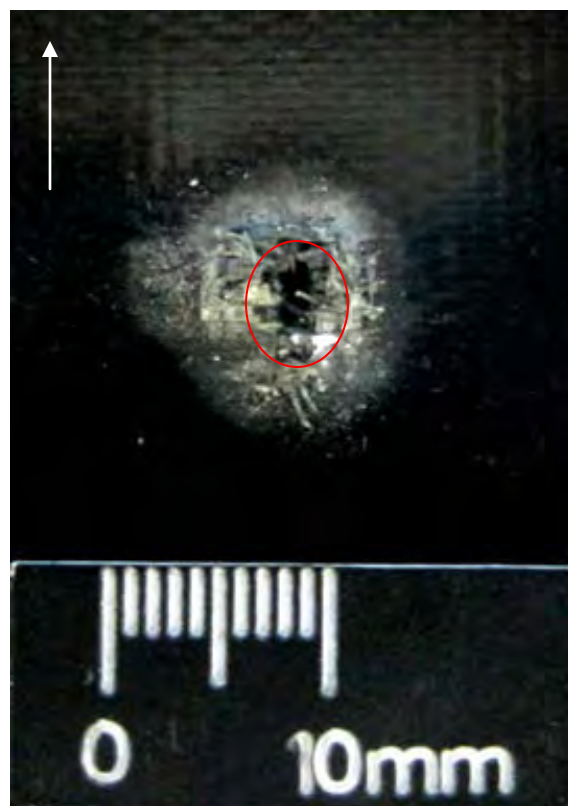
Figure 162 Close-up View of Damage to Back Side of NP 504 Substrate (scale in 1mm increments / white arrow indicates flight path of projectile)

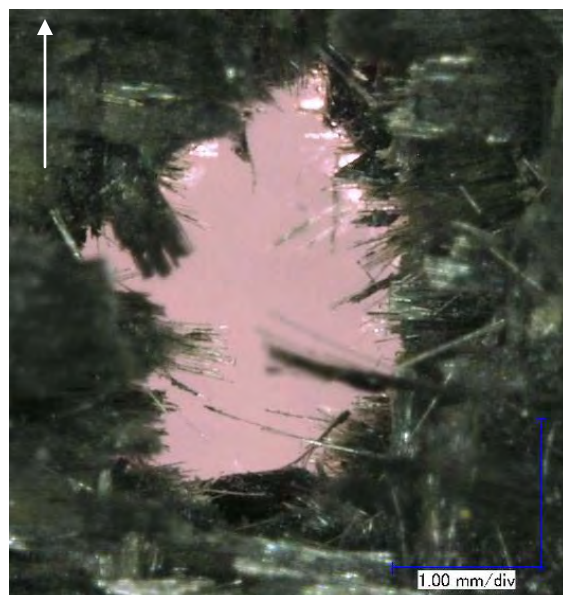
Figure 163 Close-up View of Most Significant Damage to Back Side of NP 504 Substrate (white arrow indicates flight path of projectile / damage within red circle in Figure 162)

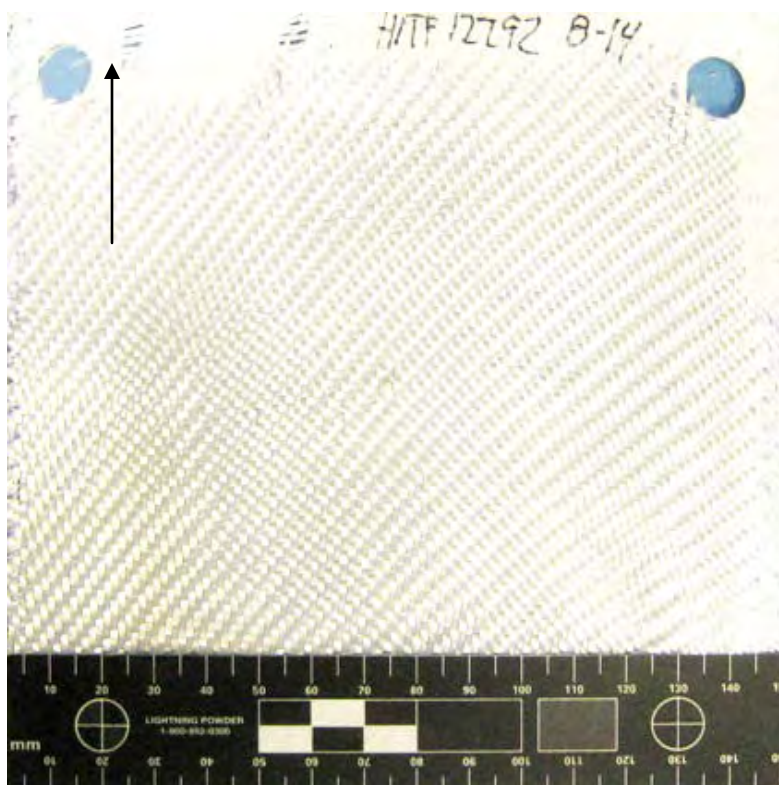
Figure 165 Overall View of Damage to Back Side of Last Fiberglass Layer (scale in 5mm increments / black arrow indicates flight path of projectile)

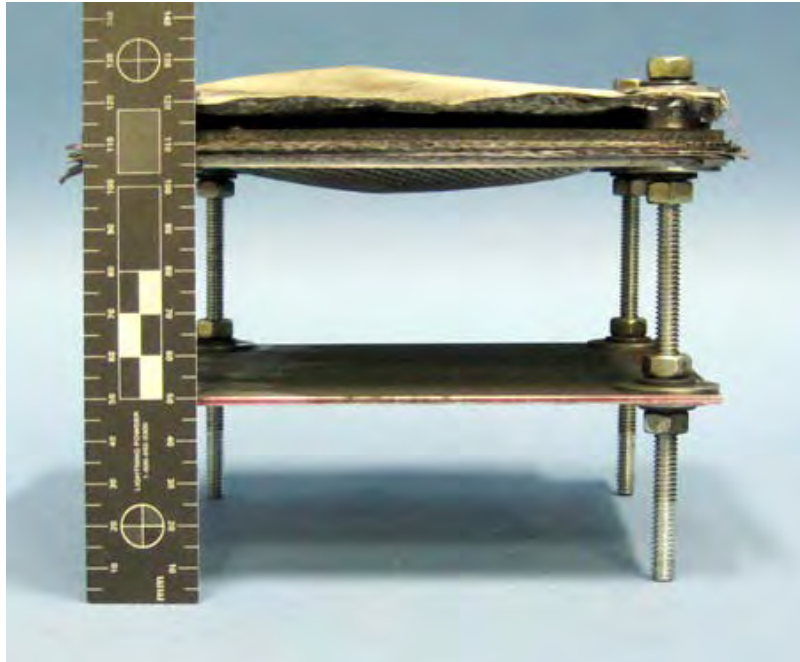
Figure 169 Overall Side View of Sample (scale in 5mm increments)

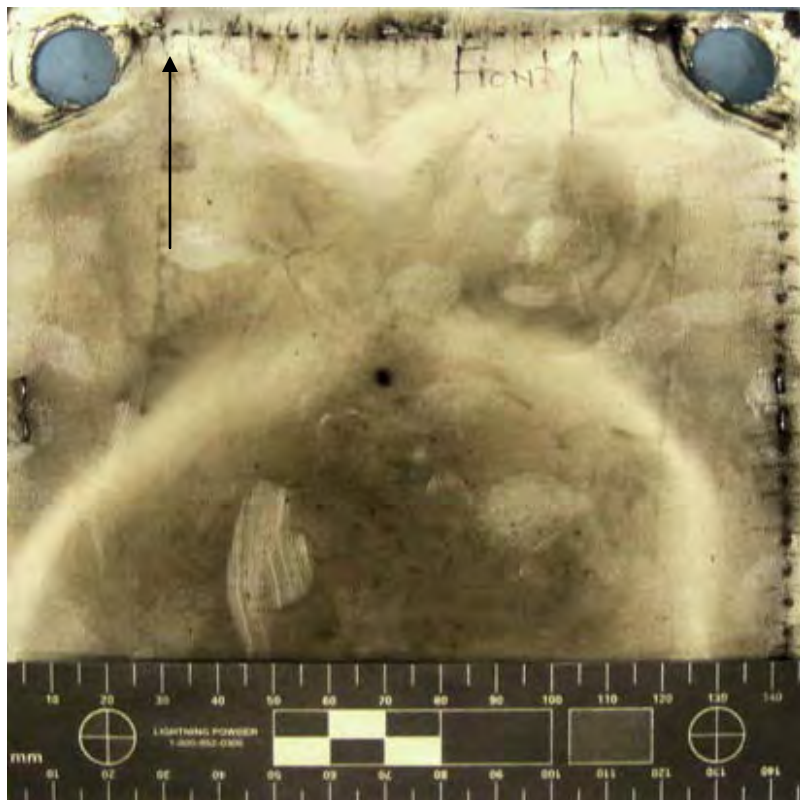
Figure 170 Overall View of Damage to Front of MLI (scale in 5mm increments / black arrow indicates flight path of projectile)
