International Space Station (ISS) Soyuz Vehicle Descent Module Evaluation of Thermal Protection System (TPS) Penetration Characteristics

Hypervelocity Impact Technology Group

February 2013

**International Space Station (ISS) Soyuz Vehicle
Descent Module Evaluation of Thermal Protection
System (TPS) Penetration Characteristics**

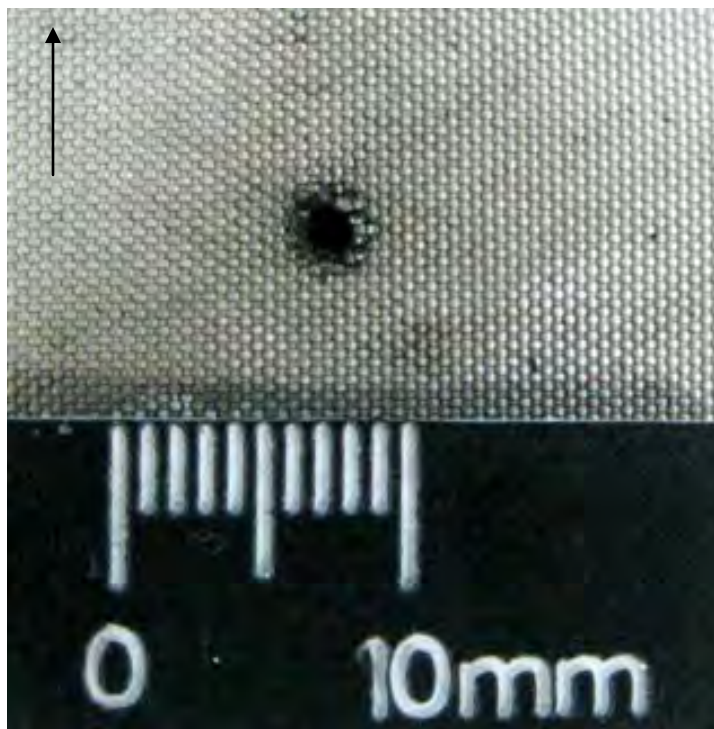
Figure 171 Close-up View of Damage to Front of MLI (scale in 1mm increments / black arrow indicates flight path of projectile / projectile impacted within red circle)

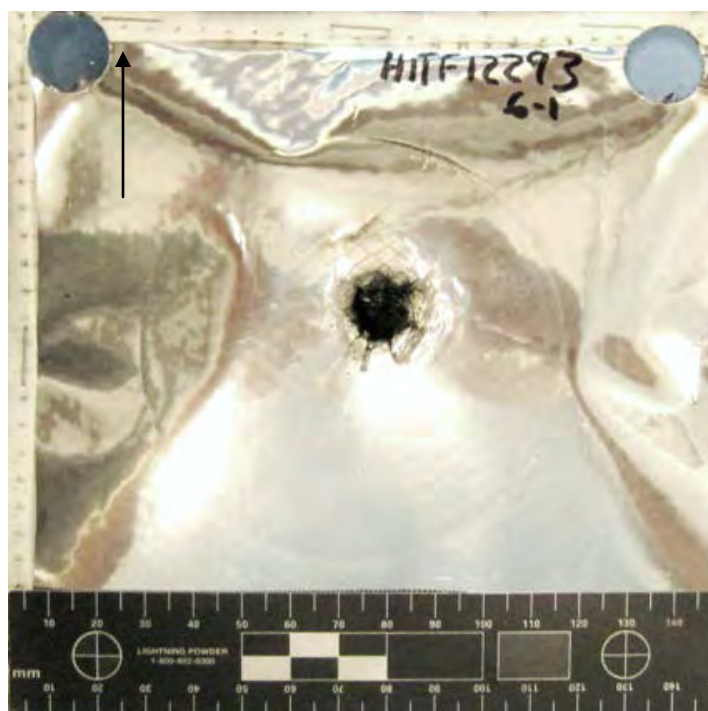
Figure 172 Overall View of Damage to Back Side of MLI (scale in 5mm increments / black arrow indicates flight path of projectile)

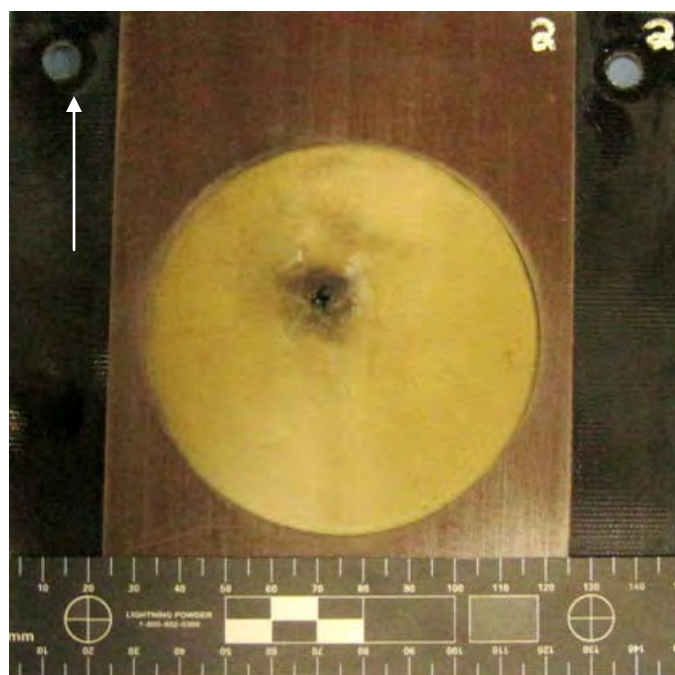
Figure 174 Overall View of Damage to Front of TORLON 5030 (scale in 5mm increments / white arrow indicates flight path of projectile)

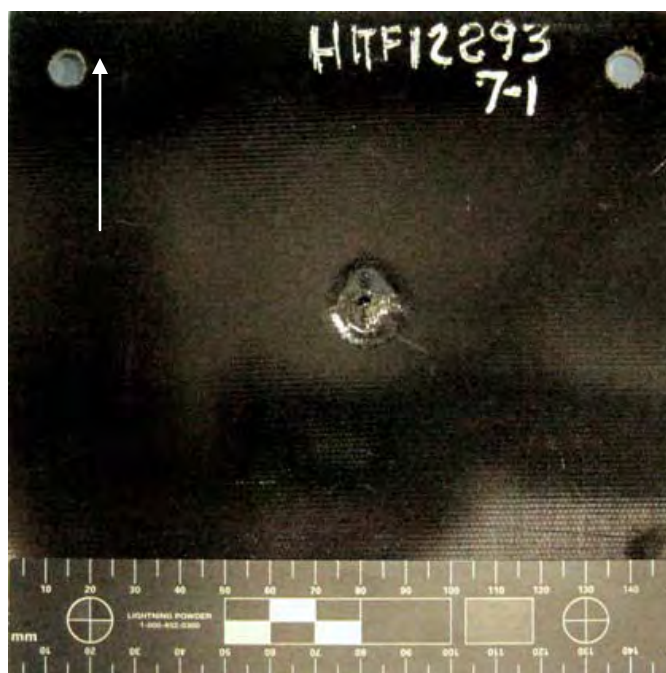
Figure 176 Overall View of Damage to Back Side of NP 504 Substrate (scale in 5mm increments / white arrow indicates flight path of projectile)

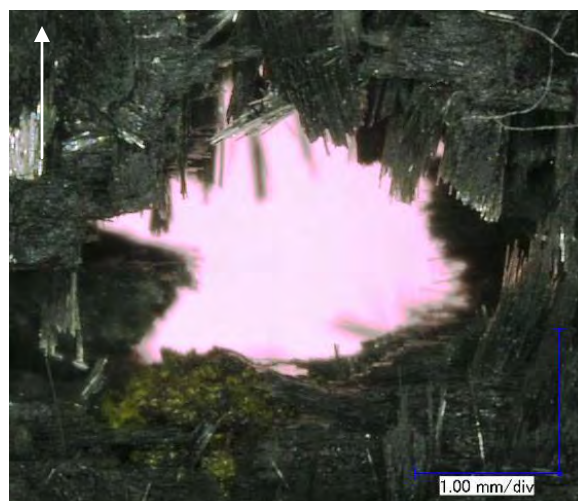
Figure 178 Close-up View of Most Significant Damage to Back Side of NP 504 Substrate (white arrow indicates flight path of projectile / damage within red circle in Figure 187)

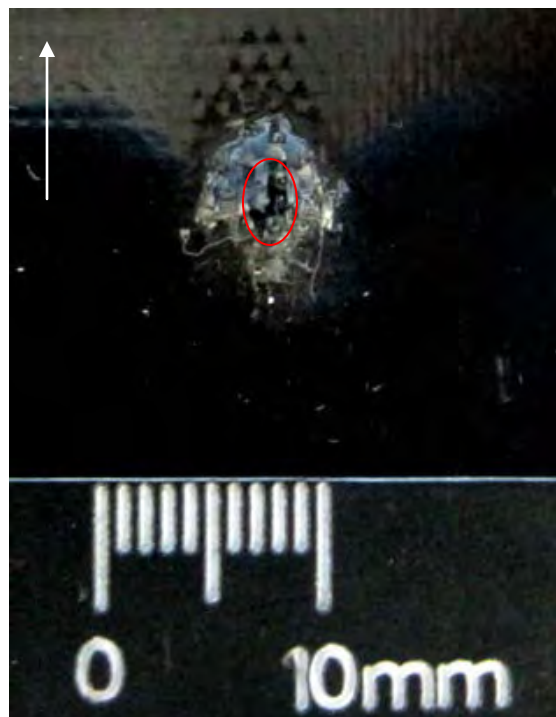
Figure 192 Close-up View of Damage to Back Side of NP 504 Substrate (scale in 1mm increments / white arrow indicates flight path of projectile)

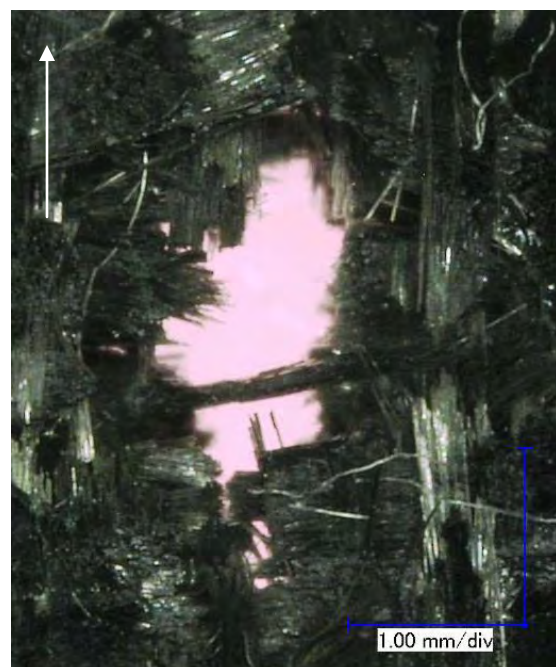
Figure 193 Close-up View of Most Significant Damage to Back Side of NP 504 Substrate (white arrow indicates flight path of projectile / damage within red circle in Figure 192)

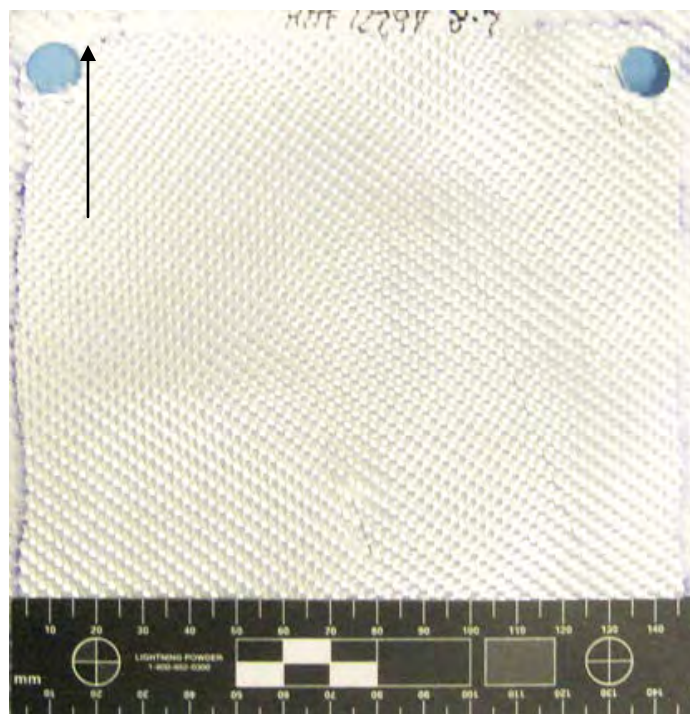
Figure 195 Overall View of Damage to Back Side of 7th Fiberglass Layer (scale in 5mm increments / black arrow indicates flight path of projectile)

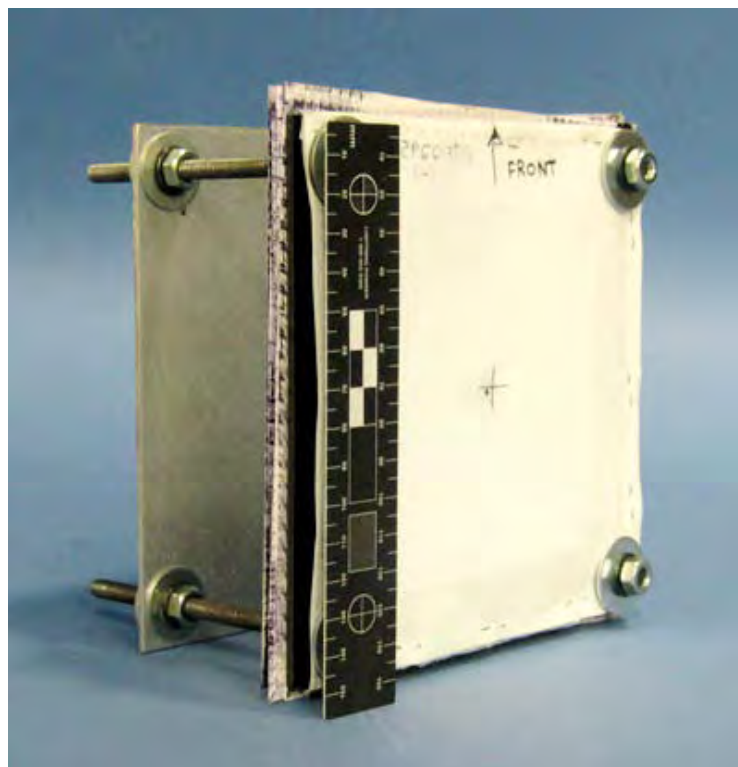
Figure 198 Overall Front Oblique View of Sample (scale in 5mm increments)

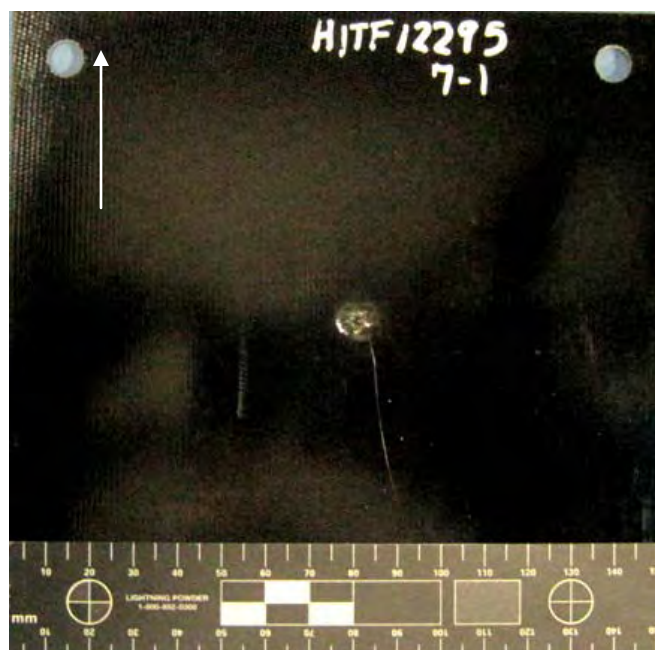
Figure 206 Overall View of Damage to Back Side of NP 504 Substrate (scale in 5mm increments / white arrow indicates flight path of projectile)

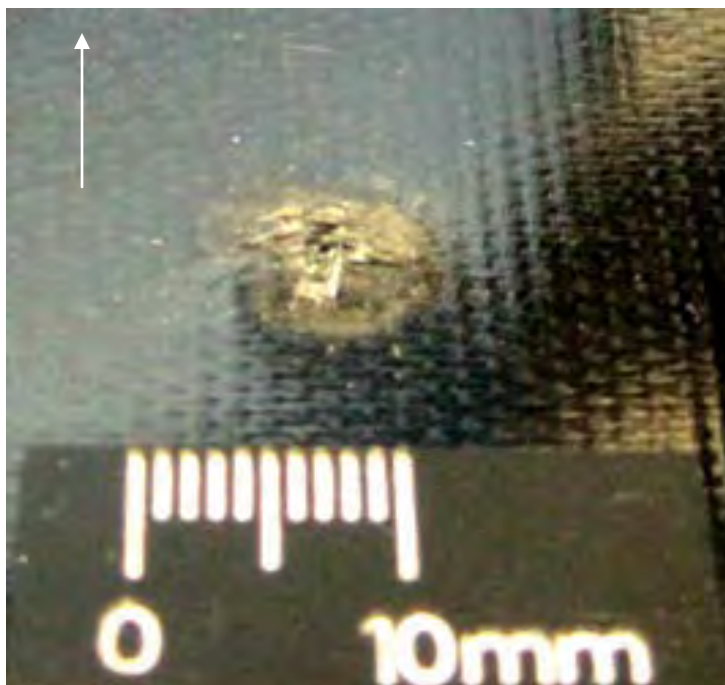
Figure 209 Close-up Oblique Side View of Damage to Back Side of NP 504 Substrate (scale in 1mm increments / white arrow indicates flight path of projectile)

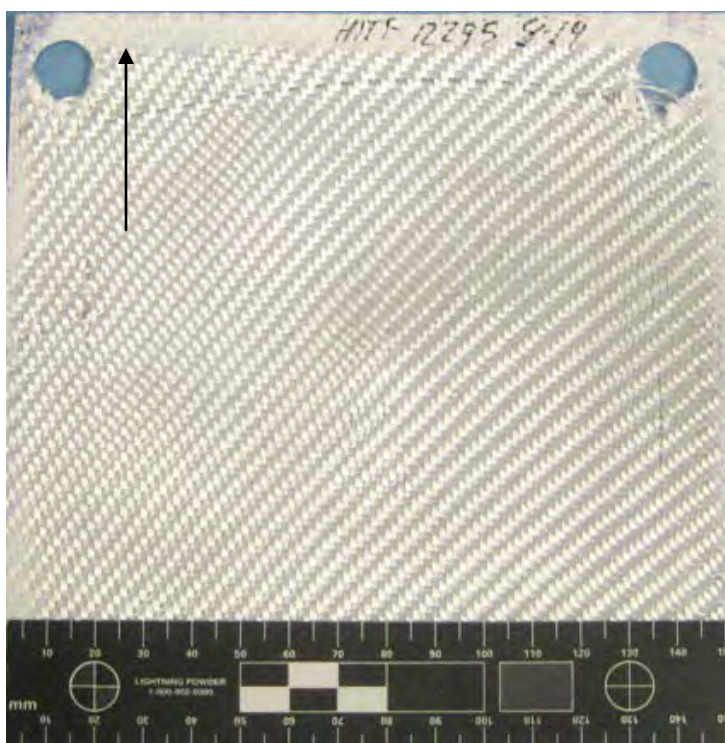
Figure 210 Overall View of Damage to Back Side of Last Fiberglass Layer (scale in 5mm increments / black arrow indicates flight path of projectile)

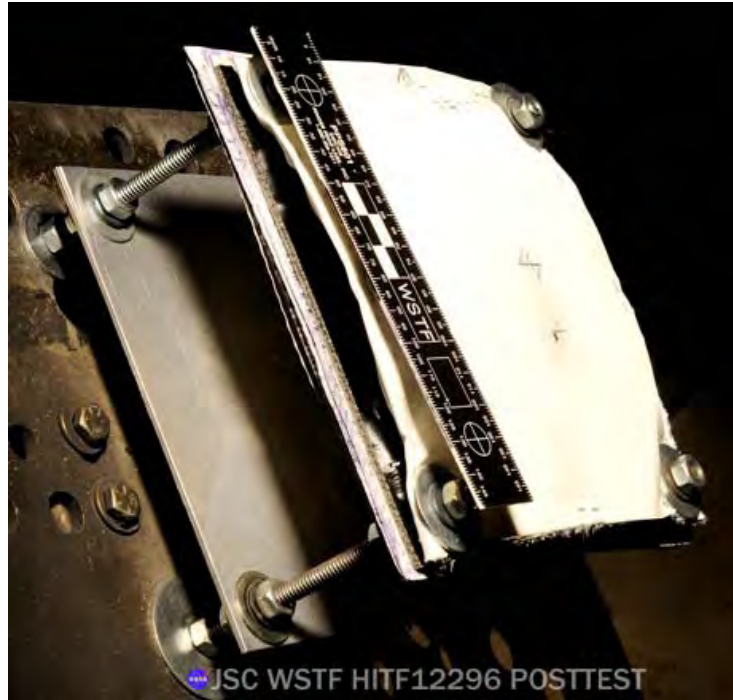
Figure 212 Overall View of Sample in the Target Tank (post-test)

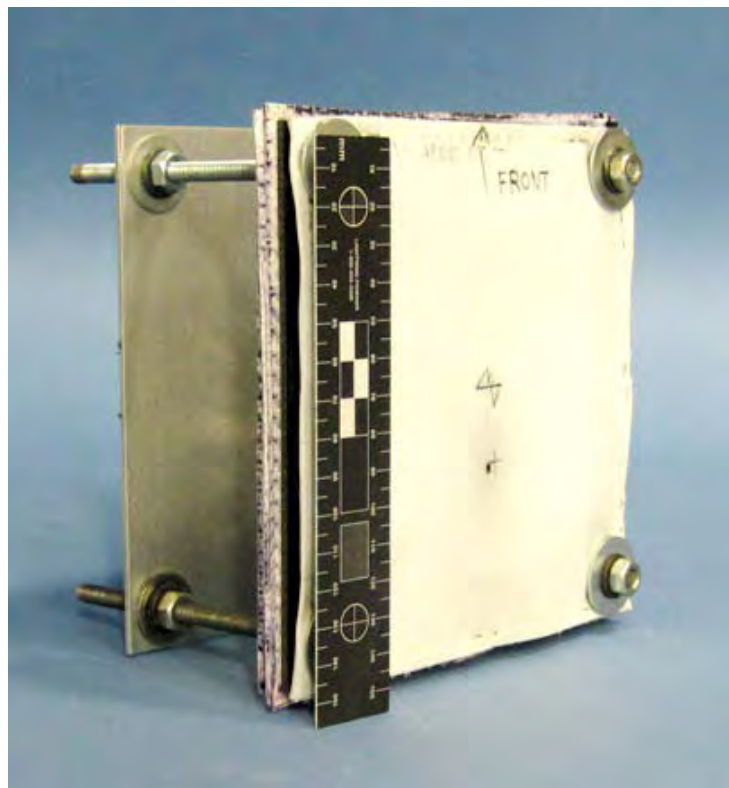
Figure 213 Overall Front Oblique View of Sample (scale in 5mm increments)

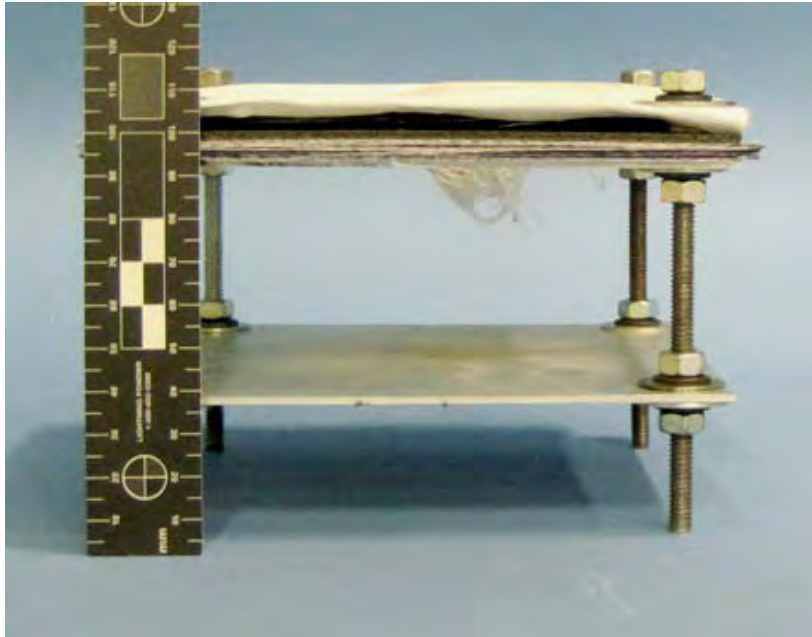
Figure 214 Overall Side View of Sample (scale in 5mm increments)

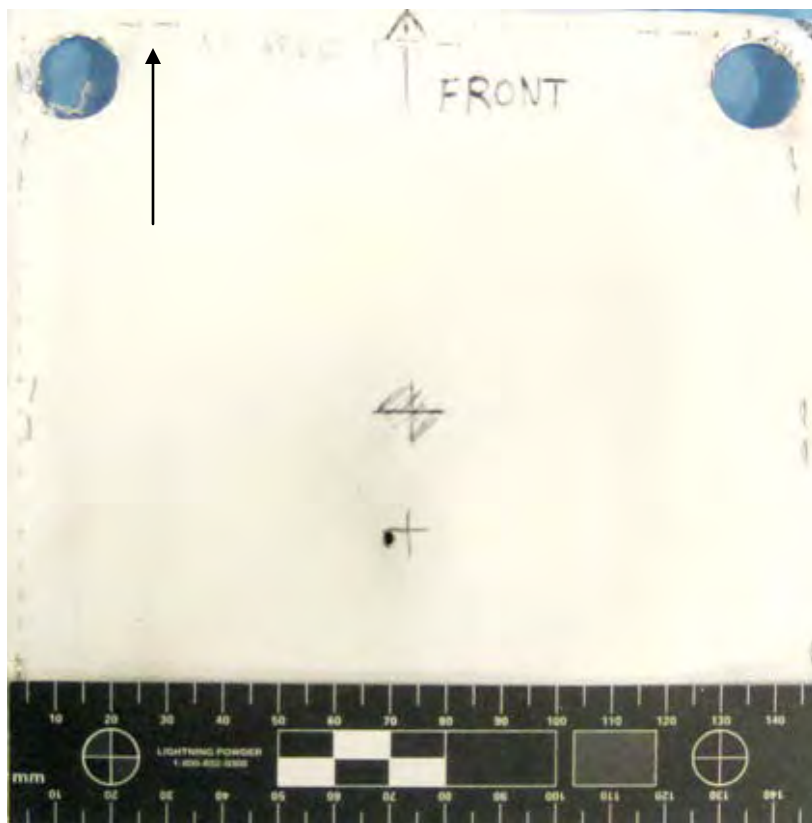
Figure 215 Overall View of Damage to Front of MLI (black arrow indicates flight path of projectile / scale in 5mm increments)

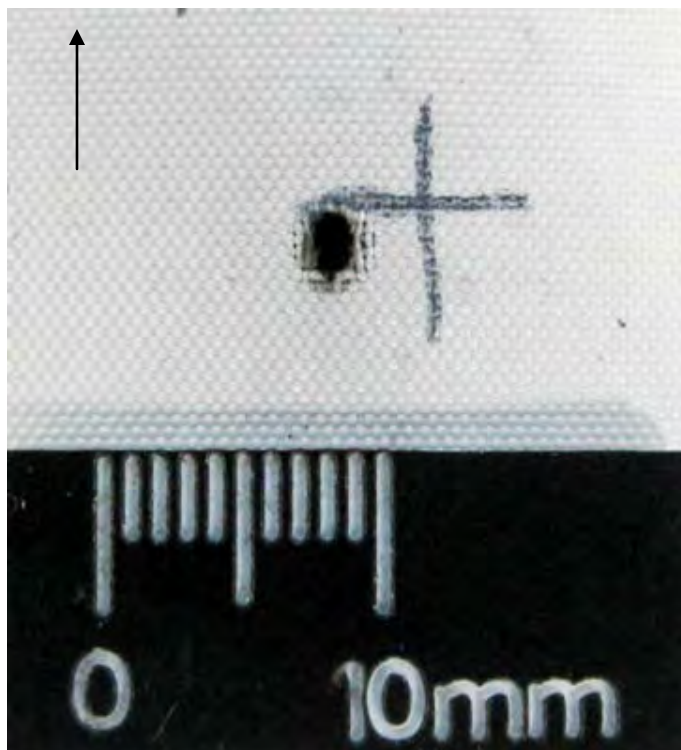
Figure 216 Close-up View of Damage to Front of MLI (scale in 1mm increments / black arrow indicates flight path of projectile)

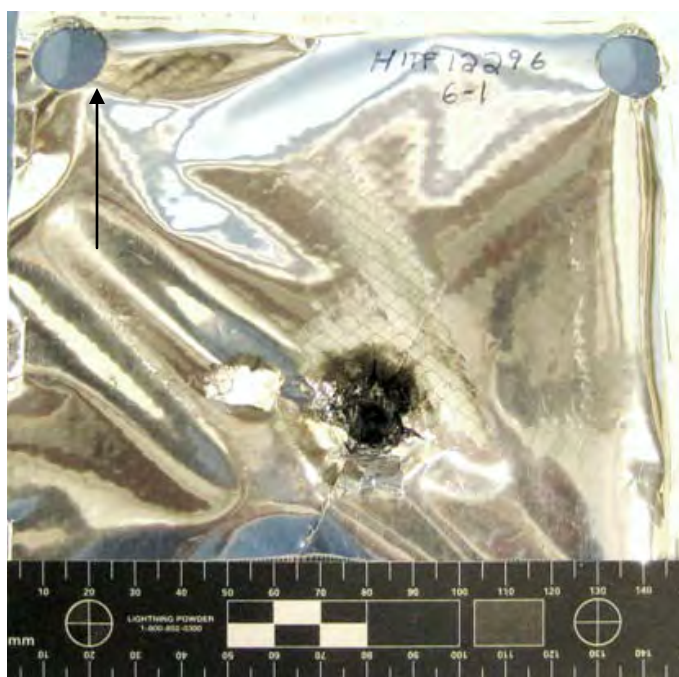
Figure 217 Overall View of Damage to Back Side of MLI (scale in 5mm increments / black arrow indicates flight path of projectile)

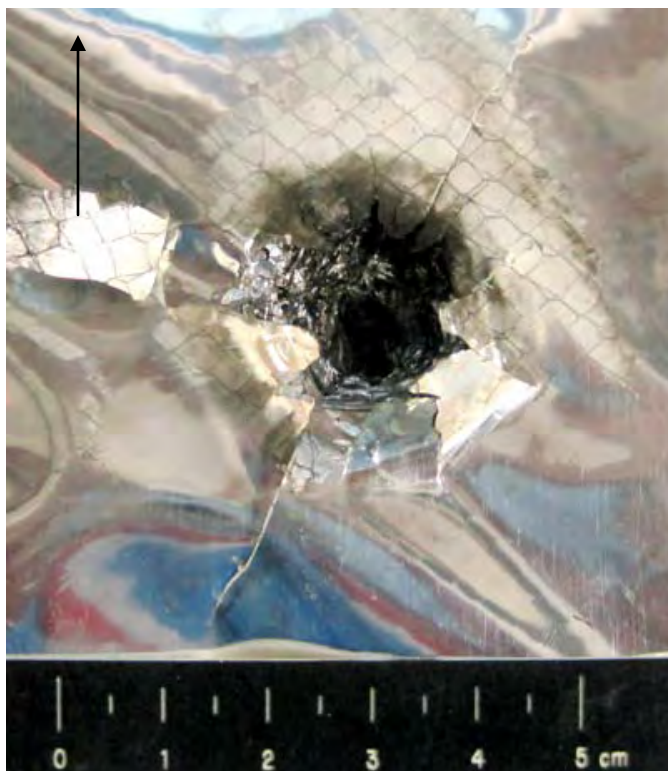
Figure 218 Close-up View of Damage to Back Side of MLI (scale in 5mm increments / black arrow indicates flight path of projectile)

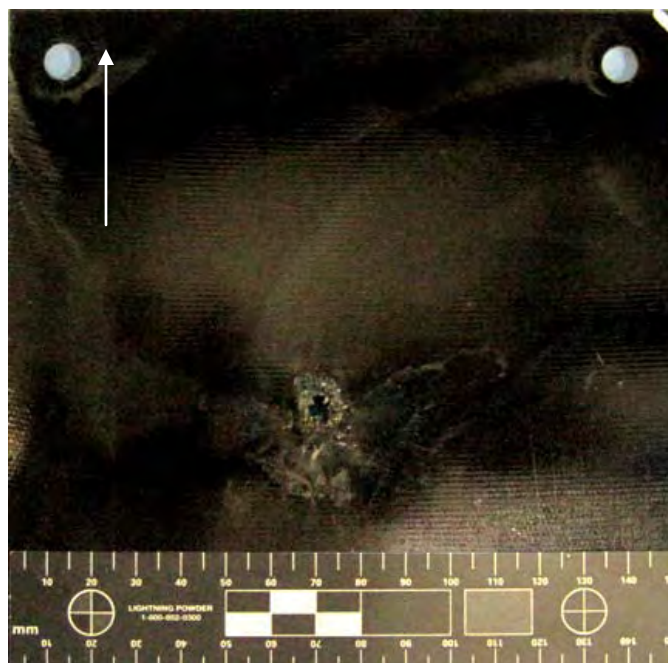
Figure 219 Overall View of Damage to Front of NP 504 Substrate (scale in 5mm increments / white arrow indicates flight path of projectile)

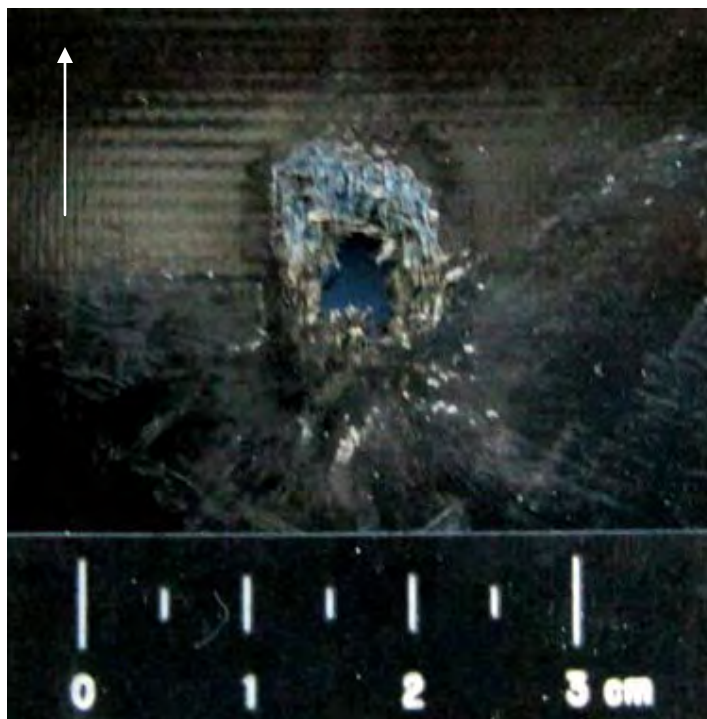
Figure 220 Close-up View of Damage to Front of NP 504 Substrate (scale in 5mm increments / white arrow indicates flight path of projectile)

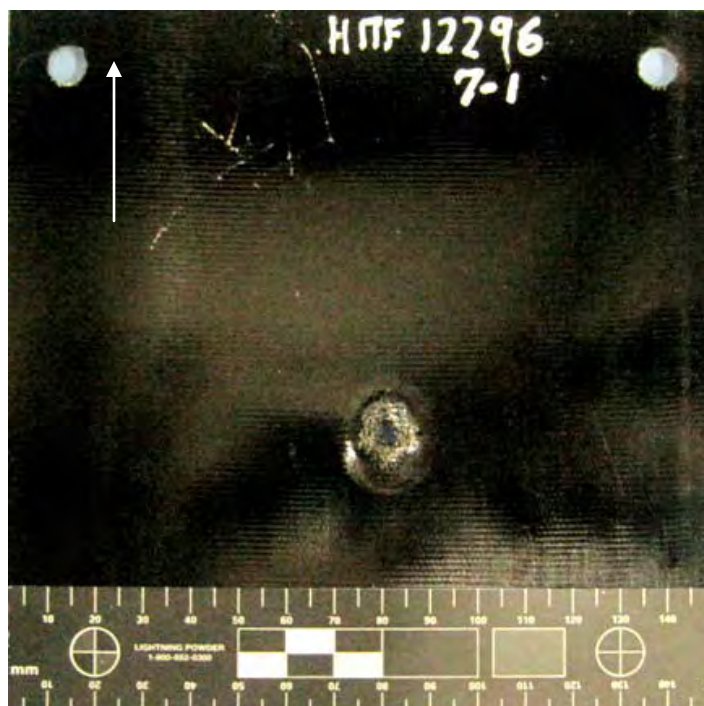
Figure 221 Overall View of Damage to Back Side of NP 504 Substrate (scale in 5mm increments / white arrow indicates flight path of projectile)

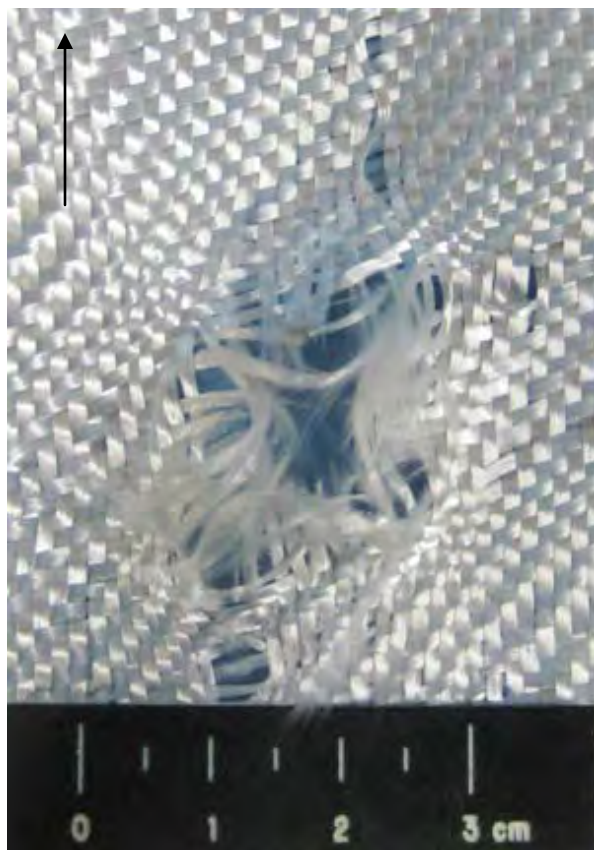
Figure 226 Close-up View of Damage to Back Side of Last Fiberglass Layer (scale in 5mm increments / black arrow indicates flight path of projectile)

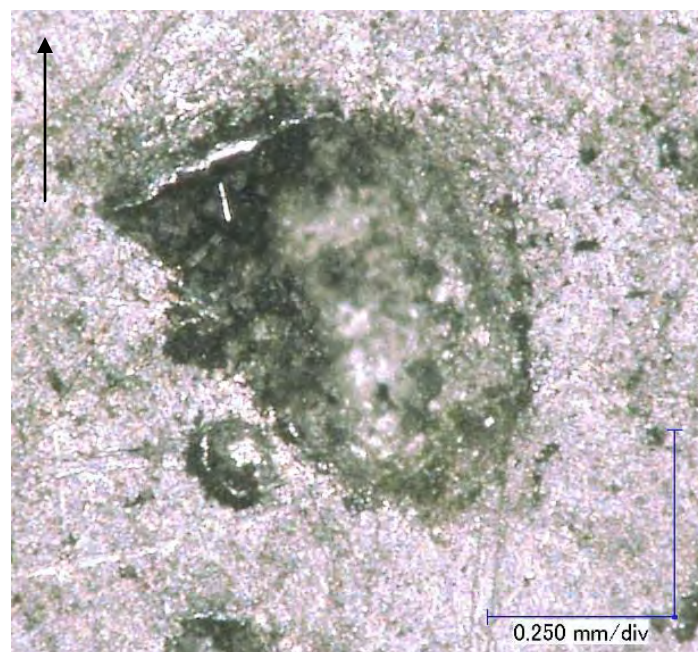
Figure 229 Close-up View of Most Significant Damage to Front of Rear Wall (black arrow indicates flight path of projectile / damage within red circle in Figure 241)

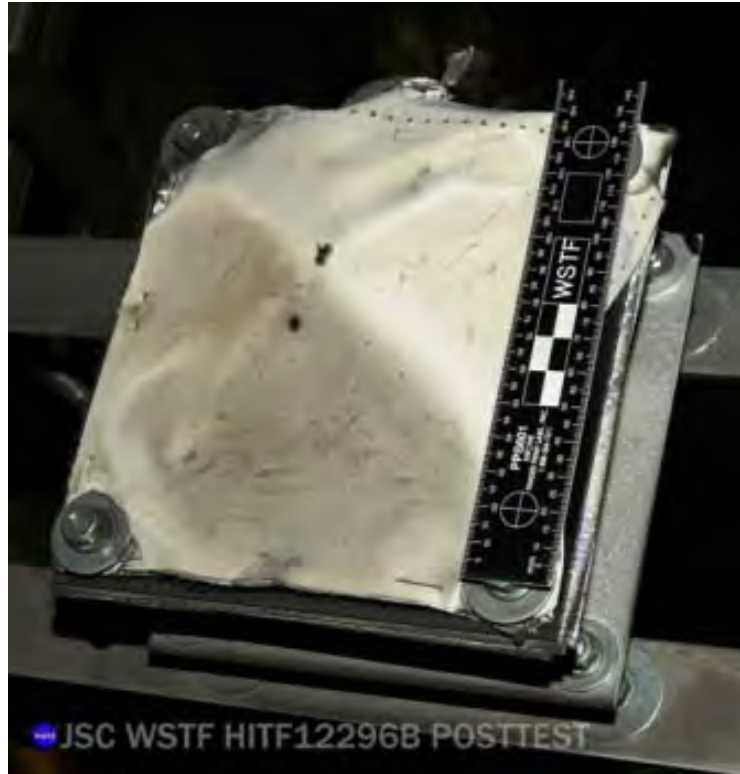
Figure 231 Overall View of Sample in the Target Tank (post-test)

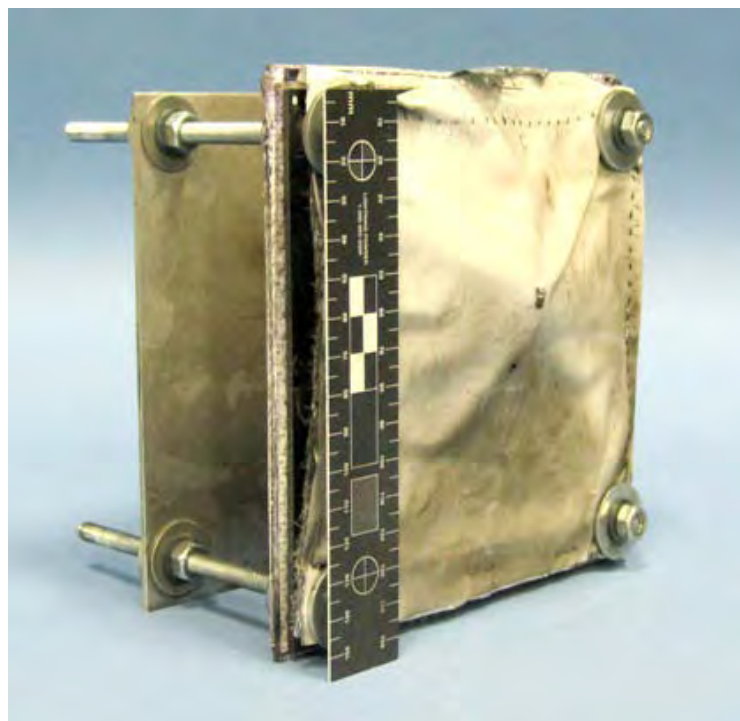
Figure 232 Overall Front Oblique View of Sample (scale in 5mm increments)

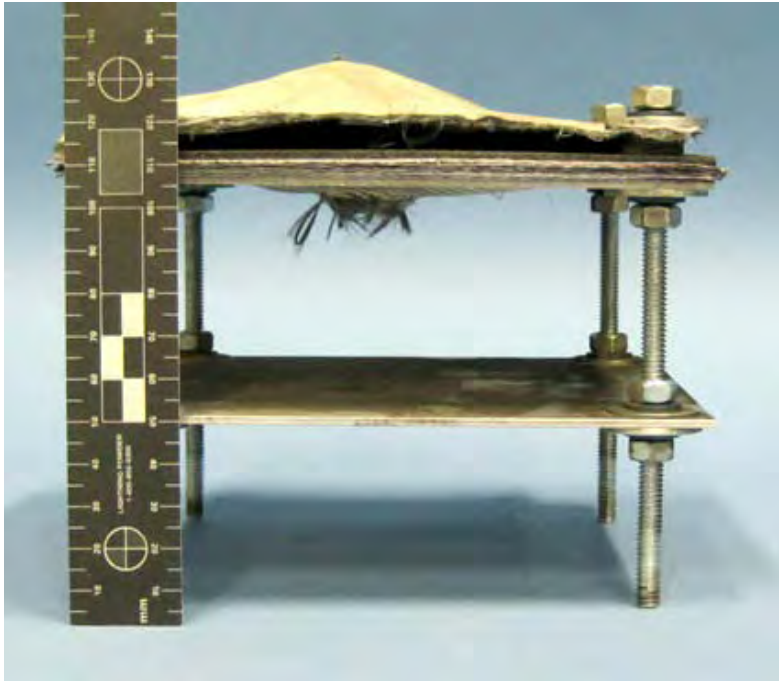
Figure 233 Overall Side View of Sample (scale in 5mm increments)

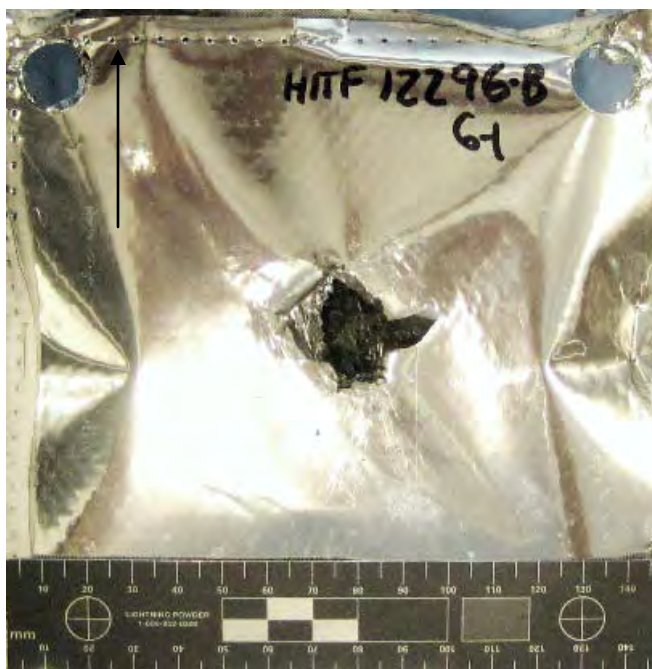
Figure 236 Overall View of Damage to Back Side of MLI (scale in 5mm increments / black arrow indicates flight path of projectile)

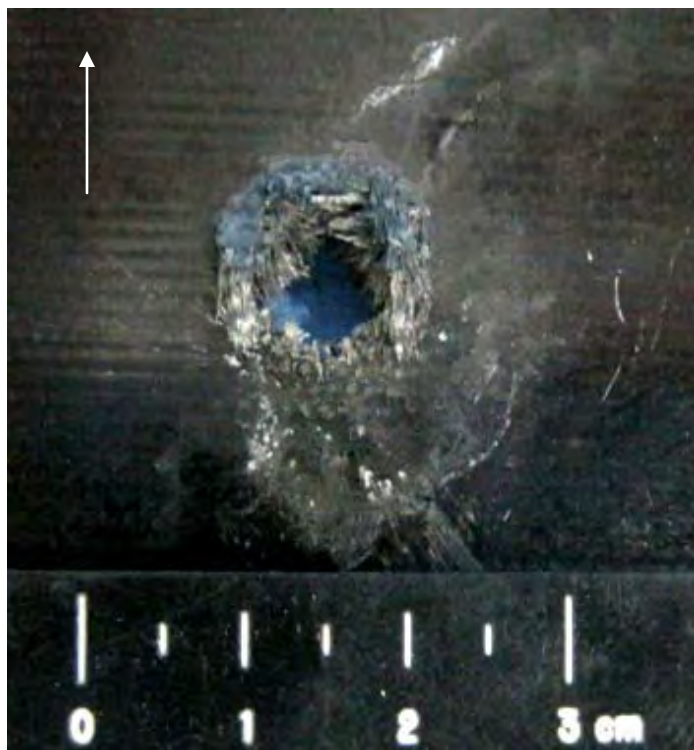
Figure 239 Close-up View of Damage to Front of NP 504 Substrate (scale in 5mm increments / white arrow indicates flight path of projectile)

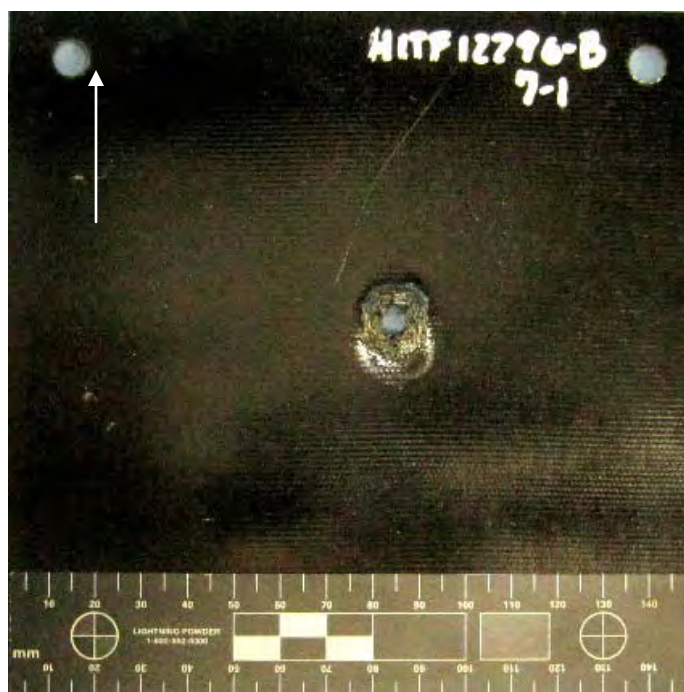
Figure 240 Overall View of Damage to Back Side of NP 504 Substrate (scale in 5mm increments / white arrow indicates flight path of projectile)

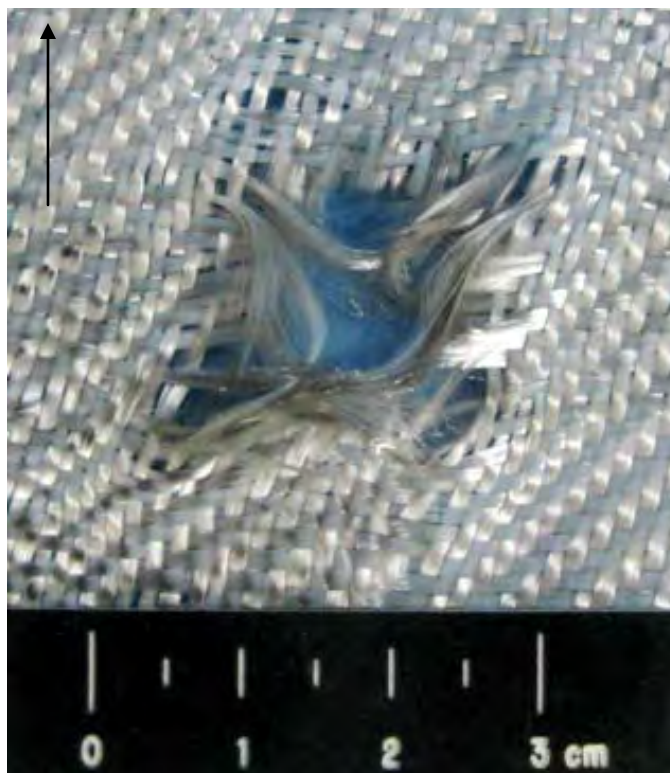
Figure 245 Close-up View of Damage to Back Side of Last Fiberglass Layer (scale in 5mm increments / black arrow indicates flight path of projectile)

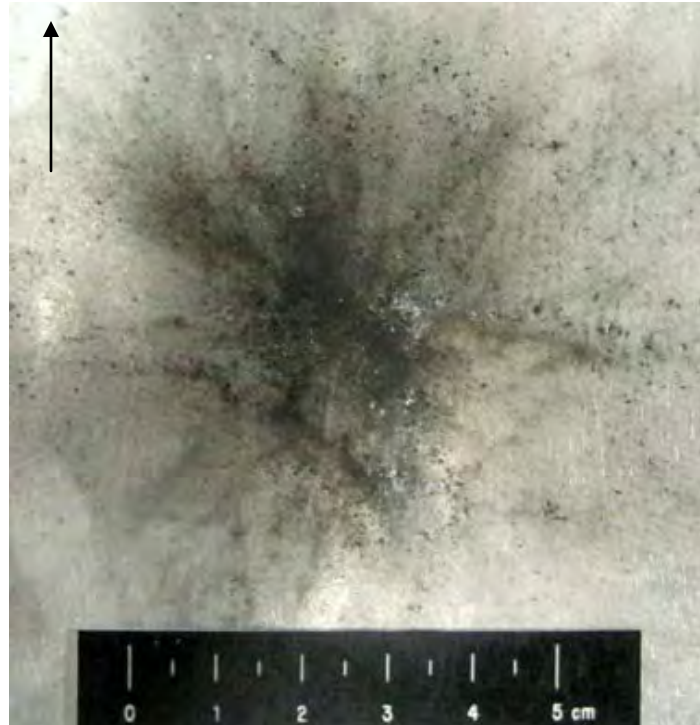
Figure 247 Close-up View of Damage to Front of Rear Wall (scale in 5mm increments / black arrow indicates flight path of projectile / uncleaned)

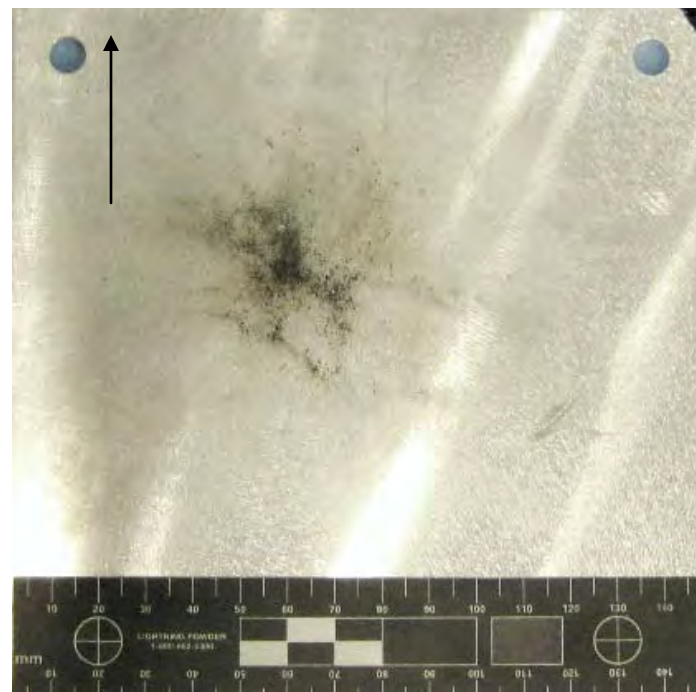
Figure 248 Overall View of Damage to Front of Rear Wall (scale in 5mm increments / black arrow indicates flight path of projectile / cleaned)

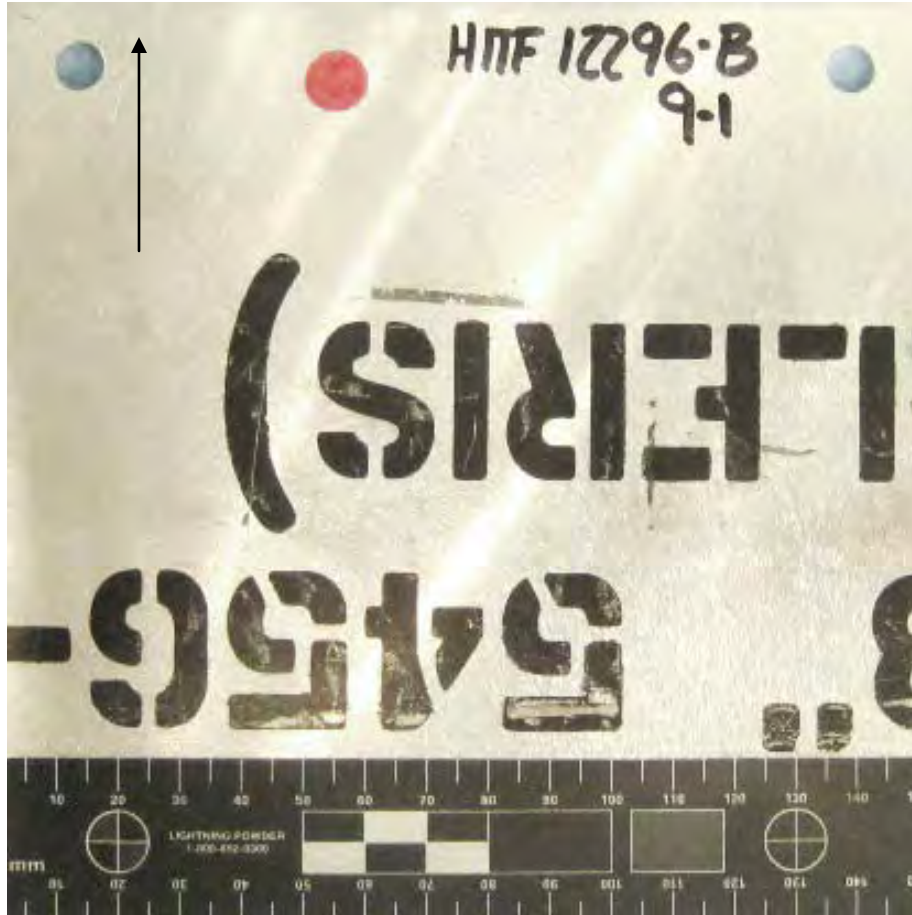
Figure 251 Overall View of Back Side of Rear Wall (scale in 5mm increments / black arrow indicates flight path of projectile)

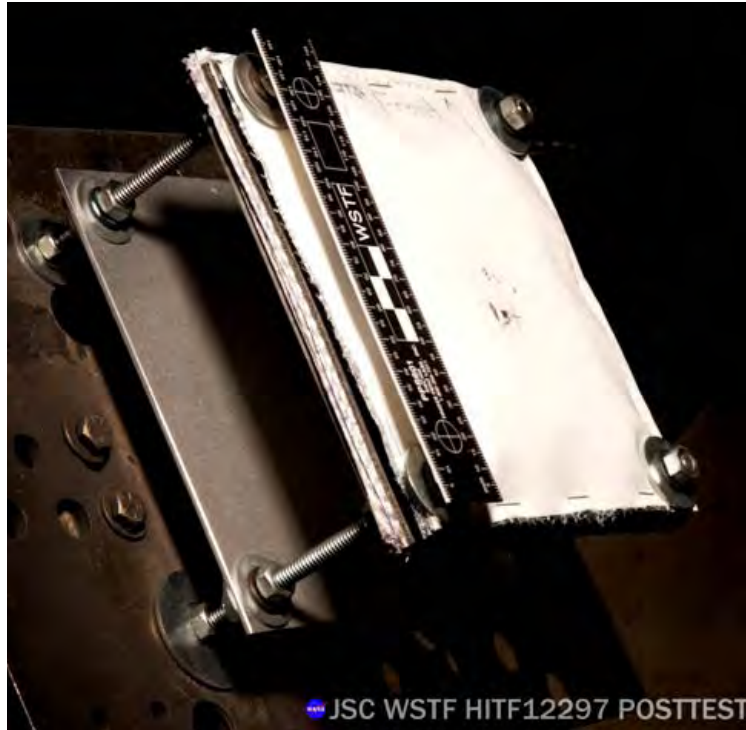
Figure 252 Overall View of Sample in the Target Tank (post-test)

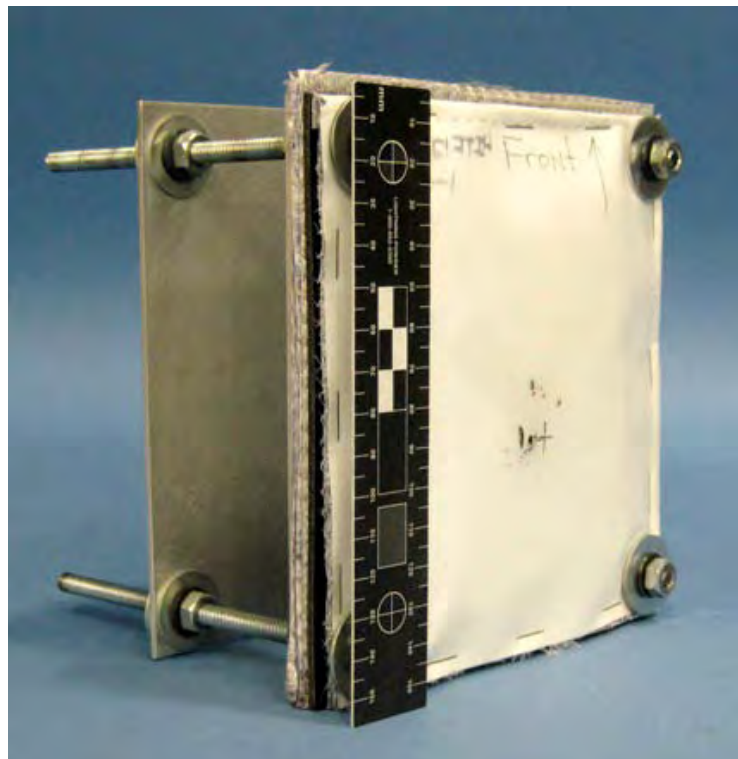
Figure 253 Overall Front Oblique View of Sample (scale in 5mm increments)

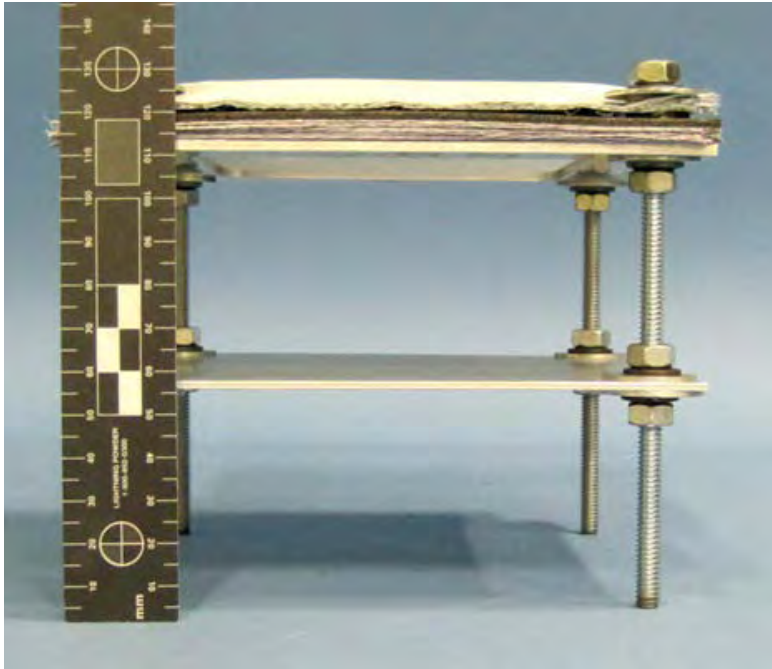
Figure 254 Overall Side View of Sample (scale in 5mm increments)

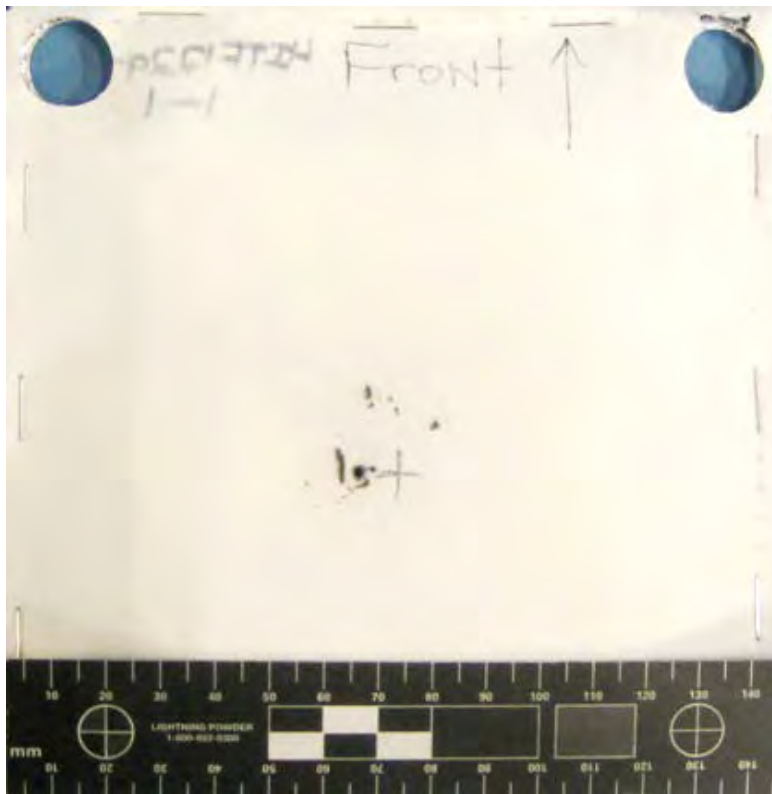
Figure 255 Overall View of Damage to Front of MLI (scale in 5mm increments / black arrow indicates flight path of projectile)

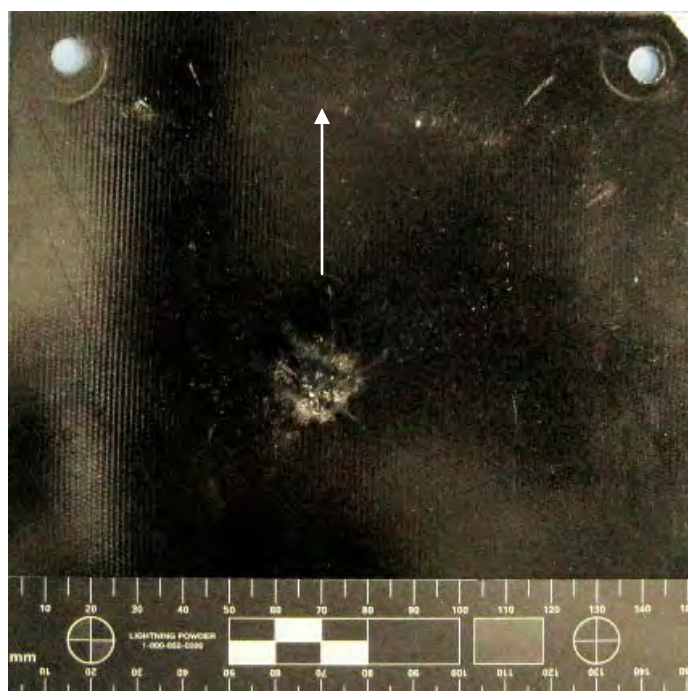
Figure 259 Overall View of Damage to Front of NP 504 Substrate (scale in 5mm increments / white arrow indicates flight path of projectile)

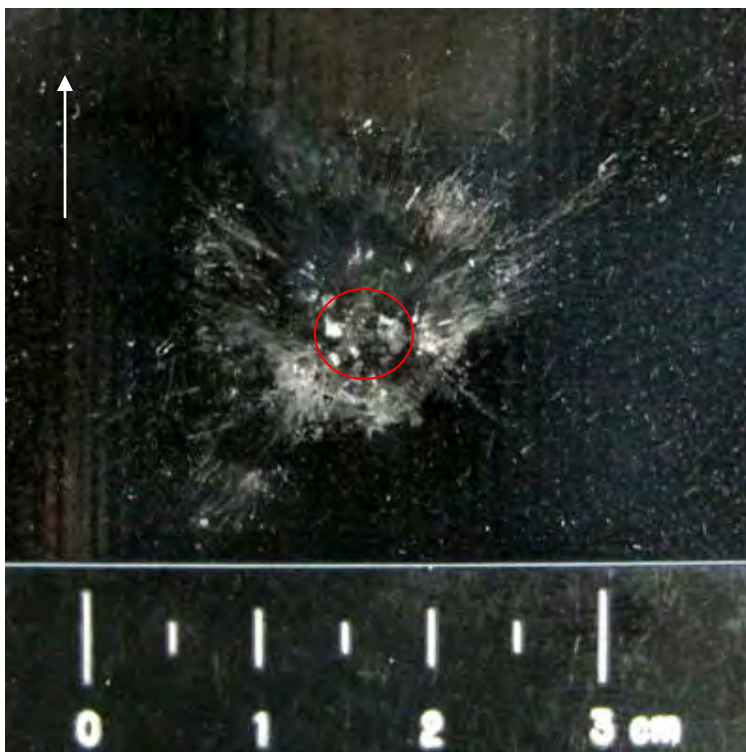
Figure 260 Close-up View of Damage to Front of NP 504 Substrate (scale in 5mm increments / white arrow indicates flight path of projectile)

Figure 261 Close-up View of Most Significant Damage to Front of NP 504 Substrate (black arrow indicates flight path of projectile / damage within red circle in Figure 260)

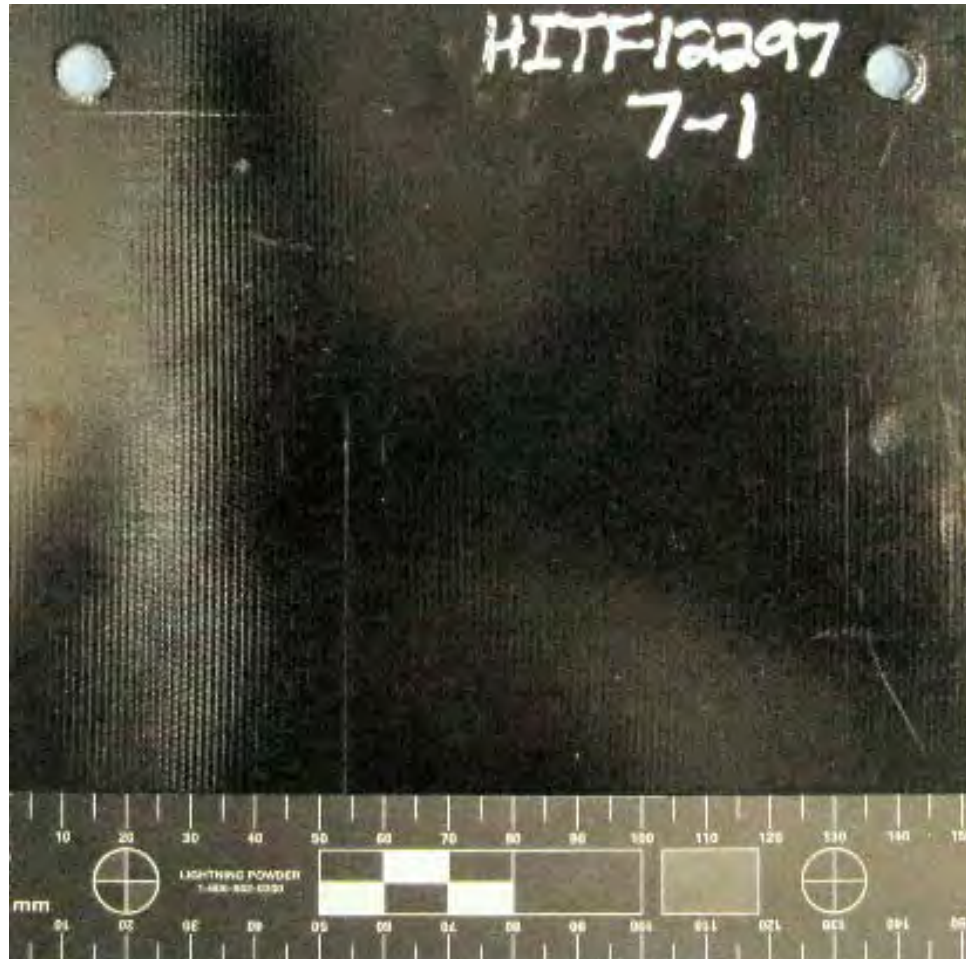
Figure 262 Overall View of Back Side of NP 504 Substrate (scale in 5mm increments / white arrow indicates flight path of projectile)
