International Space Station (ISS) Soyuz Vehicle Descent Module Evaluation of Thermal Protection System (TPS) Penetration Characteristics

Hypervelocity Impact Technology Group

February 2013

**International Space Station (ISS) Soyuz Vehicle
Descent Module Evaluation of Thermal Protection
System (TPS) Penetration Characteristics**

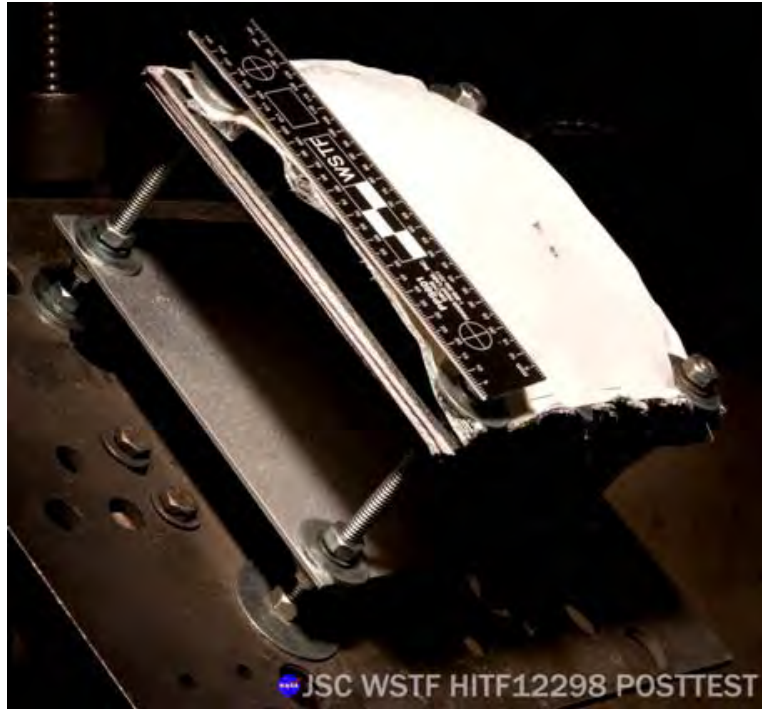
Figure 263 Overall View of Sample in the Target Tank (post-test)

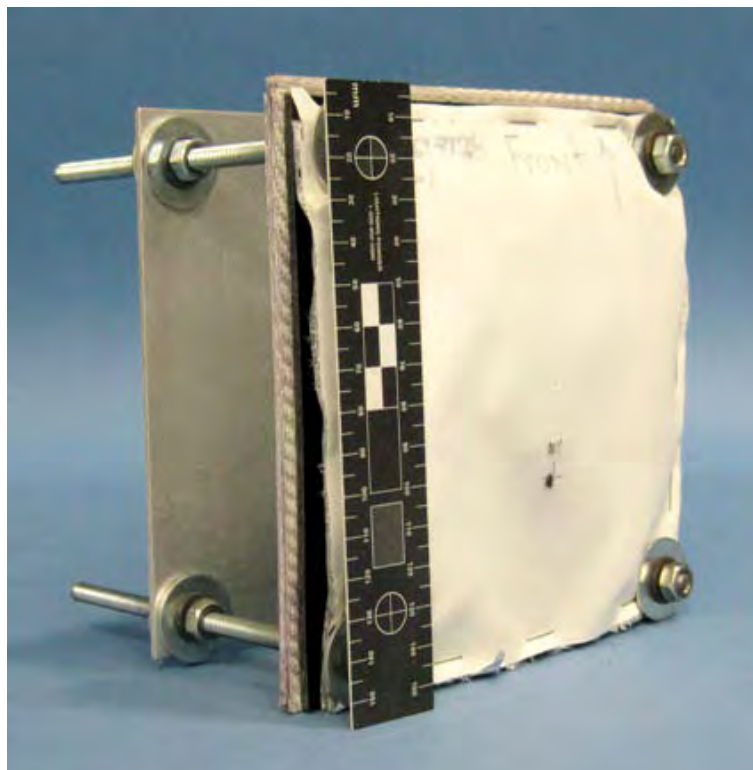
Figure 264 Overall Front Oblique View of Sample (scale in 5mm increments)

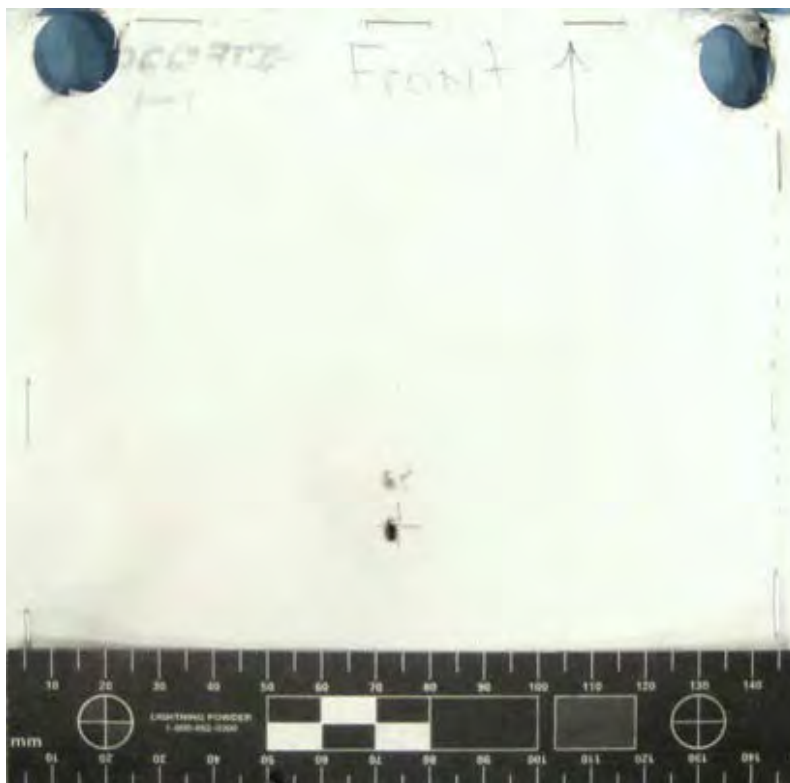
Figure 266 Overall View of Damage to Front of MLI (scale in 5mm increments / black arrow indicates flight path of projectile)

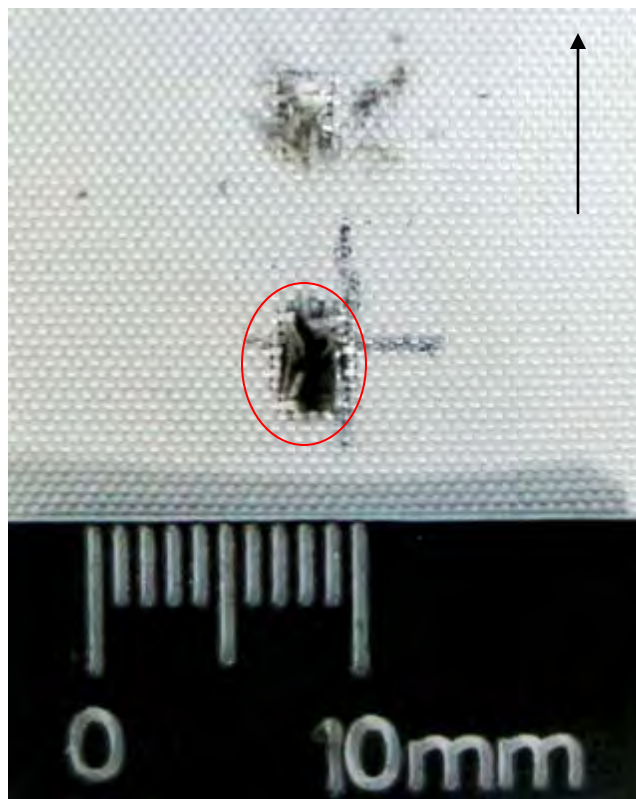
Figure 267 Close-up View of Damage to Front of MLI (scale in 1mm increments / black arrow indicates flight path of projectile / projectile impacted within red circle)

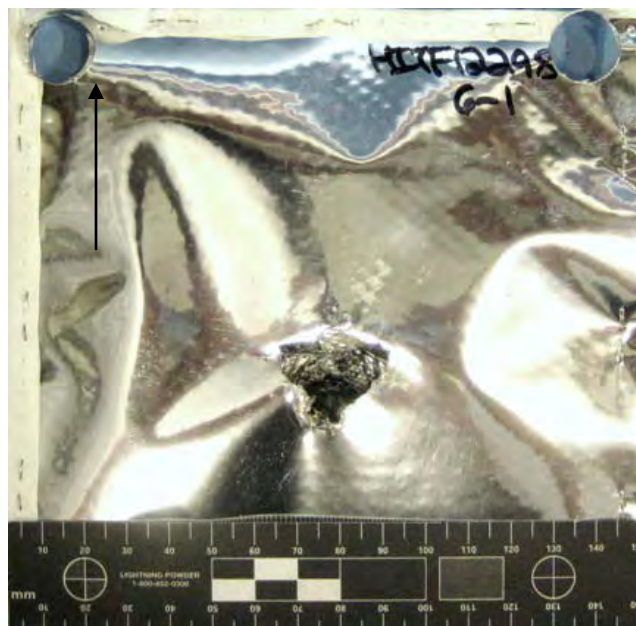
Figure 268 Overall View of Damage to Back Side of MLI (scale in 5mm increments / black arrow indicates flight path of projectile)

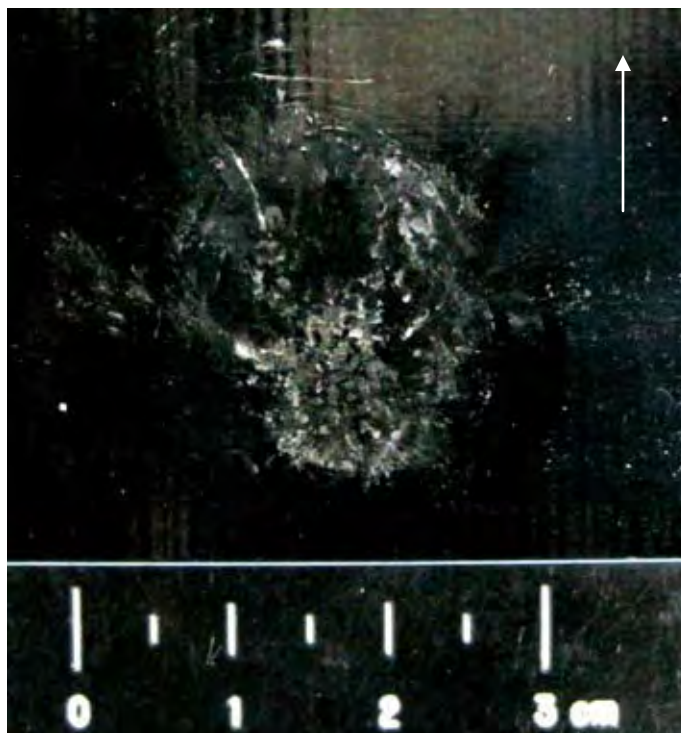
Figure 271 Close-up View of Damage to Front of NP 504 Substrate (scale in 5mm increments / white arrow indicates flight path of projectile)

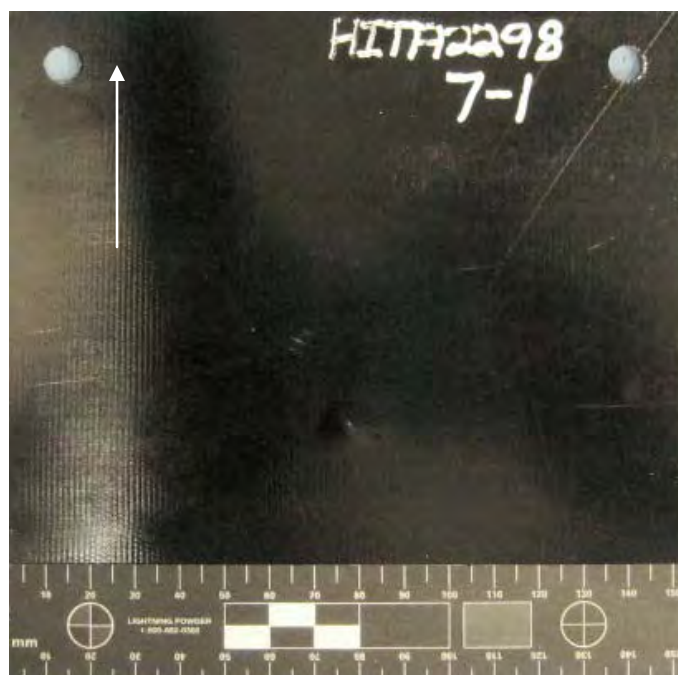
Figure 272 Overall View of Damage to Back Side of NP 504 Substrate (scale in 5mm increments / white arrow indicates flight path of projectile)

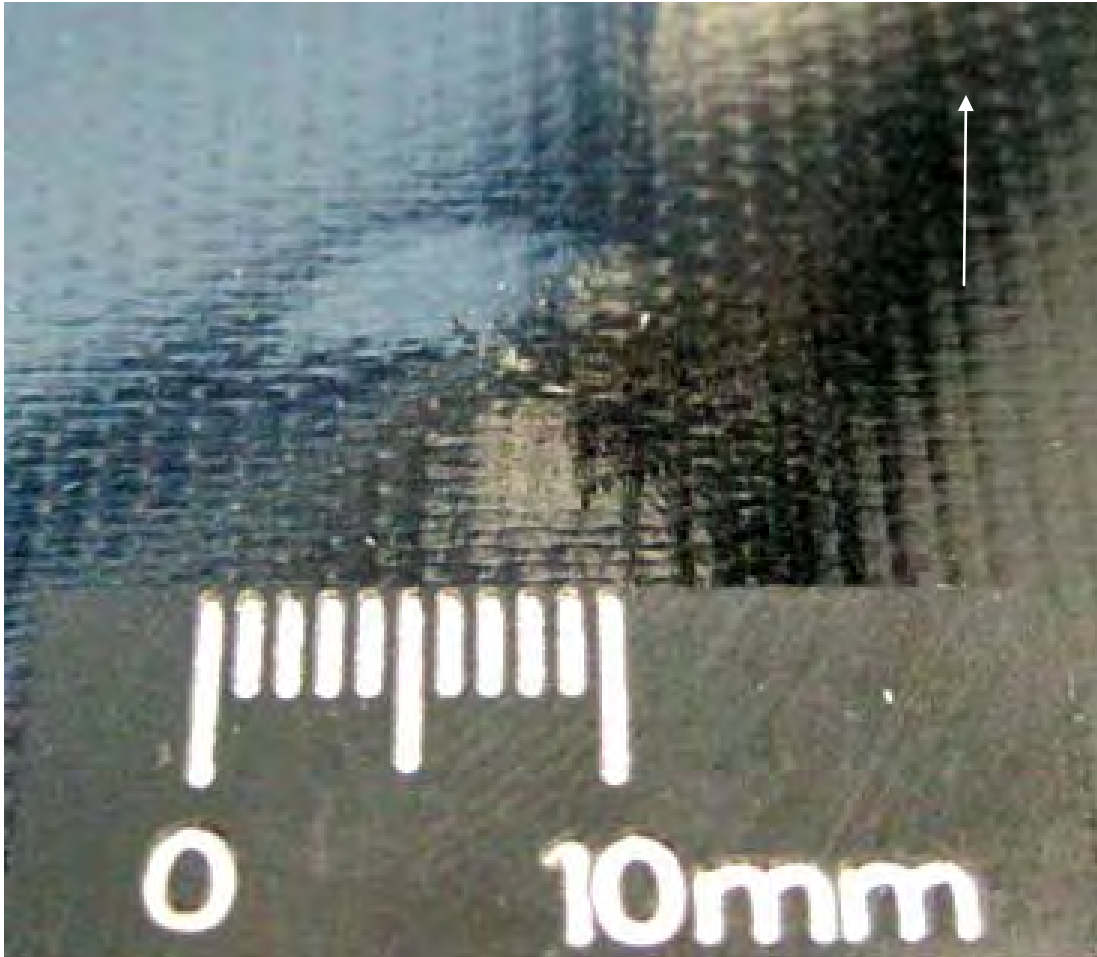
Figure 275 Close-up Oblique Side View of Damage to Back Side of NP 504 Substrate (scale in 1mm increments / white arrow indicates flight path of projectile)

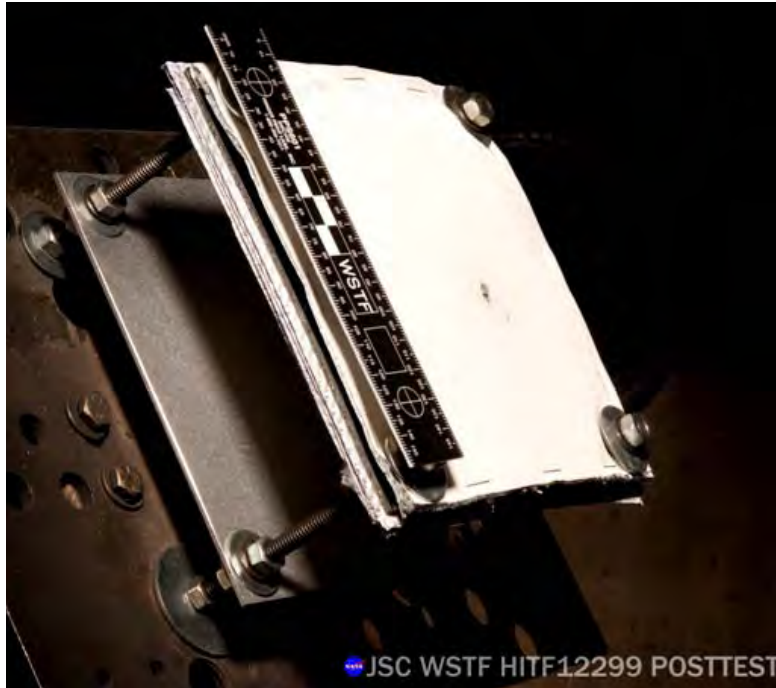
Figure 276 Overall View of Sample in the Target Tank (post-test)

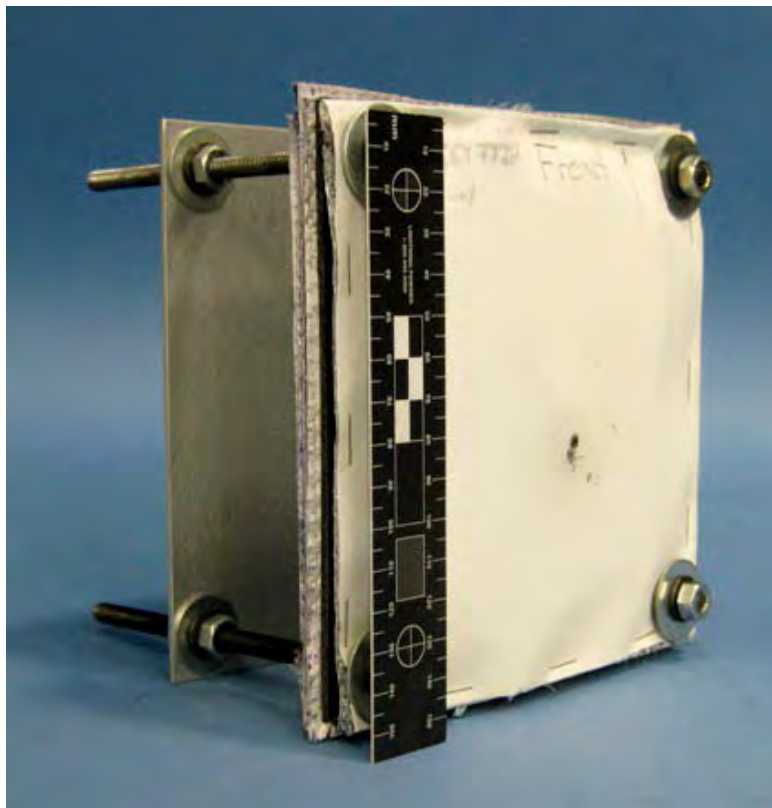
Figure 277 Overall Front Oblique View of Sample (scale in 5mm increments)

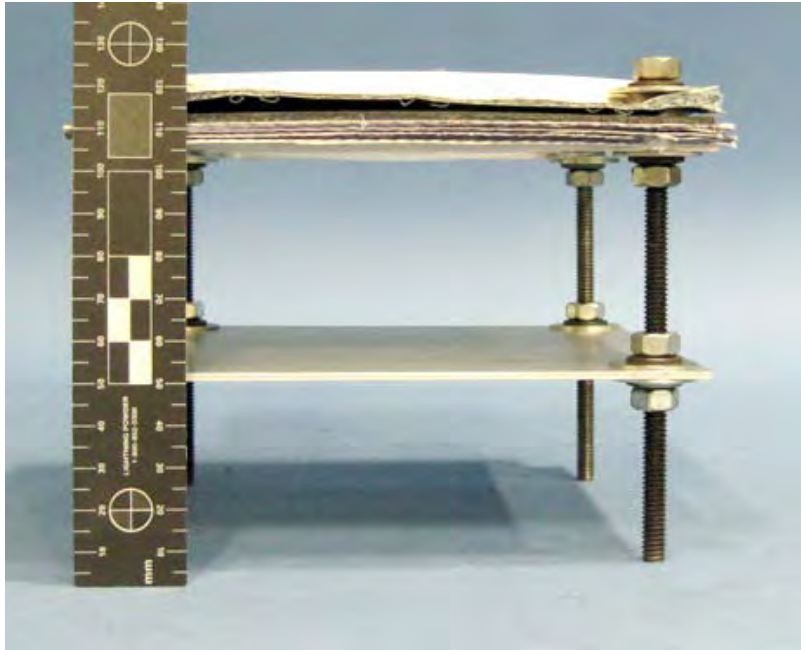
Figure 278 Overall Side View of Sample (scale in 5mm increments)

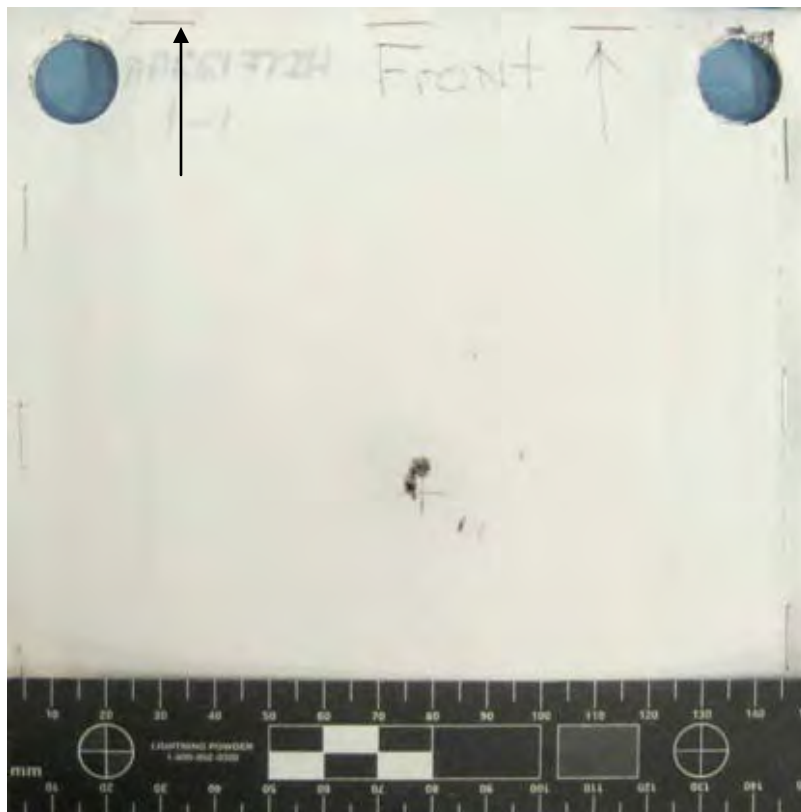
Figure 279 Overall View of Damage to Front of MLI (scale in 5mm increments / black arrow indicates flight path of projectile)

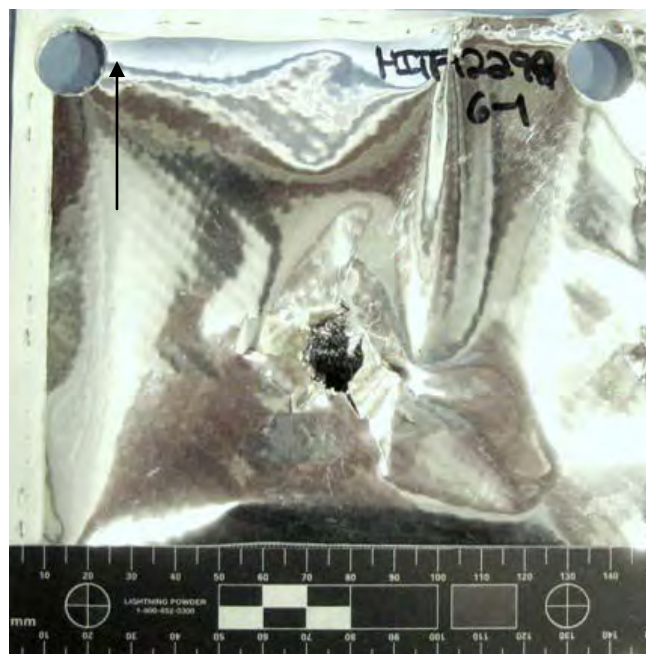
Figure 281 Overall View of Damage to Back Side of MLI (scale in 5mm increments / black arrow indicates flight path of projectile)

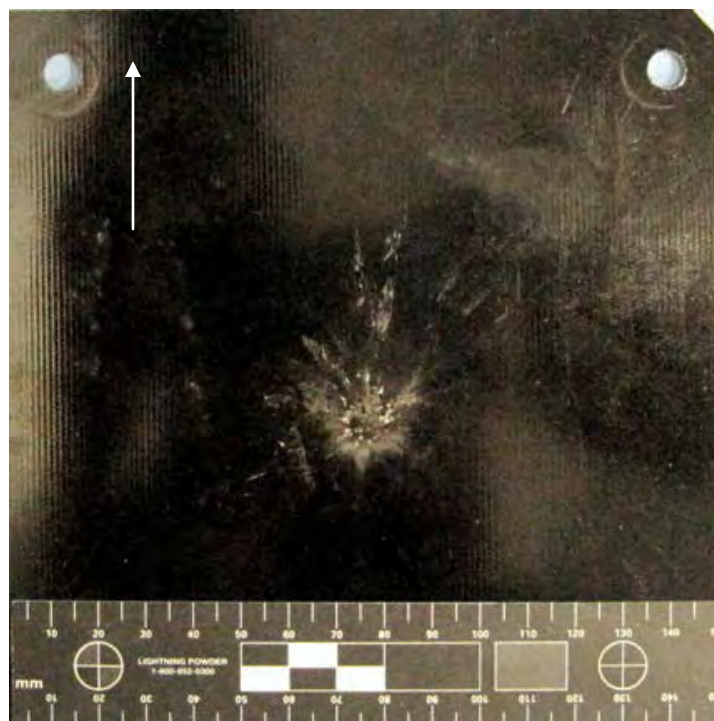
Figure 283 Overall View of Damage to Front of NP 504 Substrate (scale in 5mm increments / white arrow indicates flight path of projectile)

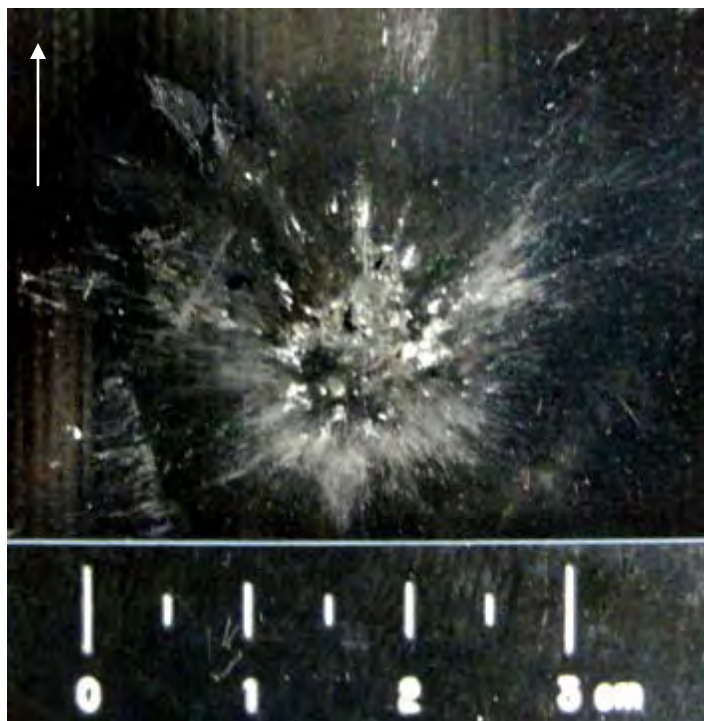
Figure 284 Close-up View of Damage to Front of NP 504 Substrate (scale in 5mm increments / white arrow indicates flight path of projectile)

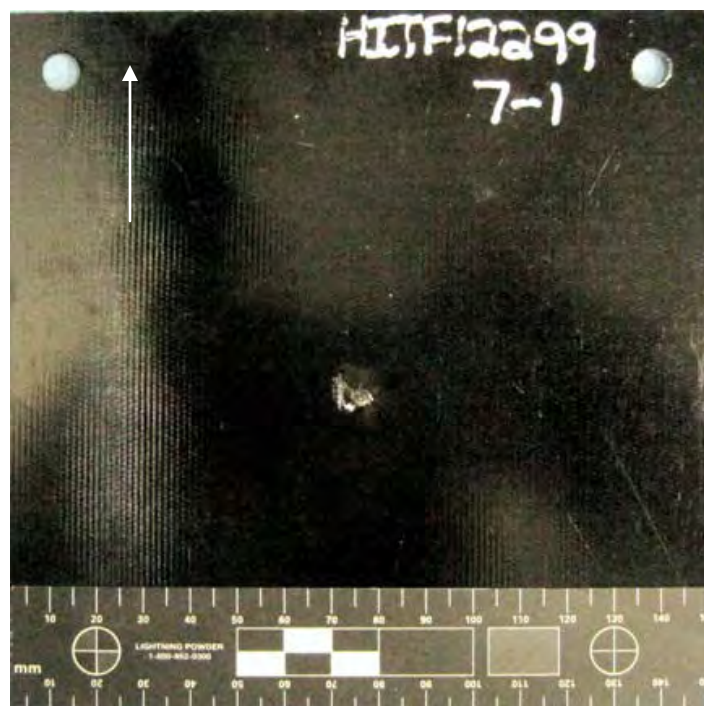
Figure 285 Overall View of Damage to Back Side of NP 504 Substrate (scale in 5mm increments / white arrow indicates flight path of projectile)

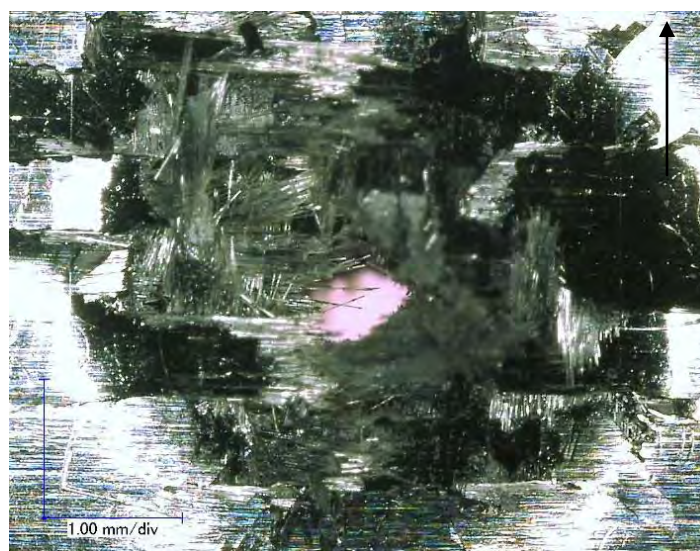
Figure 287 Close-up View of Most Significant Damage to Back Side of NP 504 Substrate (black arrow indicates flight path of projectile / damage within red circle in Figure 286)

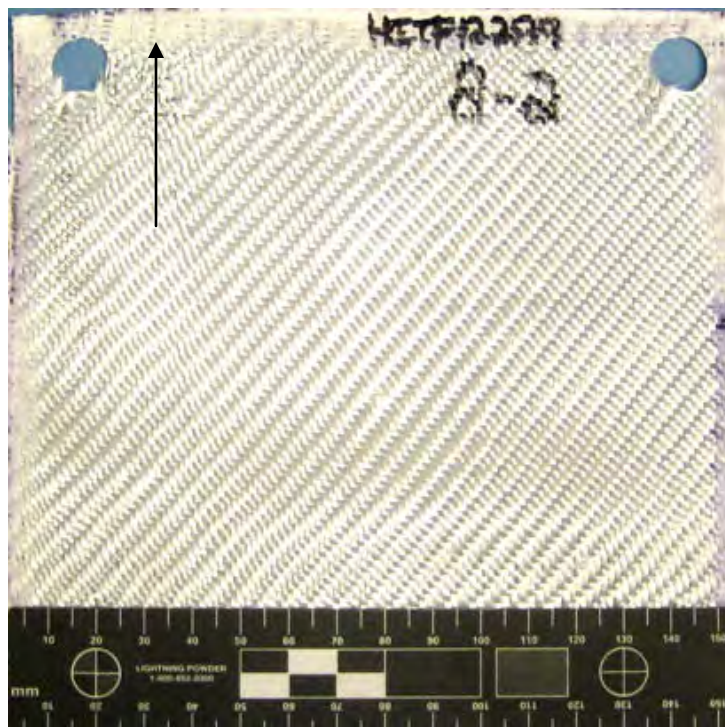
Figure 289 Overall View of Damage to Back Side of 2nd Fiberglass Layer (scale in 5mm increments / black arrow indicates flight path of projectile)

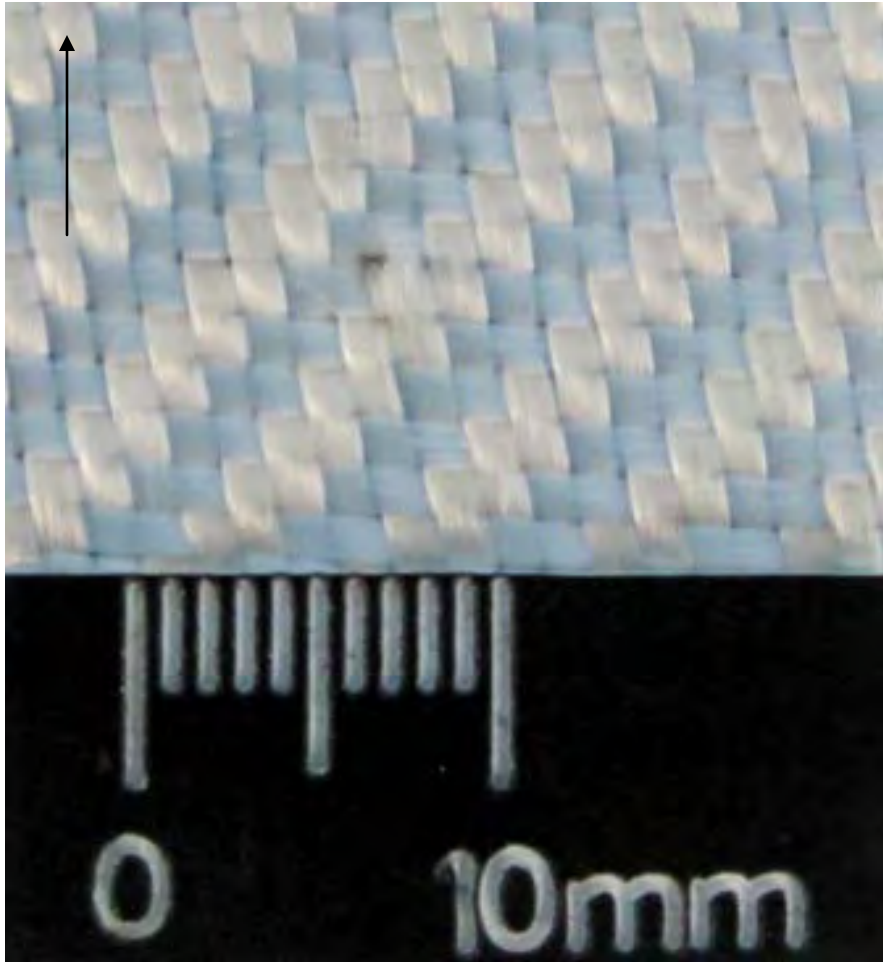
Figure 290 Close-up View of Damage to Back Side of 2nd Fiberglass Layer (scale in 1mm increments / black arrow indicates flight path of projectile)

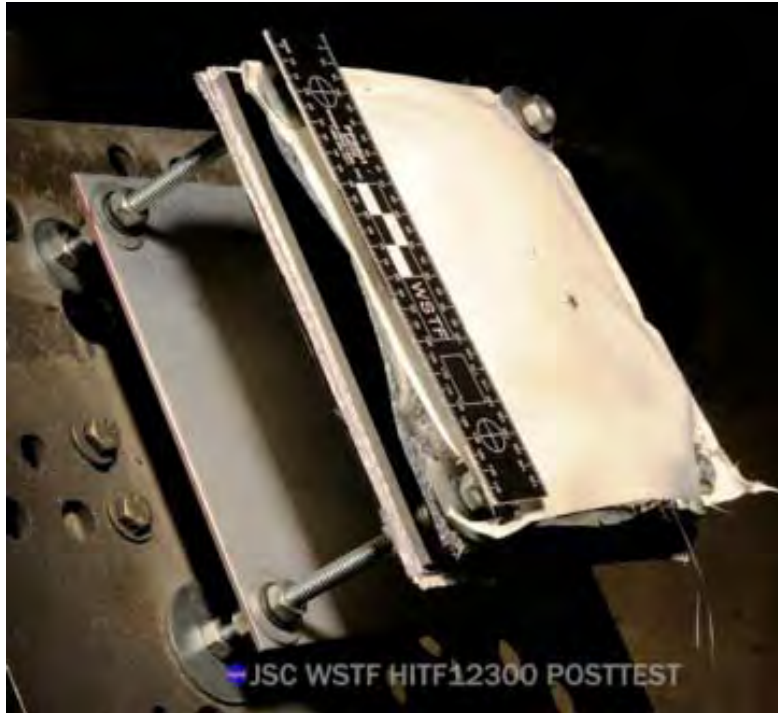
Figure 291 Overall View of Sample in the Target Tank (post-test)

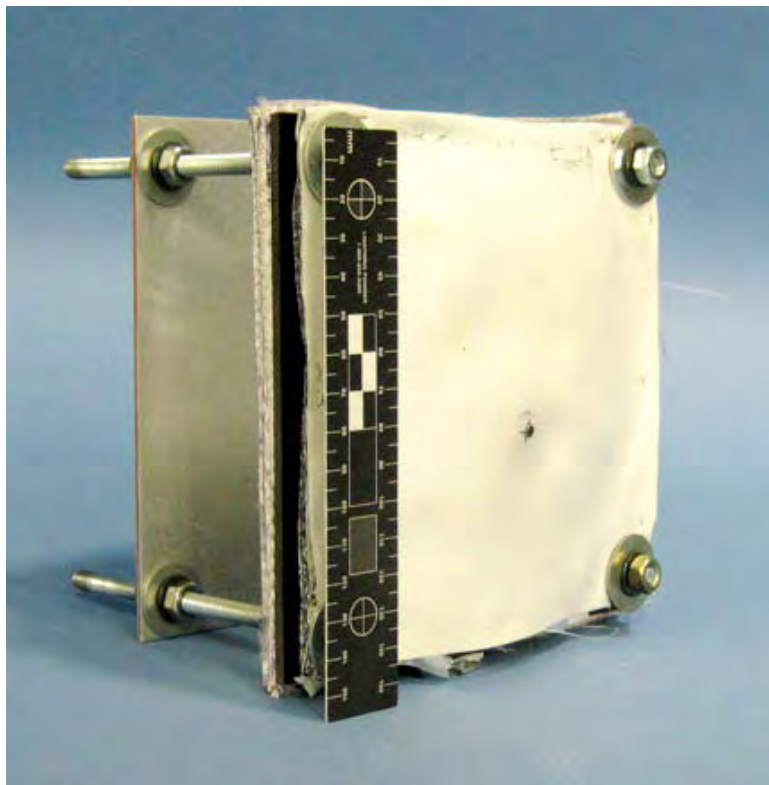
Figure 292 Overall Front Oblique View of Sample (scale in 5mm increments)

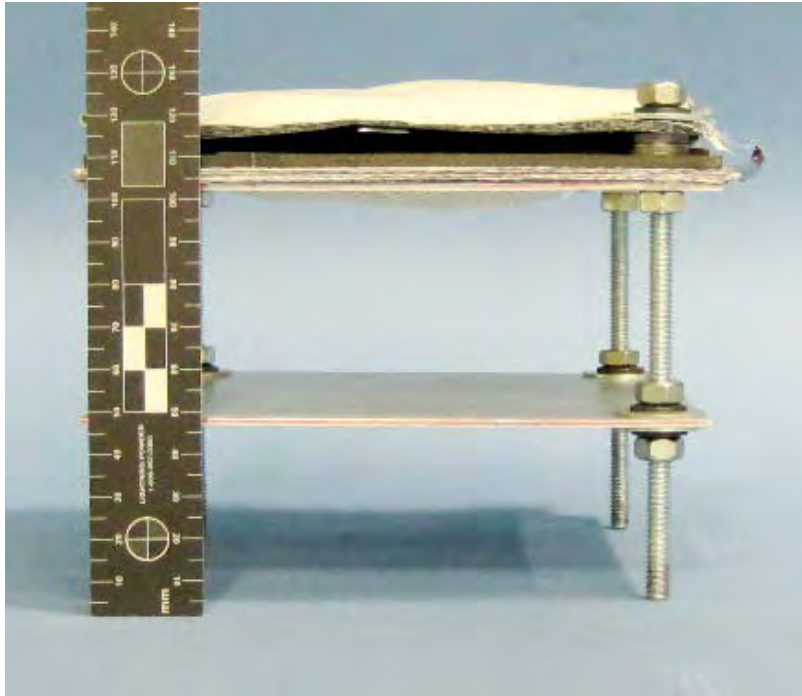
Figure 293 Overall Side View of Sample (scale in 5mm increments)

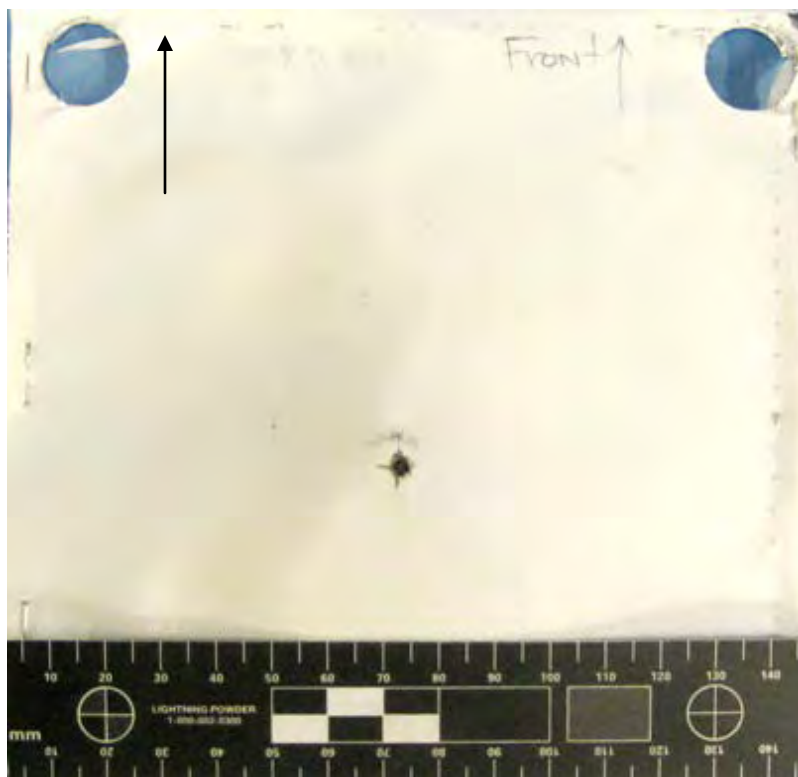
Figure 294 Overall View of Damage to Front of MLI (scale in 5mm increments / black arrow indicates flight path of projectile)

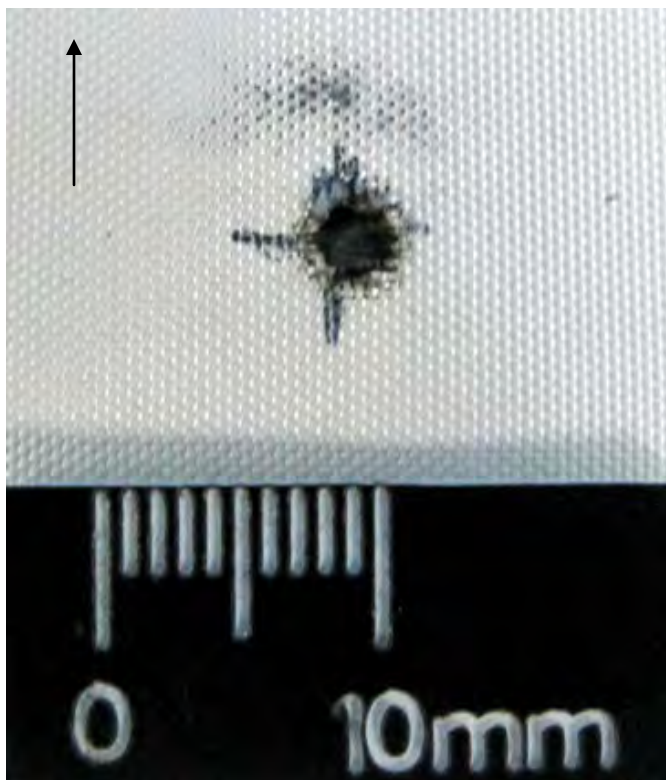
Figure 295 Close-up View of Damage to Front of MLI (scale in 1mm increments / black arrow indicates flight path of projectile)

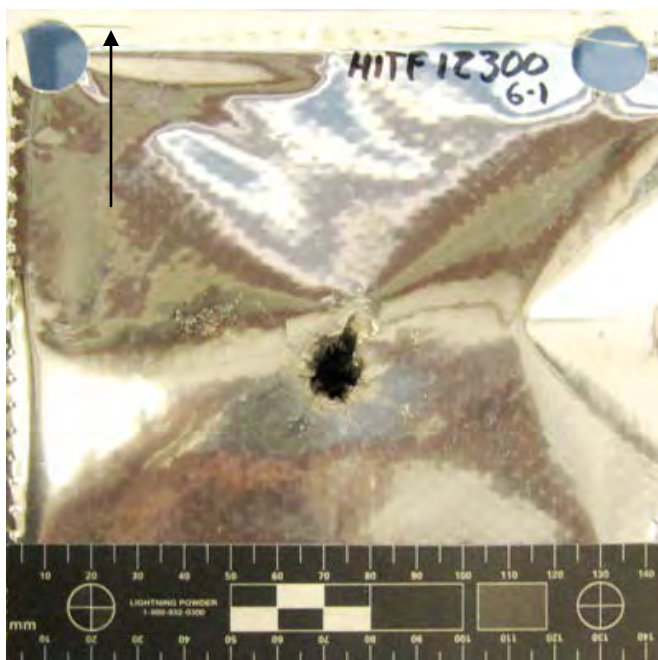
Figure 296 Overall View of Damage to Back Side of MLI (scale in 5mm increments / black arrow indicates flight path of projectile)

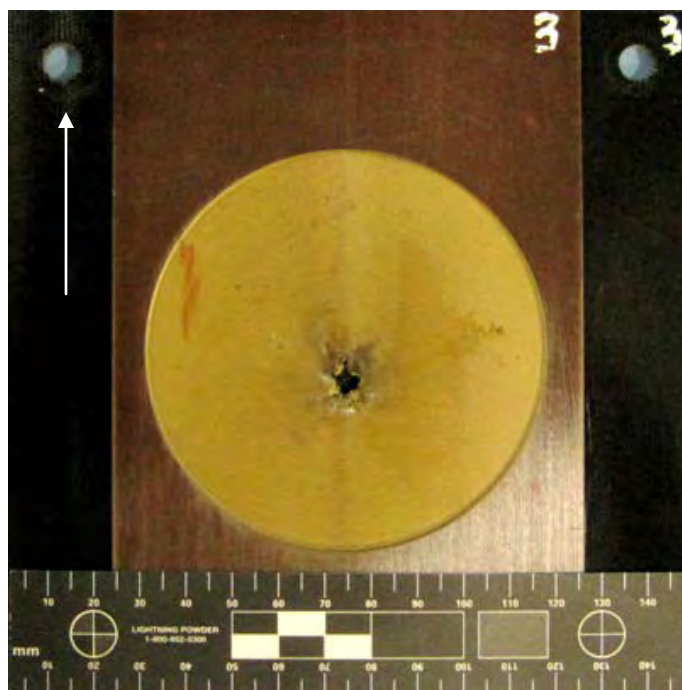
Figure 298 Overall View of Damage to Front of TORLON 5030 (scale in 5mm increments / white arrow indicates flight path of projectile)

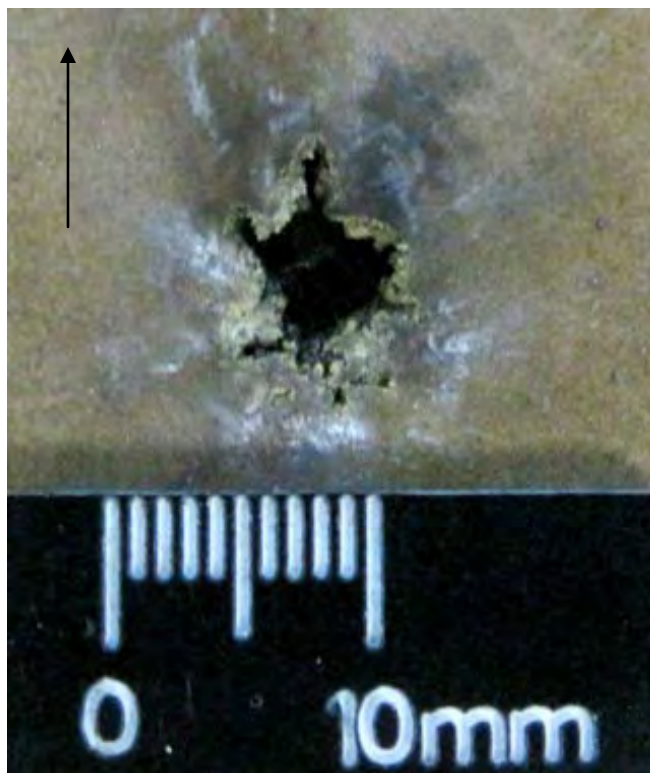
Figure 299 Close-up View of Damage to Front of TORLON 5030 (scale in 5mm increments / white arrow indicates flight path of projectile)

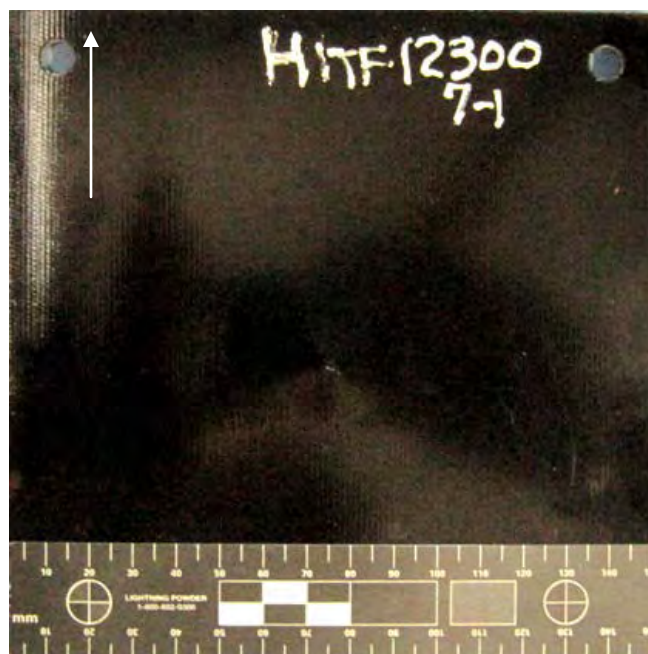
Figure 300 Overall View of Damage to Back Side of NP 504 Substrate (scale in 5mm increments / white arrow indicates flight path of projectile)

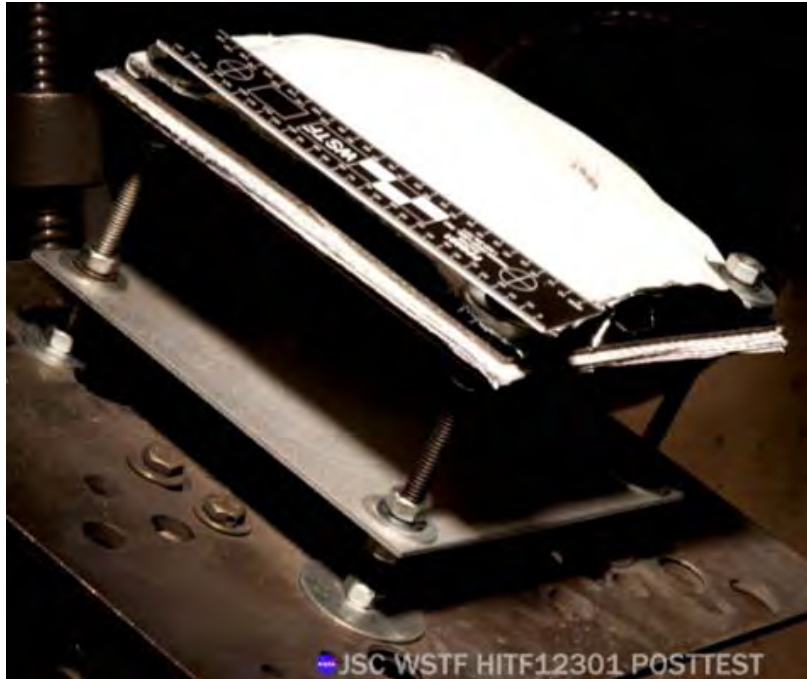
Figure 307 Overall View of Sample in the Target Tank (post-test)

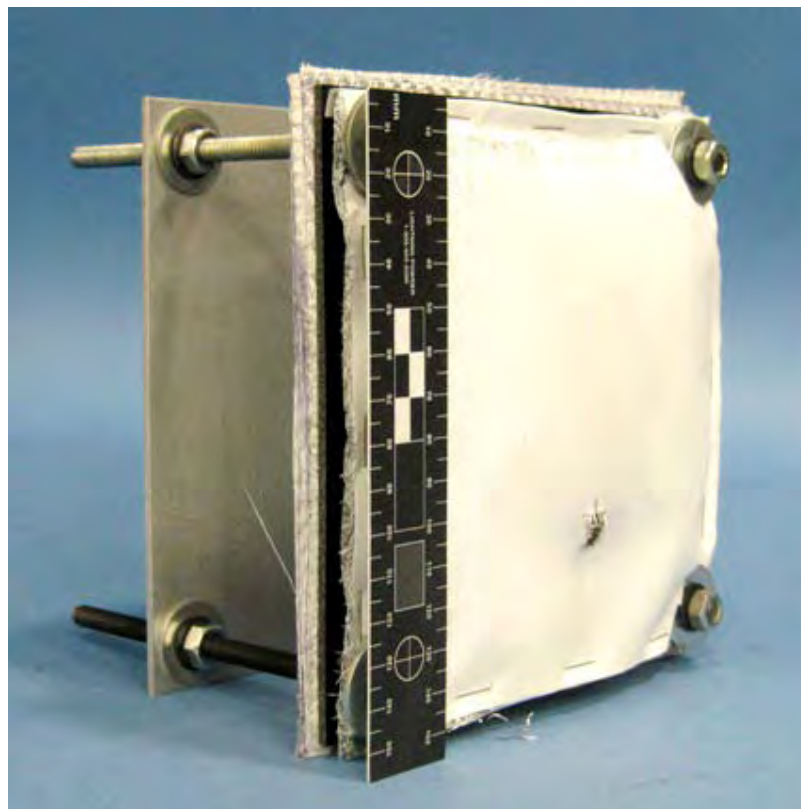
Figure 308 Overall Front Oblique View of Sample (scale in 5mm increments)

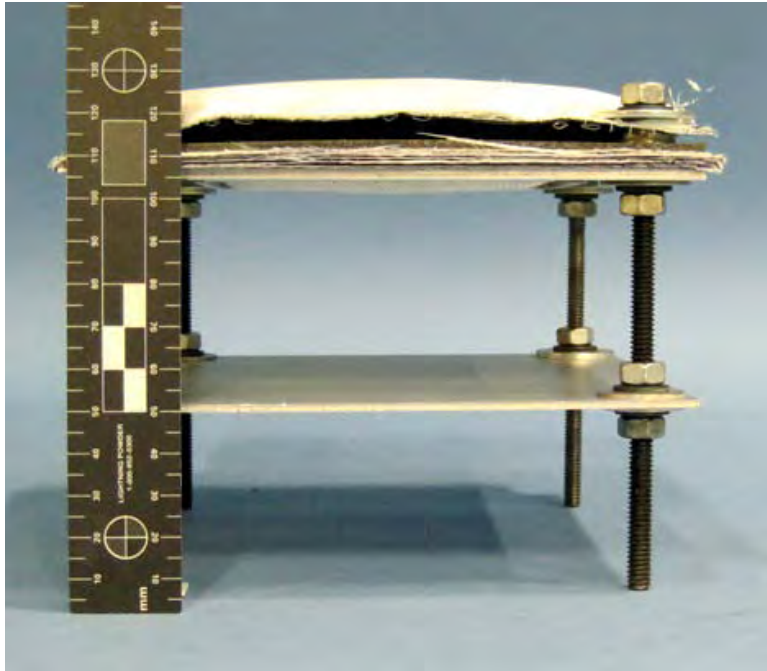
**Figure 309** Overall Side View of Sample (scale in 5mm increments)

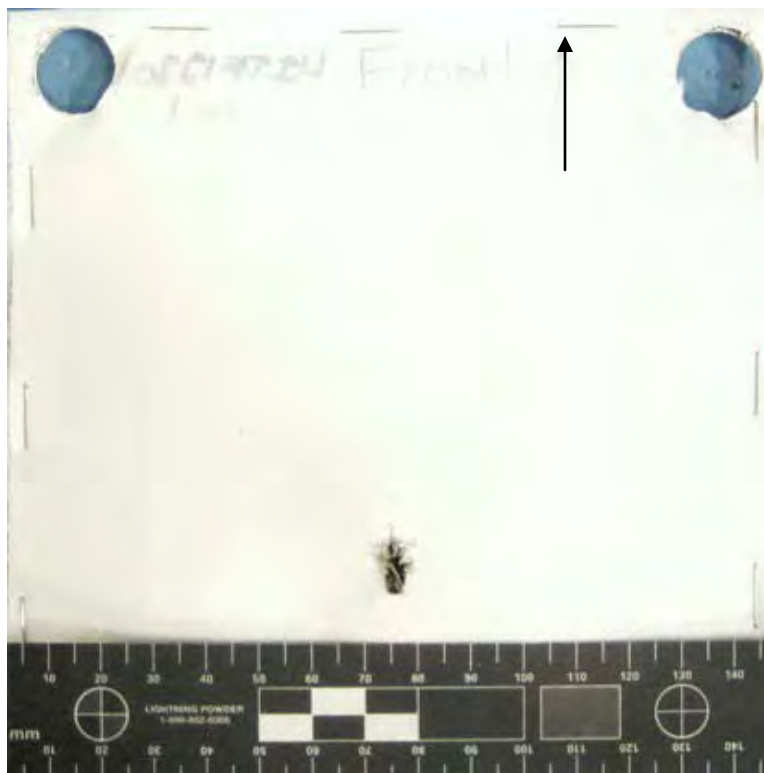
**Figure 310** Overall View of Damage to Front of MLI (scale in 5mm increments / black arrow indicates flight path of projectile)

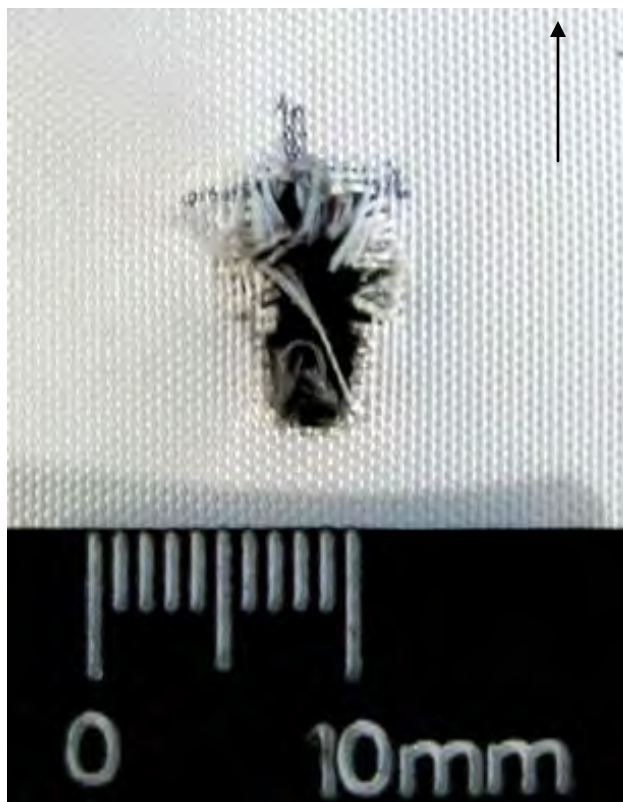
Figure 311 Close-up View of Damage to Front of MLI (scale in 1mm increments / black arrow indicates flight path of projectile)

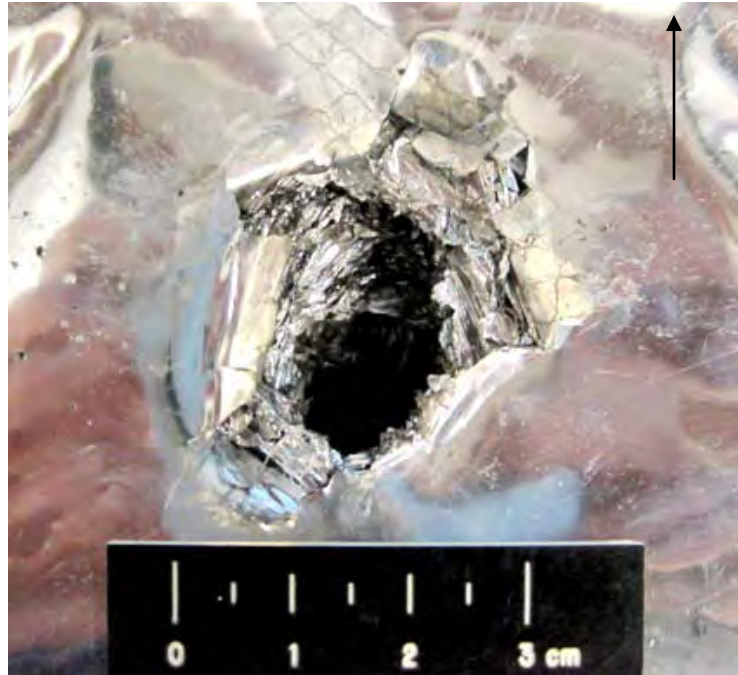
Figure 313 Close-up View of Damage to Back Side of MLI (scale in 5mm increments / black arrow indicates flight path of projectile)

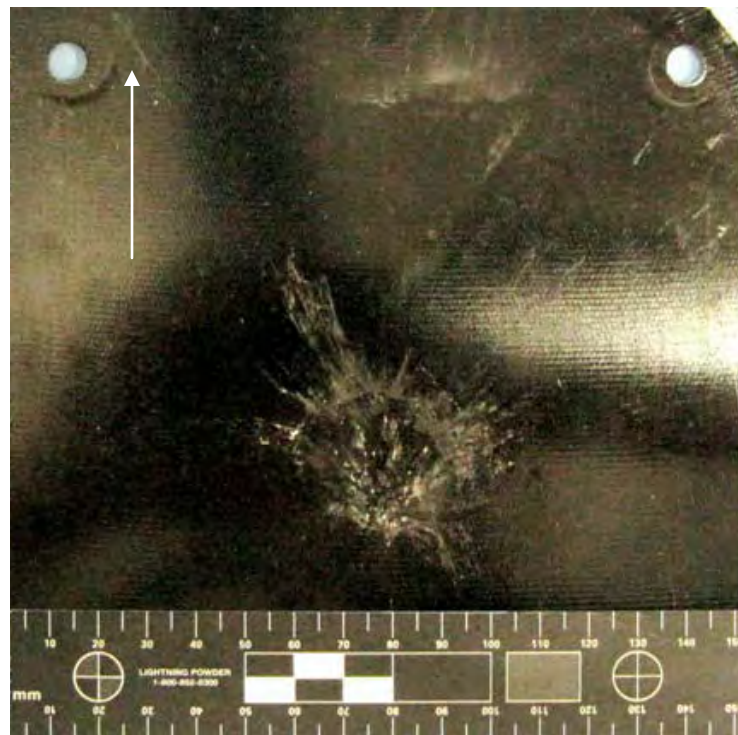
Figure 314 Overall View of Damage to Front of NP 504 Substrate (scale in 5mm increments / white arrow indicates flight path of projectile)

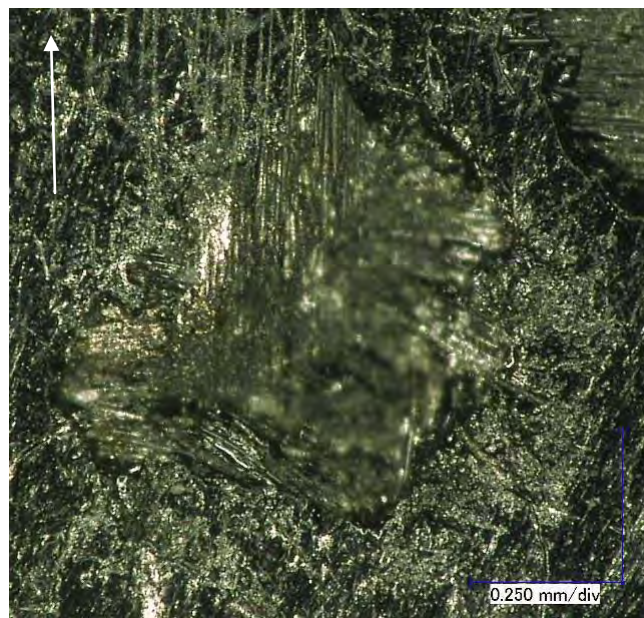
Figure 316 Close-up View of Damage to Front of NP 504 Substrate (white arrow indicates flight path of projectile / damage within red circle in Figure 128)

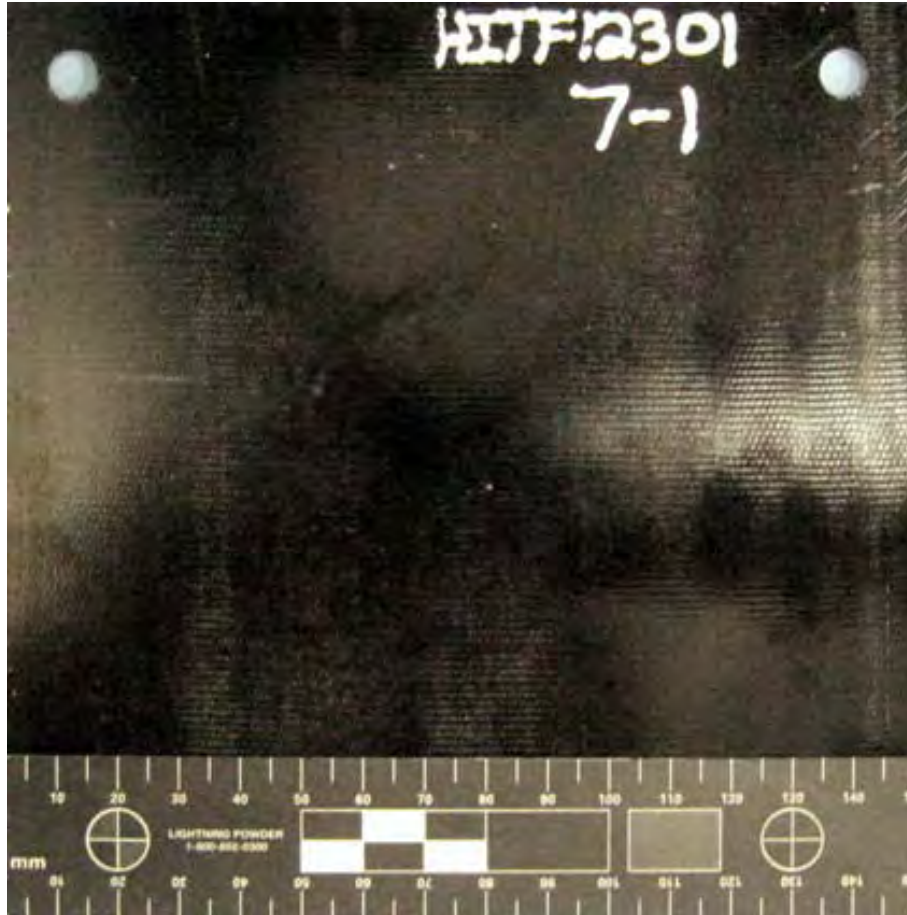
Figure 317 Overall View of Damage to Back Side of NP 504 Substrate (scale in 5mm increments / white arrow indicates flight path of projectile)

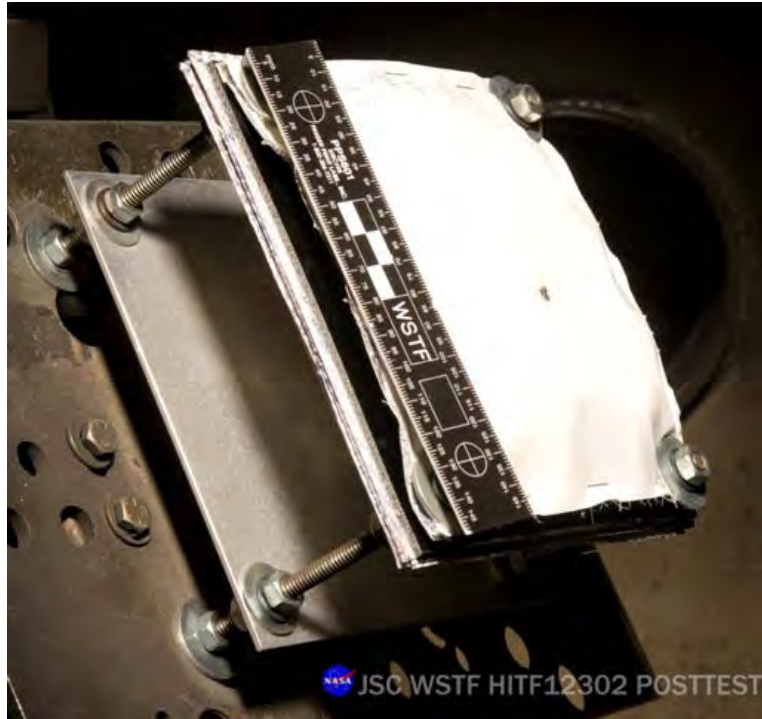
Figure 318 Overall View of Sample in the Target Tank (post-test)

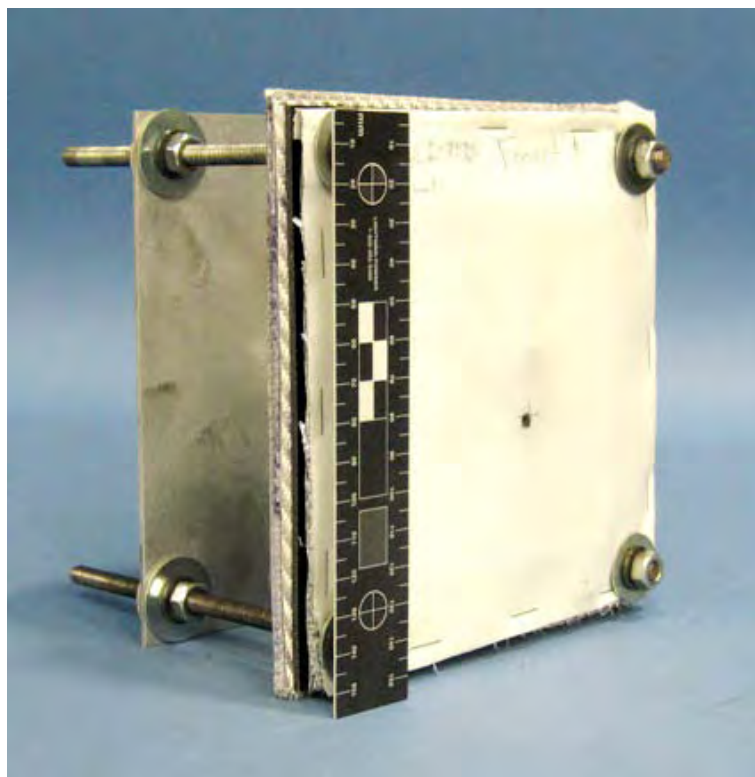
Figure 319 Overall Front Oblique View of Sample (scale in 5mm increments)
