International Space Station (ISS) Soyuz Vehicle Descent Module Evaluation of Thermal Protection System (TPS) Penetration Characteristics

Hypervelocity Impact Technology Group

February 2013

**International Space Station (ISS) Soyuz Vehicle
Descent Module Evaluation of Thermal Protection
System (TPS) Penetration Characteristics**

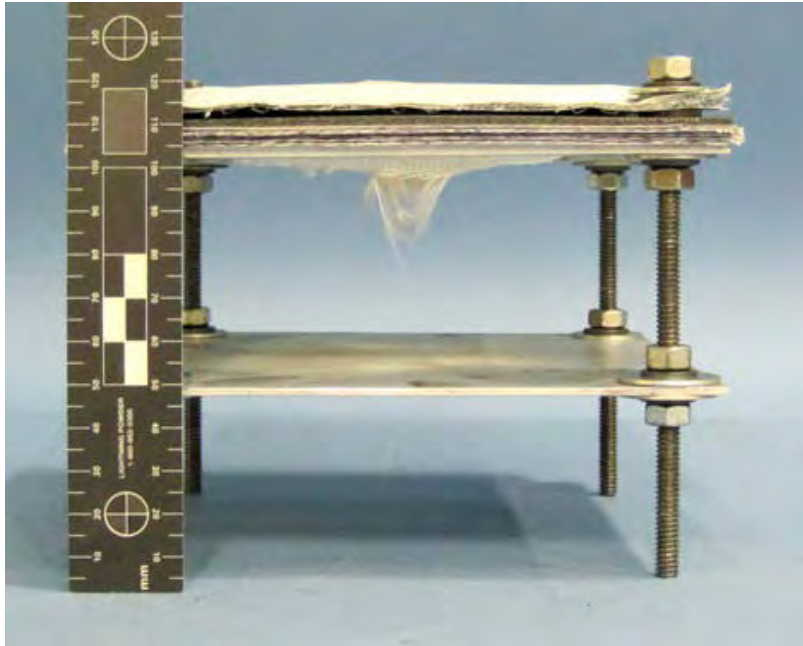
Figure 320 Overall Side View of Sample (scale in 5mm increments)

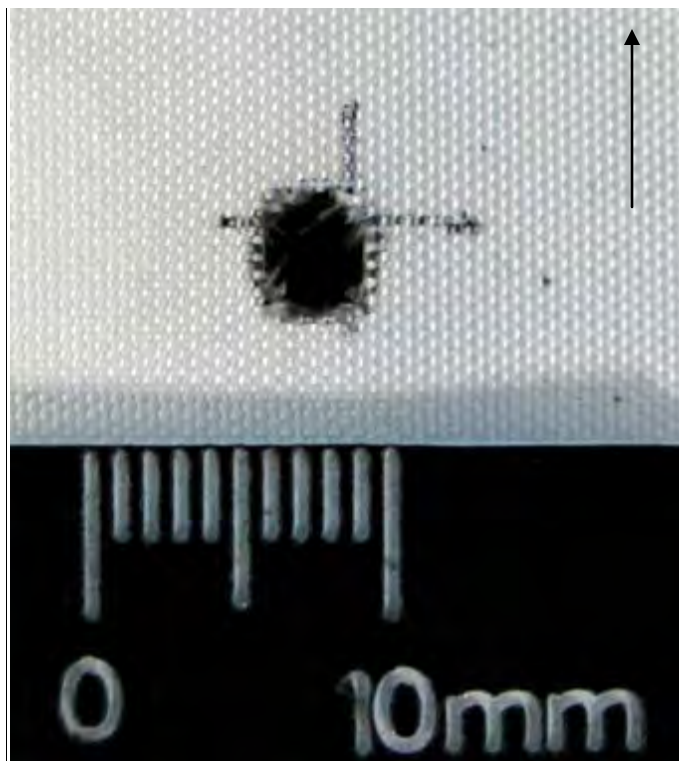
Figure 322 Close-up View of Damage to Front of MLI (scale in 1mm increments / black arrow indicates flight path of projectile)

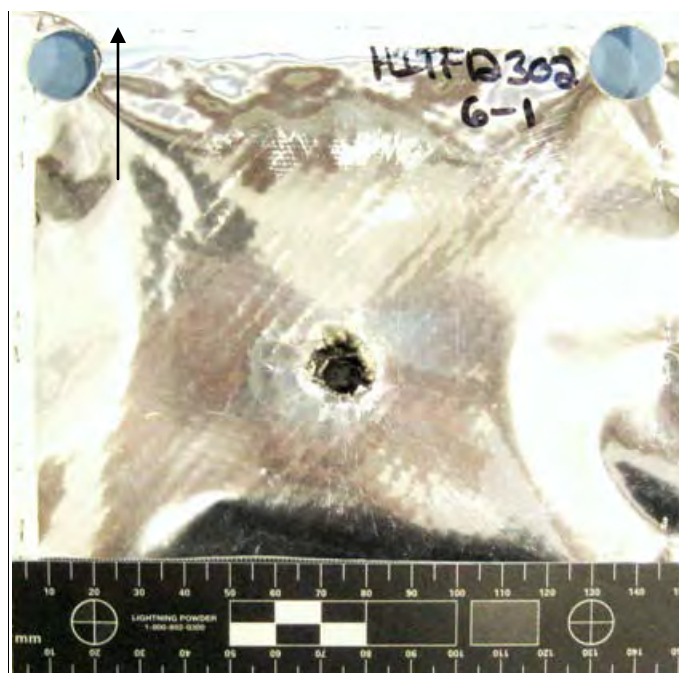
Figure 323 Overall View of Damage to Back Side of MLI (scale in 5mm increments / black arrow indicates flight path of projectile)

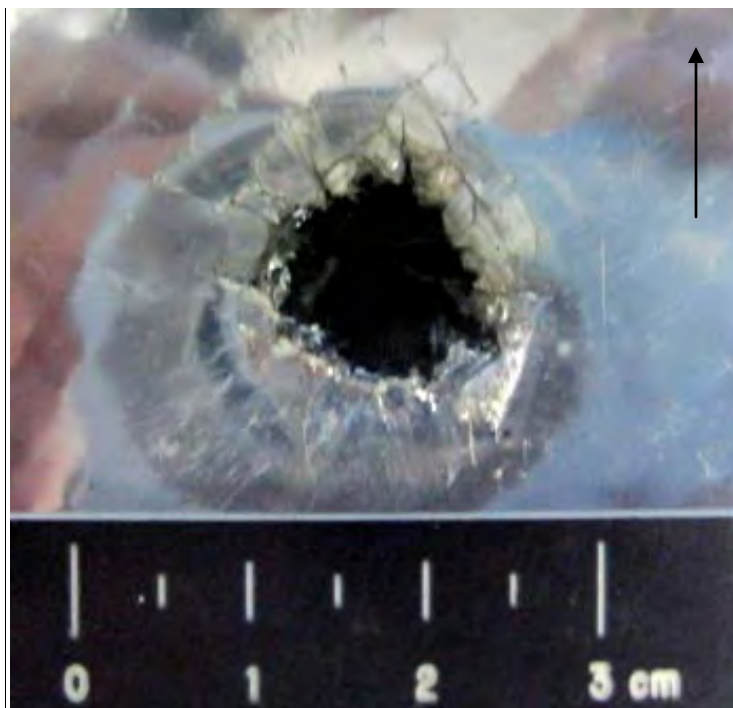
Figure 324 Close-up View of Damage to Back Side of MLI (scale in 5mm increments / black arrow indicates flight path of projectile)

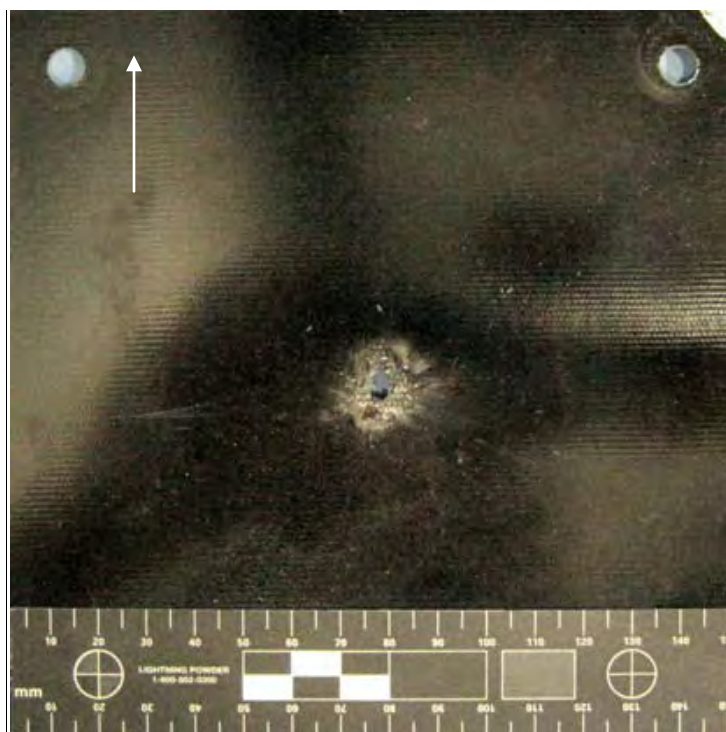
Figure 325 Overall View of Damage to Front of NP 504 Substrate (scale in 5mm increments / white arrow indicates flight path of projectile)

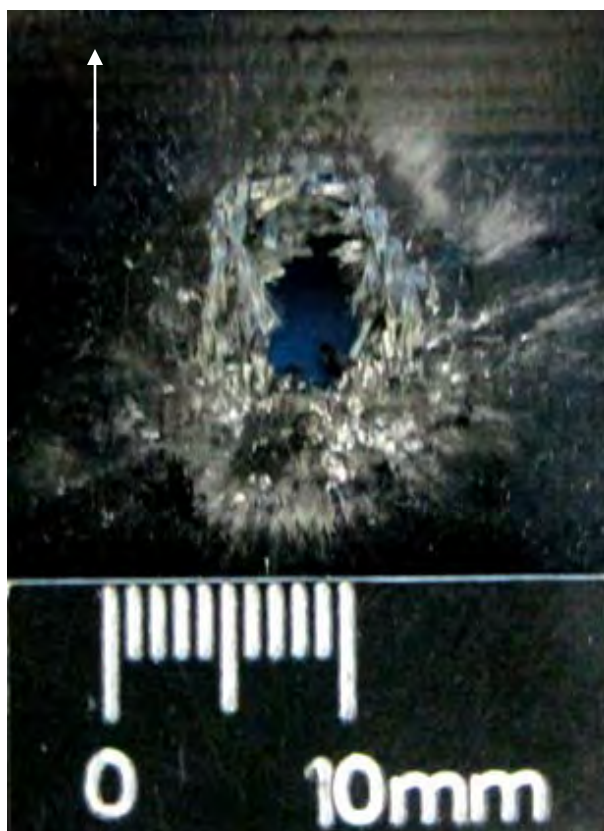
Figure 326 Close-up View of Damage to Front of NP 504 Substrate (scale in 1mm increments / white arrow indicates flight path of projectile)

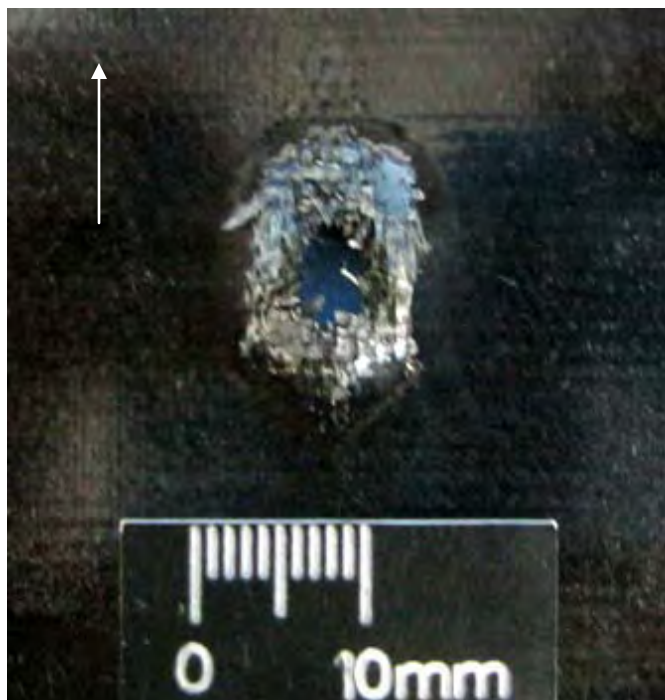
Figure 328 Close-up View of Damage to Back Side of NP 504 Substrate (scale in 1mm increments / white arrow indicates flight path of projectile)

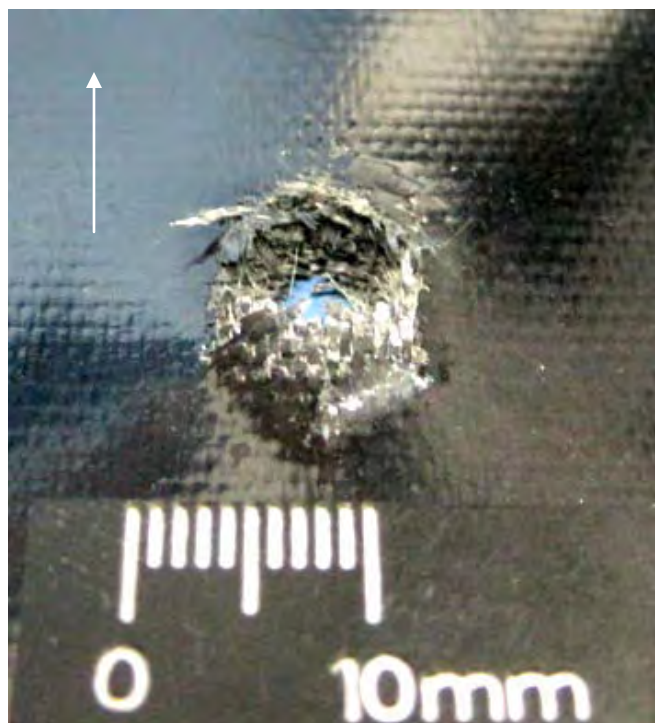
Figure 329 Close-up Oblique Side View of Damage to Back Side of NP 504 Substrate (scale in 1mm increments / white arrow indicates flight path of projectile)

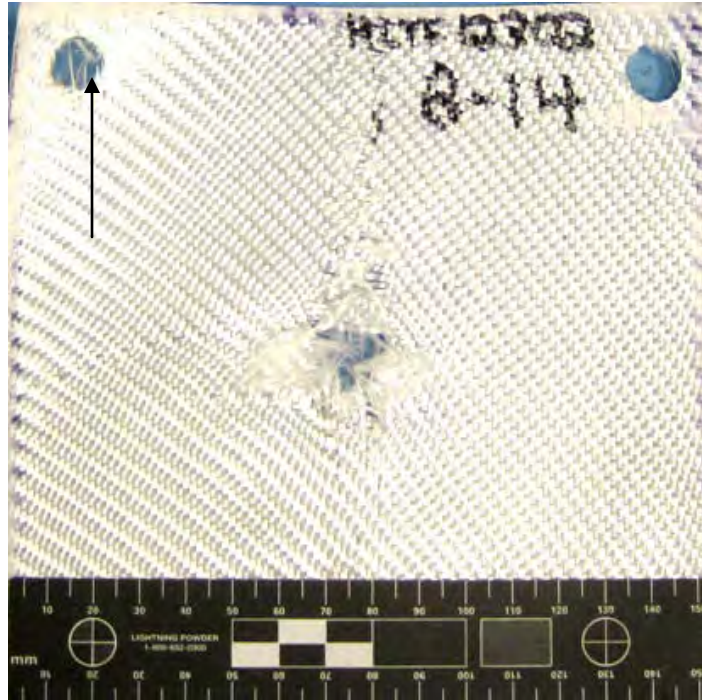
Figure 330 Overall View of Damage to Back Side of Last Fiberglass Layer (scale in 5mm increments / black arrow indicates flight path of projectile)

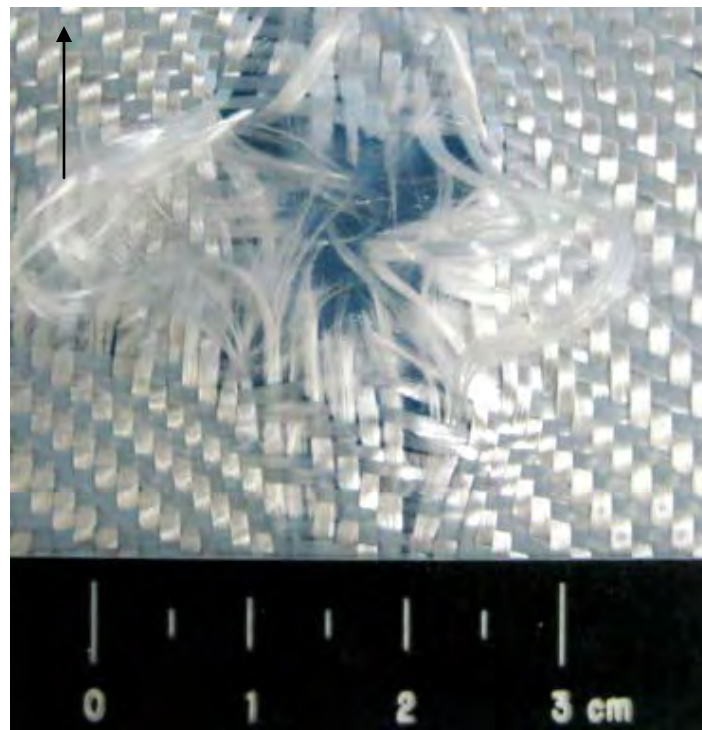
Figure 331 Overall View of Damage to Back Side of Last Fiberglass Layer (scale in 5mm increments / black arrow indicates flight path of projectile)

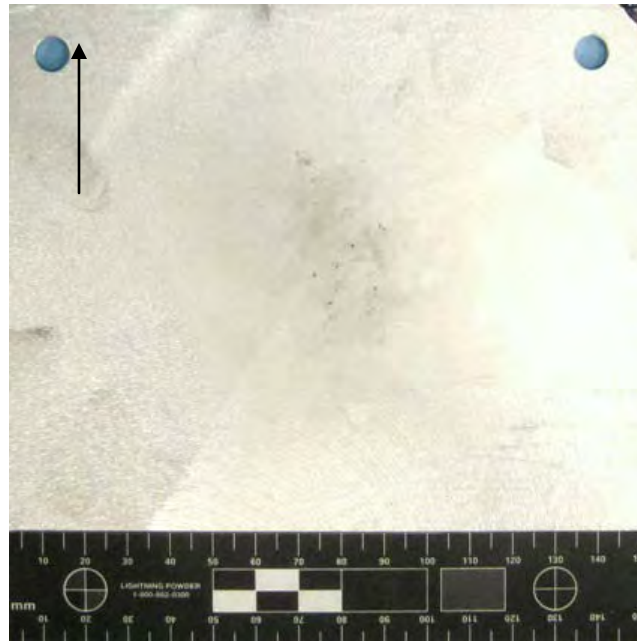
Figure 332 Overall View of Damage to Front of Rear Wall (scale in 5mm increments / black arrow indicates flight path of projectile)

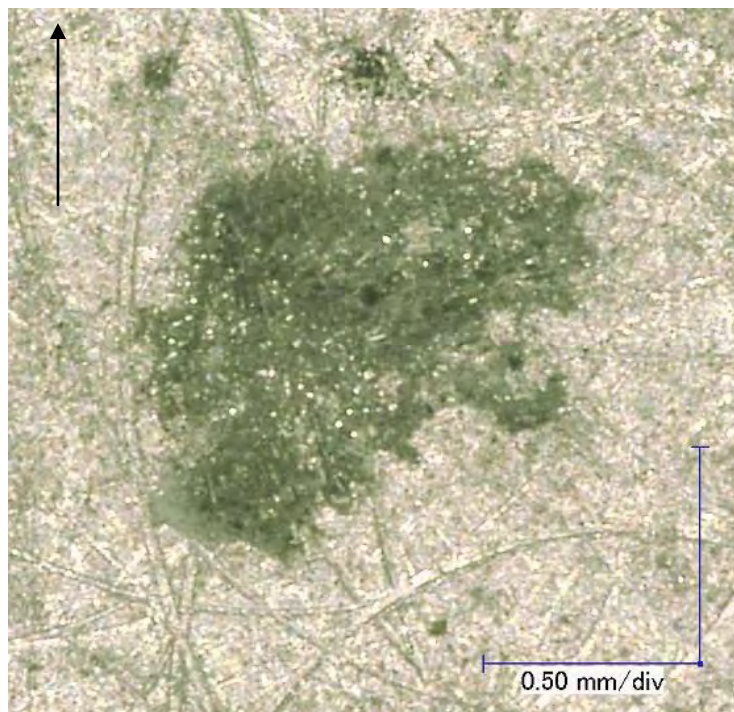
Figure 334 Close-up View of Most Significant Damage to Front of Rear Wall (black arrow indicates flight path of projectile / damage within red circle in Figure 333)

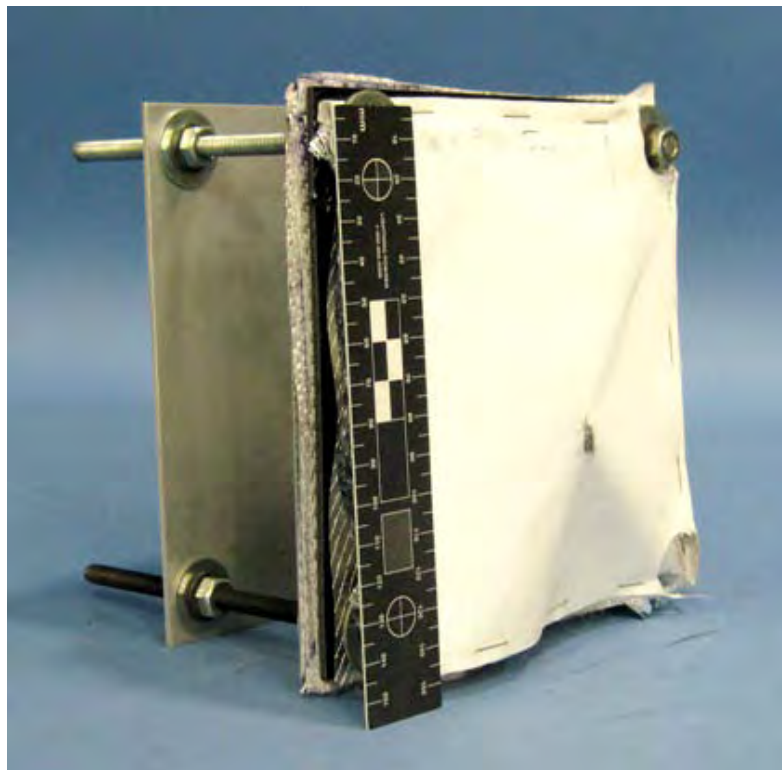
Figure 337 Overall Front Oblique View of Sample (scale in 5mm increments)

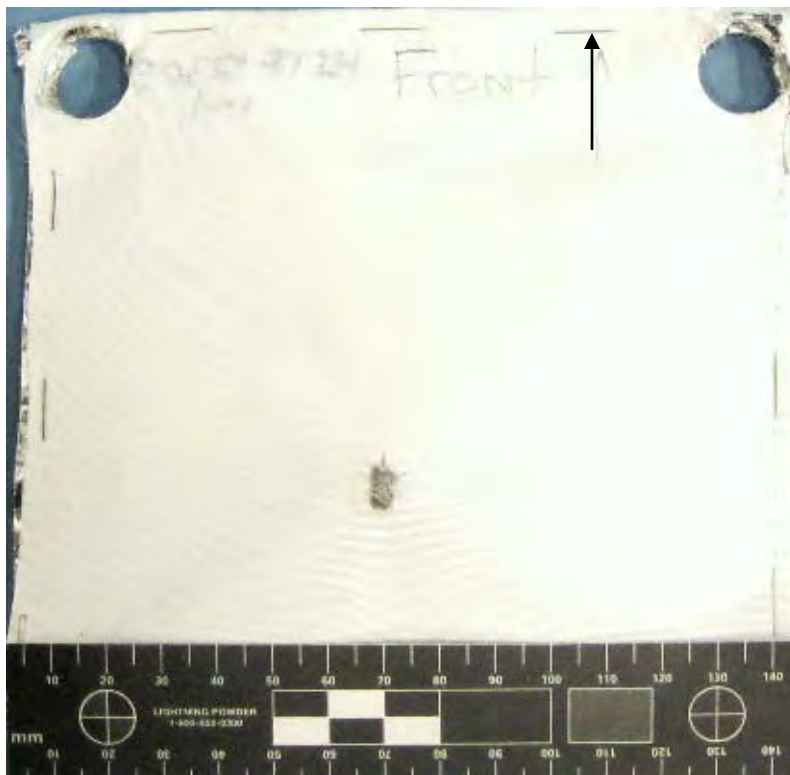
Figure 339 Overall View of Damage to Front of MLI (scale in 5mm increments / black arrow indicates flight path of projectile)

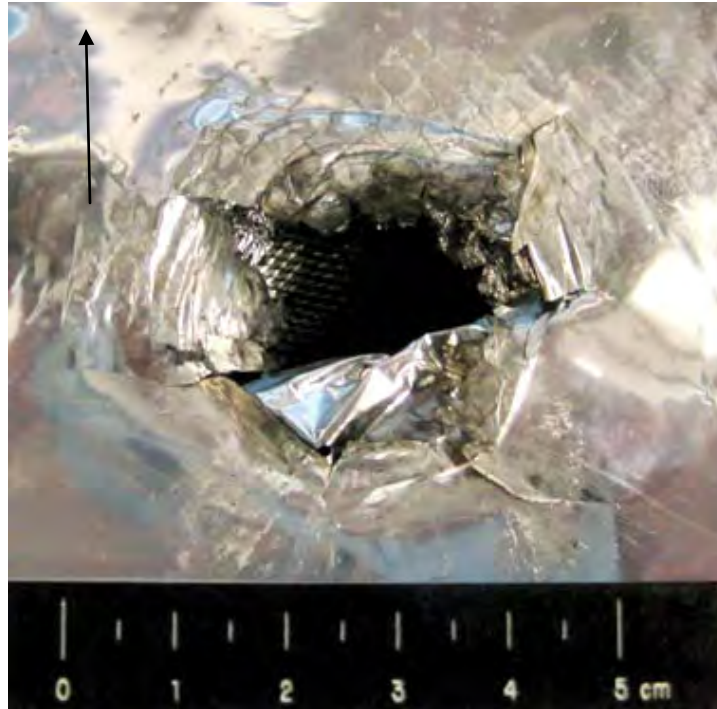
Figure 342 Close-up View of Damage to Back Side of MLI (scale in 5mm increments / black arrow indicates flight path of projectile)

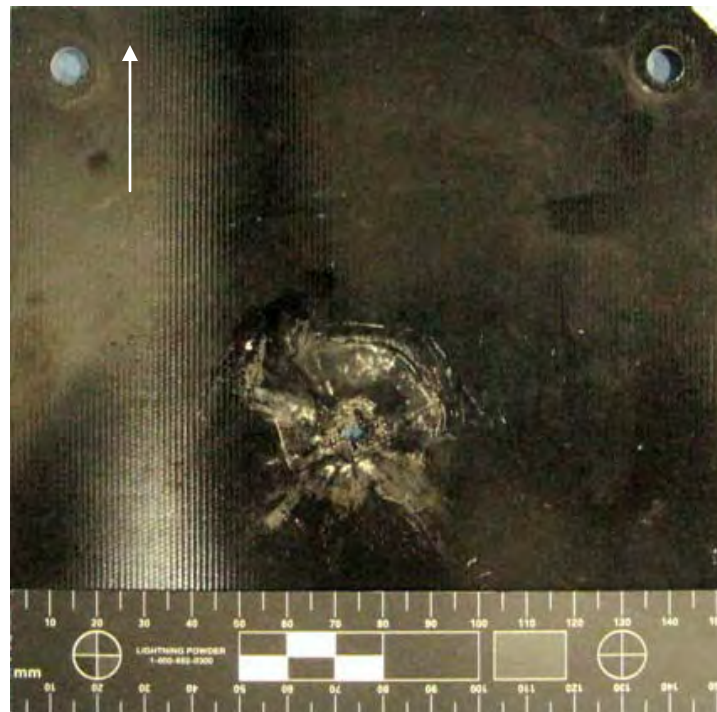
Figure 343 Overall View of Damage to Front of NP 504 Substrate (scale in 5mm increments / white arrow indicates flight path of projectile)

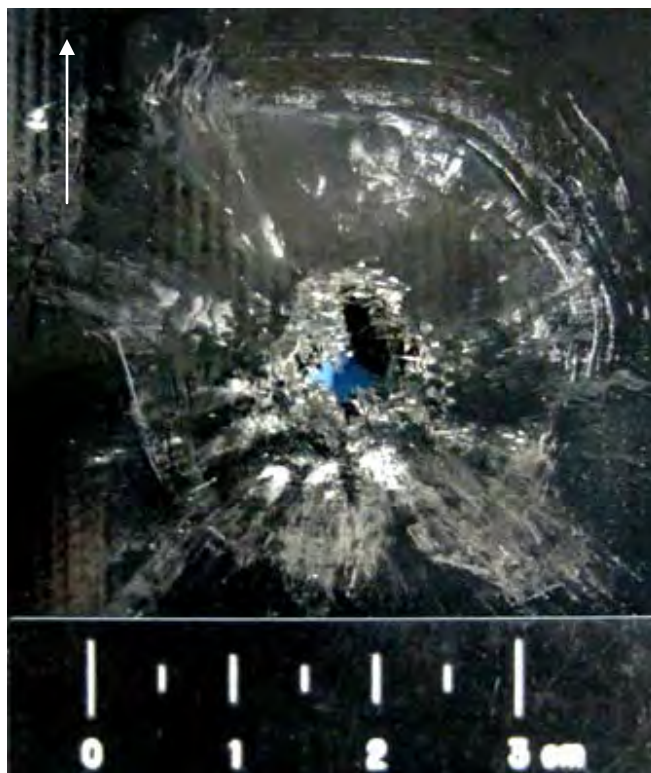
Figure 344 Close-up View of Damage to Front of NP 504 Substrate (scale in 5mm increments / white arrow indicates flight path of projectile)

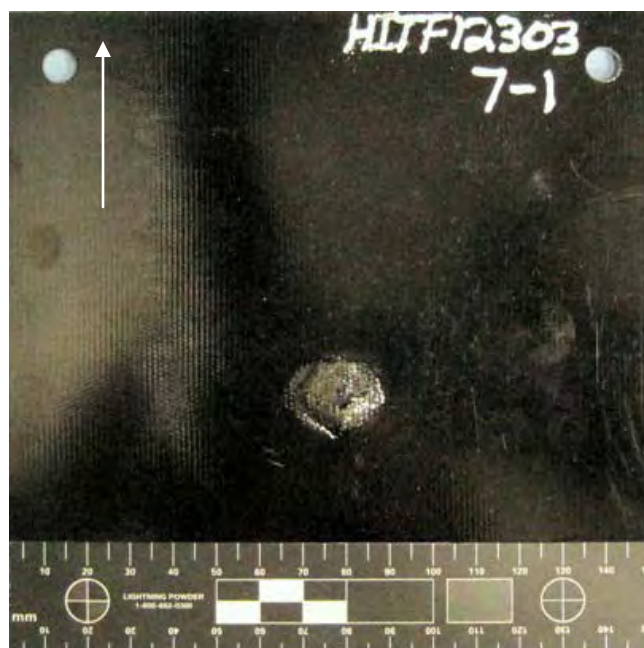
Figure 345 Overall View of Damage to Back Side of NP 504 Substrate (scale in 5mm increments / white arrow indicates flight path of projectile)

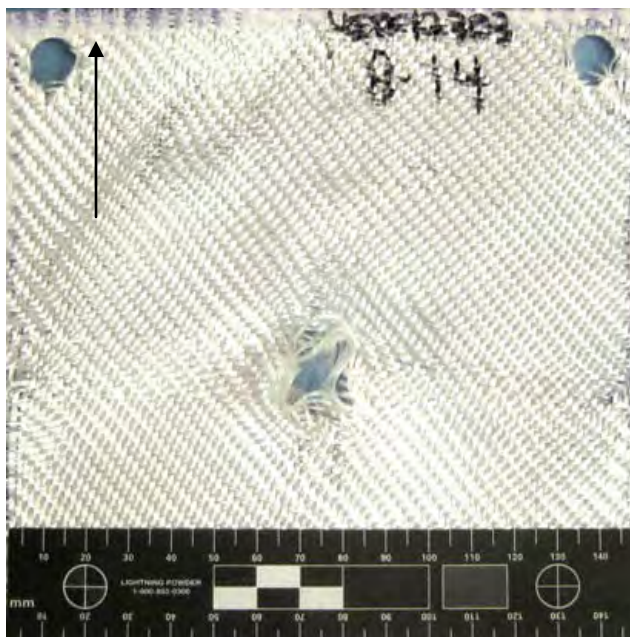
Figure 348 Overall View of Damage to Back Side of Last Fiberglass Layer (scale in 5mm increments / black arrow indicates flight path of projectile)

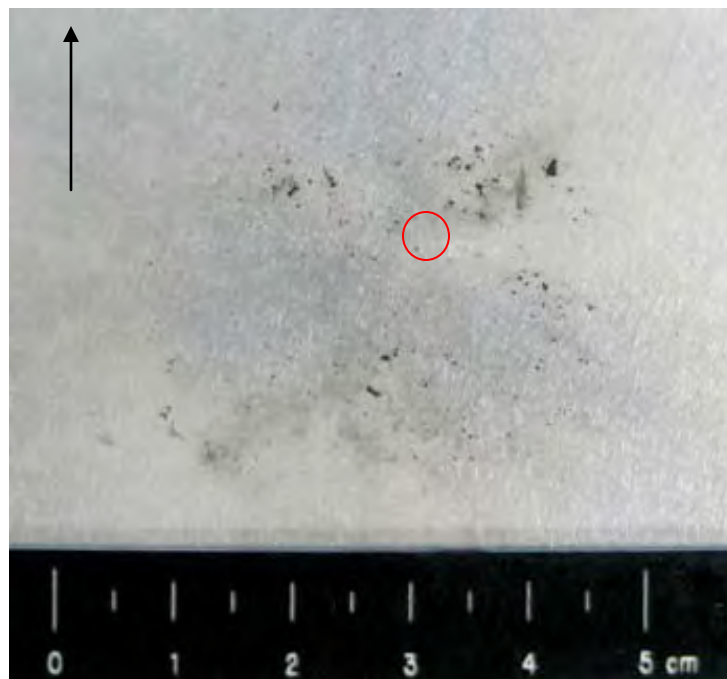
Figure 351 Close-up View of Damage to Front of Rear Wall (scale in 5mm increments / black arrow indicates flight path of projectile)

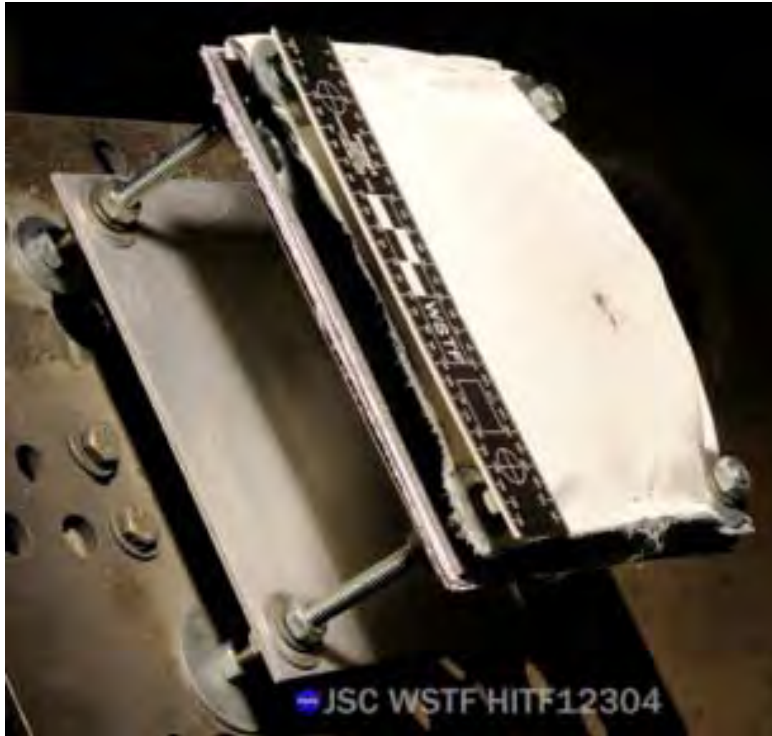
Figure 354 Overall View of Sample in the Target Tank (post-test)

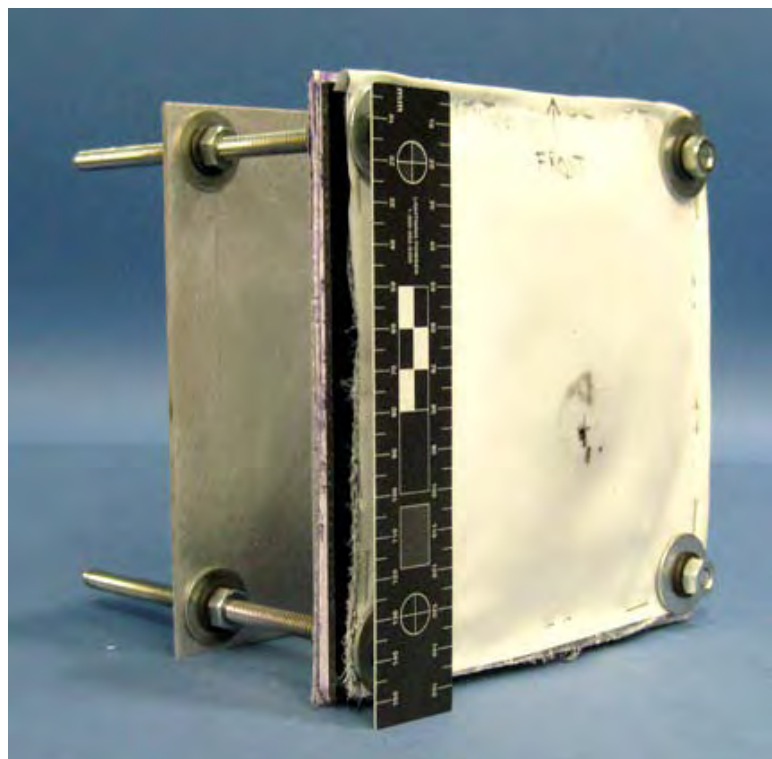
Figure 355 Overall Front Oblique View of Sample (scale in 5mm increments)

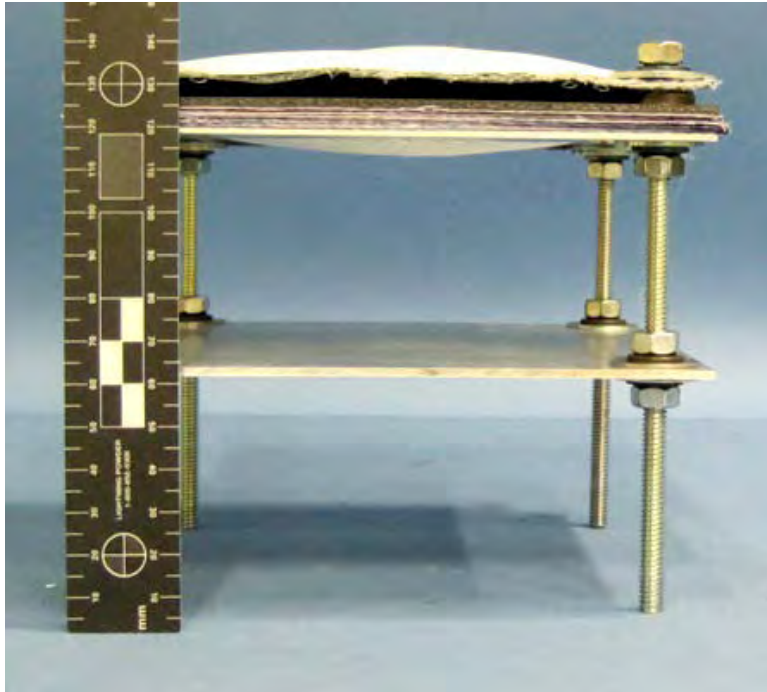
Figure 356 Overall Side View of Sample (scale in 5mm increments)

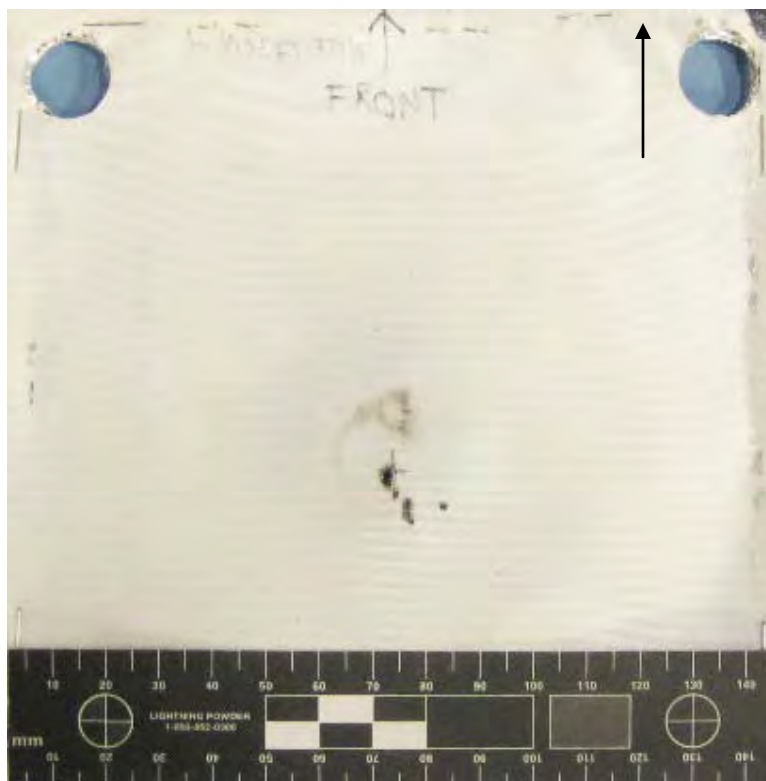
Figure 357 Overall View of Damage to Front of MLI (scale in 5mm increments / black arrow indicates flight path of projectile)

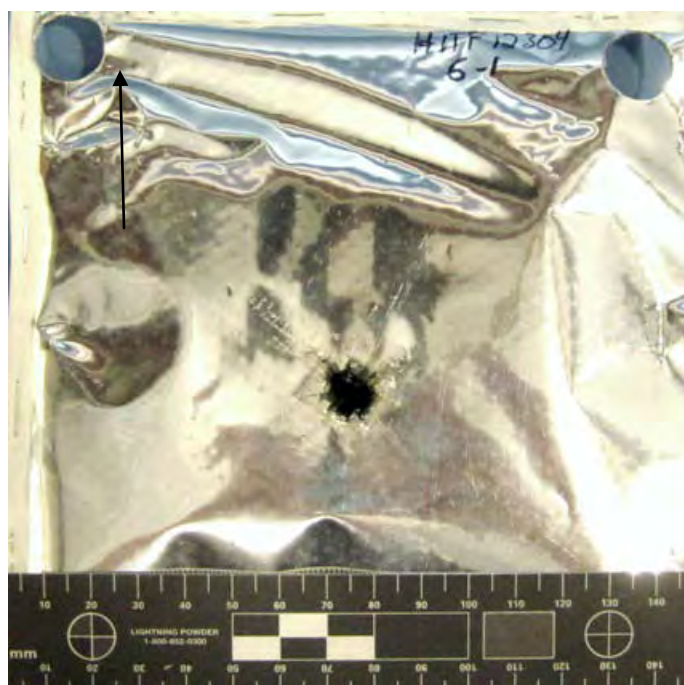
Figure 359 Overall View of Damage to Back Side of MLI (scale in 5mm increments / black arrow indicates flight path of projectile)

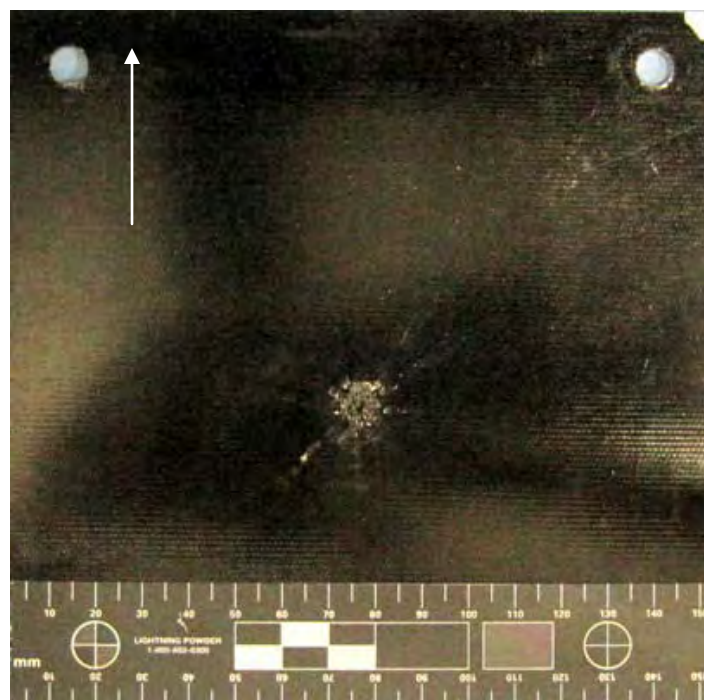
Figure 361 Overall View of Damage to Front of NP 504 Substrate (scale in 5mm increments / white arrow indicates flight path of projectile)

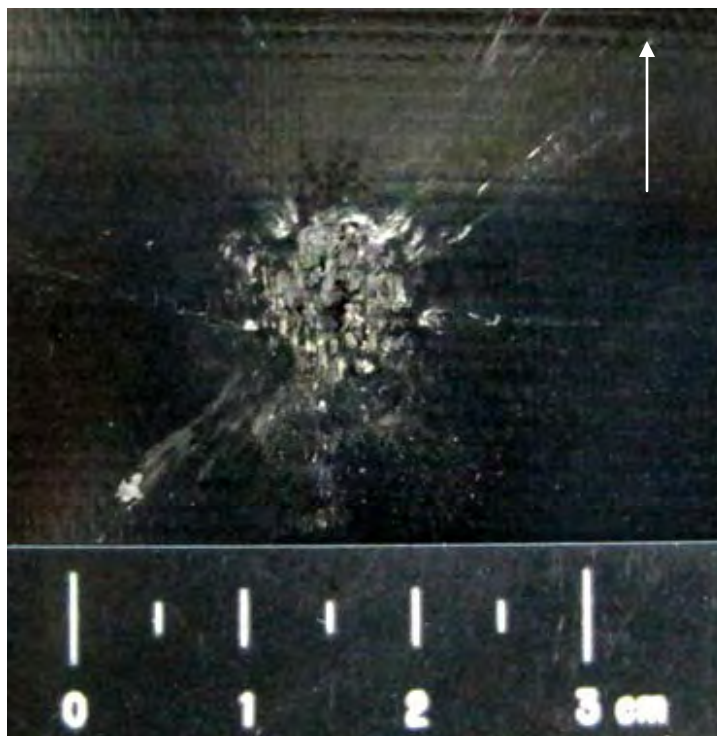
Figure 362 Close-up View of Damage to Front of NP 504 Substrate (scale in 5mm increments / white arrow indicates flight path of projectile)

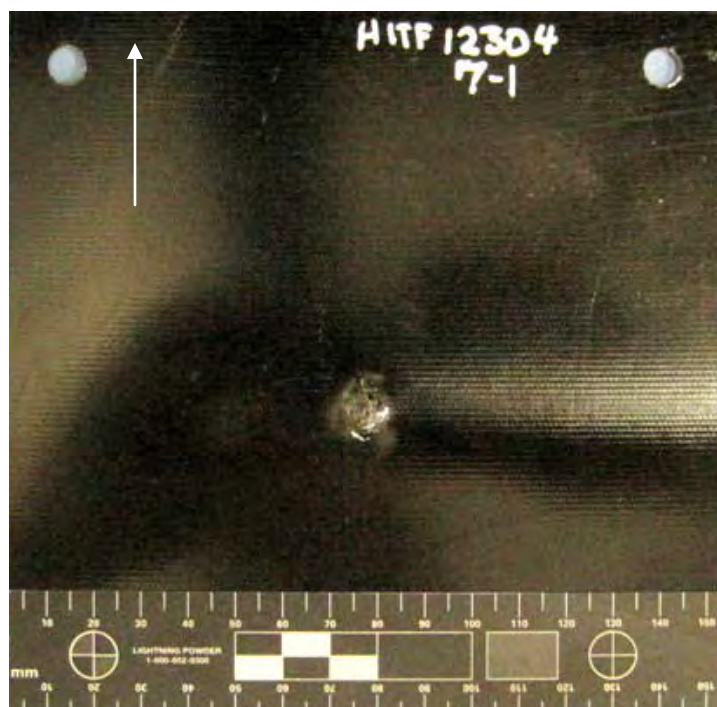
Figure 363 Overall View of Damage to Back Side of NP 504 Substrate (scale in 5mm increments / white arrow indicates flight path of projectile)

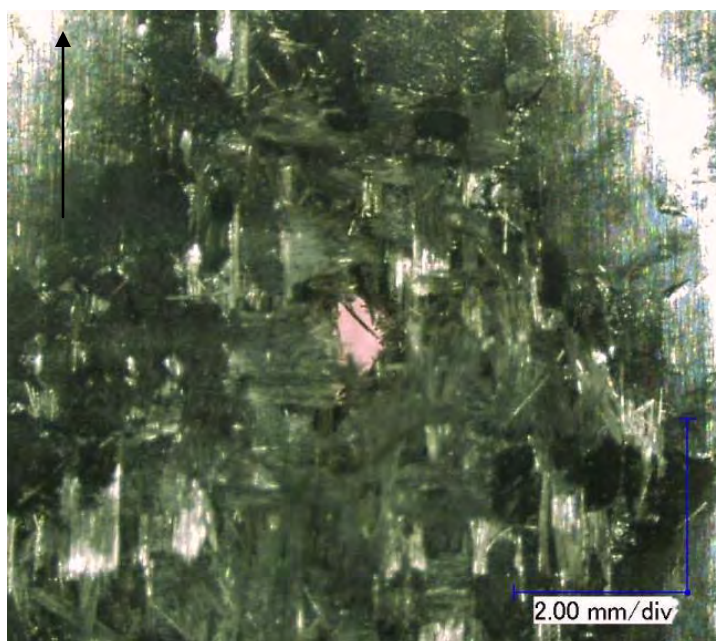
Figure 365 Close-up View of Most Significant Damage to Back Side of NP 504 Substrate (black arrow indicates flight path of projectile / damage within red circle in Figure 364)

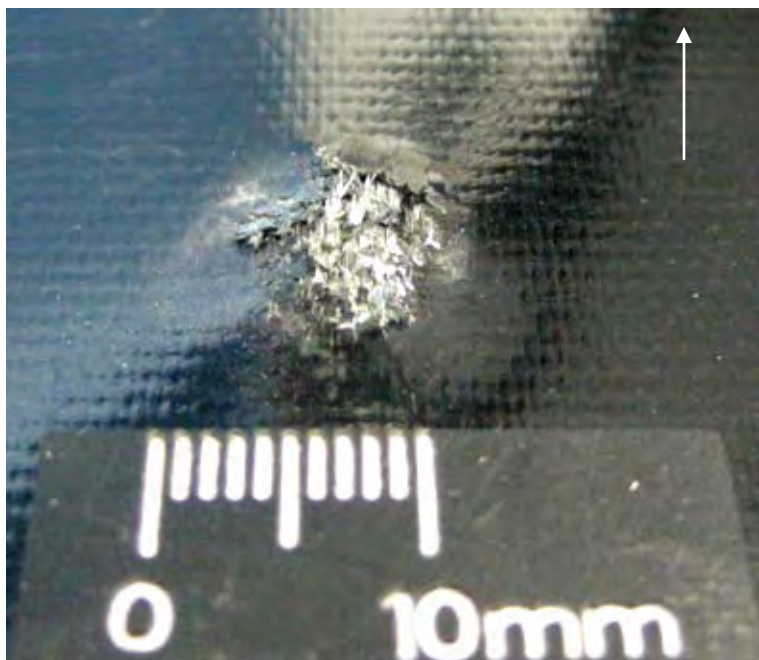
Figure 366 Close-up Oblique Side View of Damage to Back Side of NP 504 Substrate (scale in 1mm increments / white arrow indicates flight path of projectile)

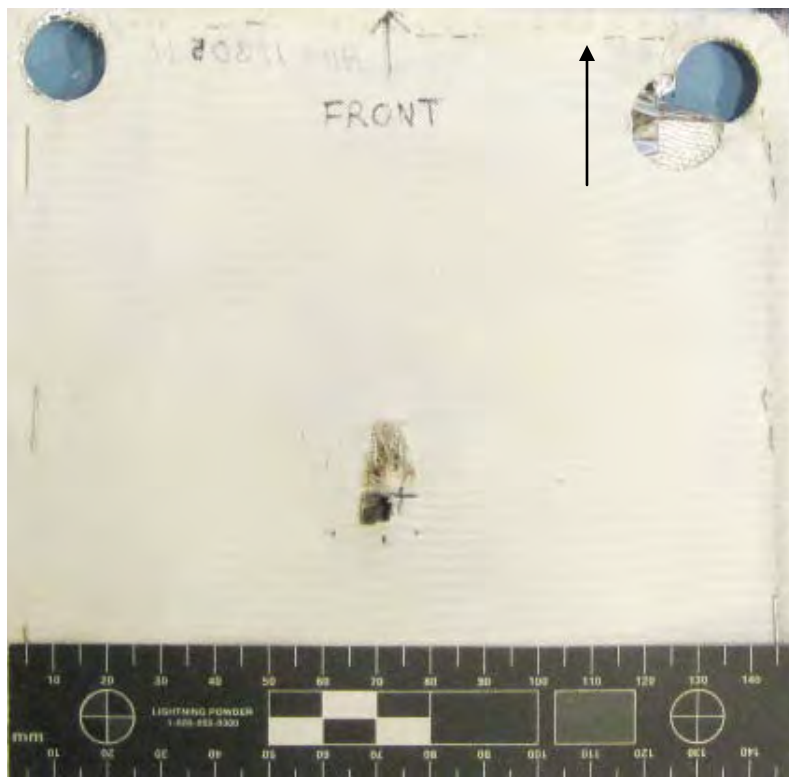
Figure 372 Overall View of Damage to Front of MLI (scale in 5mm increments / black arrow indicates flight path of projectile)

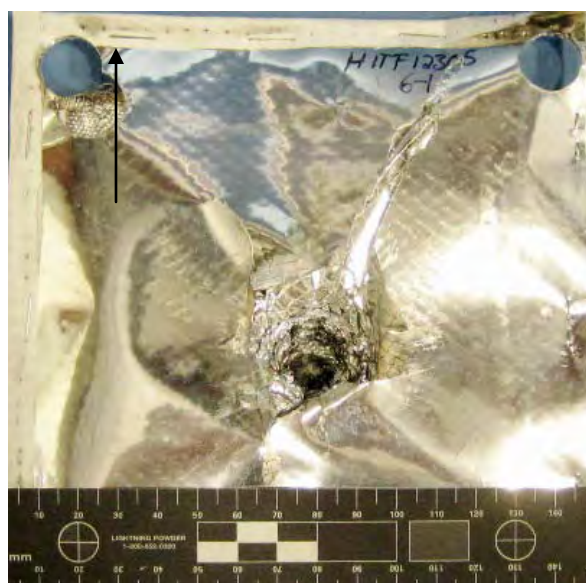
Figure 374 Overall View of Damage to Back Side of MLI (scale in 5mm increments / black arrow indicates flight path of projectile)

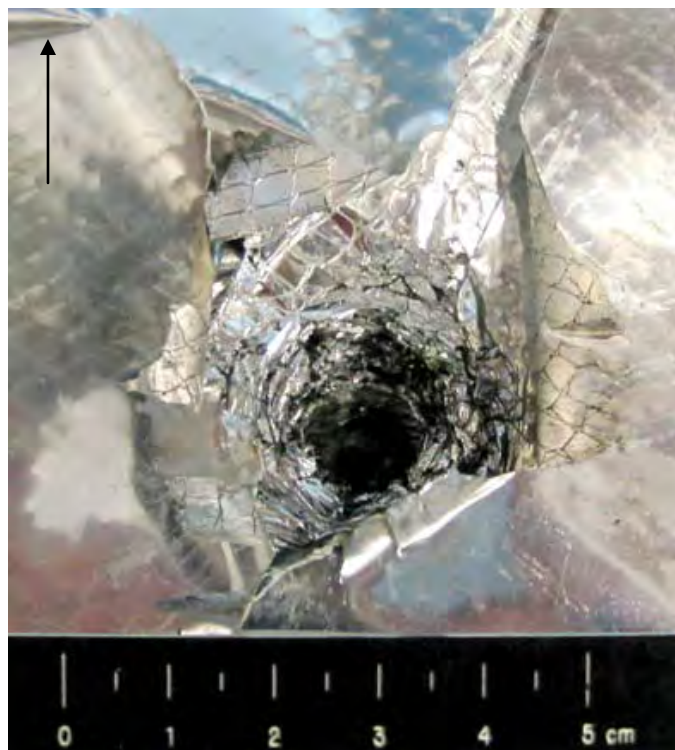
Figure 375 Close-up View of Damage to Back Side of MLI (scale in 5mm increments / black arrow indicates flight path of projectile)

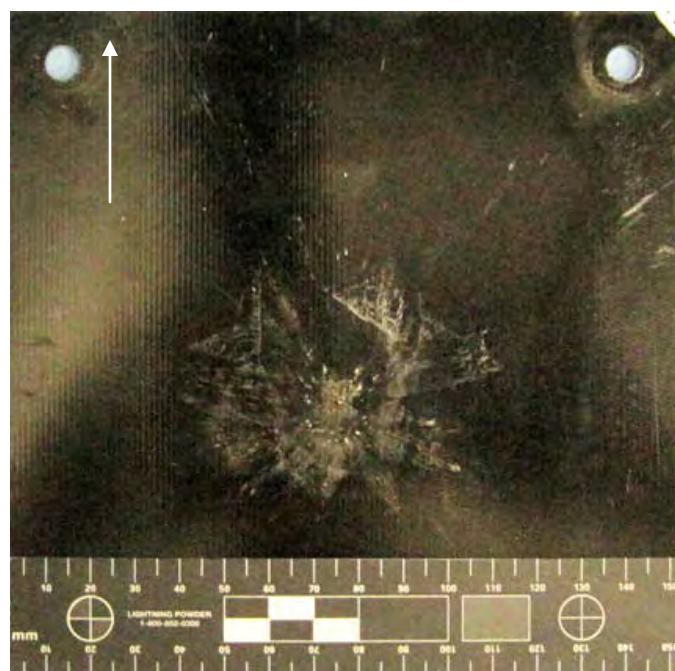
Figure 376 Overall View of Damage to Front of NP 504 Substrate (scale in 5mm increments / white arrow indicates flight path of projectile)

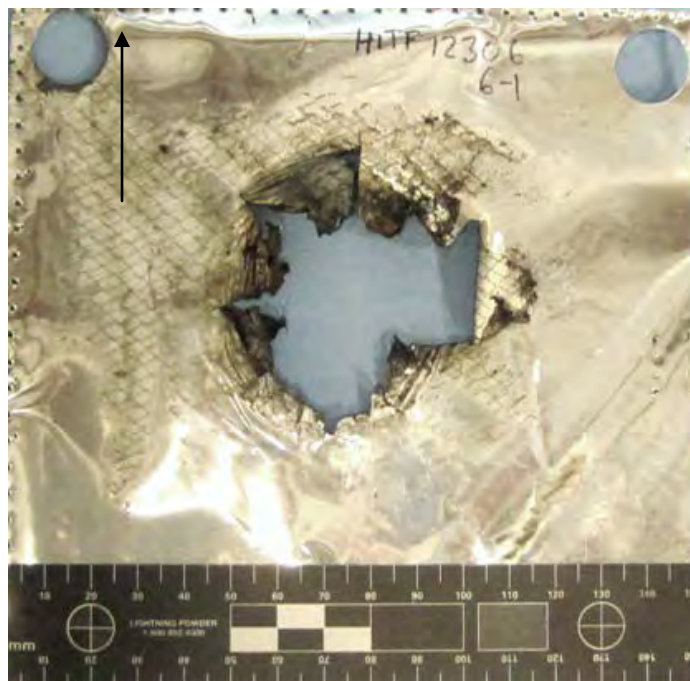
Figure 390 Overall View of Exit Damage to Last Layer of MLI Blanket (scale in 5mm increments / black arrow indicates flight path of projectile)

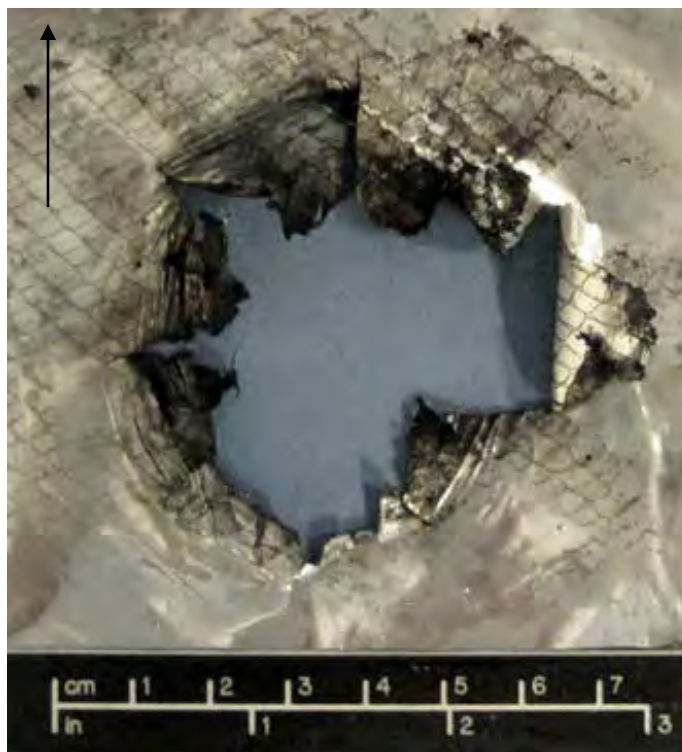
Figure 391 Close-up View of Exit Damage to Last Layer of MLI Blanket (scale in 1cm increments / black arrow indicates flight path of projectile)

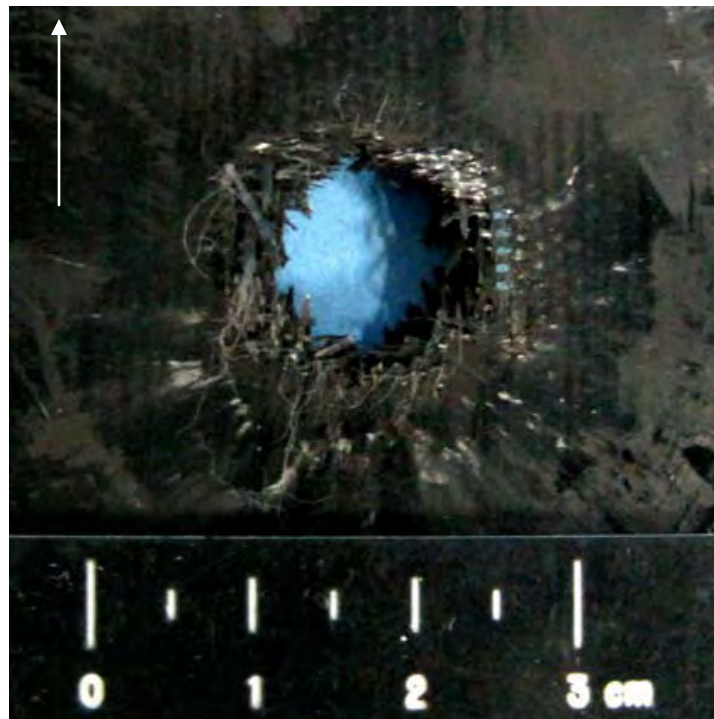
Figure 393 Close-up View of Damage to Front of NP 504 Substrate (scale in 5mm increments / white arrow indicates flight path of projectile)

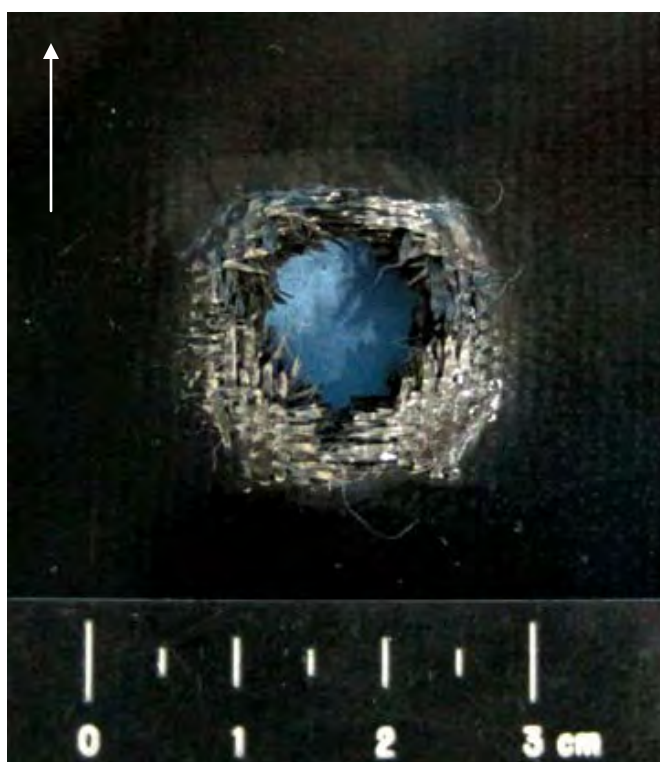
Figure 395 Close-up View of Damage to Back Side of NP 504 Substrate (scale in 1mm increments / white arrow indicates flight path of projectile)

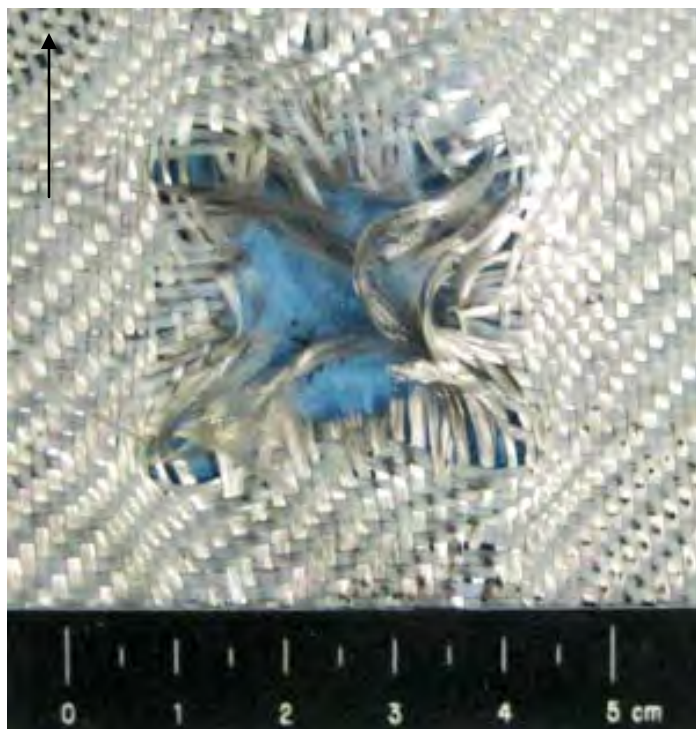
Figure 398 Close-up View of Damage to Back Side of Last Fiberglass Layer (scale in 5mm increments / black arrow indicates flight path of projectile)

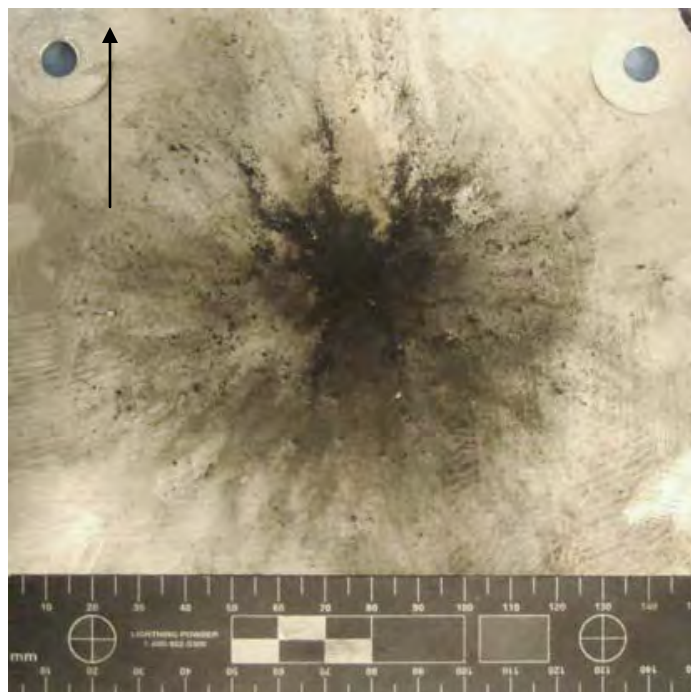
Figure 399 Overall View of Damage to Front of Rear Wall (scale in 5mm increments / black arrow indicates flight path of projectile / uncleaned)

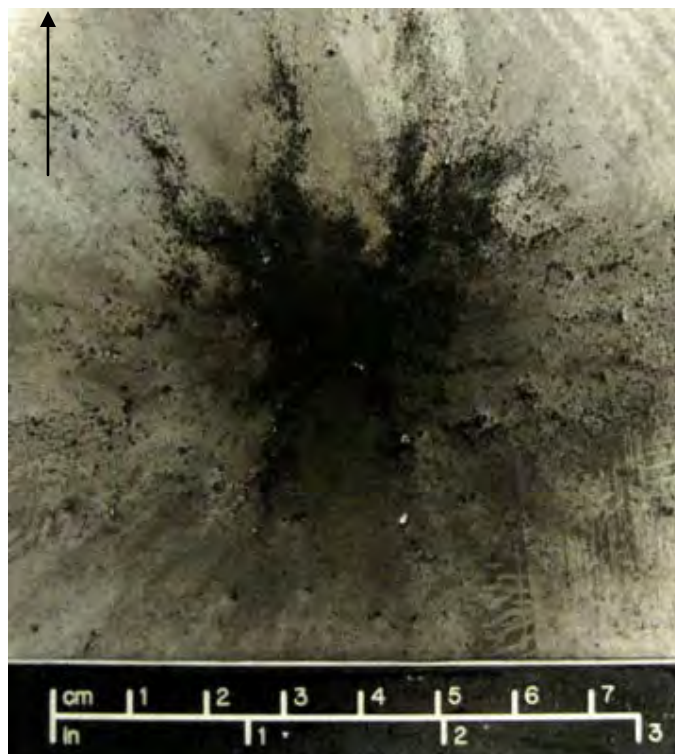
Figure 400 Close-up View of Damage to Front of Rear Wall (scale in 1cm increments / black arrow indicates flight path of projectile / uncleaned)

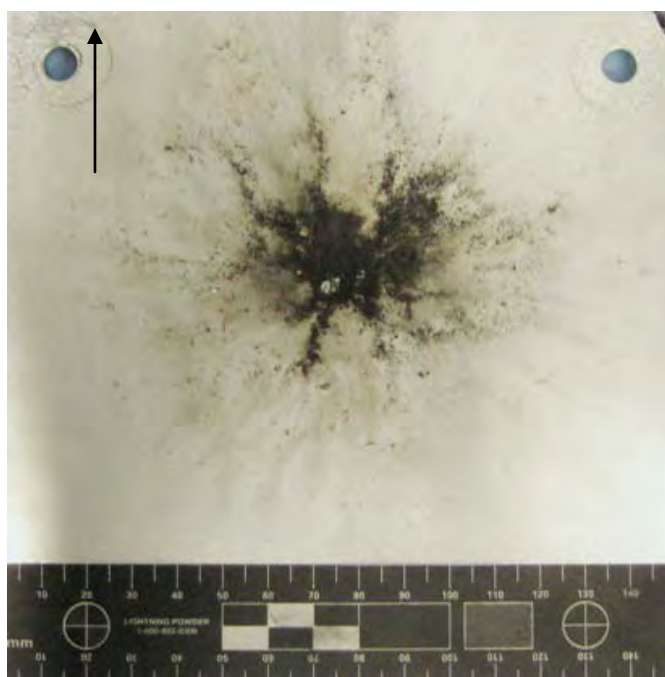
Figure 401 Overall View of Damage to Front of Rear Wall (scale in 5mm increments / black arrow indicates flight path of projectile / cleaned)

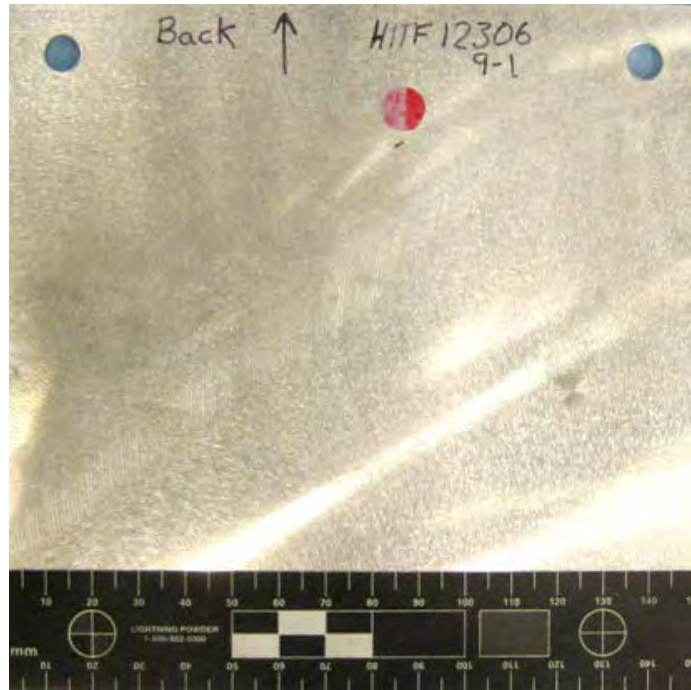
Figure 404 Overall View of Damage on Back Side of Rear Wall (scale in 5mm increments / black arrow indicates flight path of projectile)
