International Space Station (ISS) Soyuz Vehicle Descent Module Evaluation of Thermal Protection System (TPS) Penetration Characteristics

Hypervelocity Impact Technology Group

February 2013

**International Space Station (ISS) Soyuz Vehicle
Descent Module Evaluation of Thermal Protection
System (TPS) Penetration Characteristics**

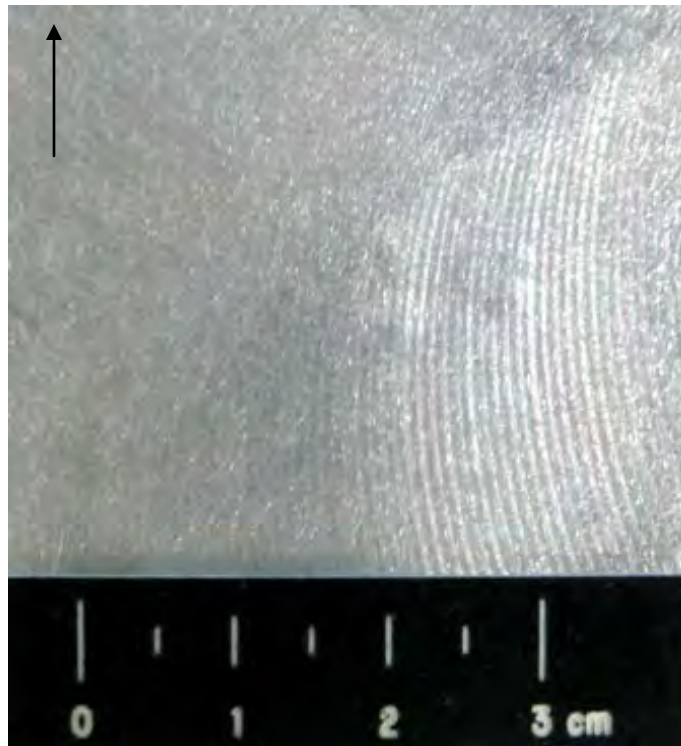
Figure 405 Close-up View of Damage on Back Side of Rear Wall (scale in 5mm increments / black arrow indicates flight path of projectile)

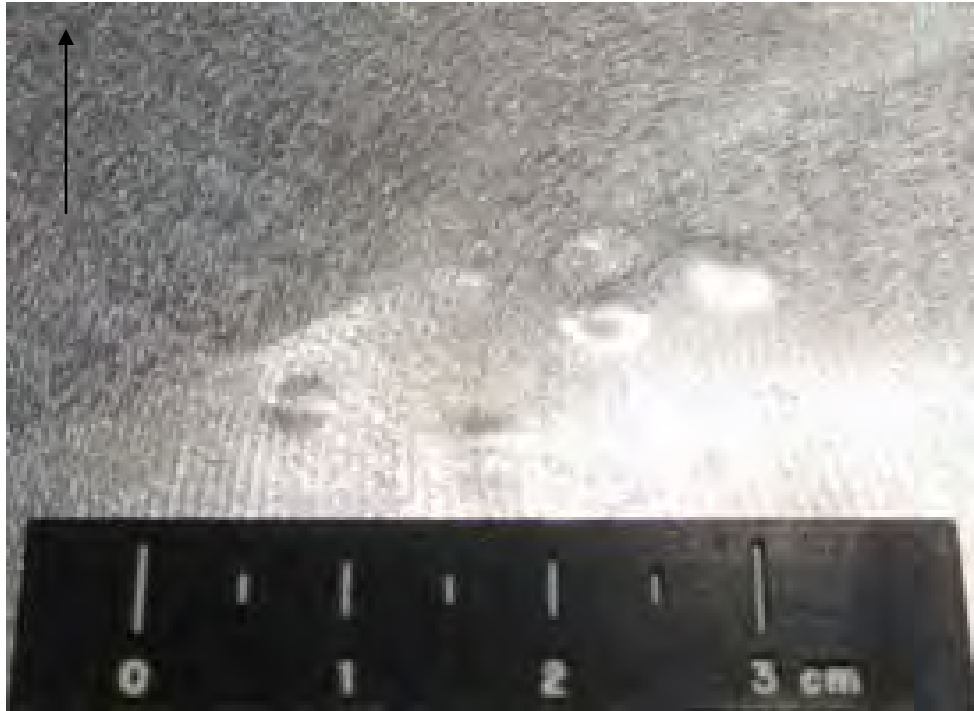
Figure 406 Close-up Oblique Side View of Damage on Back Side of Rear Wall (scale in 5mm increments / black arrow indicates flight path of projectile)

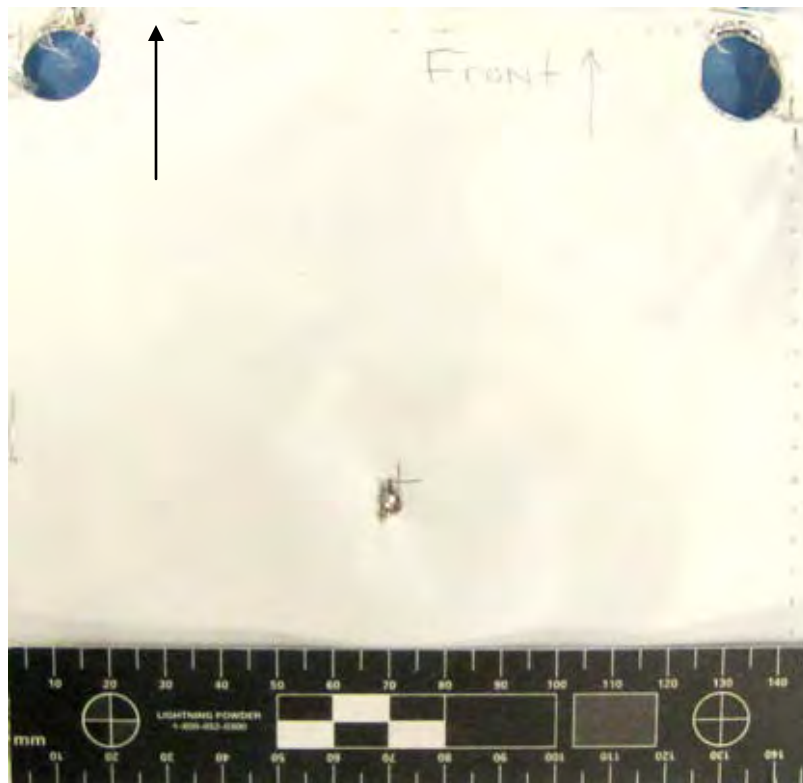
Figure 410 Overall View of Damage to Front of MLI (black arrow indicates flight path of projectile / scale in 5mm increments)

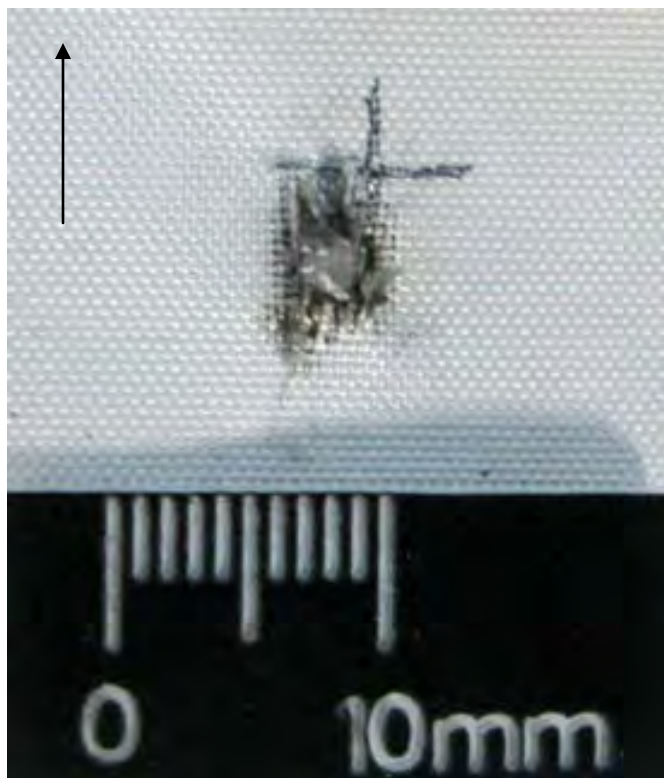
Figure 411 Close-up View of Damage to Front of MLI (scale in 1mm increments / black arrow indicates flight path of projectile)

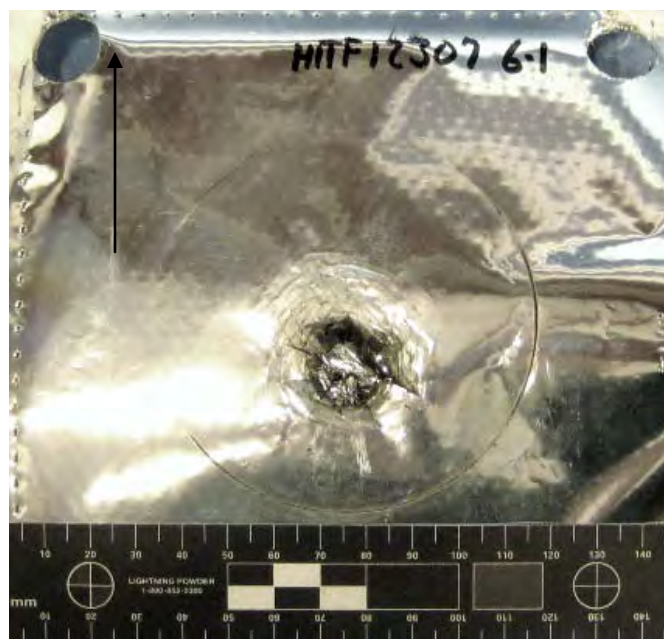
Figure 412 Overall View of Damage to Back Side of MLI (scale in 5mm increments / black arrow indicates flight path of projectile)

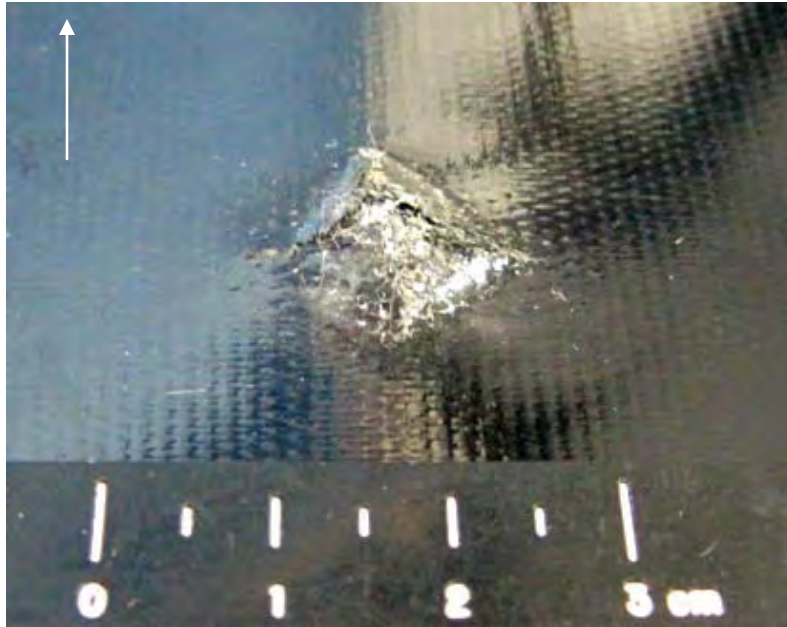
Figure 419 Close-up Oblique Side View of Damage to Back Side of NP 504 Substrate (scale in 5mm increments / white arrow indicates flight path of projectile)

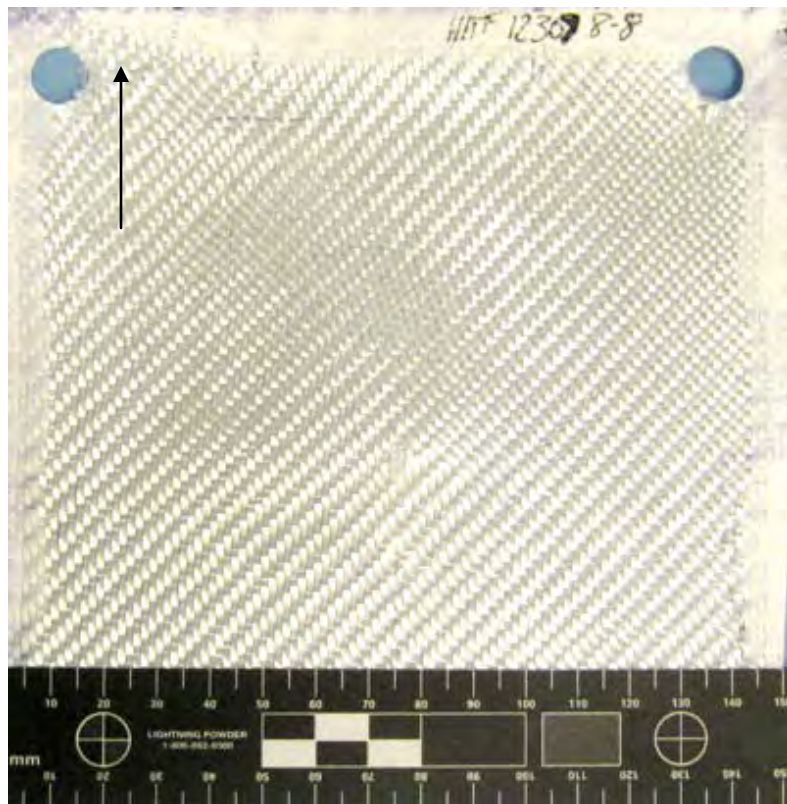
Figure 420 Overall View of Damage to Back Side of 8th Fiberglass Layer (scale in 5mm increments / black arrow indicates flight path of projectile)

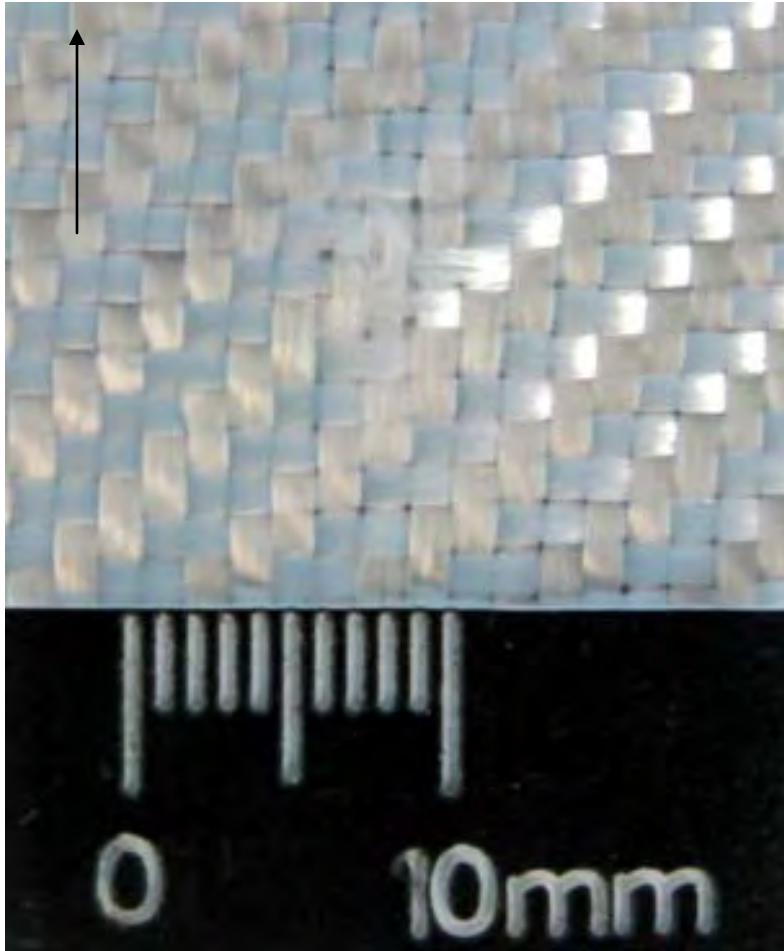
Figure 421 Close-up View of Damage to Back Side of 8th Fiberglass Layer (scale in 5mm increments / black arrow indicates flight path of projectile)

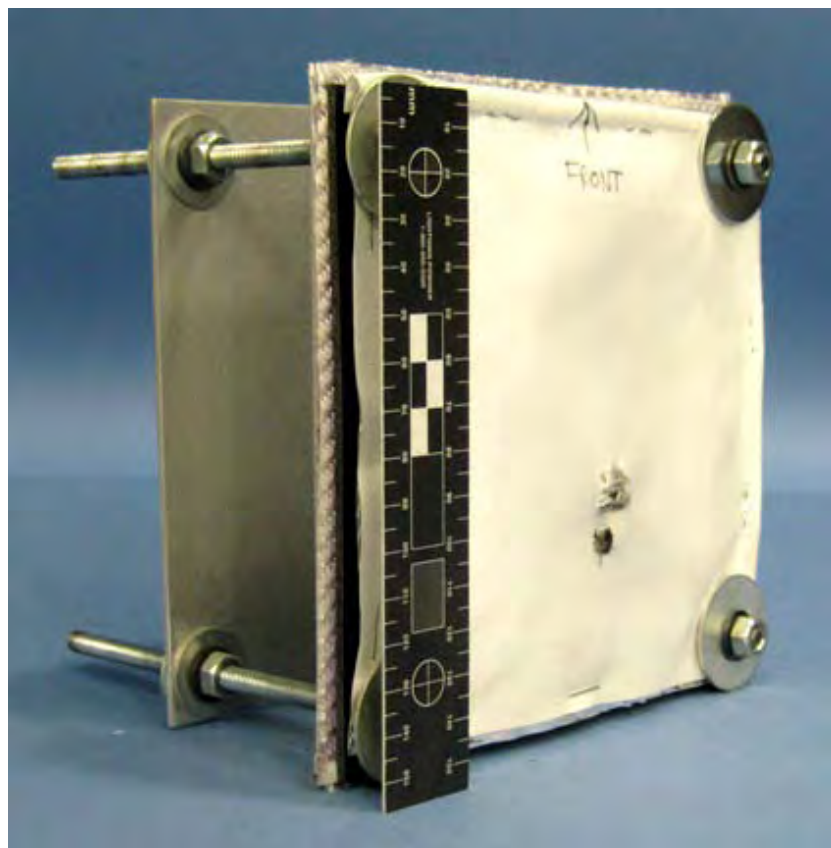
Figure 423 Overall Front Oblique View of Sample (scale in 5mm increments)

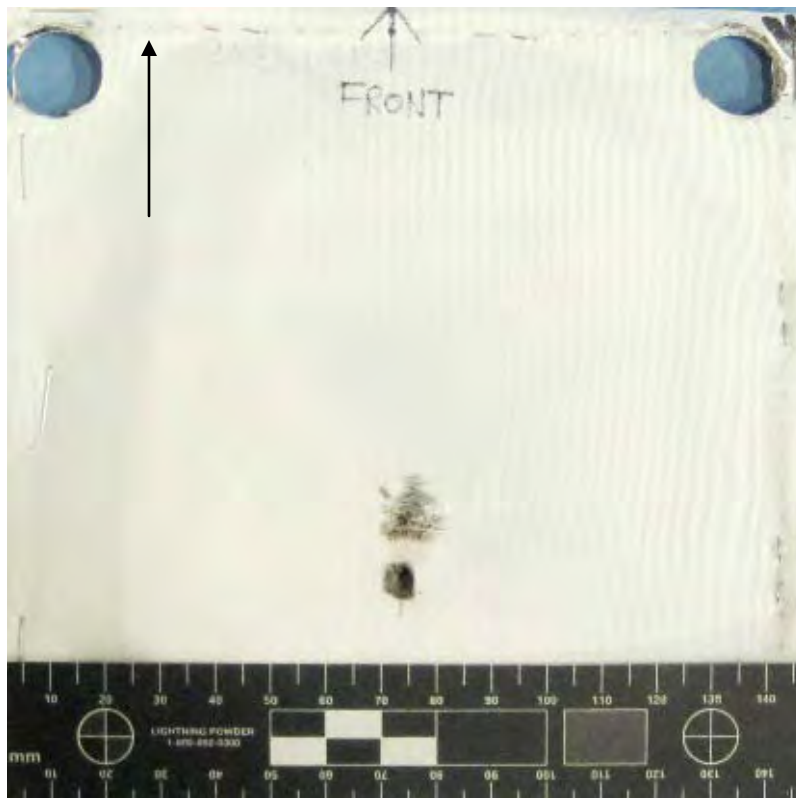
Figure 425 Overall View of Damage to Front of MLI (scale in 5mm increments / black arrow indicates flight path of projectile)

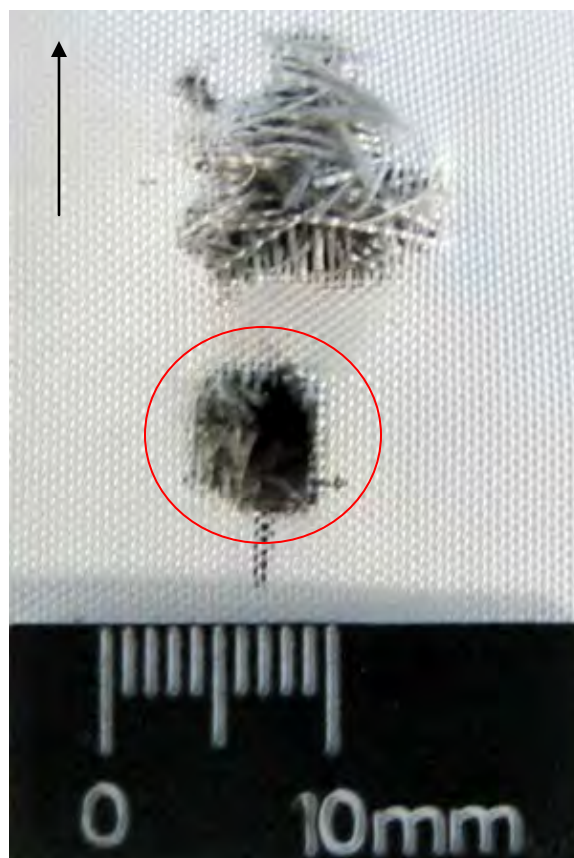
Figure 426 Close-up View of Damage to Front of MLI (scale in 1mm increments / black arrow indicates flight path of projectile / projectile impact within red circle)

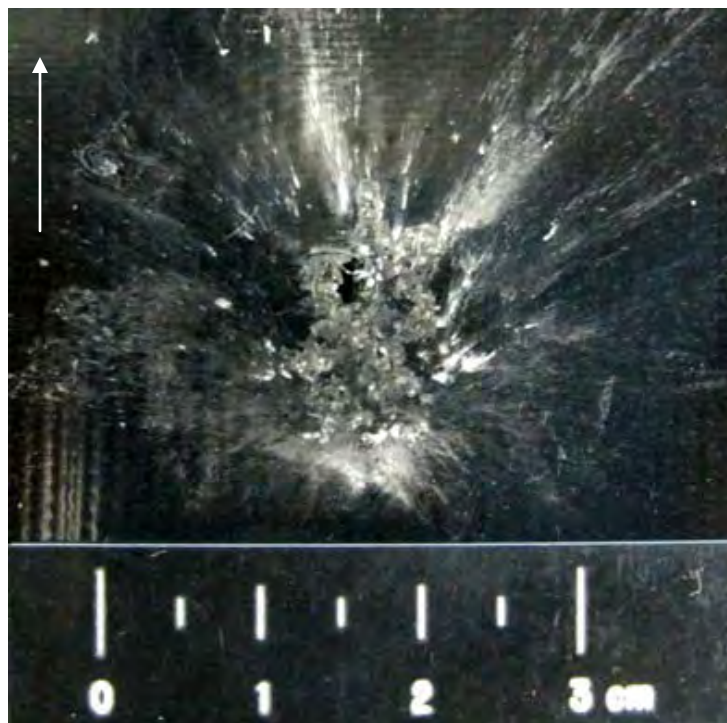
Figure 430 Close-up View of Damage to Front of NP 504 Substrate (scale in 5mm increments / white arrow indicates flight path of projectile)

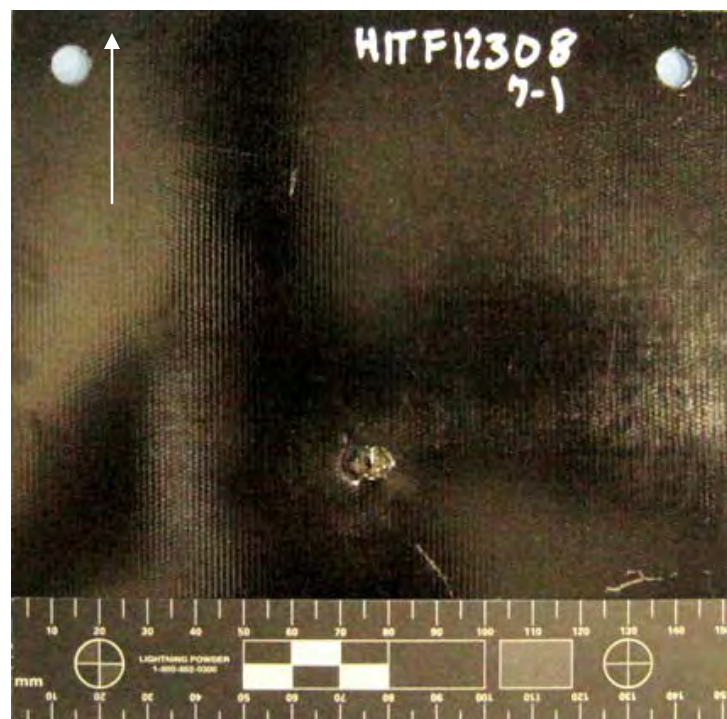
Figure 431 Overall View of Damage to Back Side of NP 504 Substrate (scale in 5mm increments / white arrow indicates flight path of projectile)

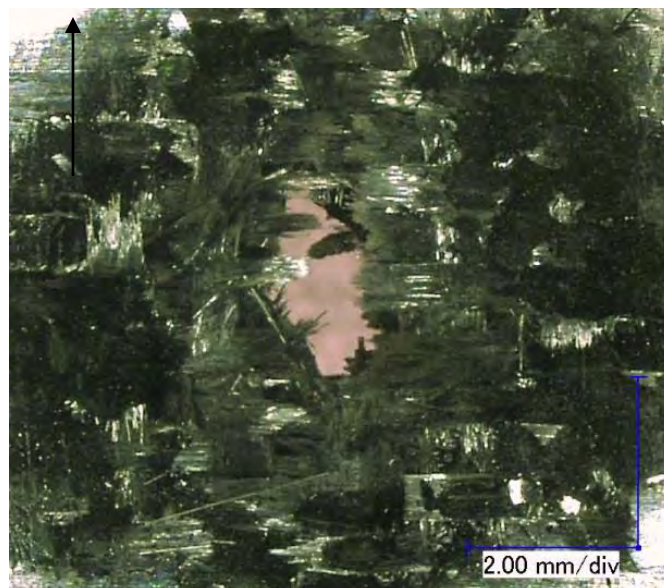
Figure 433 Close-up View of Most Significant Damage to Back Side of NP 504 Substrate (black arrow indicates flight path of projectile / damage within red circle in Figure 247)

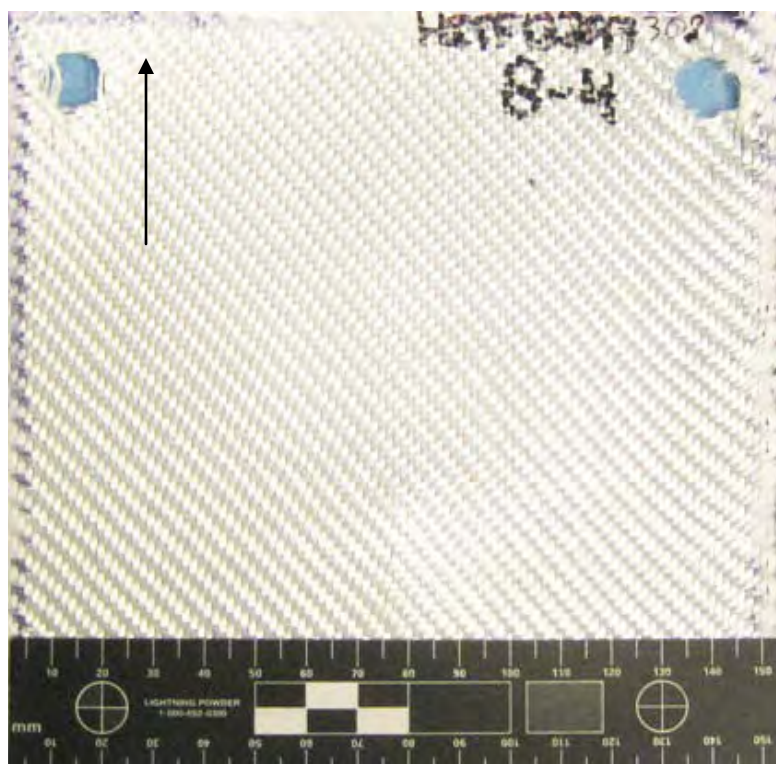
Figure 435 Overall View of Damage to Back Side of 4th Fiberglass Layer (scale in 5mm increments / black arrow indicates flight path of projectile)

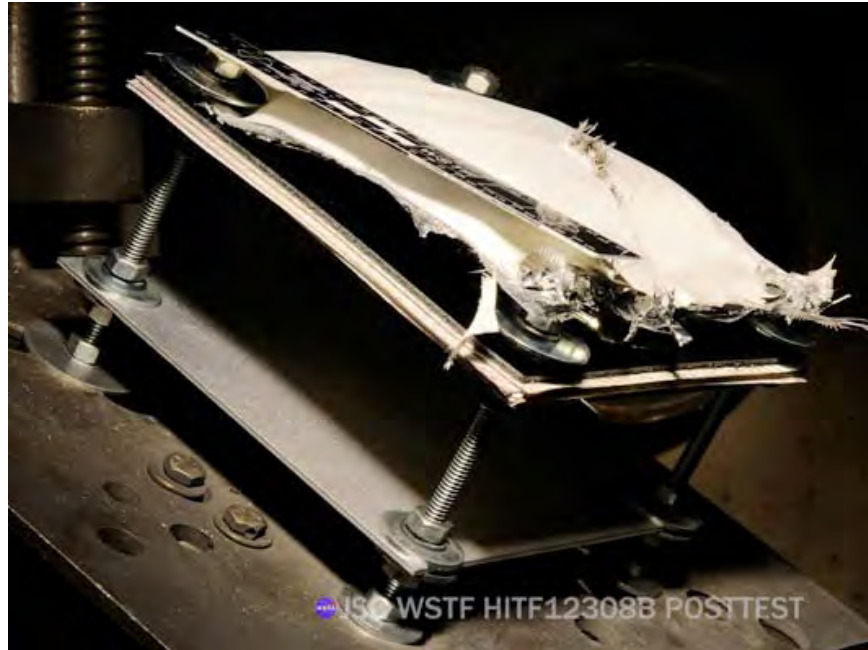
Figure 437 Overall View of Sample in the Target Tank (post-test)

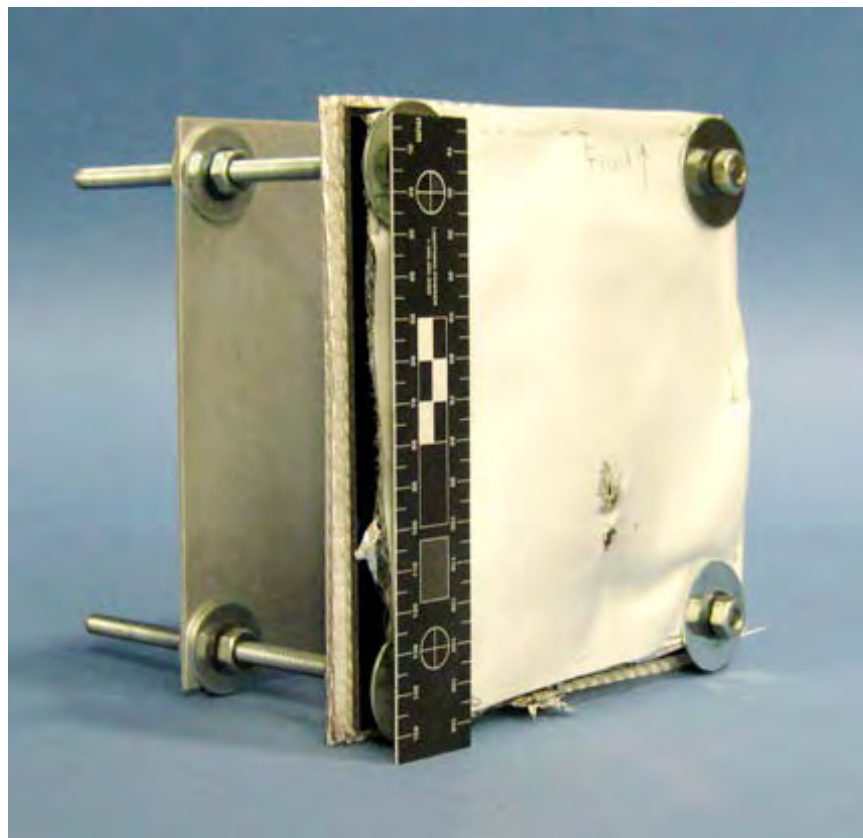
Figure 438 Overall Front Oblique View of Sample (scale in 5mm increments)

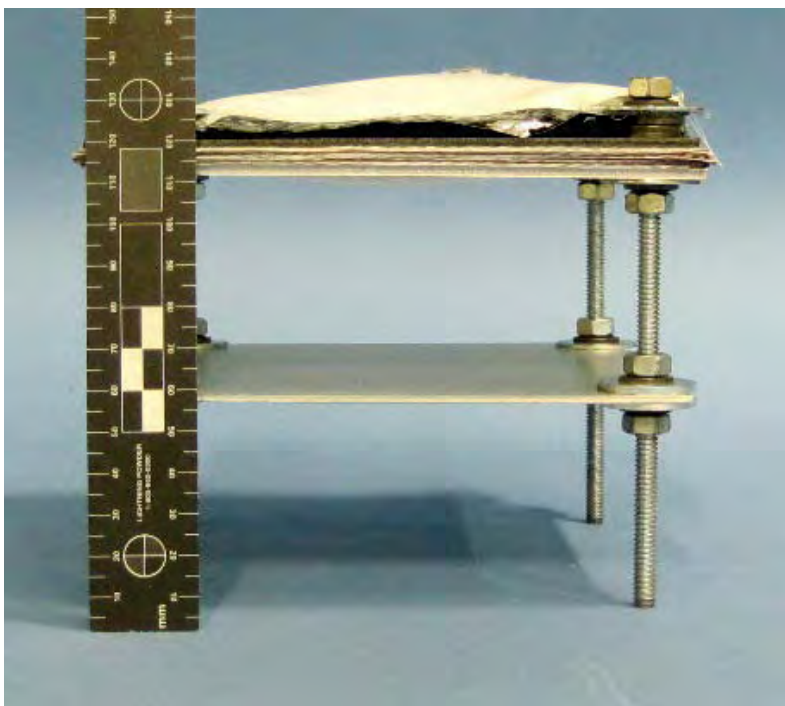
Figure 439 Overall Side View of Sample (scale in 5mm increments)

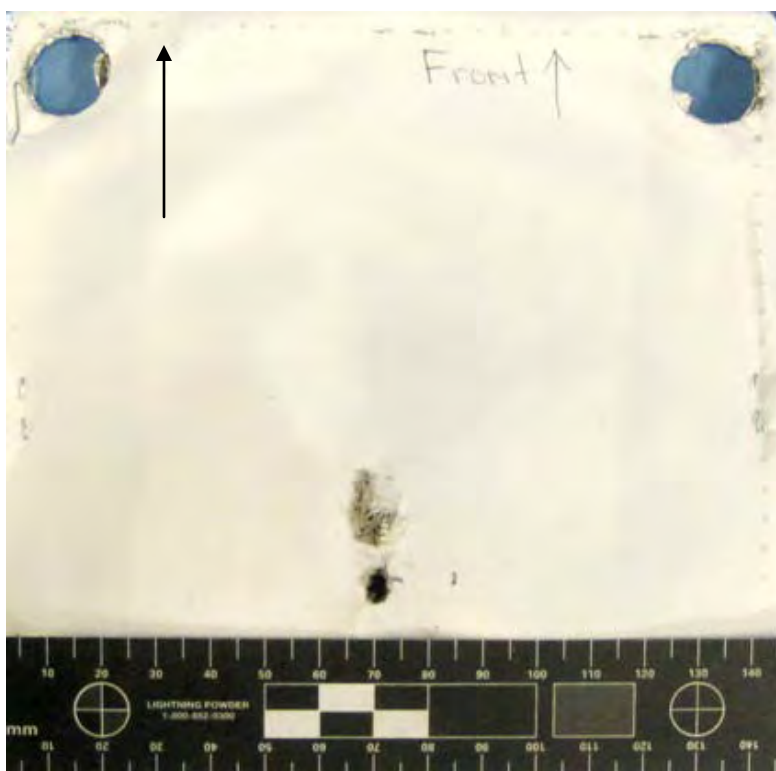
Figure 440 Overall View of Damage to Front of MLI (black arrow indicates flight path of projectile / scale in 5mm increments)

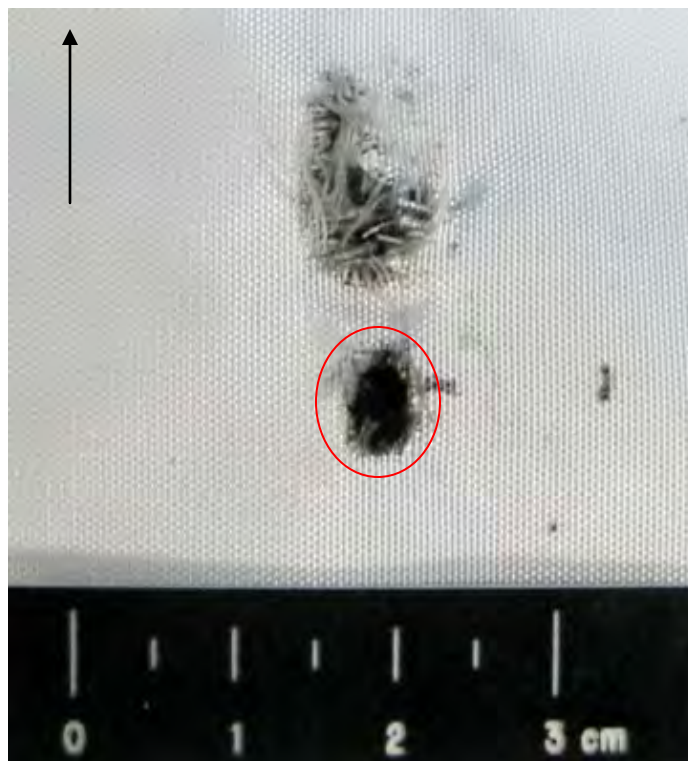
Figure 441 Close-up View of Damage to Front of MLI (scale in 5mm increments / black arrow indicates flight path of projectile / projectile impacted within red circle)

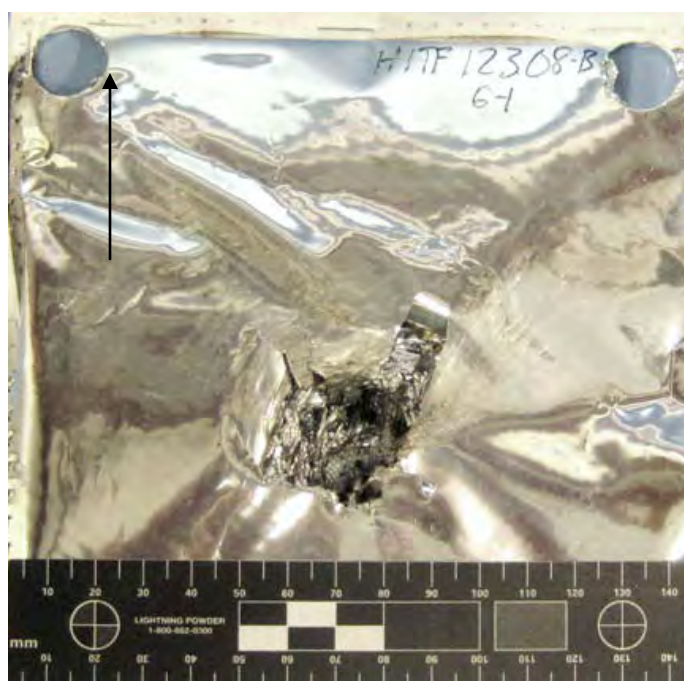
Figure 442 Overall View of Damage to Back Side of MLI (scale in 5mm increments / black arrow indicates flight path of projectile)

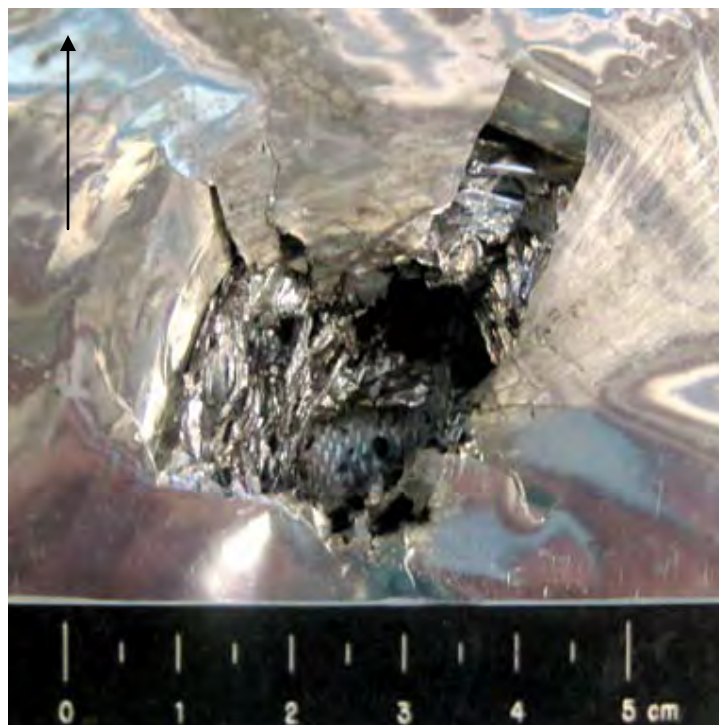
Figure 443 Close-up View of Damage to Back Side of MLI (scale in 5mm increments / black arrow indicates flight path of projectile)

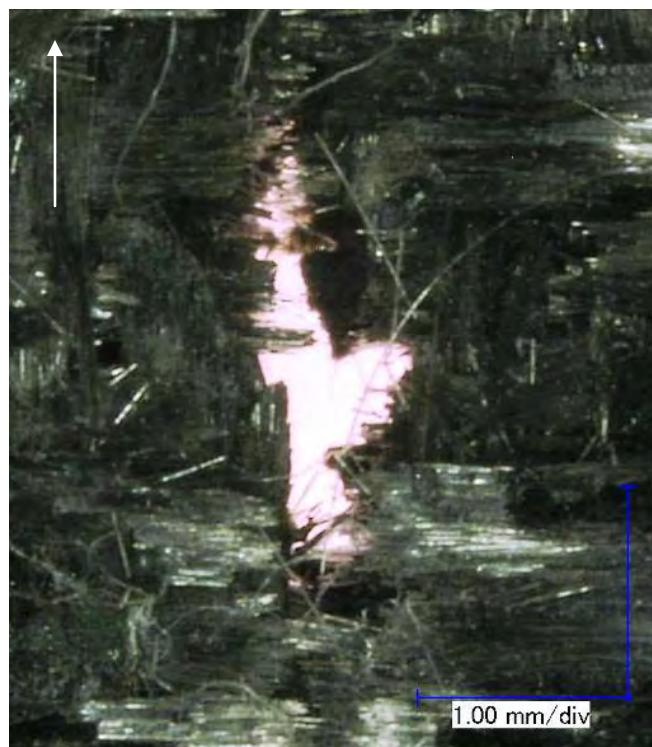
Figure 448 Close-up View of Most Significant Damage to Back Side of NP 504 Substrate (black arrow indicates flight path of projectile / damage within red circle in Figure 472)

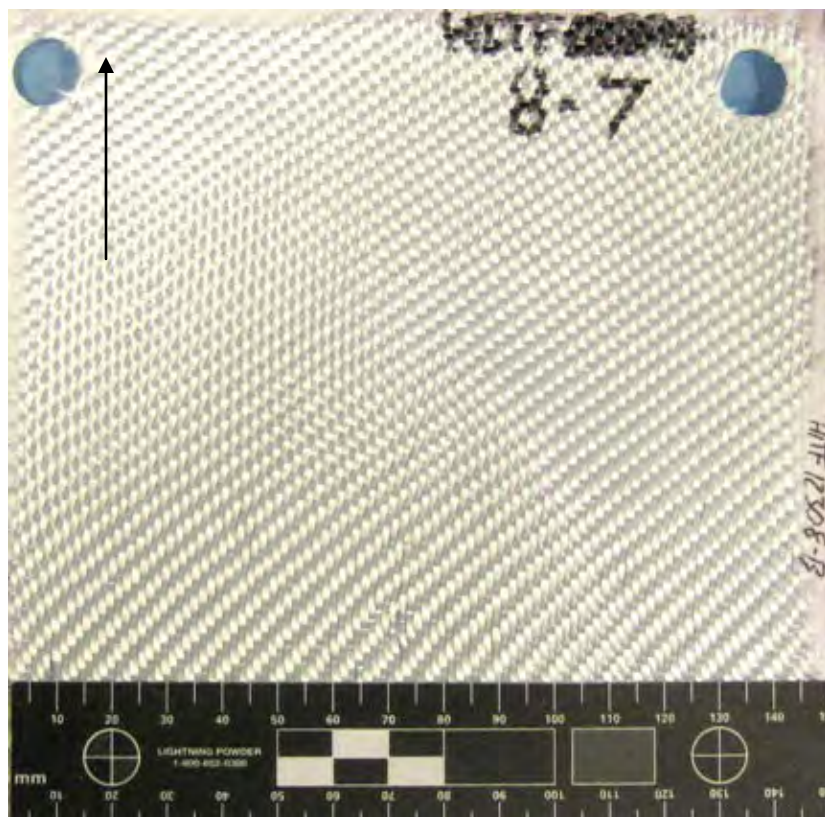
Figure 450 Overall View of Damage to Back Side of Last Fiberglass Layer (scale in 5mm increments / black arrow indicates flight path of projectile)

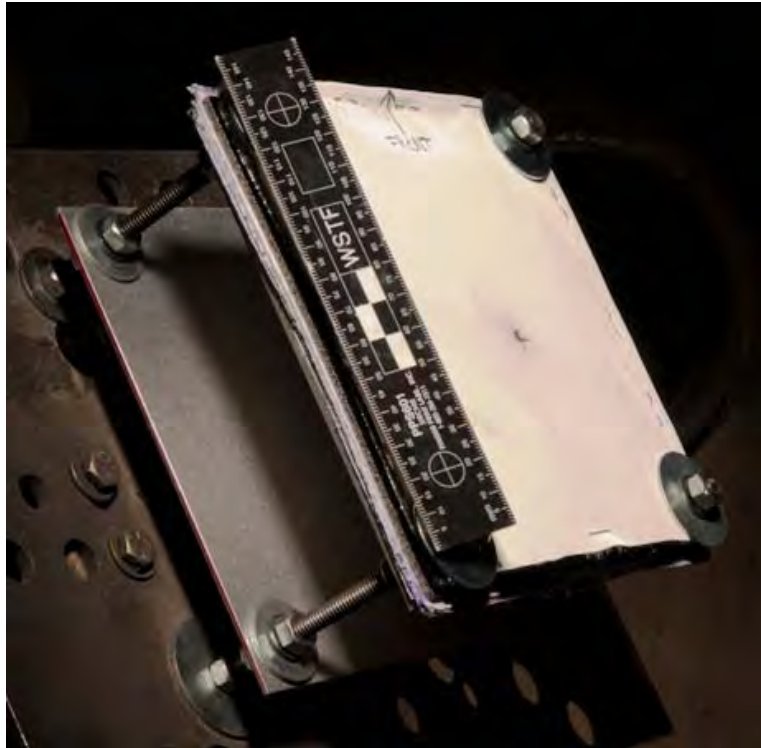
Figure 452 Overall View of Sample in the Target Tank (post-test)

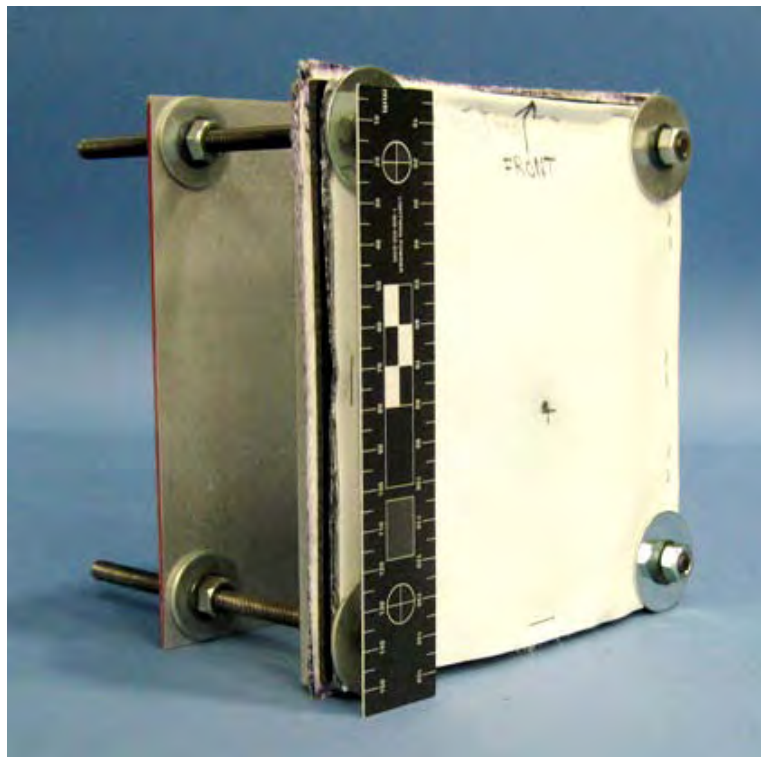
Figure 453 Overall Front Oblique View of Sample (scale in 5mm increments)

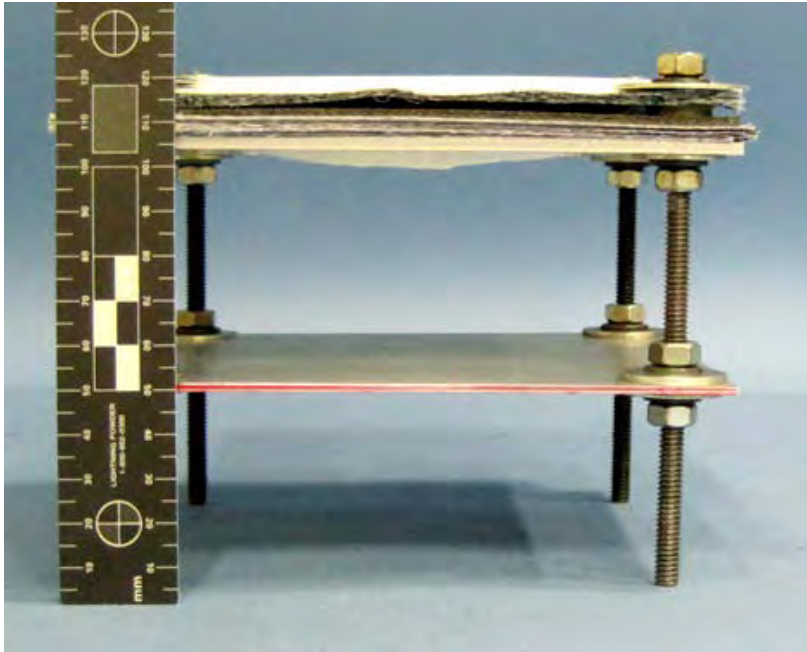
Figure 454 Overall Side View of Sample (scale in 5mm increments)

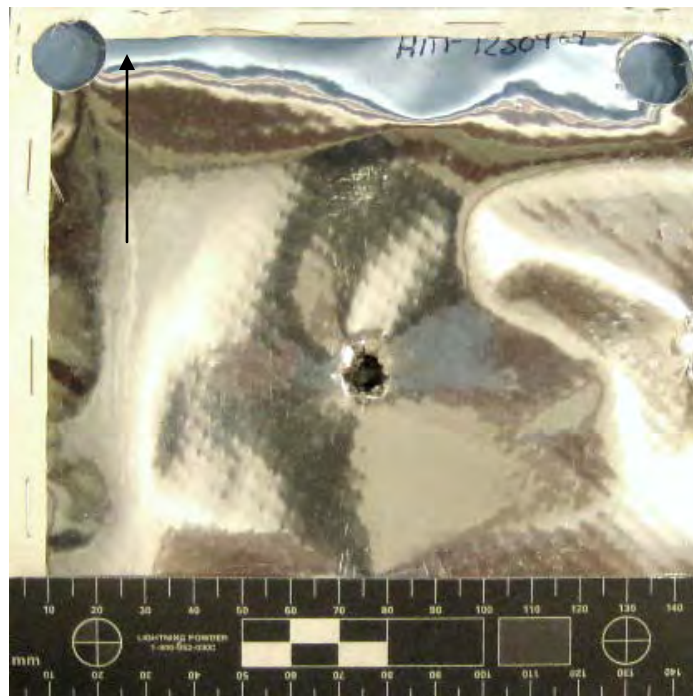
Figure 457 Overall View of Damage to Back Side of MLI (scale in 5mm increments / black arrow indicates flight path of projectile)

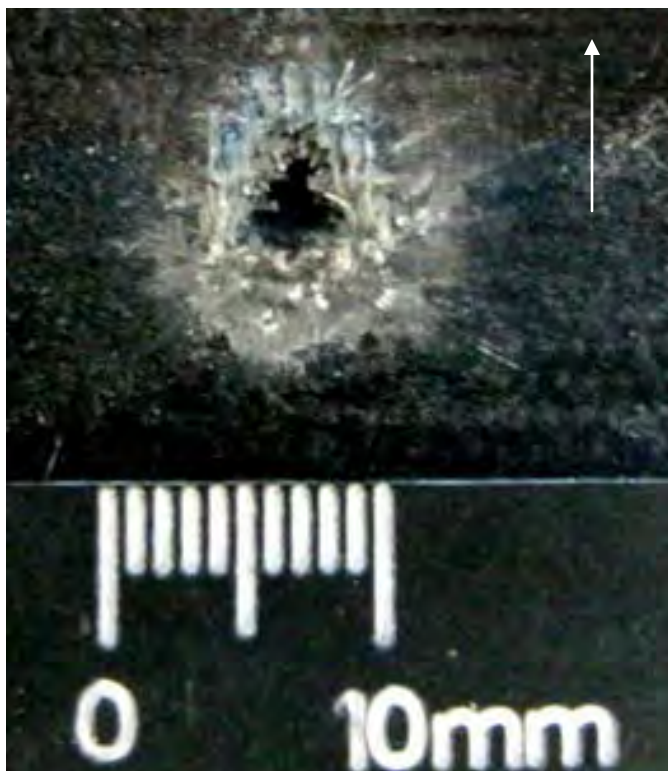
Figure 460 Close-up View of Damage to Front of NP 504 Substrate (scale in 1mm increments / white arrow indicates flight path of projectile)

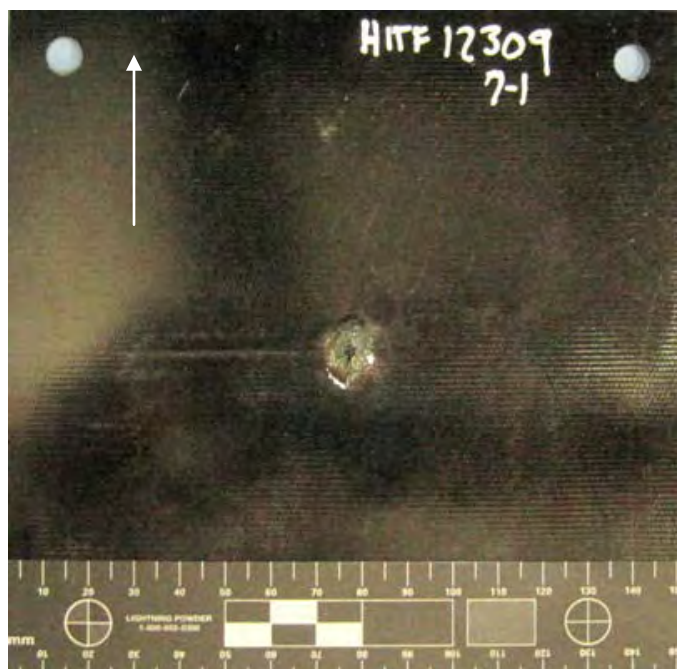
Figure 461 Overall View of Damage to Back Side of NP 504 Substrate (scale in 5mm increments / white arrow indicates flight path of projectile)

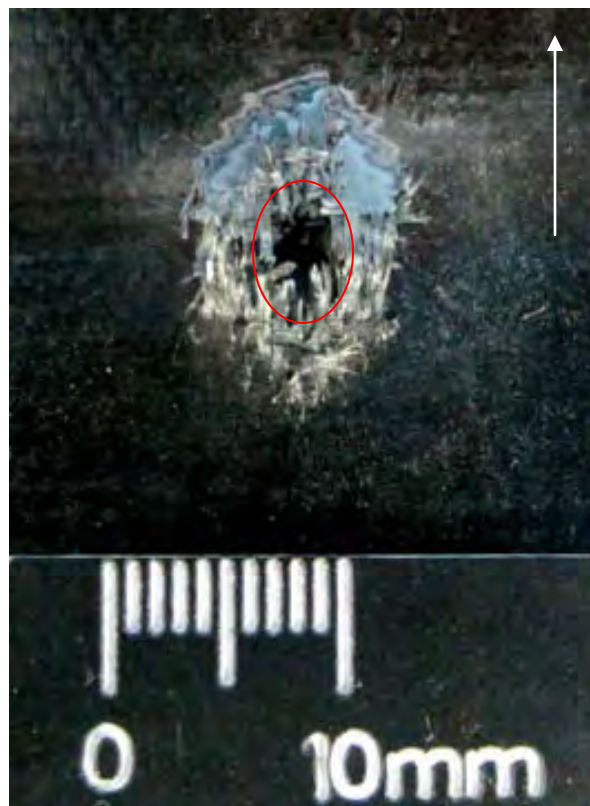
Figure 462 Close-up View of Damage to Back Side of NP 504 Substrate (scale in 1mm increments / white arrow indicates flight path of projectile)

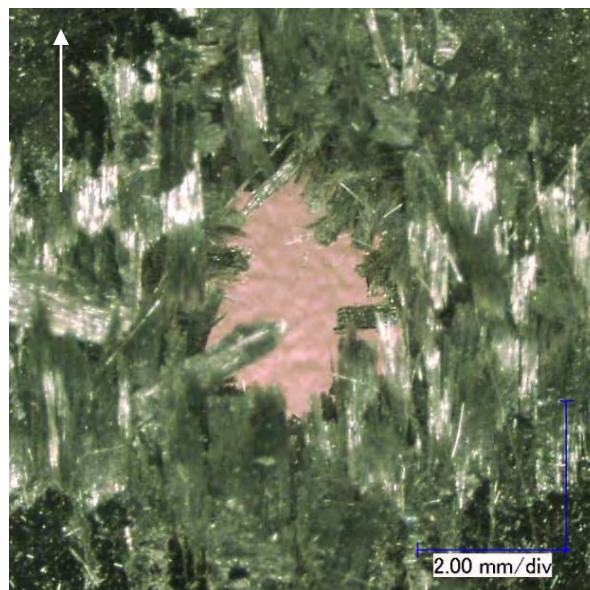
Figure 463 Close-up View of Most Significant Damage to Back Side of NP 504 Substrate (white arrow indicates flight path of projectile / damage within red circle in Figure 462)

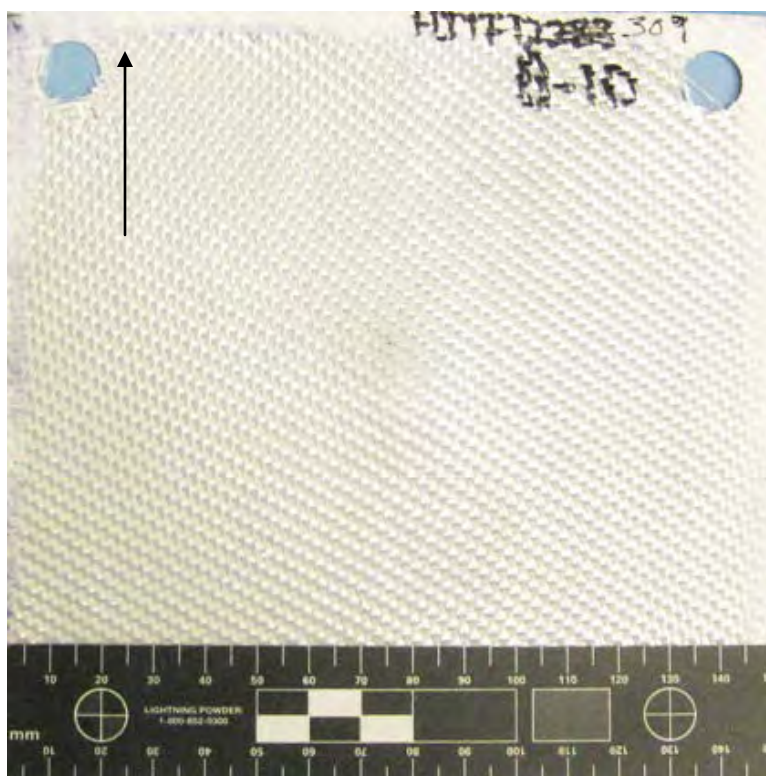
Figure 465 Overall View of Damage to Back Side of 10th Fiberglass Layer (scale in 5mm increments / black arrow indicates flight path of projectile)

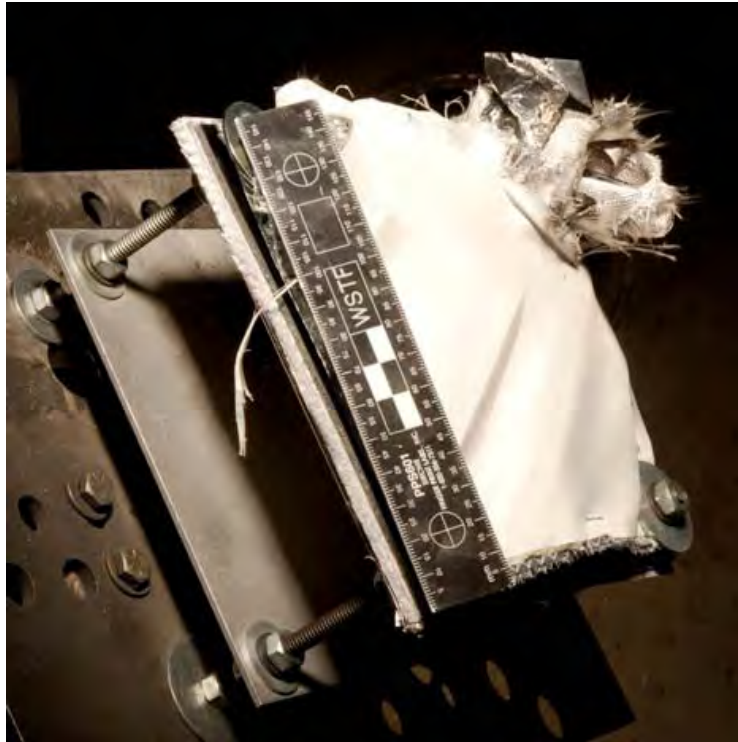
Figure 467 Overall View of Sample in the Target Tank (post-test)

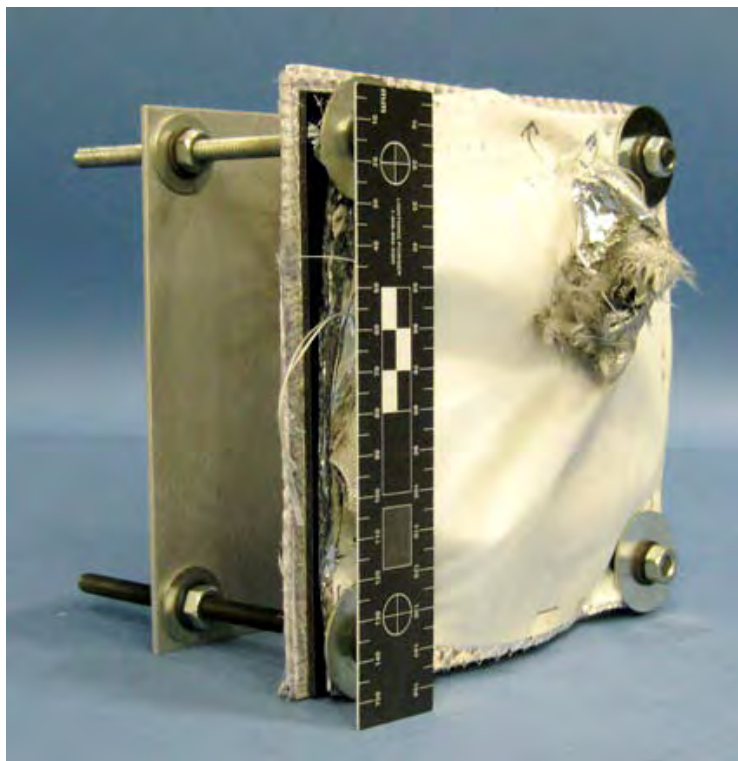
Figure 468 Overall Front Oblique View of Sample (scale in 5mm increments)

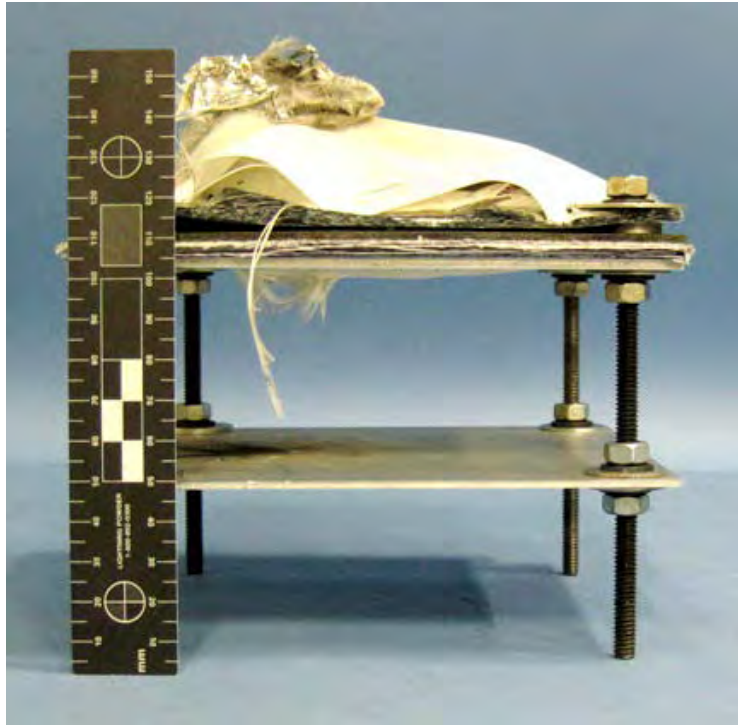
Figure 469 Overall Side View of Sample (scale in 5mm increments)

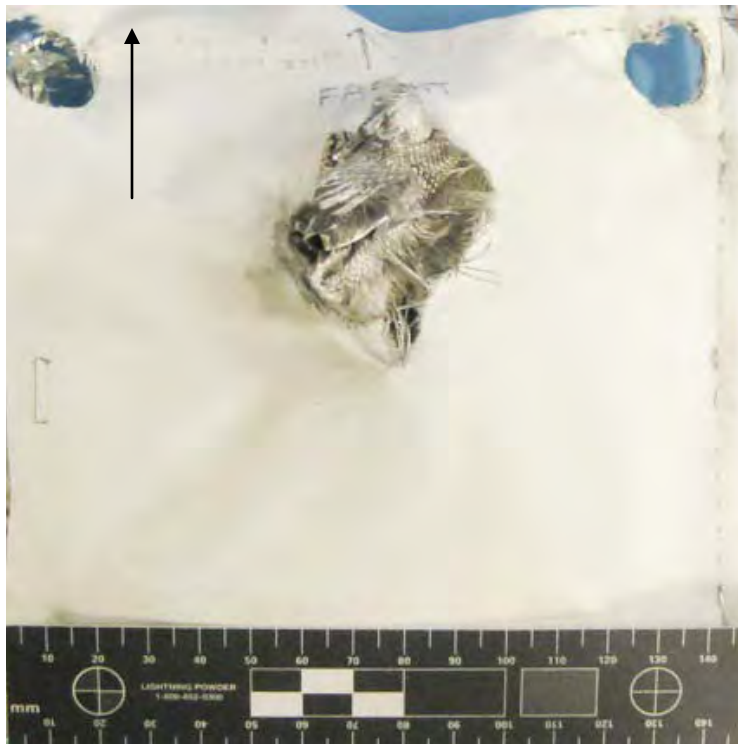
Figure 470 Overall View of Damage to Front of MLI (scale in 5mm increments / black arrow indicates flight path of projectile)

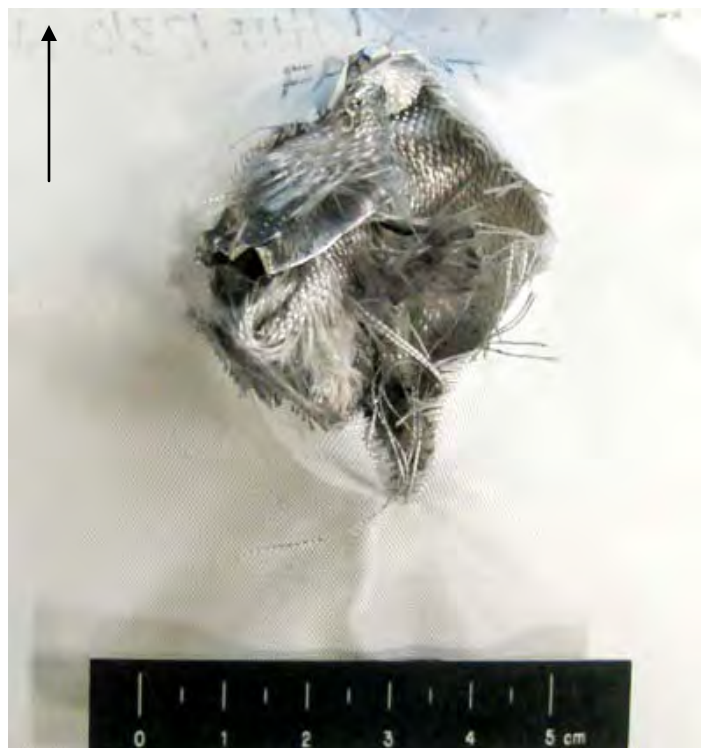
Figure 471 Close-up View of Damage to Front of MLI (scale in 5mm increments / black arrow indicates flight path of projectile)

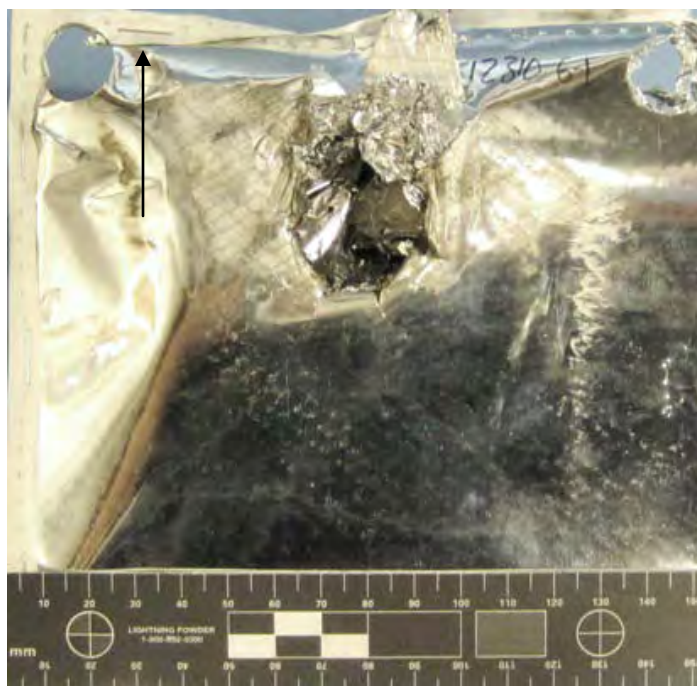
Figure 472 Overall View of Damage to Back Side of MLI (scale in 5mm increments / black arrow indicates flight path of projectile)
