International Space Station (ISS) Soyuz Vehicle Descent Module Evaluation of Thermal Protection System (TPS) Penetration Characteristics

Hypervelocity Impact Technology Group

February 2013

**International Space Station (ISS) Soyuz Vehicle
Descent Module Evaluation of Thermal Protection
System (TPS) Penetration Characteristics**

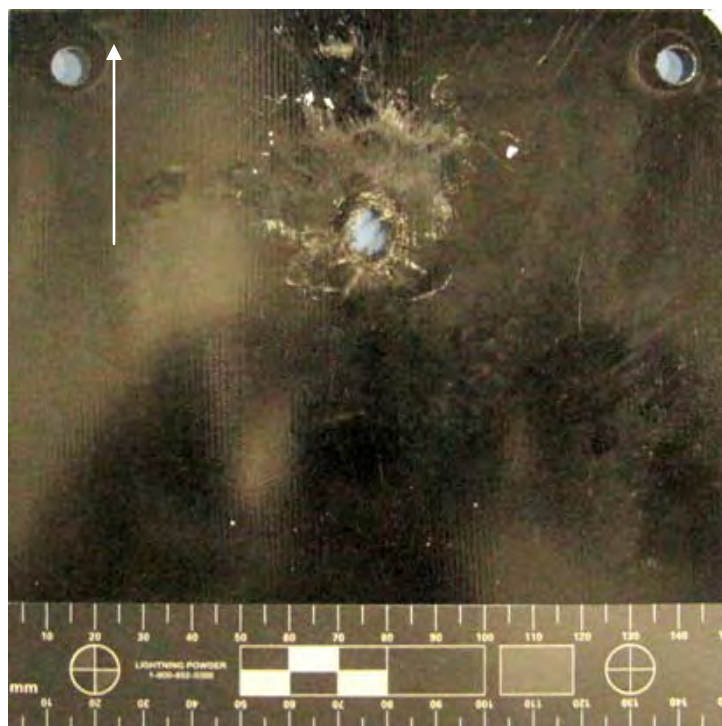
Figure 474 Overall View of Damage to Front of NP 504 Substrate (scale in 5mm increments / white arrow indicates flight path of projectile)

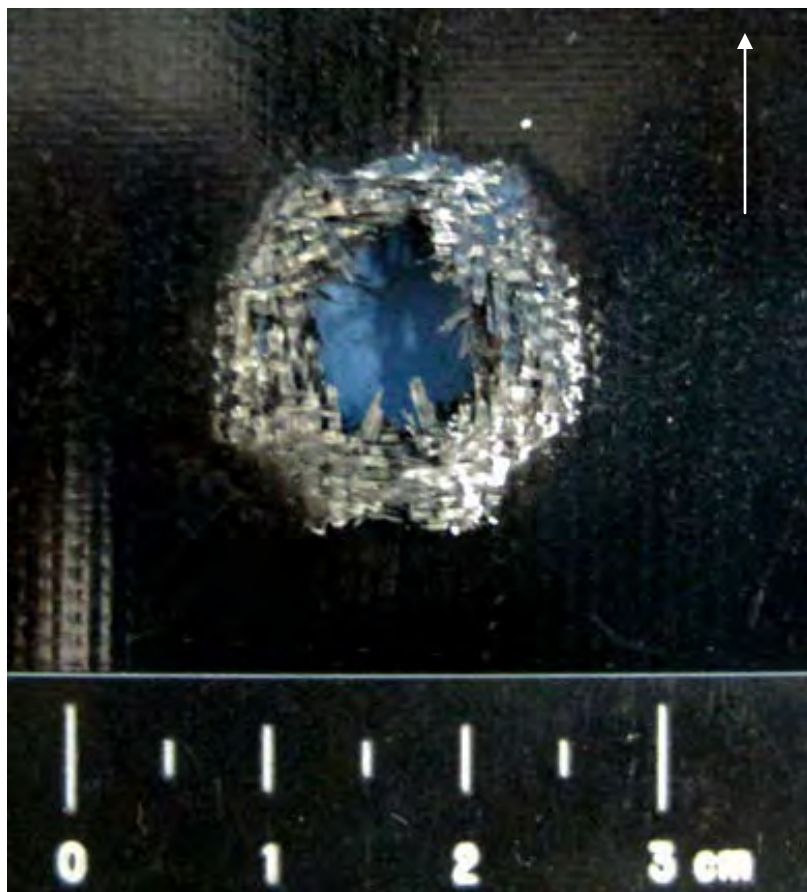
Figure 477 Close-up View of Damage to Back Side of NP 504 Substrate (scale in 5mm increments / white arrow indicates flight path of projectile)

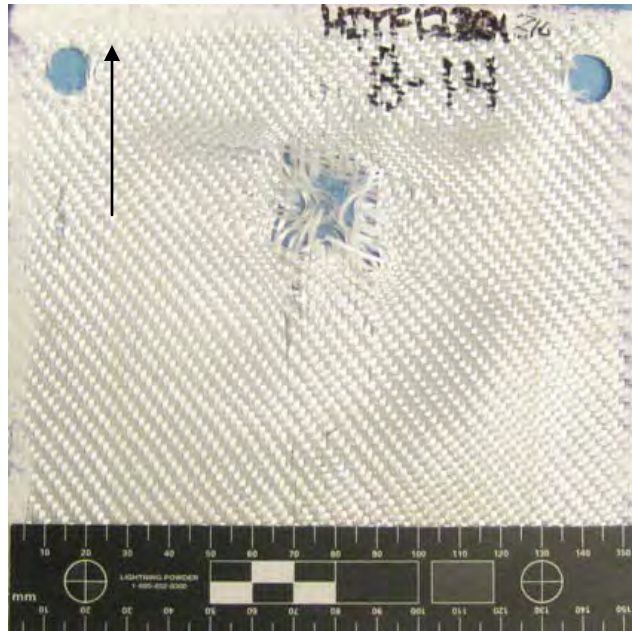
Figure 479 Overall View of Damage to Back Side of Last Fiberglass Layer (scale in 5mm increments / black arrow indicates flight path of projectile)

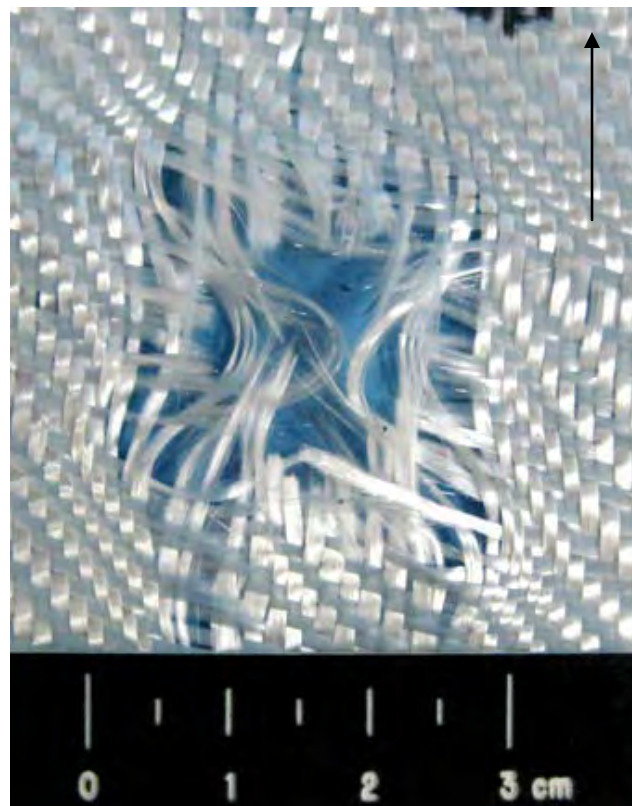
Figure 480 Overall View of Damage to Back Side of Last Fiberglass Layer (scale in 5mm increments / black arrow indicates flight path of projectile)

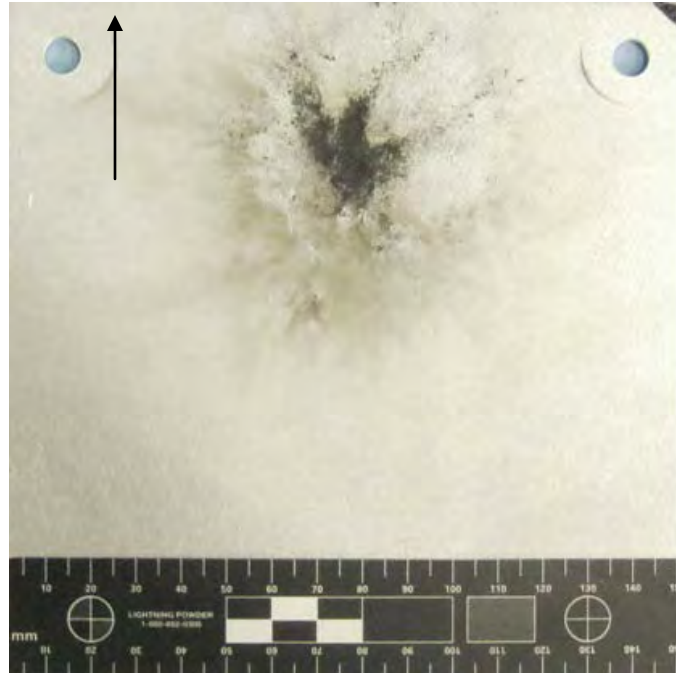
Figure 481 Overall View of Damage to Front of Rear Wall (scale in 5mm increments / black arrow indicates flight path of projectile)

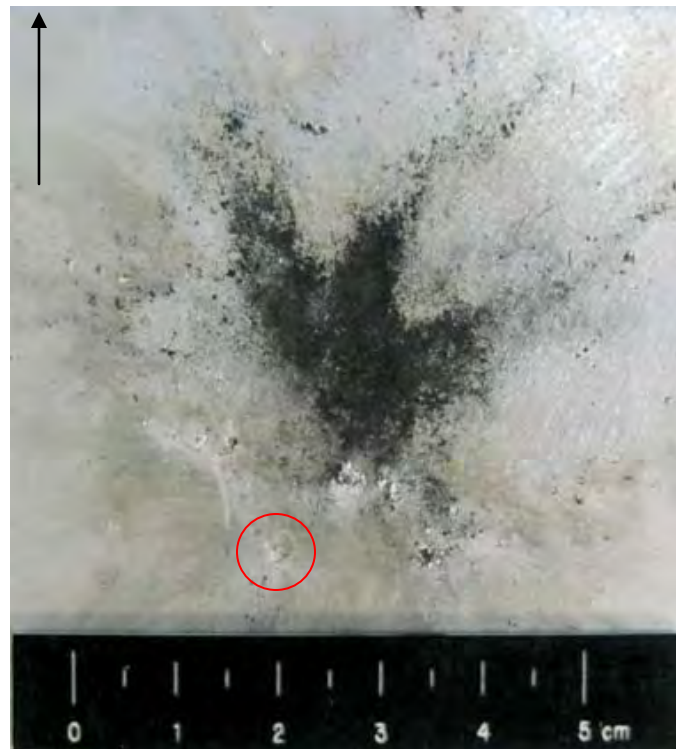
Figure 482 Close-up View of Damage to Front of Rear Wall (scale in 5mm increments / black arrow indicates flight path of projectile)

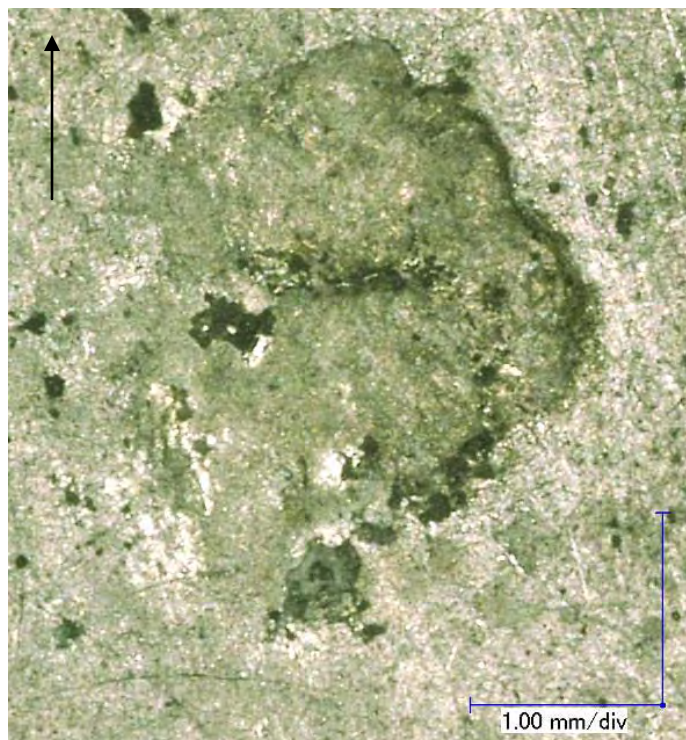
Figure 483 Close-up View of Most Significant Damage to Front of Rear Wall (black arrow indicates flight path of projectile / damage within red circle in Figure 482)

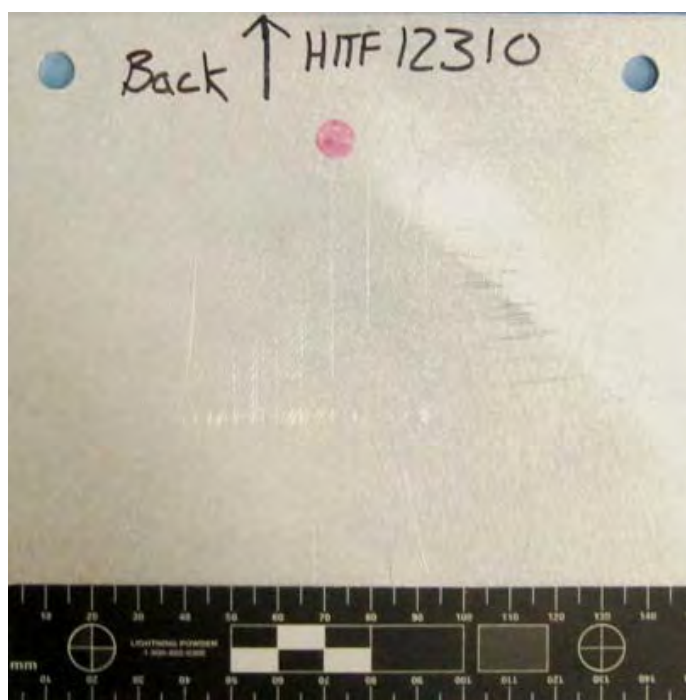
Figure 484 Overall View of Back Side of Rear Wall (scale in 5mm increments / black arrow indicates flight path of projectile)

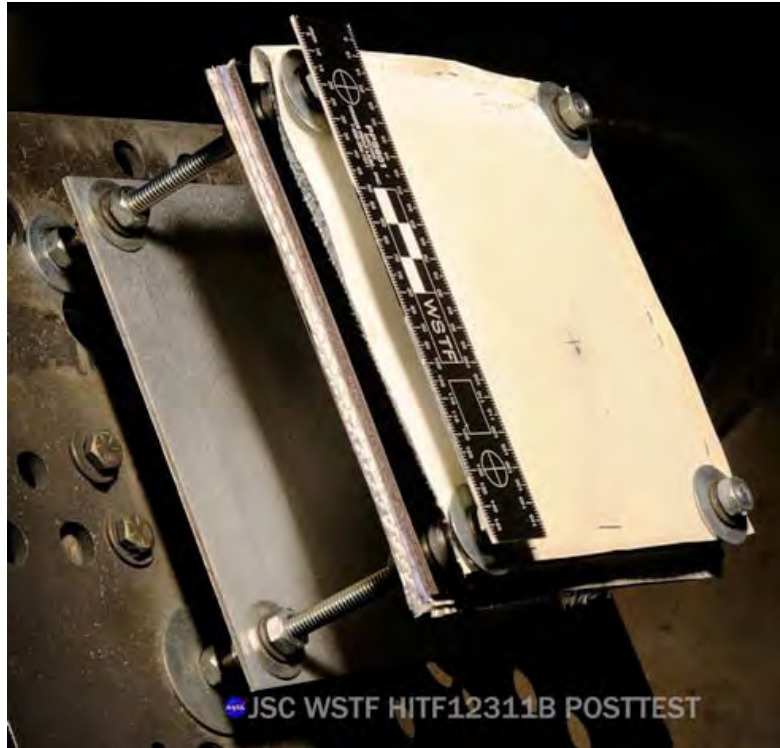
Figure 486 Overall View of Sample in the Target Tank (post-test)

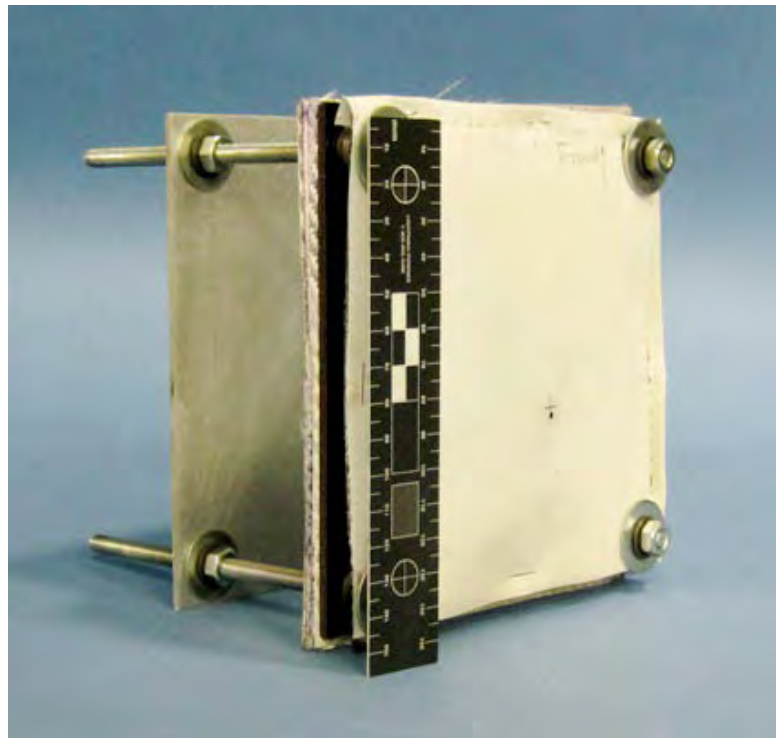
Figure 487 Overall Front Oblique View of Sample (scale in 5mm increments)

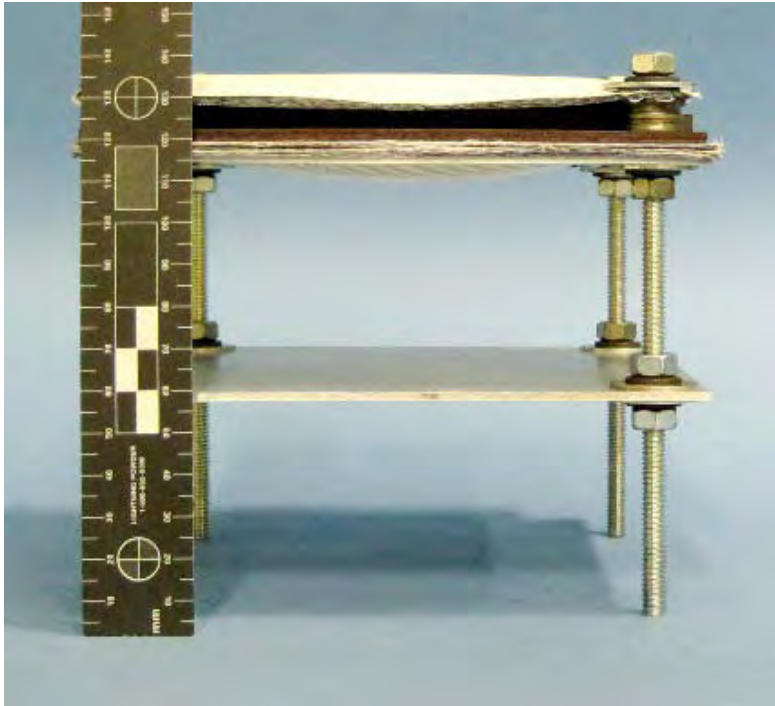
Figure 488 Overall Side View of Sample (scale in 5mm increments)

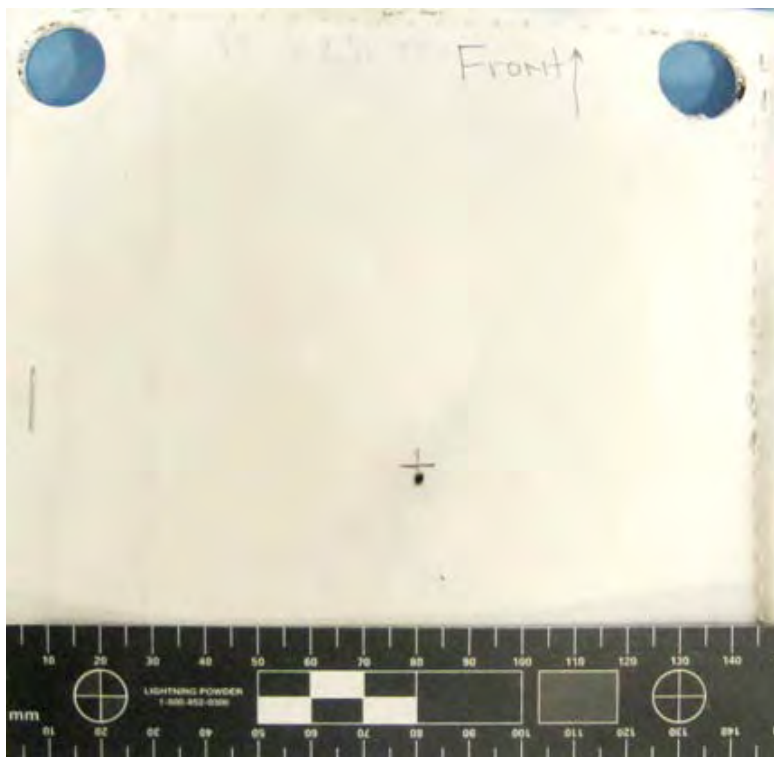
Figure 489 Overall View of Damage to Front of MLI (black arrow indicates flight path of projectile / scale in 5mm increments)

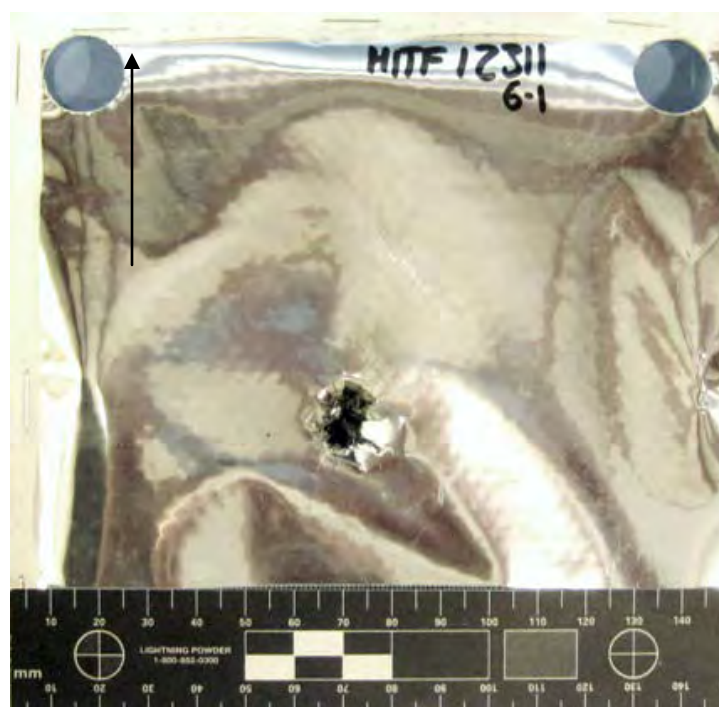
Figure 491 Overall View of Damage to Back Side of MLI (scale in 5mm increments / black arrow indicates flight path of projectile)

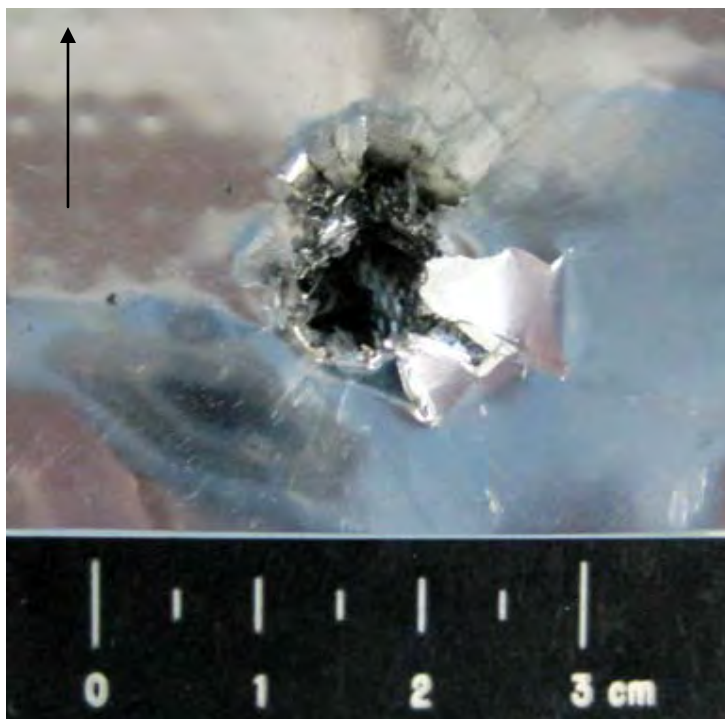
Figure 492 Close-up View of Damage to Back Side of MLI (scale in 5mm increments / black arrow indicates flight path of projectile)

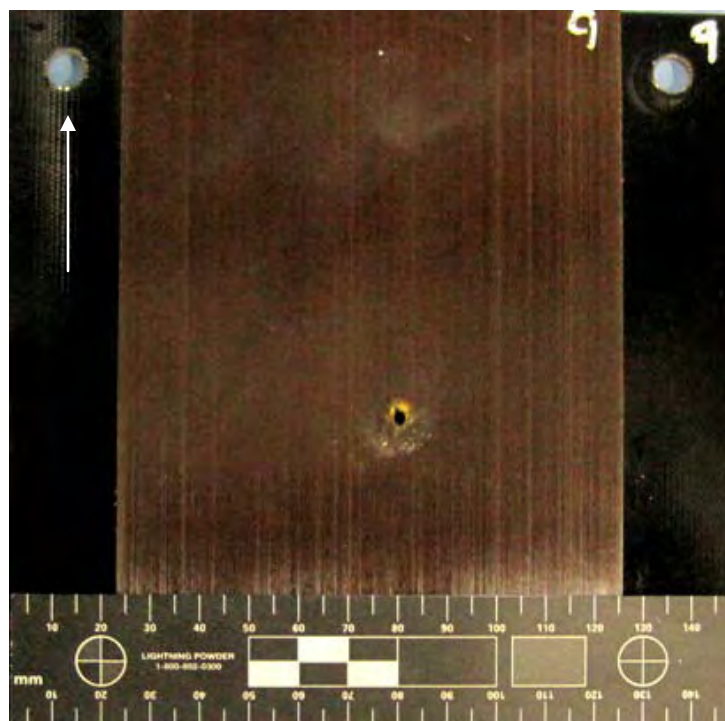
Figure 493 Overall View of Damage to Front of TORLON 5030 (scale in 5mm increments / white arrow indicates flight path of projectile)

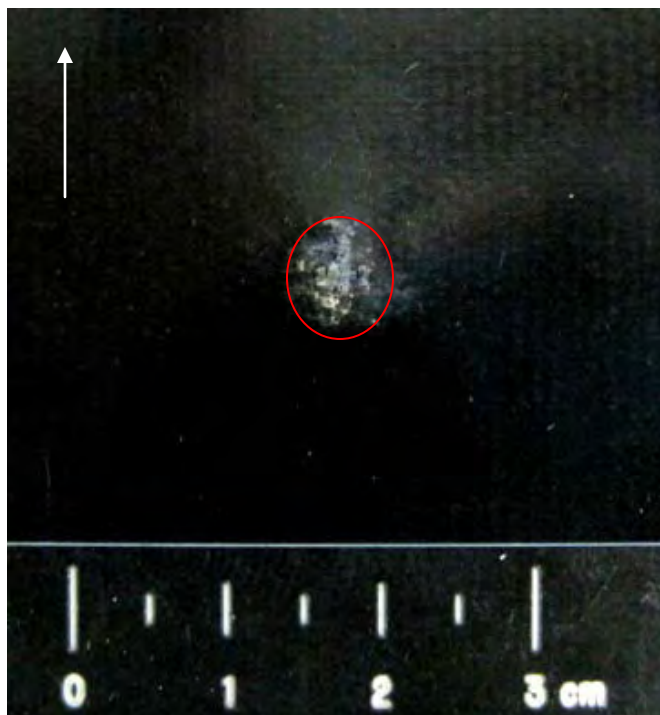
Figure 496 Close-up View of Damage to Back Side of NP 504 Substrate (scale in 5mm increments / white arrow indicates flight path of projectile)

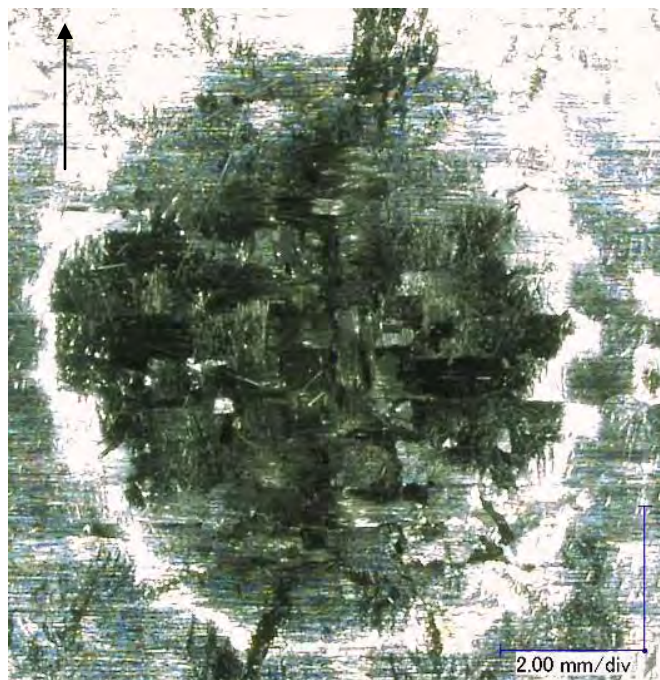
Figure 497 Close-up View of Most Significant Damage to Back Side of NP 504 Substrate (black arrow indicates flight path of projectile / damage within red circle in Figure 496)

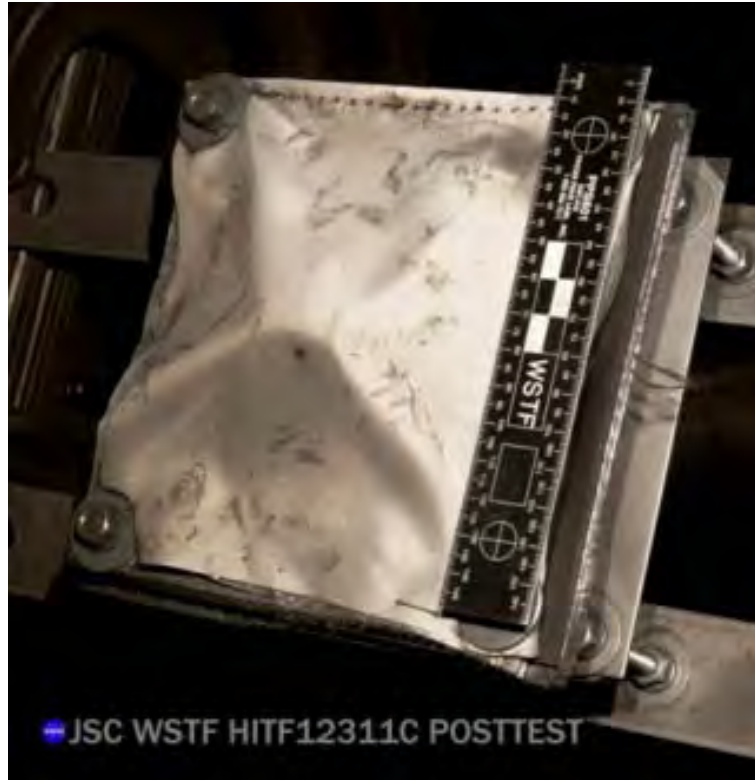
Figure 501 Overall View of Sample in the Target Tank (post-test)

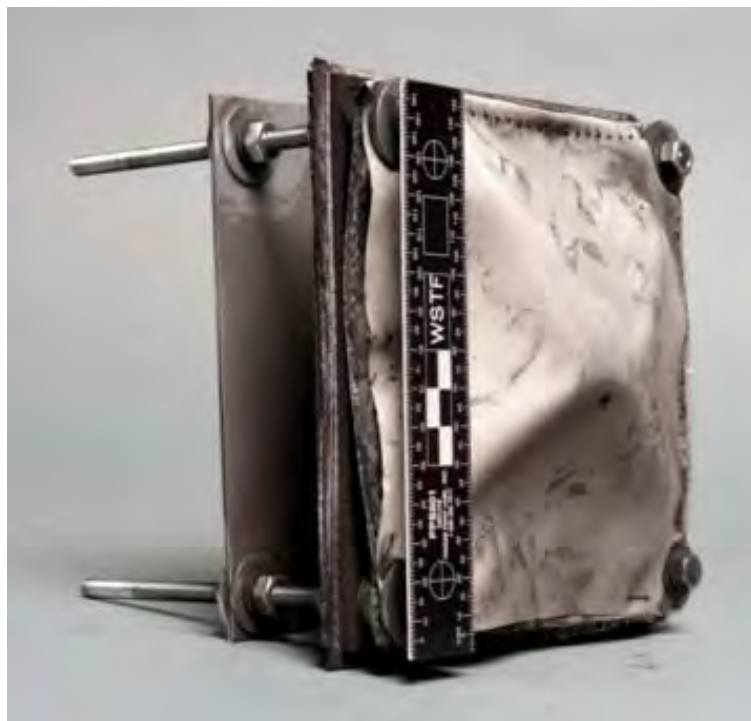
Figure 502 Overall Front Oblique View of Sample (scale in 5mm increments)

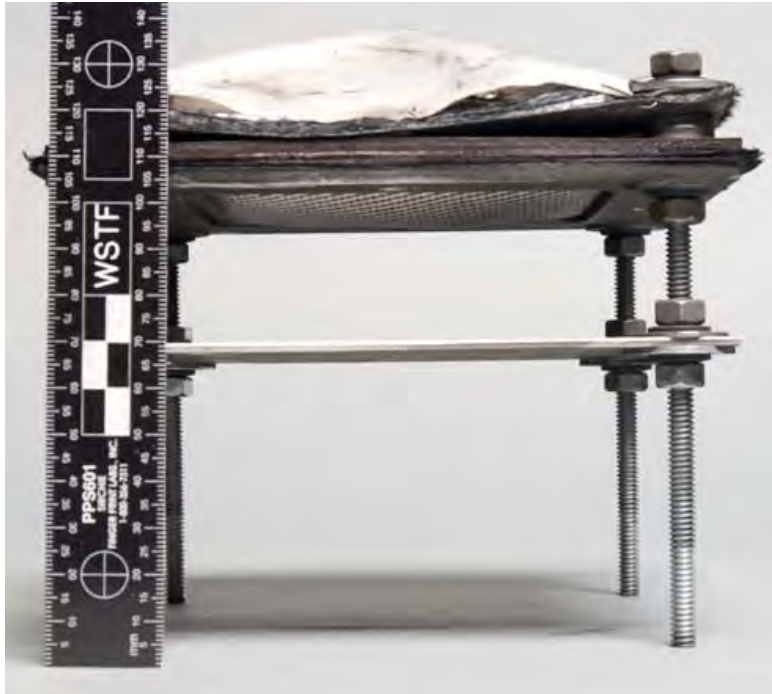
**Figure 503** Overall Side View of Sample (scale in 5mm increments)

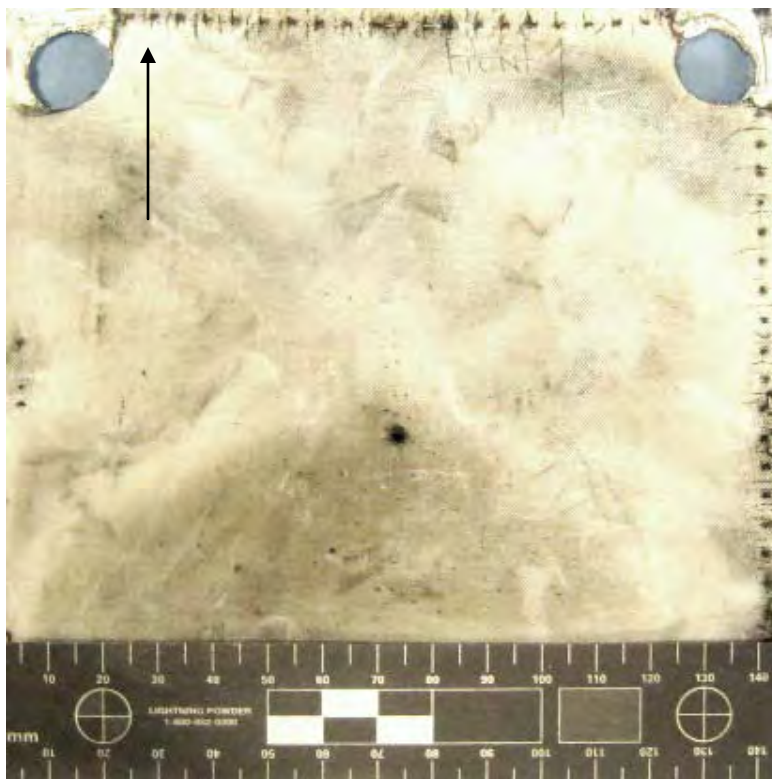
**Figure 504** Overall View of Damage to Front of MLI (black arrow indicates flight path of projectile / scale in 5mm increments)

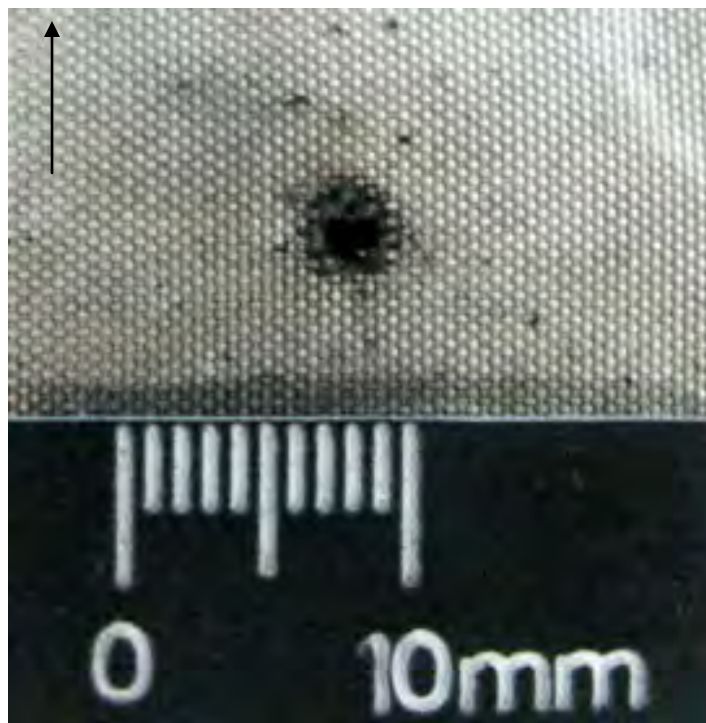
Figure 505 Close-up View of Damage to Front of MLI (scale in 1mm increments / black arrow indicates flight path of projectile)

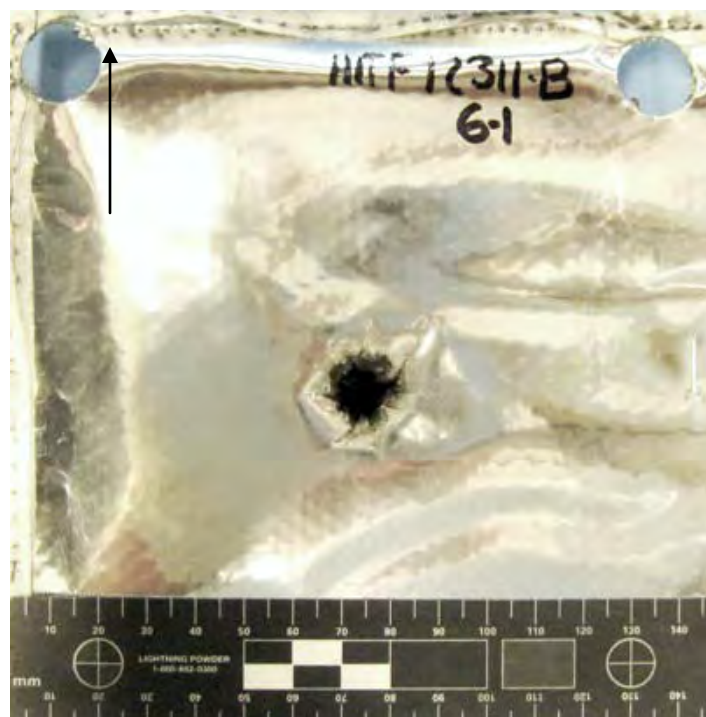
Figure 506 Overall View of Damage to Back Side of MLI (scale in 5mm increments / black arrow indicates flight path of projectile)

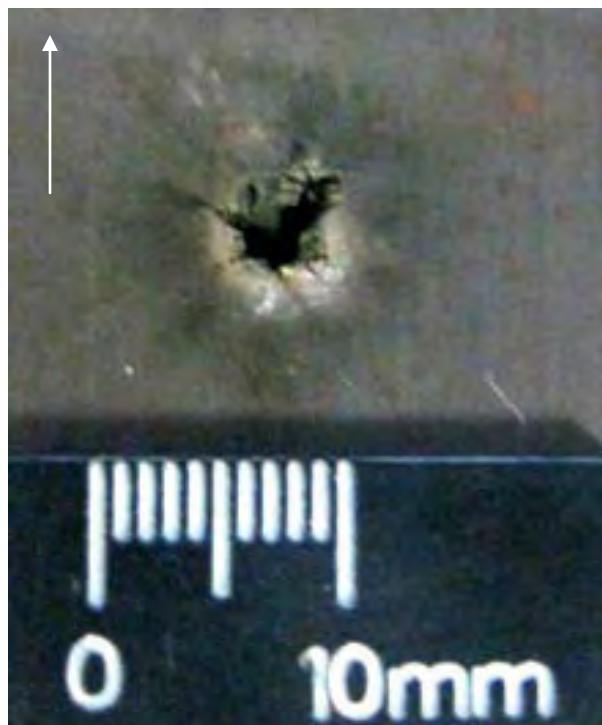
Figure 511 Close-up View of Exit Damage to TORLON 503 (scale in 1mm increments / white arrow indicates flight path of projectile)

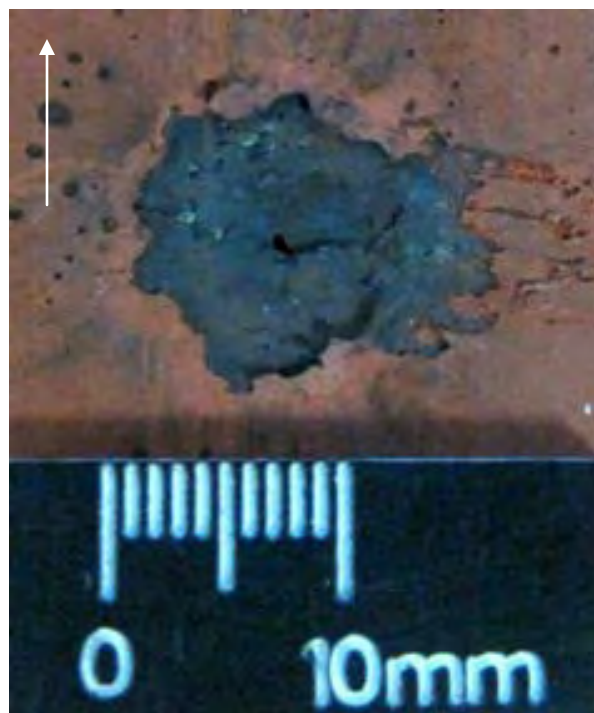
Figure 512 Close-up View of Entry Damage to NP 504 Substrate (scale in 1mm increments / white arrow indicates flight path of projectile)

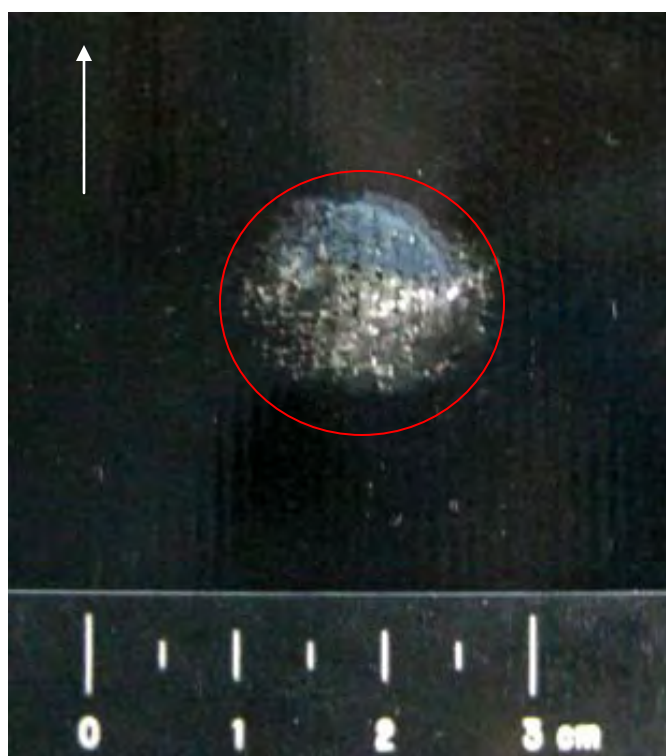
Figure 514 Close-up View of Damage to Back Side of NP 504 Substrate (scale in 5mm increments / white arrow indicates flight path of projectile)

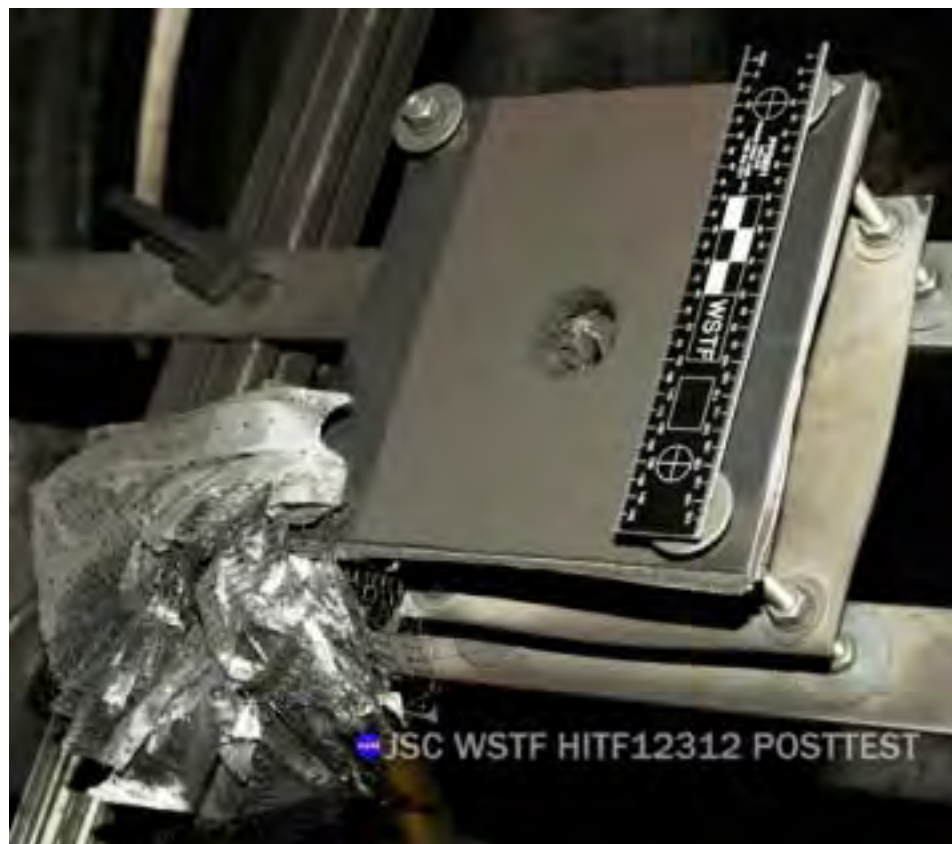
Figure 519 Overall View of Sample in the Target Tank (post-test)

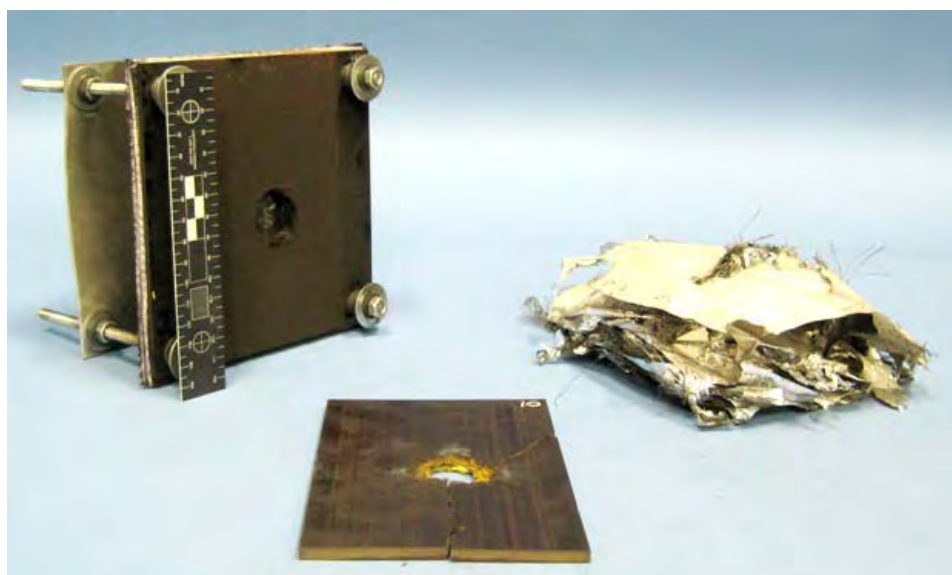
Figure 520 Overall View of TORLON 5030 Delaminated from NP 504 Substrate and MLI Blanket Displaced from Test Configuration All Bi-products of the Impact Test (scale in 5mm increments)

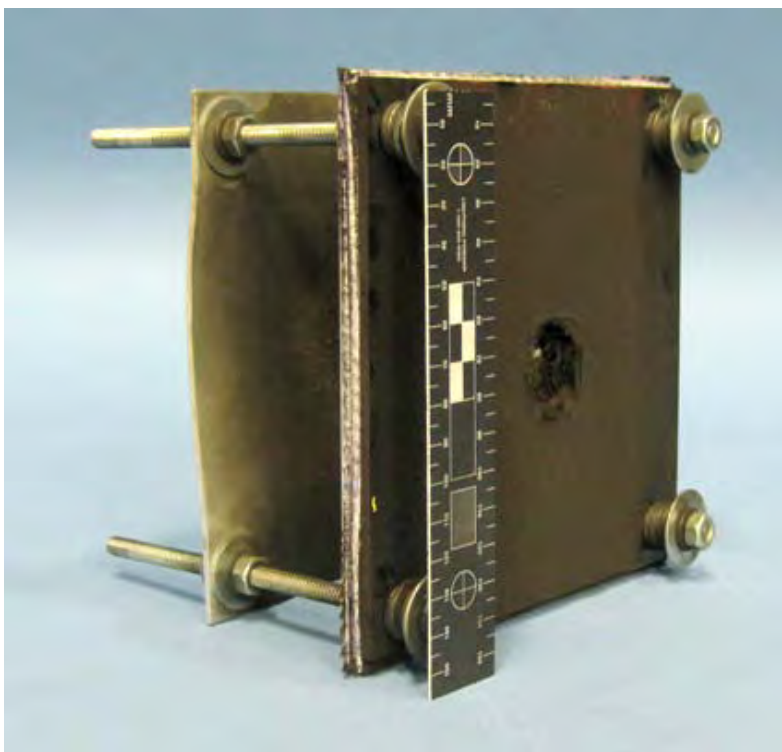
Figure 521 Overall Oblique Front View of Sample (scale in 5mm increments / with TORLON 5030 and MLI displaced from test configuration)

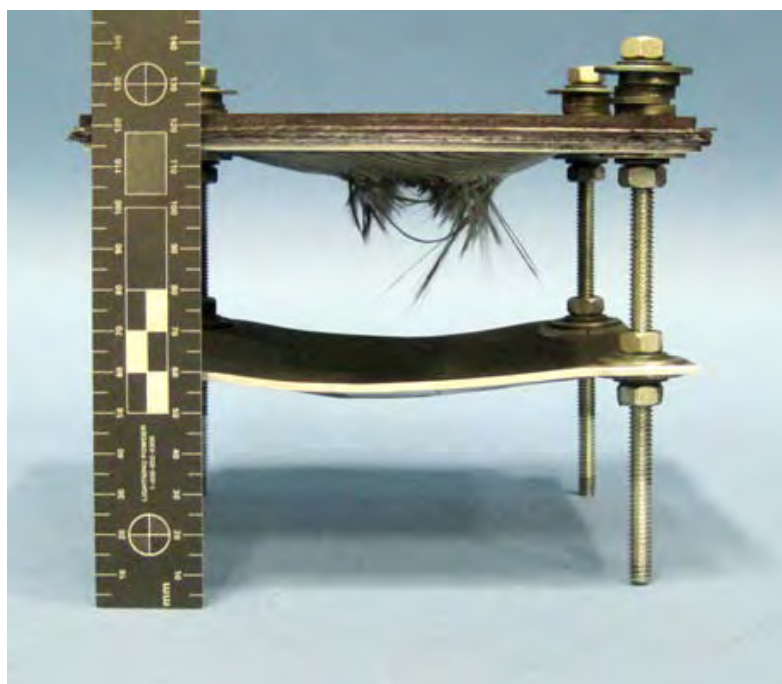
Figure 522 Overall Side View of Sample (scale in 5mm increments / with TORLON 5030 and MLI displaced from test configuration)

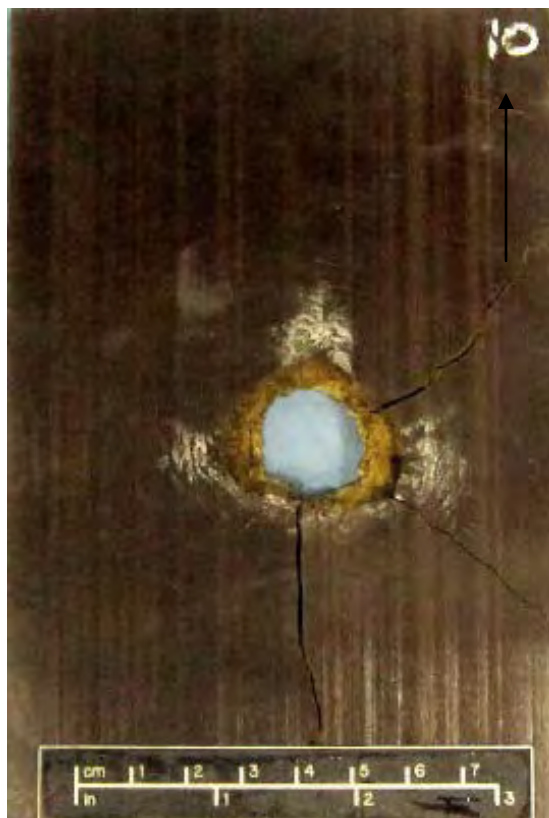
Figure 523 Overall View of Damage to Front of TORLON 5030 Delaminated from Substrate
(black arrow indicates flight path of projectile / scale in 1cm increments)

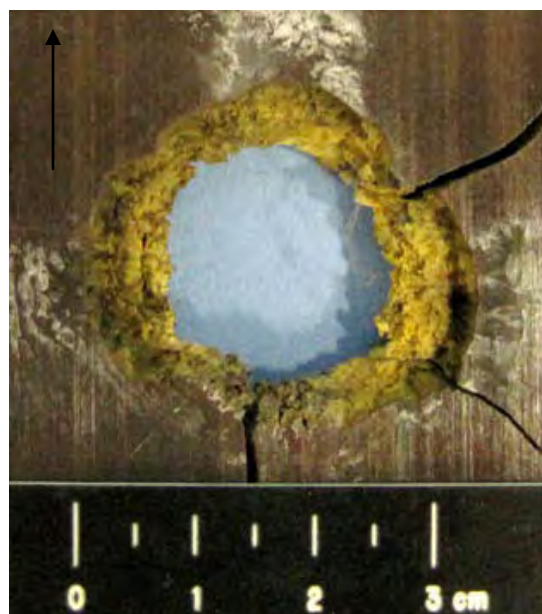
Figure 524 Overall View of Damage to Front of TORLON 5030 Delaminated from Substrate
(black arrow indicates flight path of projectile / scale in 5mm increments)

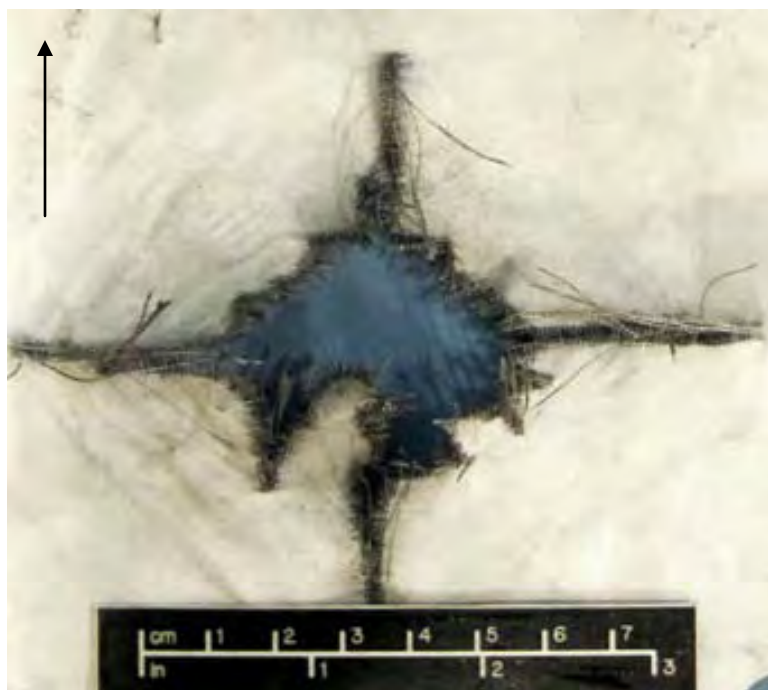
Figure 526 Close-up View of Entry Damage to Front of MLI (scale in 1cm increments / black arrow indicates flight path of projectile)

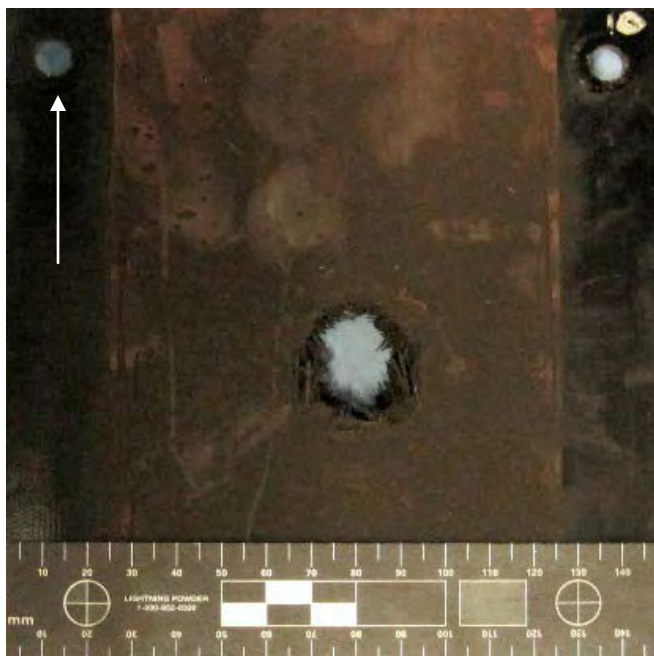
Figure 527 Overall View of Damage to Front NP 504 Substrate with TORLON 5030 Delaminated (scale in 5mm increments / white arrow indicates flight path of projectile)

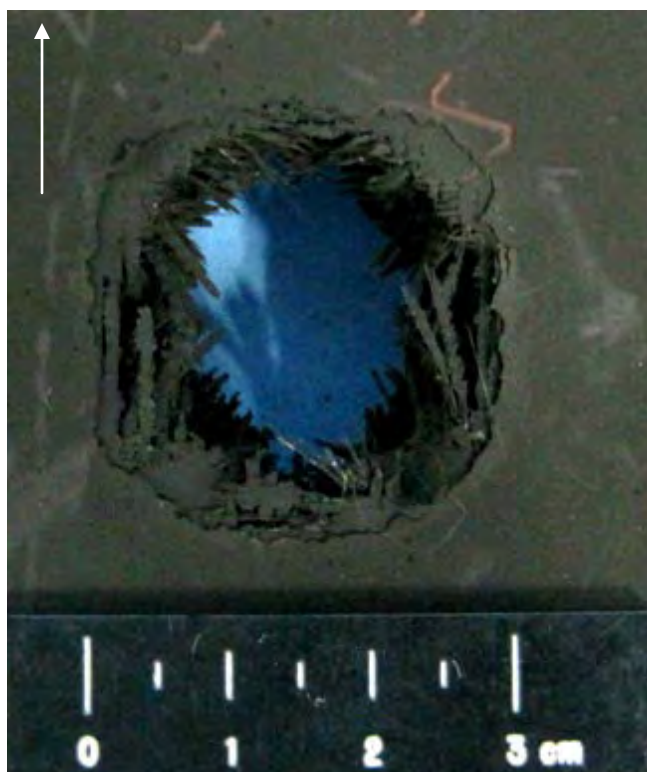
Figure 528 Close-up View of Damage to Front NP 504 Substrate with TORLON 5030 Delaminated (scale in 5mm increments / white arrow indicates flight path of projectile)

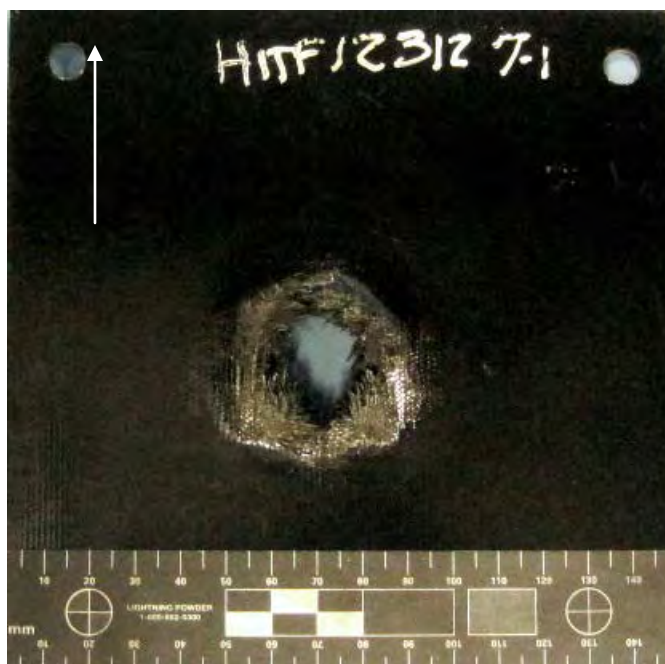
Figure 529 Overall View of Damage to Back Side of NP 504 Substrate (scale in 5mm increments / black arrow indicates flight path of projectile)

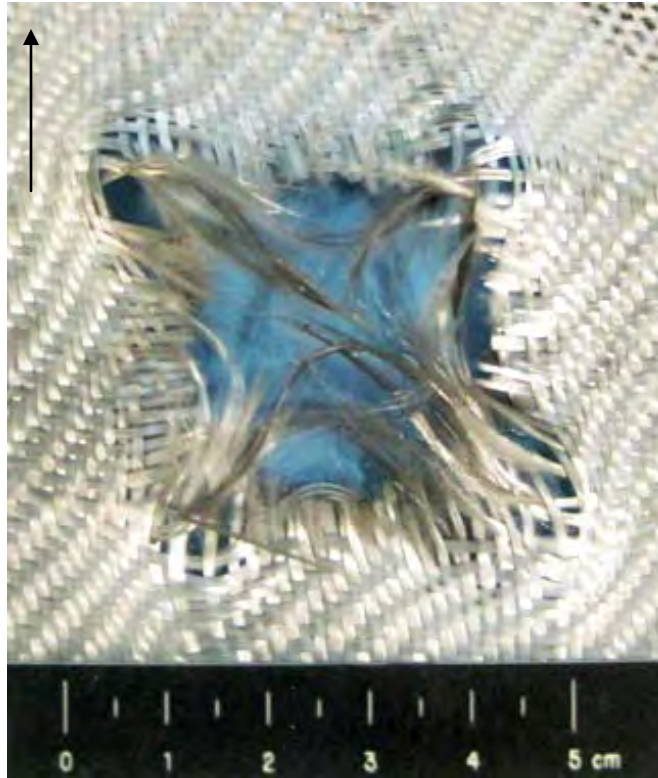
Figure 533 Close-up View of Damage to Back Side of Last Fiberglass Layer (scale in 5mm increments / black arrow indicates flight path of projectile)

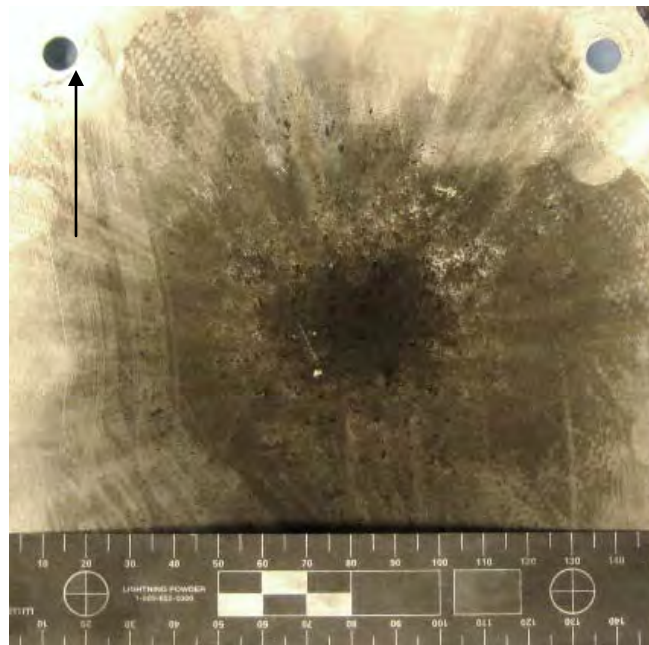
Figure 534 Overall View of Damage to Front of Rear Wall (scale in 5mm increments / black arrow indicates flight path of projectile / uncleaned)

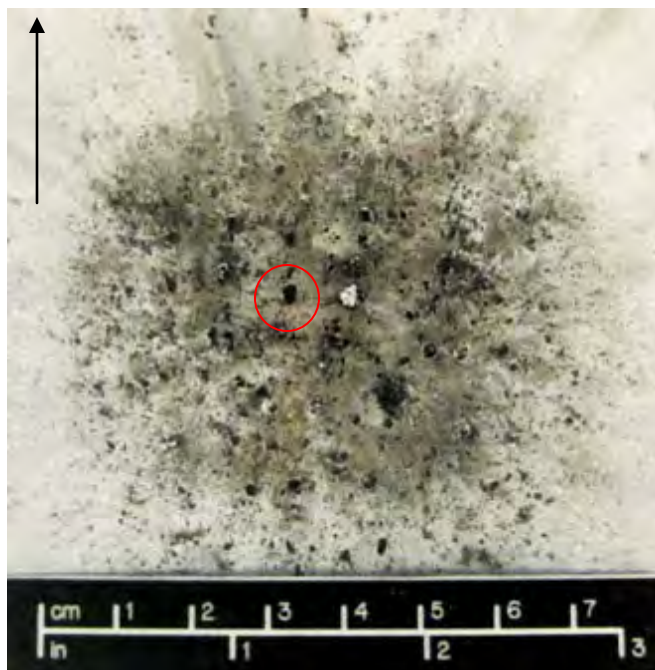
Figure 537 Close-up View of Damage to Front of Rear Wall (scale in 1cm increments / black arrow indicates flight path of projectile / cleaned)

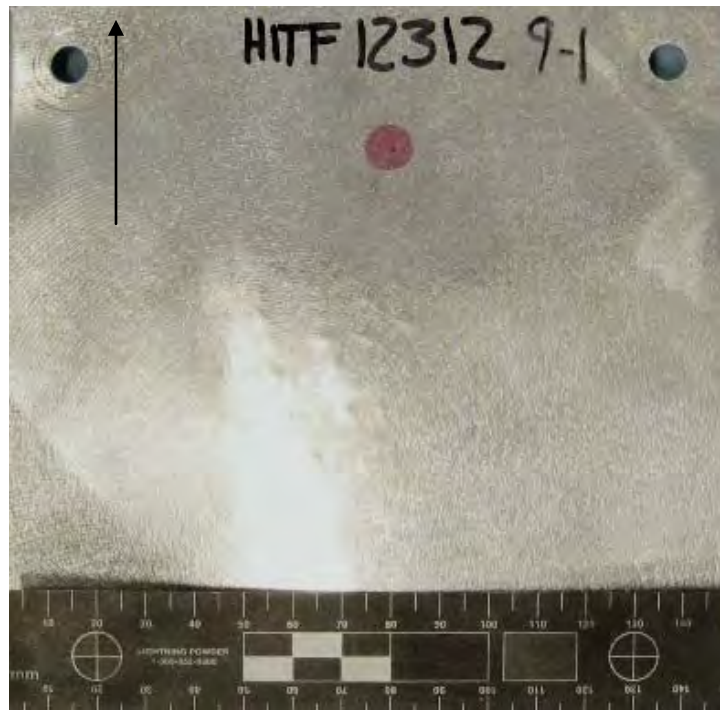
Figure 539 Overall View of Damage to Back Side of Rear Wall (scale in 5mm increments / black arrow indicates flight path of projectile)

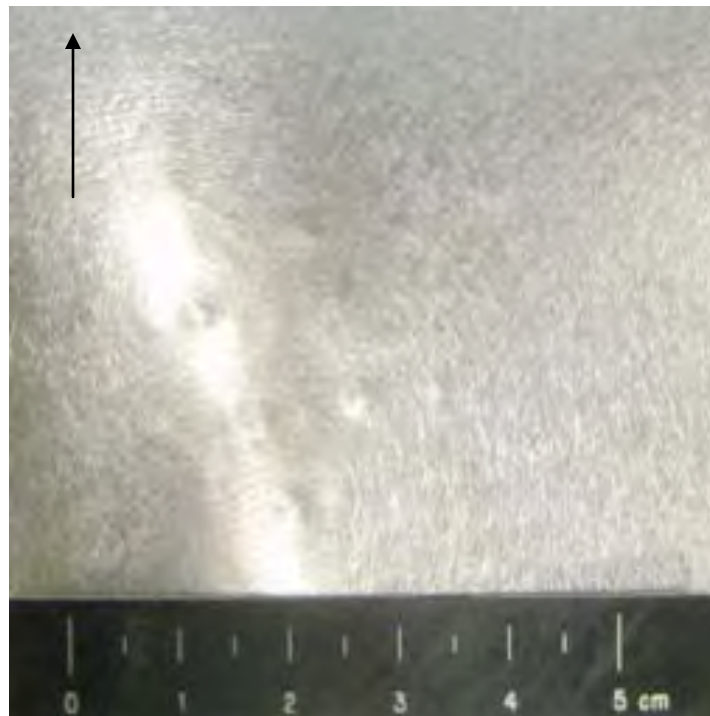
Figure 540 Close View of Damage to Back Side of Rear Wall (scale in 5mm increments / black arrow indicates flight path of projectile)
